HIE's Health and Safety record at Cairn Gorm

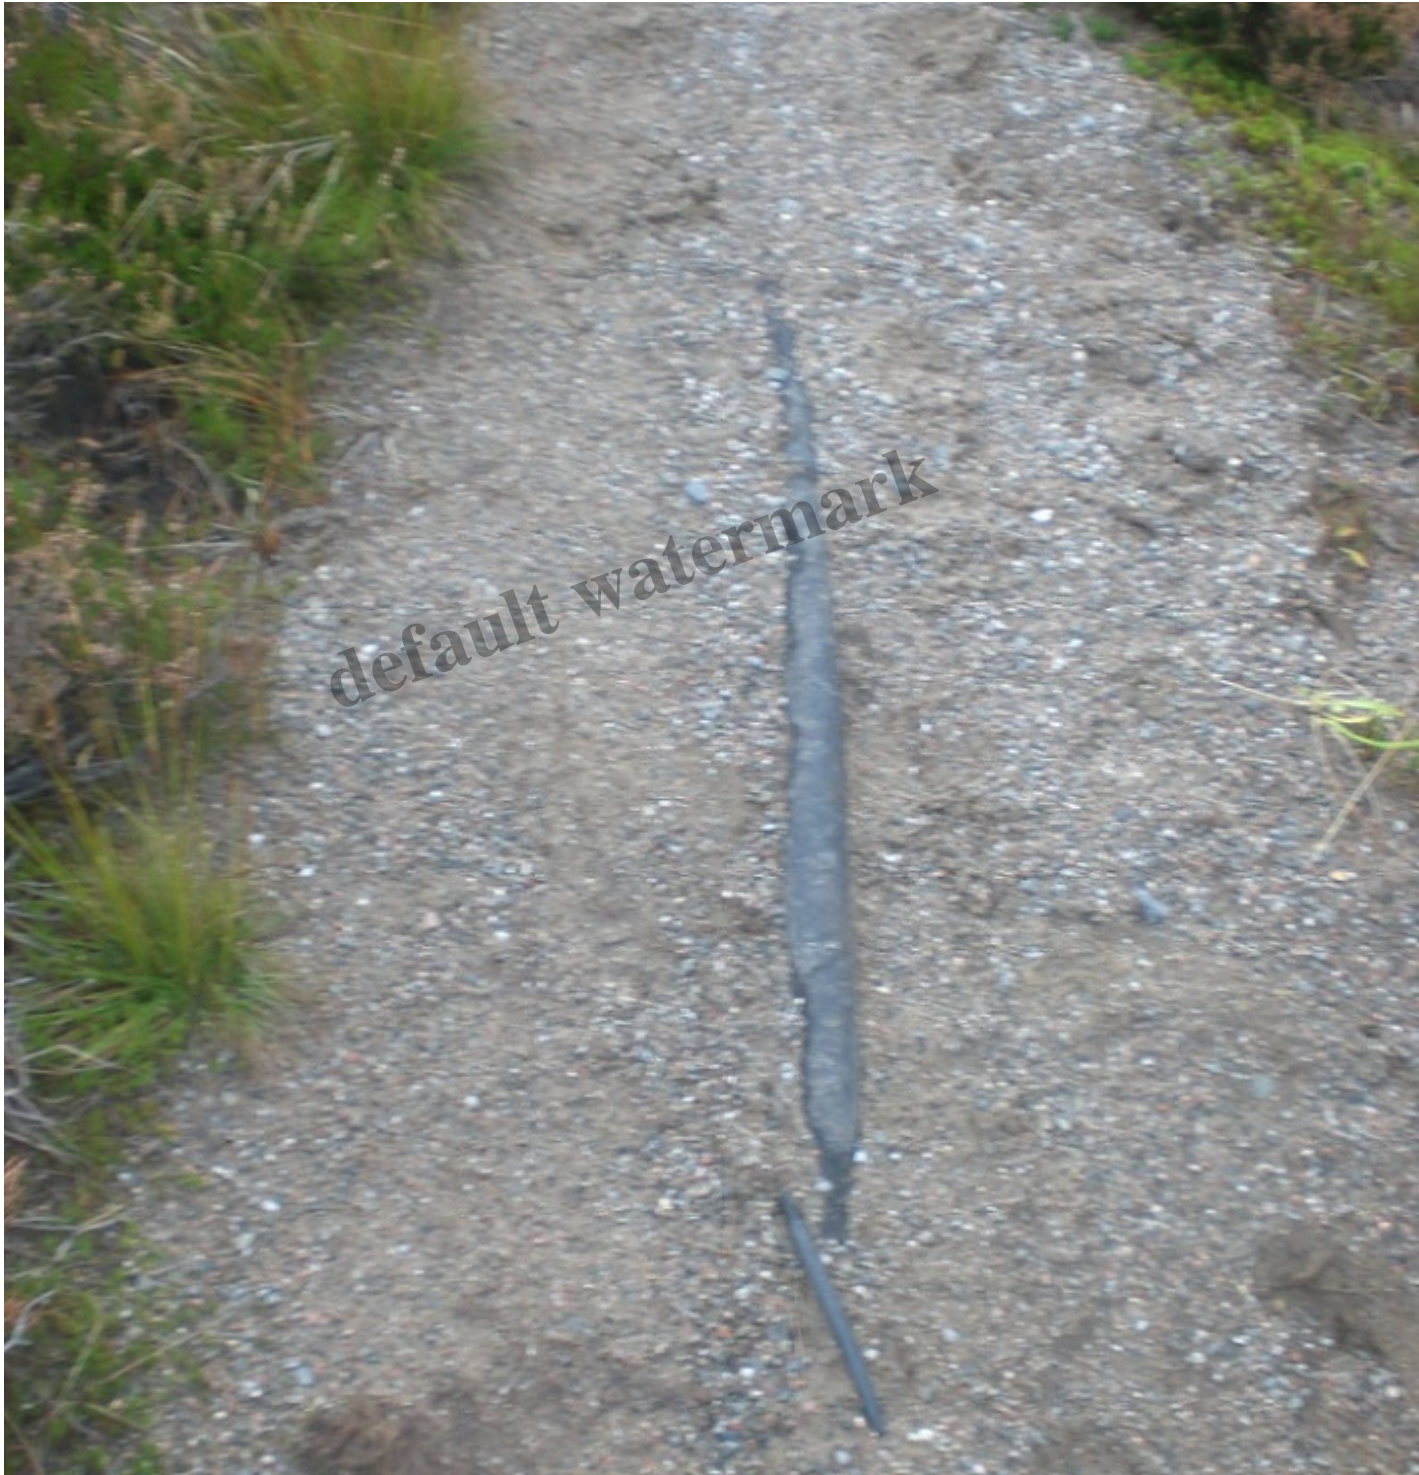
Exposed mains power cable in Coire na Ciste November 2020 – imagine someone walking along this path in crampons in winter

“I can confirm that SSEN has now attended site to make the cable safe and install further sand bagging. In addition, signage has been erected to make walkers and others aware of the cable location. To help explain, sand bagging and signage are a temporary measure to ensure public safety and protect the cable. Due to the terrain in the area and the elements certain sections are more vulnerable to exposure.

This situation will be rectified by a project currently in design to replace the existing cable. The on-site works are scheduled commence in the Spring, subject to obtaining all relevant consents.”

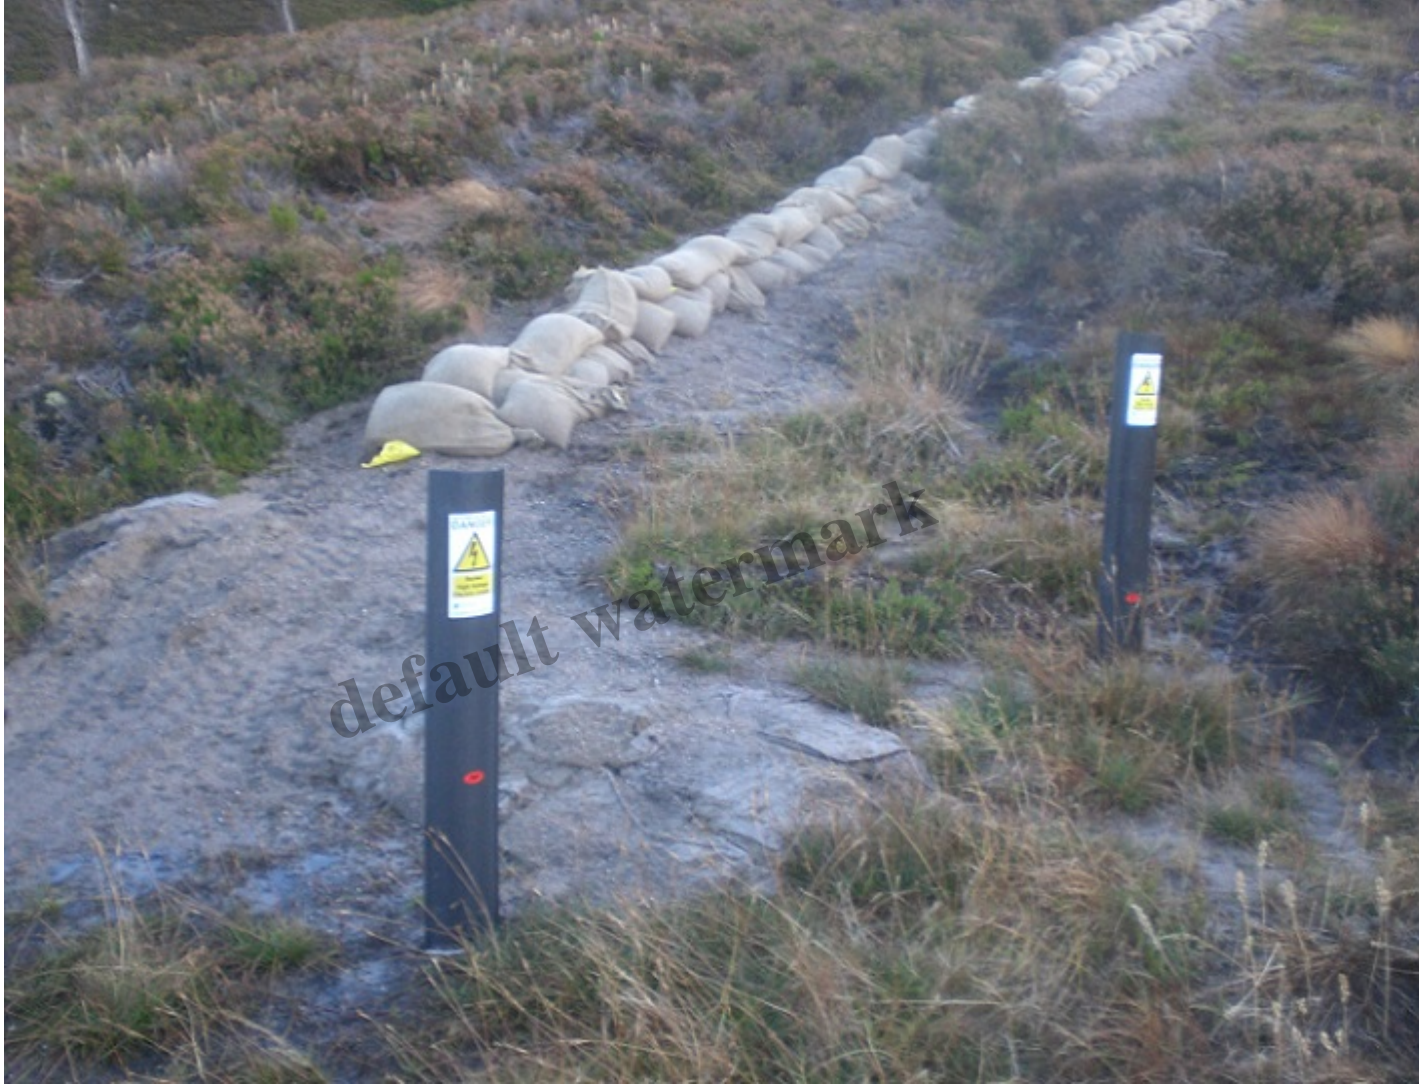
New warning signs – there were none before – and sandbags December 2020. Note the remains of former sandbags just behind the left hand sign

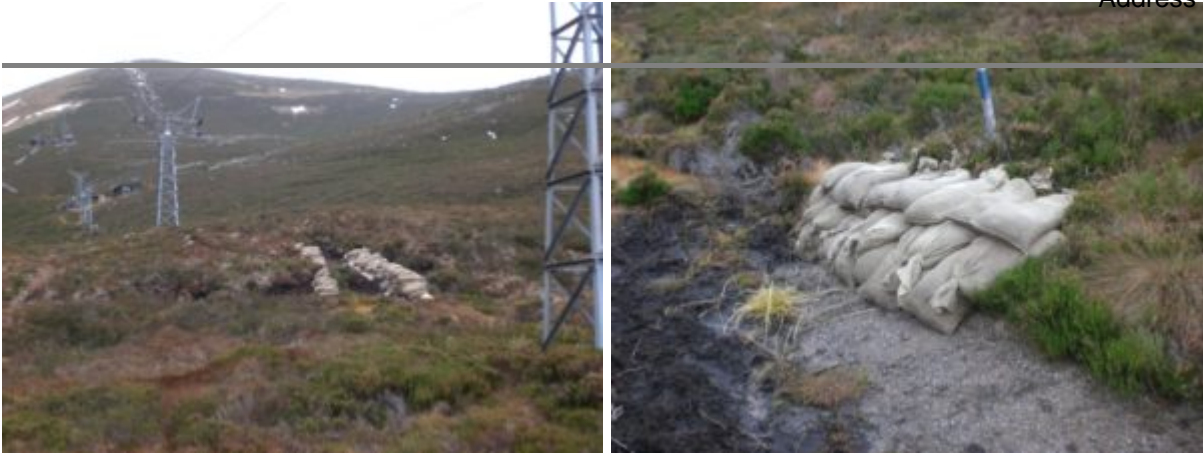
These photos of sandbags were both taken in 2016, when Natural Retreats was in charge, although many of the hill staff are the same as they are now. In 2017, the Aviemore and Glenmore Community Trust asked HIE what they intended to do about the section of the 11kv ring main cable which was exposed on the surface of the Sheiling piste (red area in map above). HIE did nothing to address that issue, hence why it appeared in the 2019 risk assessment, and it has taken the intervention of a member of the public to get anything done.

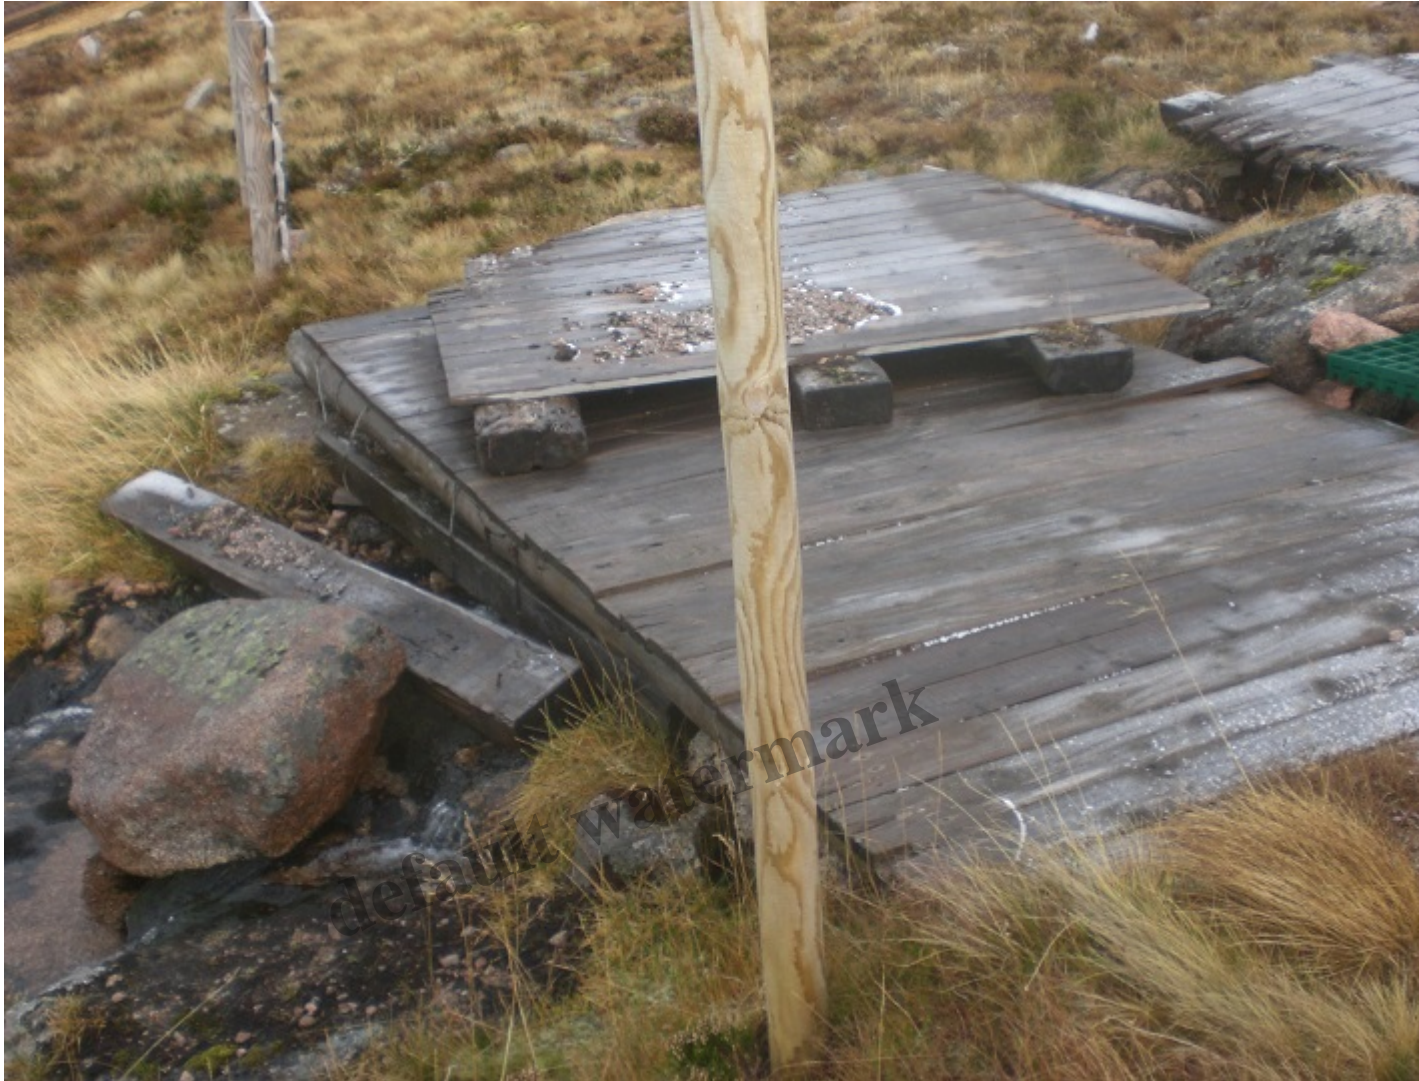
Bridge over the burn that runs down towards the Pump House on the lower Zig Zags known as chicken gully, so called as its less steep than the Cas gunbarrel

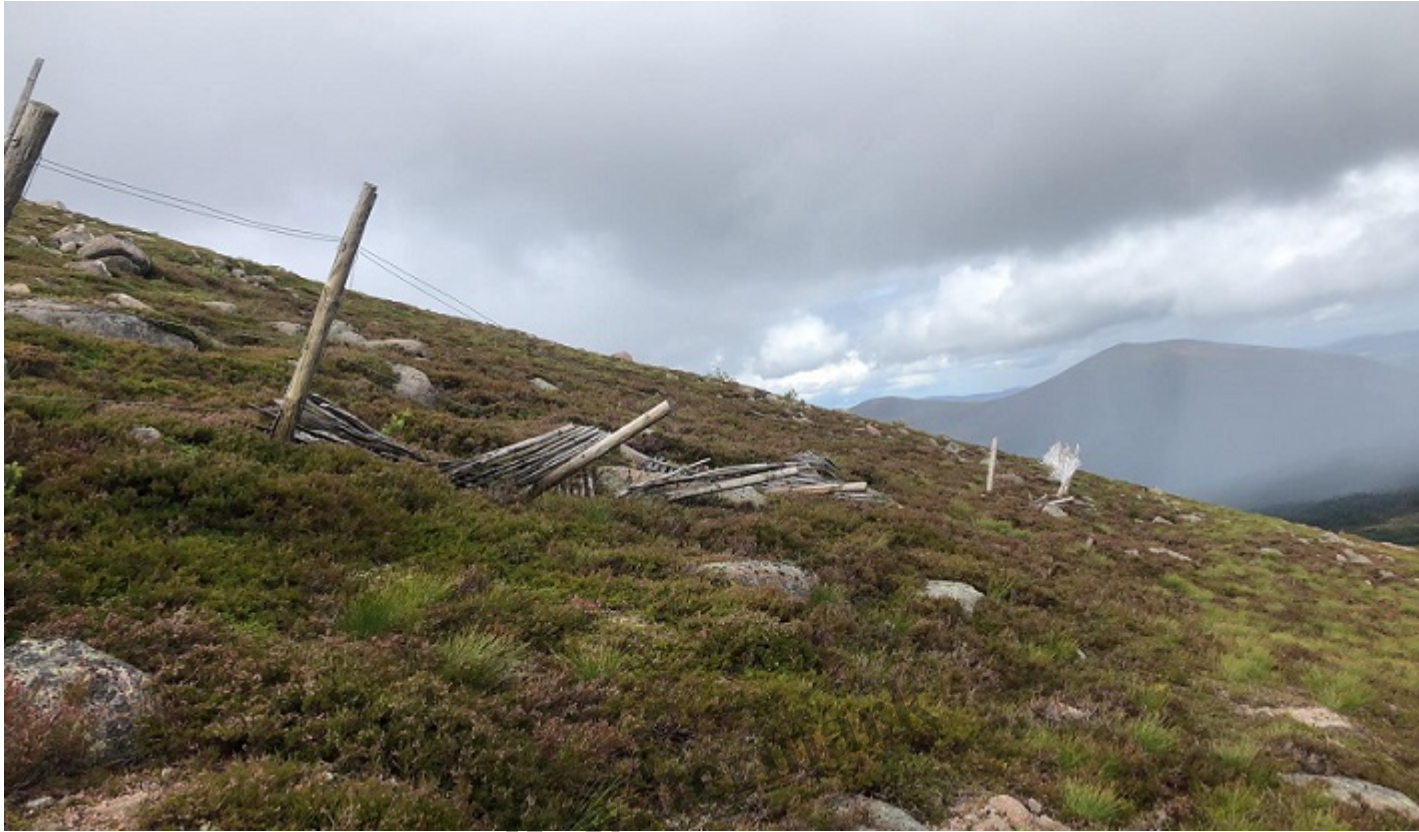
Ruined fencing high on the Aonach Ridge, also known as Rita's ridge, used by skiers and boarders to return to the Ciste Car Park

In cloud, a frequent occurrence on Cairn Gorm, these wires would be hidden from skiers and boarders and could cause a nasty accident.

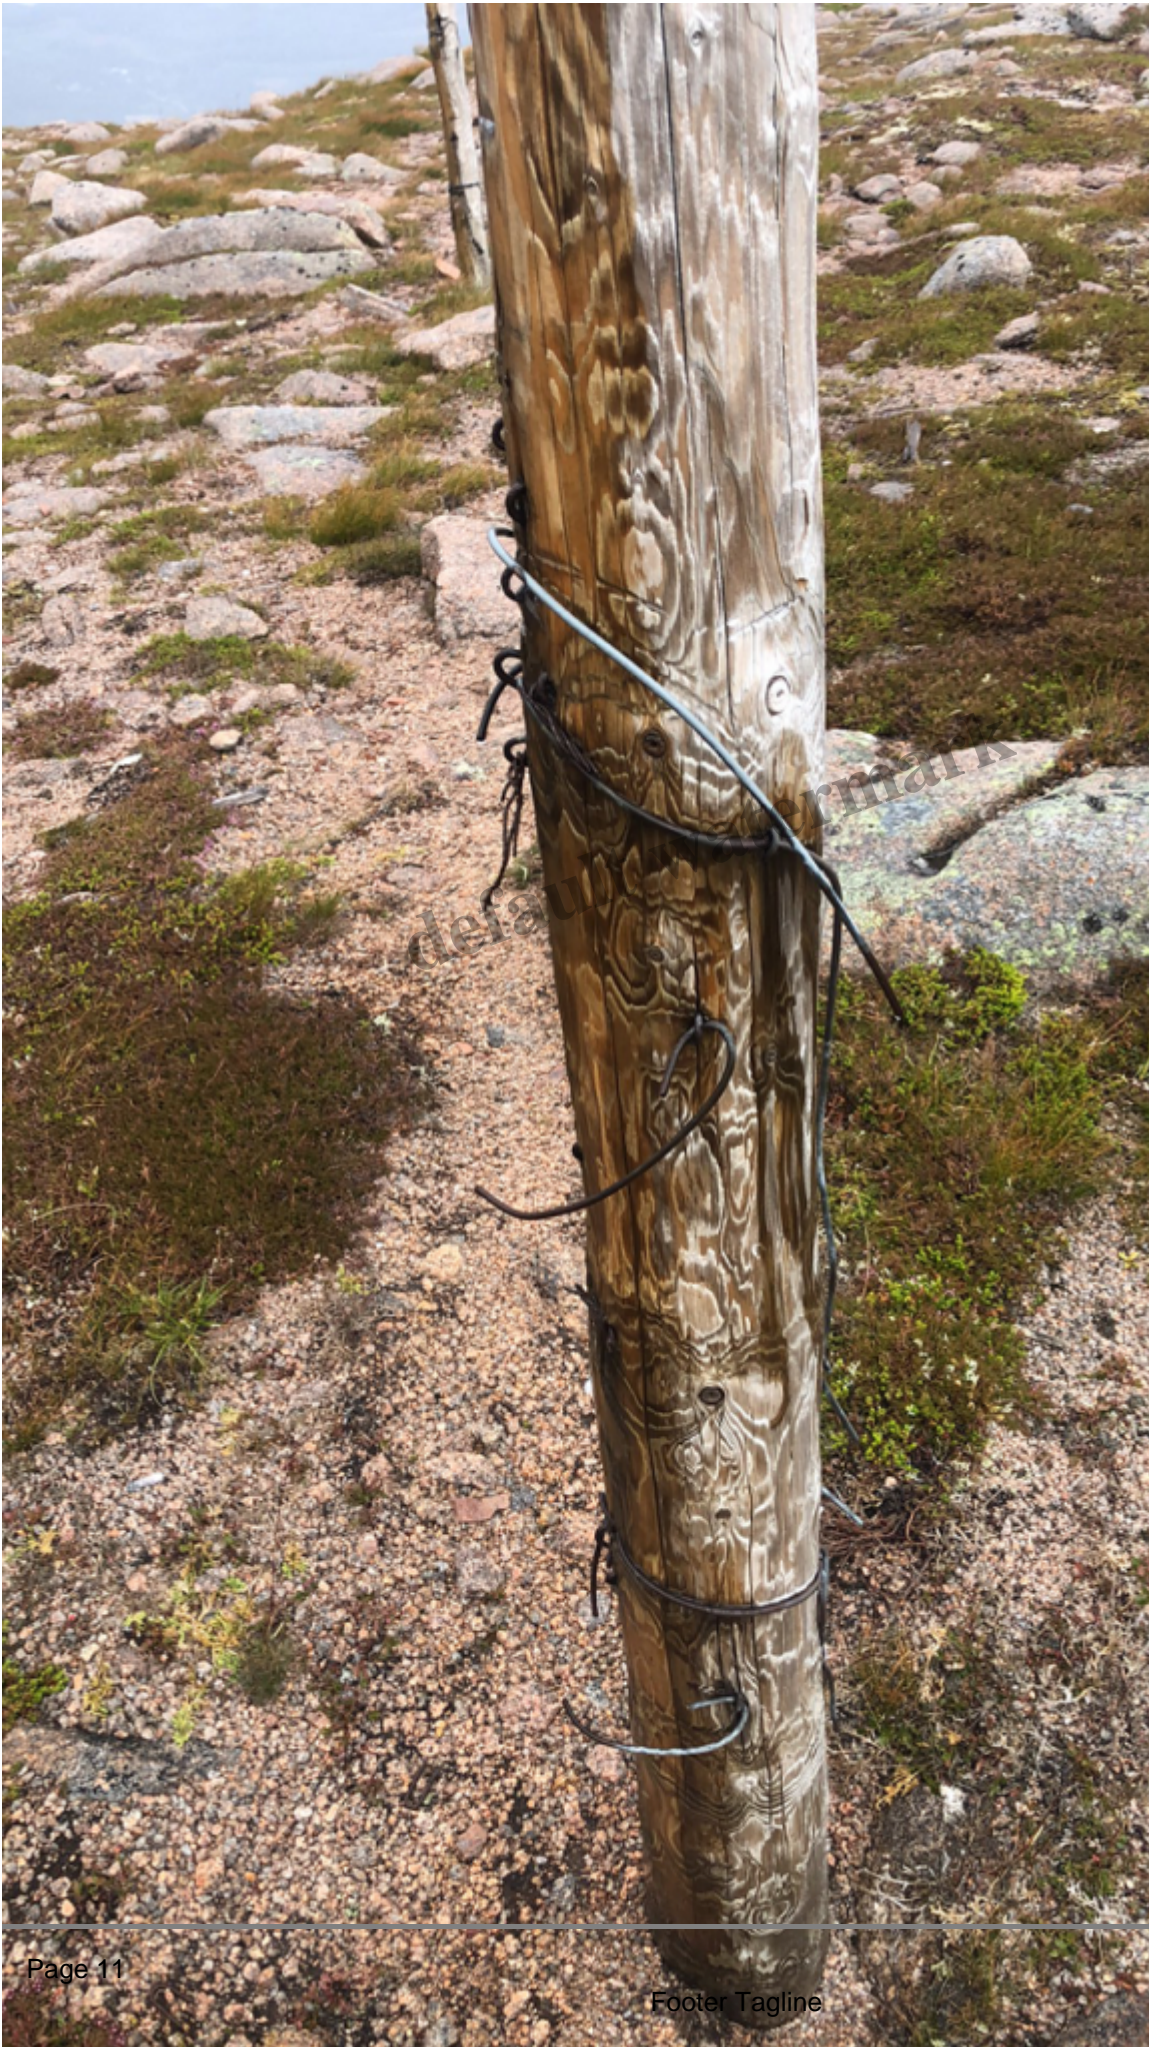
Imagine a beginner sliding out of control and being impaled on one of these wires. When were these posts wires ever clad in protective matting?
