## Will the repair of the Cairngorm Funicular railway Work (5)?

## Propping proposals

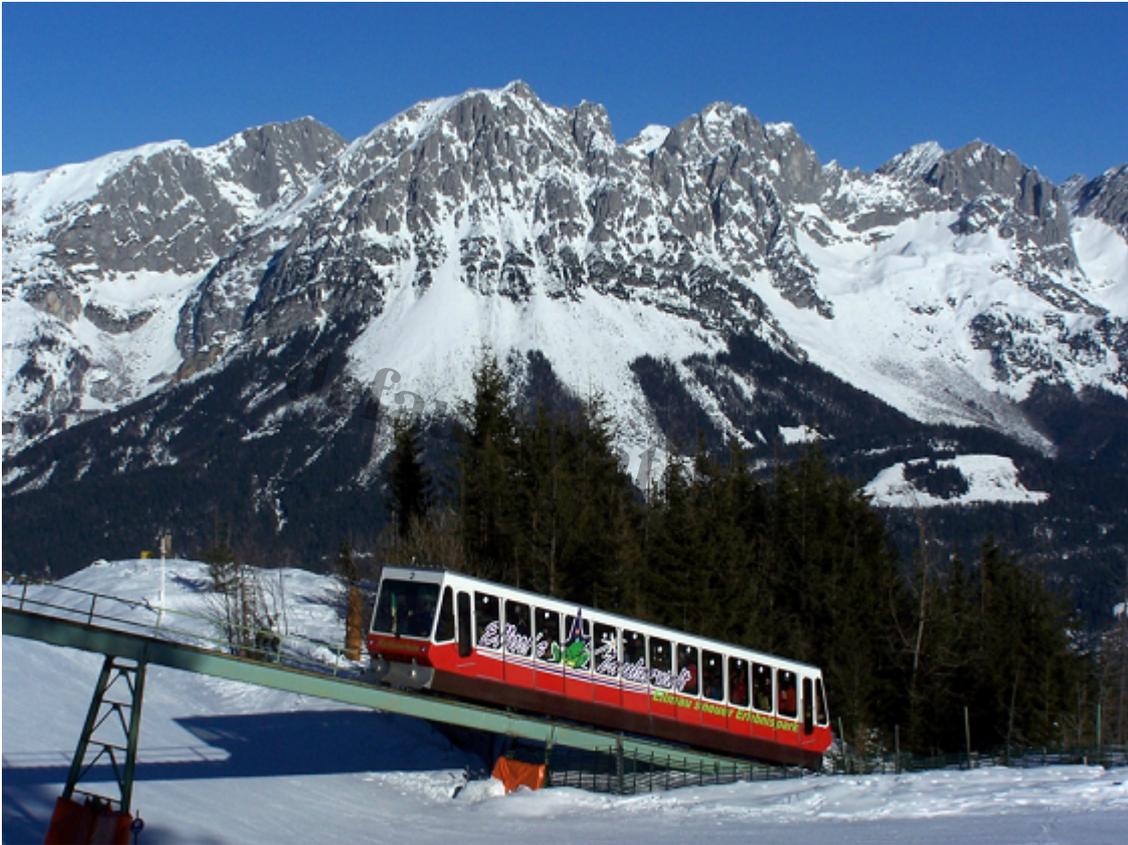
Ellmau Funicular – Photo Credit Funimag

The most outstanding difference is the viaduct itself, steel piers and beams of a much reduced volume, not the massive concrete support used on Cairn Gorm. The original design for the Cairn Gorm Funicular was for steel to be used, but when Morrison's Construction won the contract they proposed the supports should be constructed out of concrete. This change appears to have been prompted by the initial costings for the funicular construction coming in £2m over budget and was therefore a cost-cutting measure:

It can also be seen from the funimag photo that because the main supports are slimmer and much further apart there is much less of a "snowfence" effect than occurs on Cairn Gorm, a problem that is only going to increase with the proposed propping arrangement.

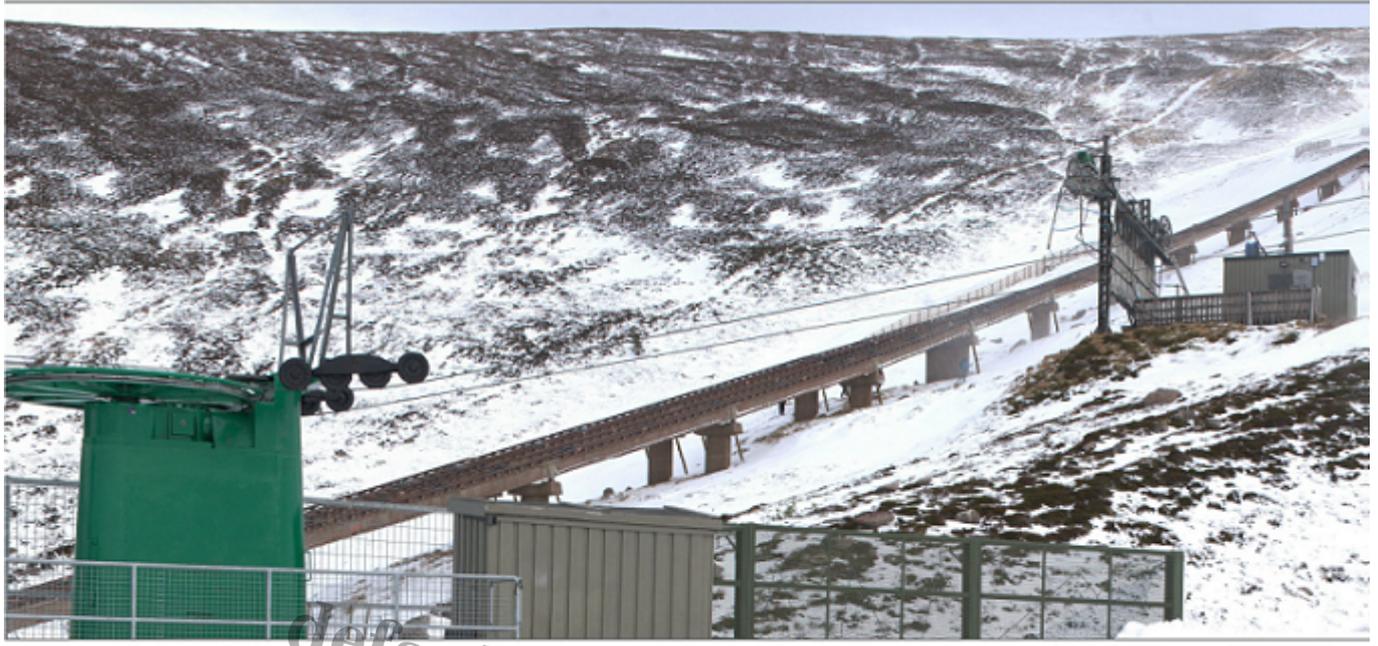
Figure Number: o7k  
WP04C: South of Shiering Station  
Blowing Rock  
2020/0076/DET

Photo montage showing how the metal props (the thin lines on the uphill side of the concrete piers) will appear. Credit: document LVA FIGURE 07K VP04C from National Park planning portal

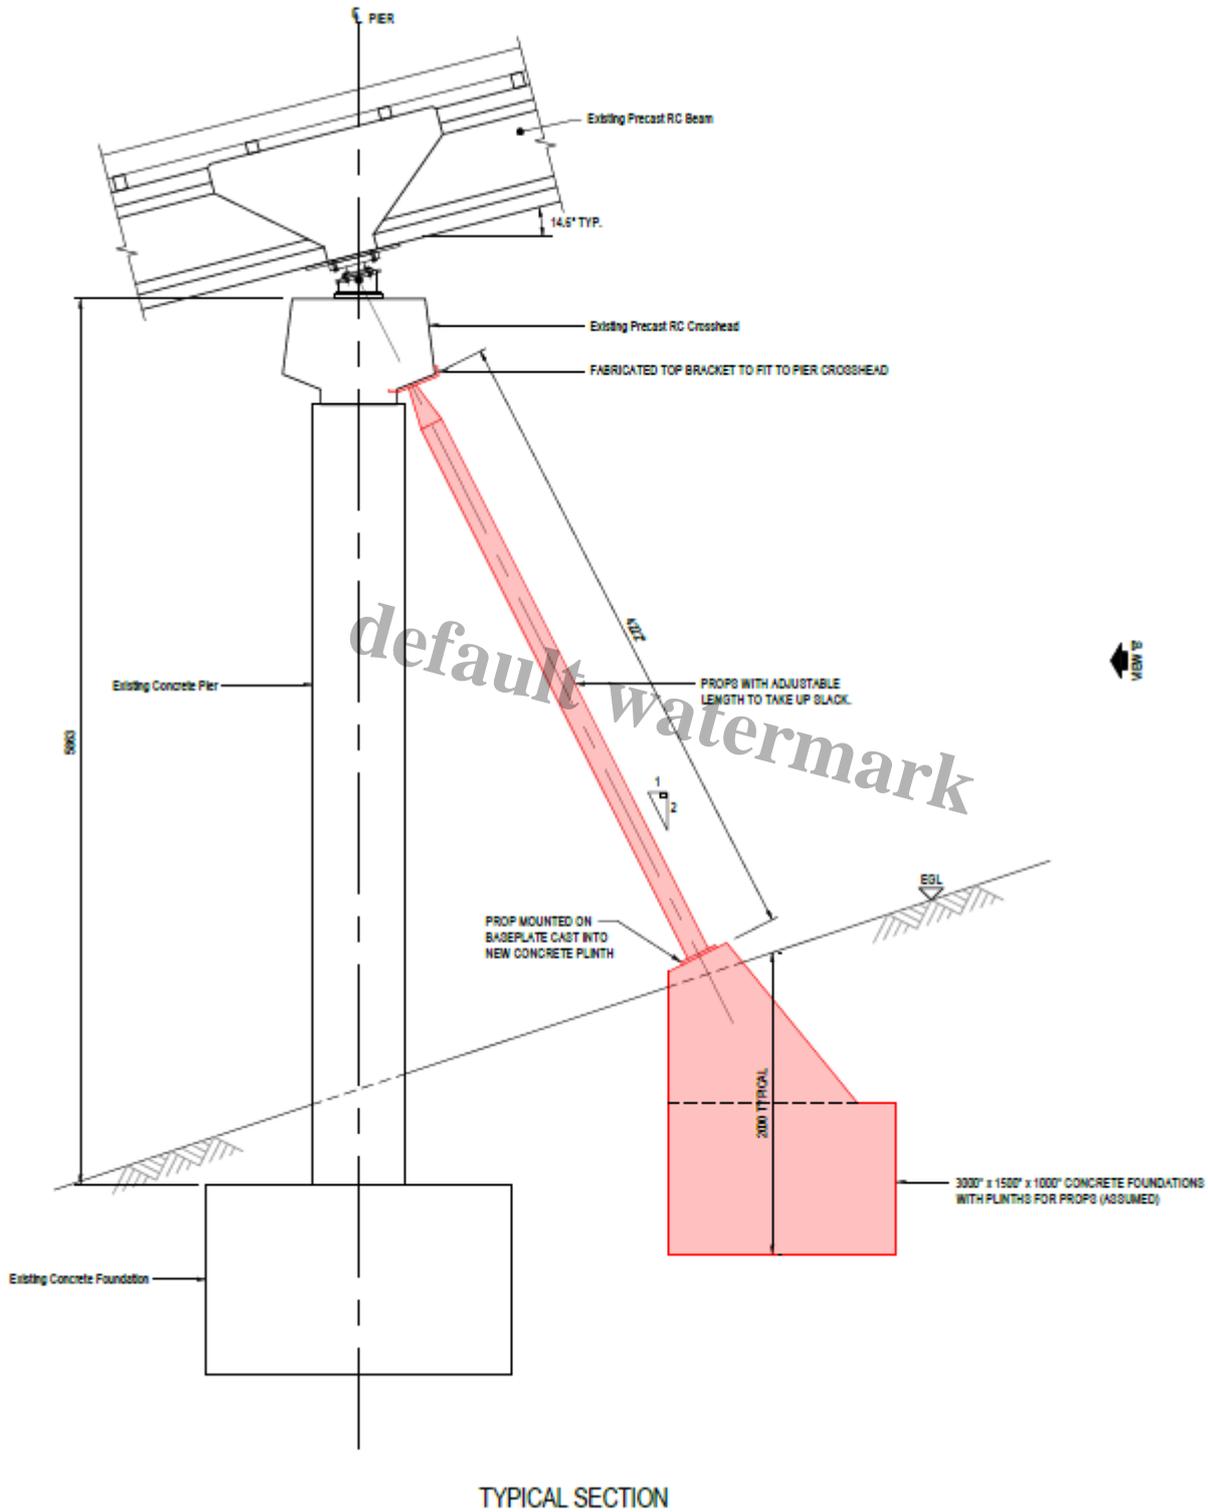
There is currently little information as to what the "propping" entails, apart from the diagrams in the planning application which indicate props of adjustable length will be used.

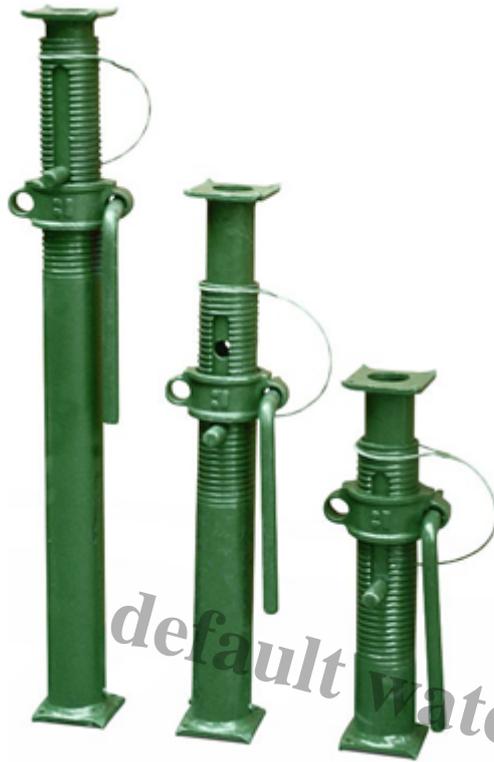
- (1) Steel Acrow type props as shown in the next photo.

These are adjustable and are the kind of props that are often used on house building projects, e.g. propping up floors when installing patio doors or larger windows. Their use on the Funicular is probably not ideal due to the weight of the track, train etc.

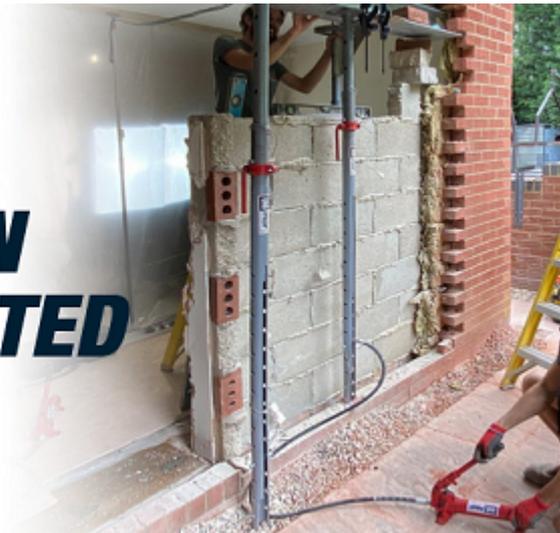
(2) The second type is a combination of the Acrow prop shown above and a hydraulic jack as shown in the next picture:-

This is a basic model which is obviously not suitable to carry the weight of the funicular, but gives you an idea of what I suspect will be used. They are the only type that appears to meet the specifications in

These props and the hydraulic jacks are made of steel which expands and contracts depending on temperature and, as anyone who has skied Cairn Gorm can tell you, there can be quite dramatic changes in temperatures even over the course of a couple of hours. When the sun is out those steel props could be warm to the touch, but if an hour later the temperature has dropped below freezing your hand would stick to them.

The question is will there be a pressure gauge in the system so that the jacking pressure exerted on the piers can be monitored and there will be safe limits for that pressure? Too much pressure will push the piers over backwards while not enough and the props will not be doing their job. That is where a major problem arises, even if expansion/contraction was only  $\frac{1}{4}$  ins that would rock the already insecure piers! The answer to that would be to have pressure gauges which will need to be monitored on a regular basis, either manually or by an automated system.
