Consequences of the flawed design of the Cairngorm Funicular – the mid-station

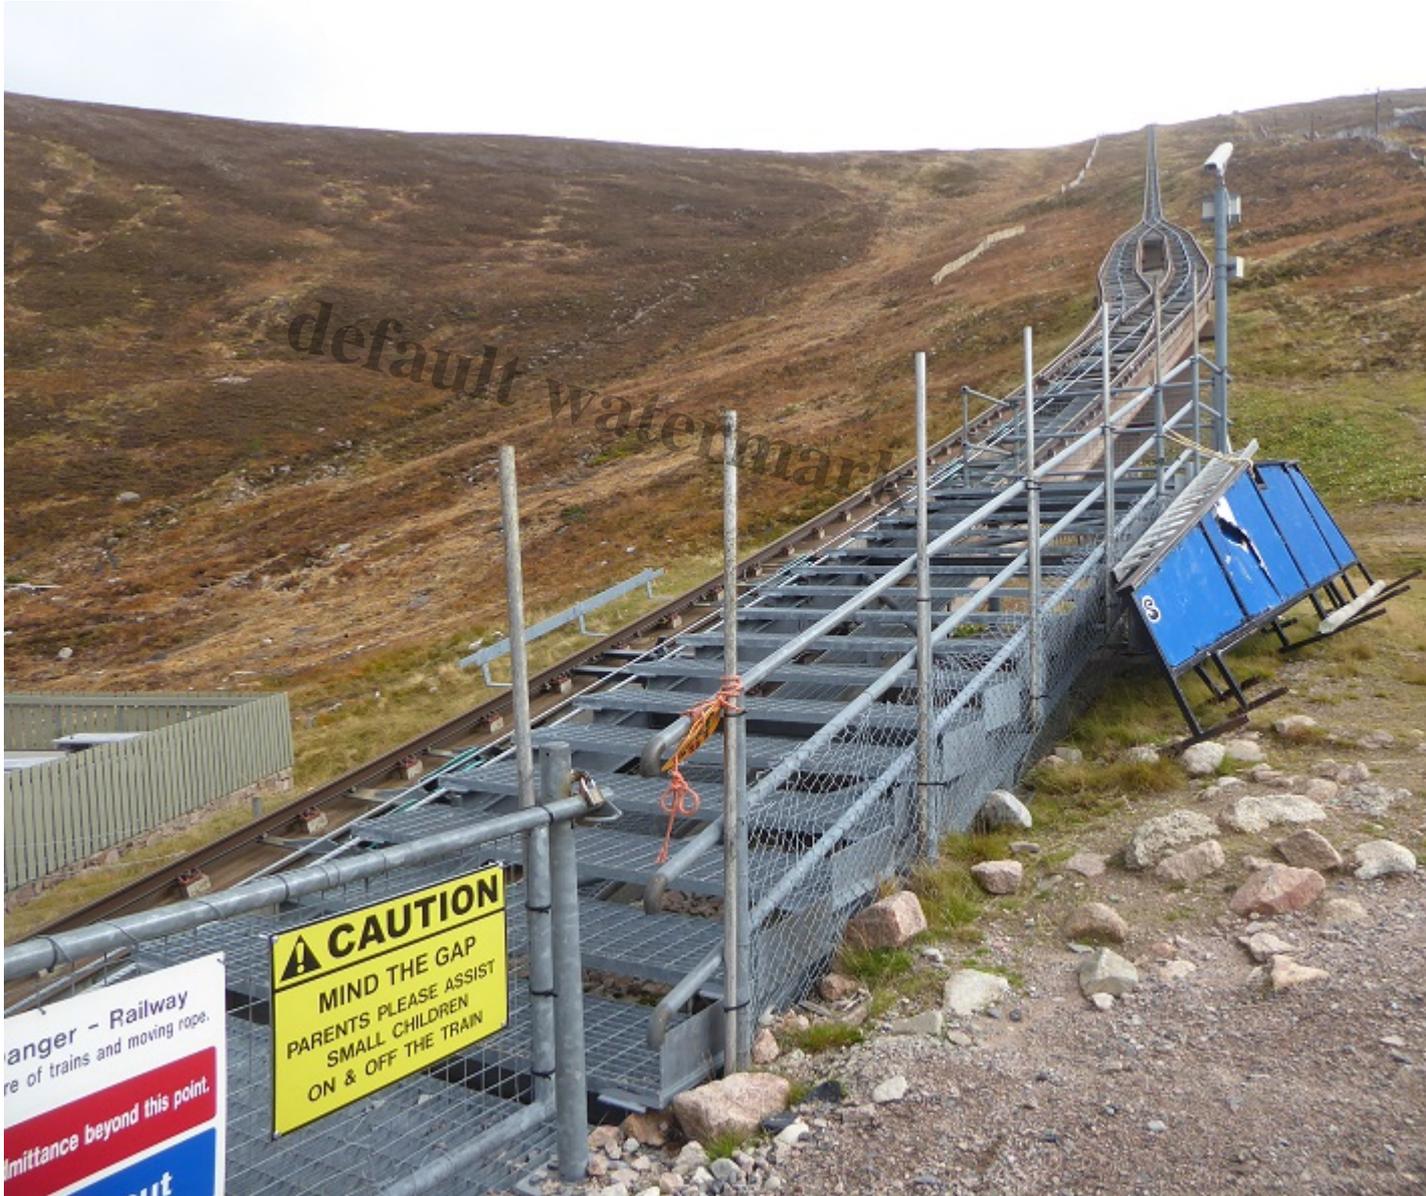
The mid-loading station October 2018, with the passing loop above

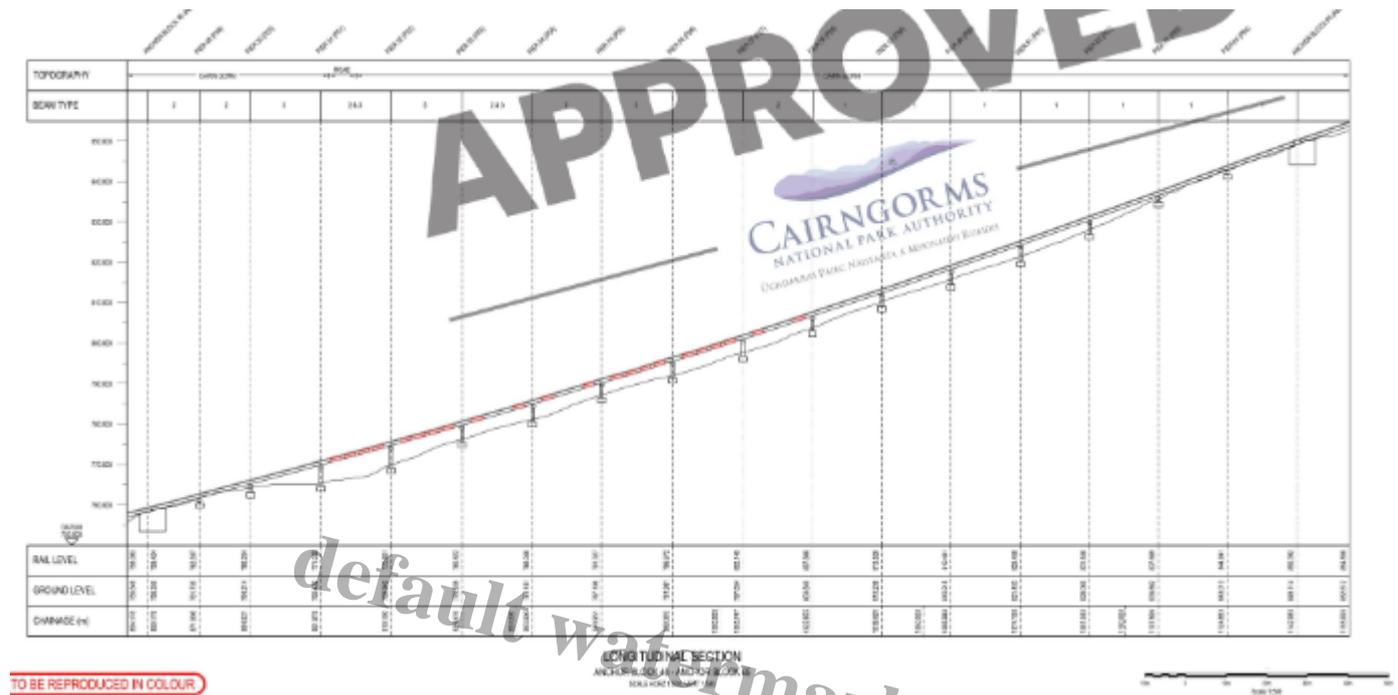
Extract from the planning application to repair the Cairngorm funicular. The block in the bottom left is Anchor Block 48, going uphill are piers 49 & 50, the mid-station loading area, with the passing loop beginning at pier 51 and ending at pier 57

By moving the loading area further down construction costs would have been even further reduced because, as you can see from the screenshot and the photo above, the passing loop is about 4m above ground level, and would have required step access, whereas the loading area is almost sitting on the ground

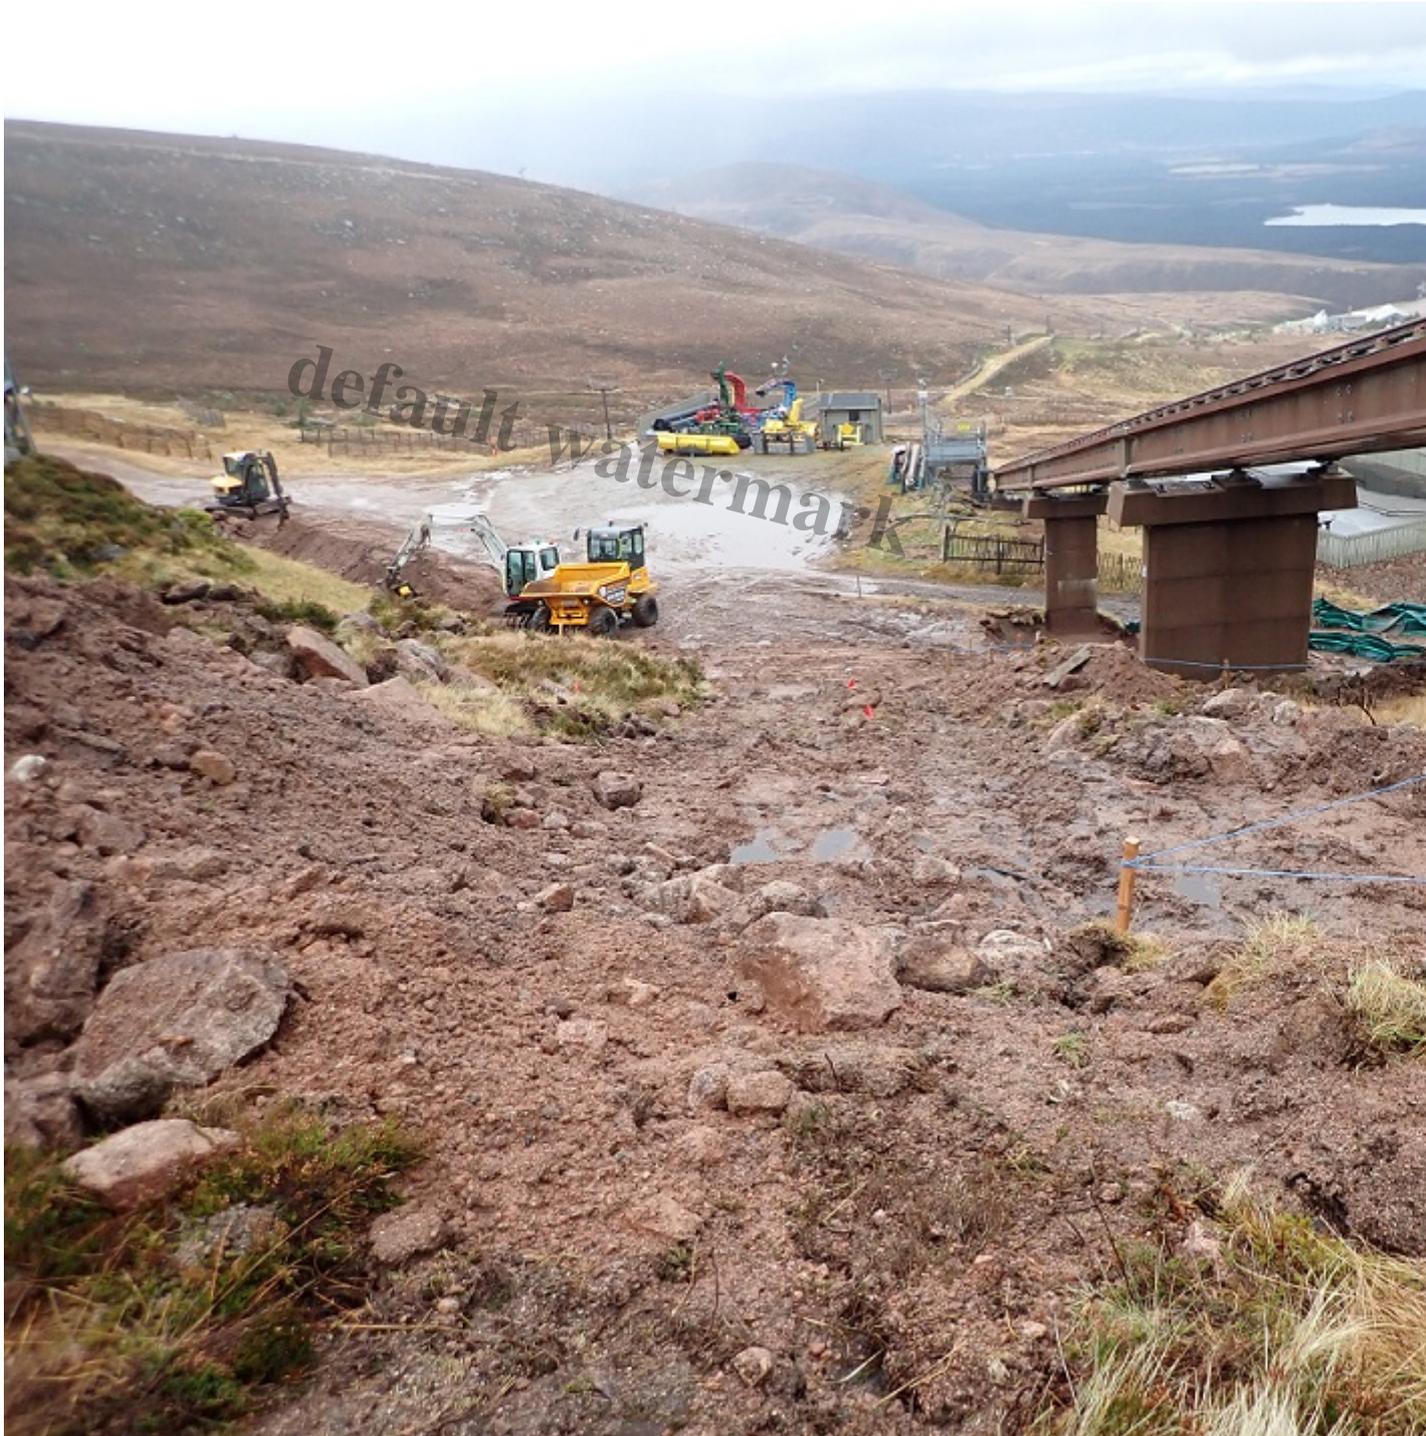
Pillars by passing loop with loading area visible by parking area below. Photo credit parkswatch 2021 repairs had started
