## Consequences of the flawed design of the Cairngorm Funicular – the mid-station

### Description

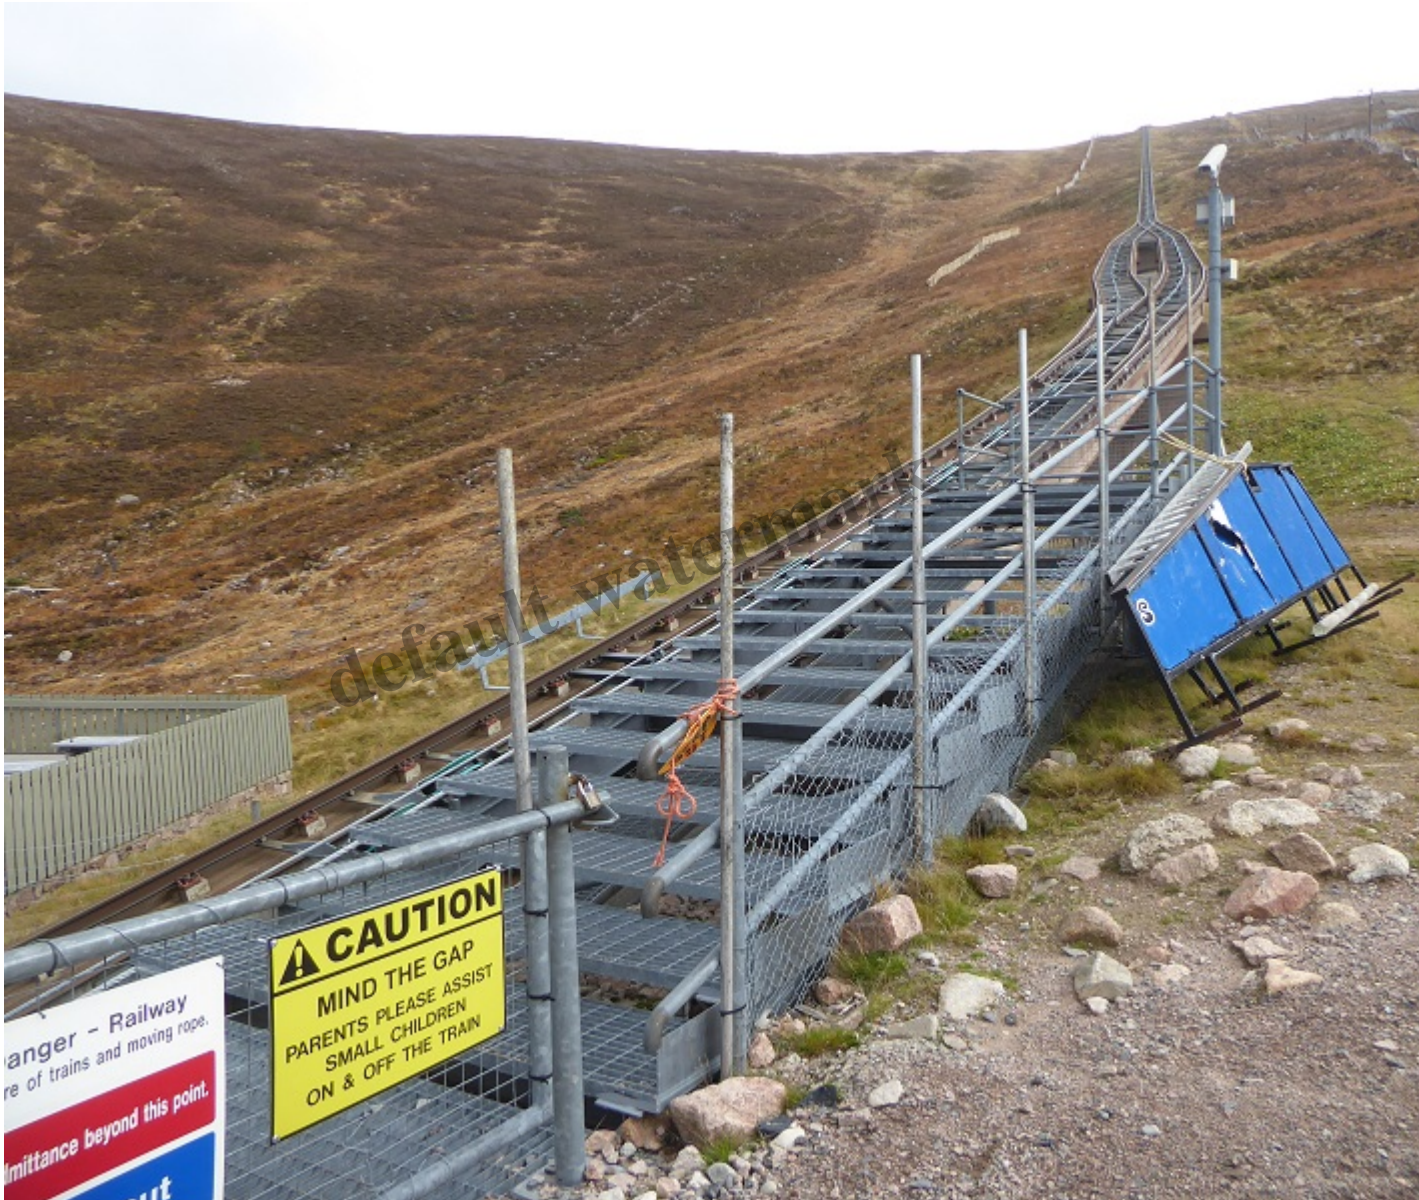
The mid-loading station October 2018, with the passing loop above

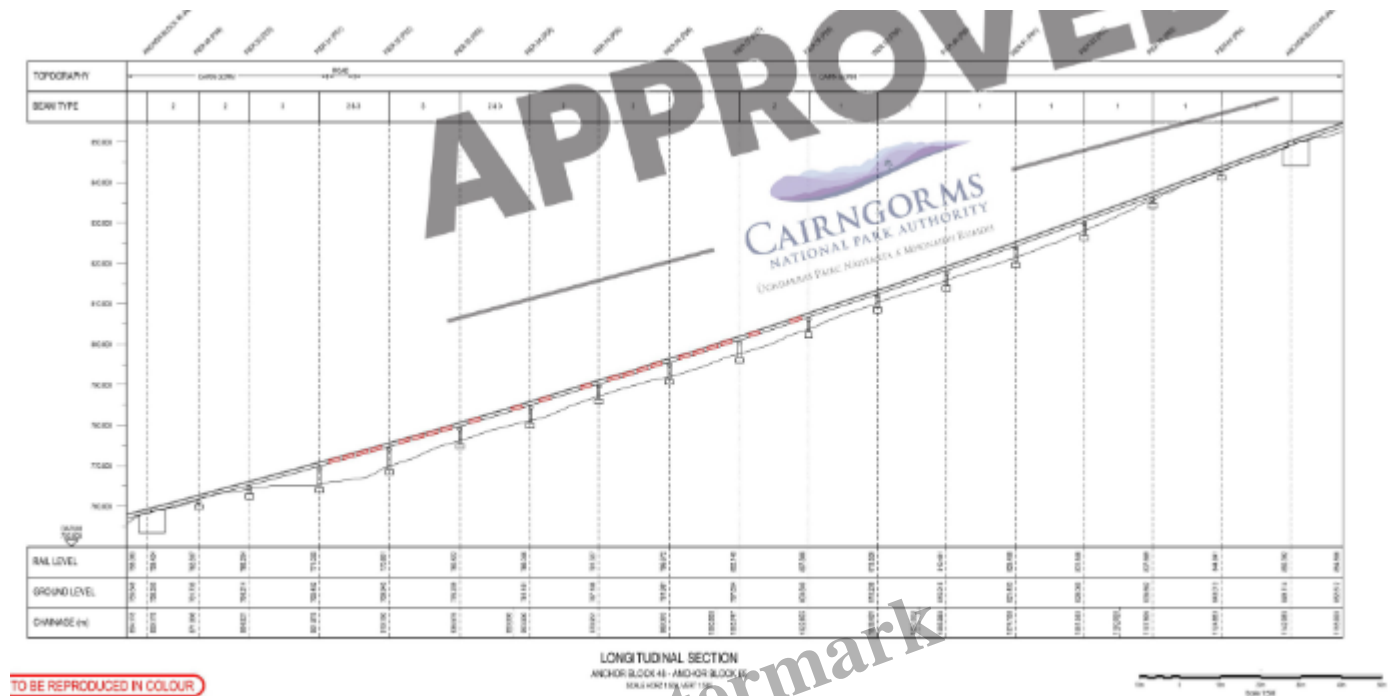
Extract from the planning application to repair the Cairngorm funicular. The block in the bottom left is Anchor Block 48, going uphill are piers 49 & 50, the mid-station loading area, with the passing loop beginning at pier 51 and ending at pier 57

because, as you can see from the screenshot and the photo above, the passing loop is about 4m above ground level, and would have required step access, whereas the loading area is almost sitting on the ground

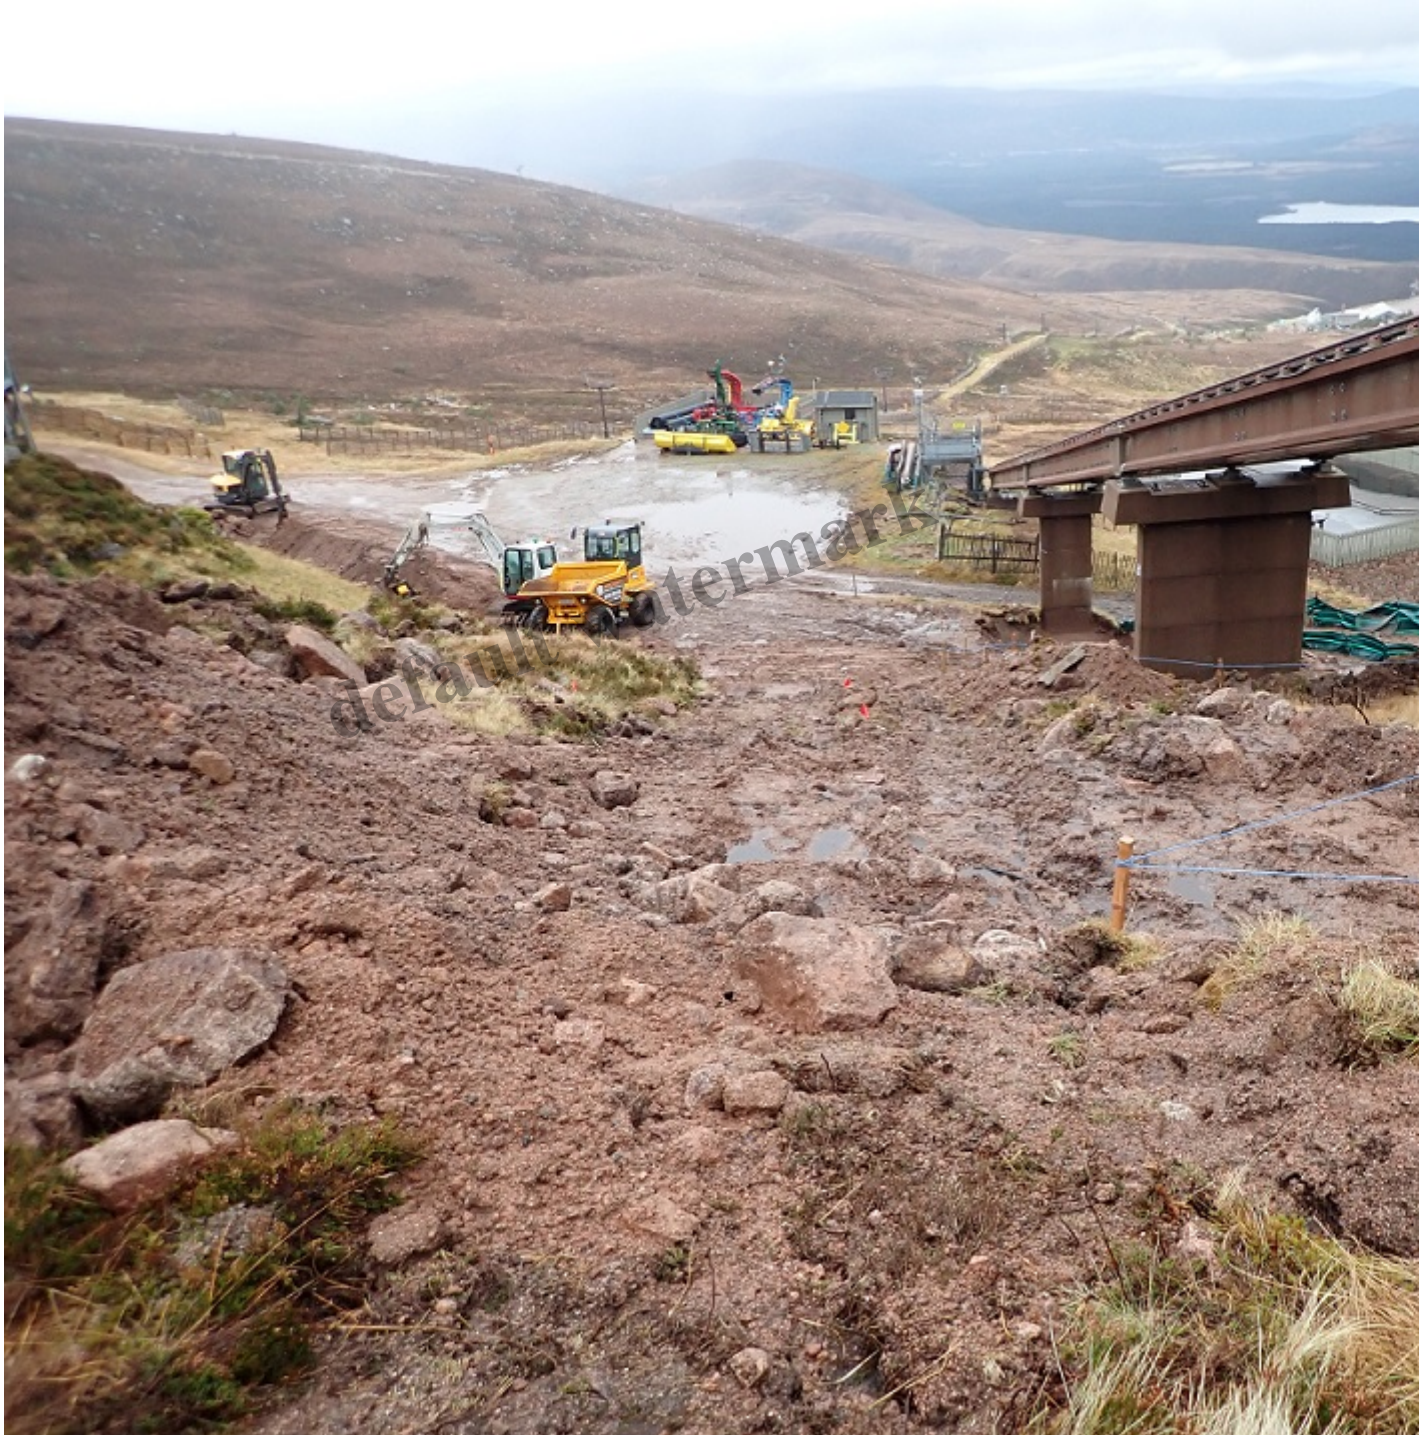
Pillars by passing loop with loading area visible by parking area below. Photo credit parkswatch 2020 repairs had started

By moving the loading area further down construction costs would have been even further reduced
