Cononish goldmine – the unfolding environmental disaster

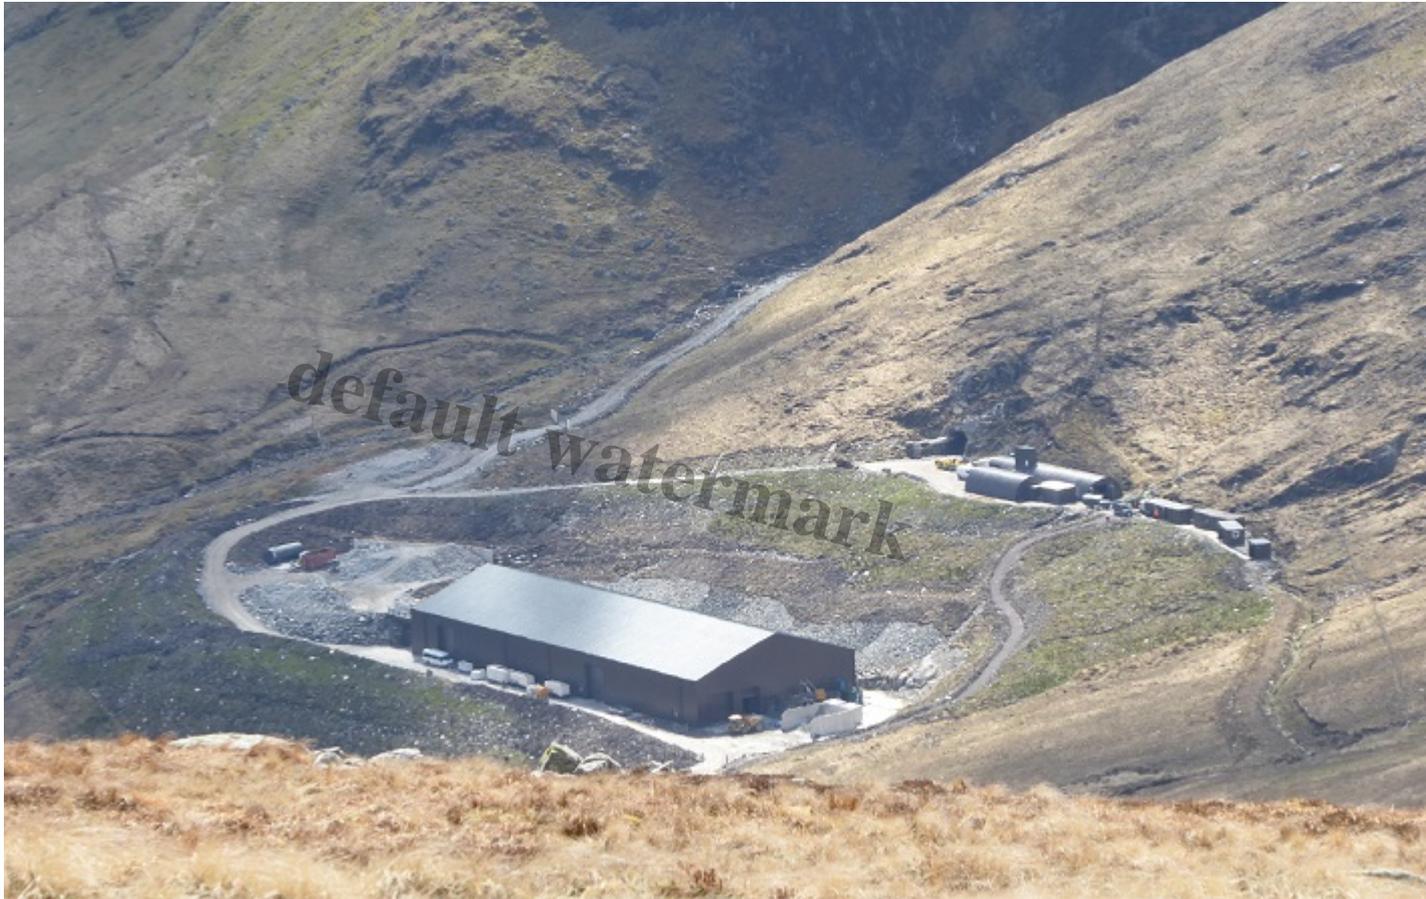
The new platform and bund (embankment) at the Cononish gold mine designed to screen the enormous shed from view. Note how peat has been placed on the bund and the steep slopes surrounding the shed contrary to the original planning consent and how only a proportion of the slopes have been covered with turves (see below).

This was made for the very good reason that *“a peat bund of this size and slope would not be appropriate for permanent or long-term landscaping as the peat would dry out and lead to potential erosion”*.

The LLTNPA’s report of February makes no mention of this requirement. Instead it reversed the LLTNPA’s original position by giving the go-ahead to Scotgold to use the peat to restore the slopes of the bund:

“The peat found within the footprint of the plant platform and bund area required to be removed in order to expose rock for construction and in accordance with the planning approval for the mine, the removed peat was to be used progressively in restoration”

Part of the problem of what to do with the embarrassing excess of peat, as the top photo shows, solved! use it like the peat garden compost which campaigners have been trying to ban for years!!

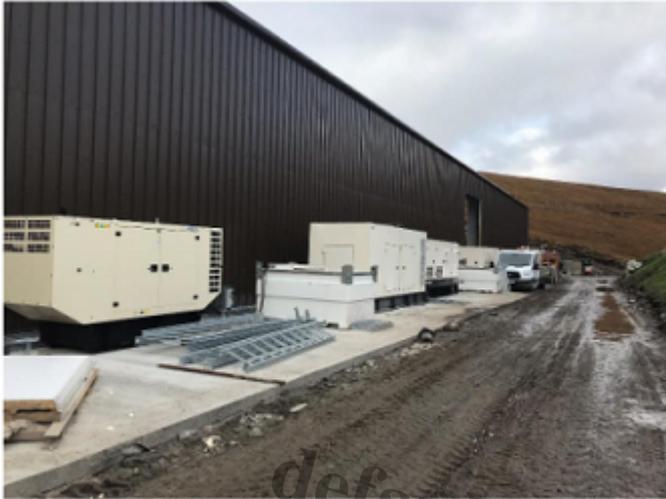
Plant Platform - Front of the processing building the area for Fuel storage tanks and generators (all generators are integrally bunded). Heavy duty protective barrier system to be installed

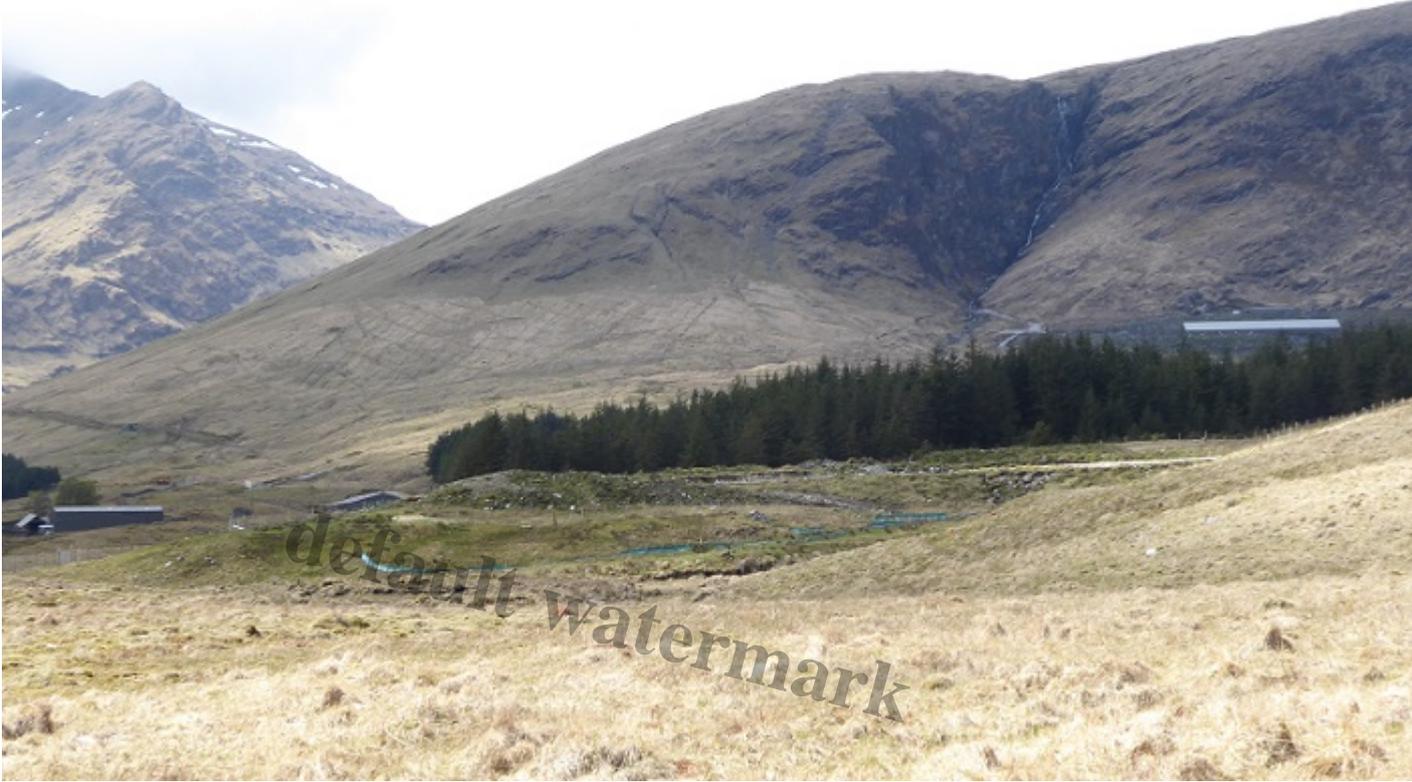
The peat store, in front of the plantation, with the gold mine by the Eas Anie on the far side

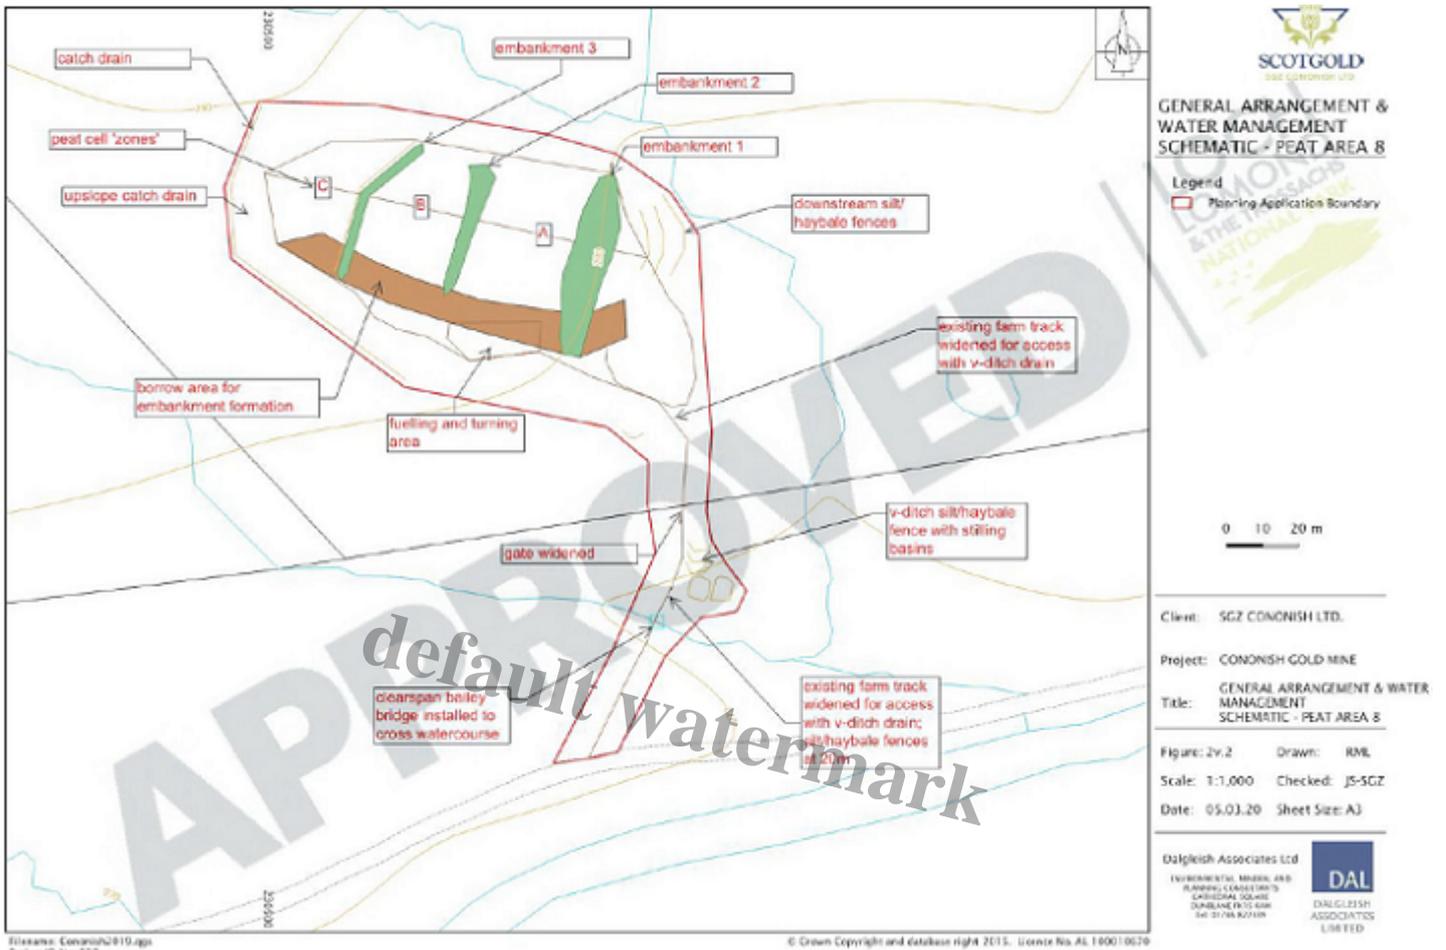
The temporary temporary peat storage area lies outwith the planning boundary for the mine, below Cononish Farm and in a “dip” in the landscape. Originally three “cells” were planned in which to store the peat:

In the event Scotgold only excavated two (A and B) and has only used one (A). That lends support to the idea that when the amount of excess peat first became apparent, the LLTNPA's initial reaction was to stick with the planning conditions about how peat could be used on site. With nowhere to use it, their only option if the mine was to go ahead was to create a large storage facility while they figured out what to do next. Unable to come up with any other options, they then decided to relax the requirements of their peat management plan.

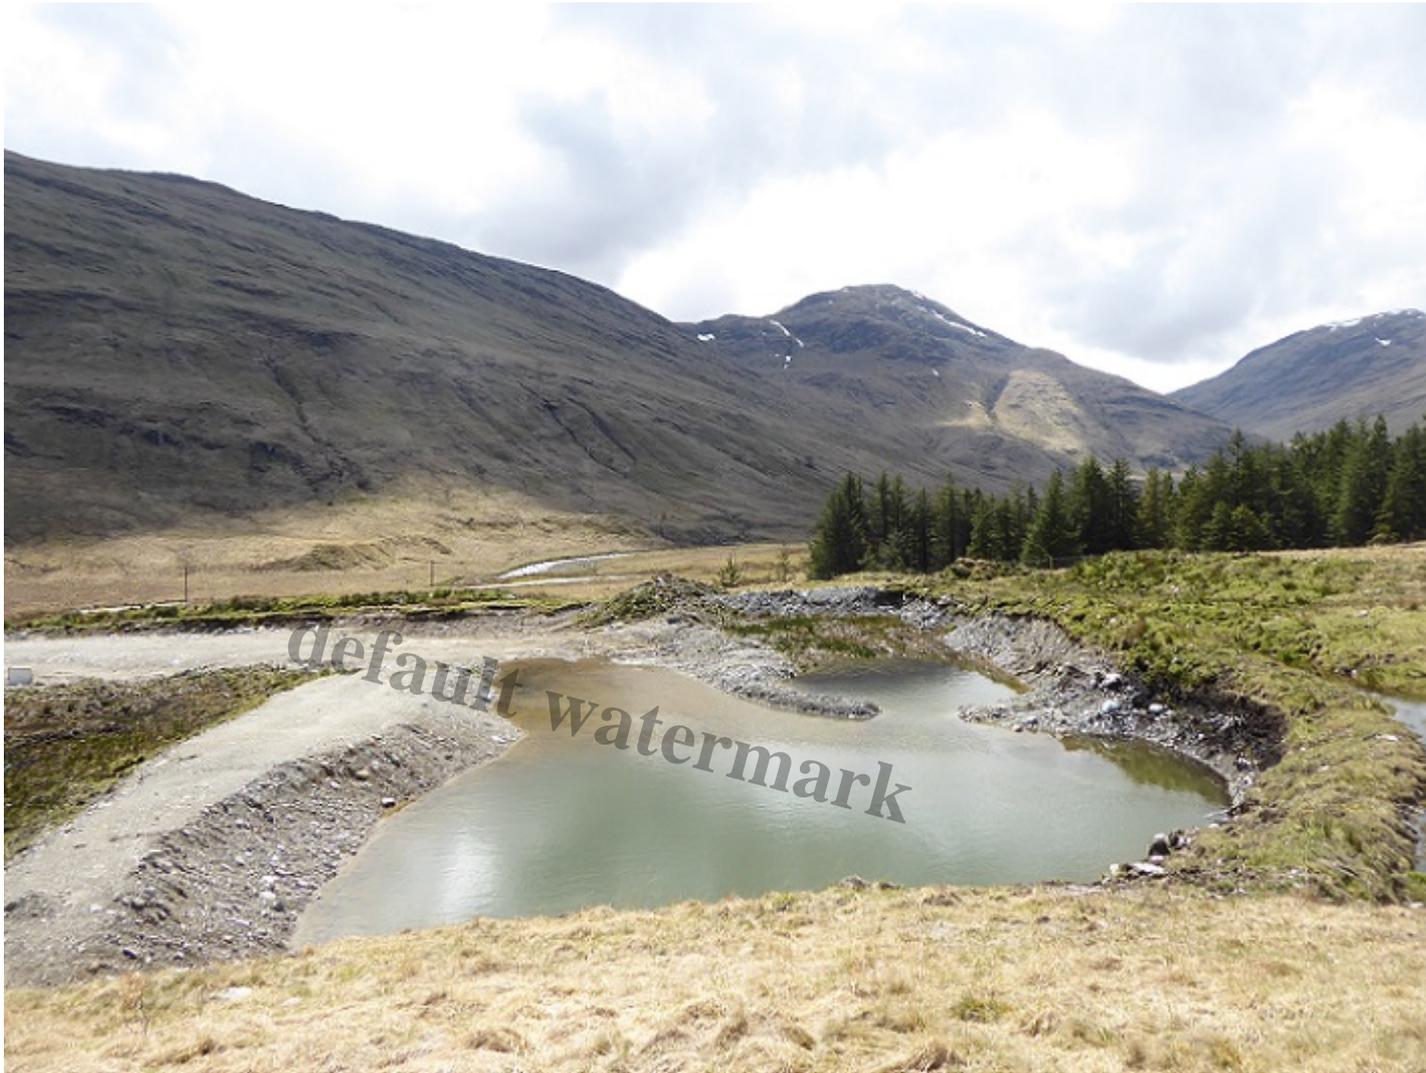
Peat storage cell B, with Ben Oss behind. Note the turves heaped up, one on top of the other, on the far side of what is now a pool.

In creating this large pit, which has so far never been used, yet more peat was excavated and moved.

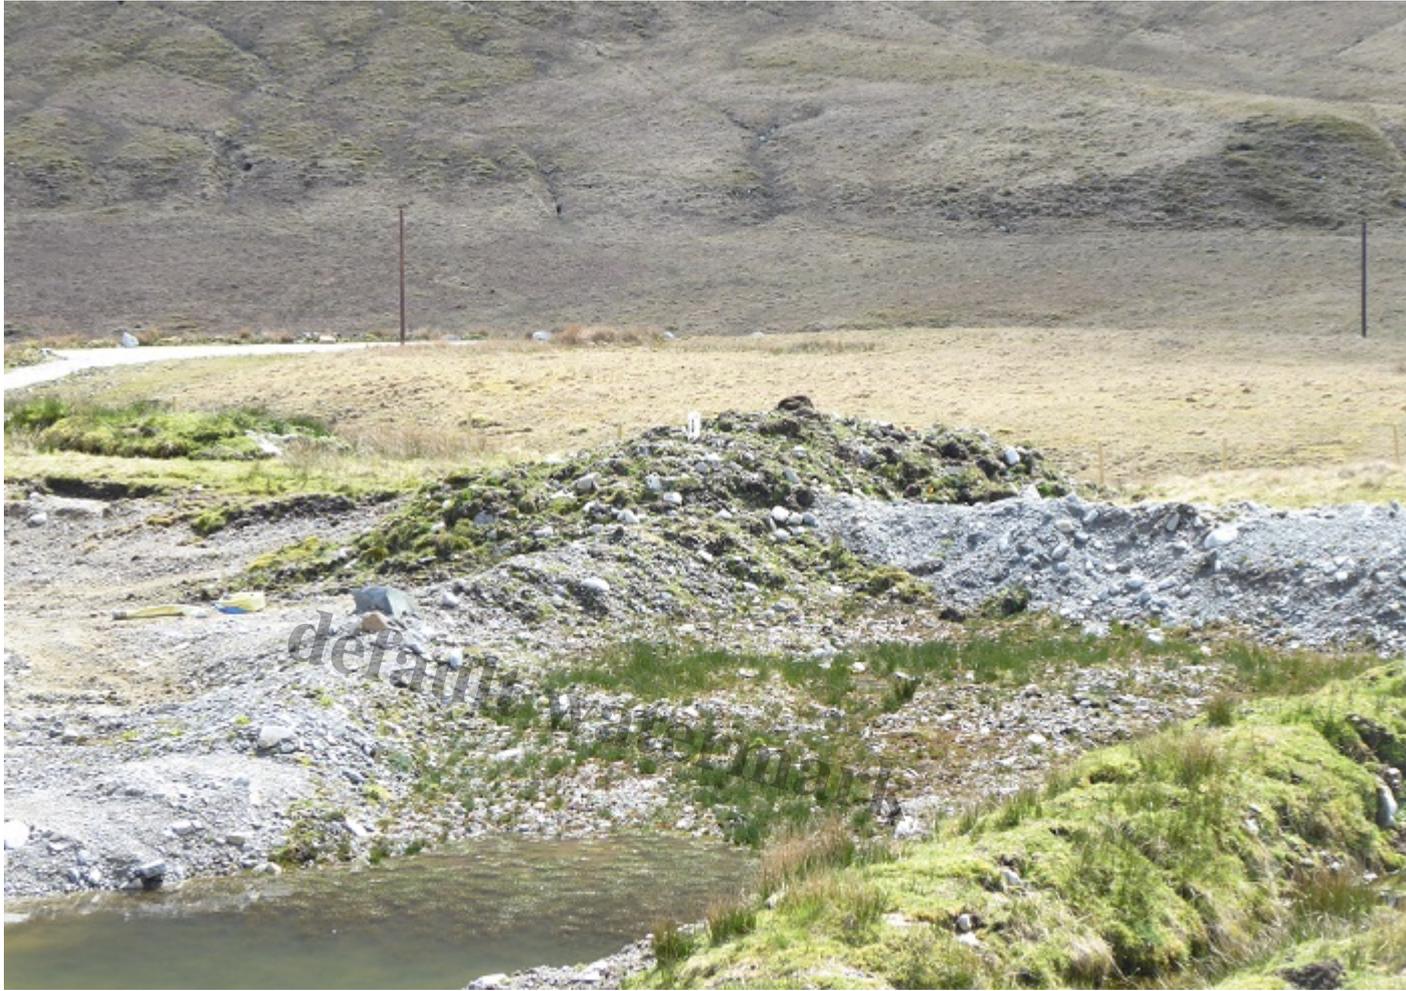
Close up of the heaps of turves at the end of storage area B.

The most recently published monitoring report for the mine, from last October, clearly stated Scotgold had failed to comply with the turf management plan: *“Storage of turves has not been in a single layer on tarp/geotextile”*. Over six months later, the LLTNPA and Scotland appear to have done nothing to address this failure.

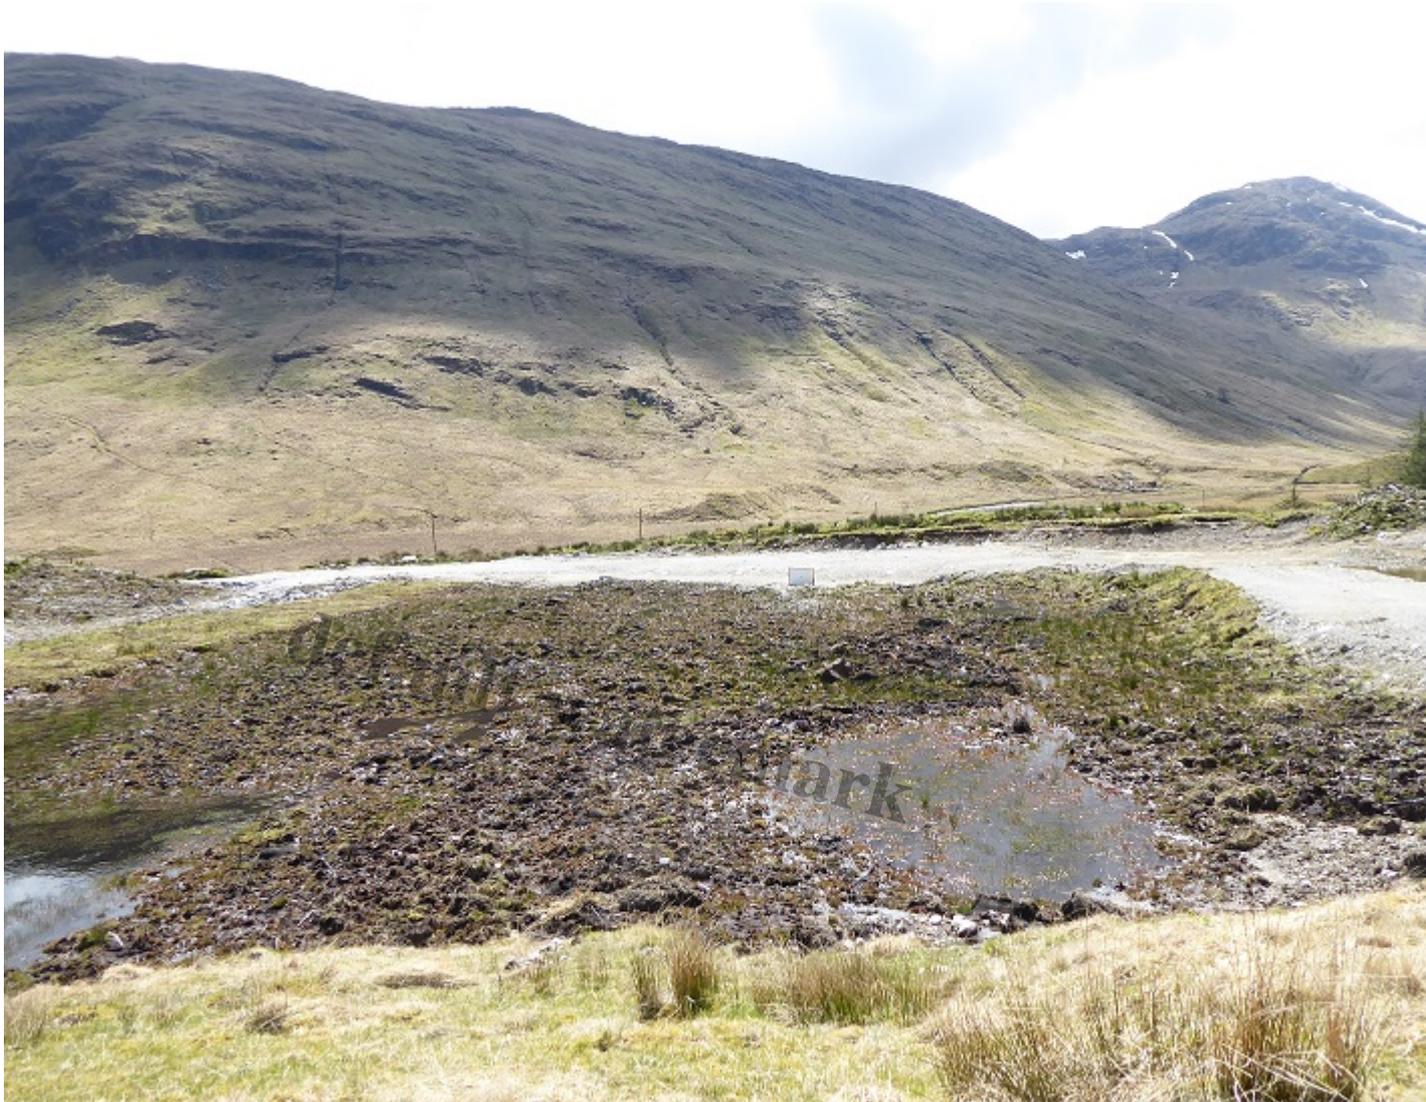
Peat Storage cell A

While the remaining peat in storage cell A is being kept wet, which helps prevent it disintegrate, a considerable surface area is exposed to the atmosphere, where it reacts with oxygen and steadily releases Carbon Dioxide into the atmosphere.

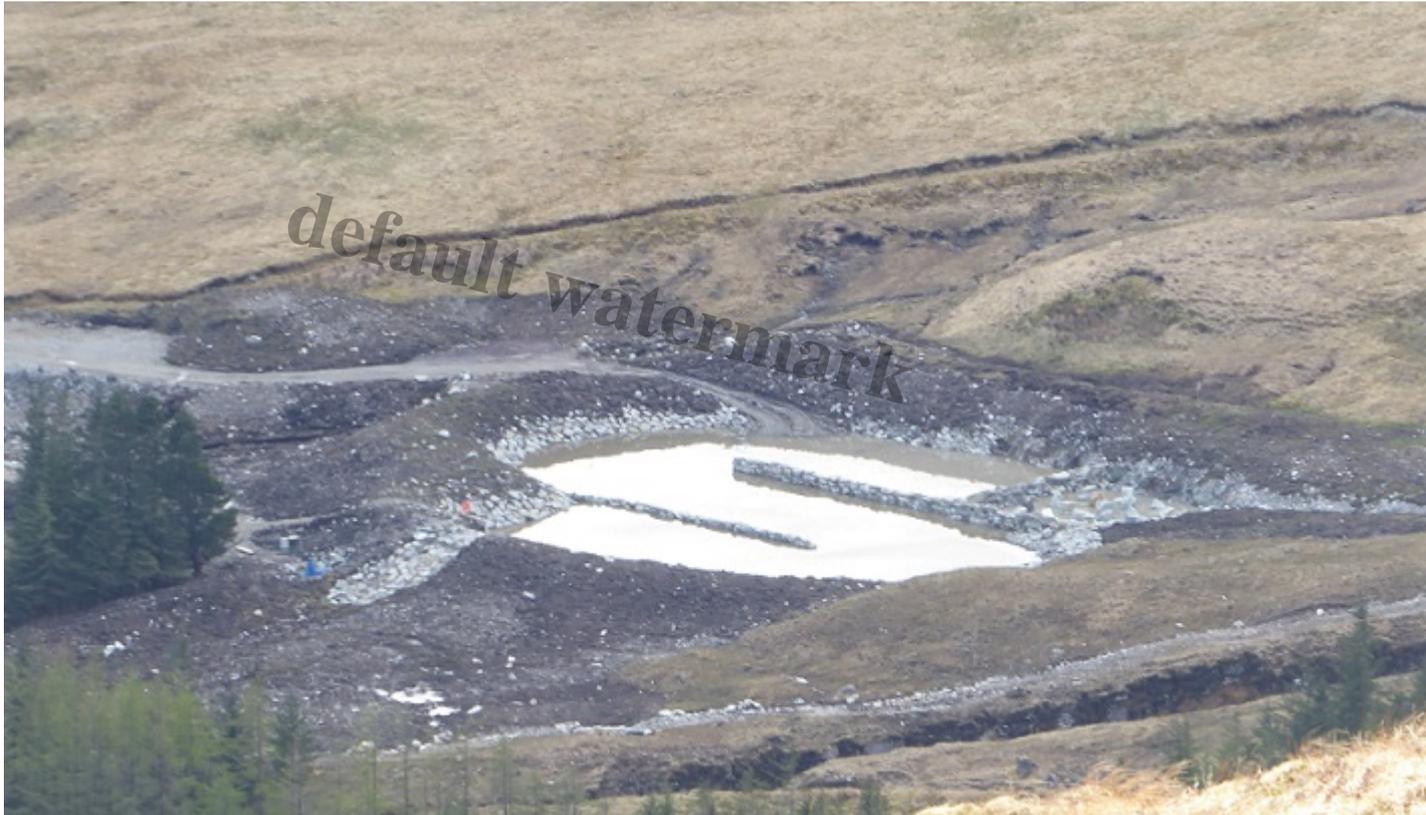
Note the large areas of exposed soils and peat – another example of the failure to re-use turfs or acrotelmic peat.

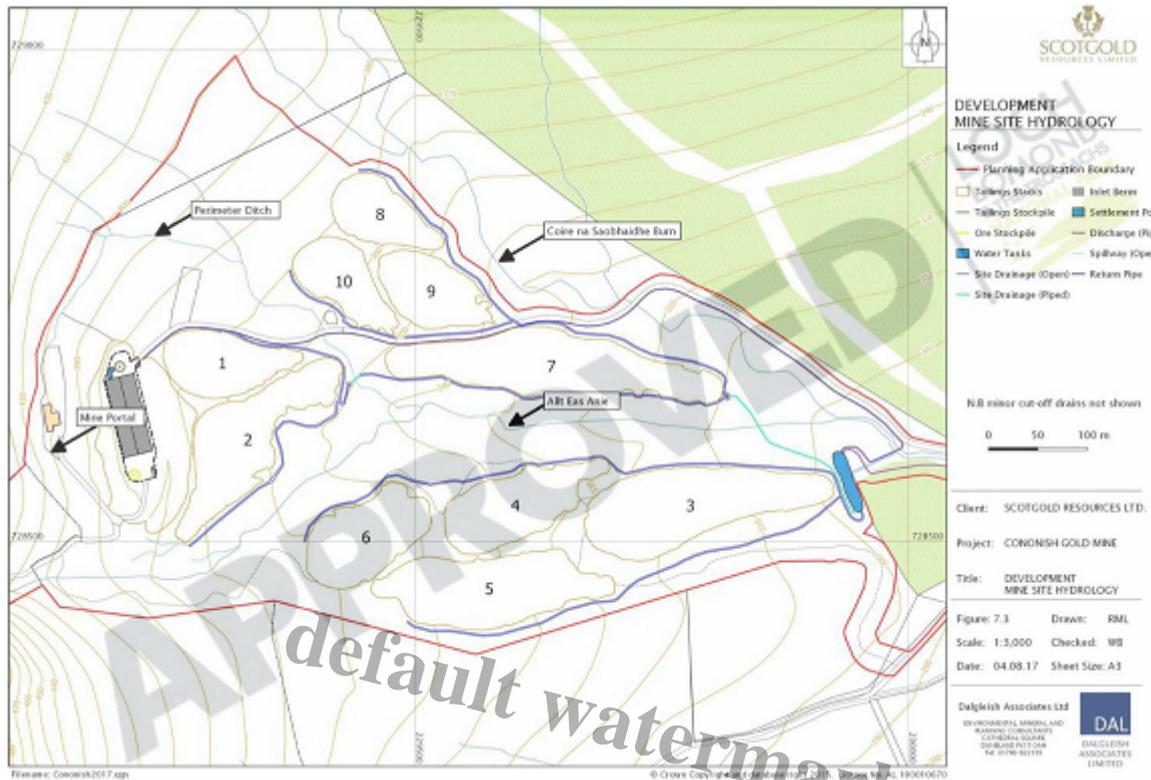
Settling pond marked in blue, below the ten proposed tailings stacks

The Planning Monitoring reports indicate that the design and location of the settling pond have changed since the original application. There is nothing on the planning portal to show how this was approved (normally planning officers would either consent to a "Non-Material Variation" or require a new planning application to be submitted). This represents another big hole in the planning process. Without agreed plans, there are no planning conditions to be enforced and, when it comes to restoration, it will be anyone's guess as to what should be removed from the site. My bet is that this settling pond, with its rip rap bouldering, stone vetements and suburban-type landscaping will never be restored.
