Cononish goldmine – the unfolding environmental disaster

The destruction of peat

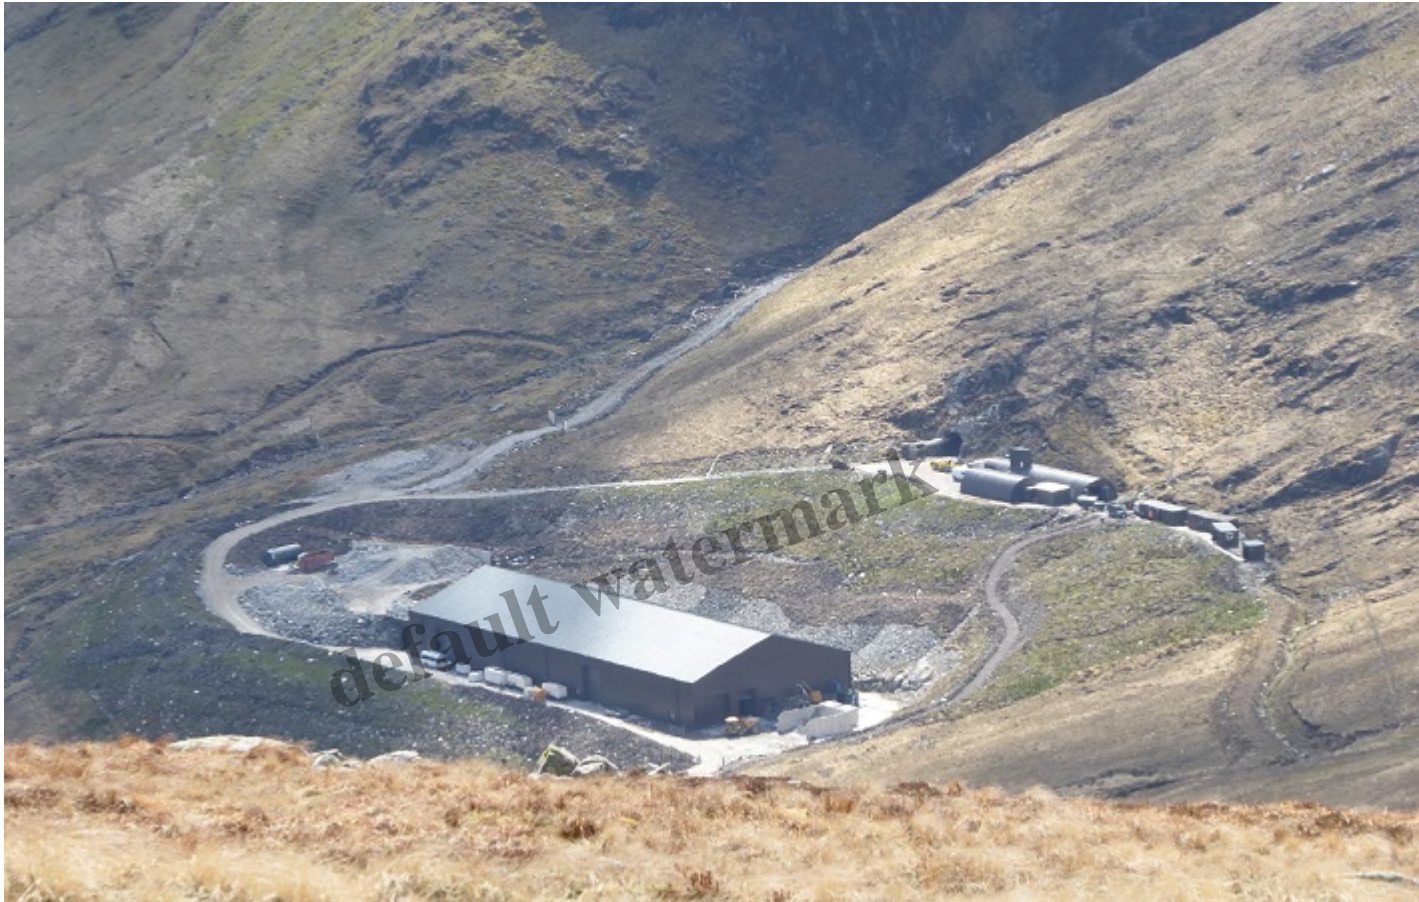
The new platform and bund (embankment) at the Cononish gold mine designed to screen the enormous shed from view. Note how peat has been placed on the bund and the steep slopes surrounding the shed contrary to the original planning consent and how only a proportion of the slopes have been covered with turves (see below).

Part of the problem of what to do with the embarrassing excess of peat, as the top photo shows, solved.....use it like the peat garden compost which campaigners have been trying to ban for years!!

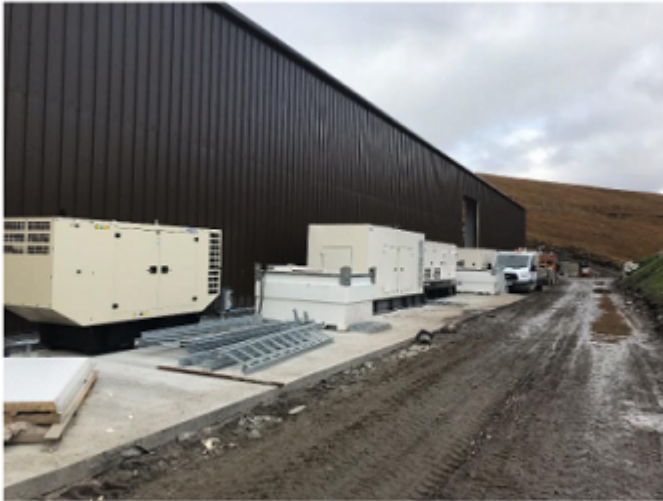
Plant Platform - Front of the processing building the area for Fuel storage tanks and generators (all generators are integrally bunded). Heavy duty protective barrier system to be installed

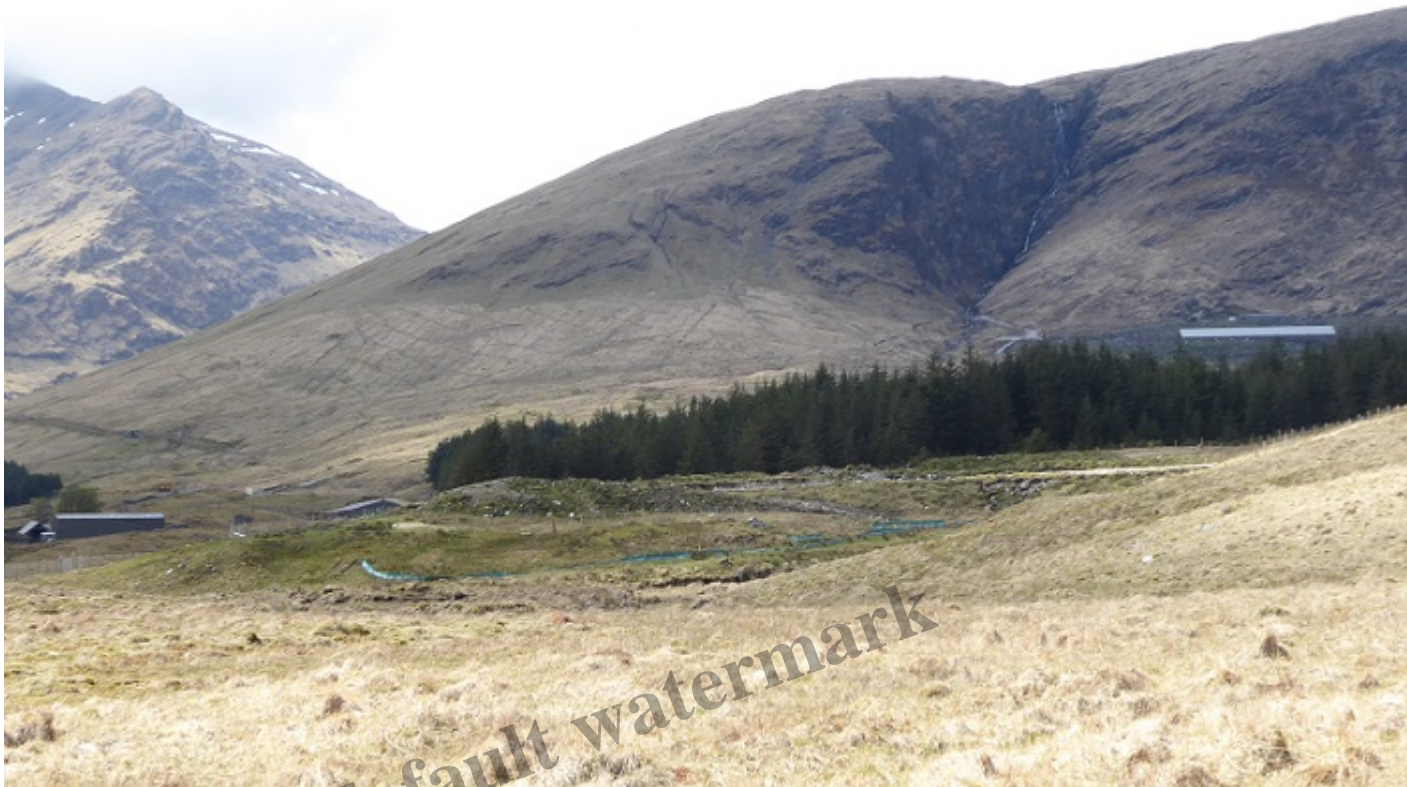
The peat store, in front of the plantation, with the gold mine by the Eas Anie on the far side

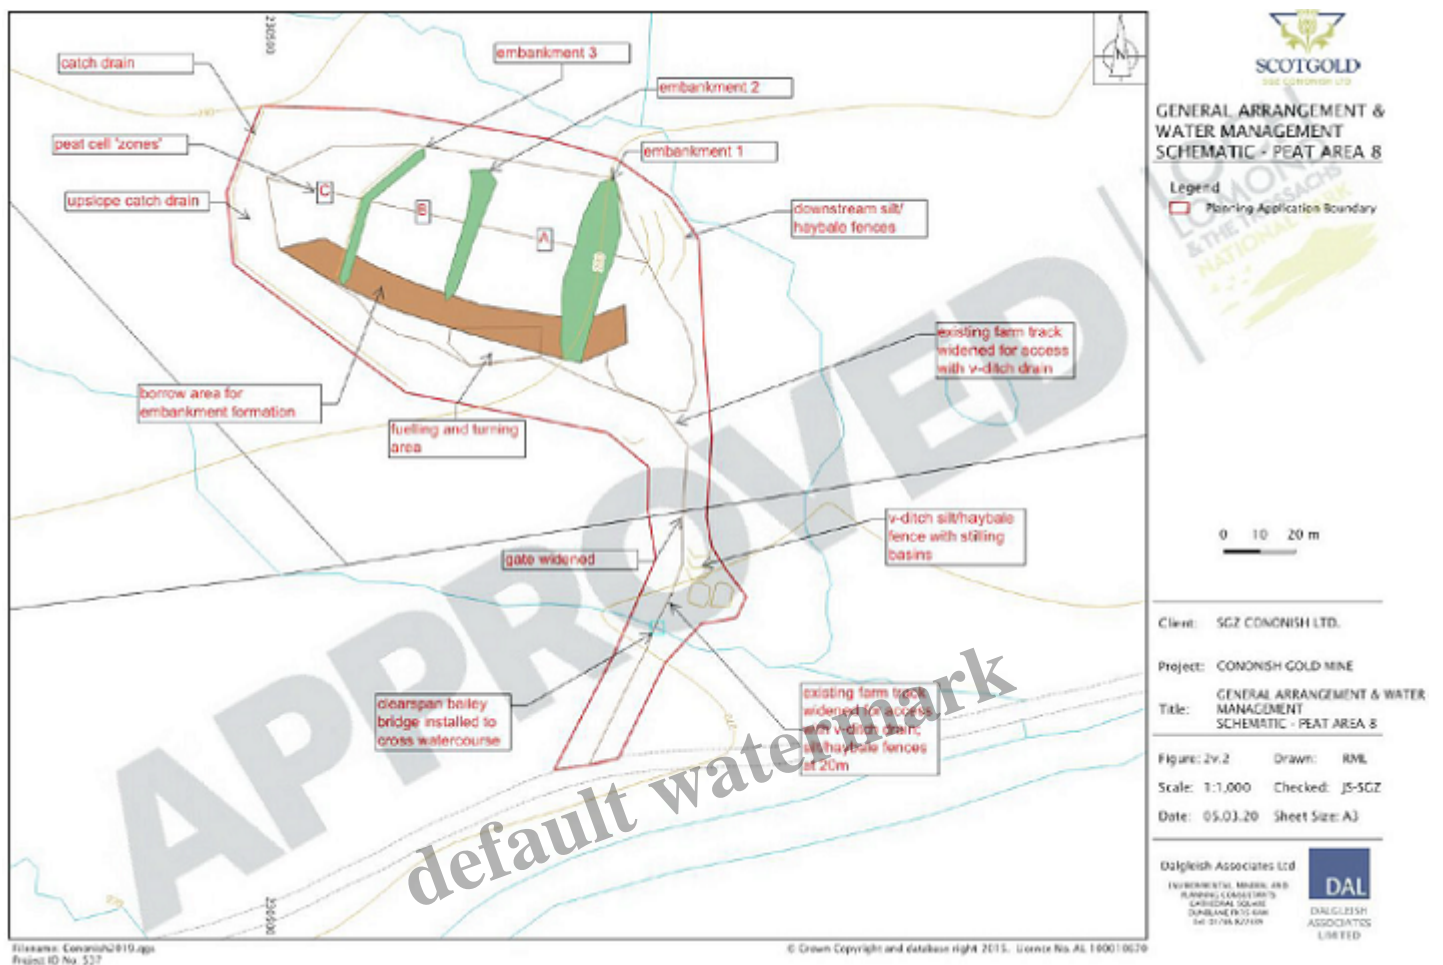
The temporary temporary peat storage area lies outwith the planning boundary for the mine, below Cononish Farm and in a “dip” in the landscape. Originally three “cells” were planned in which to store

the peat:

In the event Scotgold only excavated two (A and B) and has only used one (A). That lends support to the idea that when the amount of excess peat first became apparent, the LLTNPA's initial reaction was to stick with the planning conditions about how peat could be used on site. With nowhere to use it, their only option if the mine was to go ahead was to create a large storage facility while they figured out what to do next. Unable to come up with any other options, they then decided to relax the requirements of their peat management plan.

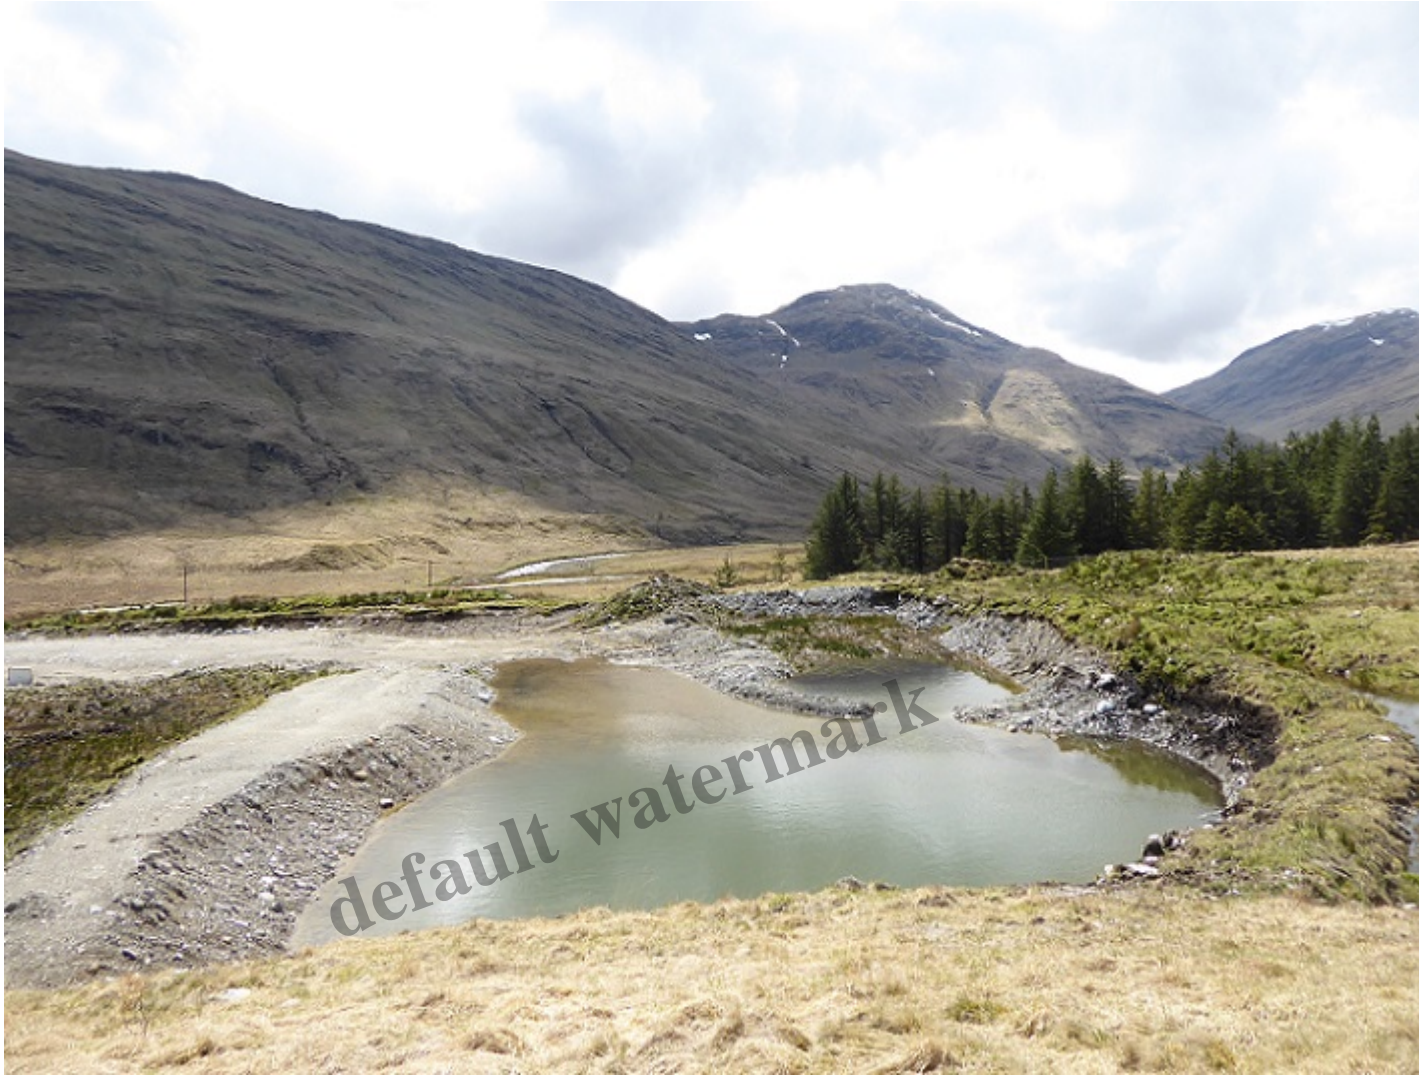
Peat storage cell B, with Ben Oss behind. Note the turves heaped up, one on top of the other, on the far side of what is now a pool.

In creating this large pit, which has so far never been used, yet more peat was excavated and moved.

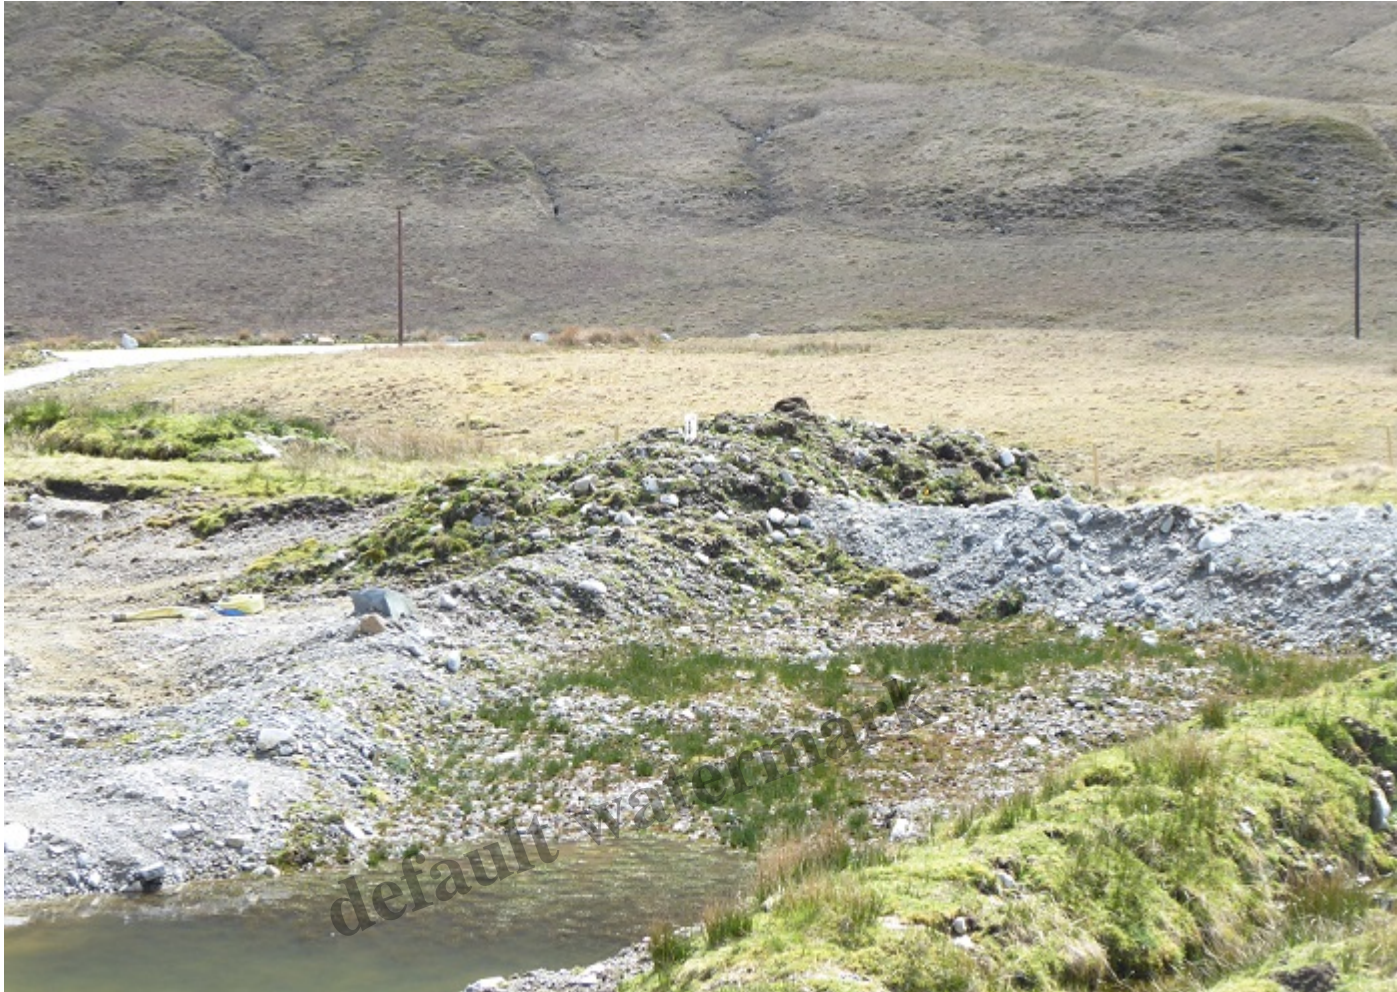
Close up of the heaps of turves at the end of storage area B.

The most recently published monitoring report for the mine, from last October, clearly stated Scotgold had failed to comply with the turf management plan: *“Storage of turves has not been in a single layer on tarp/geotextile”*. Over six months later, the LLTNPA and Scotland appear to have done nothing to address this failure.

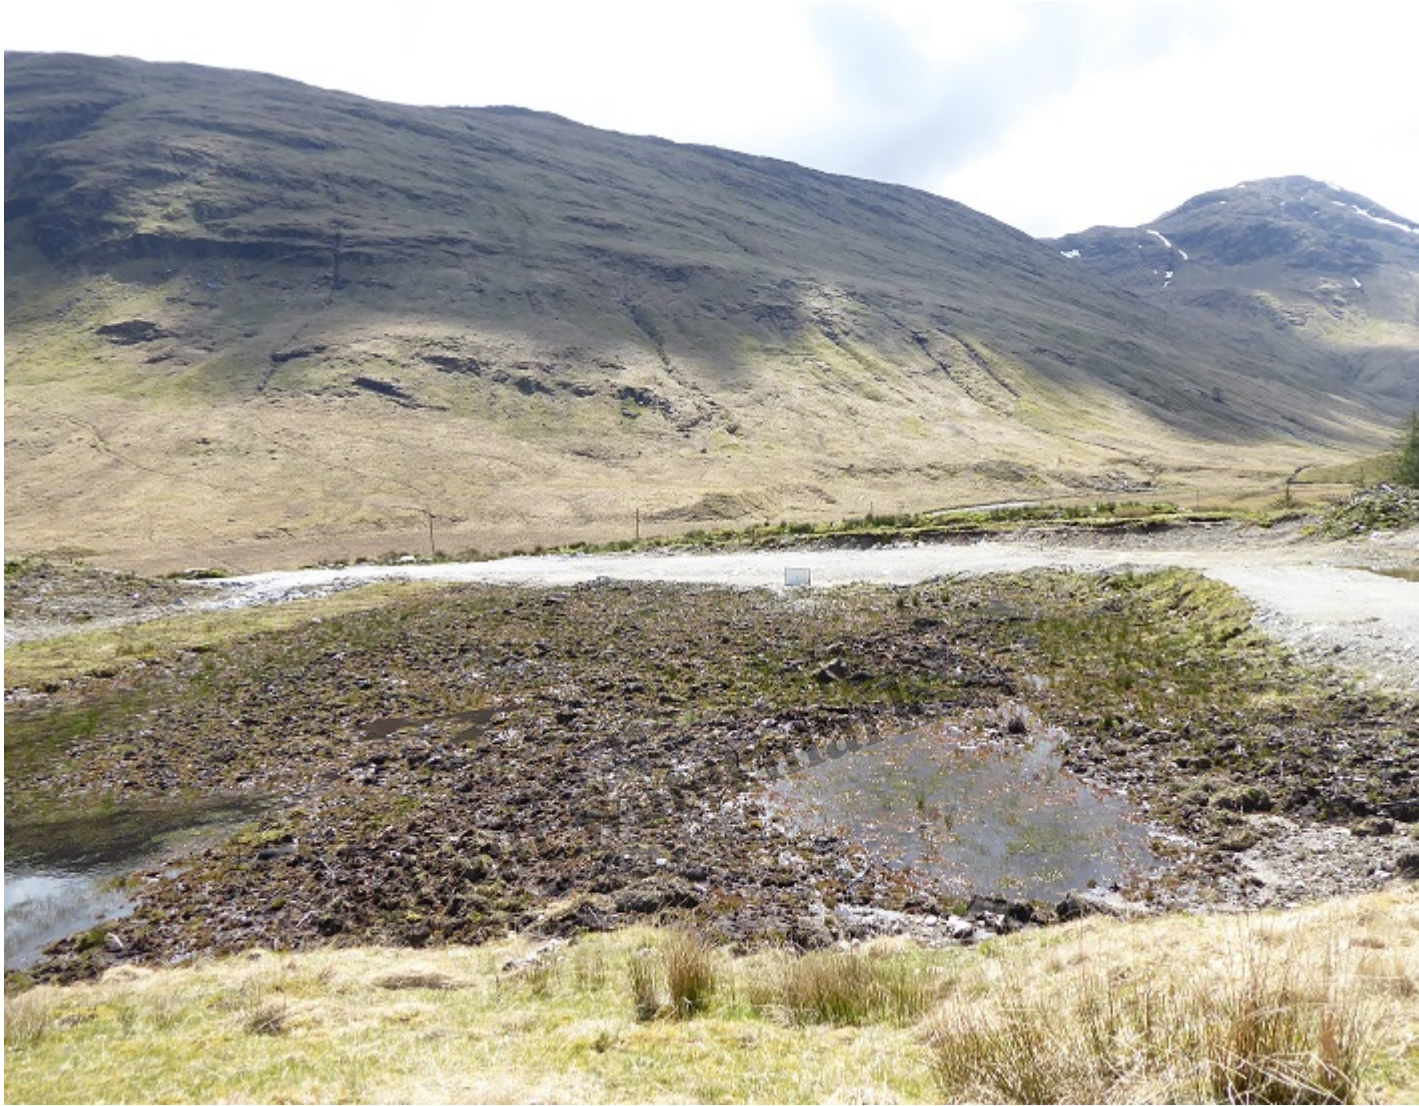
Peat Storage cell A

While the remaining peat in storage cell A is being kept wet, which helps prevent it disintegrate, a considerable surface area is exposed to the atmosphere, where it reacts with oxygen and steadily releases Carbon Dioxide into the atmosphere.

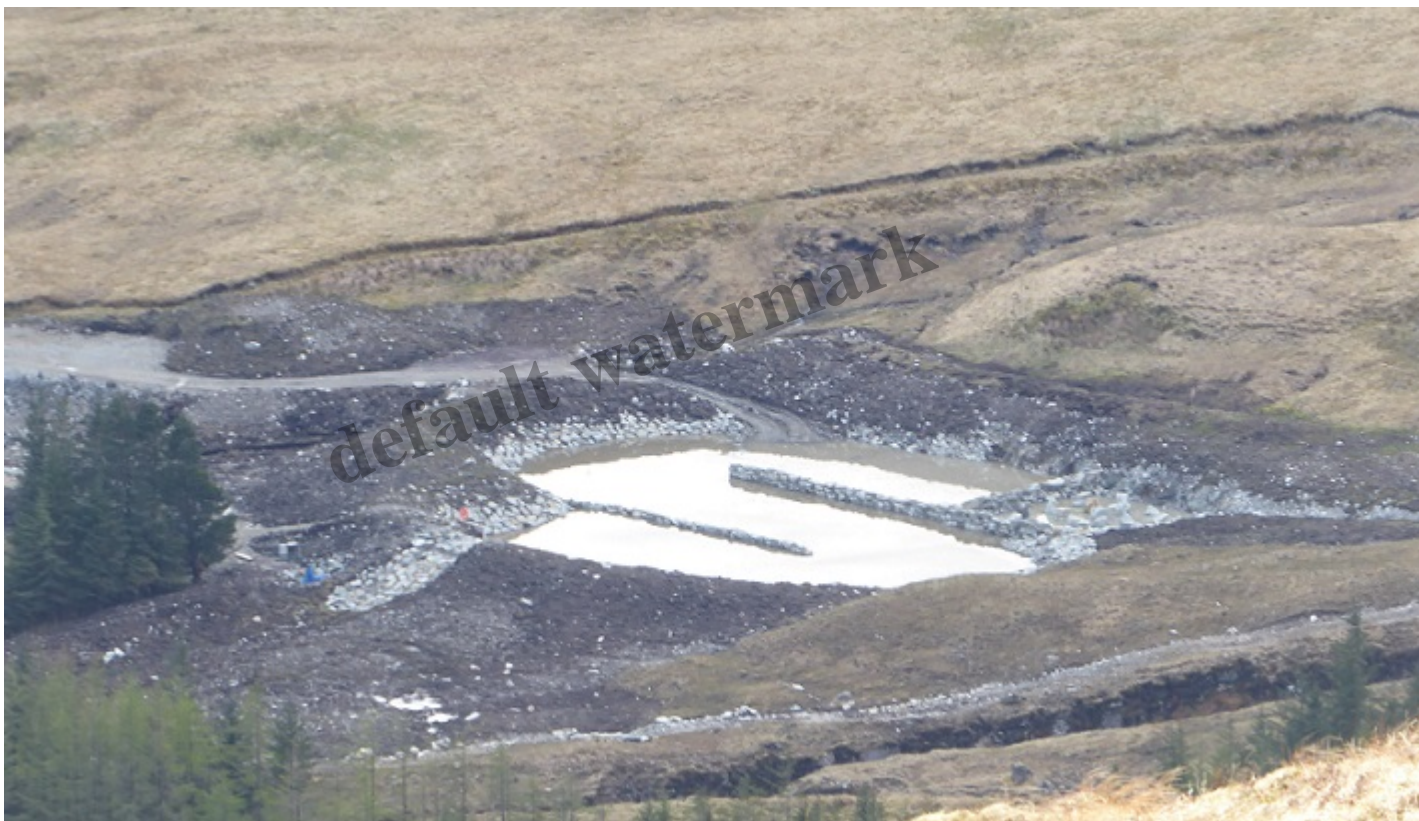
One of the areas where some of the excess peat may have been used is around the new settling pond at the bottom of the mining area:

Note the large areas of exposed soils and peat – another example of the failure to re-use turfs or “acrotelmic peat”.

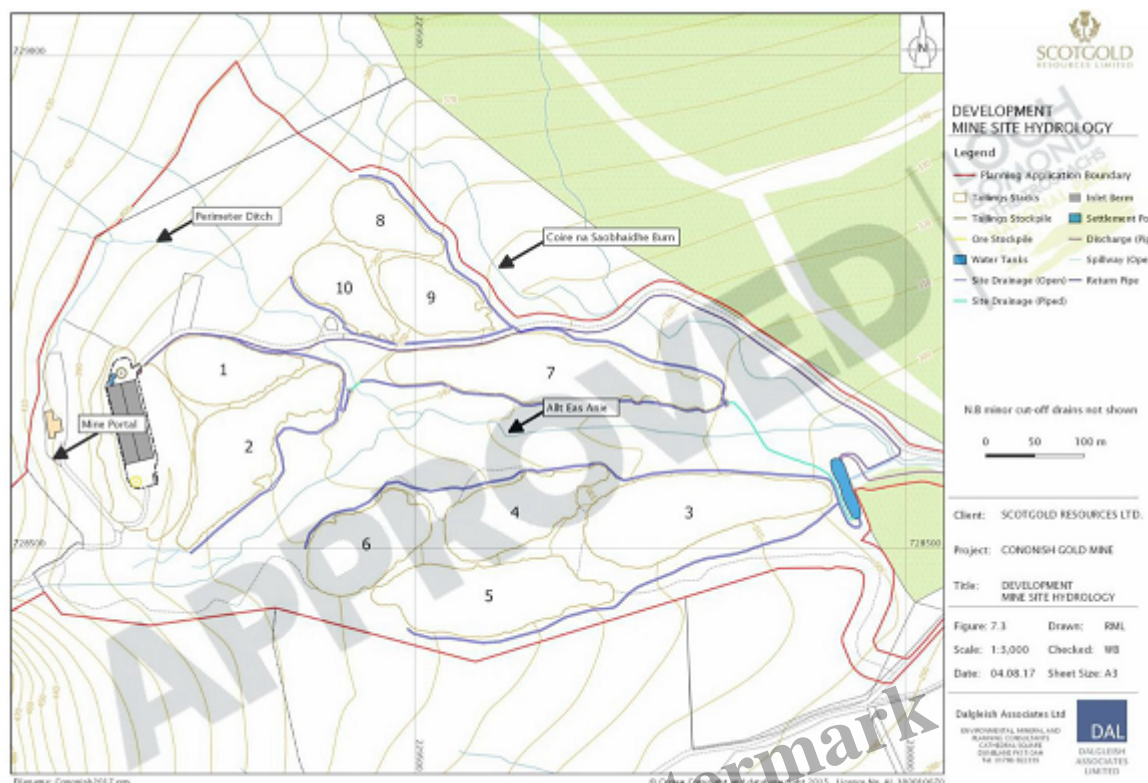
Settling pond marked in blue, below the ten proposed tailings stacks

The Planning Monitoring reports indicate that the design and location of the settling pond have changed since the original application. There is nothing on the planning portal to show how this was approved (normally planning officers would either consent to a “Non-Material Variation” or require a new planning application to be submitted). This represents another big hole in the planning process. Without agreed plans, there are no planning conditions to be enforced and, when it comes to restoration, it will be anyone’s guess as to what should be removed from the site. My bet is that this settling pond, with its rip rap bouldering, stone vetements and suburban-type landscaping will never be restored.
