Cairn Gorm – the construction site at the heart of the National Park (2)

Changes to the repair plans

What’s happening on the ground

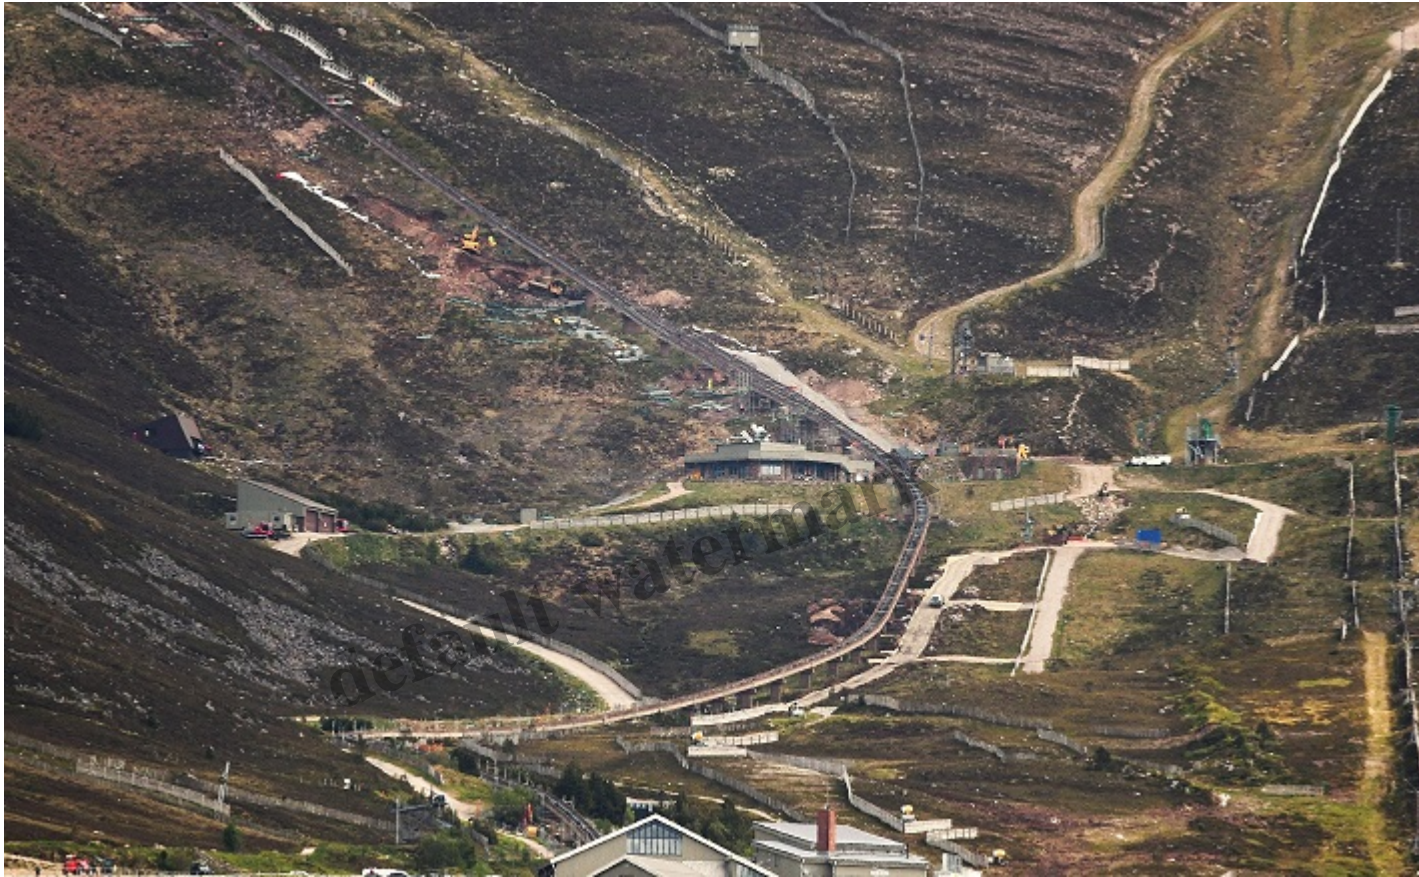
View of middle section of funicular repair work showing temporary access tracks on righthand side of track and extensive earthworks by and above the mid-station. Photo credit George Paton mid-June

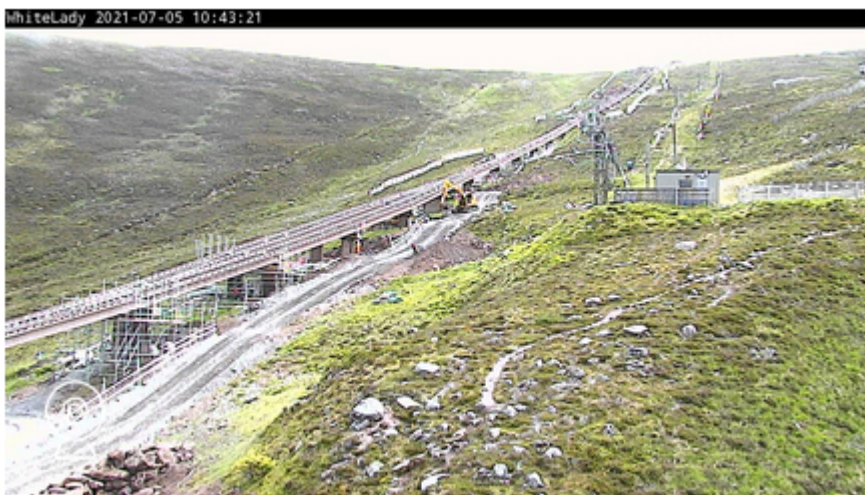
The minor earth works at the passing area earlier today

In the report to the Cairngorms National Park Authority Planning Committee last May, drawings ([see here](#)) were included of proposals to strengthen the support beams with braces and add 63 props to the 94 piers that supported the viaduct. These, it was claimed, “will involve minor earth works to allow construction”.

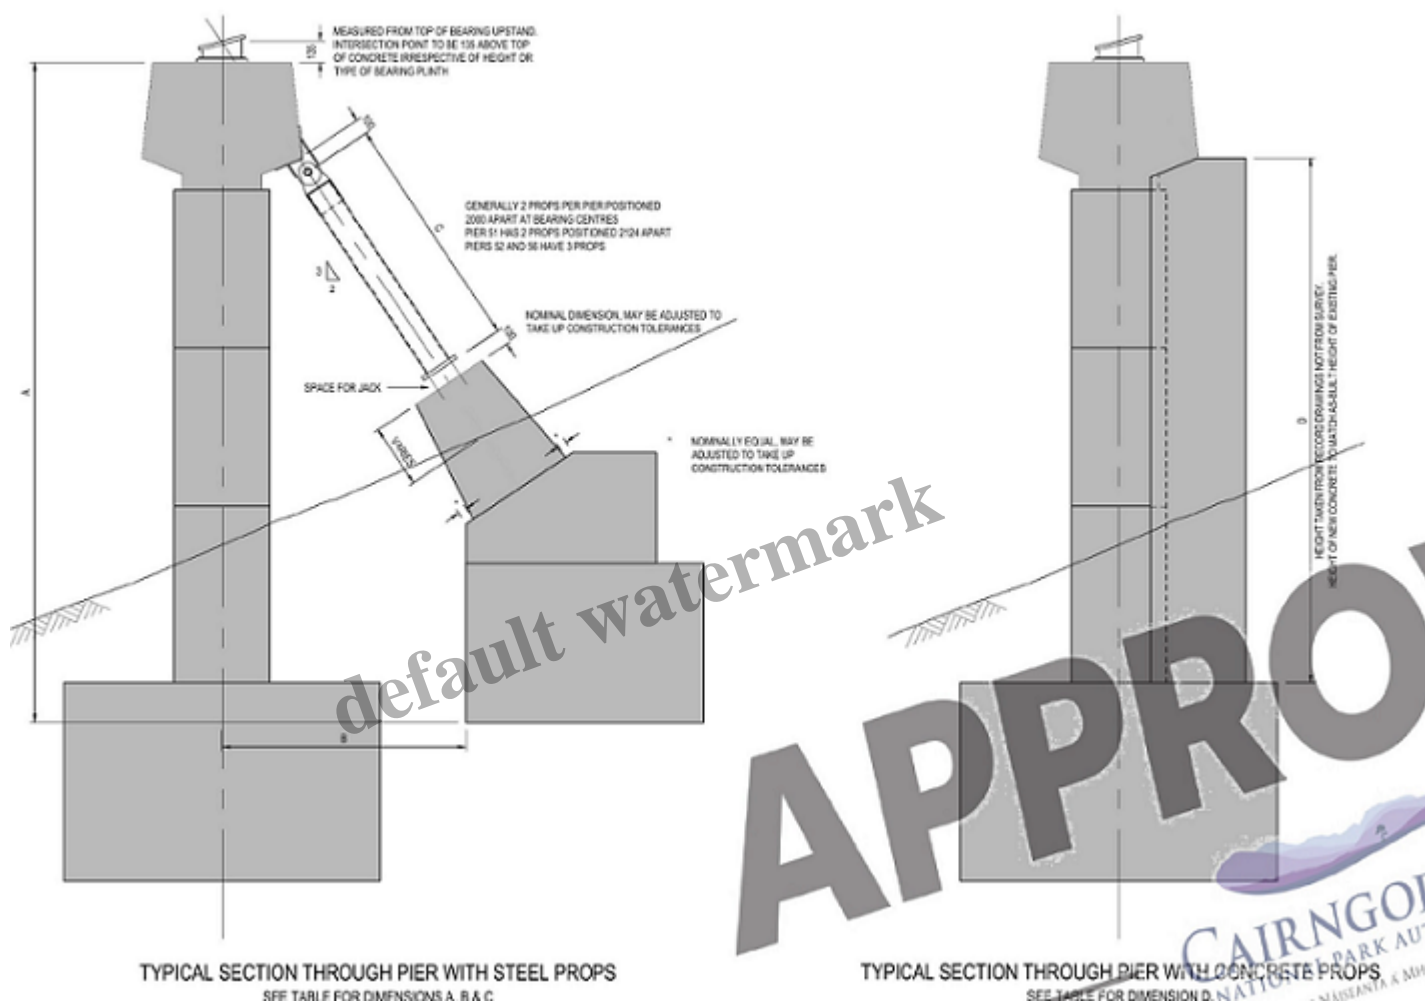
Extract from the new plans. The left hand diagram appeared in the CNPA Planning Papers, the right hand one is new!

What the documents do show that is instead of adding props supported by new foundations to all 63 piers, the plan now is to reinforce 19 of the piers with additional concrete supports, as in the diagram on the right and, in three cases, to strength the piers with short concrete jackets.

The revised proposal to install 22 concrete props/jackets suggests that in these cases the problem has not been that the piers are tilting, but rather they are not strong enough to support the viaduct above.

Given that the other piers appear to be tilting and need propping up due to inadequate foundations, one wonders at the wisdom of adding a lot more weight to the foundations of these 22 piers. How does Liff know that the new concrete props won't make the foundations tilt or slide?

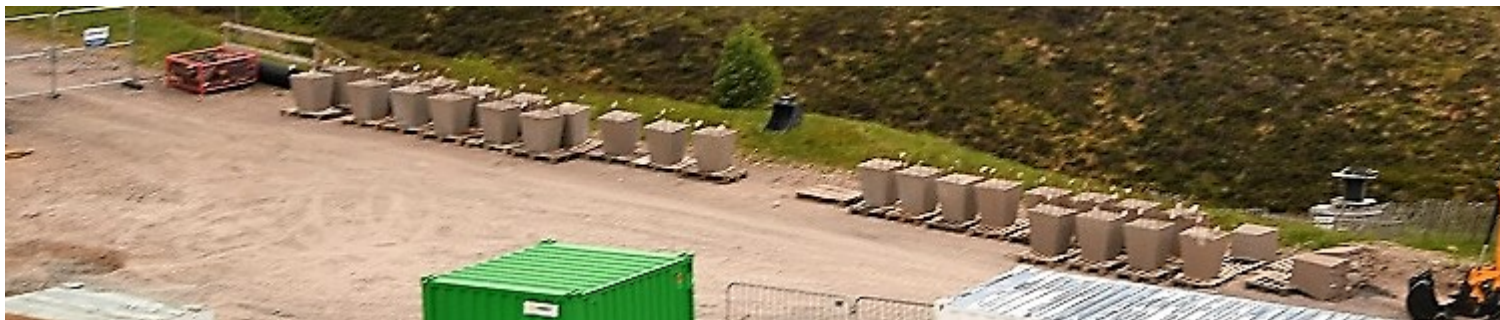
PIER NUMBER	TYPE OF PROPPING	DIMENSION	DIMENSION	DIMENSION	DIMENSION	DIMENSION	DIMENSION
		A	B	C	C	C	D
				NORTH	MIDDLE	SOUTH	
ON HOLD							
	1	??	0	0	0	0	
	2	??	0	0	0	0	
	3	??	0	0	0	0	
No Propping required for Piers 4 to 33							
34	Steel props with symmetric deep foundation	4891	2096	2500	-	2500	-
35	Steel props with symmetric deep foundation	4475	1818	2000	-	2000	-
36	Steel props with symmetric deep foundation	4142	1596	1600	-	1600	-
37	Steel props with symmetric deep foundation	4142	1596	1600	-	1600	-
38	Steel props with symmetric deep foundation	4058	1541	1500	-	1500	-
39	Steel props with symmetric deep foundation	3975	1486	1400	-	1400	-
40	Steel props with symmetric deep foundation	3809	1375	1200	-	1200	-
41	Steel props with symmetric deep foundation	4142	1596	1600	-	1600	-
42	Steel props with symmetric deep foundation	3892	1430	1300	-	1300	-
43	Steel props with asymmetric foundation	4359	1541	1861	-	1500	-

44	Steel props with asymmetric foundation	4858	1874	2461	-	2100	-
45	Steel props with asymmetric foundation	5357	2207	3061	-	2700	-
46	Steel props with asymmetric foundation	5607	2373	3361	-	3000	-
47	Concrete prop	-	-	-	-	-	1535
48							
49	Short concrete jacket	-	-	-	-	-	390
50	Concrete prop	-	-	-	-	-	1230

Extract from latest plans. Foundations for the supports hold the steel props are described as symmetric or asymmetric and as “deep foundation”, “foundation”, “shallow foundation” or “triple foundation”.

(As an aside, note how in the case of the first three piers, the props are described as being “on hold”. That hardly inspires one with confidence that HIE has got to the bottom of what has gone wrong).

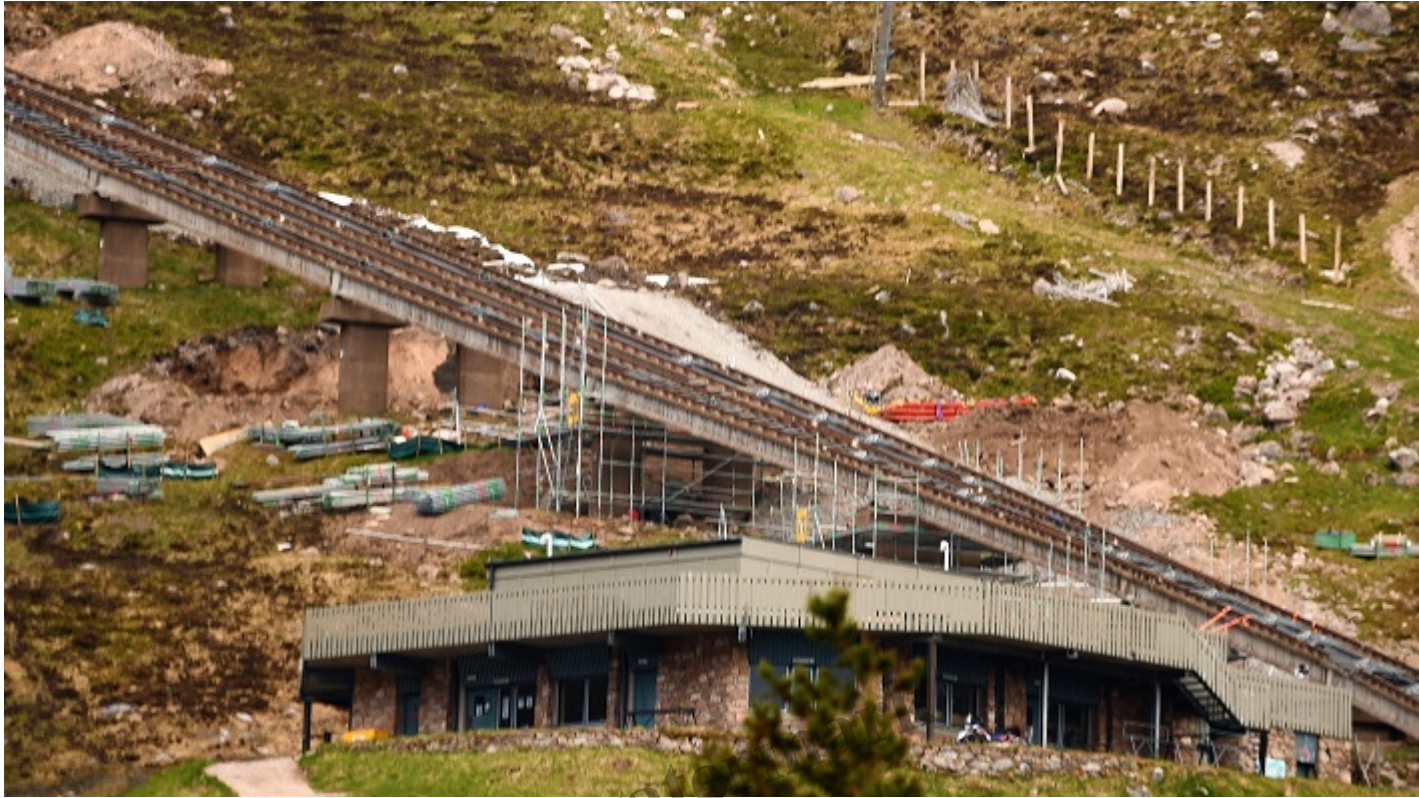
George apologises for the slightly blurry photo but it helps show the extent of the “minor earthworks” approved by the CNPA! Photo Credit George Paton

The area around the double track passing place and loading station appears far worse: huge holes, a large excavated “temporary” access track (on the far side) and piles of excavated material.

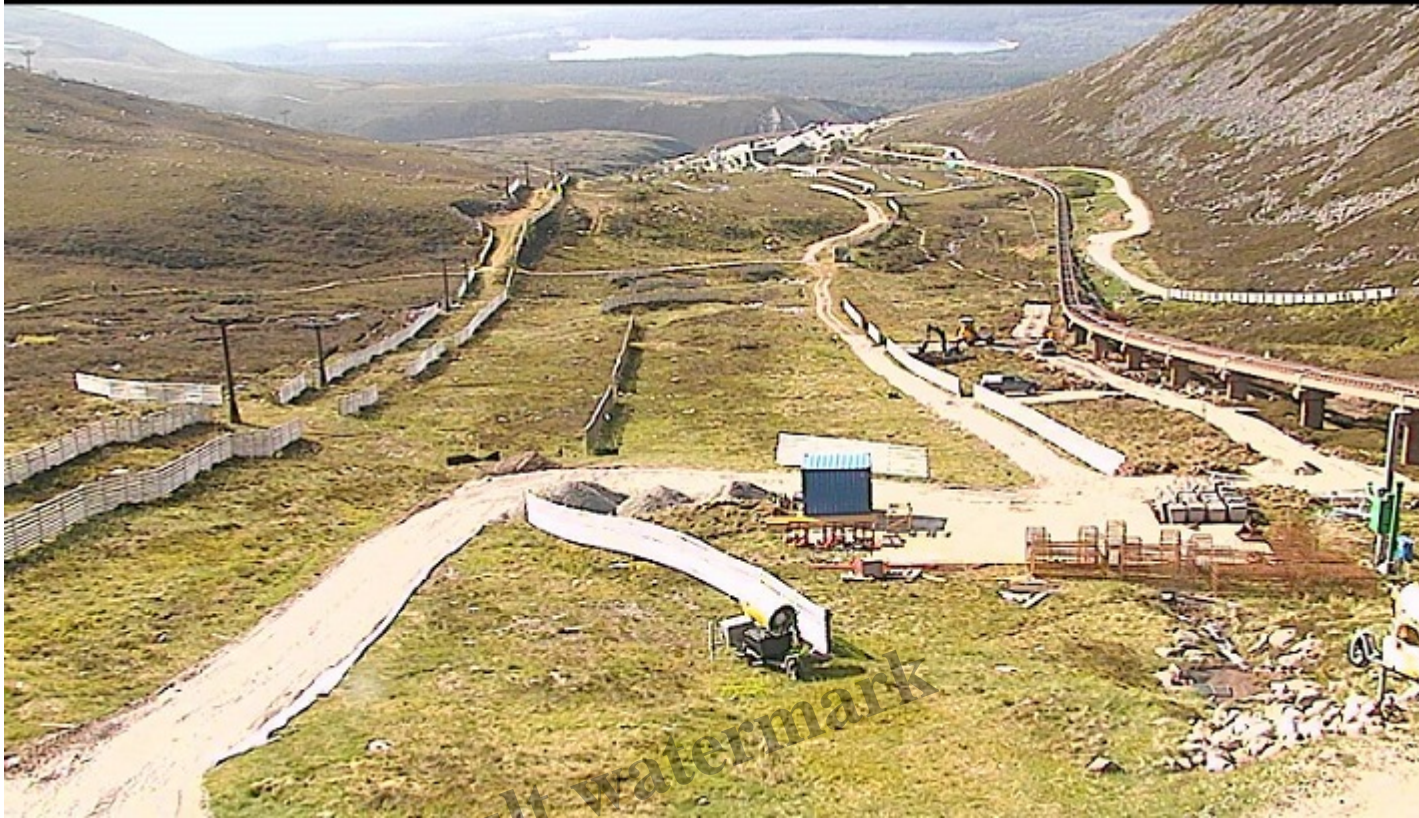
Looking down the Shielling “SunKid” Rope tow. Photo credit CMSL webcam

The track on the left was constructed unlawfully as part of the installation of the SunKid tow ([see here](#)) but then granted retrospective planning permission by the CNPA. It has now been “temporarily” upgraded and a further new temporary track created parallel to the funicular to provide access for the repair work. A geotextile, visible on the left of the screenshot, has been placed below the new surface. This appears to follow a recommendation from SEPA that *“all temporary tracks where peat would otherwise be excavated comprise of geotextile or plastic track matting unless there is a significant technical reason why this is not feasible.”*

While the ground by the funicular is very peaty, any peat under the sunkid track was destroyed during its construction (see link above for photos). All the geotextile matting will do therefore is kill the vegetation below. Where the track needed to be widened temporarily it would have been far less damaging to have excavated and saved the surface vegetation and then replaced this. The photos provide no evidence that such protection and restoration techniques are happening at Cairn Gorm, whether on the temporary access tracks or around the pits that have been excavated for the new piers. My guess is that is far too expensive and instead HIE will re-seed the damaged areas in due course.
