## Cairn Gorm – the environmental impacts of HIE's developments

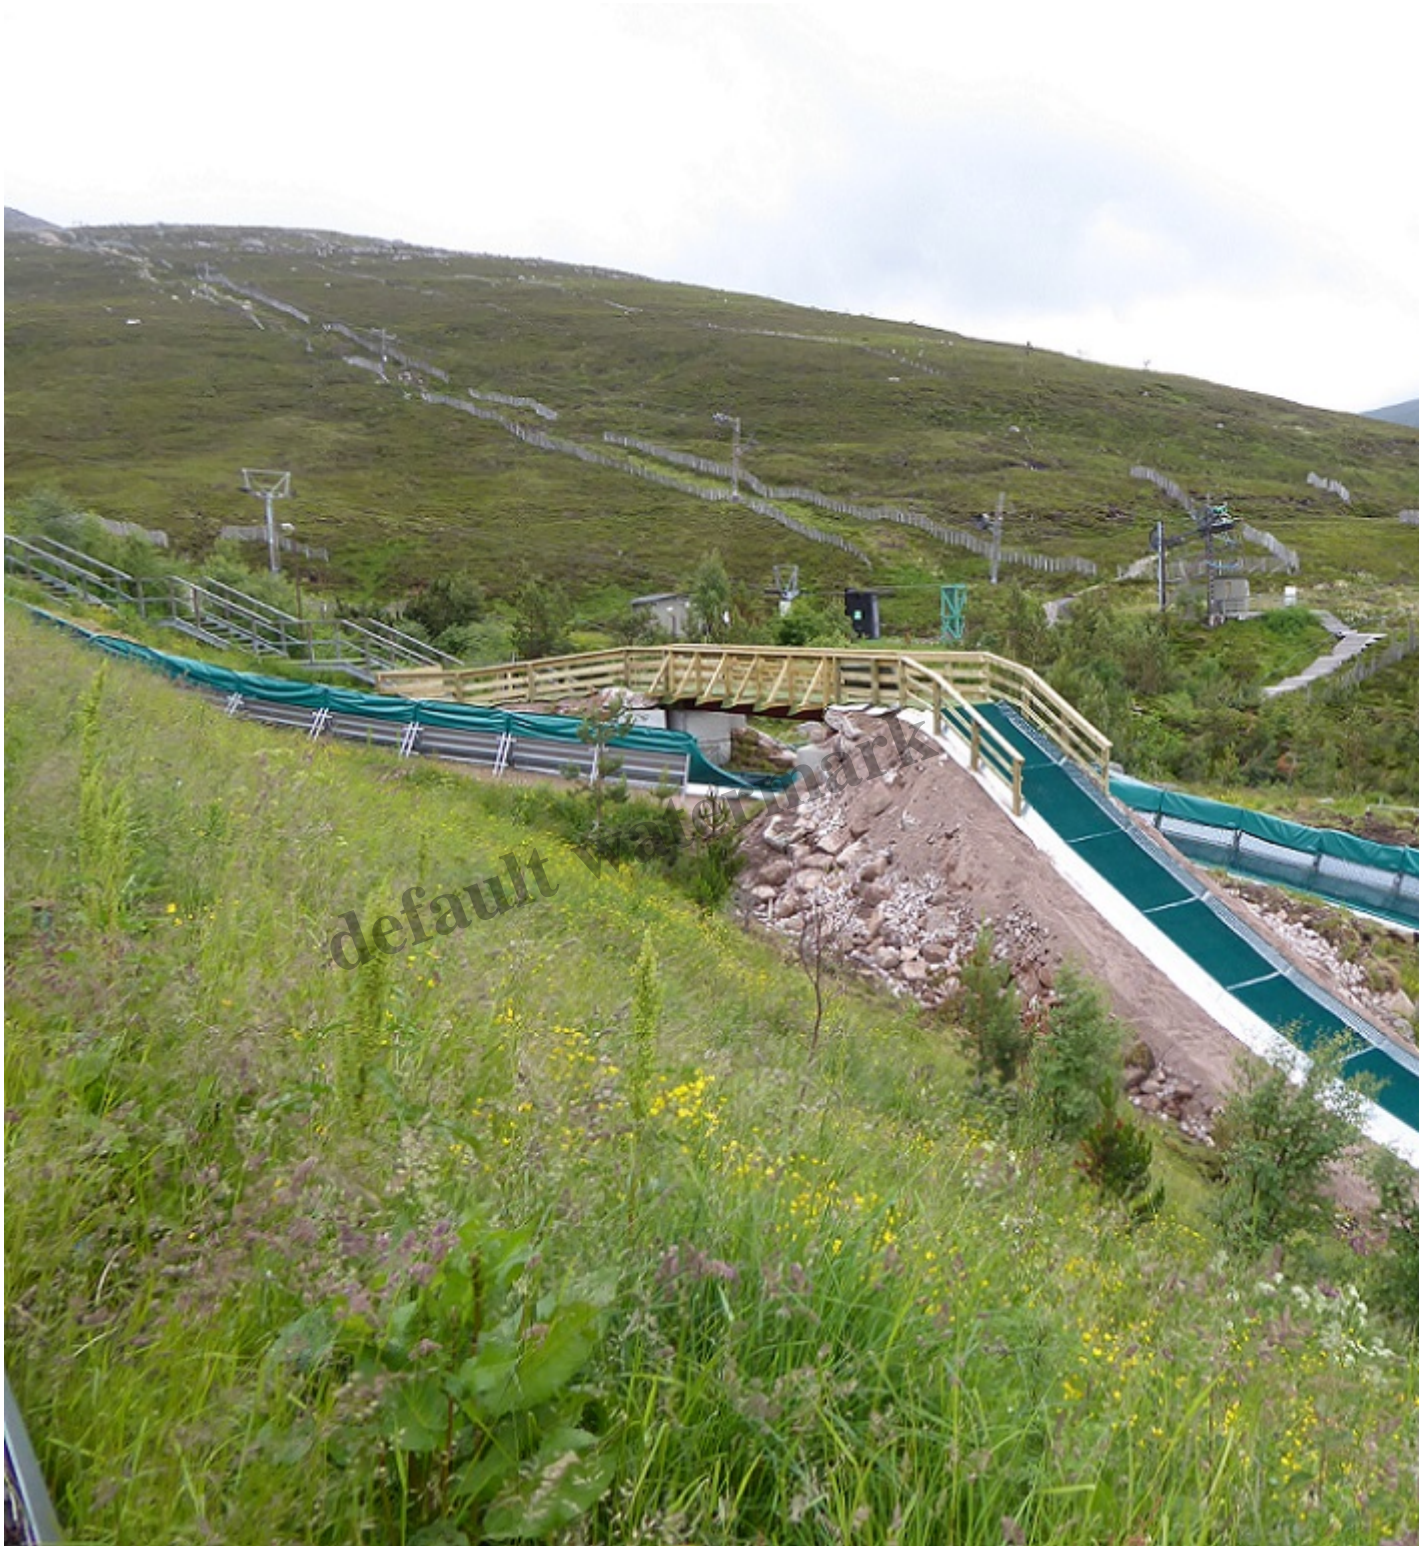
Note how the steep sides of the tube slide by the bridge have already started to erode

On Sunday evening I went up to take a look at Cairn Gorm, the first time since the repair of the funicular started. I got a photo of the construction ([see here](#)) of the tube slides before the rain started. The steel support structure for the slides, referred to in the planning application, appear to have disappeared

The steel supports were also referred to in this email from Jim Cornfoot of Cairngorm Mountain Scotland Ltd to the Cairngorms National Park Authority just six weeks ago. In place of steel supports the tube slides have been placed on a pile of what appears to be excavated glacial till. There is no indication on the planning portal that the CNPA Planners have agreed to this or how Cairngorm Mountain Scotland Ltd intend to “finish” the sides. These appear far too steep to “restore” with vegetation. It’s hard to see how wood “to match the handrails” on the bridge, will be much use here but perhaps I have missed something?

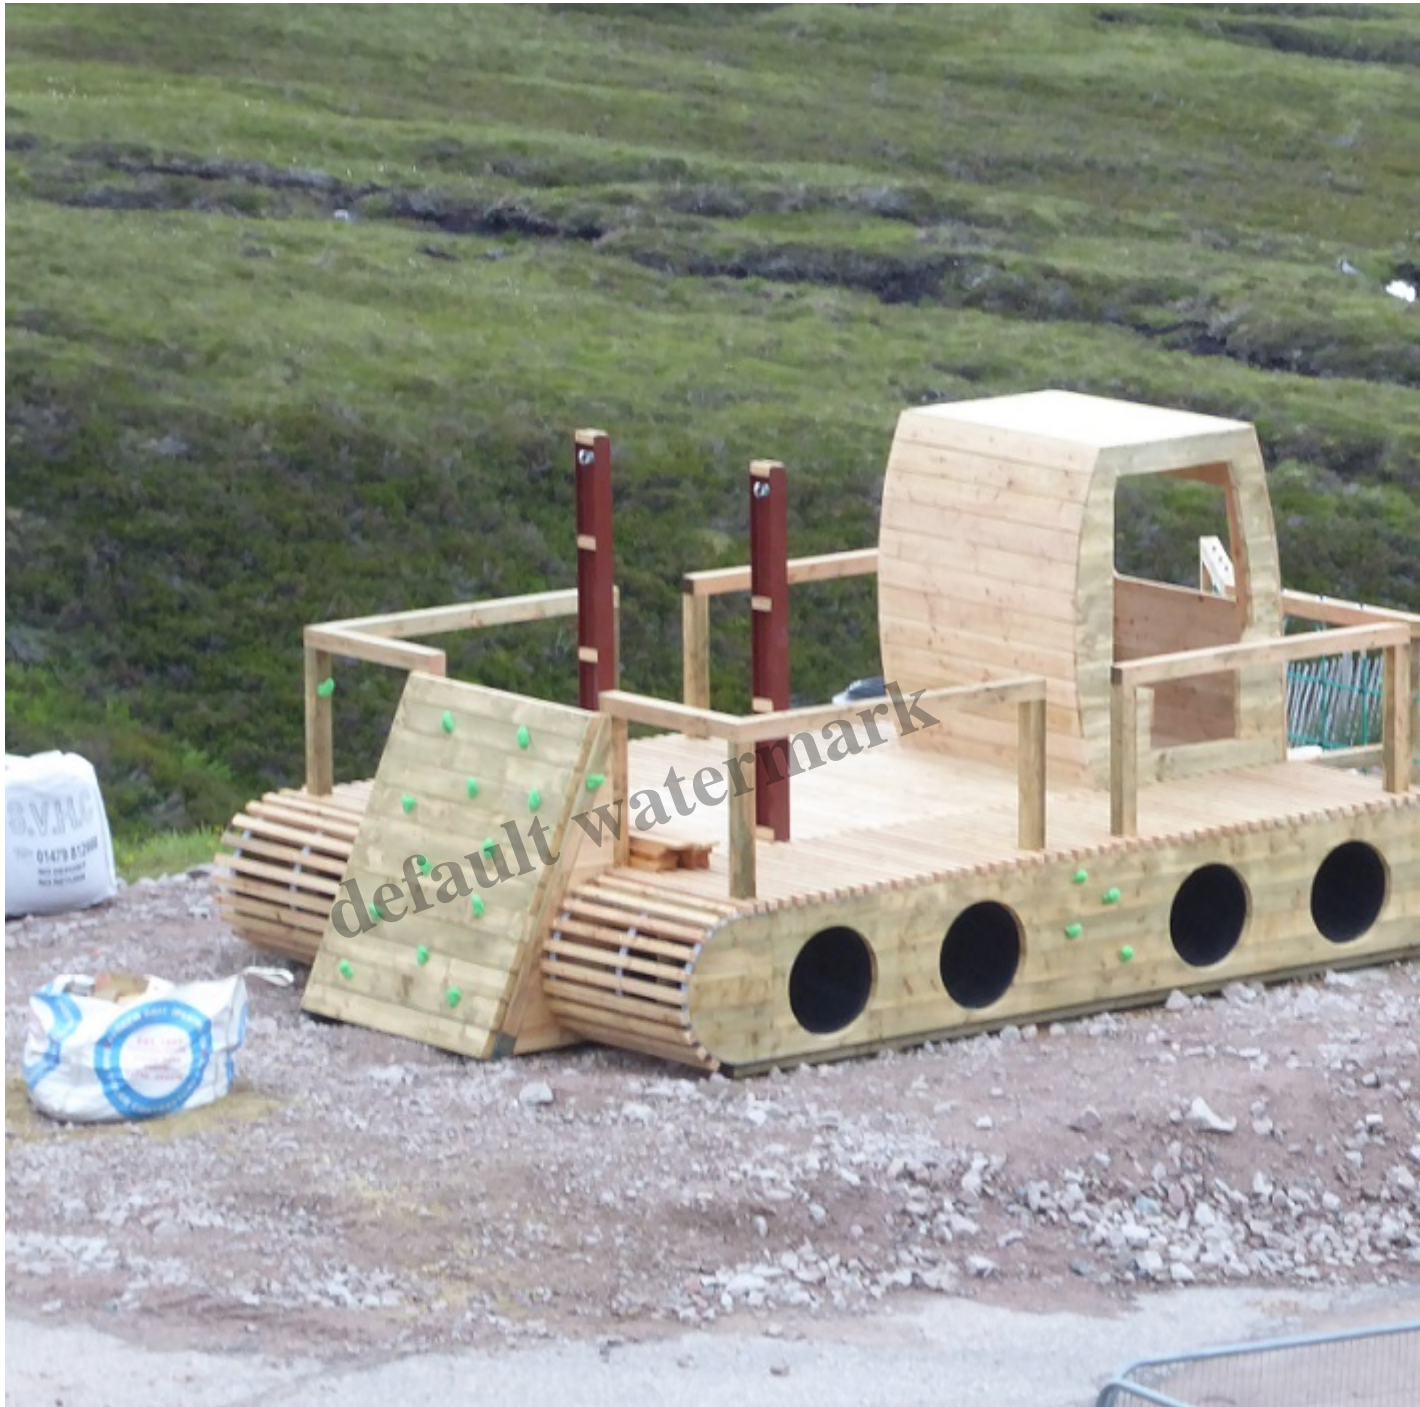
Piste machine on a new raised platform.

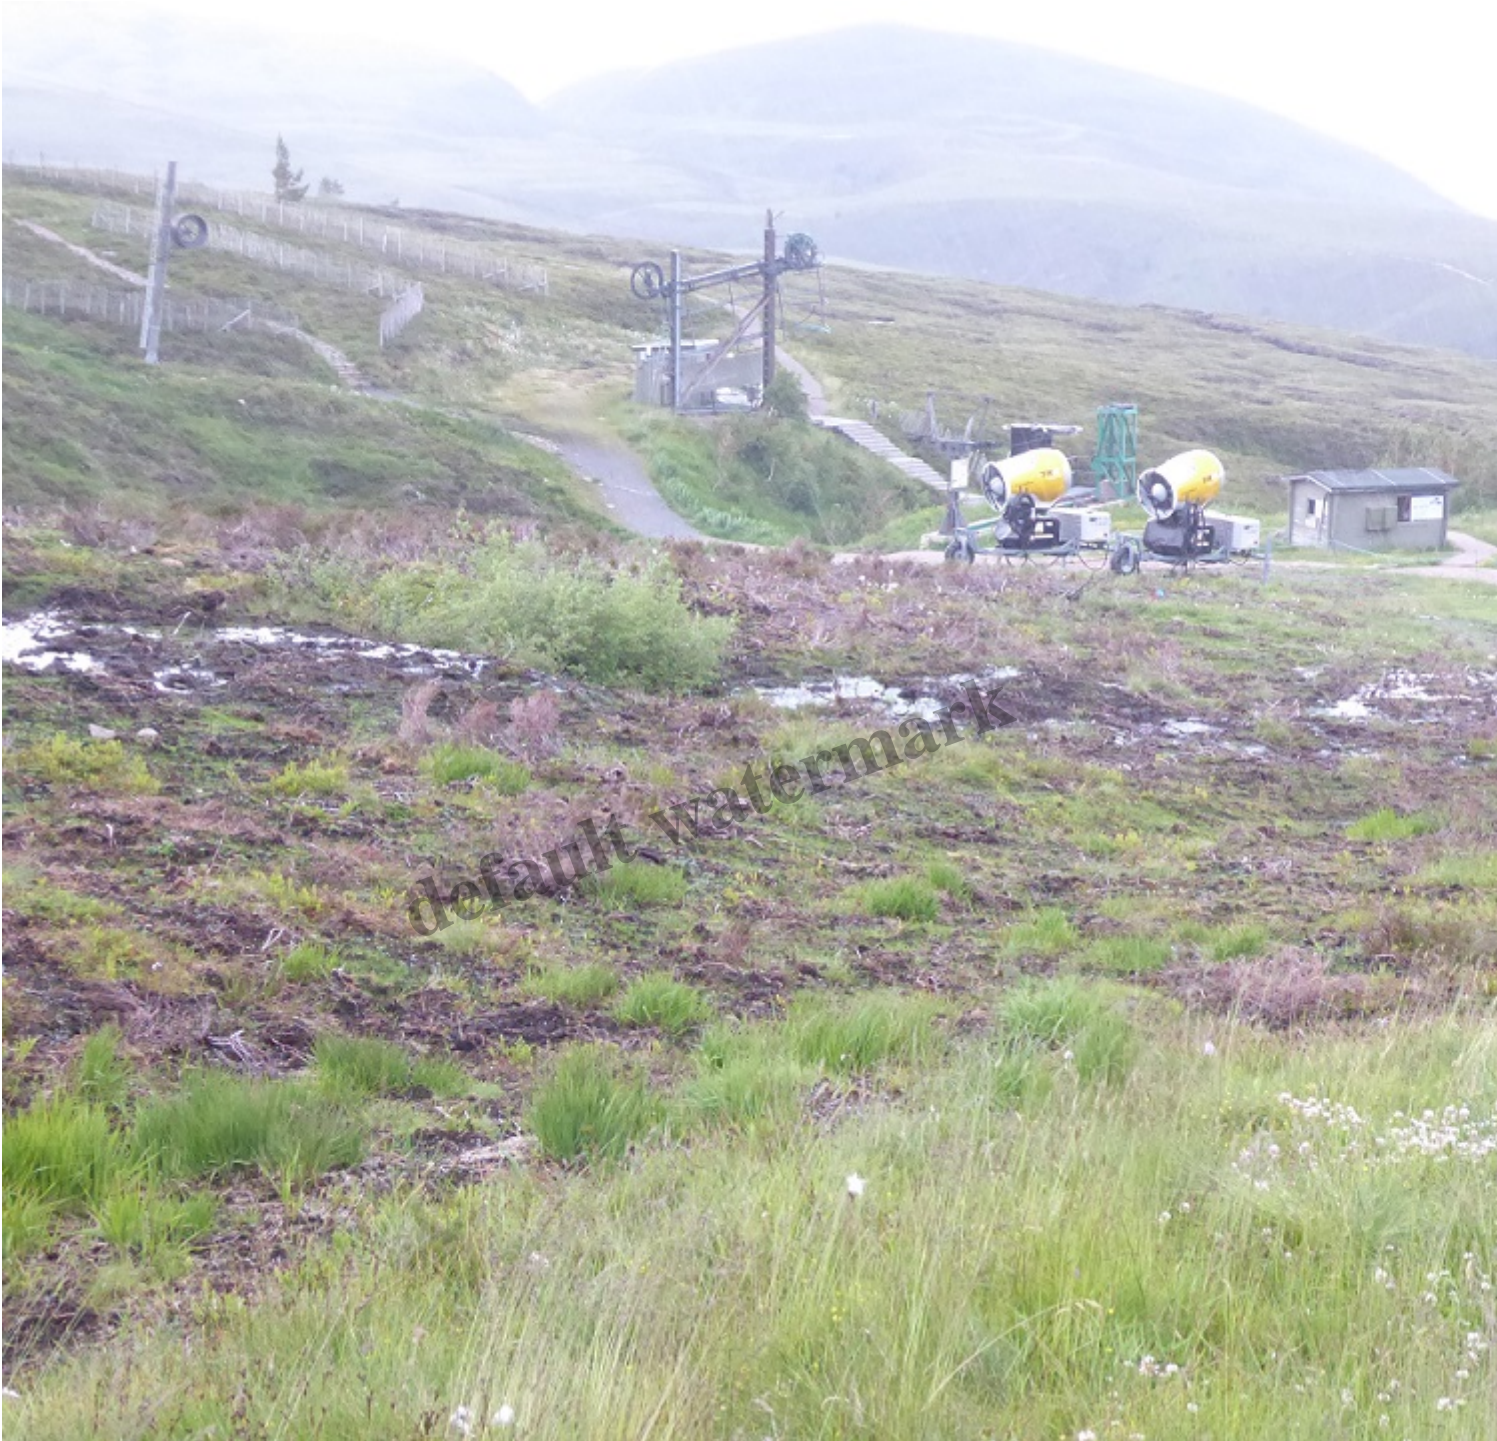
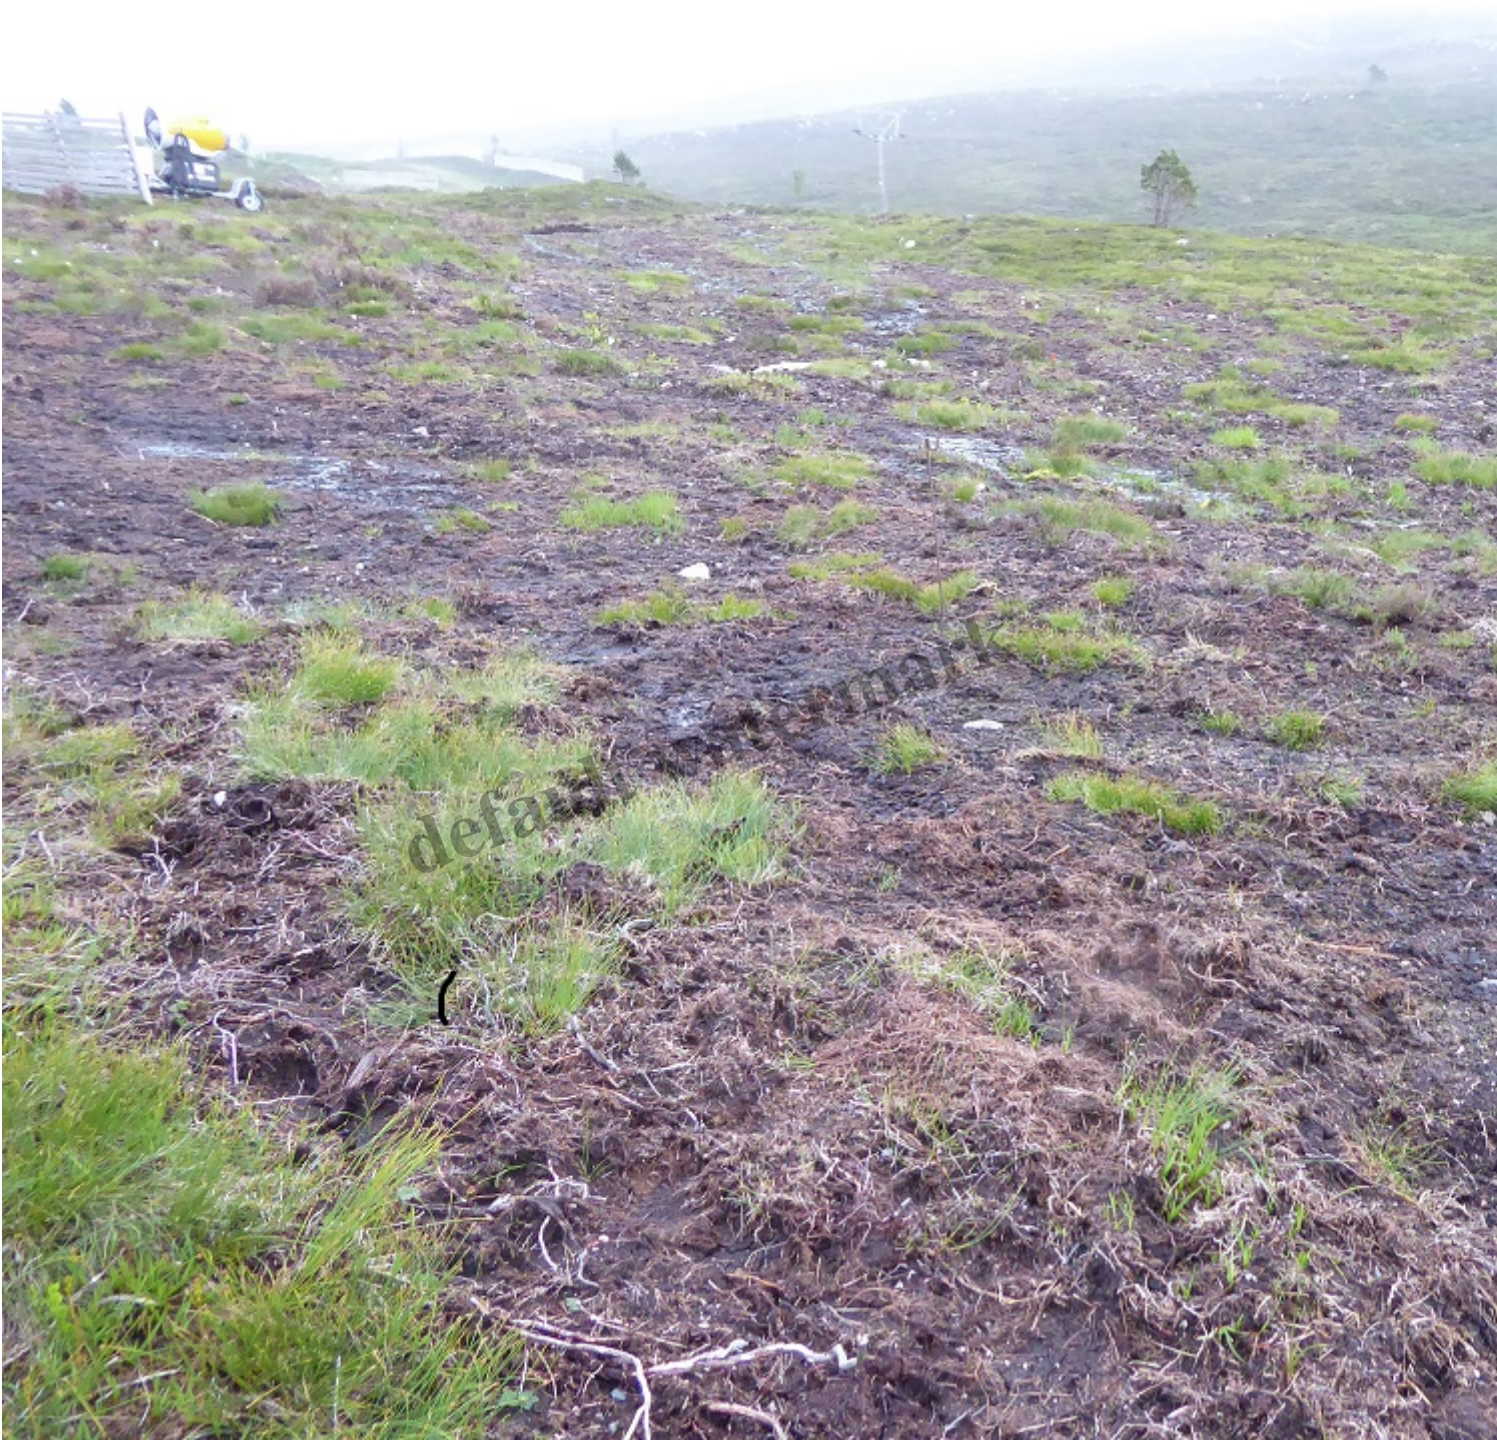
As we left the car park, the new beginner's area Highlands and Island Enterprise had created above the snow machines – the ground was smoothed to make the artificial snow go further – was already pouring with water when it started to rain. It appears that Parkswatch's prediction ([see here](#)) that the development would increase water run off and risk of flooding is correct. Instead of a bog, which absorbs water, HIE and CMSL appear to have destroyed much of the water holding quality of the peat and in doing so have instigated the creation of new watercourses.

The lesson, which also applies to the funicular repairs, is that you mess with the hydrology of slopes in the mountains at your peril. On our return, by which time the rain was very heavy and it was too wet for photos, one of my companions noted that a culvert that had been installed under the slope was bone dry. Another indication, perhaps, that the works have resulted in more water now flowing over the surface. Not much good either as a base for artificially created snow or skiing!

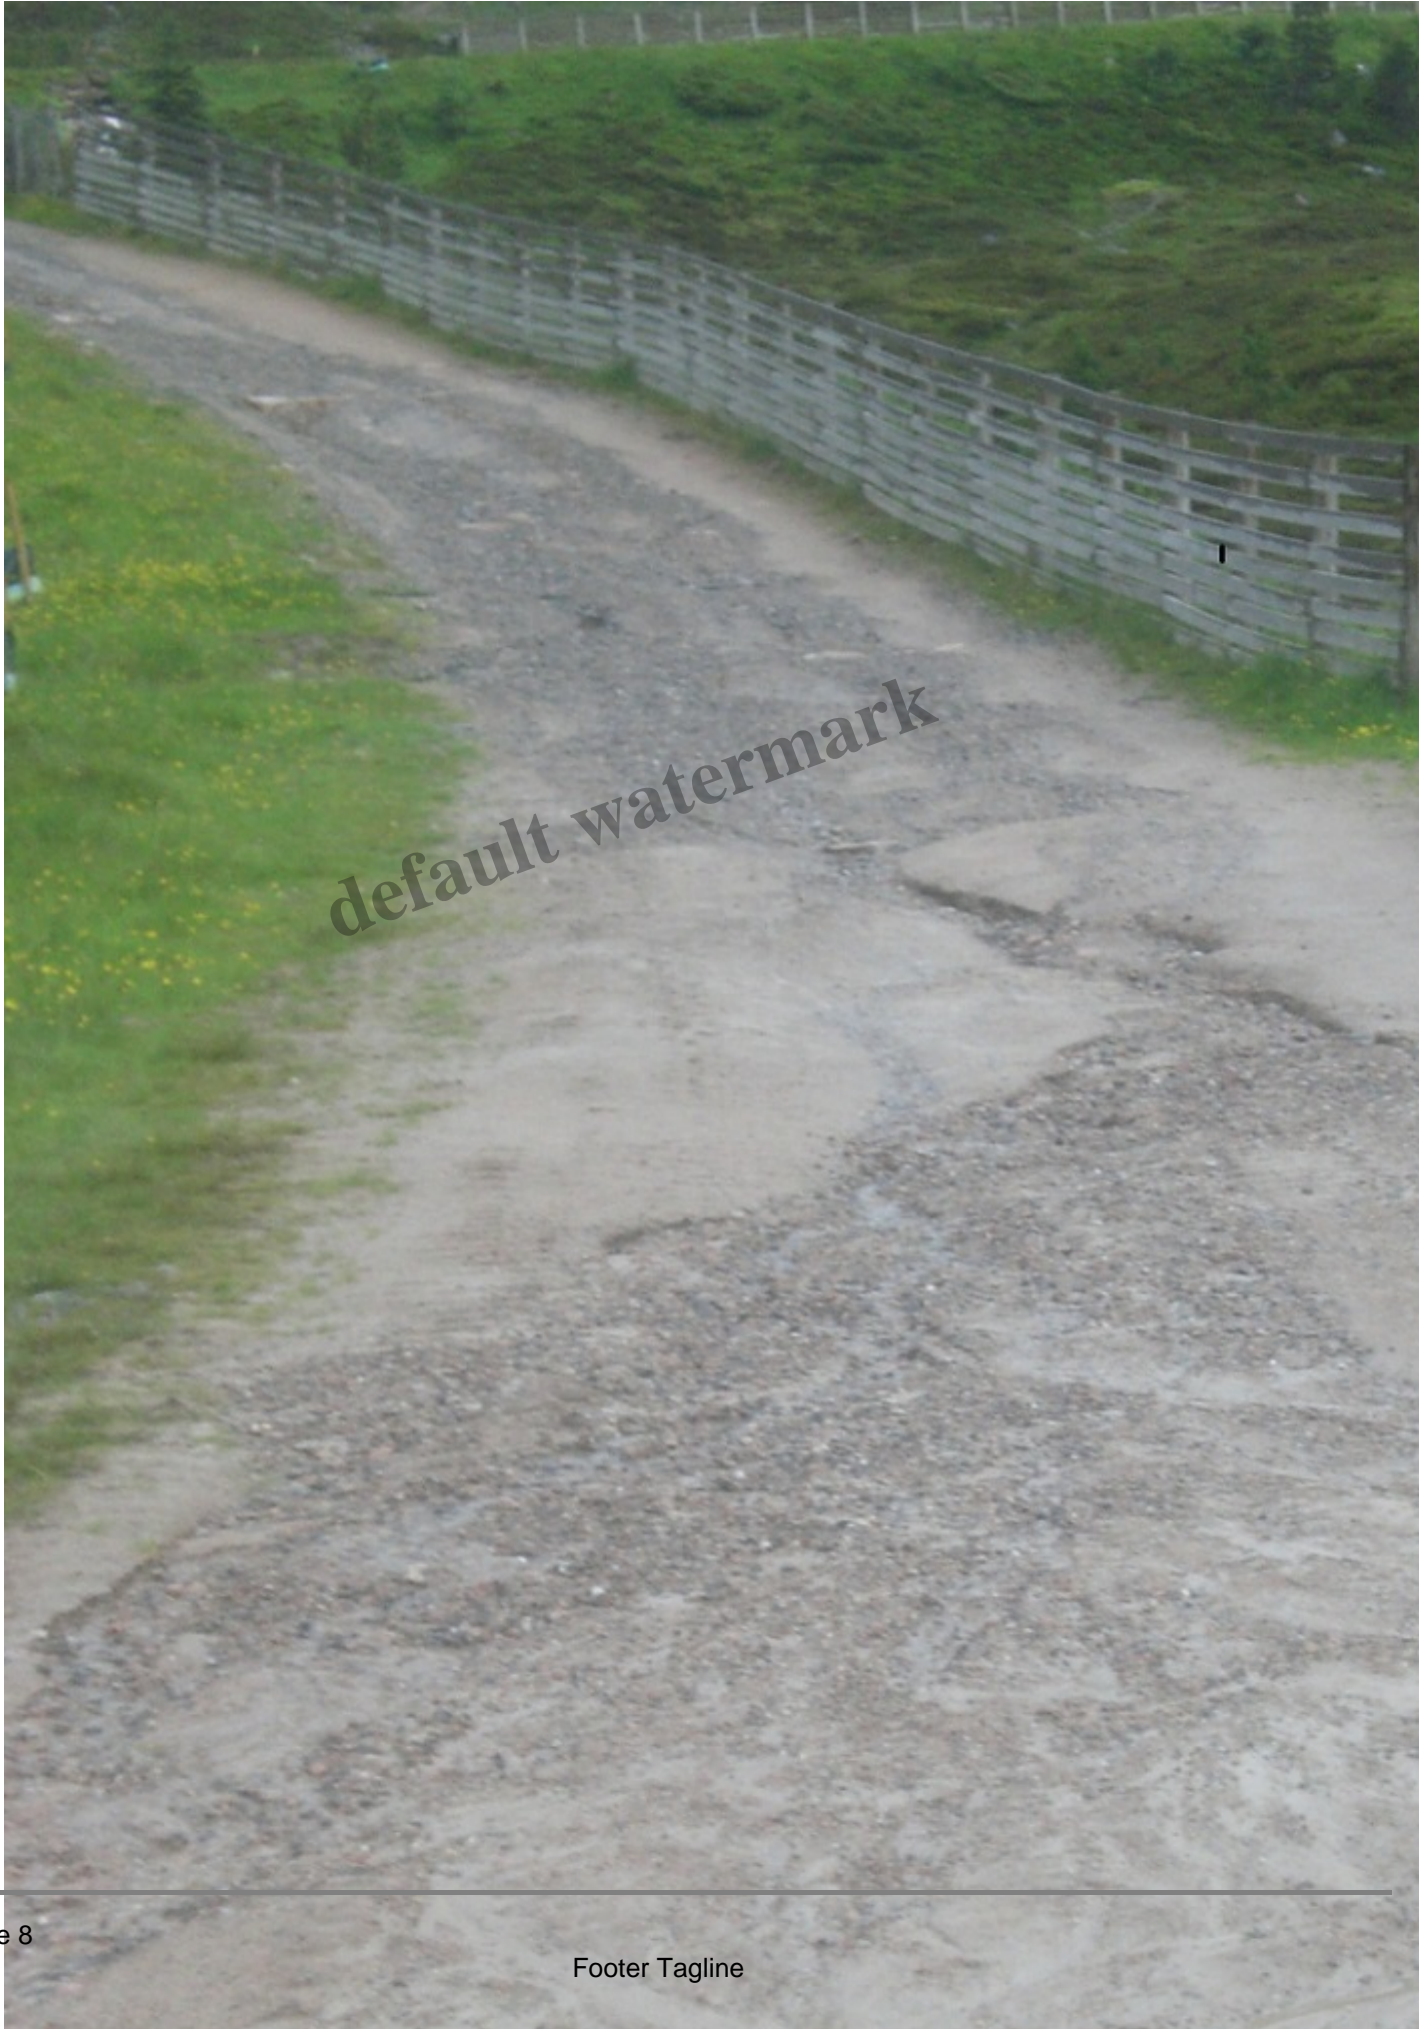
Keeping to the water theme, walking back down from the shieling, the hill road was awash with water and eroding fast. There had been reference in the funicular repair planning application to the need to improve this road for construction traffic and you can see that below the fence and alongside it that new surface material appears to have been added. Whatever its origins, the surface is now eroding fast. Unfortunately the CNPA agreed that none of the access tracks required planning consent so they now cannot do anything about this except ask politely and that, as everyone should know by now, gets you nowhere with HIE.

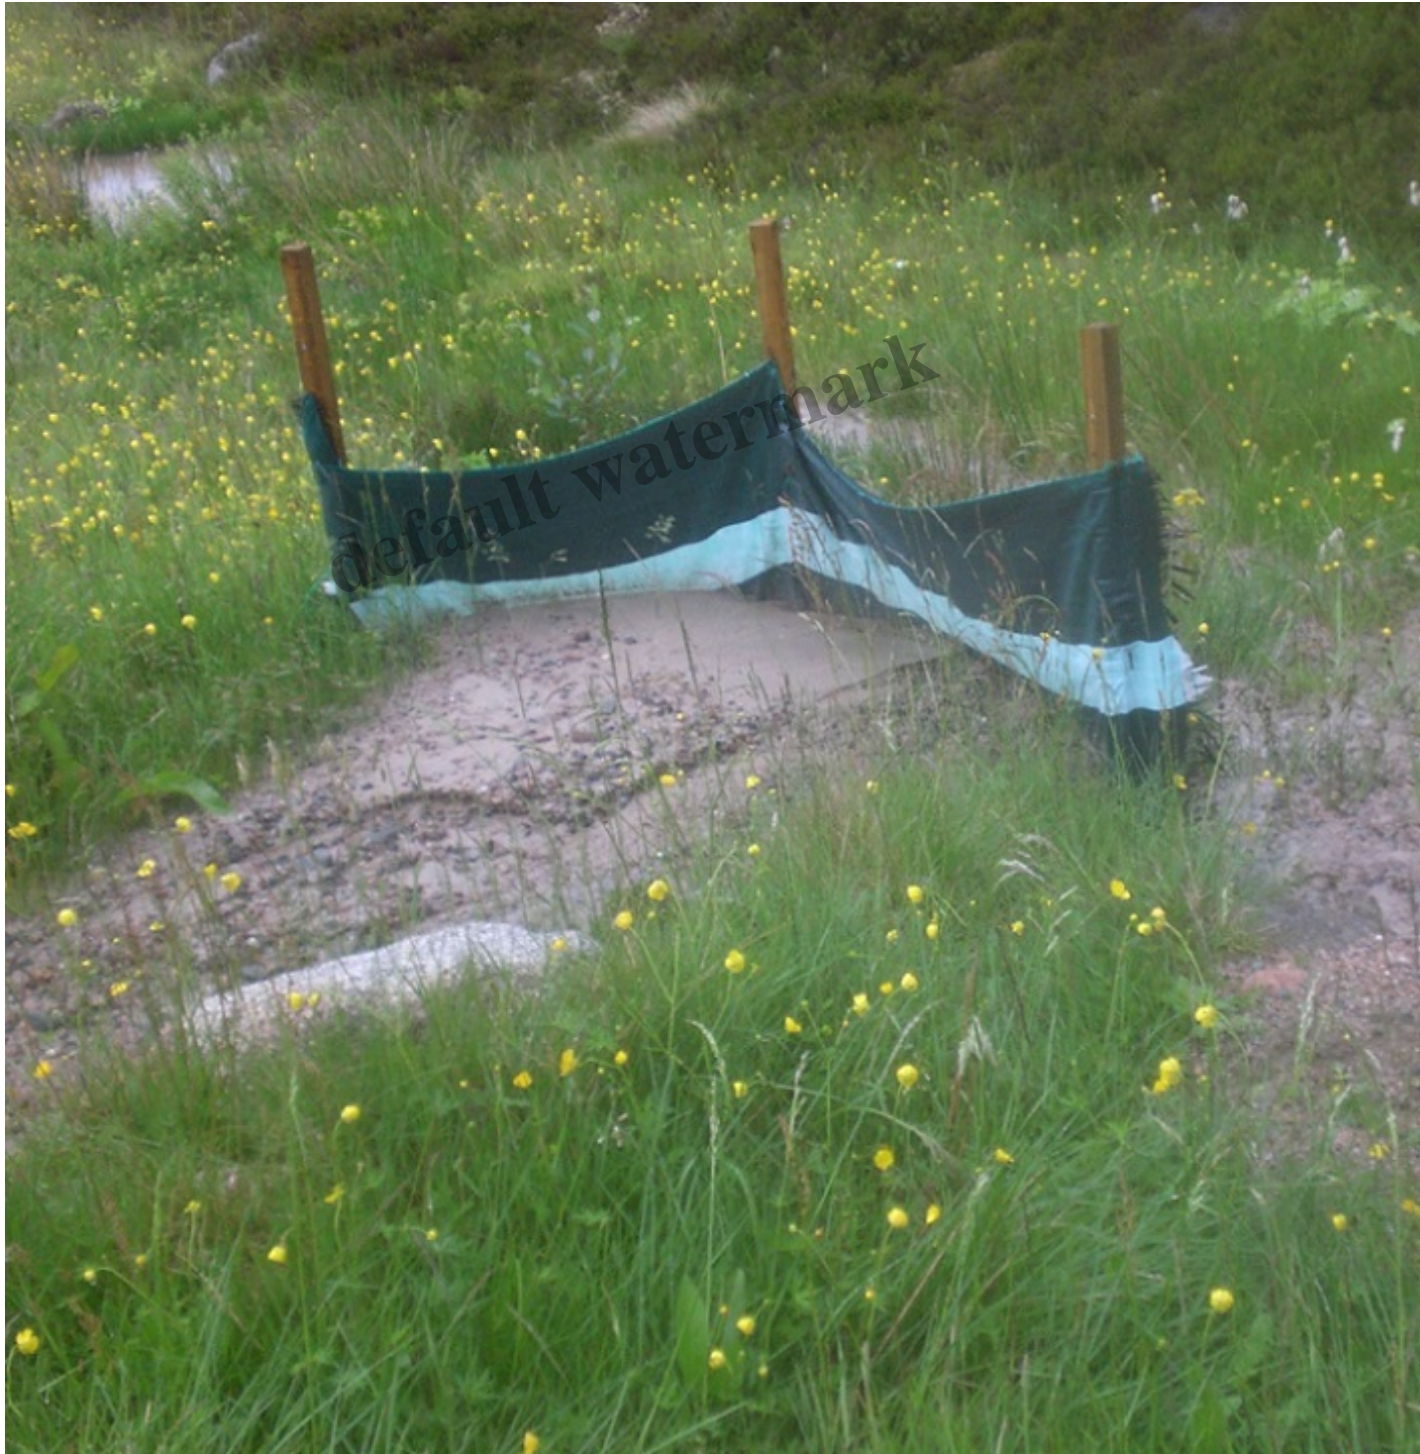
While a silt trap had been installed below where the stream flowed off the road, it was obviously ineffective..

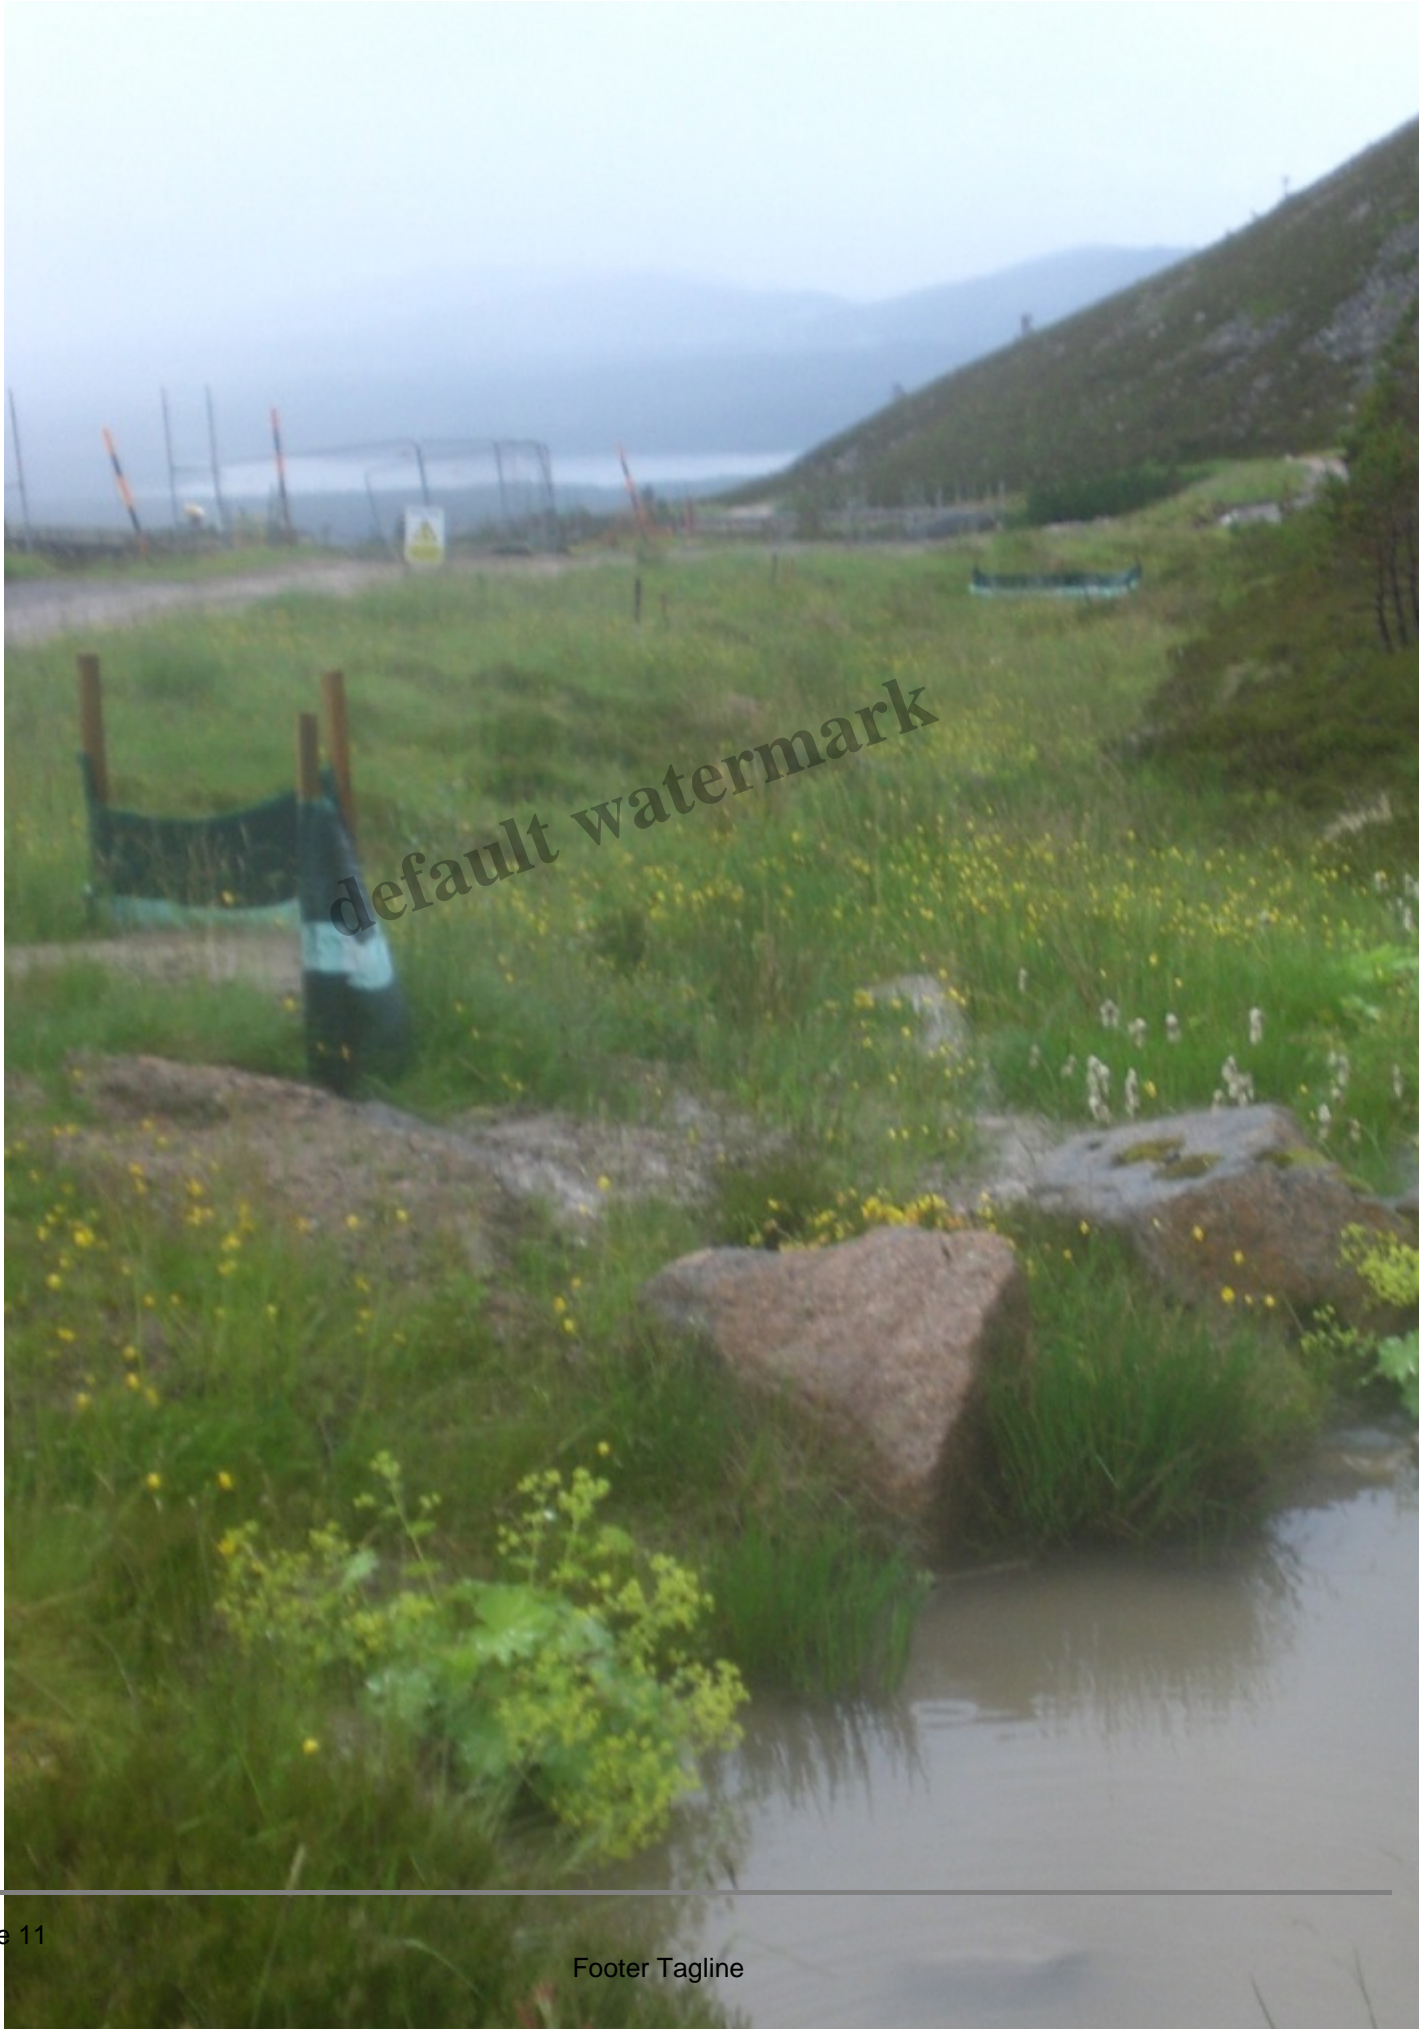
The stream was full of silt, being washed down into the Allt Mhor, which drains Coire Cas. This is part of the River Spey Special Area of Conservation, supposedly the strongest level of protection that can be applied to a river system. In other planning applications – such as the Gynack overflow AT Kingussie – the CNPA has been keen to reduce the risks of silt being washed into the Spey SAC, but at Cairn Gorm the repair of the funicular appears to have been put first, whatever the environmental cost. Whether the Scottish Environmental Protection Agency, who are also supposedly trying to stop silt being washed unnecessarily into rivers, are prepared to act remains to be seen.

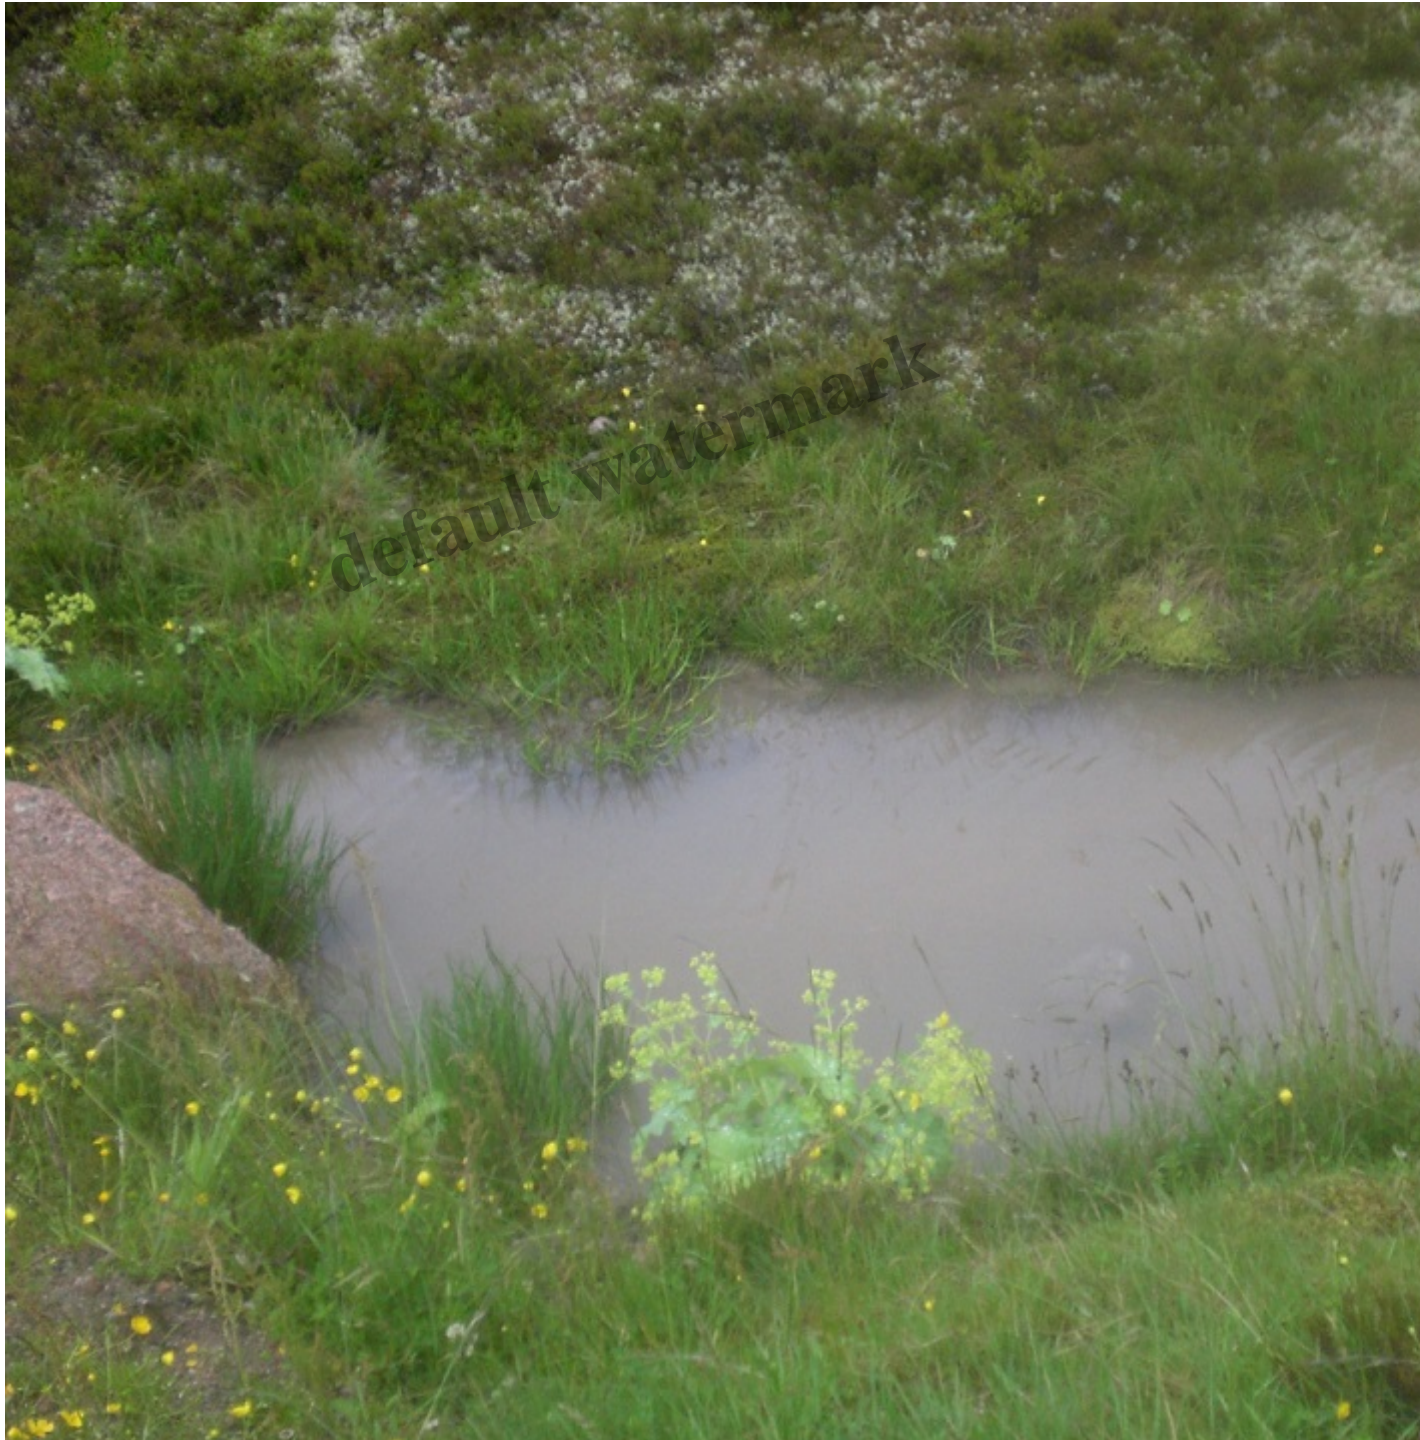
More of HIE's dirty water. Photo credit Cairn Gorm companion.
