Cairn Gorm – the environmental impacts of HIE’s developments

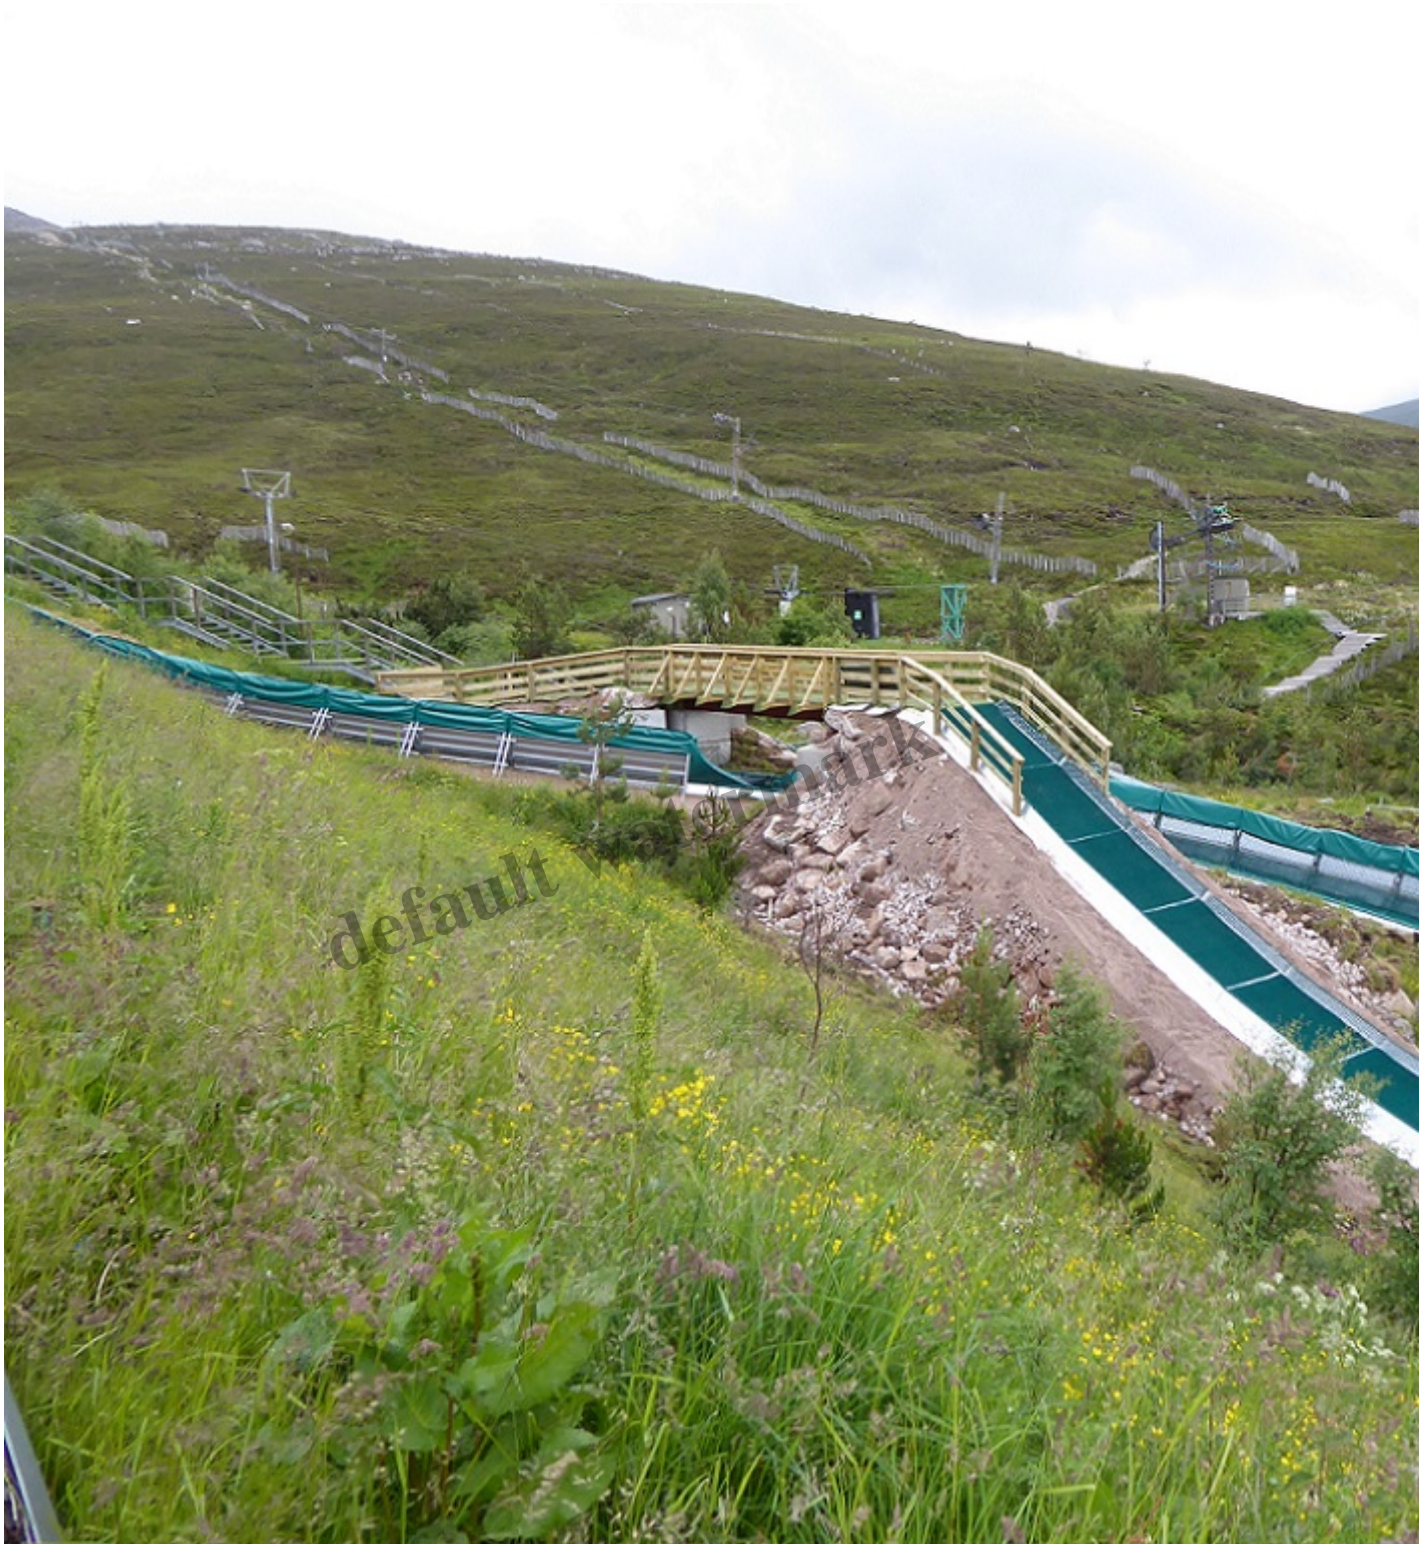
Note how the steep sides of the tube slide by the bridge have already started to erode

On Sunday evening I went up to take a look at Cairn Gorm, the first time since the repair of the funicular started. I got a photo of the construction ([see here](#)) of the tube slides before the rain started. The steel support structure for the slides, referred to in the planning application, appear to have disappeared

The steel supports were also referred to in this email from Jim Cornfoot of Cairngorm Mountain Scotland Ltd to the Cairngorms National Park Authority just six weeks ago. In place of steel supports the tube slides have been placed on a pile of what appears to be excavated glacial till. There is no indication on the planning portal that the CNPA Planners have agreed to this or how Cairngorm Mountain Scotland Ltd intend to “finish” the sides. These appear far too steep to “restore” with vegetation. It’s hard to see how wood “to match the handrails” on the bridge, will be much use here but perhaps I have missed something?

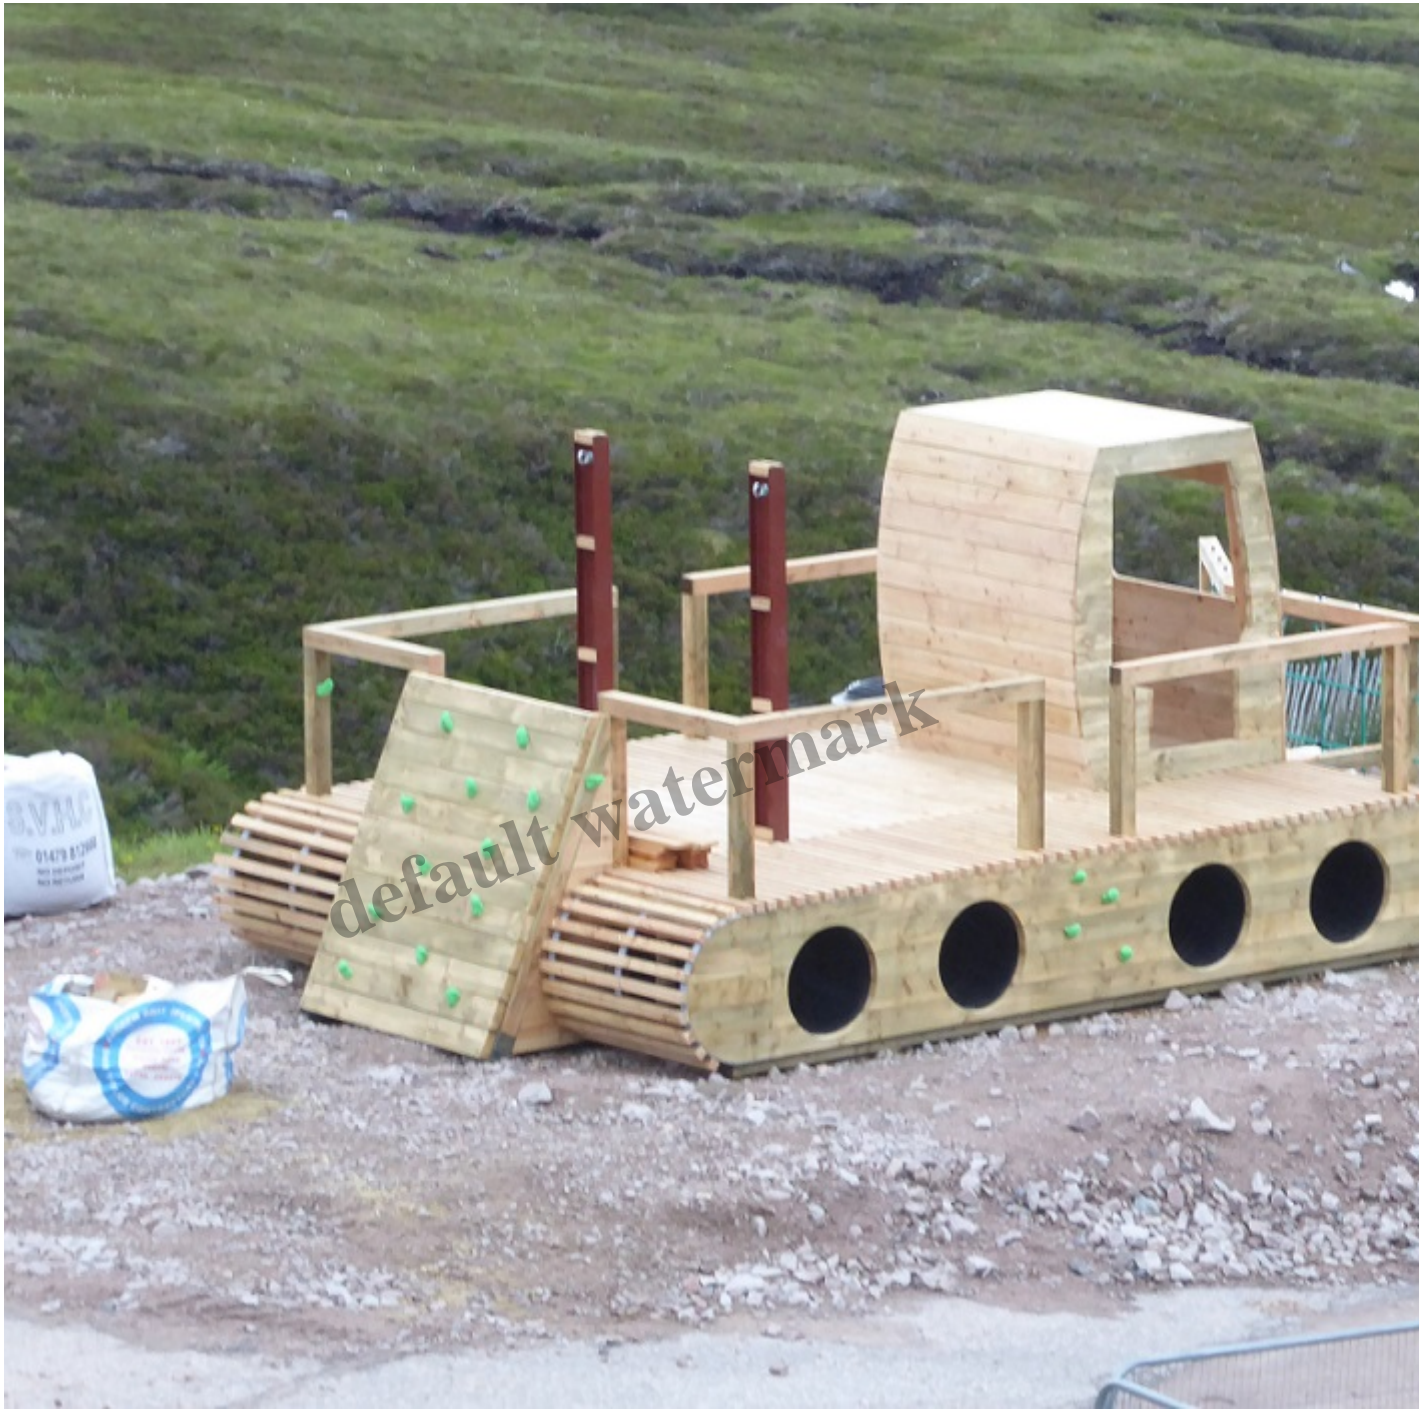
Piste machine on a new raised platform.

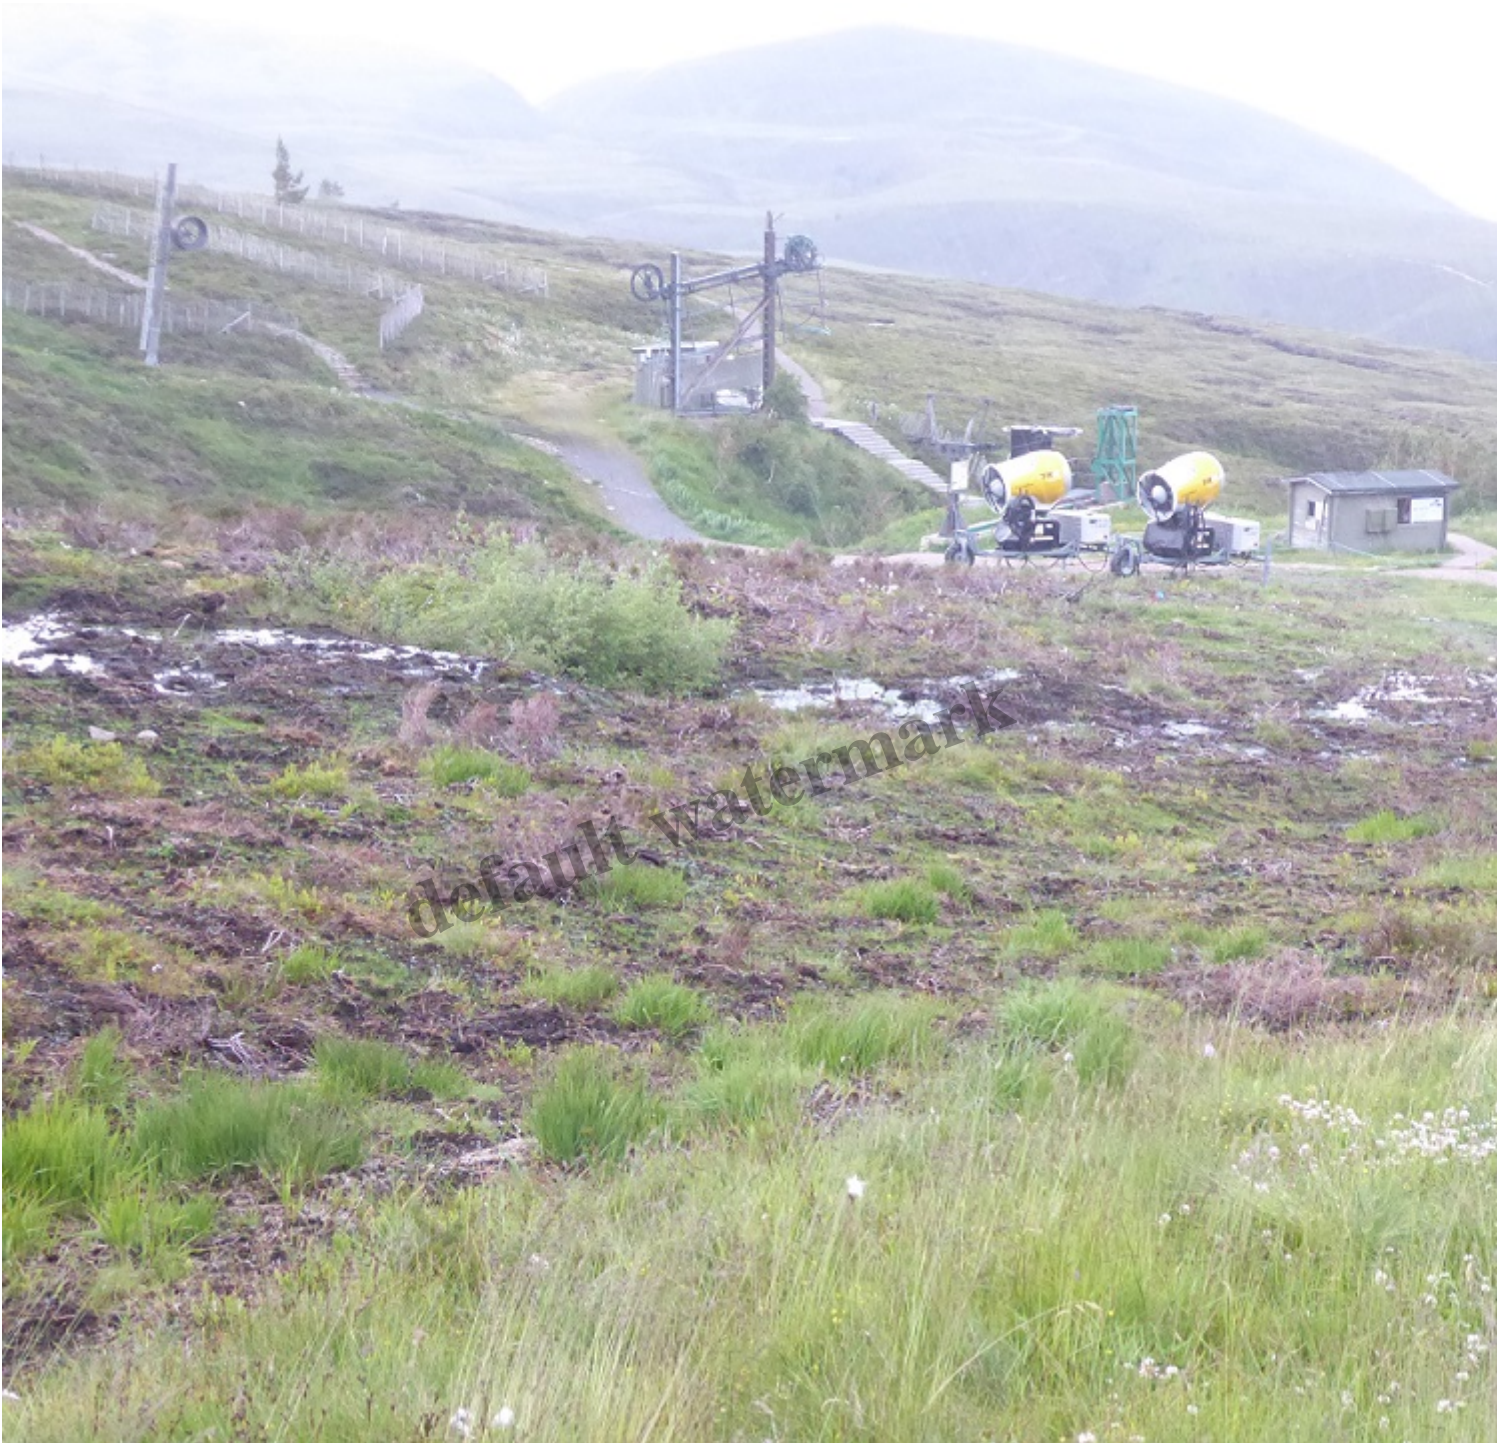
As we left the car park, the new beginner's area Highlands and Island Enterprise had created above the snow machines – the ground was smoothed to make the artificial snow go further – was already pouring with water when it started to rain. It appears that Parkswatch's prediction ([see here](#)) that the development would increase water run off and risk of flooding is correct. Instead of a bog, which absorbs water, HIE and CMSL appear to have destroyed much of the water holding quality of the peat and in doing so have instigated the creation of new watercourses.

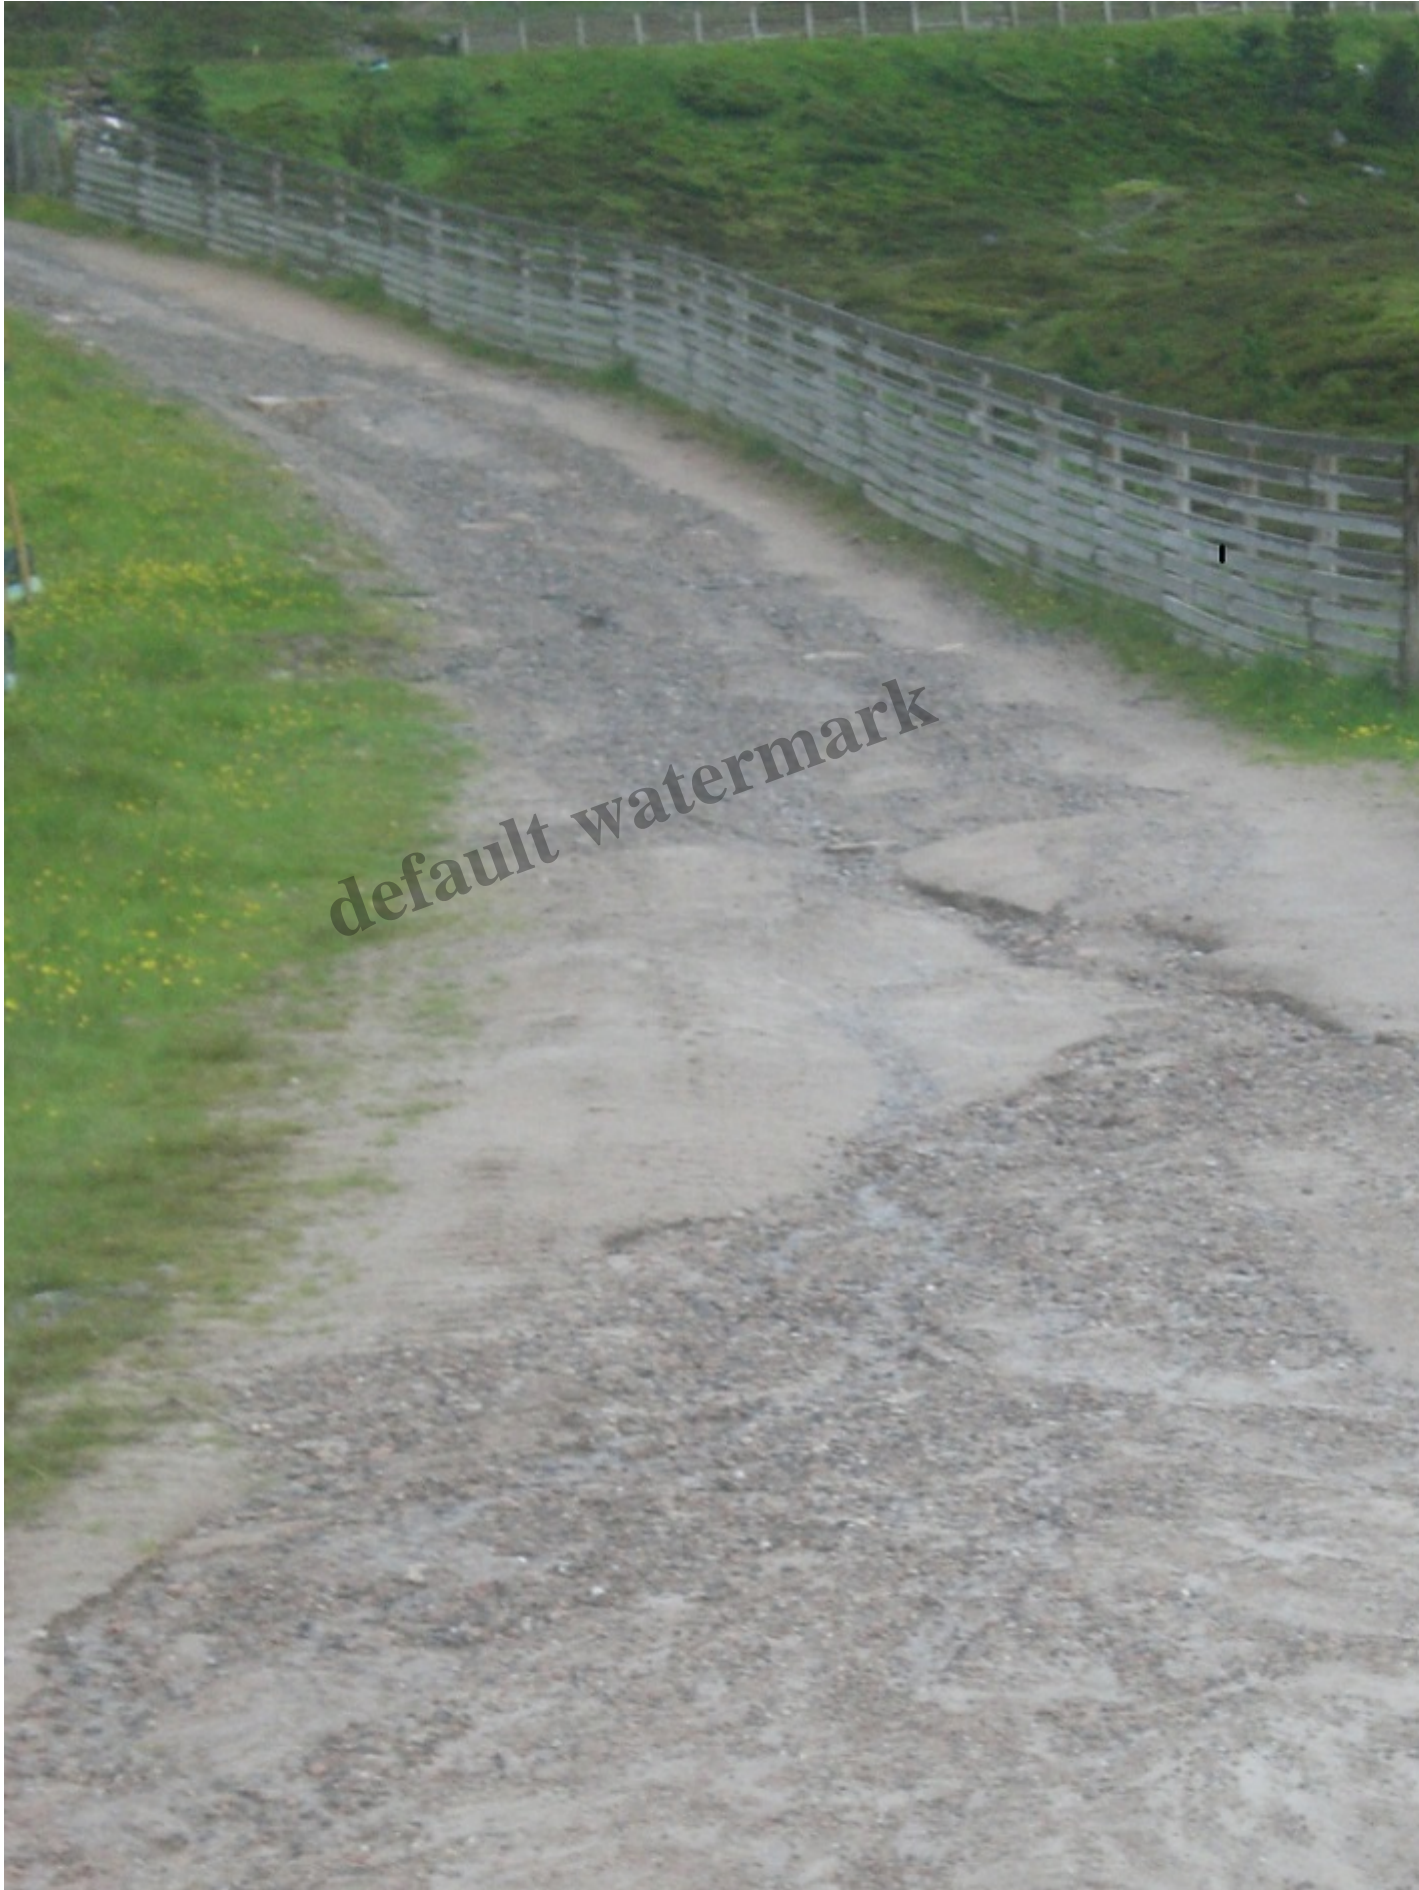
Keeping to the water theme, walking back down from the shieling, the hill road was awash with water and eroding fast. There had been reference in the funicular repair planning application to the need to improve this road for construction traffic and you can see that below the fence and alongside it that new surface material appears to have been added. Whatever its origins, the surface is now eroding fast. Unfortunately the CNPA agreed that none of the access tracks required planning consent so they now cannot do anything about this except ask politely and that, as everyone should know by now, gets you nowhere with HIE.

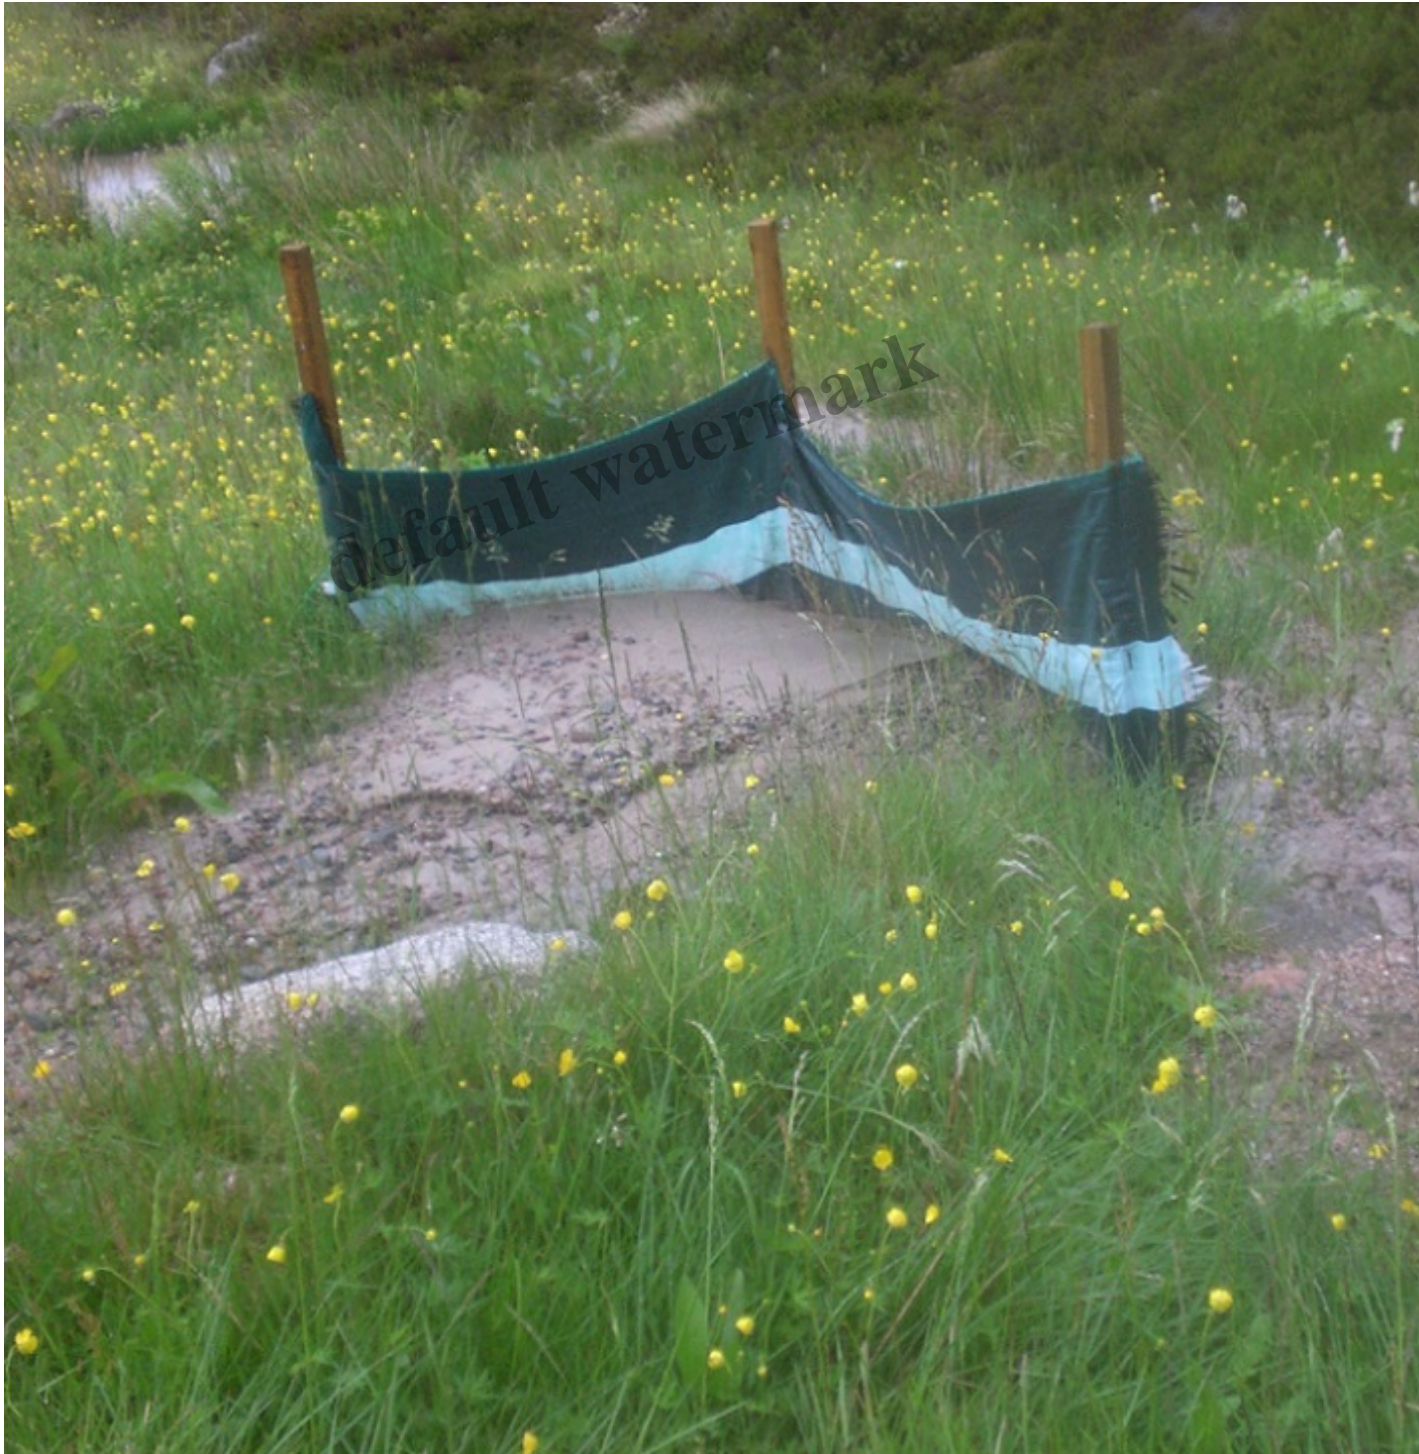
While a silt trap had been installed below where the stream flowed off the road, it was obviously ineffective..

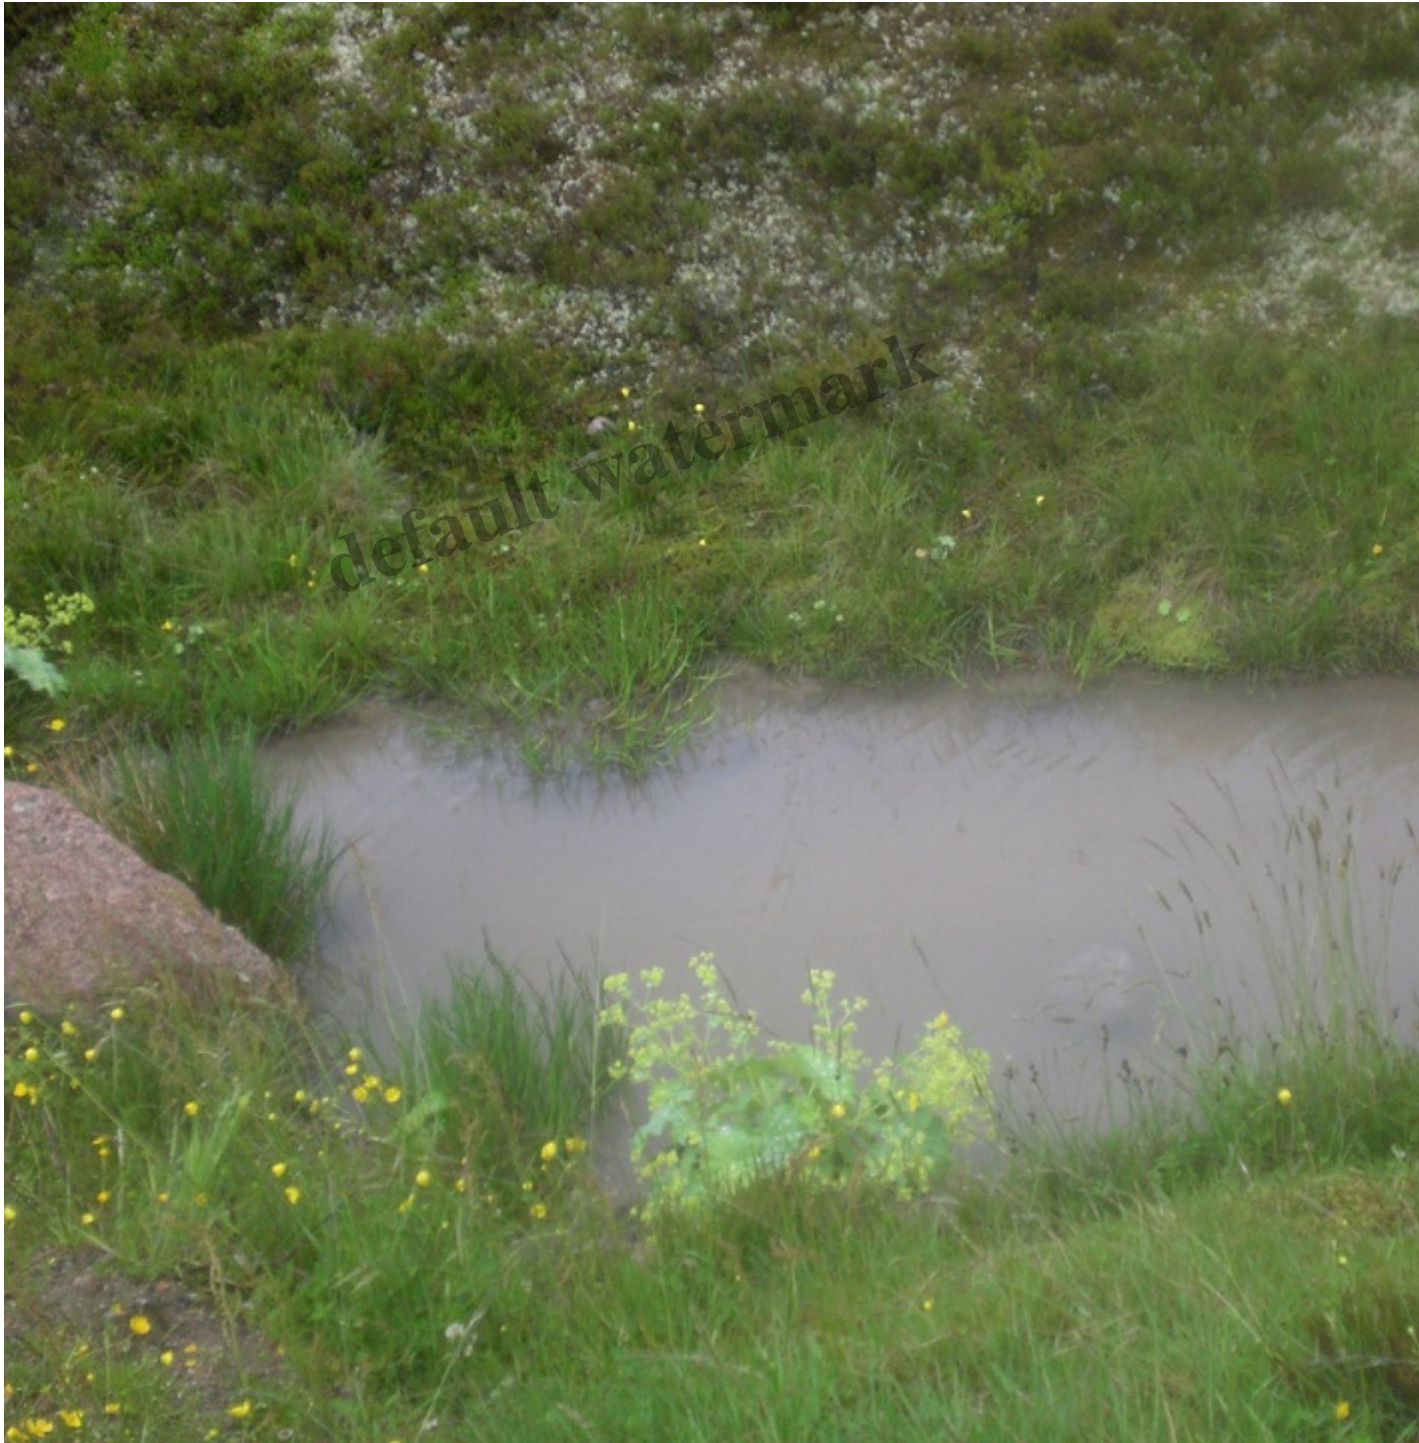
More of HIE's dirty water. Photo credit Cairn Gorm companion.
