## Cairn Gorm – the environmental impacts of HIE’s developments

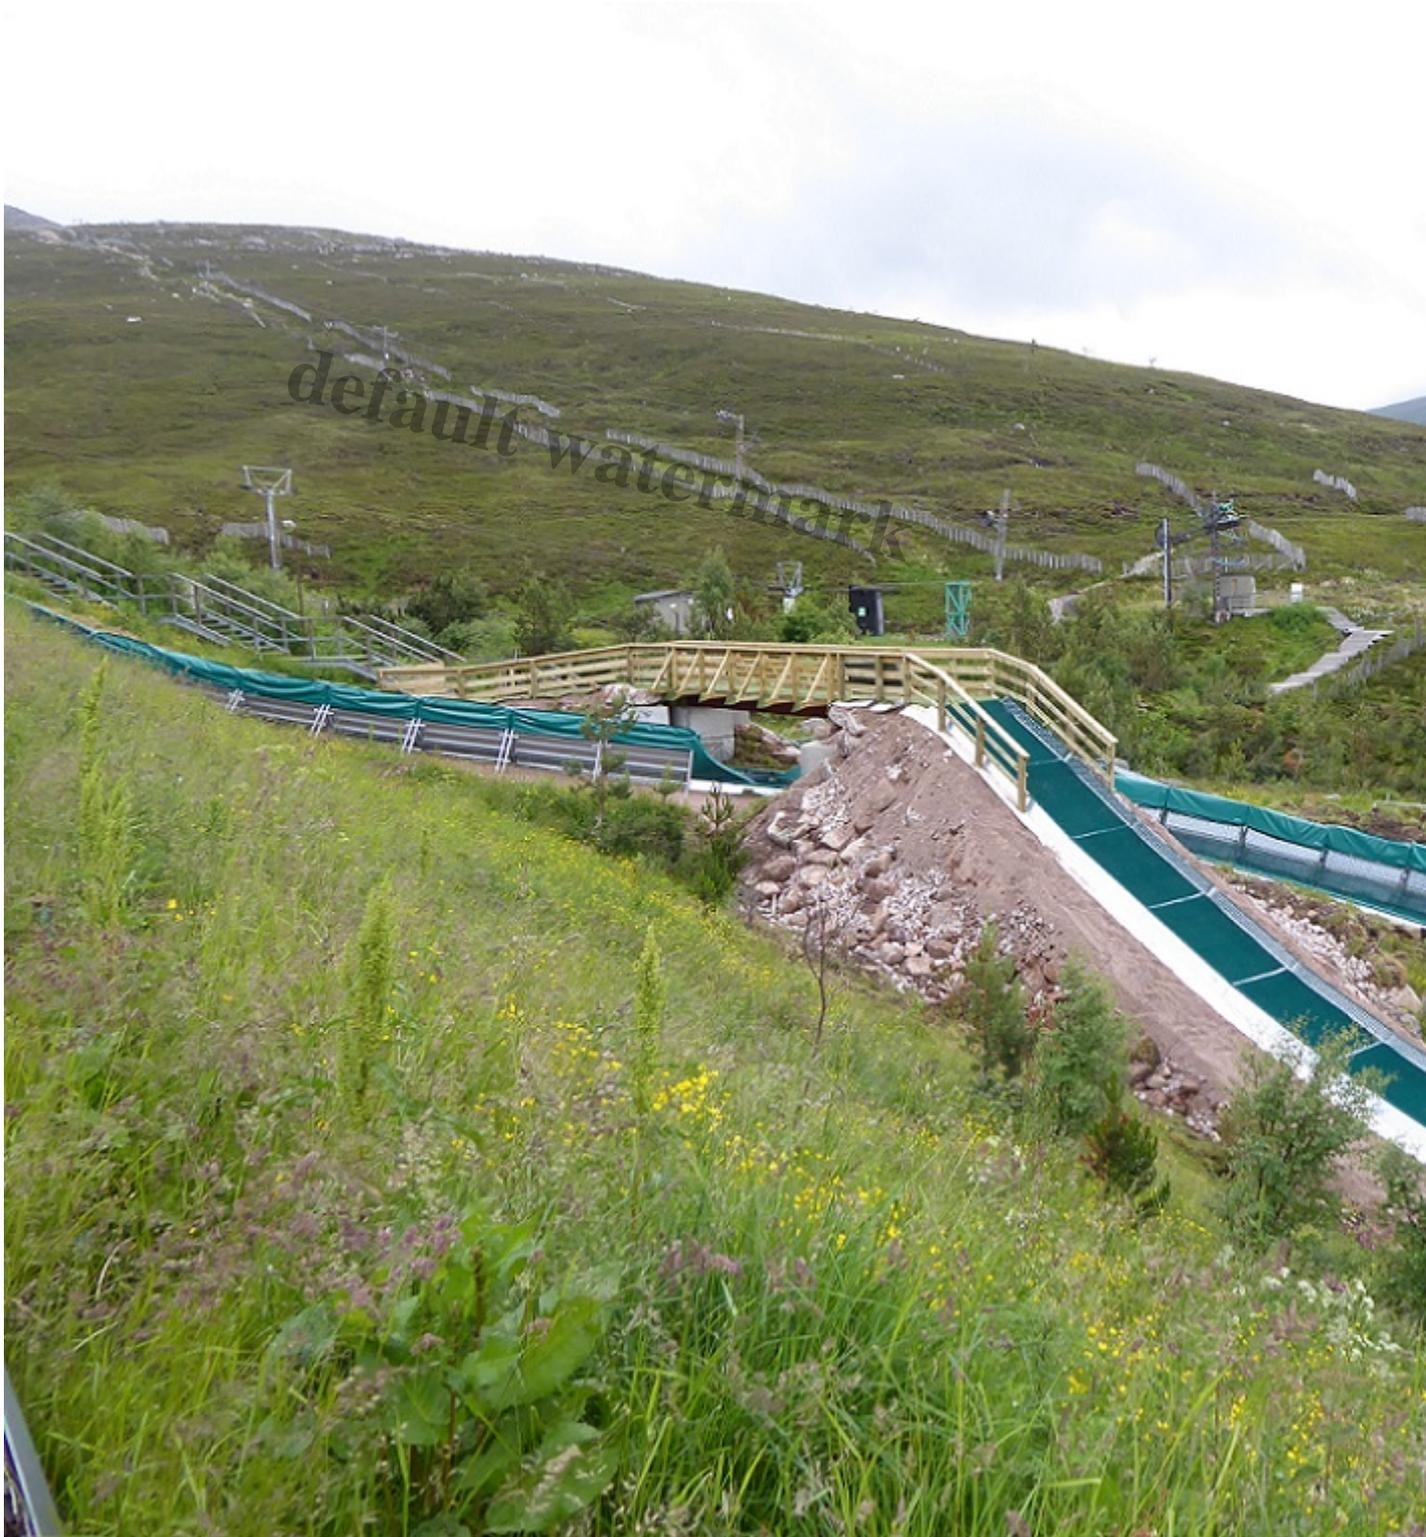
Note how the steep sides of the tube slide by the bridge have already started to erode

On Sunday evening I went up to take a look at Cairn Gorm, the first time since the repair of the funicular started. I got a photo of the construction ([see here](#)) of the tube slides before the rain started. The steel support structure for the slides, referred to in the planning application, appear to have disappeared

The steel supports were also referred to in this email from Jim Cornfoot of Cairngorm Mountain Scotland Ltd to the Cairngorms National Park Authority just six weeks ago. In place of steel supports the tube slides have been placed on a pile of what appears to be excavated glacial till. There is no indication on the planning portal that the CNPA Planners have agreed to this or how Cairngorm Mountain Scotland Ltd intend to finish the sides. These appear far too steep to restore with vegetation. It's hard to see how wood to match the handrails on the bridge, will be much use here but perhaps I have missed something?

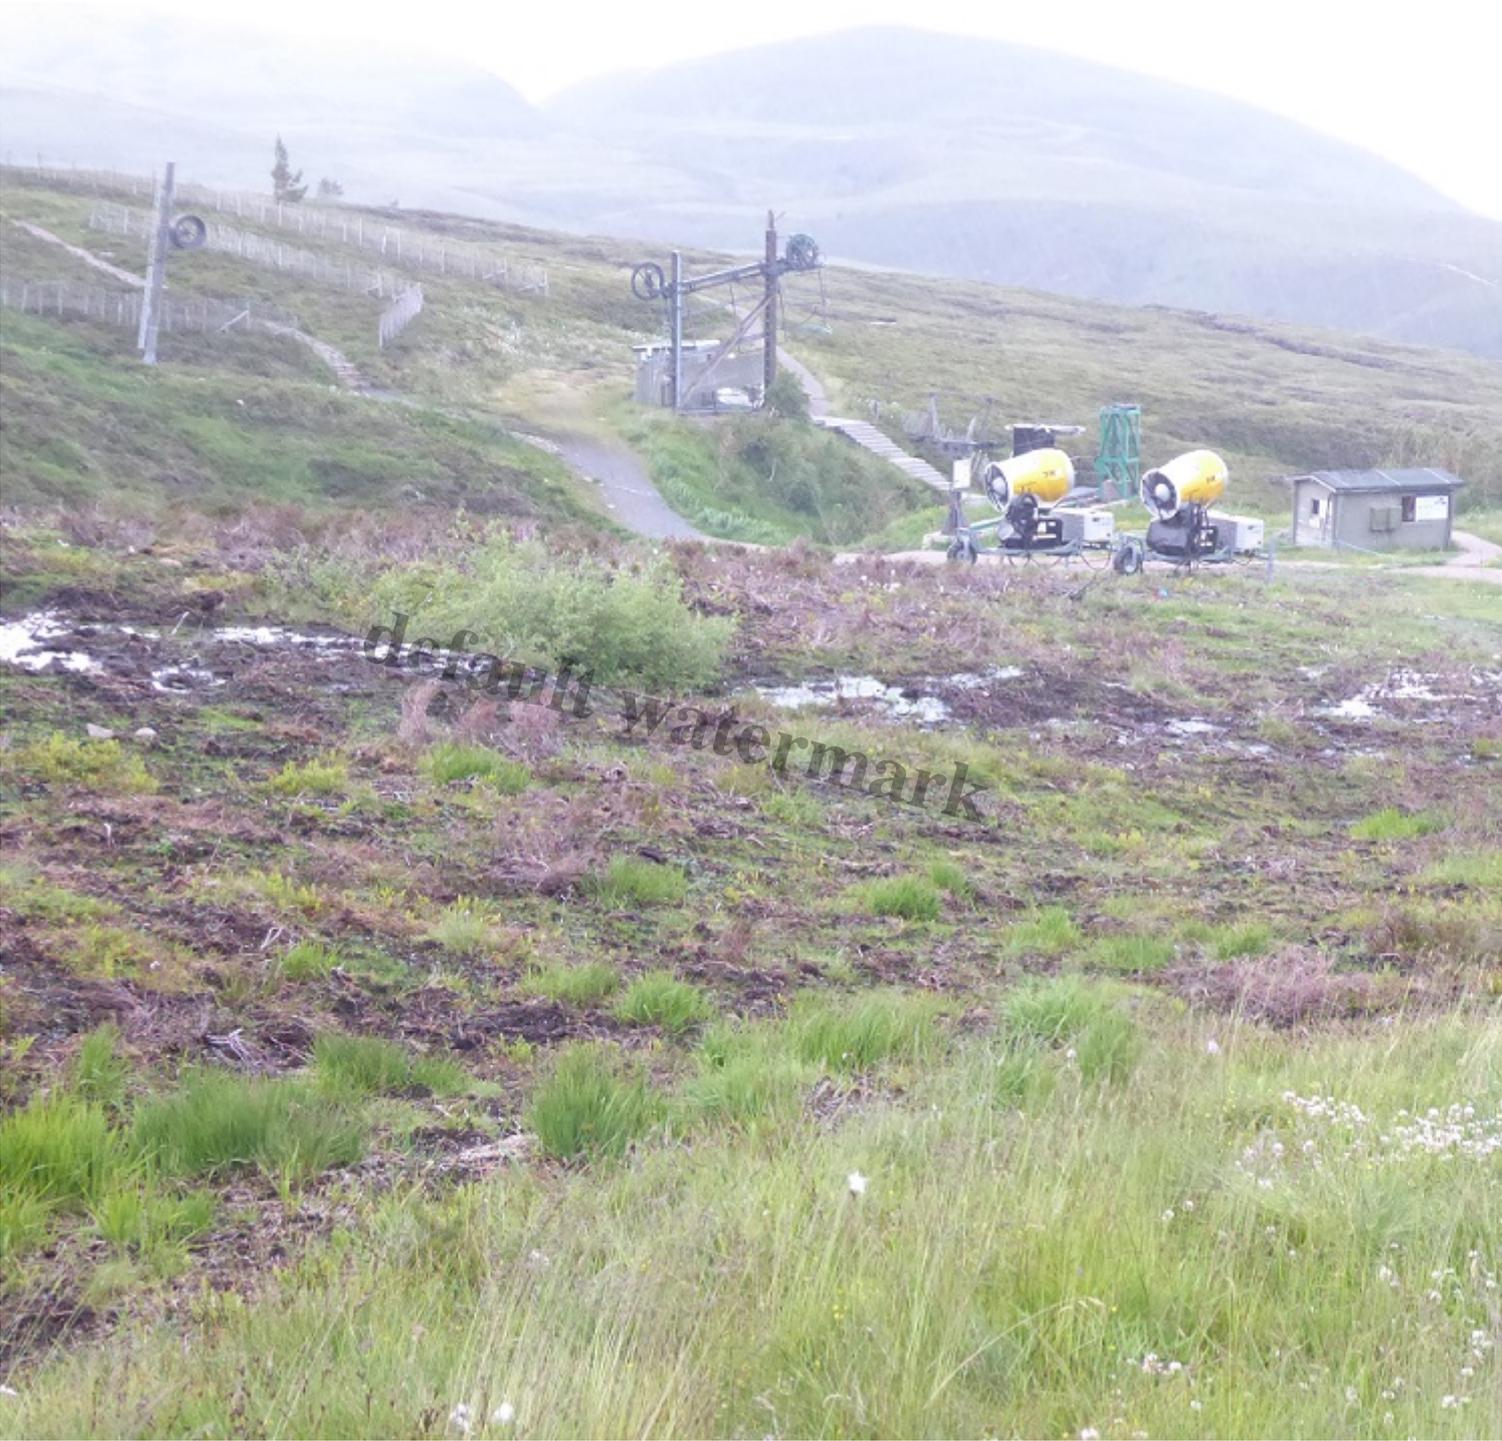
As we left the car park, the new beginner area Highlands and Island Enterprise had created above the snow machines the ground was smoothed to make the artificial snow go further was already pouring with water when it started to rain. It appears that Parkswatch's prediction ([see here](#)) that the development would increase water run off and risk of flooding is correct. Instead of a bog, which absorbs water, HIE and CMSL appear to have destroyed much of the water holding quality of the peat and in doing so have instigated the creation of new watercourses.

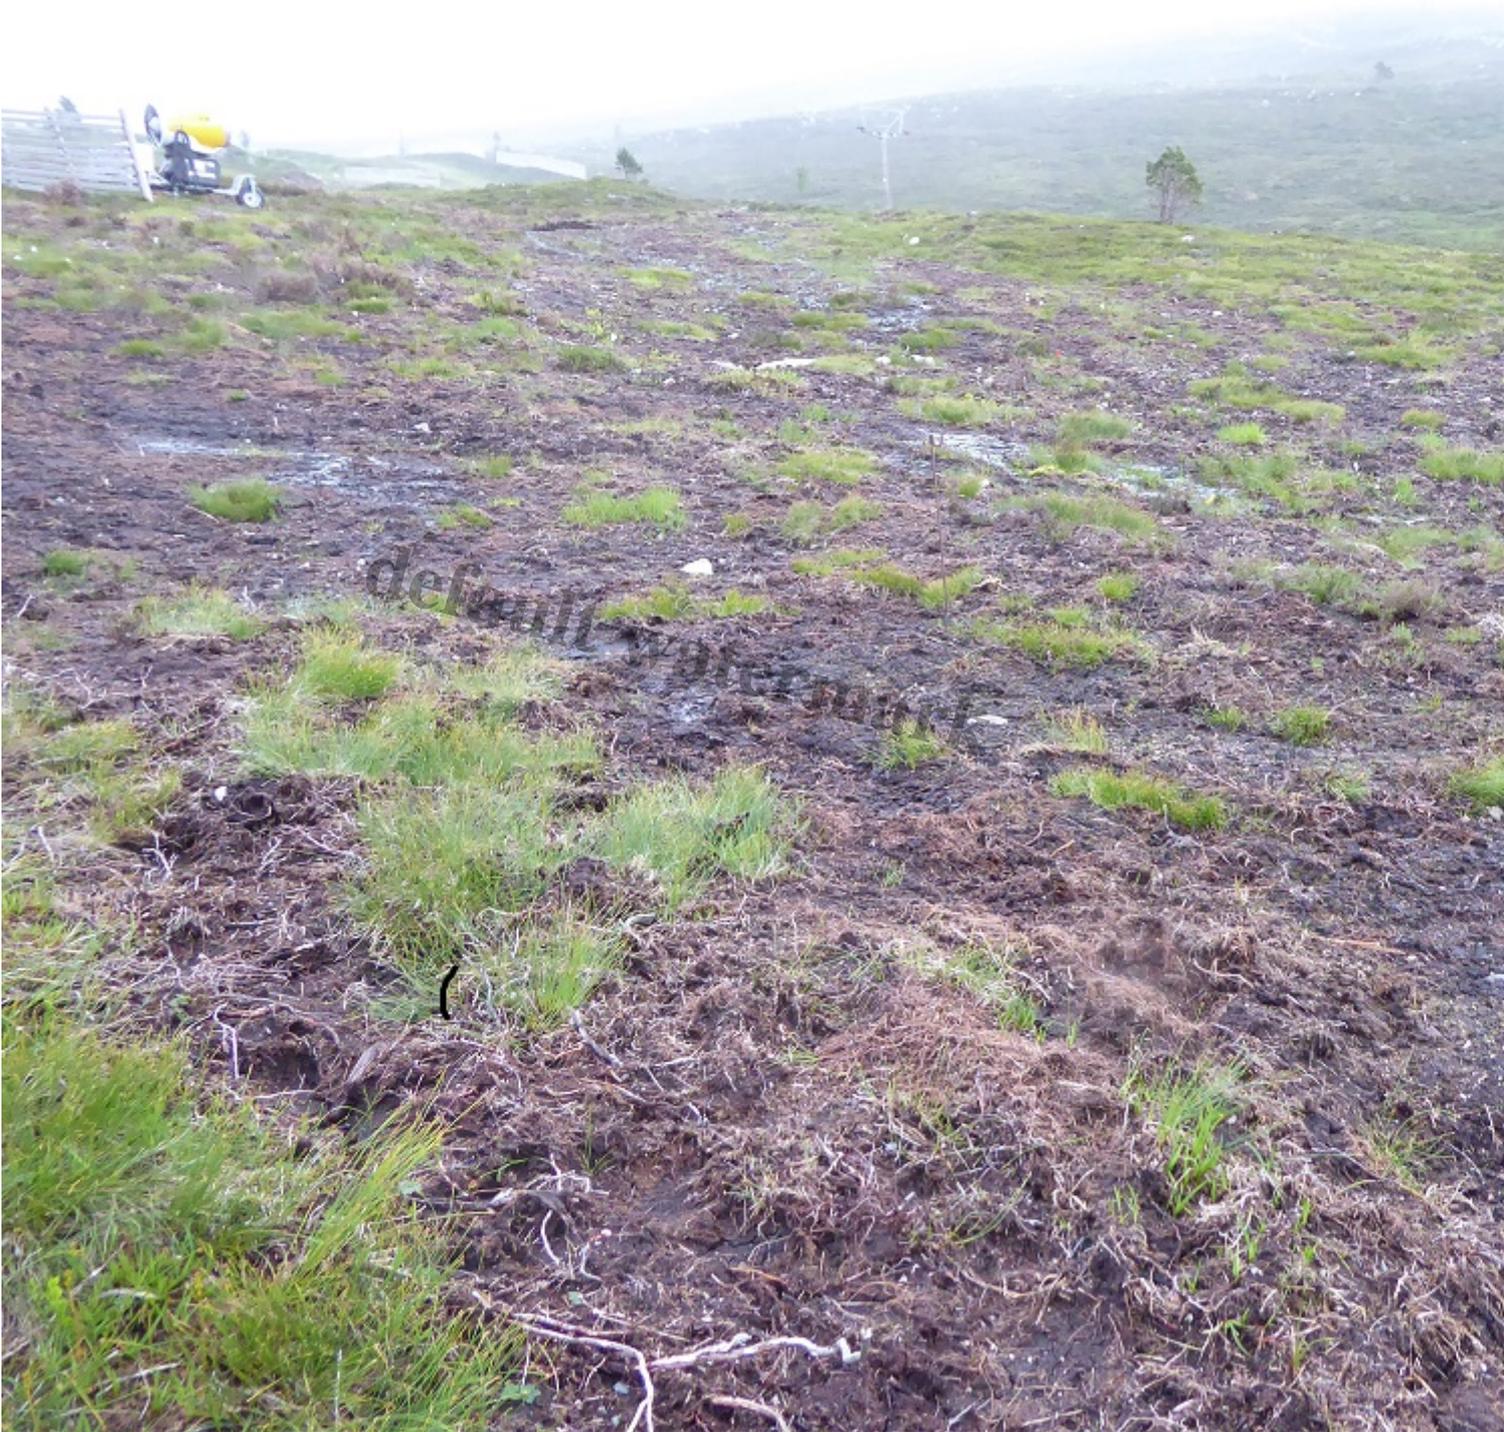
The lesson, which also applies to the funicular repairs, is that you mess with the hydrology of slopes in the mountains at your peril. On our return, by which time the rain was very heavy and it was too wet for photos, one of my companions noted that a culvert that had been installed under the slope was bone dry. Another indication, perhaps, that the works have resulted in more water now flowing over the surface. Not much good either as a base for artificially created snow or skiing!

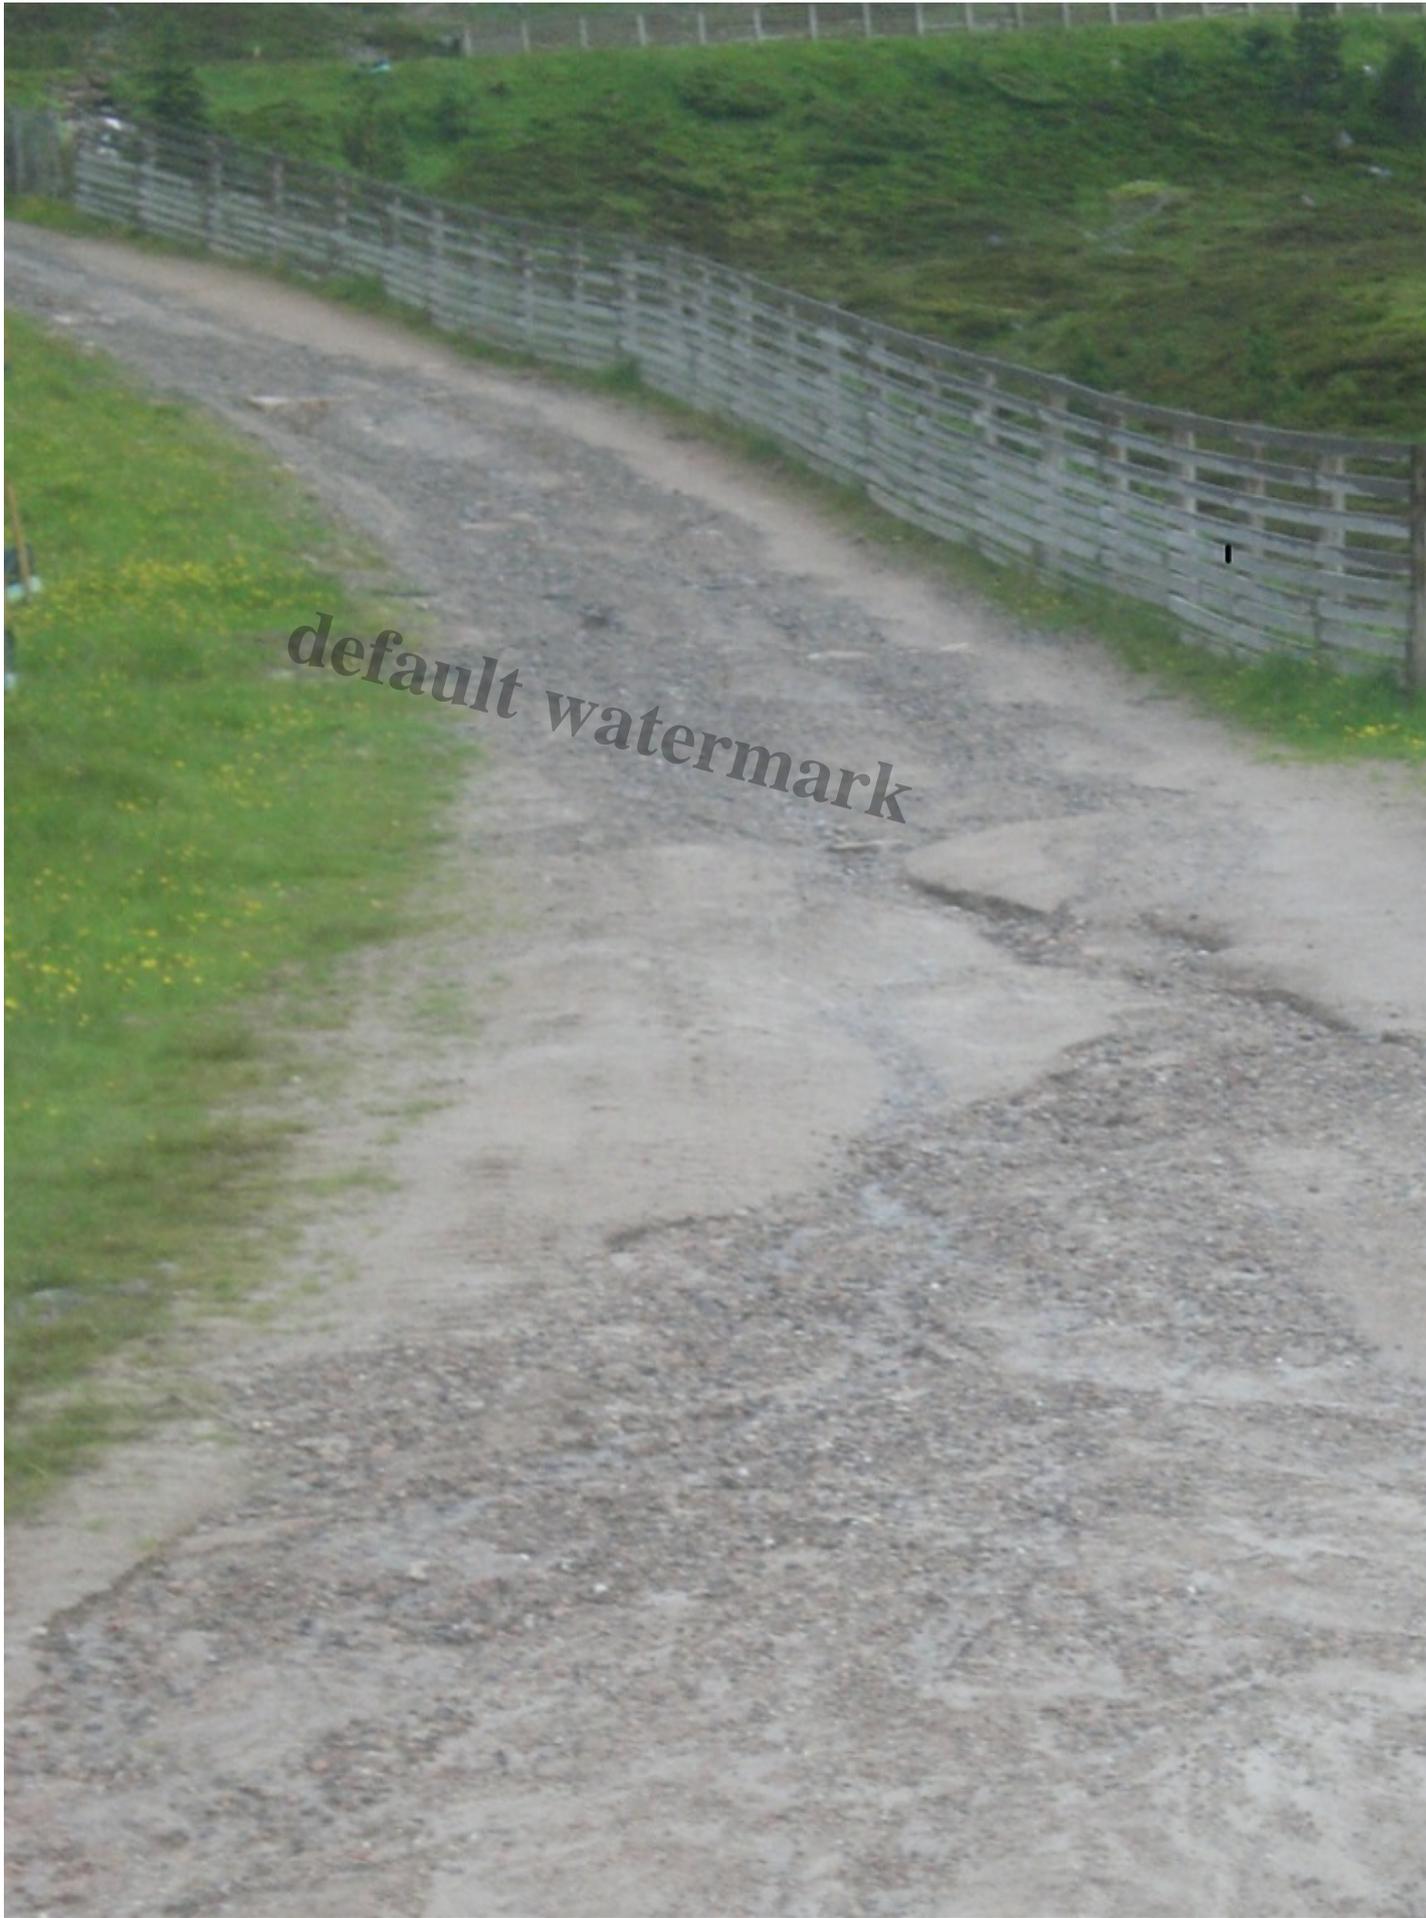
Keeping to the water theme, walking back down from the shieling, the hill road was awash with water and eroding fast. There had been reference in the funicular repair planning application to the need to improve this road for construction traffic and you can see that below the fence and alongside it that new surface material appears to have been added. Whatever its origins, the surface is now eroding fast. Unfortunately the CNPA agreed that none of the access tracks required planning consent so they now cannot do anything about this except ask politely and that, as everyone should know by now, gets you nowhere with HIE.

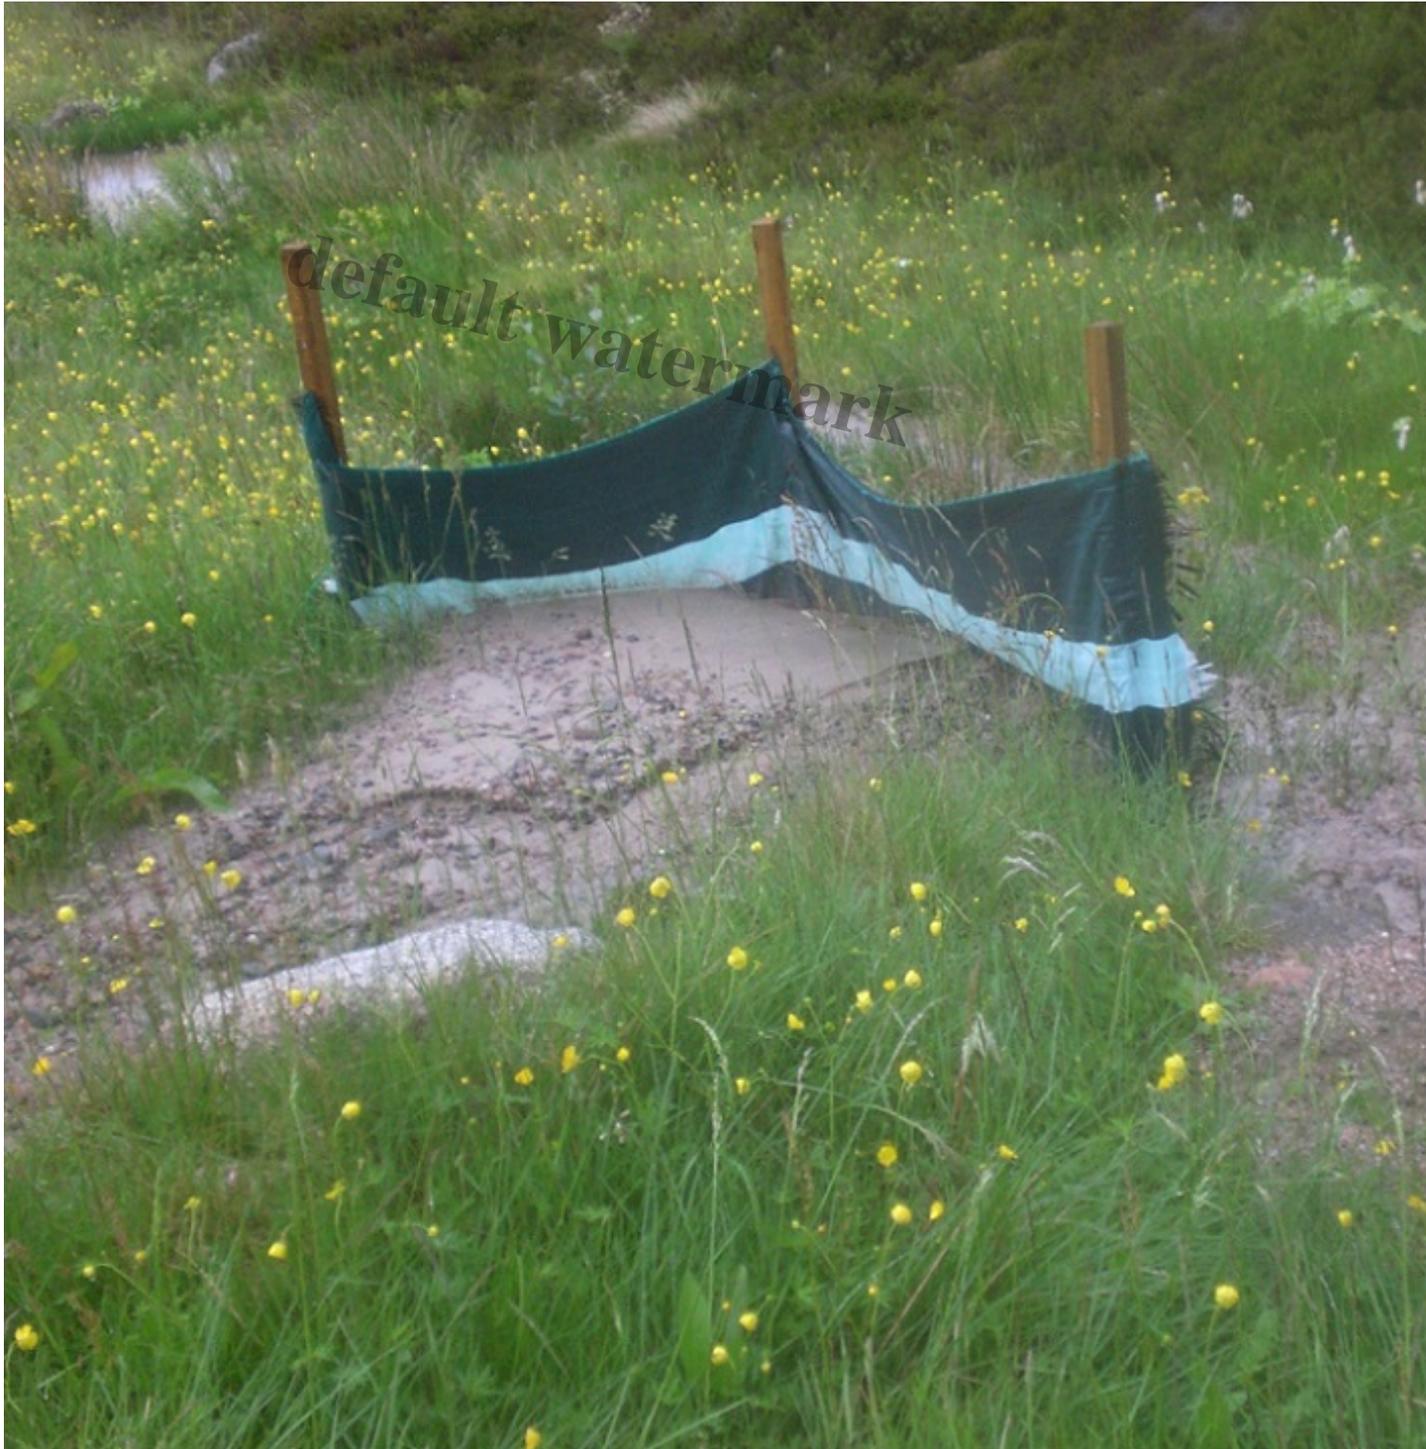
While a silt trap had been installed below where the stream flowed off the road, it was obviously ineffective..

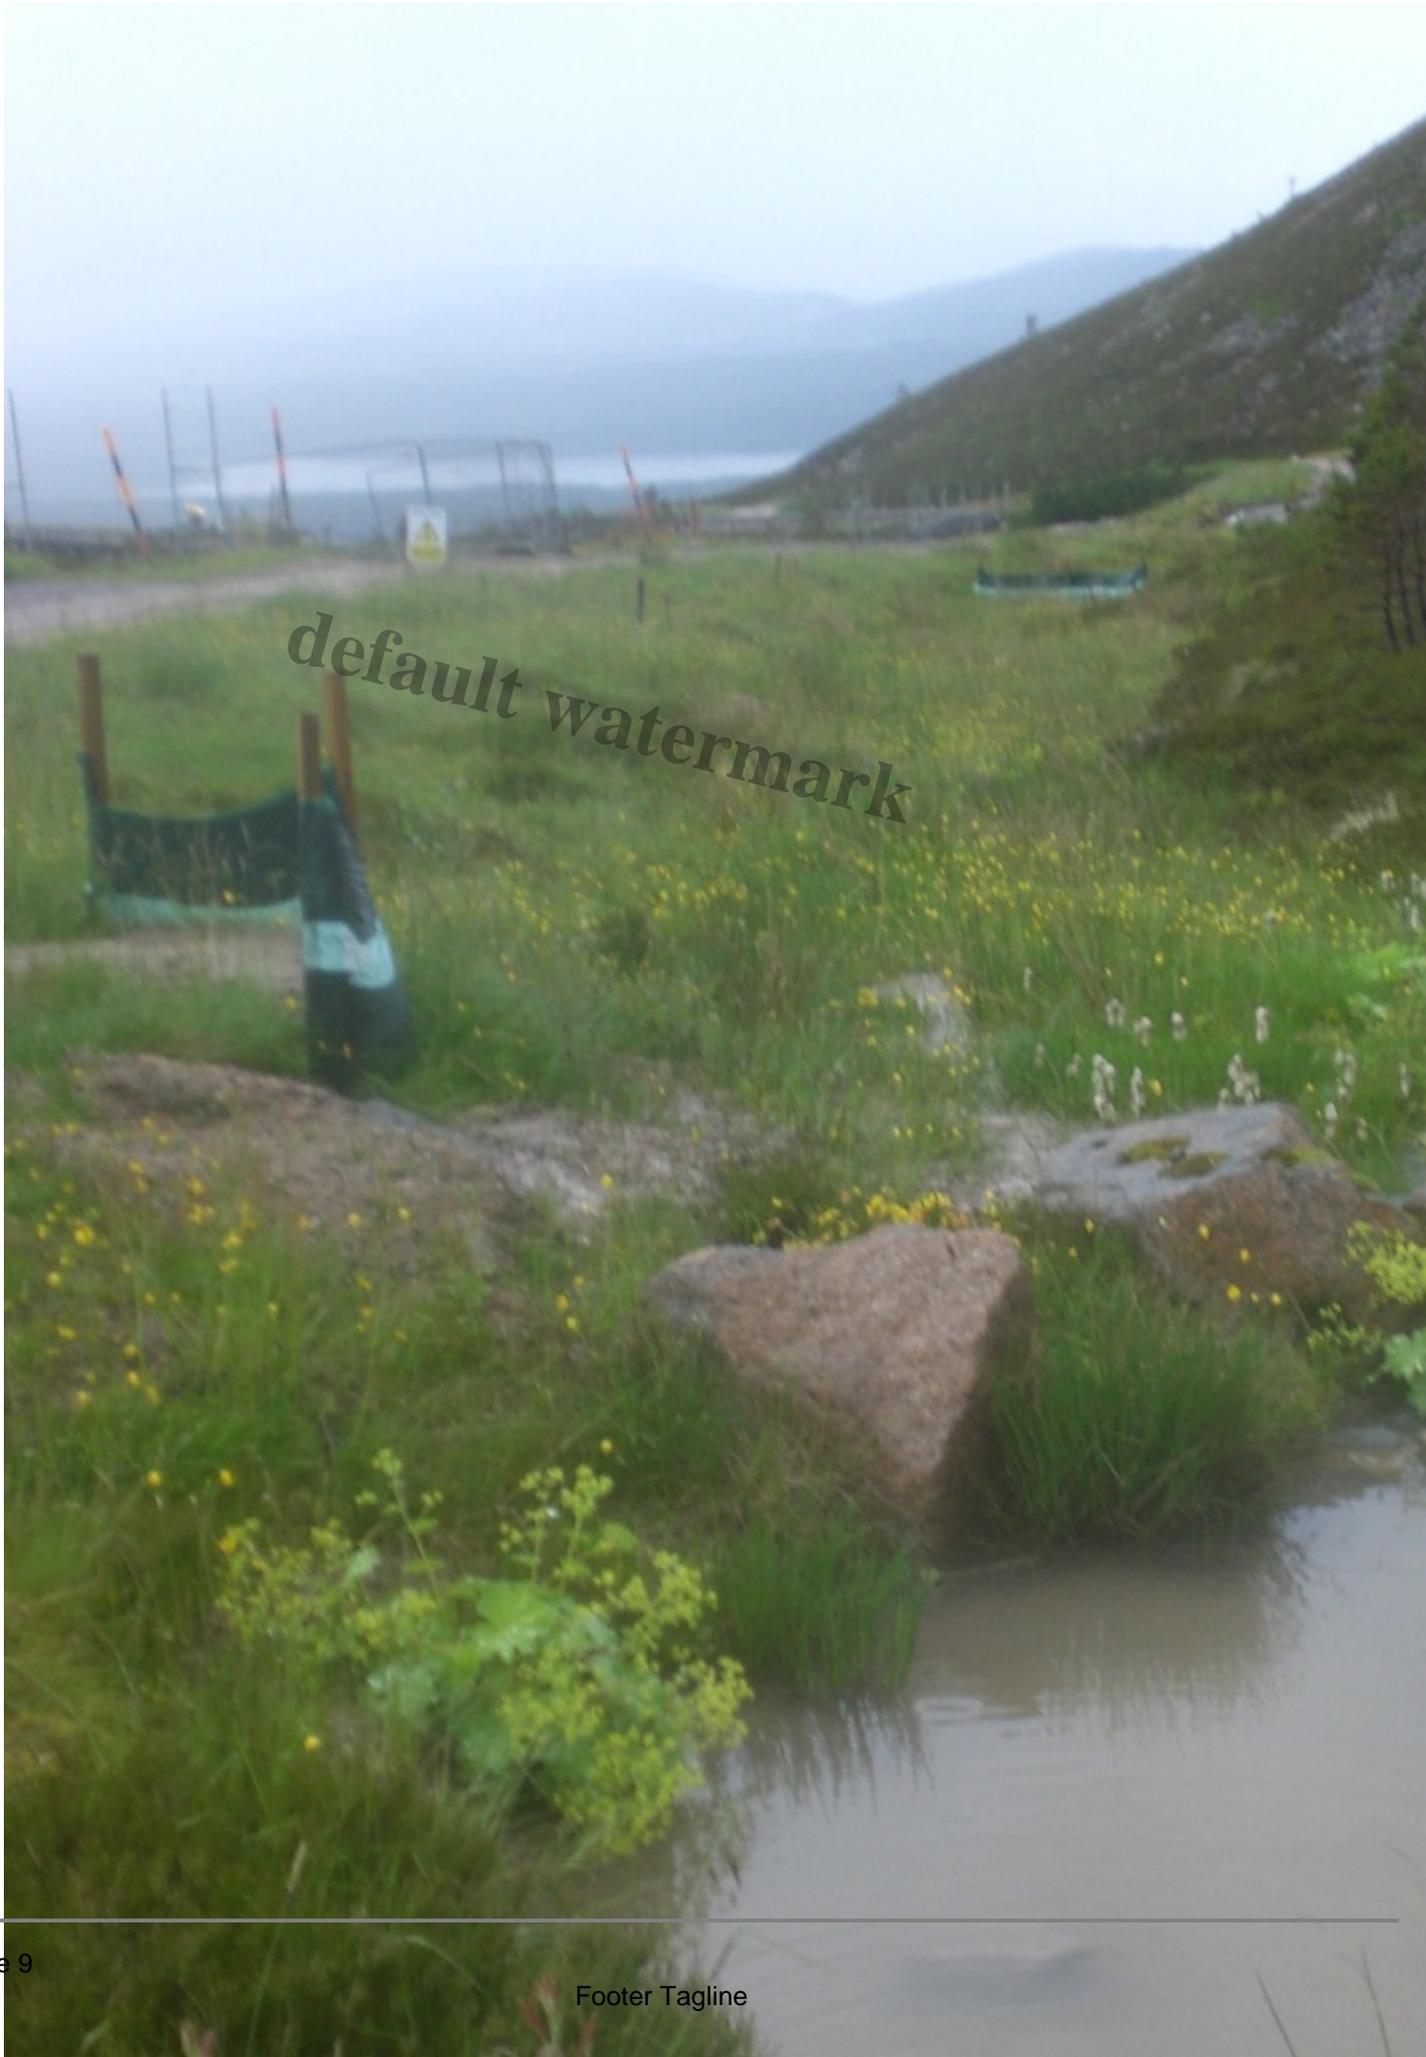
The stream was full of silt, being washed down into the Allt Mhor, which drains Coire Cas. This is part of the River Spey Special Area of Conservation, supposedly the strongest level of protection that can be applied to a river system. In other planning applications – such as the Gynack overflow AT Kingussie – the CNPA has been keen to reduce the risks of silt being washed into the Spey SAC, but at Cairn Gorm the repair of the funicular appears to have been put first, whatever the environmental cost. Whether the Scottish Environmental Protection Agency, who are also supposedly trying to stop silt being washed unnecessarily into rivers, are prepared to act remains to be seen.

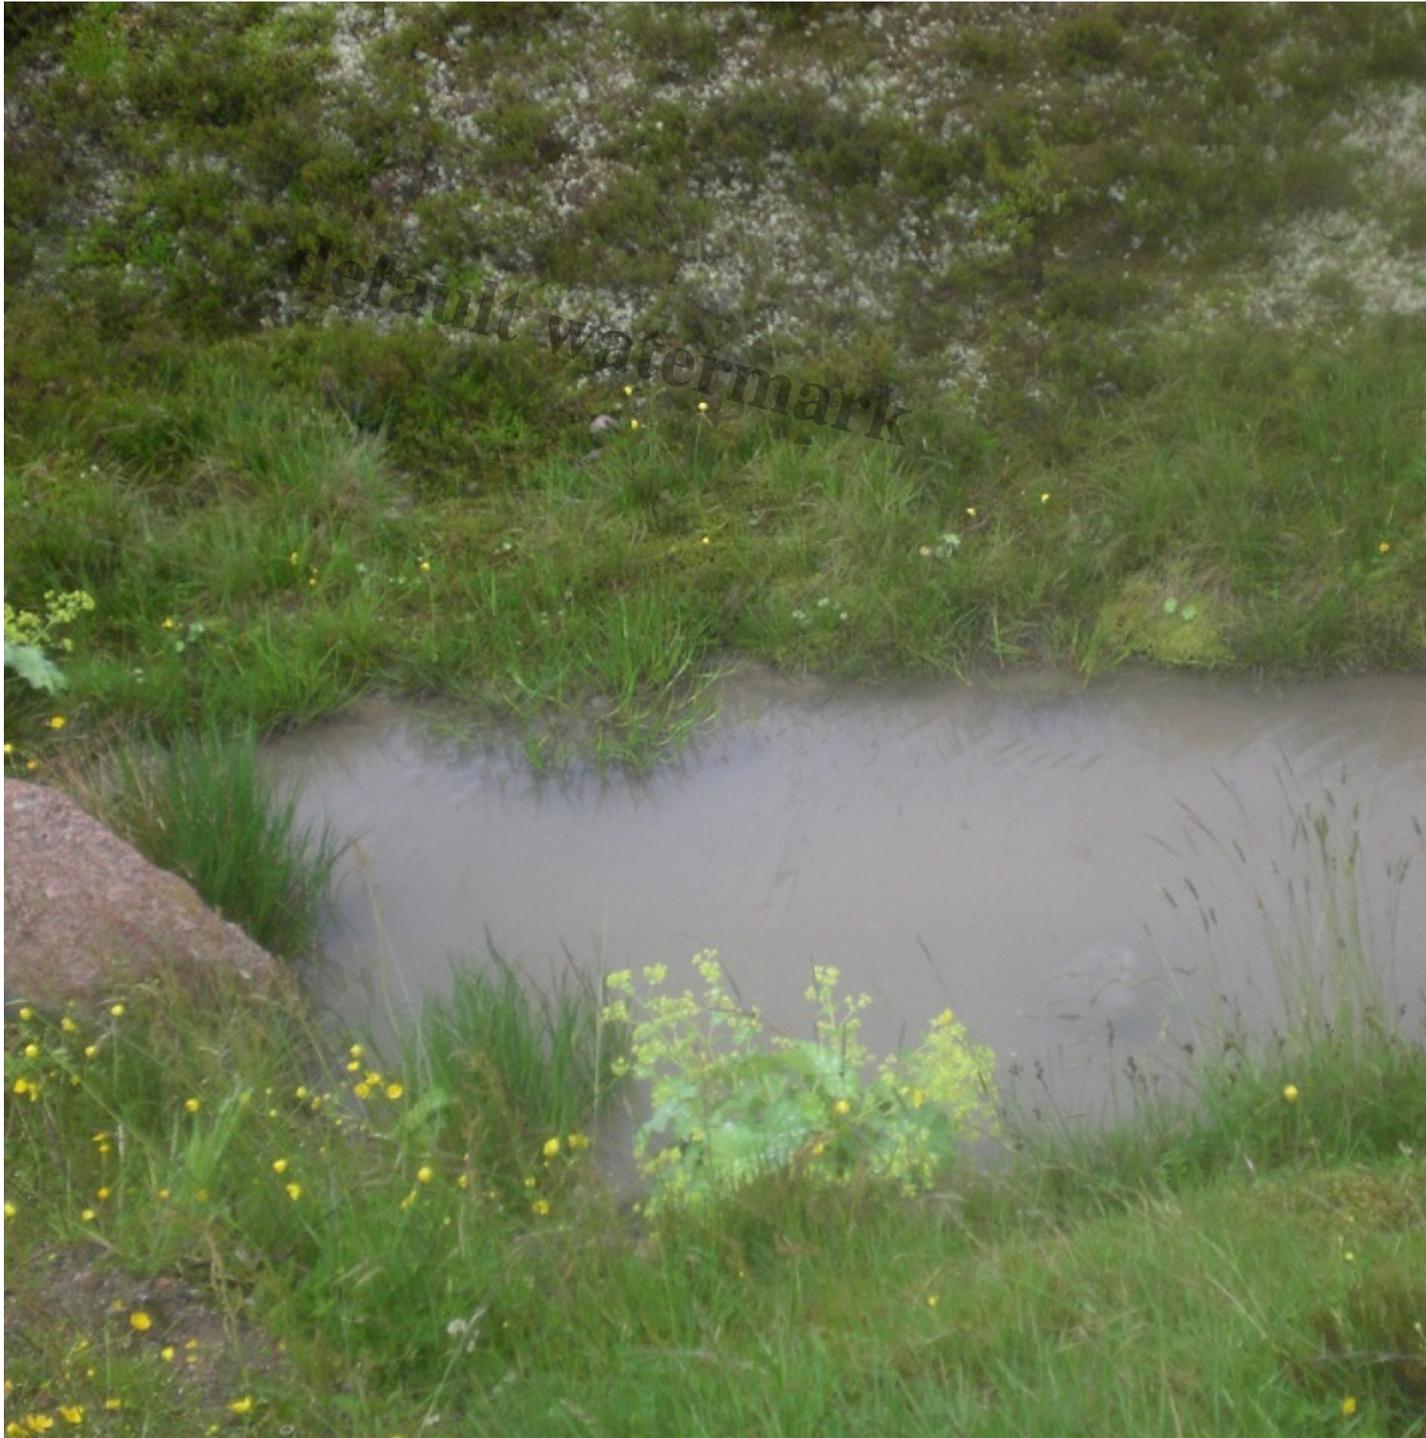
More of HIE's dirty water. Photo credit Cairn Gorm companion.
