## The state of the Cairngorms (2) – restoration of hill tracks

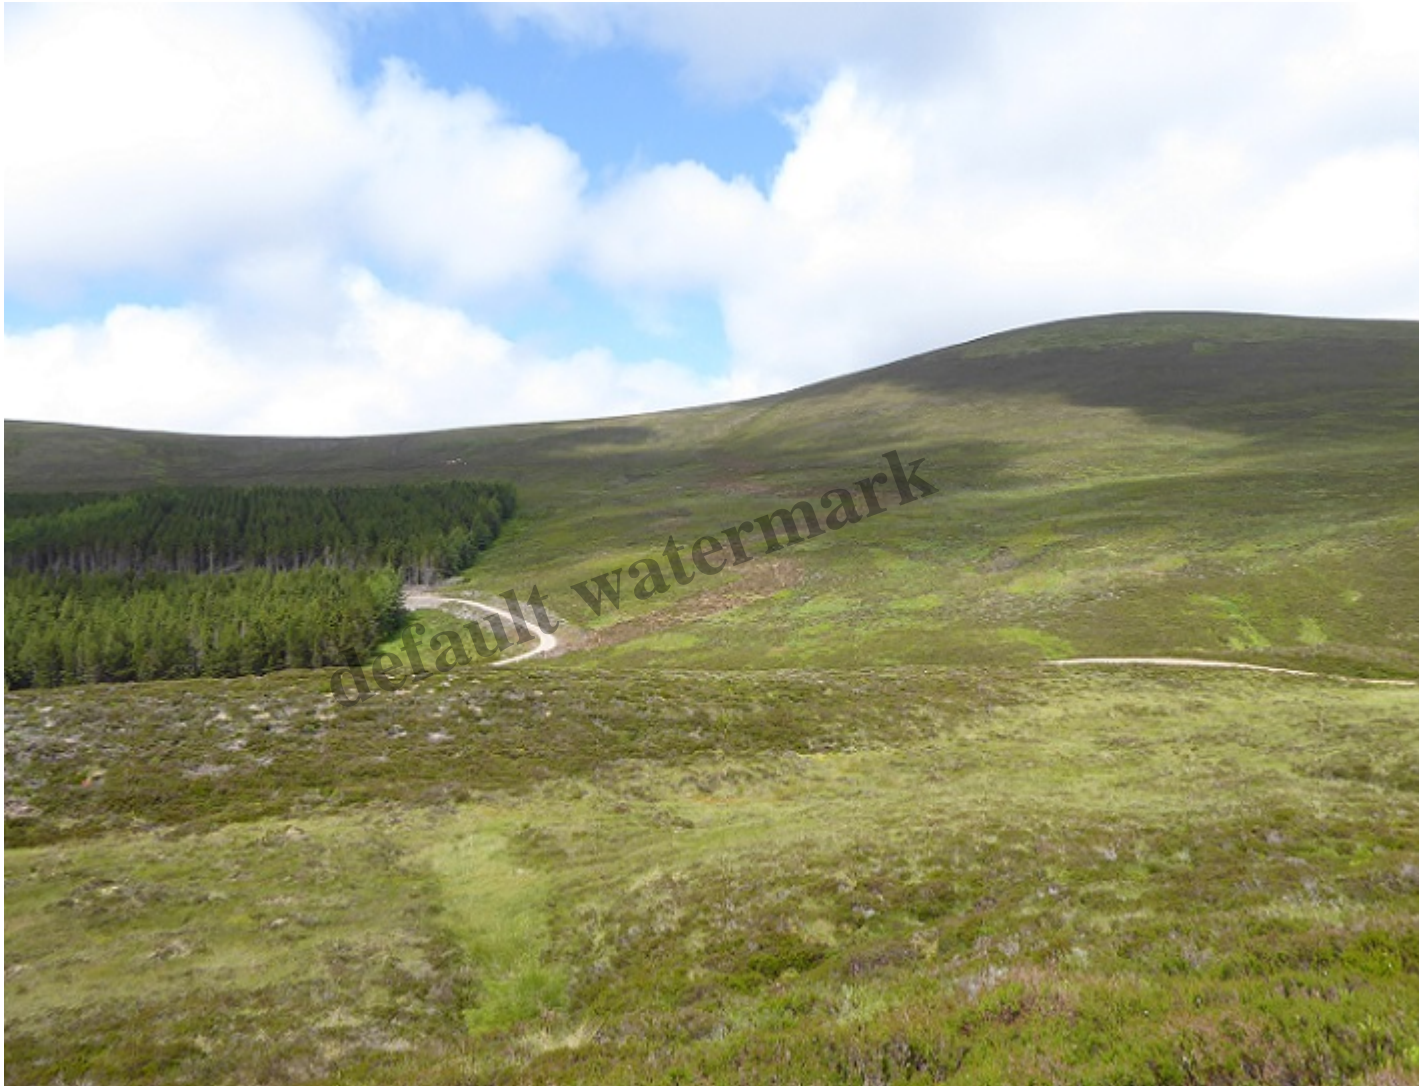
View towards Carn Dearg Mor (right) from south. A digger being used for the restoration work is just visible above the plantation

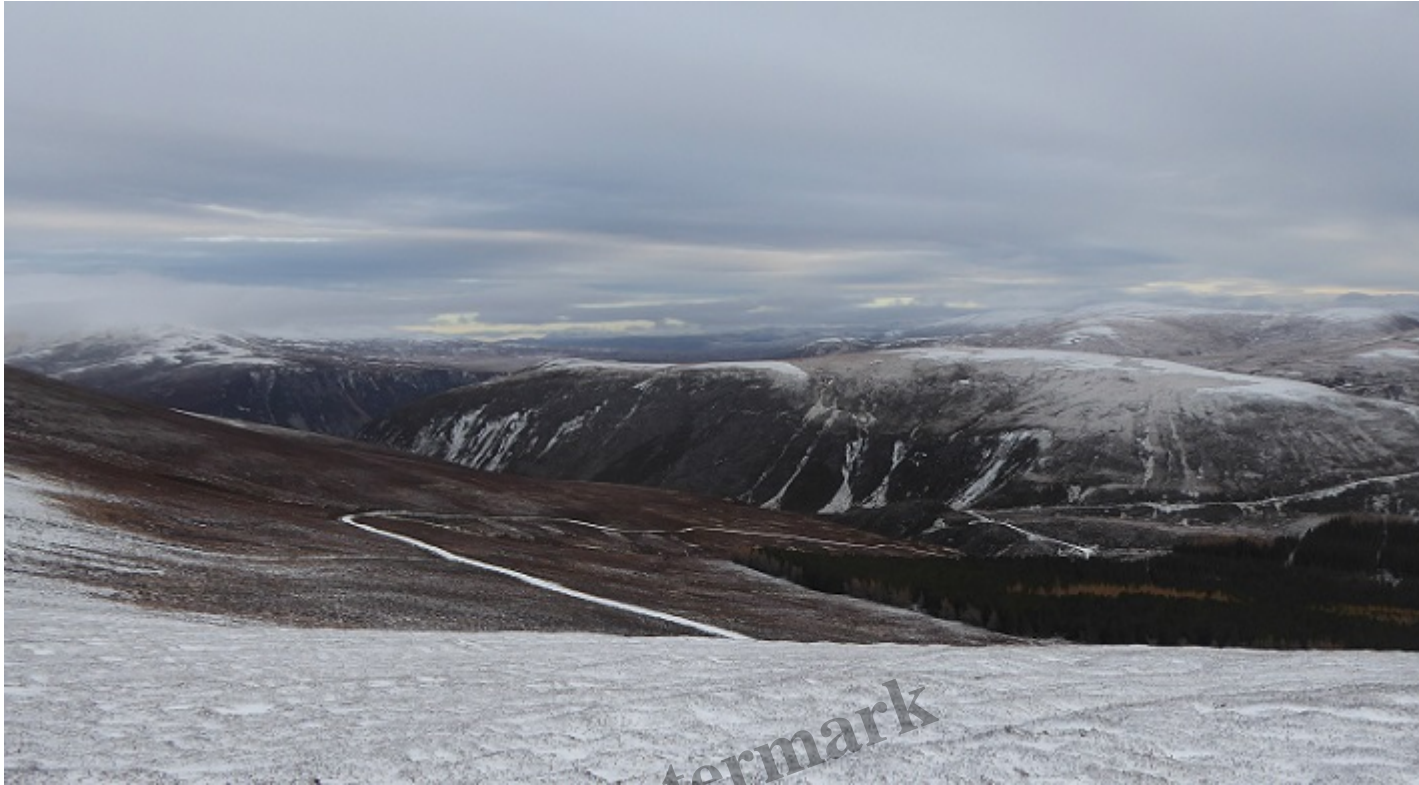
View from above November 2017. The hill road in the foreground has been removed. That on the far side of the col between Glen Feshie and Glen Tromie remains and is currently being used for deer culling and to access peat bog restoration sites

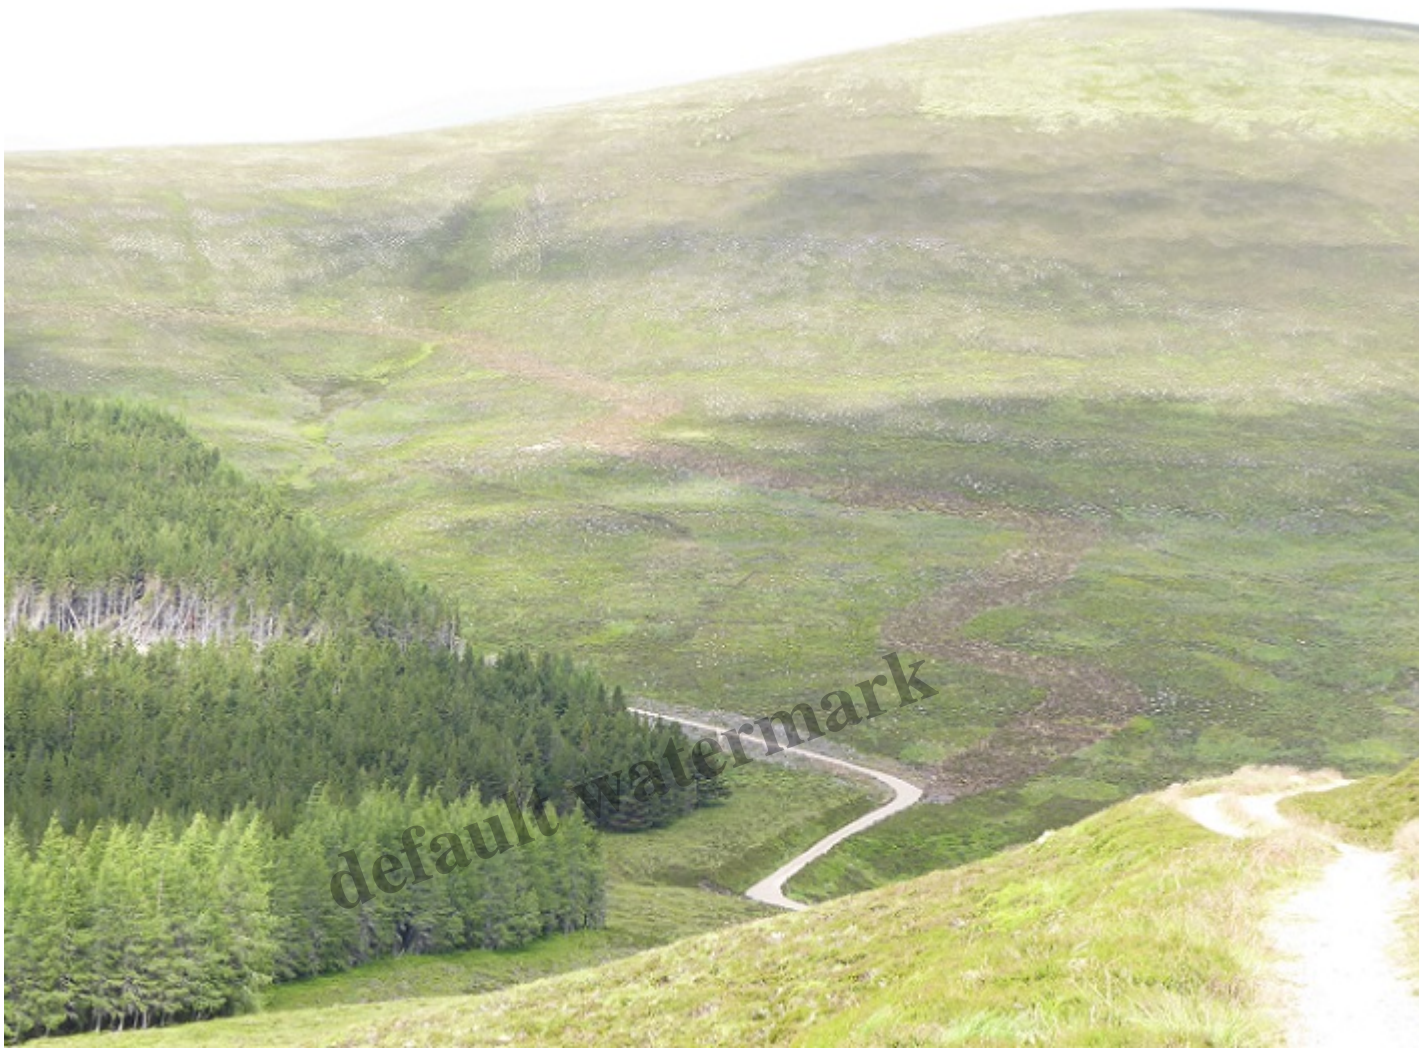
The removal of this track is part of a plan to rationalise and reduce the landscape impact of hill tracks on the Glen Feshie and Glen Tromie estates. While the track to the plantation remains prominent, as woodland develops it should eventually become concealed from view.

Because this was a longstanding road, there was no “spare” vegetation to cover its surface once this had been re-moulded to fit back into the landscape. The pockmarks on the slope show where vegetation has been “borrowed” and used to cover the track. Because the areas of borrowed vegetation are small and well spaced, each should be re-colonised by the plants surrounding them in a year or two despite the short growing season at this altitude (600-700m). That process will have been assisted by the work having been carried out fairly early in the growing season this year.

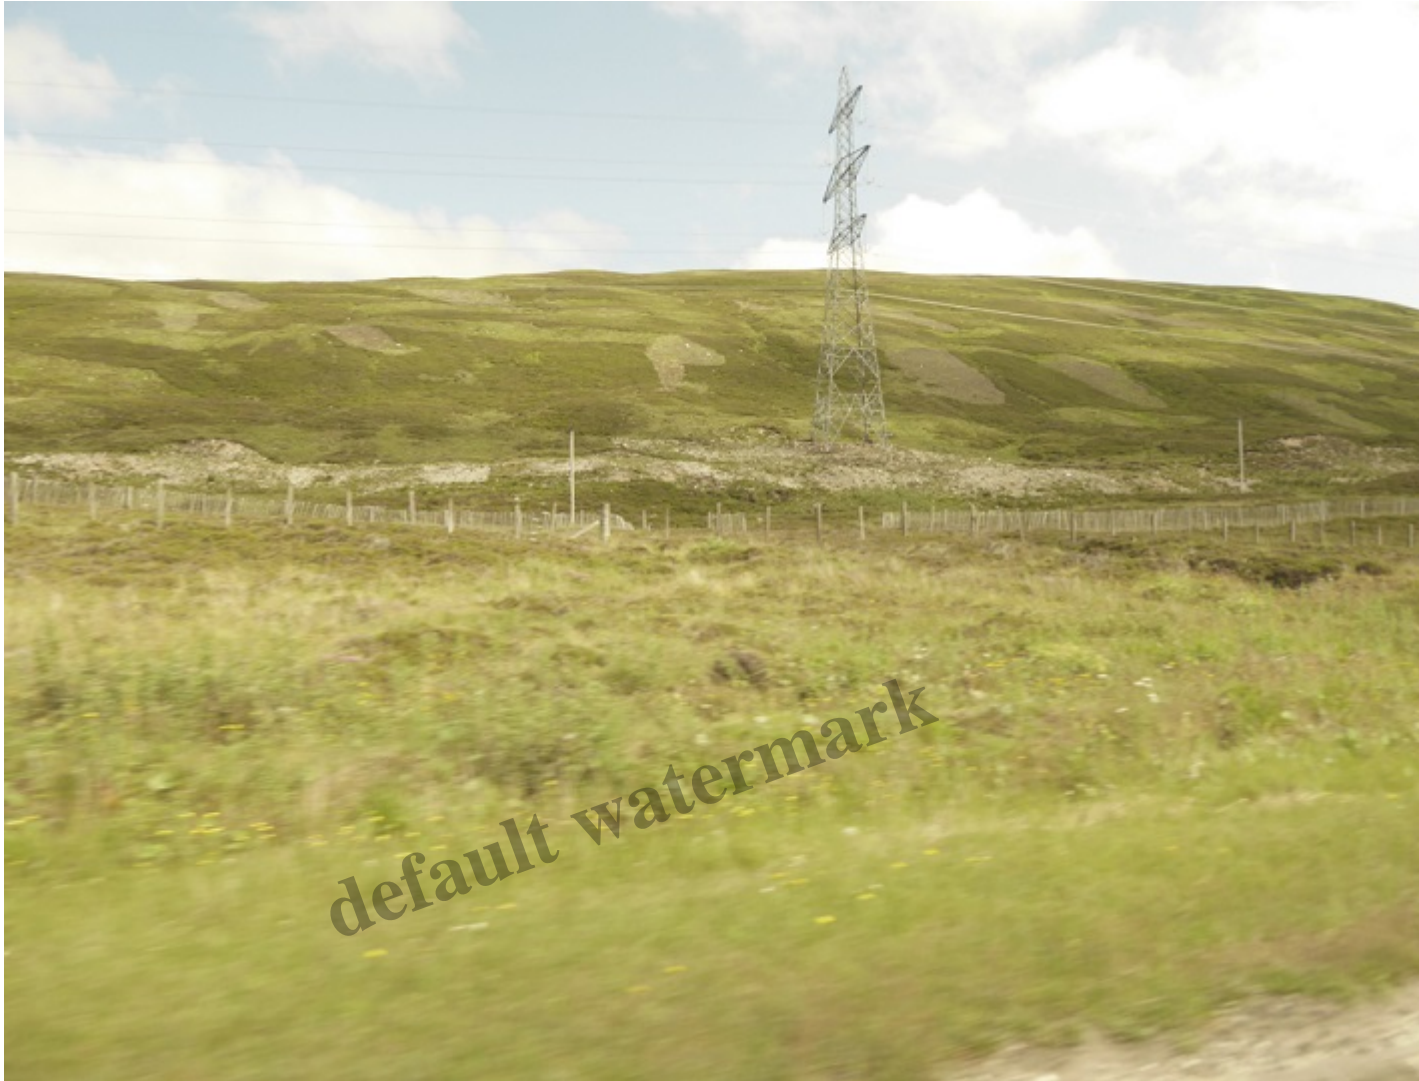
The Beaully Denny restoration should have been far simpler than that on Carn Dearg Mor, as the access roads were supposed to be only temporary and it also lies at a lower altitude. Had vegetation along the line of the access roads been removed carefully and stored properly, it could have simply been replaced once the line of the road had been re-moulded to fit the landscape. The scars should then have disappeared in a year or so. Instead five years later the scar is almost as prominent as it was when the roads were constructed:

View of section of Beauly Denny access track taken from the car 17th July

Had SSE ensured suitably skilled contractors were employed to work on the construction and restoration of the Beauly Denny access roads, none of the landscape scarring at the Drumochter need have occurred. Remedial work could still start tomorrow if the Scottish Government had the political will to hold SSE to account. There is plenty of vegetation on the surrounding ground that could be “borrowed” to help resurface these roads and there would be even more if the muirburn that is scarring the hillside above was stopped. But first the surface of the access road needs to be re-moulded to fit the contours of the hillside, removing the straight line that currently cuts across it.
