The state of the Cairngorms (3) – land falling apart

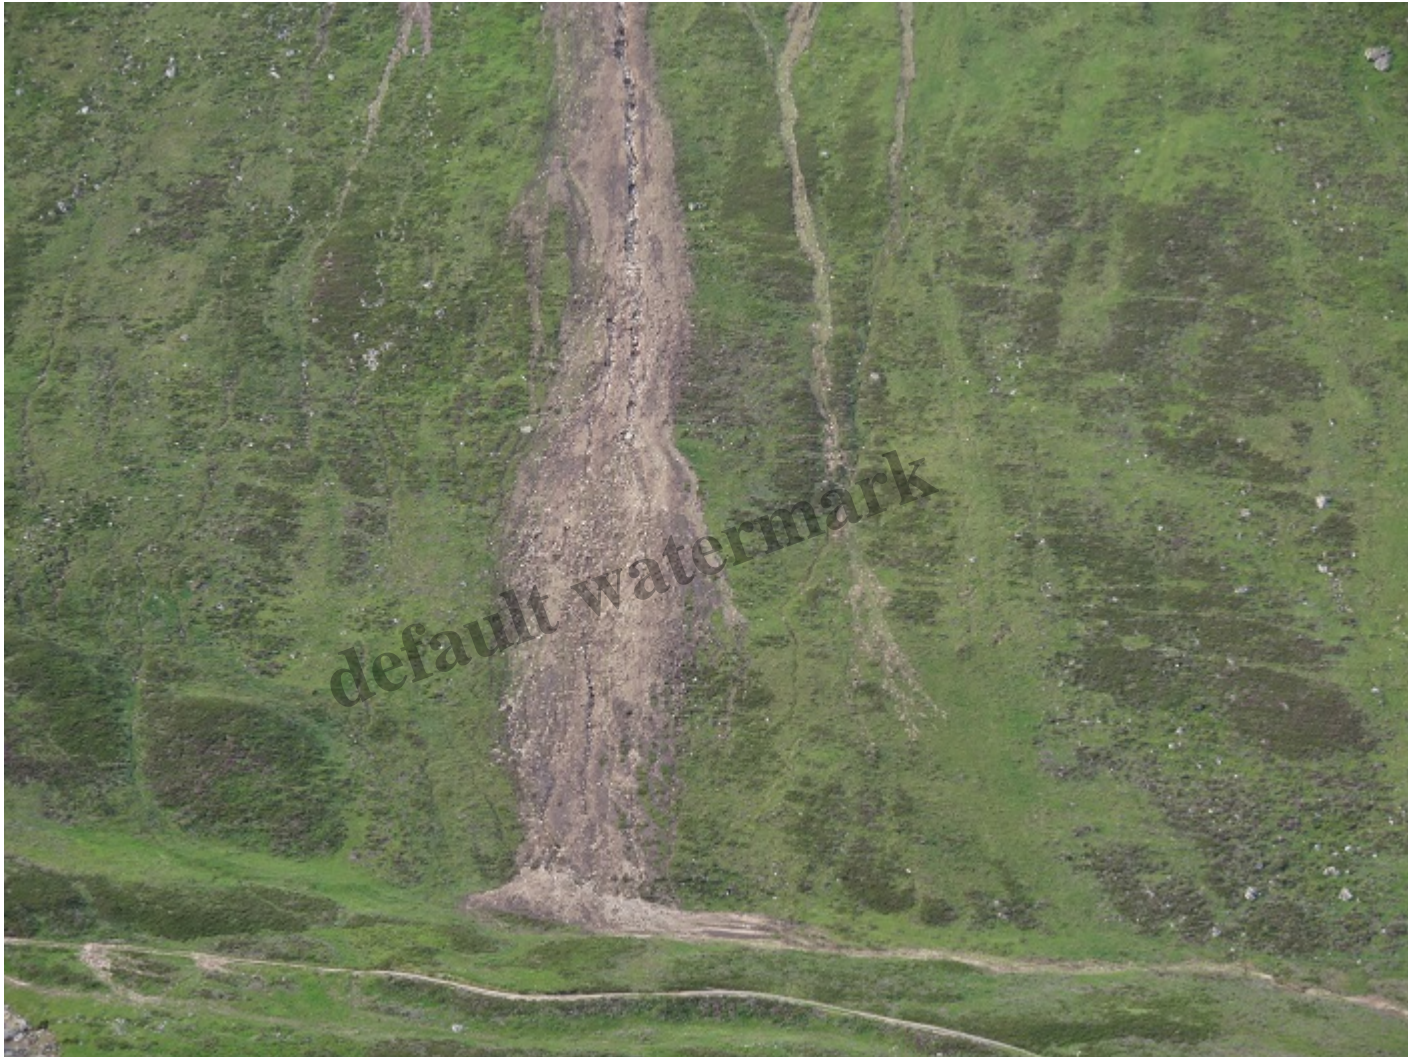
The recent landslide above the Allt Fionndrigh, off Glen Banchor above Newtonmore from Creag Liath. Note the multiple green lines, marking tracks created by animals, traversing the hillside. Photo credit Dave Morris

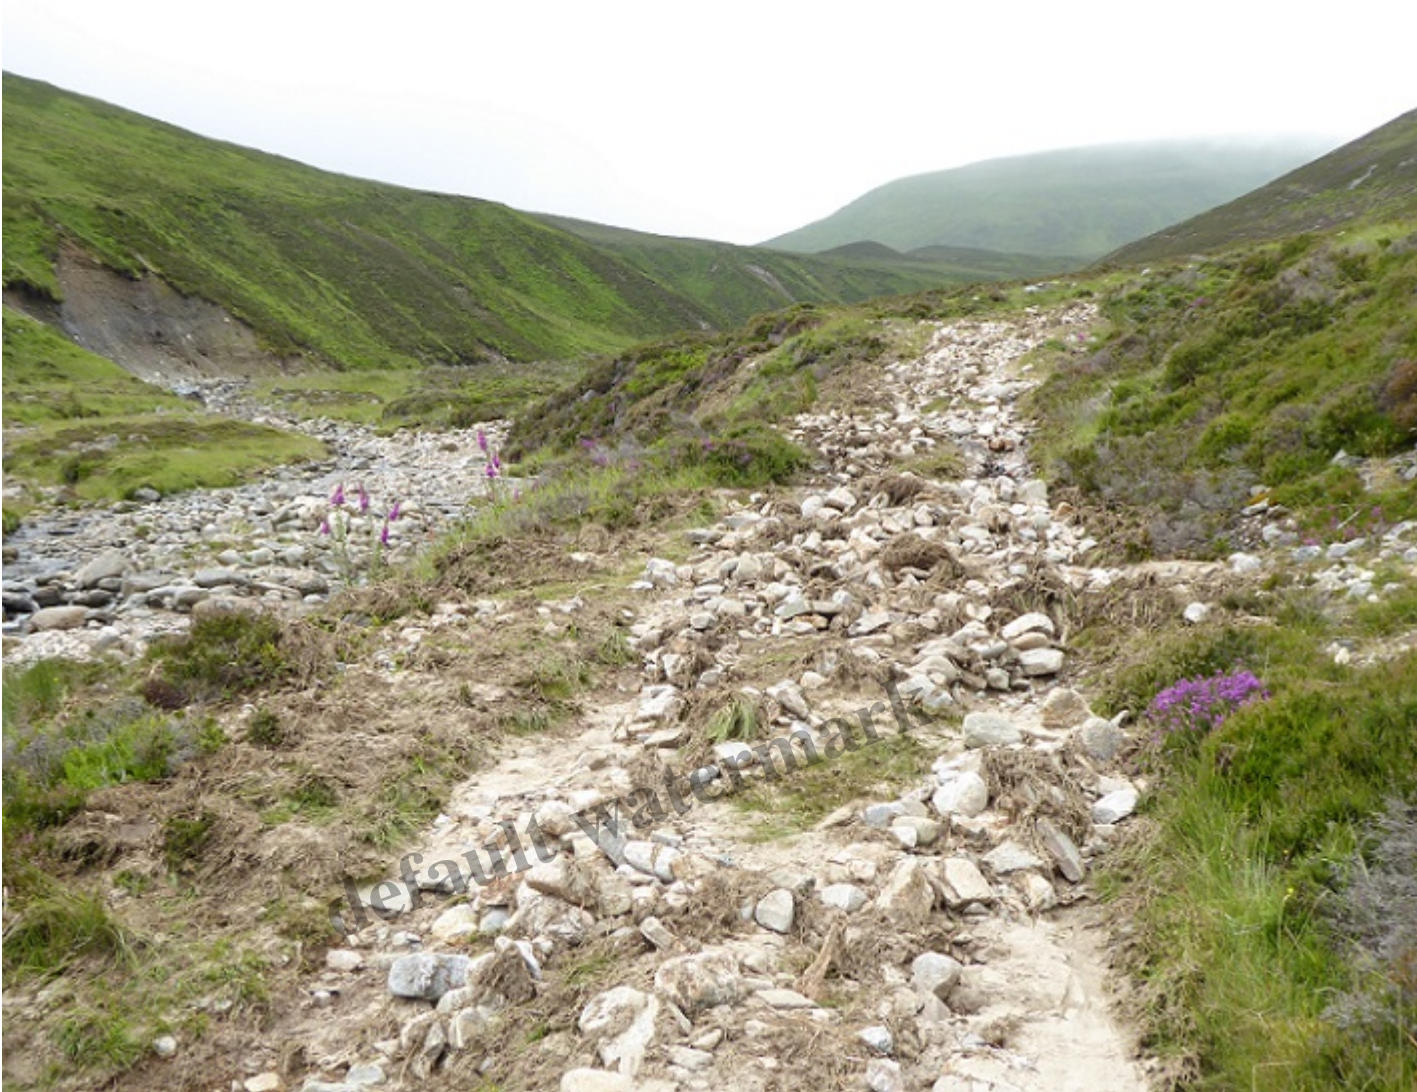
Note the absence of any flood debris on the river opposite. That and my first photo suggests this rain event was very restricted in extent and the main river did not flood. How much silt, however, was washed into the River Spey Special Area of Conservation?

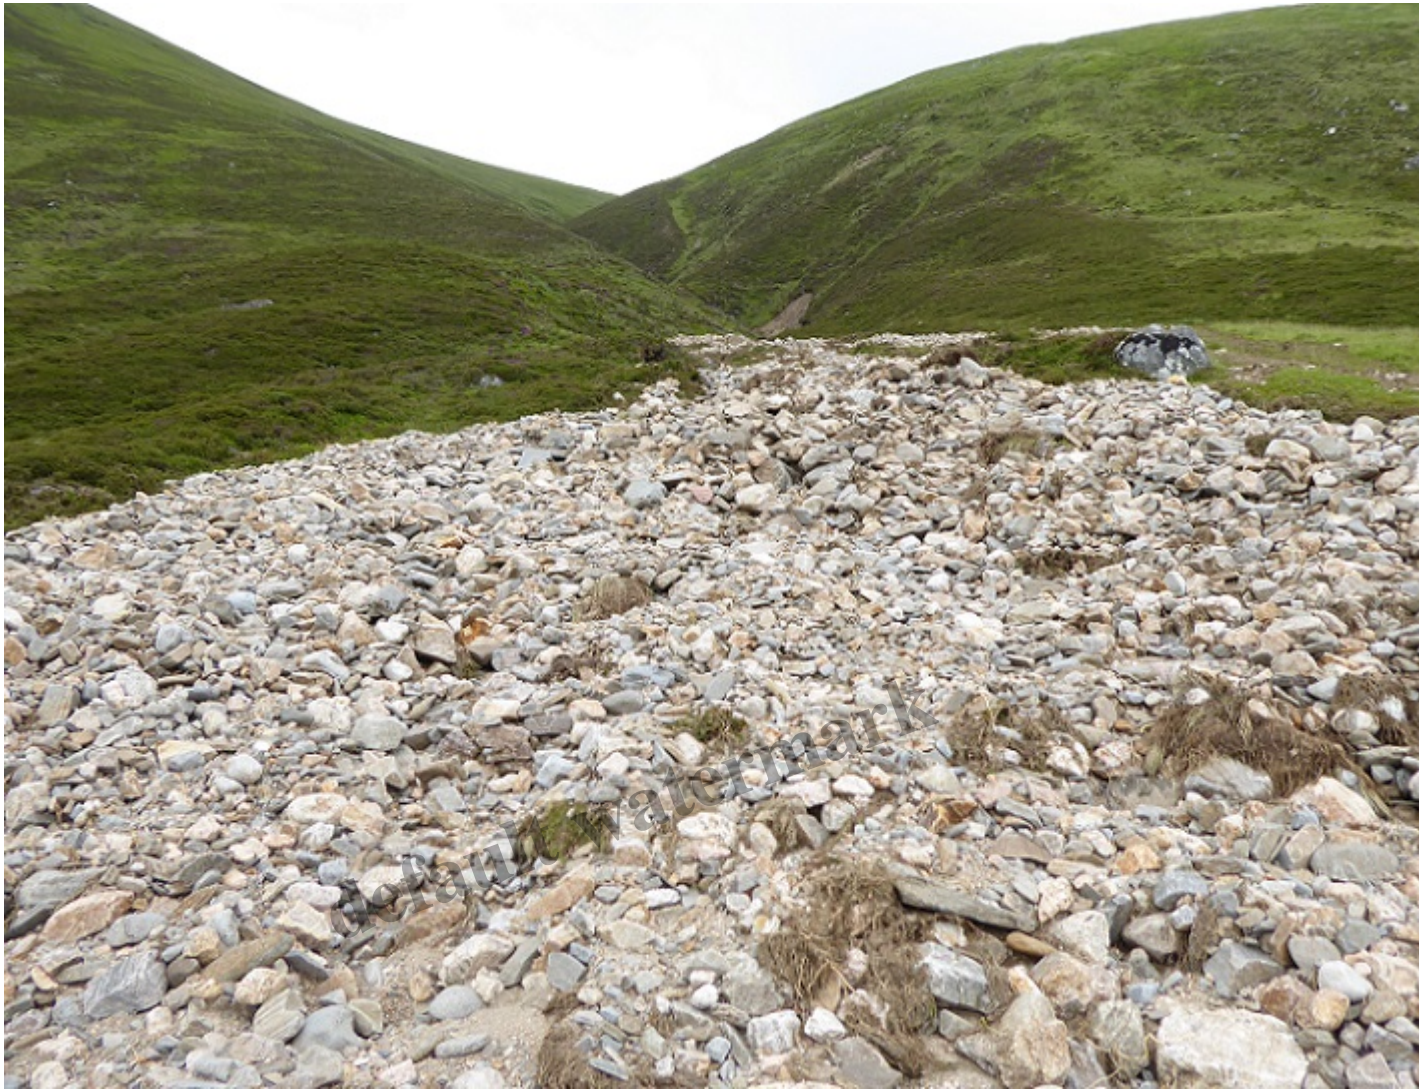
The large landslip is on the hillside just to the right of this photo

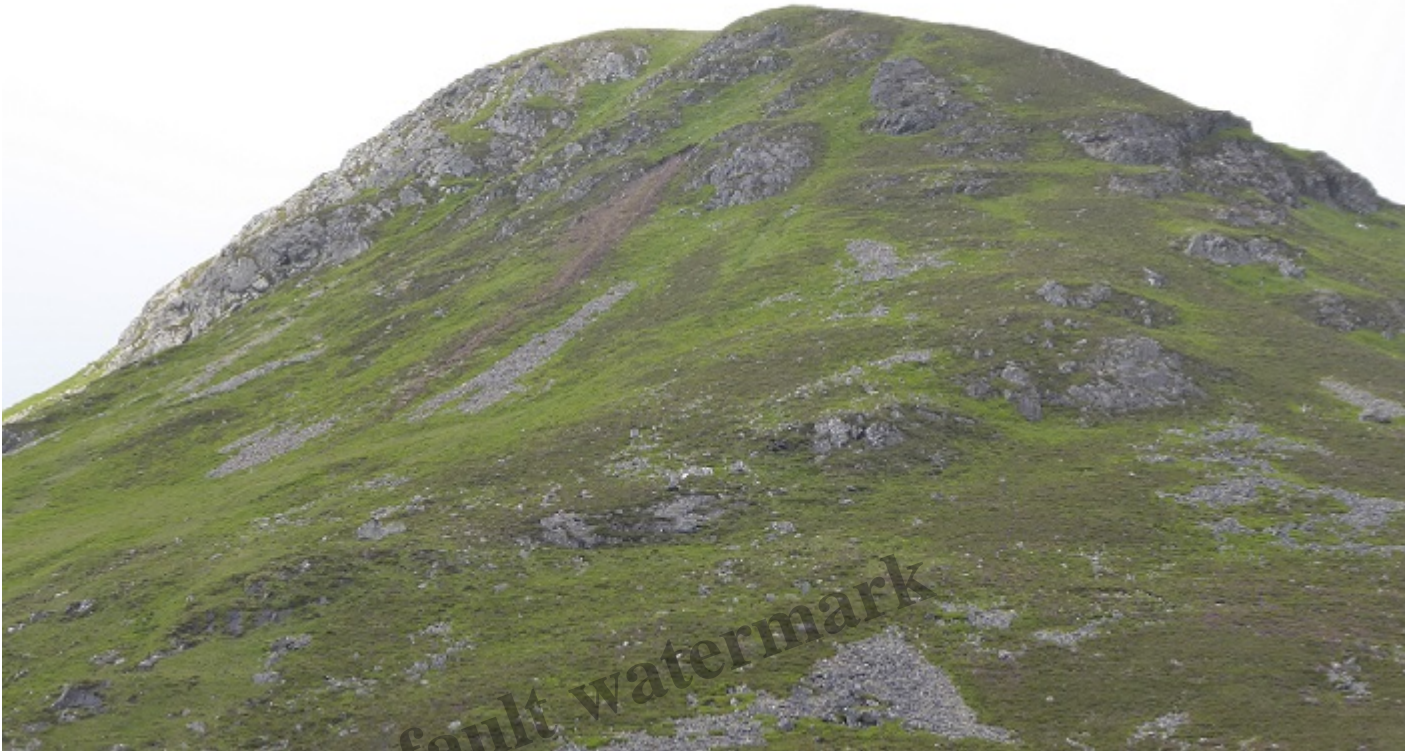
Landslip below the crags on Geal Charn, about 400m beyond the gully (off photo to the right)

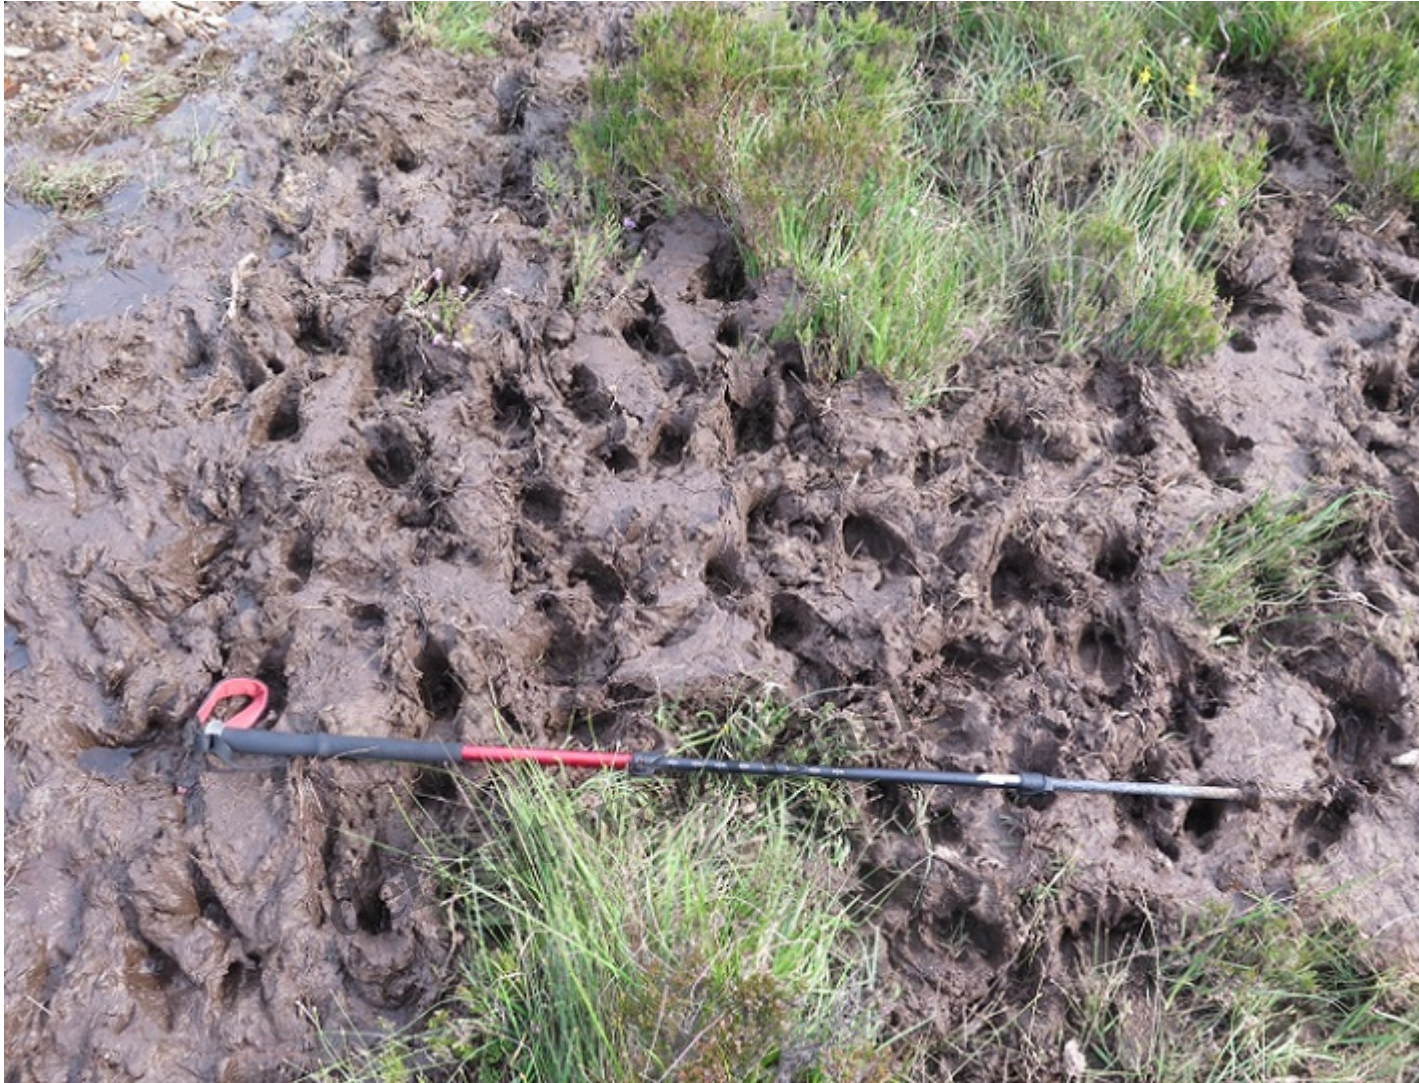
The mud deposited by the landslips was covered with red deer hoof prints:

The evidence strongly suggests that high population of red deer has been one of the main causes of the environmental degradation that has made these slopes so vulnerable to climate change. Deer have trampled the hillsides, munched the vegetation that might have helped hold these slopes together and helped erode the peat bog above.
