The state of the Cairngorms (3) – land falling apart

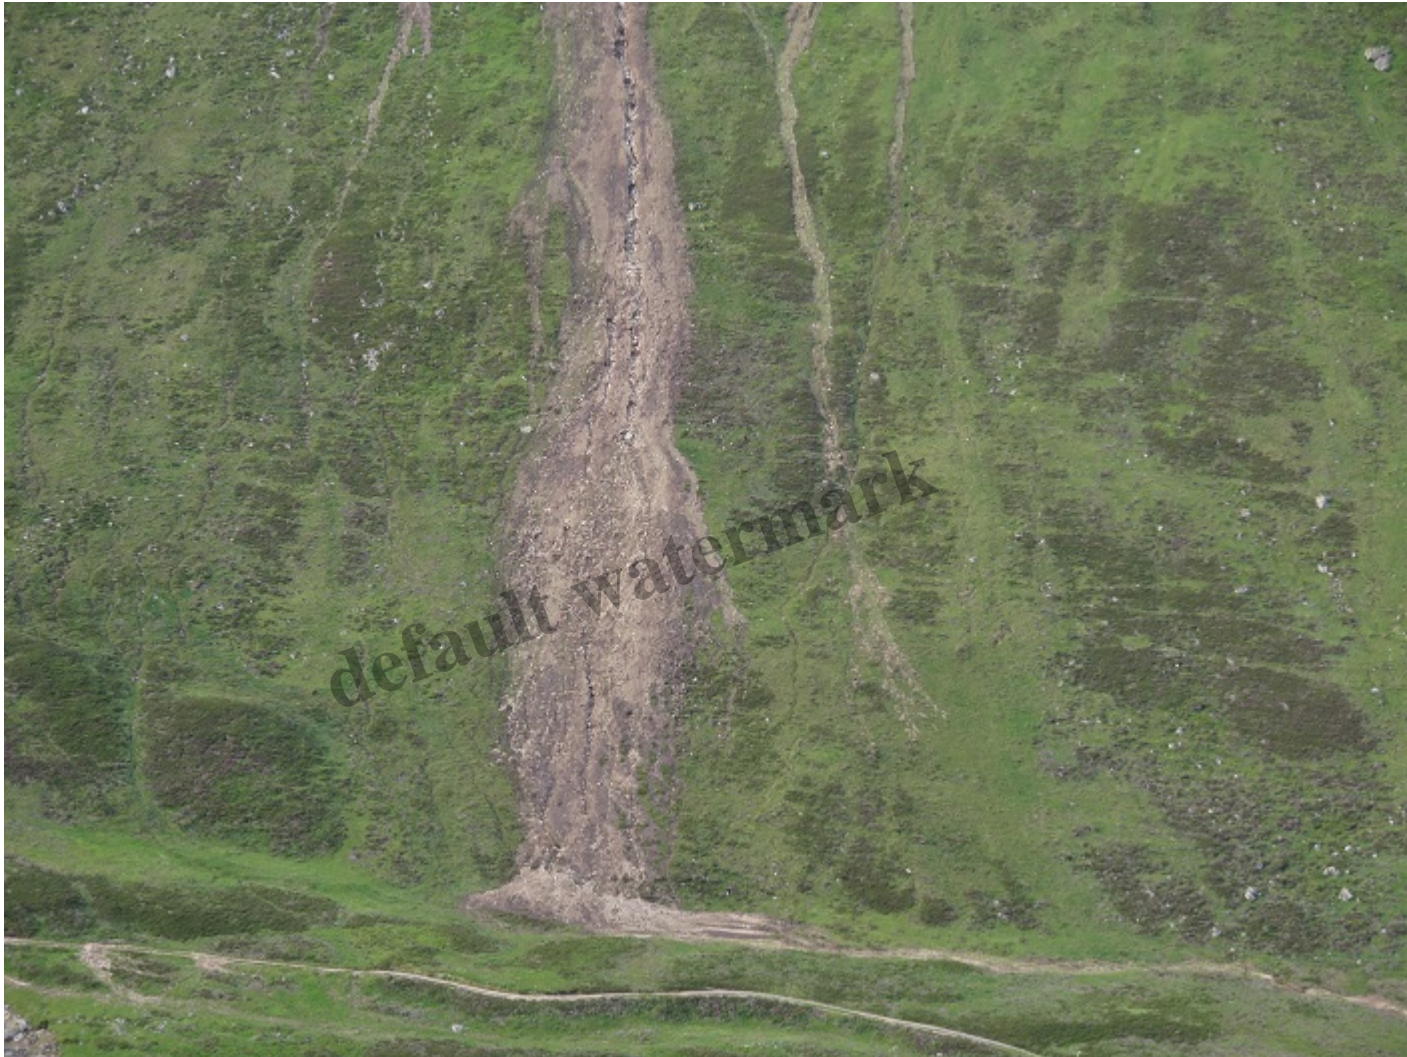
The recent landslide above the Allt Fionndrigh, off Glen Banchor above Newtonmore from Creag Liath. Note the multiple green lines, marking tracks created by animals, traversing the hillside. Photo credit Dave Morris

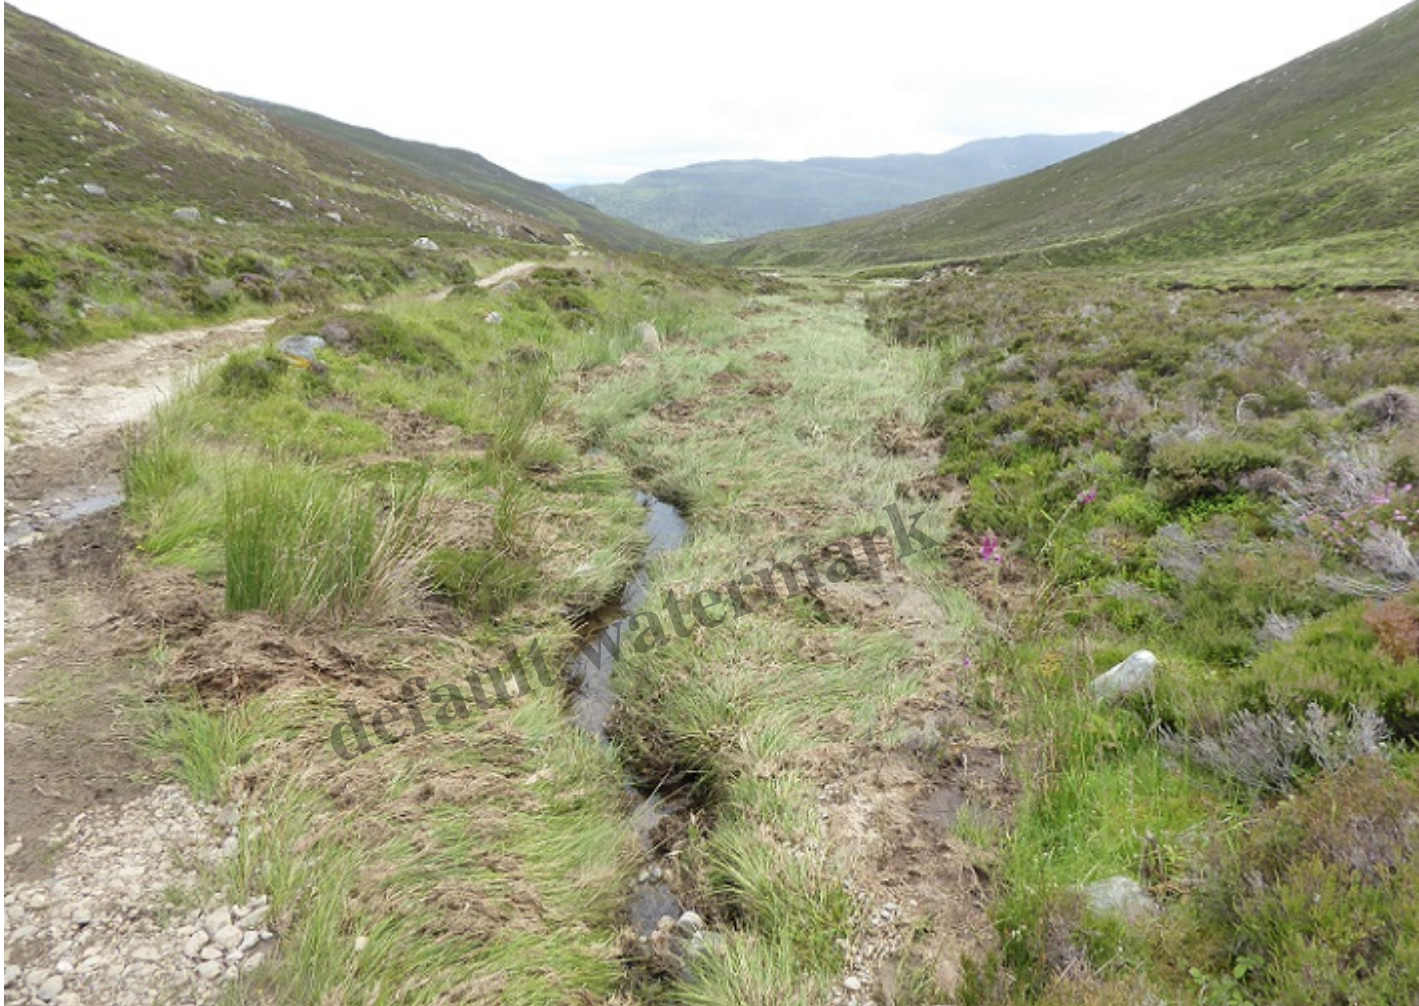
Looking back down the flood line

I was not that surprised as ten days earlier intense but localised rainfall had been forecast. I had also had heard from two people I know that that day two inches of rain had fallen in Grantown on Spey, the heaviest downpour they had ever experienced. But it took me a couple of minutes, by which time we had moved a little further up the glen, to work out why the flood was above the main river. It had originated from up the hillside, rather than up the glen, and was associated with a large landslide.

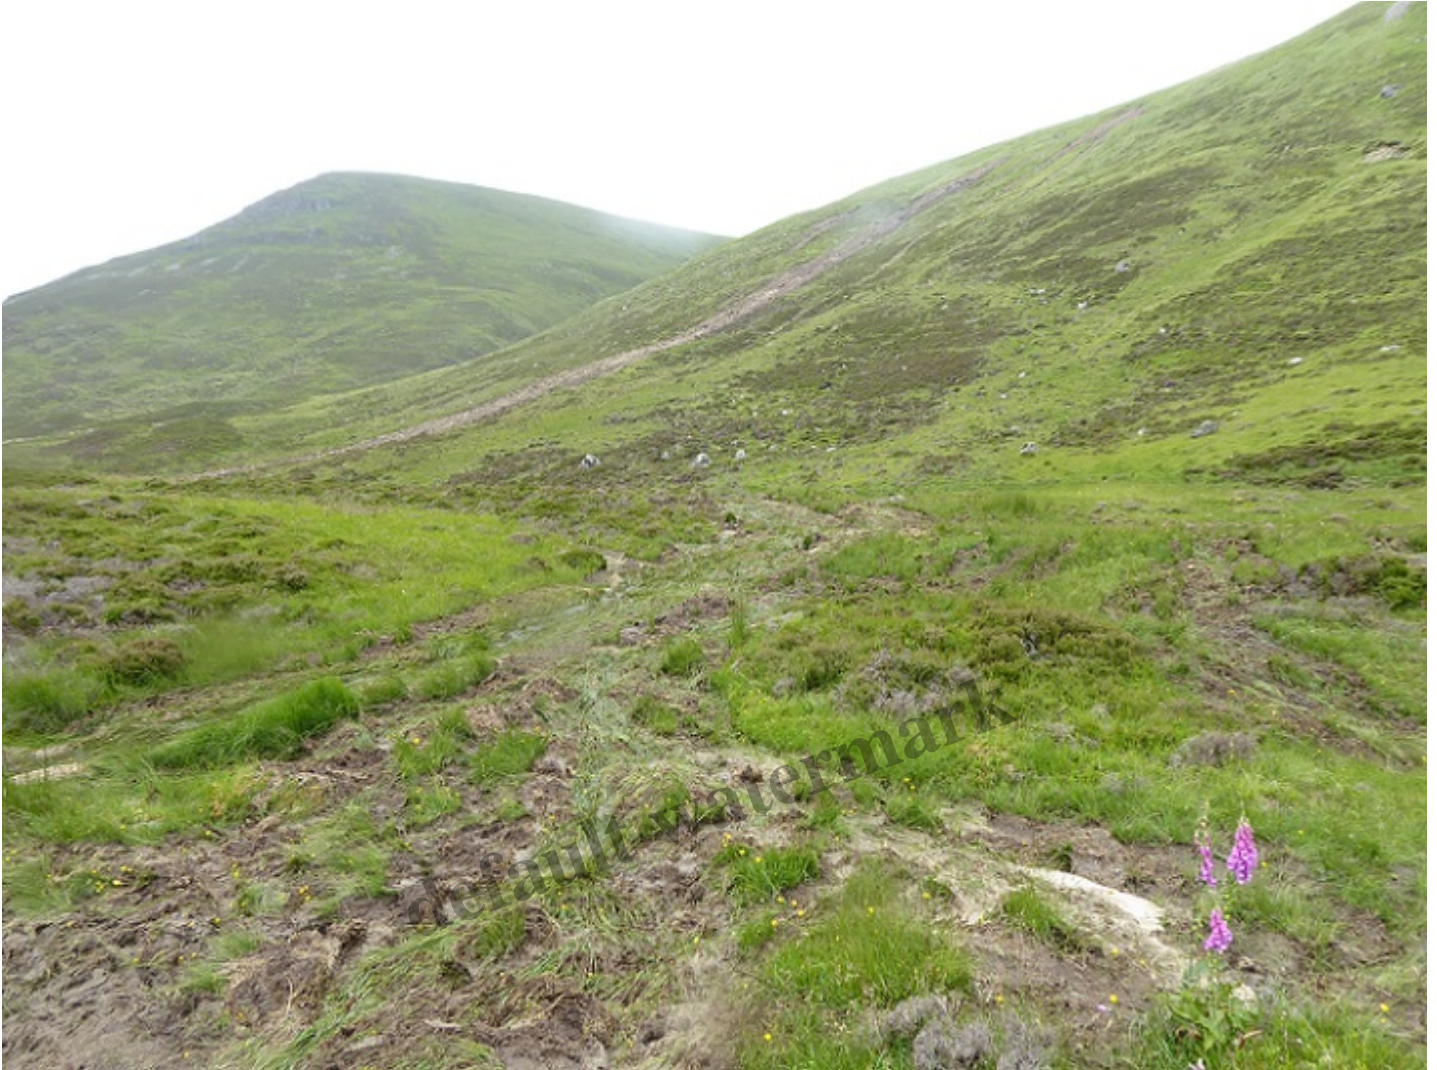
The scale of the landslide and the damage that been wrought to the hillside became evident as we got closer.

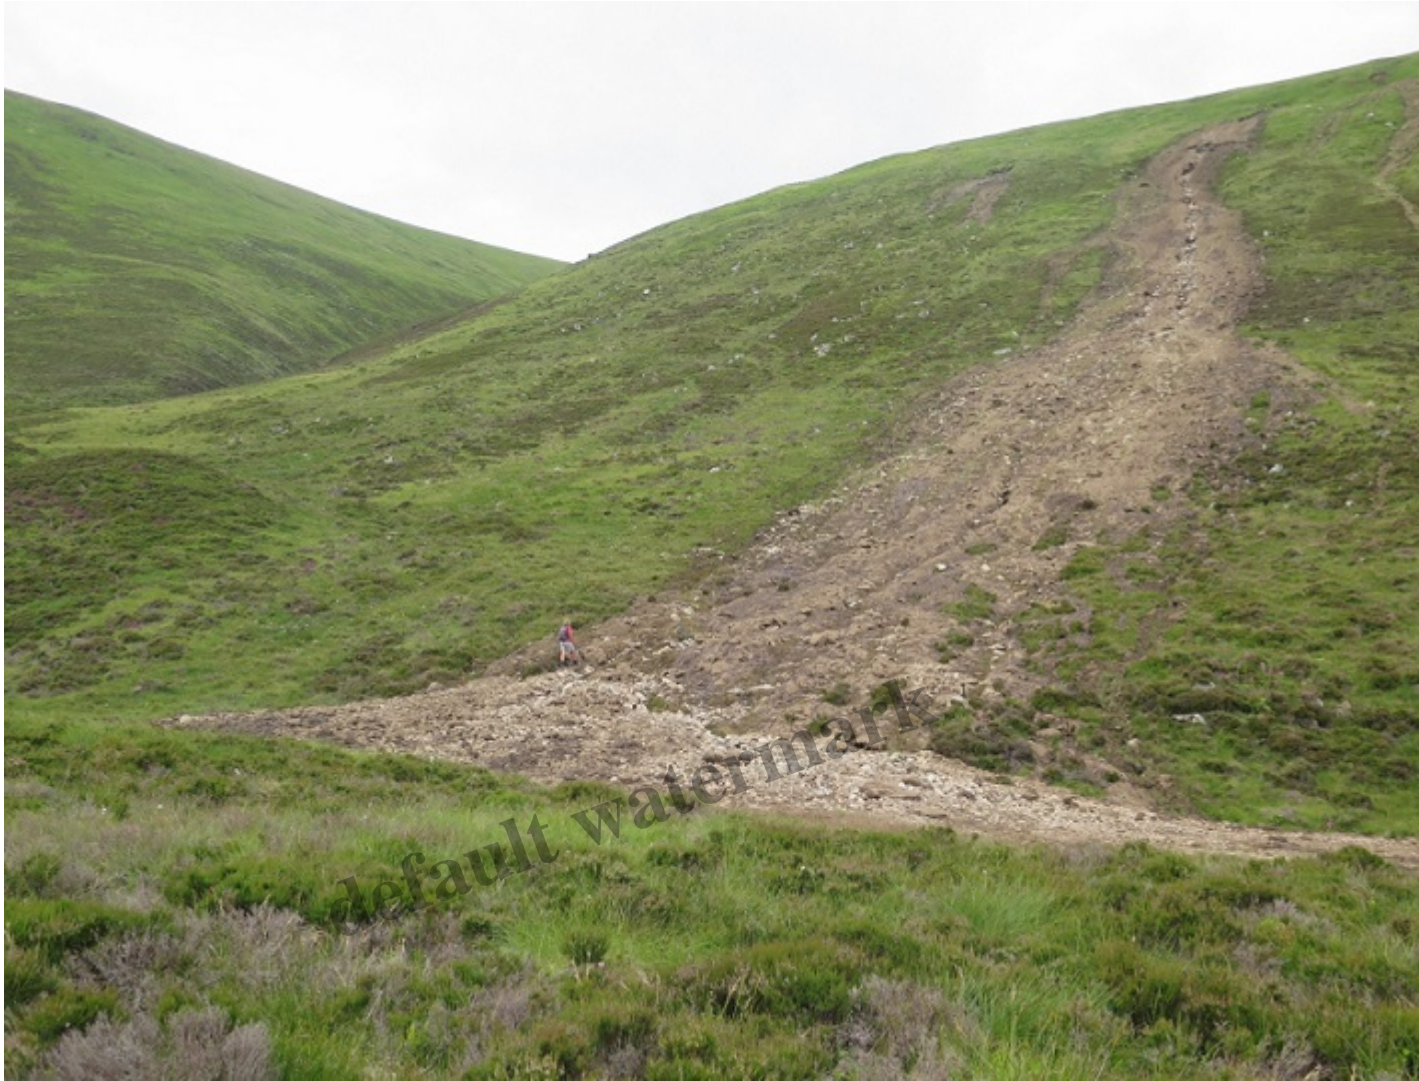
Note figure bottom left for scale. Photo credit Dave Morris

Alongside the large landslide were a number of smaller ones.

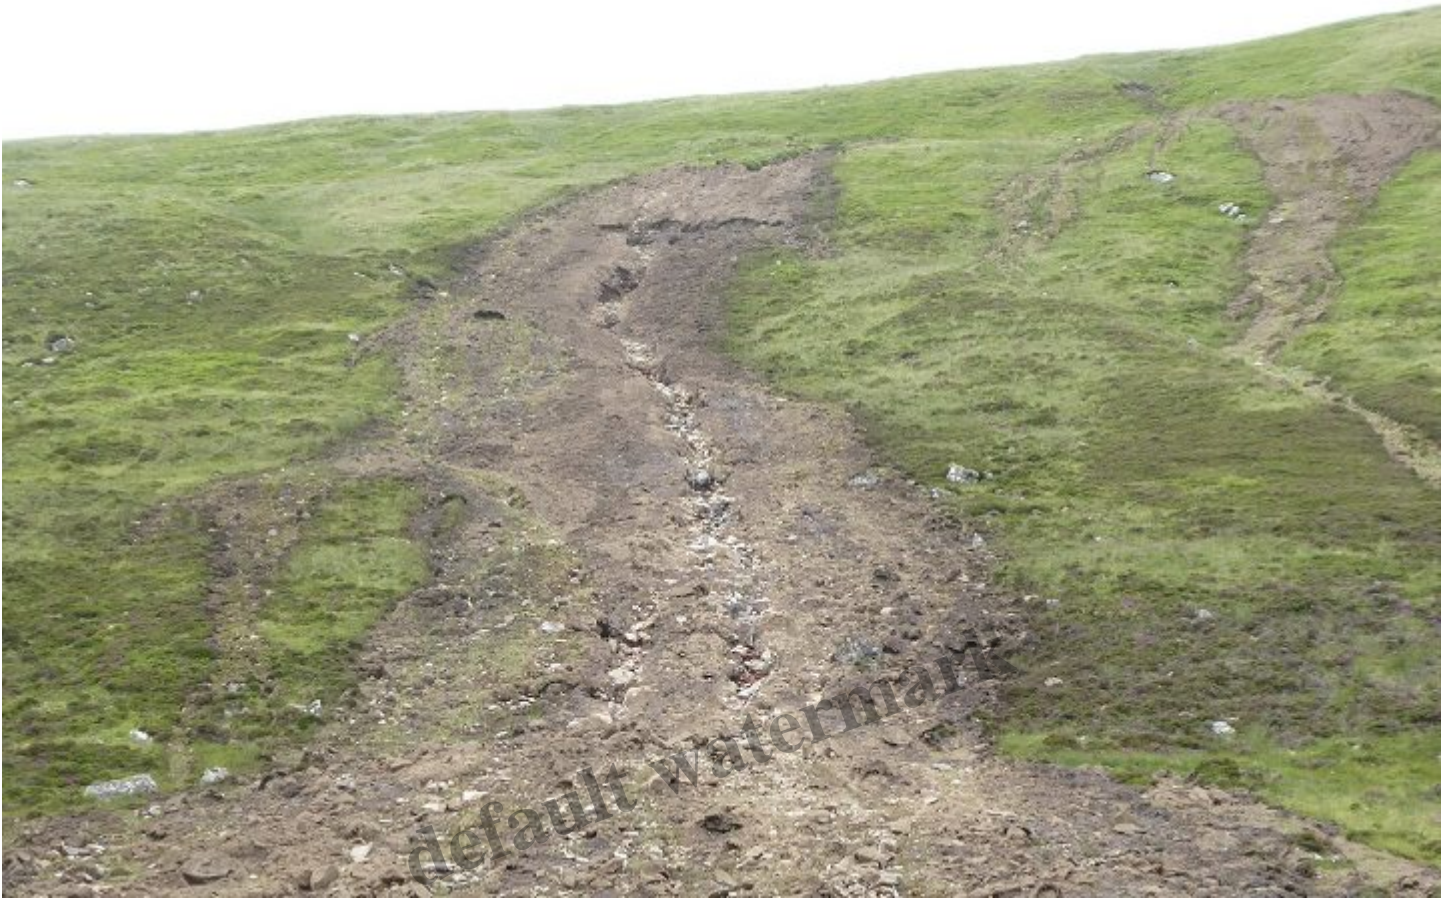
The top of the main landslide was marked by the equivalent of a half depth avalanche which had swept down peaty soils across a front 10-20 metres wide:

Below the shear-line the former drainage line down the central axis of the landslide had been gouged out down to the glacial till below. It had formed a new burn which was still trickling. This sudden erosive event has removed significant quantities of peaty soils which have been storing carbon and retaining water, possibly for for thousands of years.

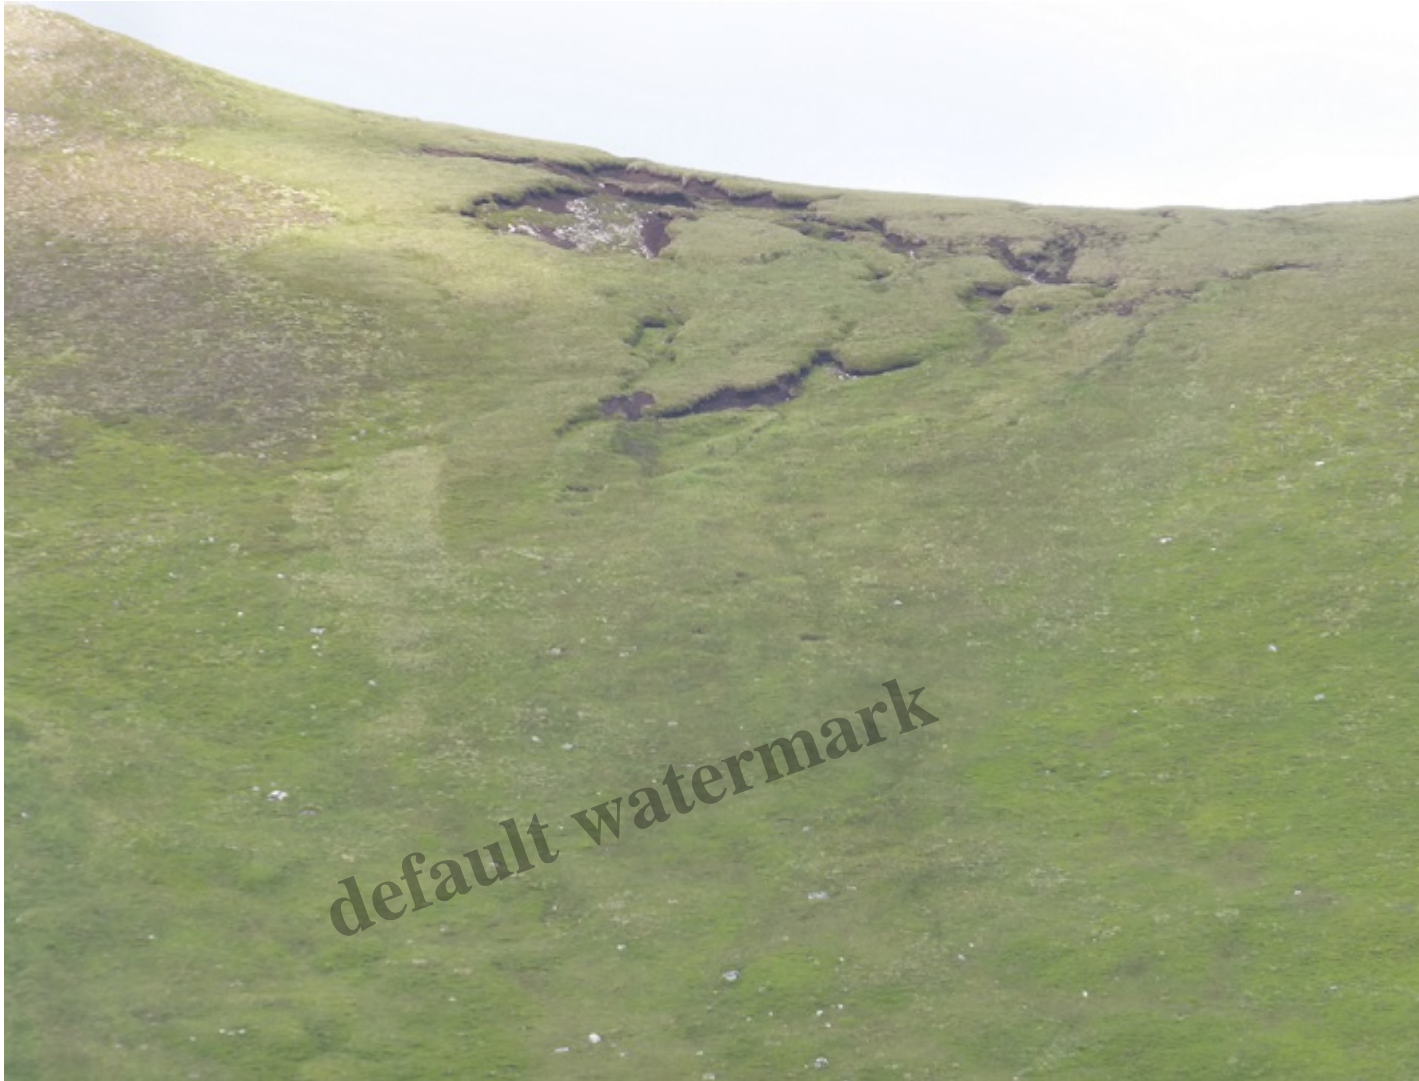
A large patch of peat within the hags (top left) has eroded away completely, allowing water to flow freely downhill, while below that you can see evidence of a drainage line.

There is a peat bog at the top of the slope immediately above the landslip but this appears severely eroded. Had this bog been in better condition, might the damage from the rain event been reduced, or even avoided completely?

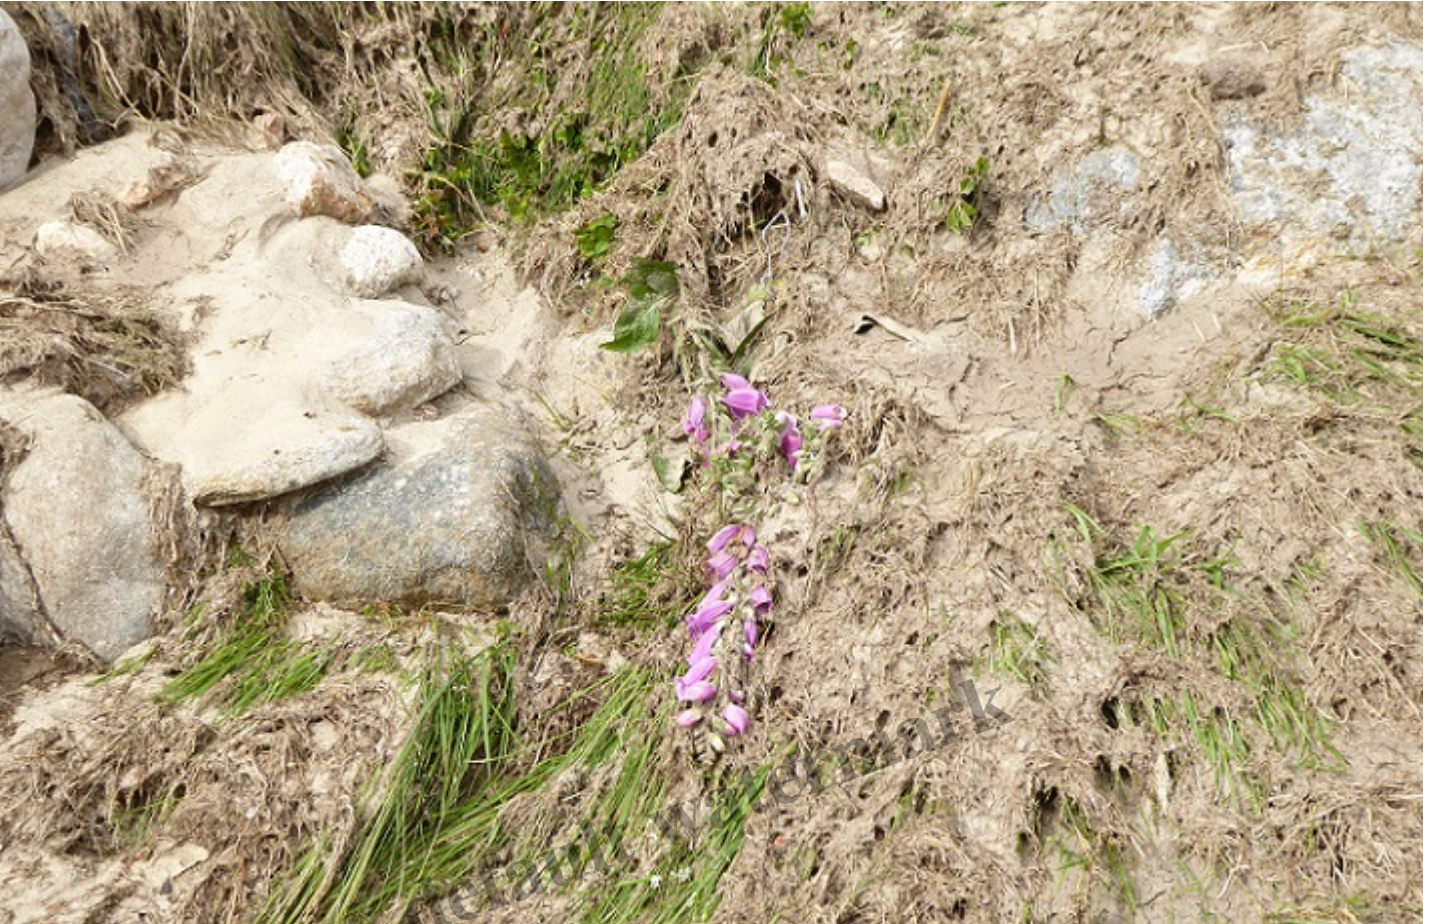
Flowers caught up in the debris provided evidence that the landslide was very recent.

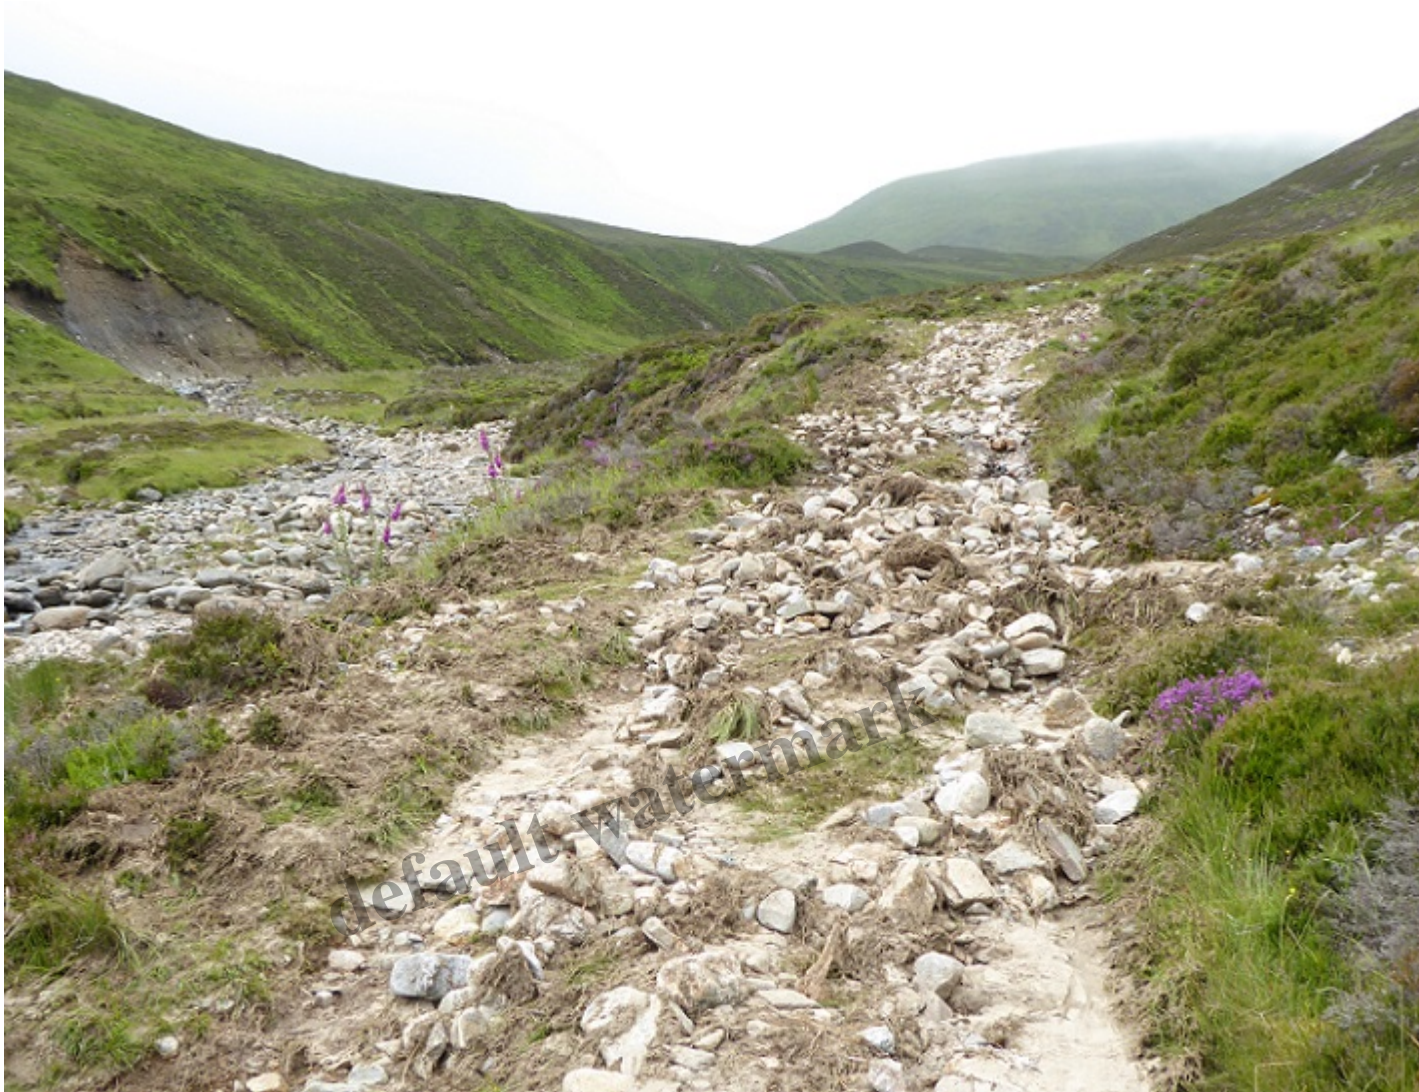
Note the absence of any flood debris on the river opposite. That and my first photo suggests this rain event was very restricted in extent and the main river did not flood. How much silt, however, was washed into the River Spey Special Area of Conservation?

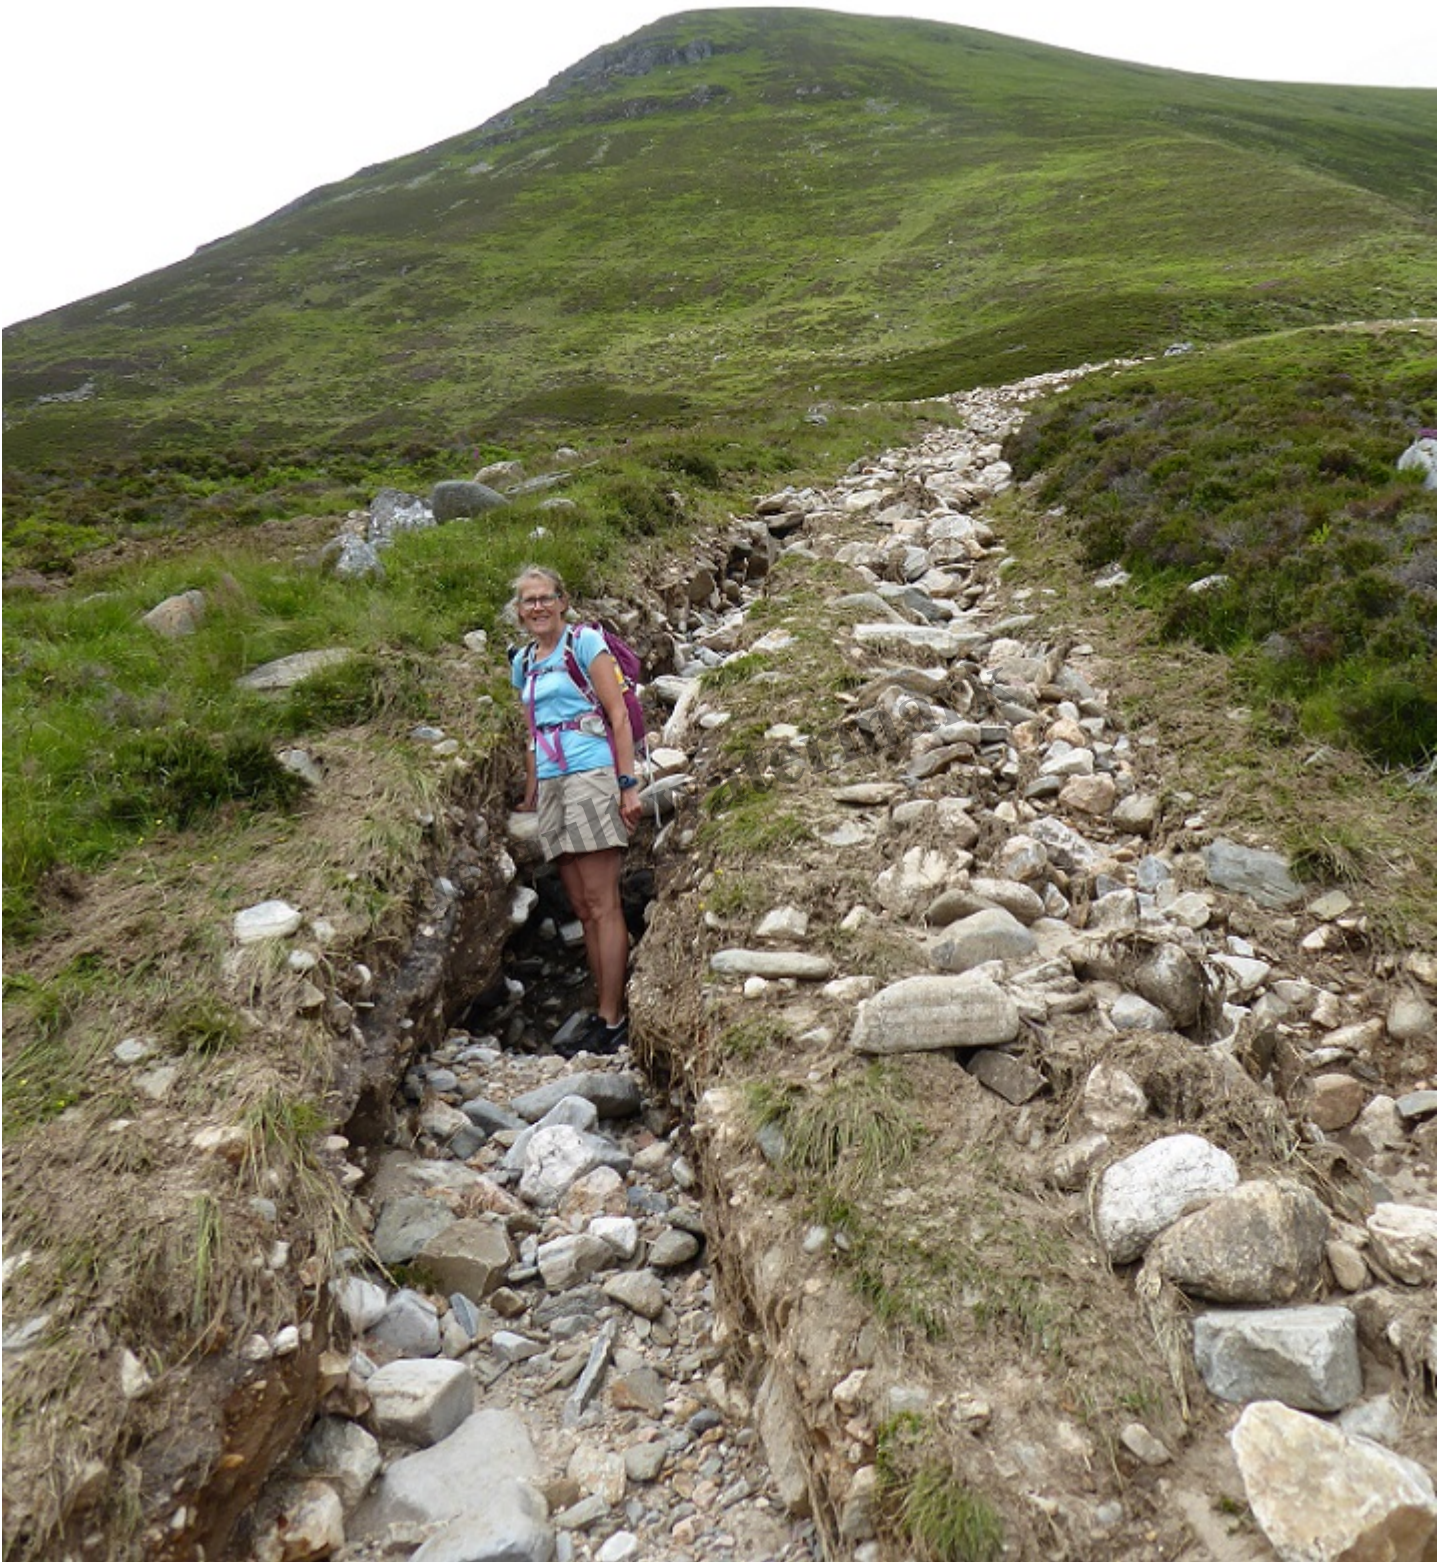
Just beyond the landslip, the former track was covered in debris. It then turned uphill to cross the burn that drains the southern slopes of Geal Charn, a subsidiary top of the Munro A'Chailleach.

What had happened is the burn had partly diverted down the line of the track from former crossing point, gouging it out in the process. The force of water that created this must have been extraordinary. It would have been amazing, but very frightening, to watch.

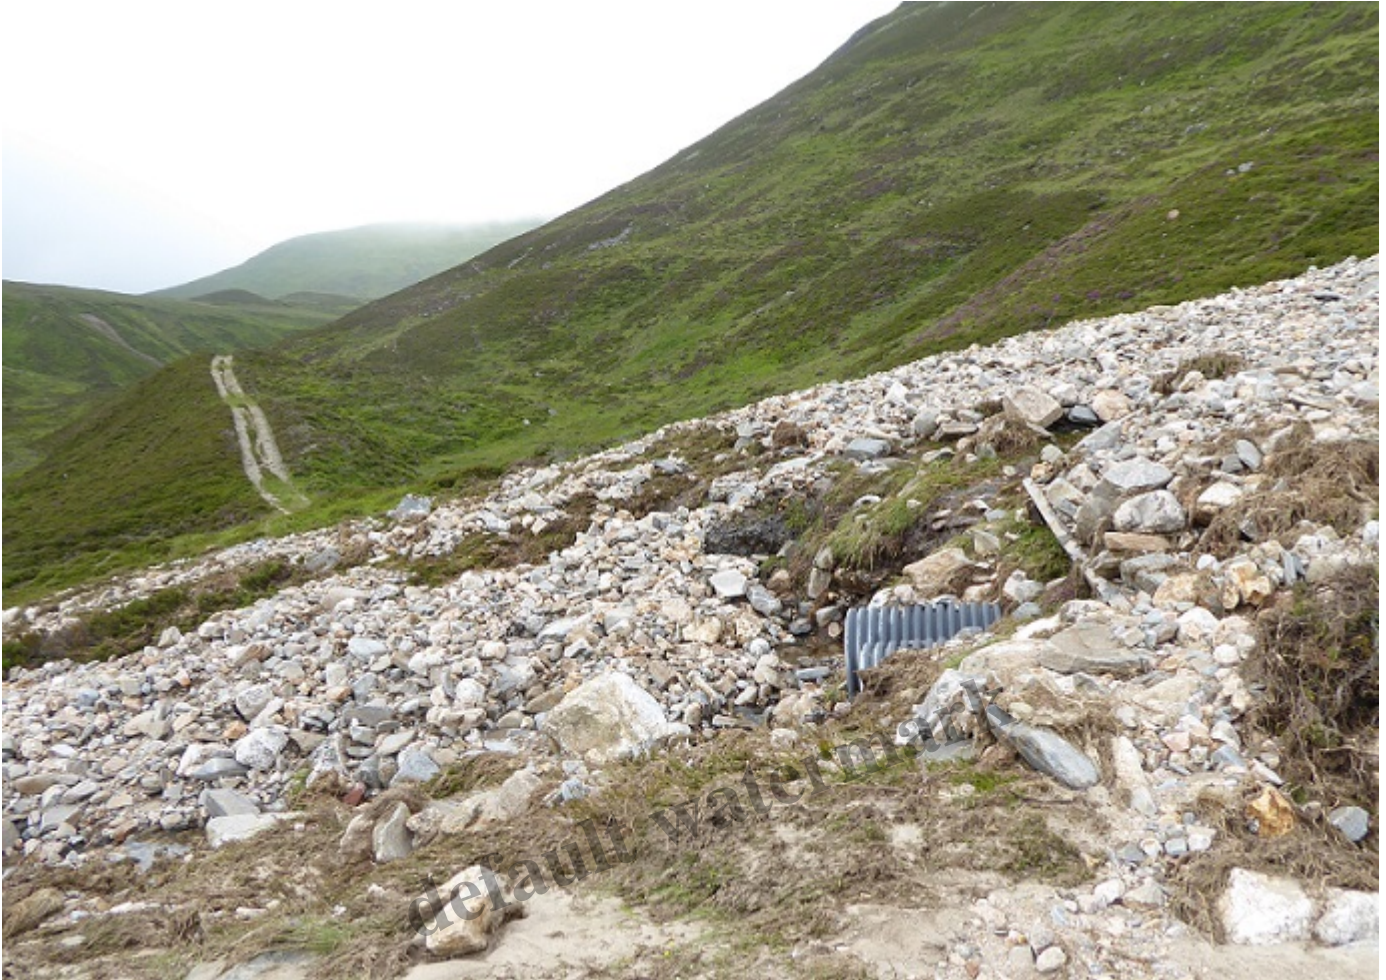
The former crossing point had been completely overwhelmed with boulders disgorged from the gully above.

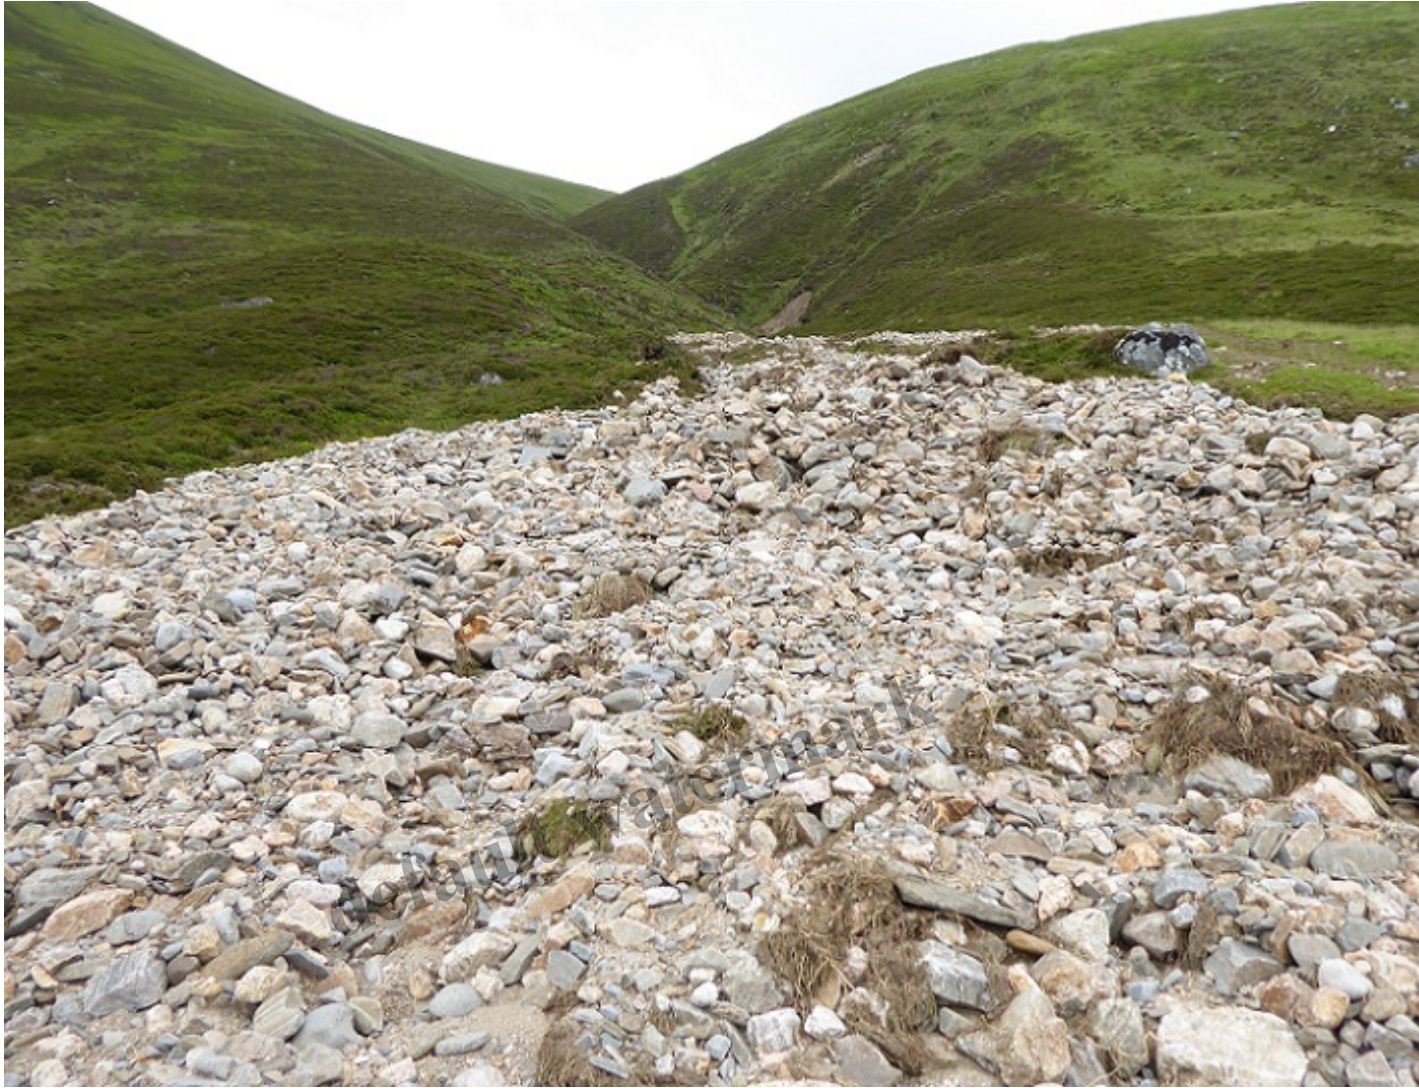
The large landslide is on the hillside just to the right of this photo

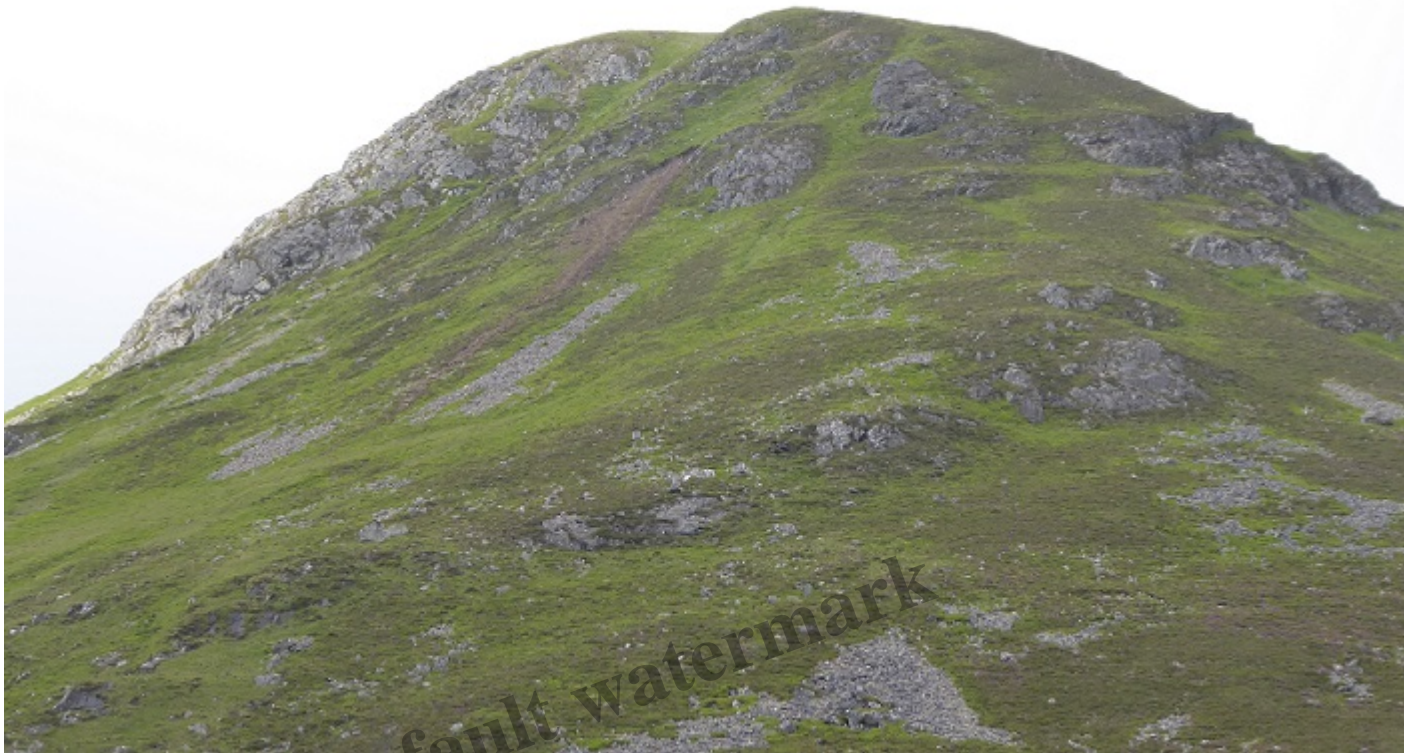
Landslip below the crags on Geal Charn, about 400m beyond the gully (off photo to the right)

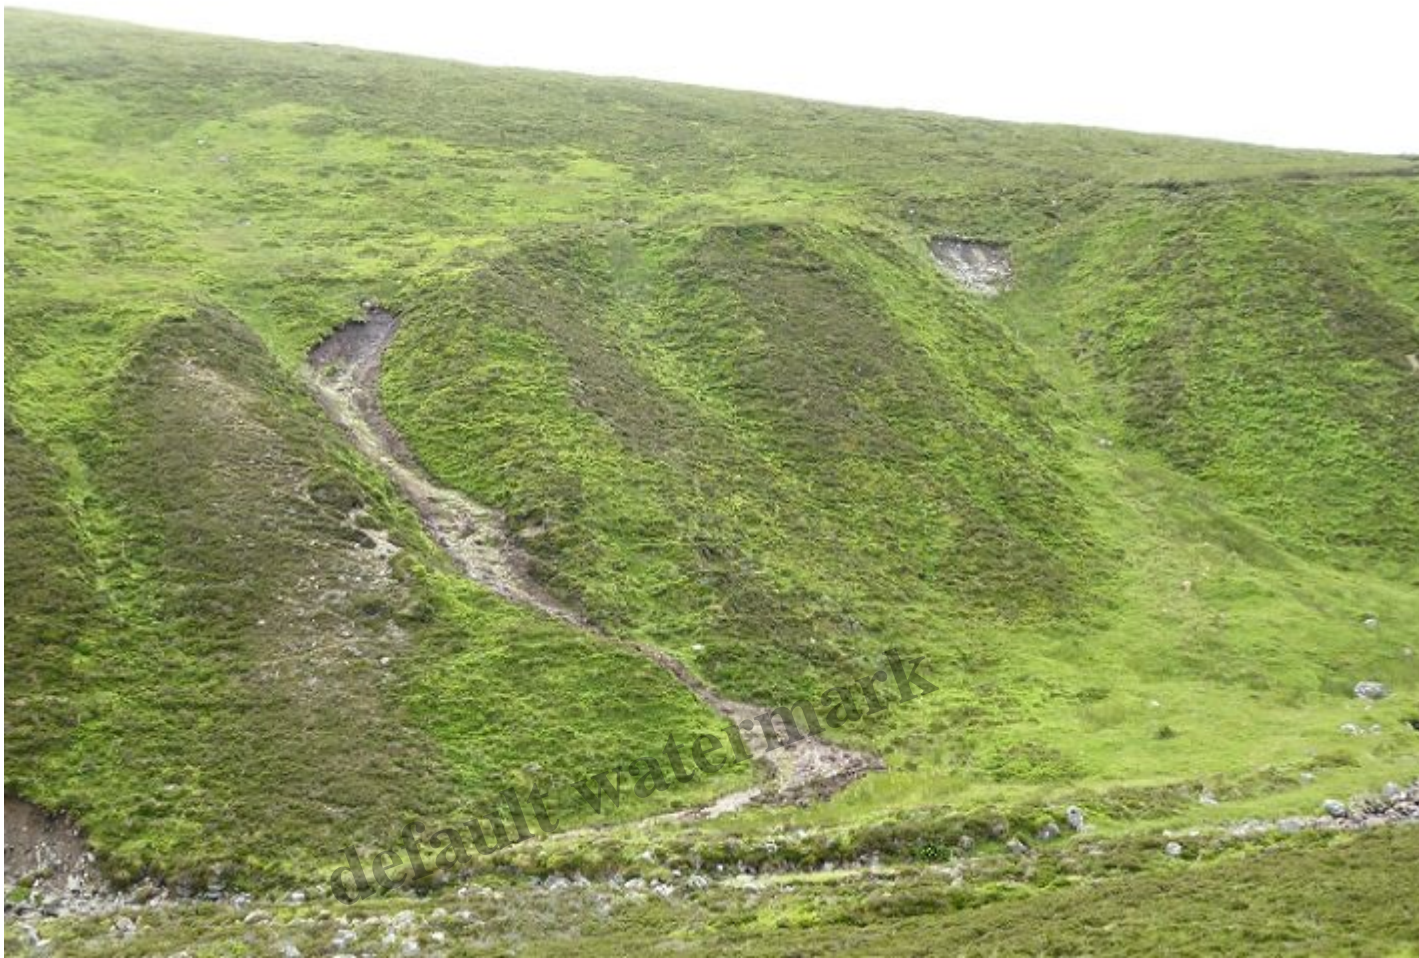
Landslips on the opposite bank of the Allt Fionndrigh, about 400m upstream.

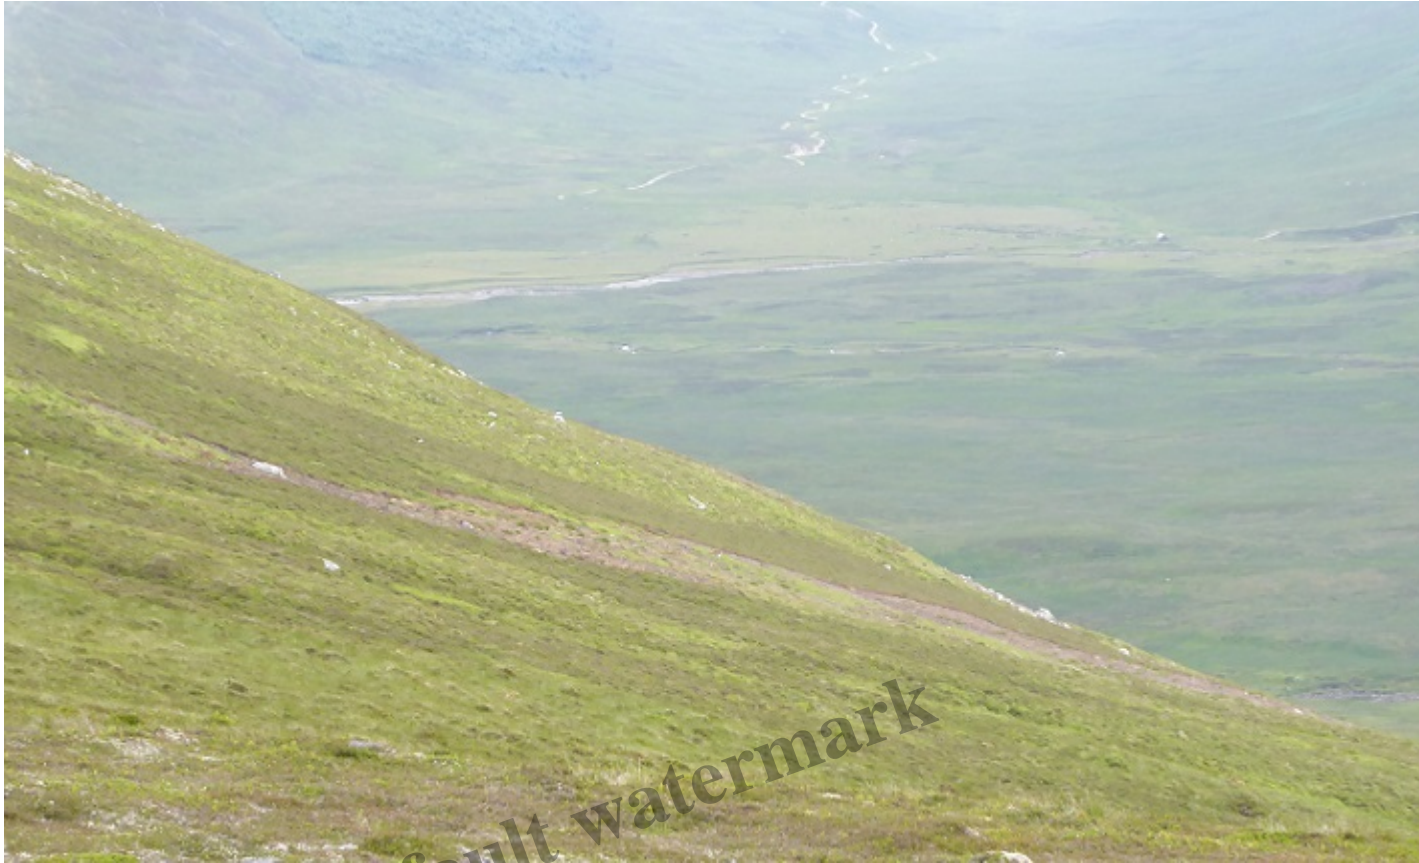
And on the western flank of Creag Liath, about 700m as the crow flies from the main landslip, we spotted another.....

Evidence from the photos suggests that most if not all of these landslips have been triggered by the recent extreme rain event. Rainfall alone, however, is not responsible.
