The state of the Cairngorms (3) – land falling apart

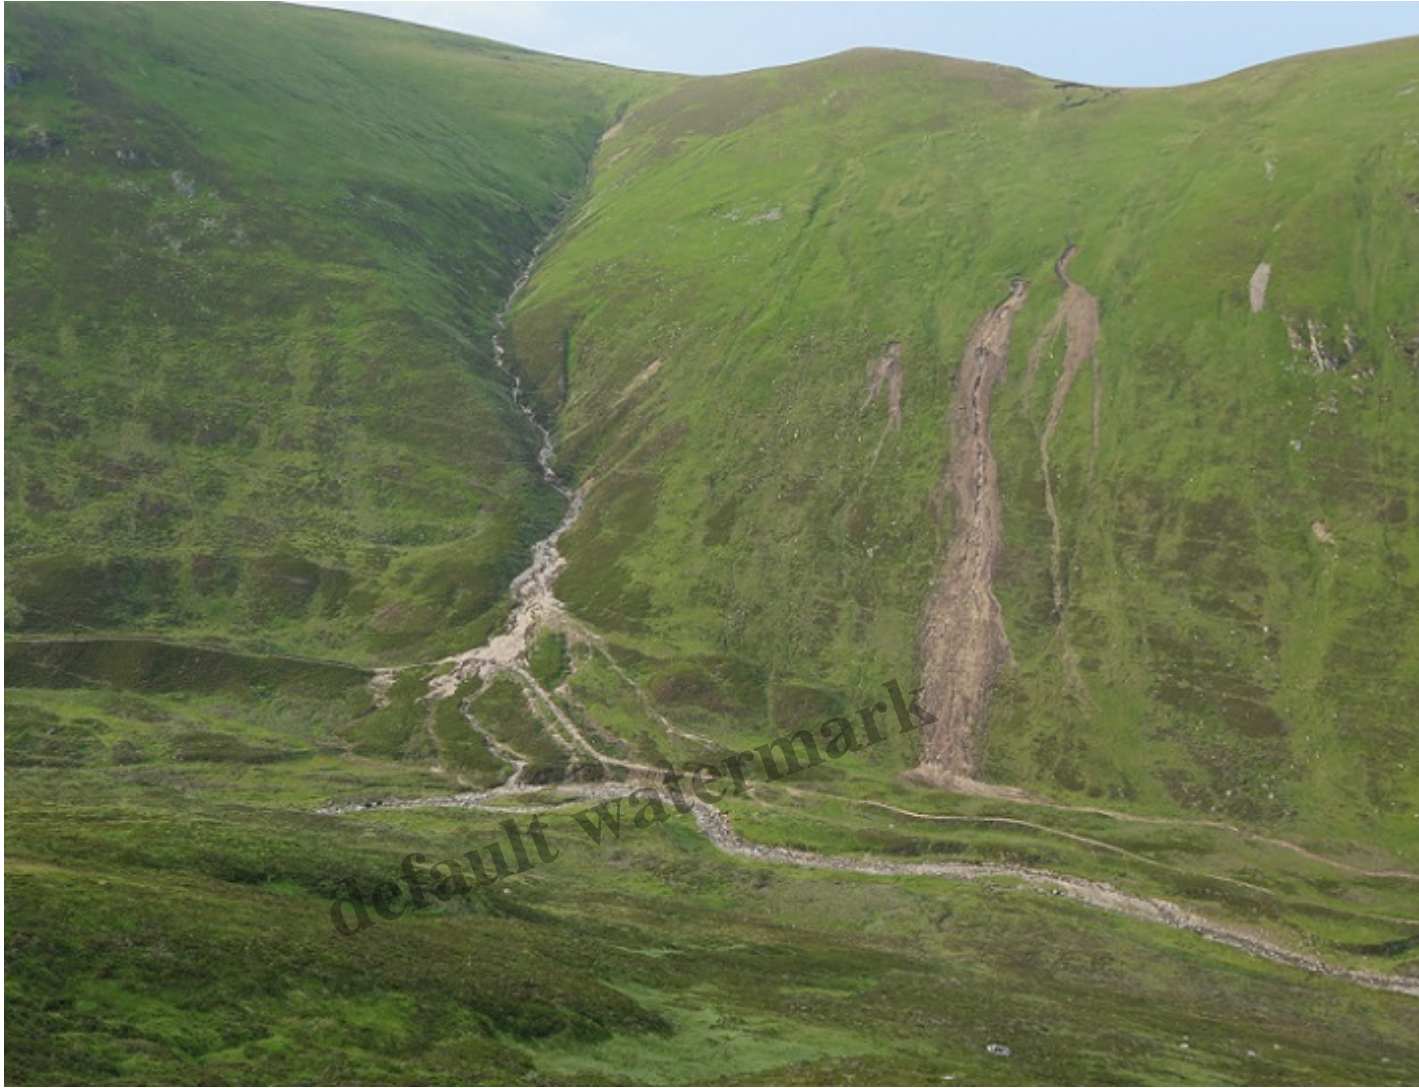
Overview of the largest landslip and the gully, with eroded material at the bottom of both then flowing rightwards down the glen. Note the absence of trees and the multiple lines marking where deer have traversed the hillside. Photo credit Dave Morris

The evidence strongly suggests that high population of red deer has been one of the main causes of the environmental degradation that has made these slopes so vulnerable to climate change. Deer have trampled the hillsides, munched the vegetation that might have helped hold these slopes together and helped erode the peat bog above.

The Cairngorms National Park Authority and NatureScot, responsible for protecting SSSIs and SACs, have sadly sat on their hands when it comes to reducing deer numbers. With climate change, we cannot afford to spend years in endless negotiations with “sporting” estates about how to reduce deer numbers voluntarily and rely on the actions by estates being managed for conservation purposes to protect the land and us from the impacts of climate change.

What has happened in Glen Banchor should be sufficient for the Scottish Government to instruct NatureScot to use the powers it has under Section 8 of the Deer (Scotland) Act 1996 ([see here](#)) to force the estates in the Monadhliath which are managed for “sporting” purposes to reduce deer numbers. Over the hill in the upper River Dulnain catchment, those high numbers of Red Deer descend the glen when the weather is bad and start feeding off the regenerating Caledonian Pinewood at Kinveachy undermining the work that is being done there to provide more habitat for the capercaillie which once again faces extinction. The landslips around the Allt Fionndrigh provide more evidence of the urgent need to change how sporting estates manage land in the Cairngorms.

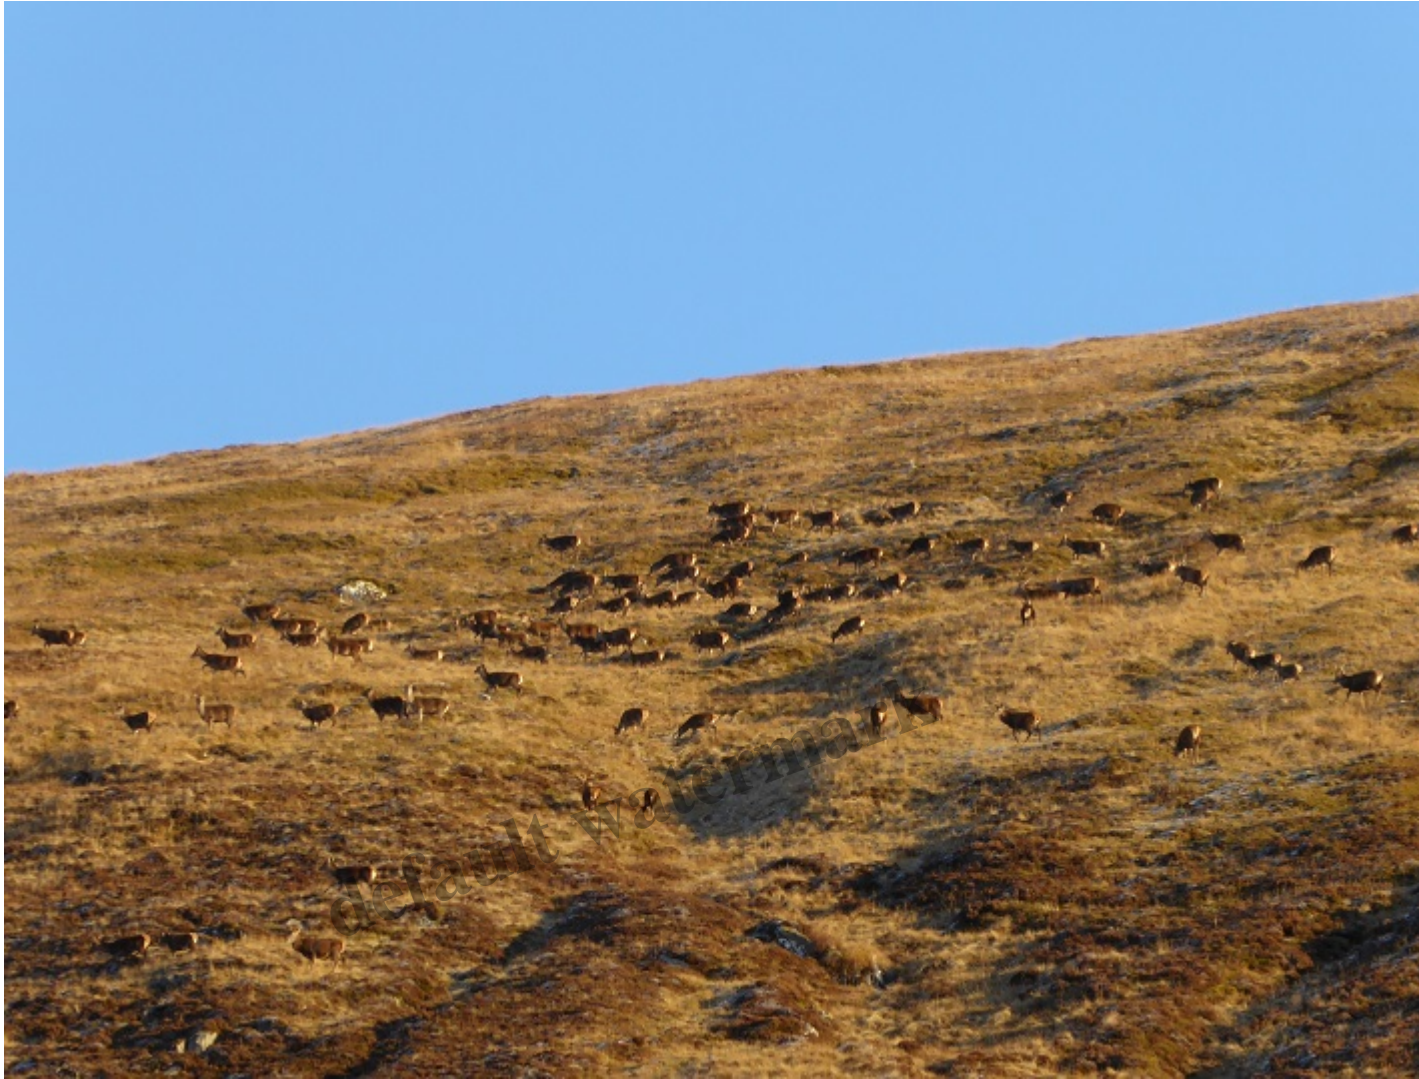
A section of the deer covered hillside on Creag na h-Iolaire, 30th November 2019

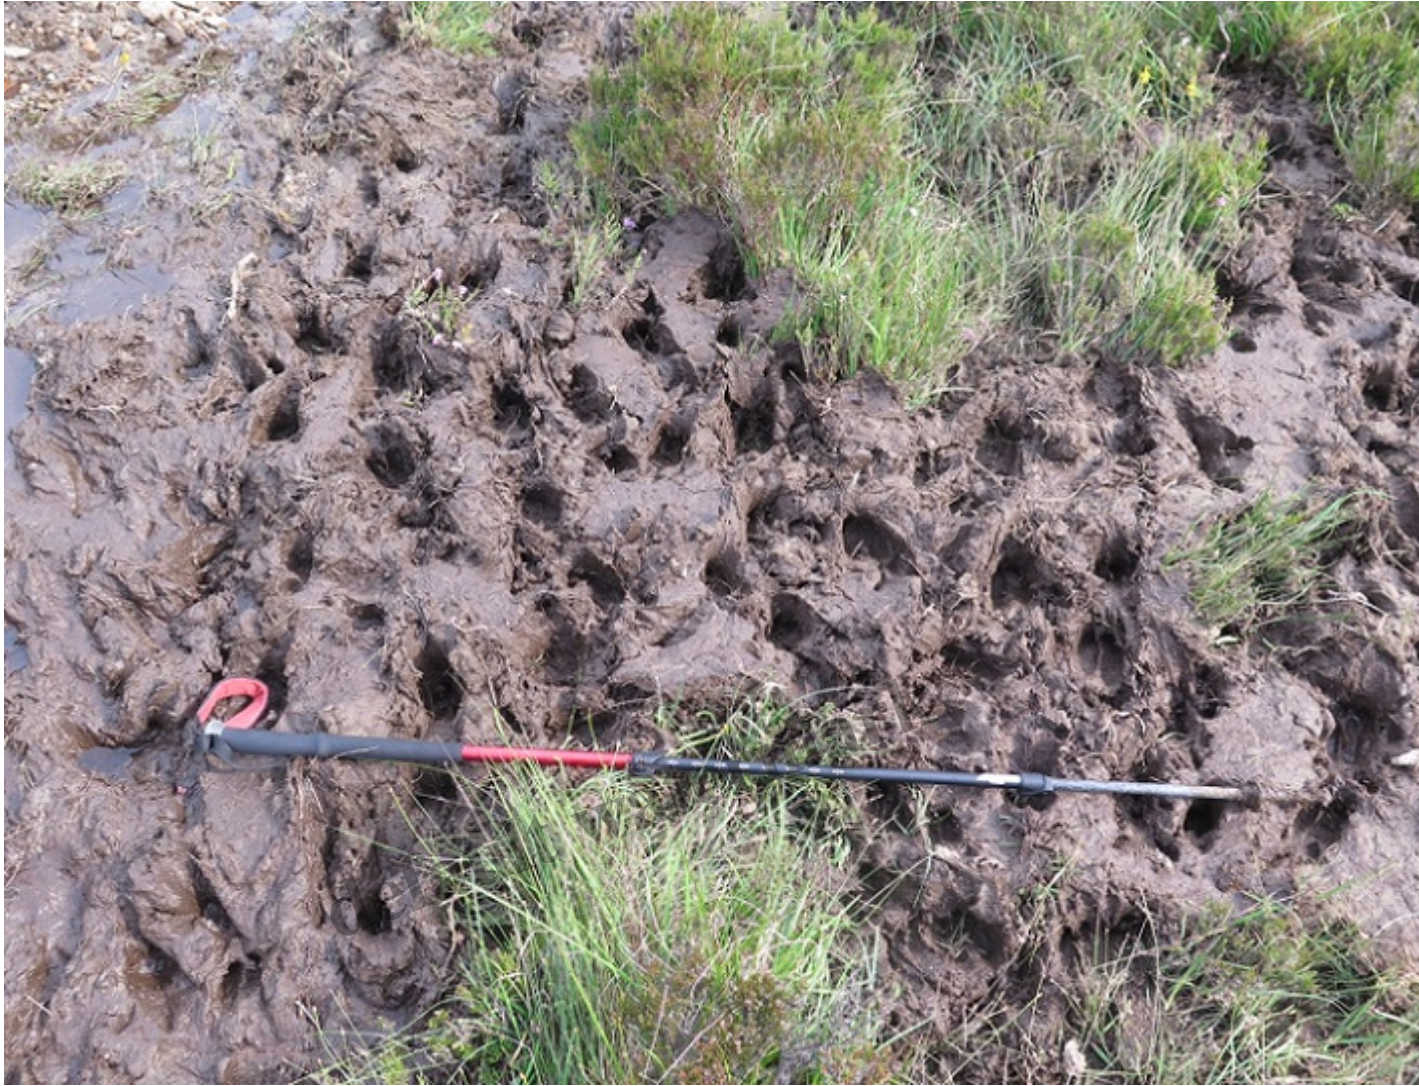
The mud deposited by the landslips was covered with red deer hoof prints:
