The state of the Cairngorms (5) – environmental catastrophe and the funicular

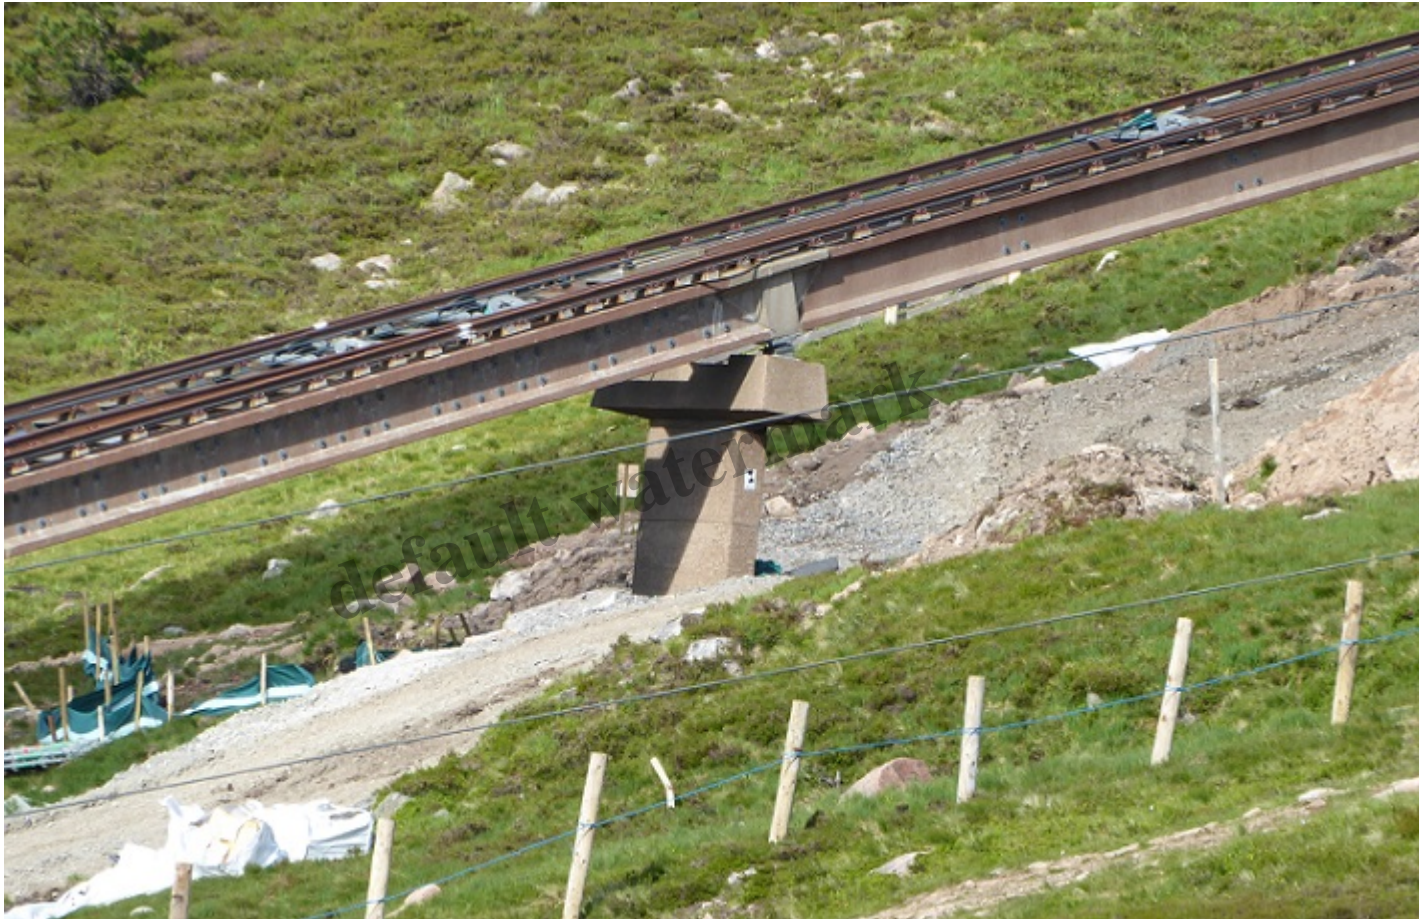
The funicular construction works 14th July, a few days after the intense rainstorms which affected parts of Speyside. Photo credit Louise Brimelow

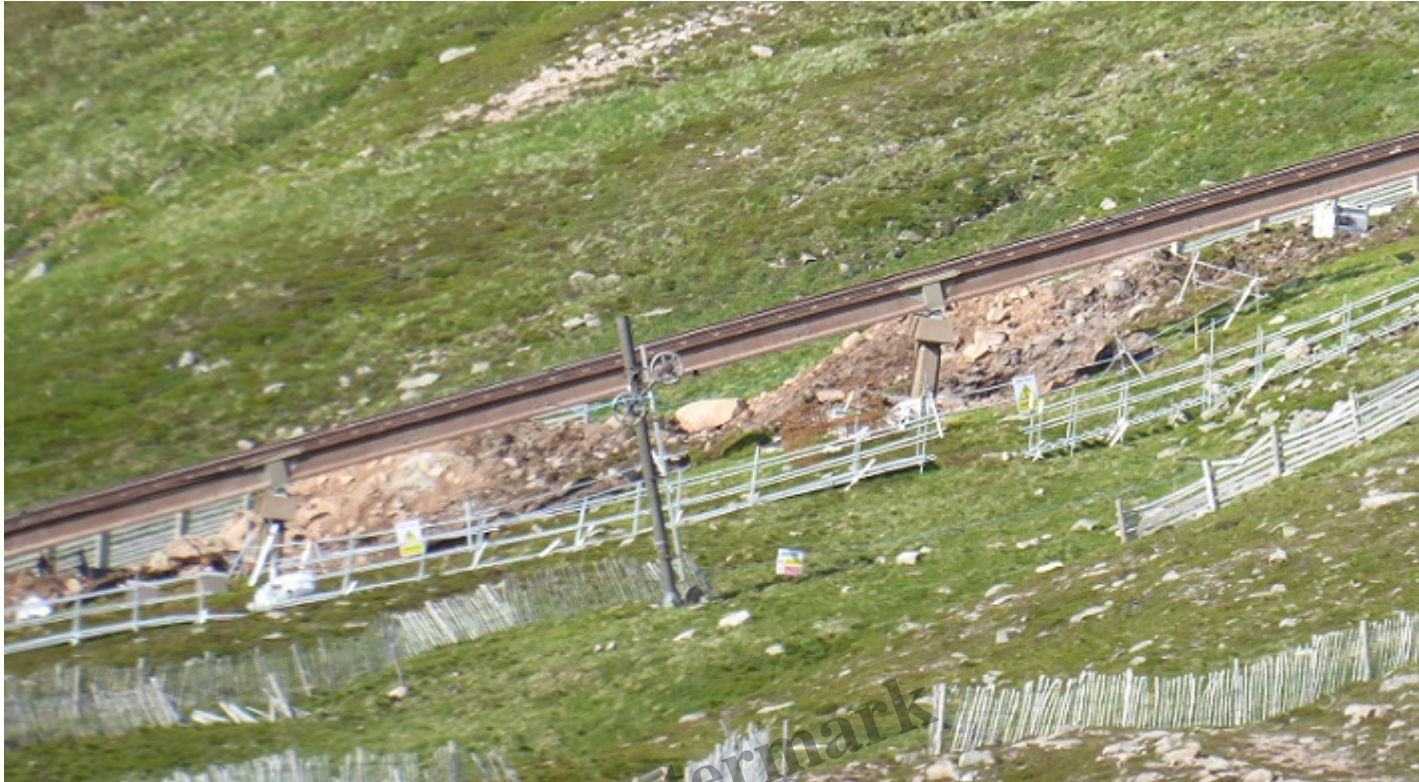
Two weeks ago there were heaps of excavated material all the way up the funicular:

Photo credit Louise Brimelow 14th July.

Whatever the merits of repairing the funicular, heaping piles of excavated material and imported material all the way up the construction site *at the same time* is not a sensible idea in a mountain environment. The work should have been phased. By luck Highlands and Islands Enterprise may get away with it.....unlike those developers in Japan.

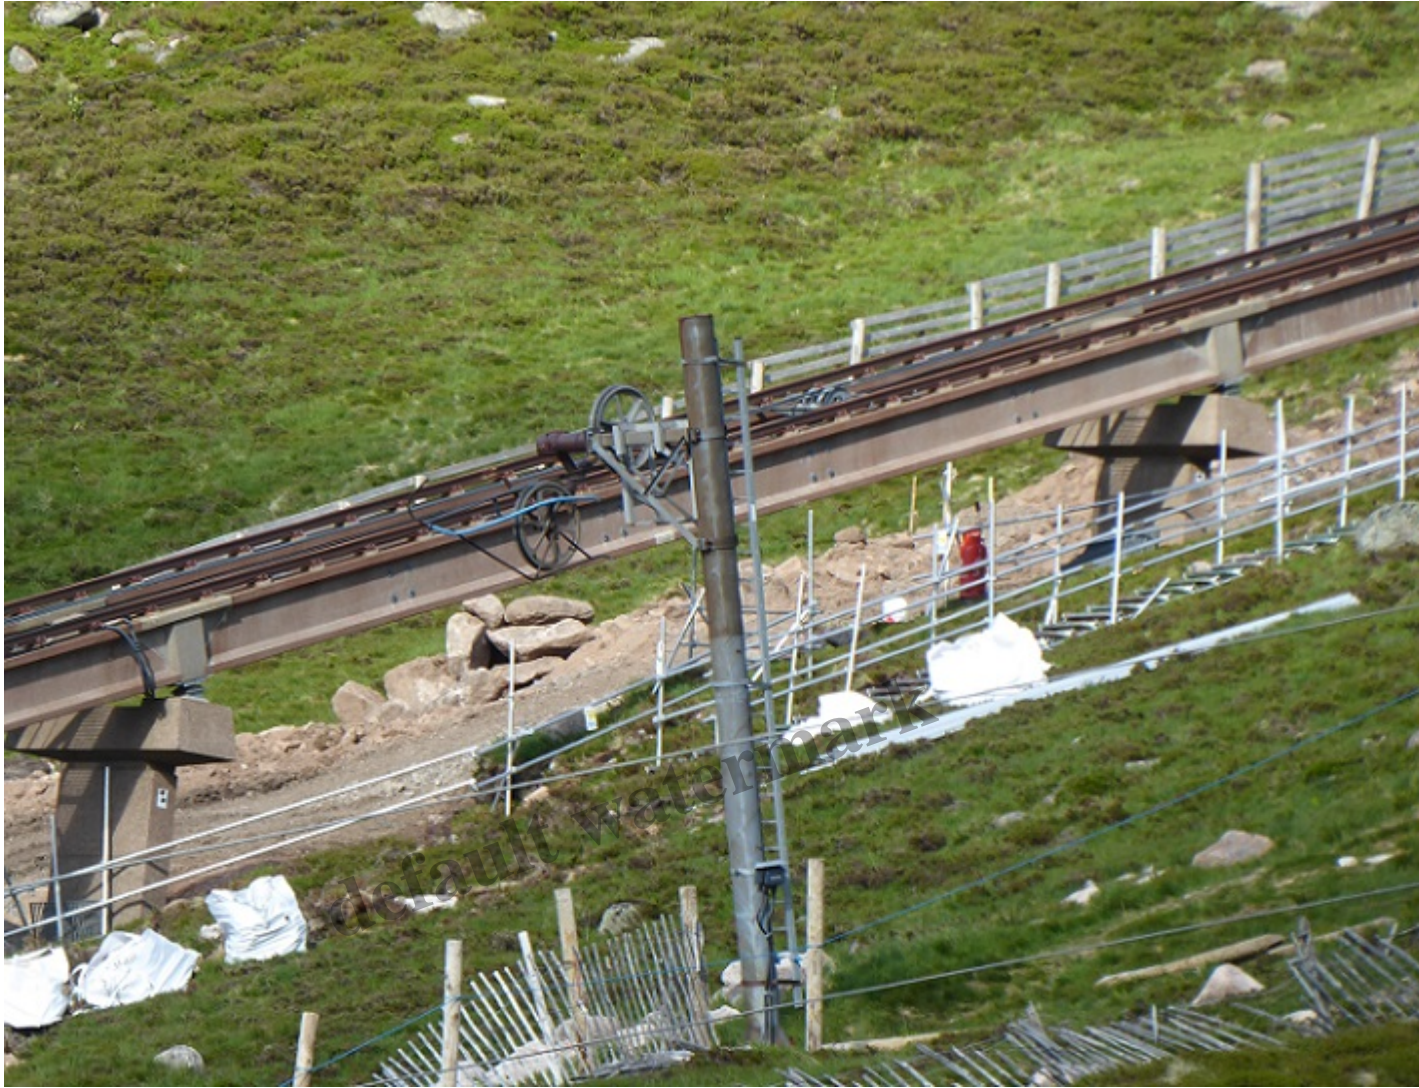
Photo credit Louise Brimelow

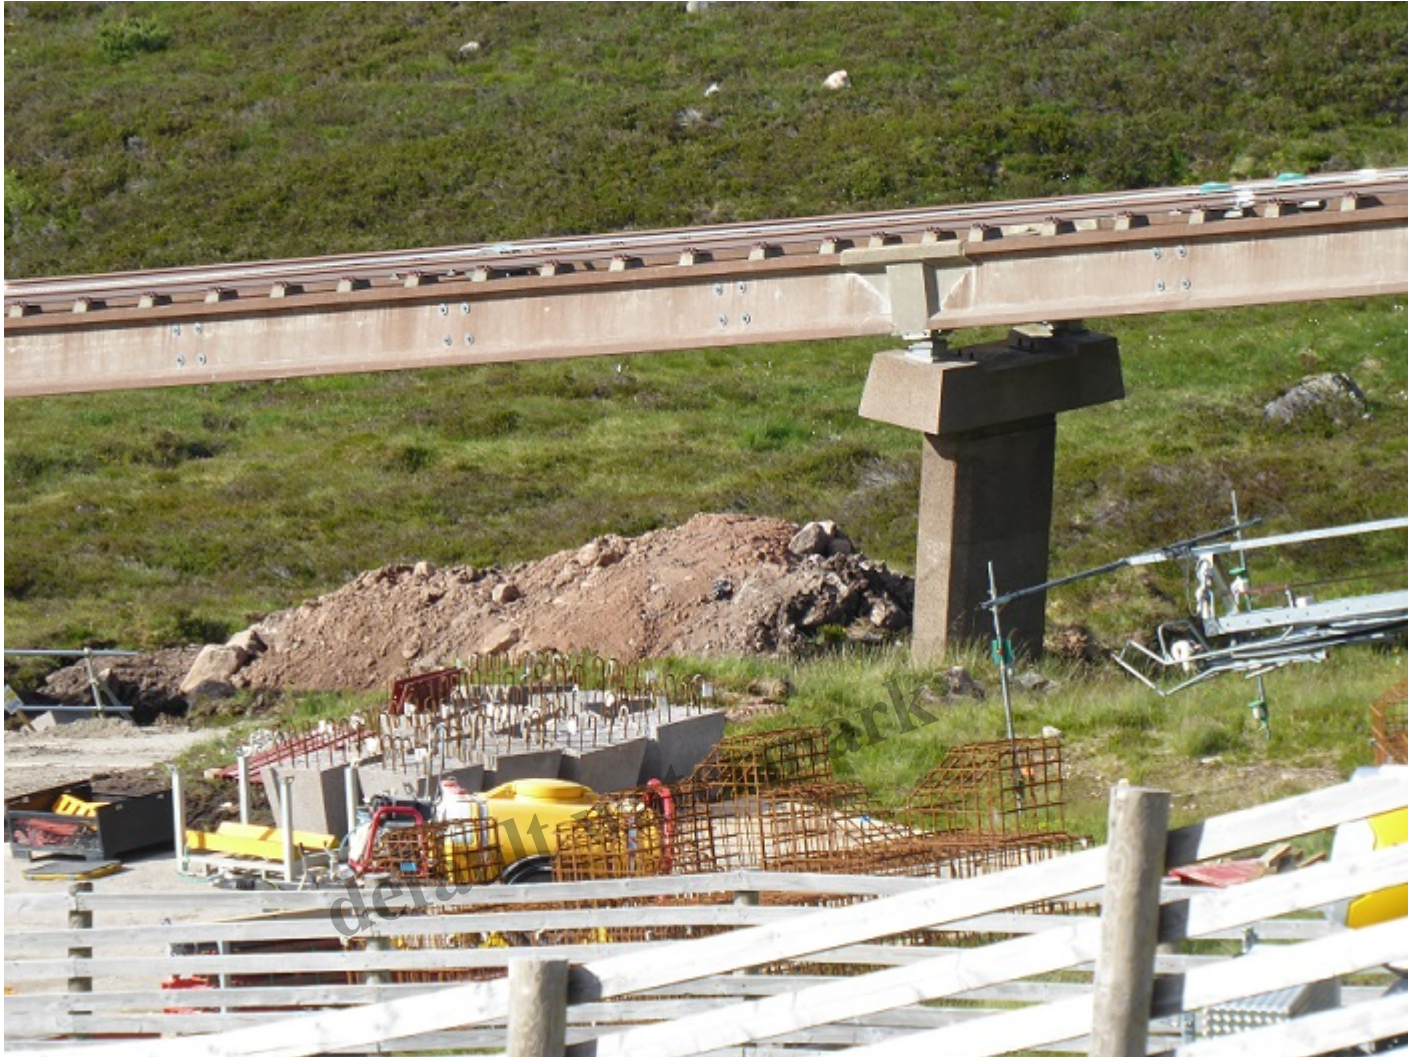
Lower down a heap of excavated material had been placed downhill of a pier and beneath the beams supporting the rails – apparently to protect peat – where it would have been offered some protection against rain. Photo Credit Louise Brimelow.

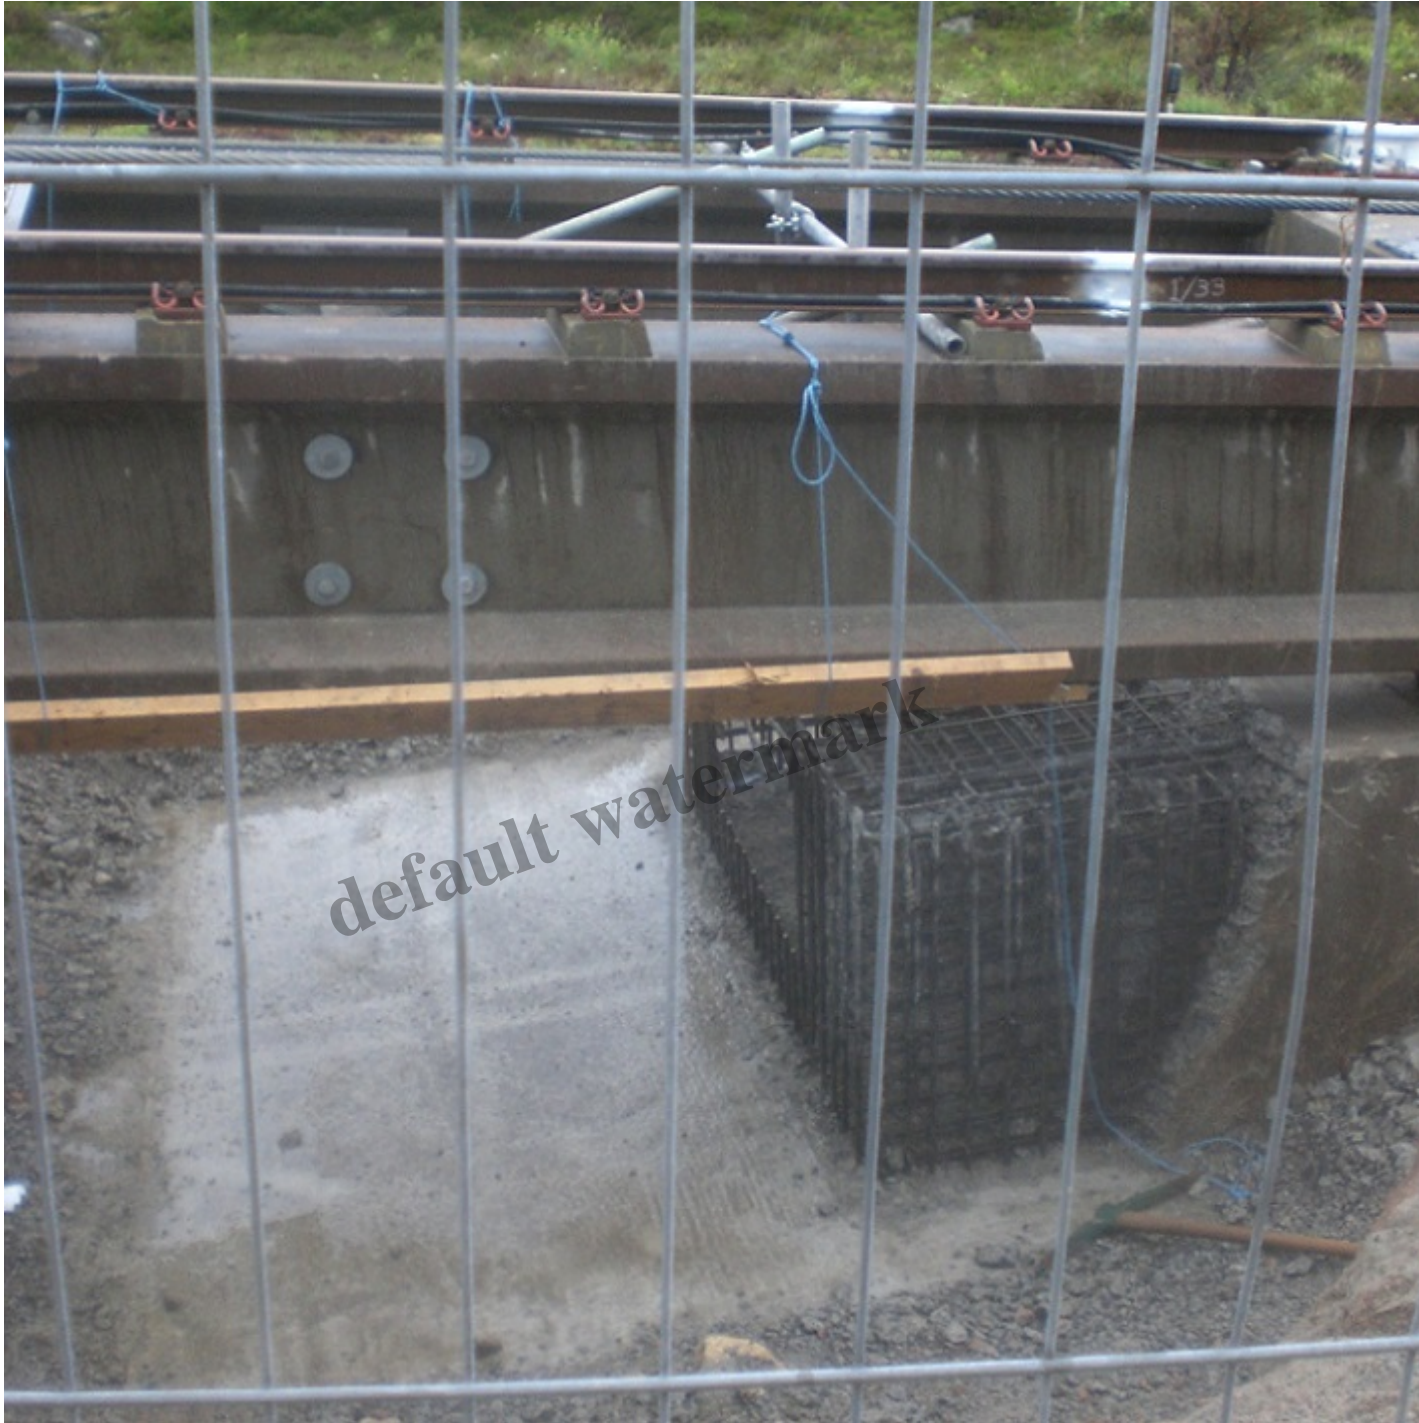
Anchor block extension. Photo credit one of my Cairngorm companions

The amount of concrete – 900 kg of CO<sub>2</sub> is emitted in the fabrication of every ton of cement – being added to the funicular to prop it up and stop it sliding downhill is considerable.

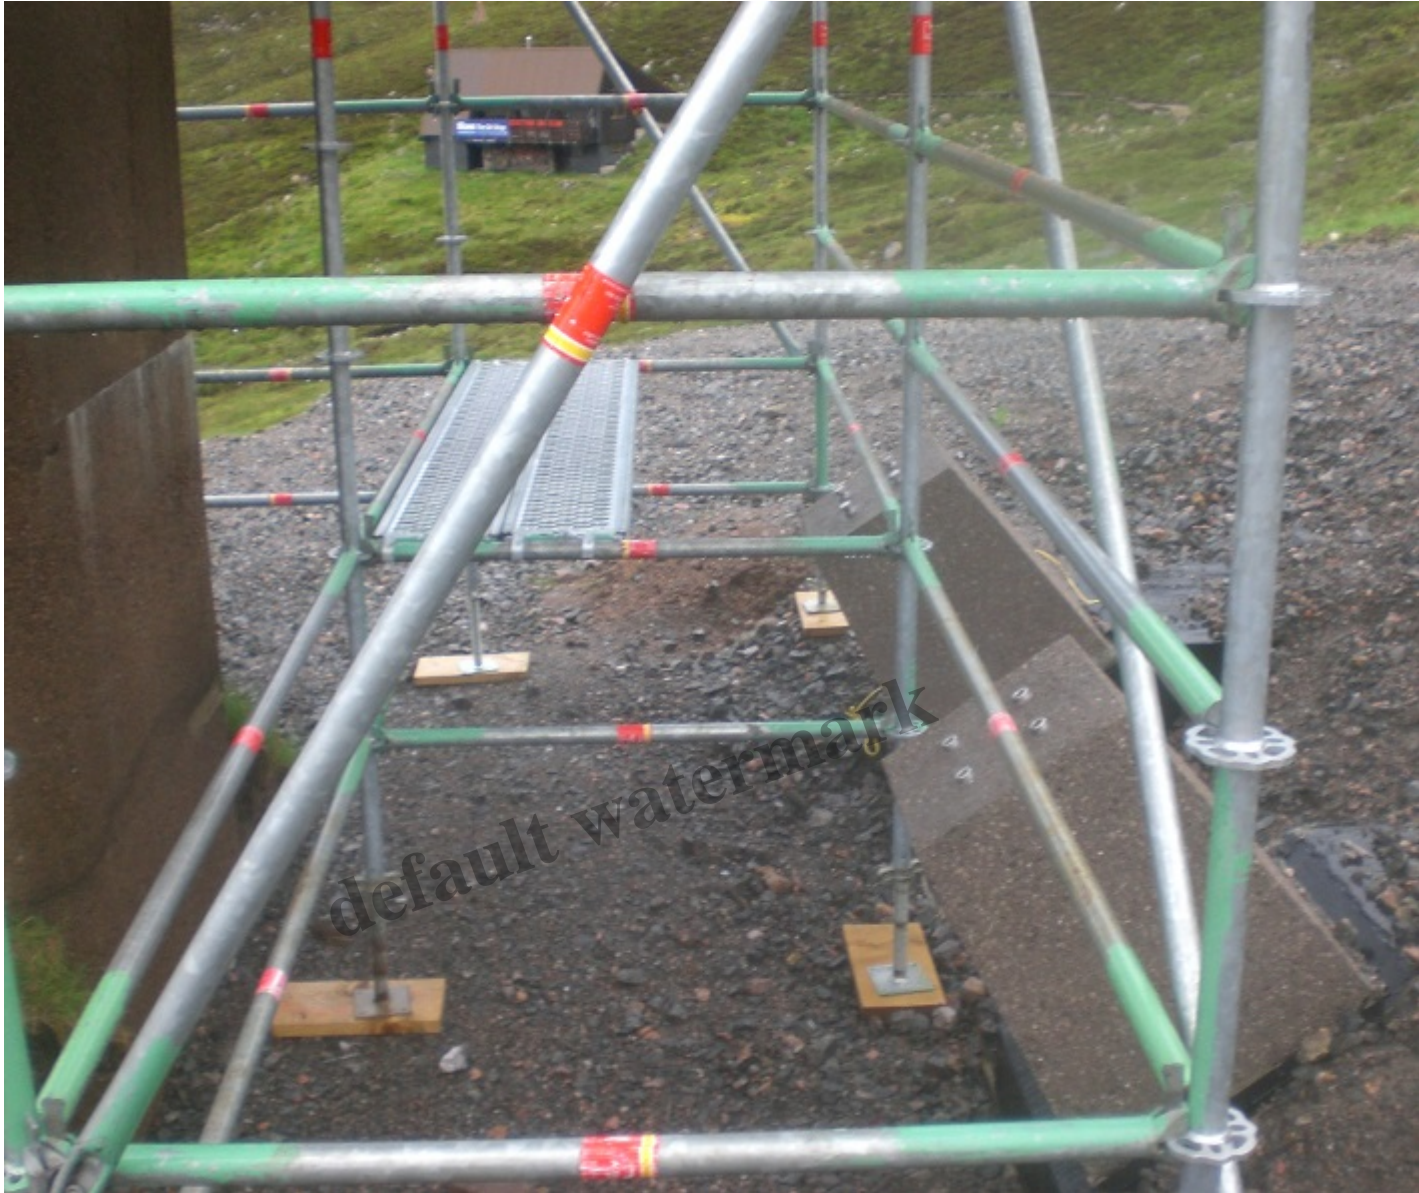
While only the pre-constructed blocks which will support the metal props will be visible once construction is complete, below they are supported by much larger blocks of concrete. Photo credit my Cairngorm companion.

As well as the concrete, significant quantities of imported aggregate have been used in the construction. Together they have altered what remained of the natural granite based soils around the funicular and will change the drainage patterns, with unpredictable consequences.

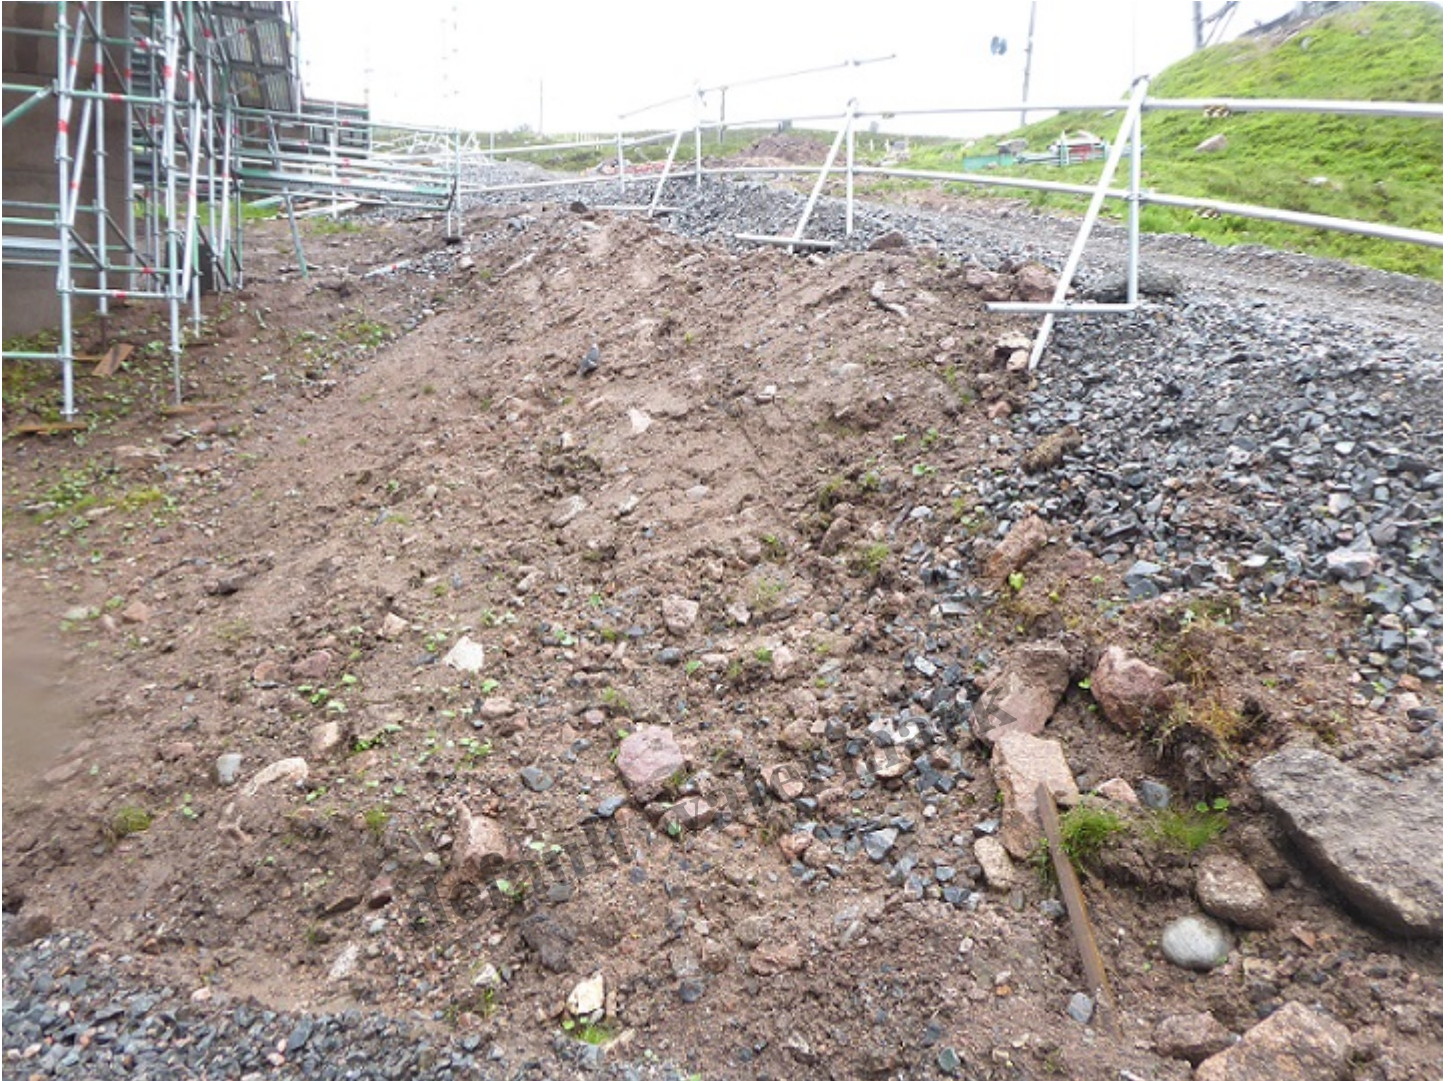
The planning application claimed that the original funicular construction tracks above the mid-station which had been restored would be uncovered and re-used. This always was nonsense. What the photo shows it that Balfour Beatty has been allowed to bring in imported aggregate to surface a new “temporary” access track. It is hard to see how this can ever be removed – it is spilling all over the mountain – and its still not clear what will be done with this and all the surplus material displaced from the pits. Spread it around, perhaps, and hope for the best?

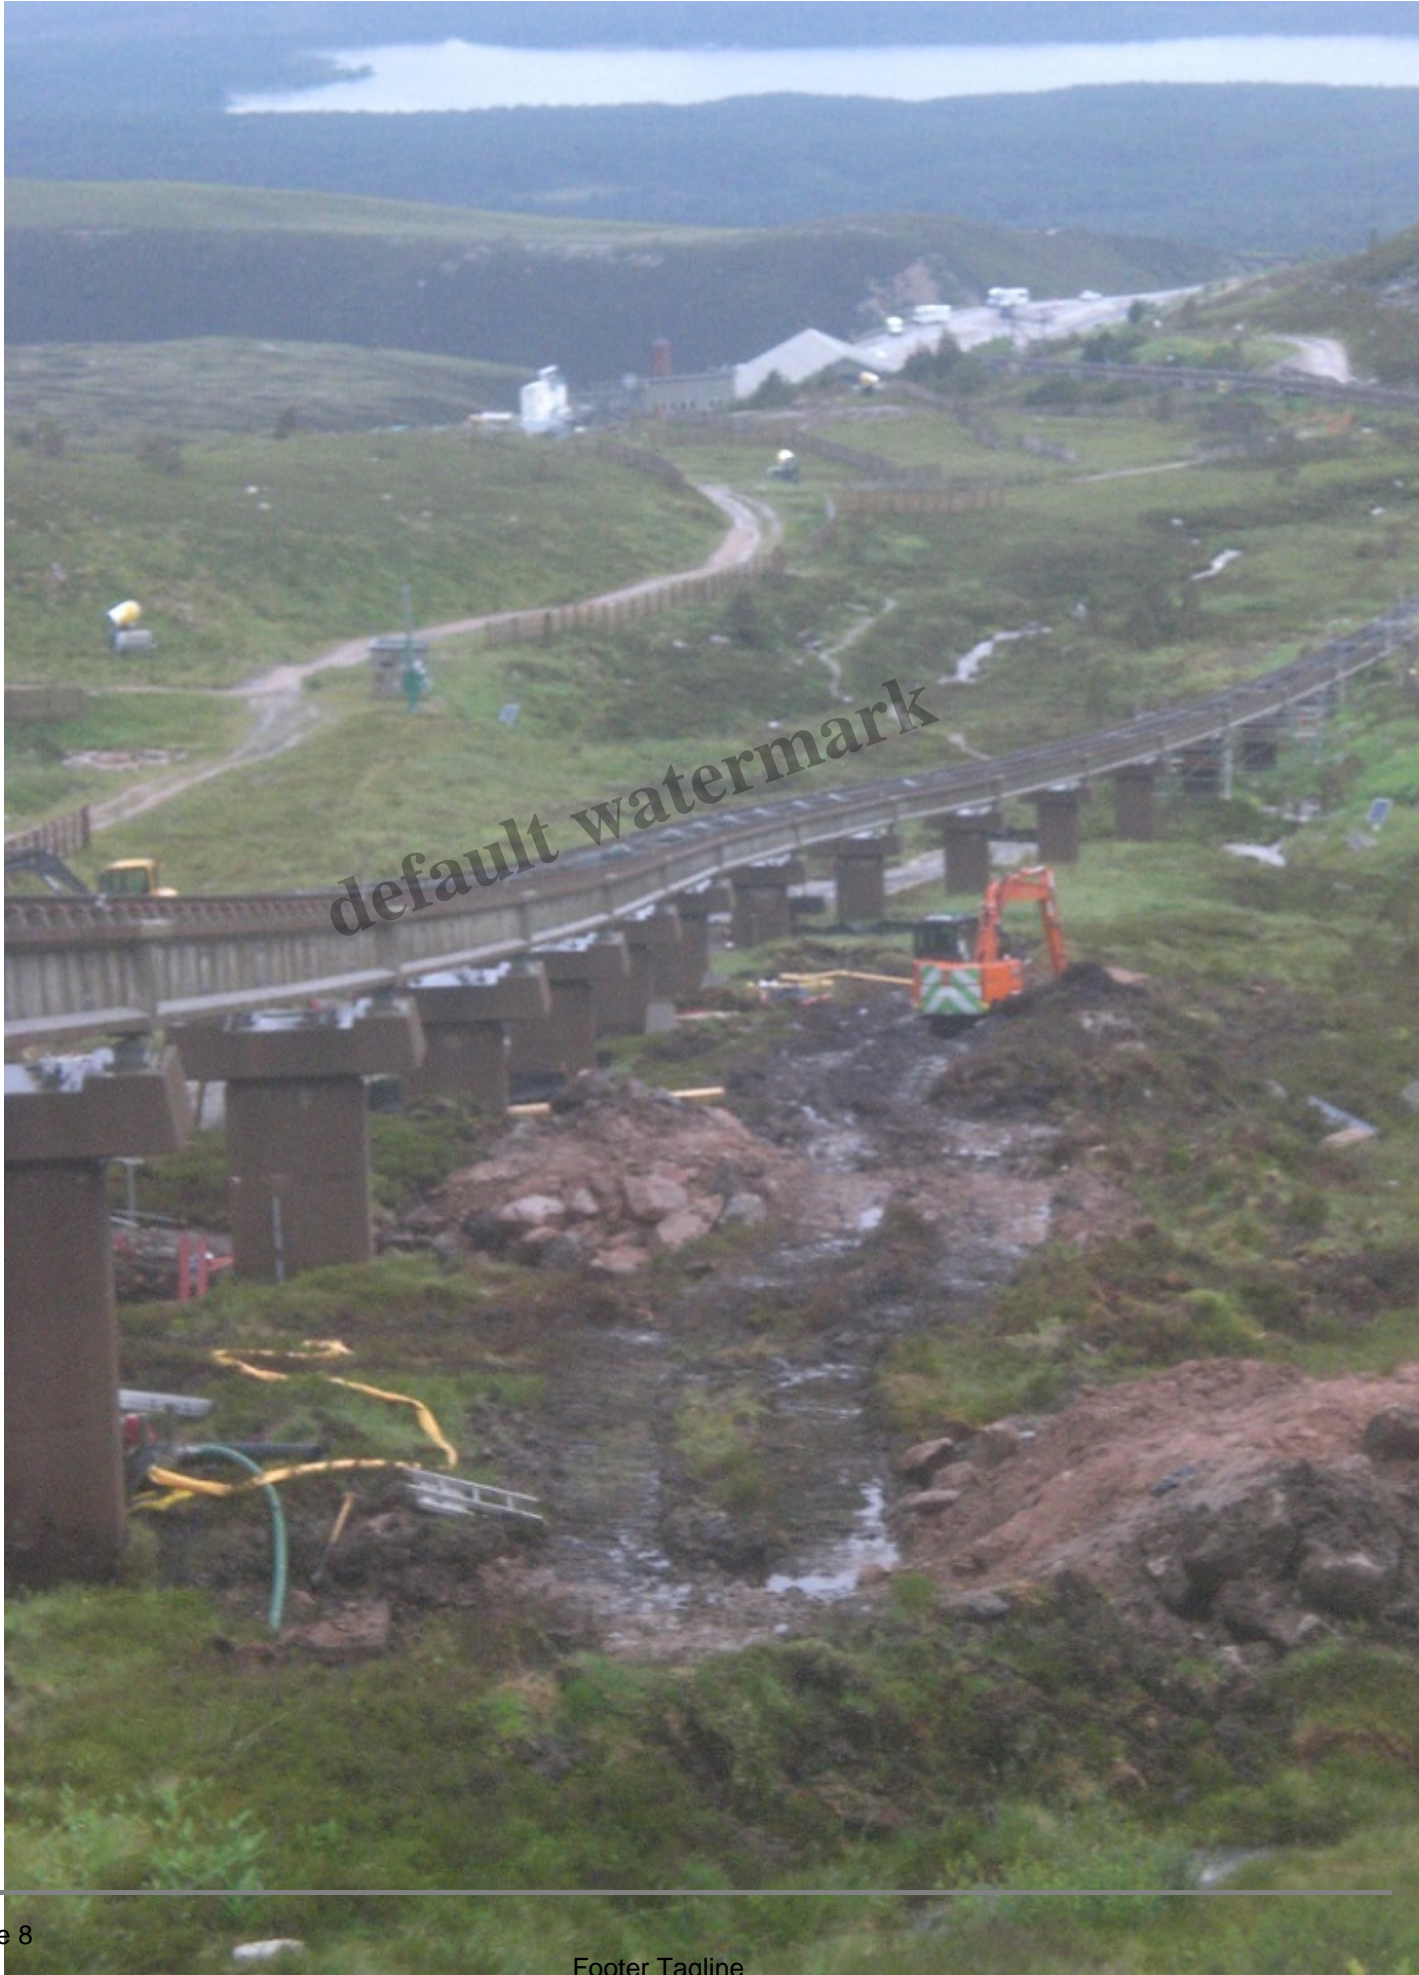
No signs of the ground being protected, the peaty turf (centre foreground) is not being stored properly while large quantities of excavated material have been dumped on peaty vegetation outwith the construction corridor. Photo credit my Cairngorm companion.

*“SUSTAINABLE PEAT MANAGEMENT: SEPA welcomes the utilisation of existing tracks where possible and acknowledge that there is little scope for mitigation in terms of reducing volumes of excavated peat with regards to the proposed new pier supports [yet more carbon emissions]. However, there appears to be scope for further mitigation in relation to the new temporary tracks proposed with a significant volume of peat estimated to be excavated for these in table 3 of the Outline Peat Management Plan and SEPA therefore request that all temporary tracks where peat would otherwise be excavated comprise of geotextile or plastic track matting unless there is a significant technical reason why this is not feasible”. (Extract from the CNPA Committee Report on the Planning Application).*

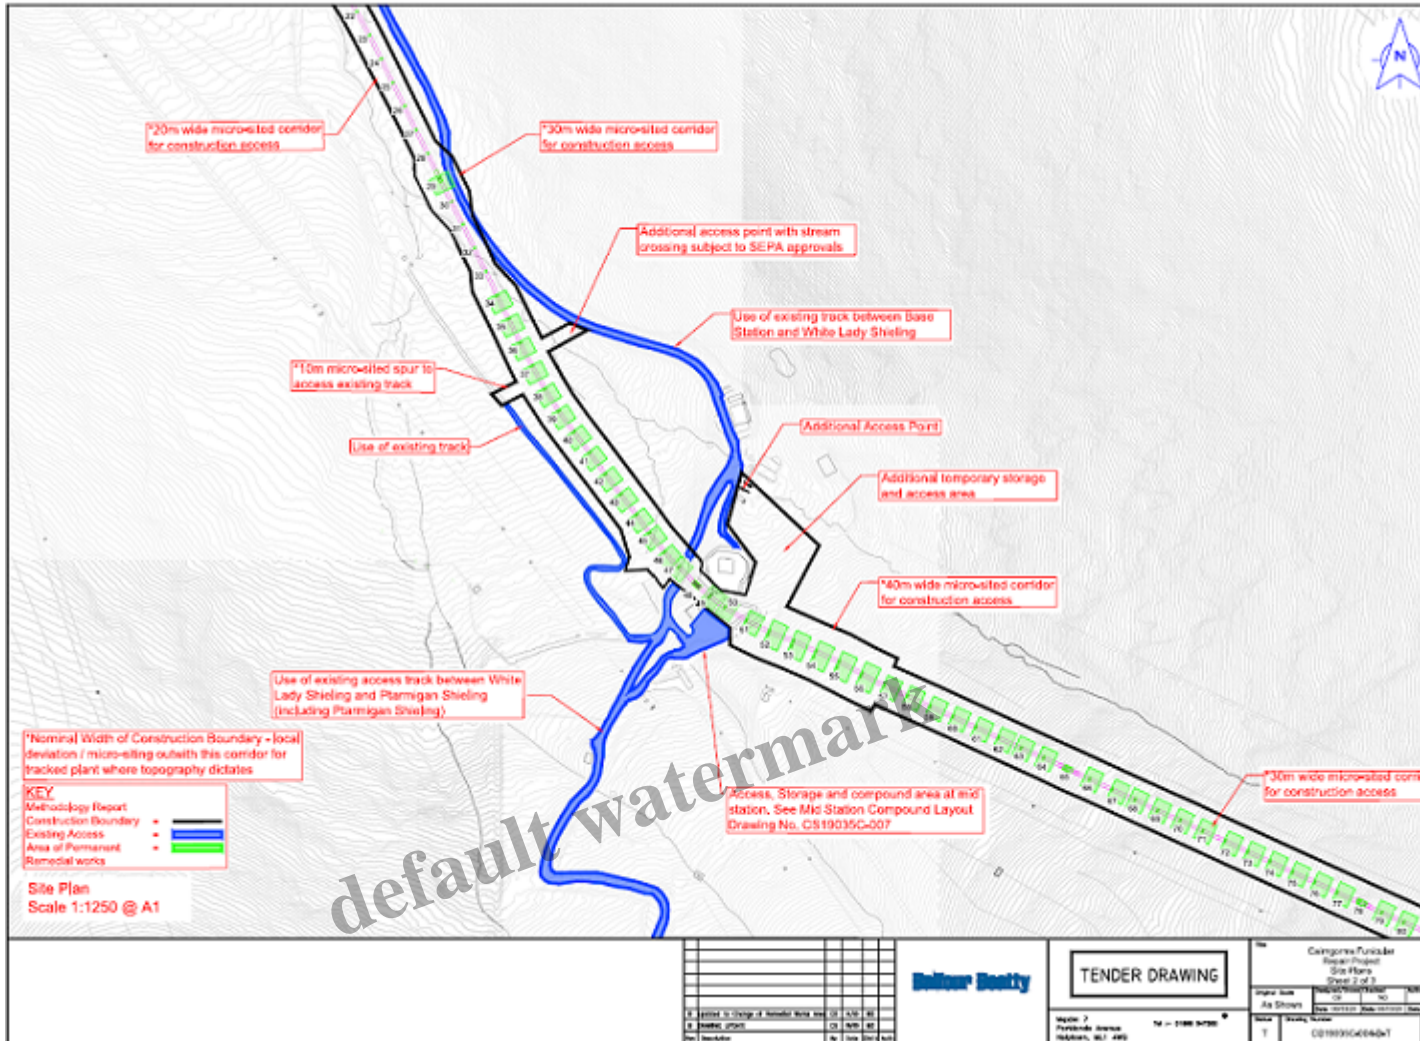
The construction corridor outlined in black, 20m at the top and 30m for the rest, apart from 6 piers above the mid-station. The shieling, outlined in grey, and mid-station are just below centre in the plan.

- 20m where new bearings and pier strengthening was required (generally lower down the hill – top left in map above);
- 30m where new props were required to strengthen the piers which were toppling over (generally from 10 piers below the mid station to the funicular tunnel);
- 40m for the six piers above the mid-station; and
- a few section where there were projecting access spurs and storage areas.

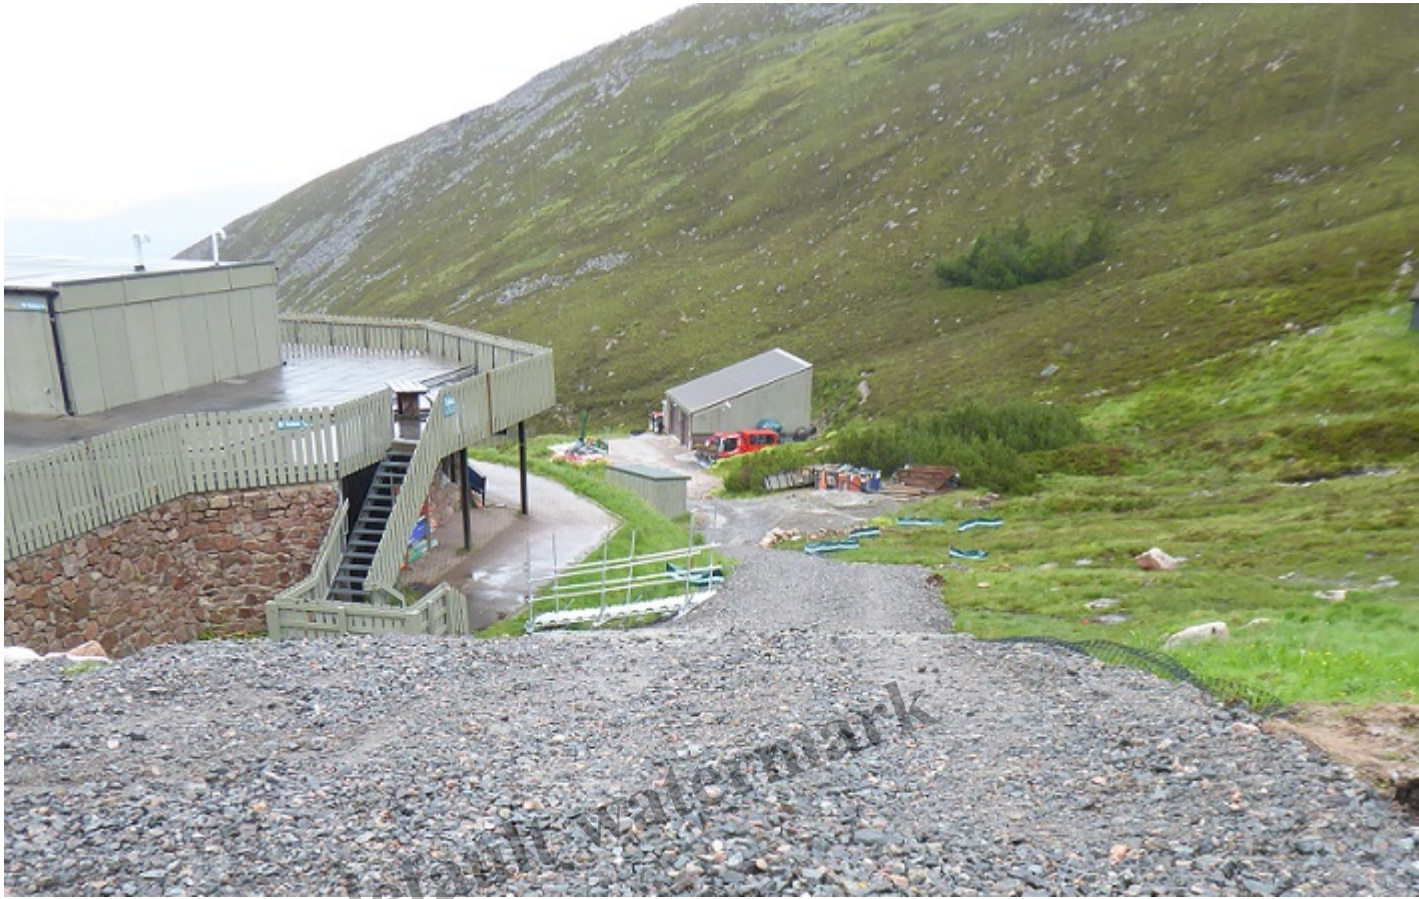
The temporary storage area above the shieling, marked as lying within the construction site appears mostly unused albeit an enormous new track has been constructed..

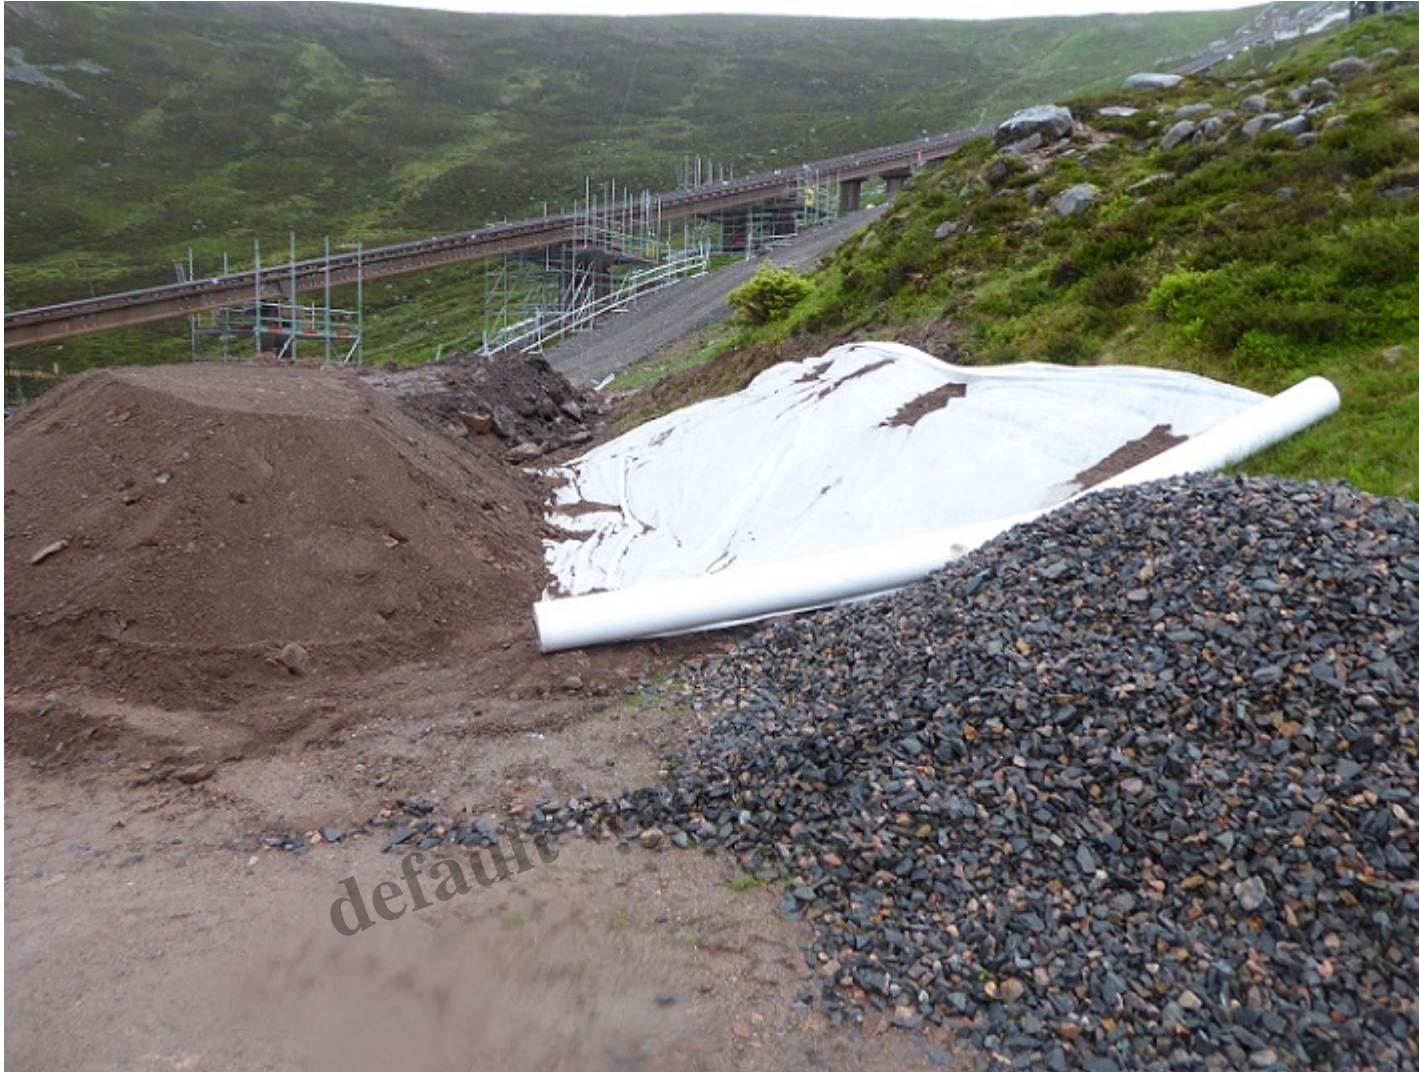
These piles of sand and aggregate, together with the sheeting, lie outwith the construction area, the shaded blue area in the plans above

To their credit, the Scottish Environment Protection Agency in their response to the planning application had queried the construction site area and noted “*that should the construction site area be over 4ha, a Construction Site Licence (CSL) would be required.*” That never appears to have been followed up by the CNPA.

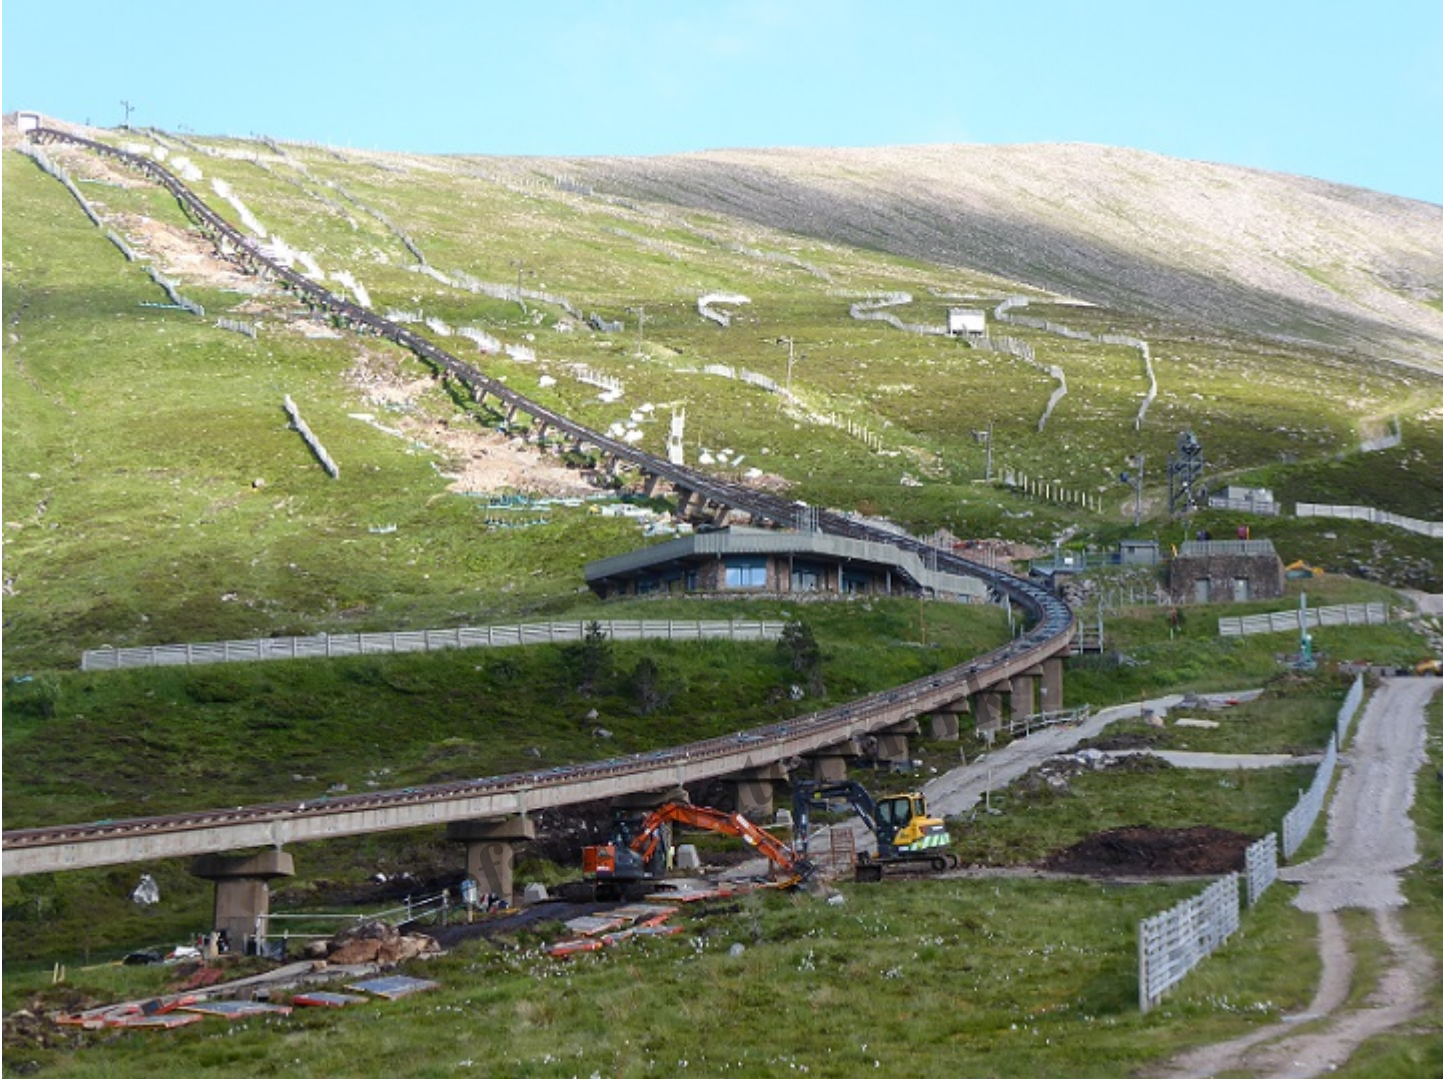
Evidence of work impact on areas outwith the construction corridor, by the heap of soil/peat lower right and higher up the mountain the construction has clearly affected an area more than 30m wide. So why didn't the Cairngorms National Park Authority insist the construction corridor was first sized and then marked out properly? Why has it since not taken enforcement action on this and other issues (like failure to store vegetation)? It was quite predictable that, given their record, HIE and Cairngorm Mountain Scotland Ltd would make little effort to ensure planning conditions were kept, so why weren't CNPA Planning staff out on site each day?
