The state of the Cairngorms (5) – environmental catastrophe and the funicular

Storms and construction work

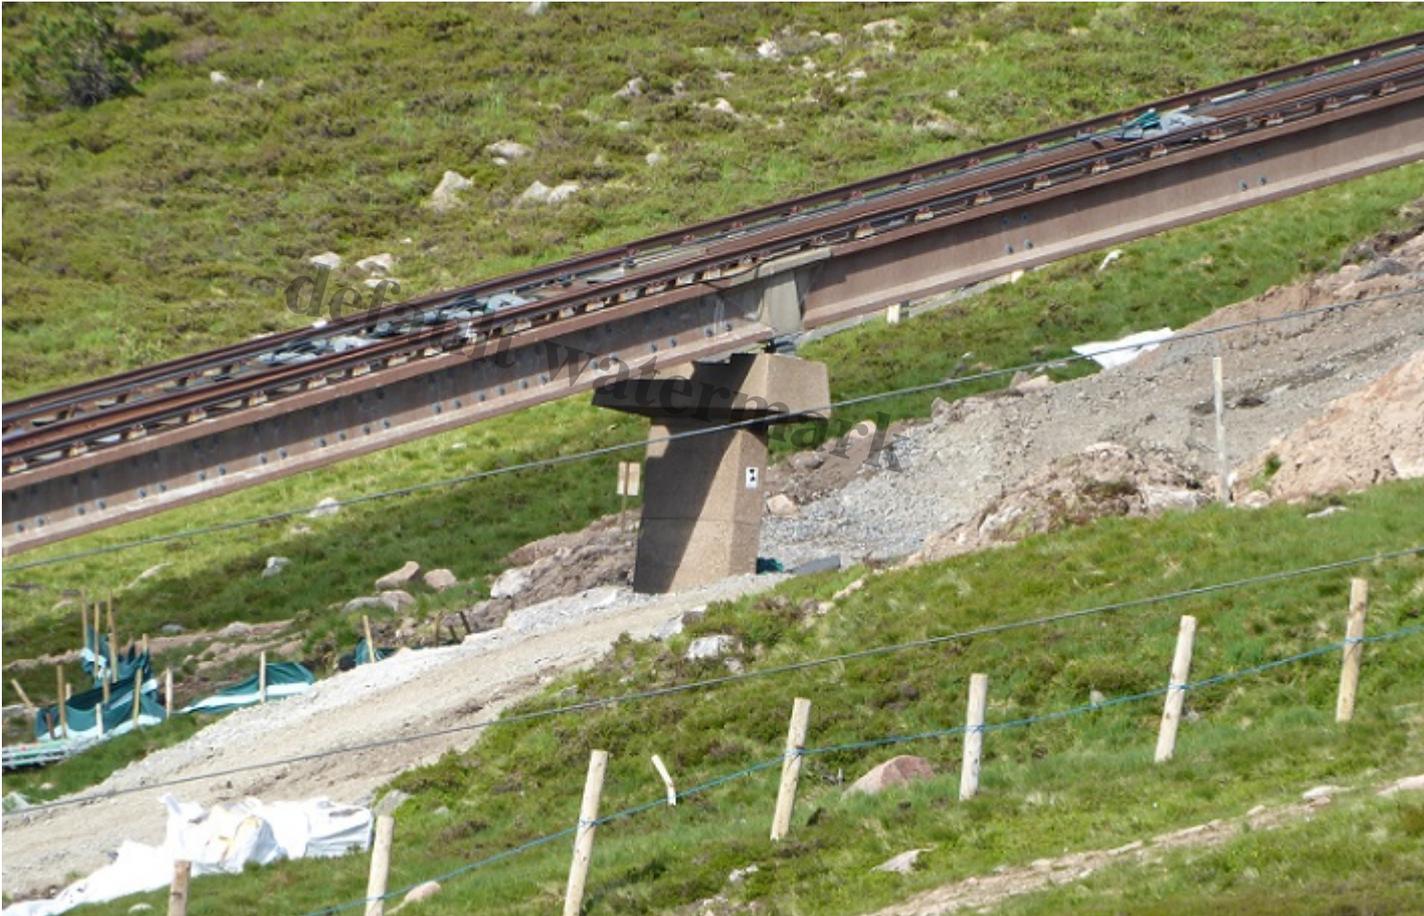
The funicular construction works 14th July, a few days after the intense rainstorms which affected parts of Speyside. Photo credit Louise Brimelow

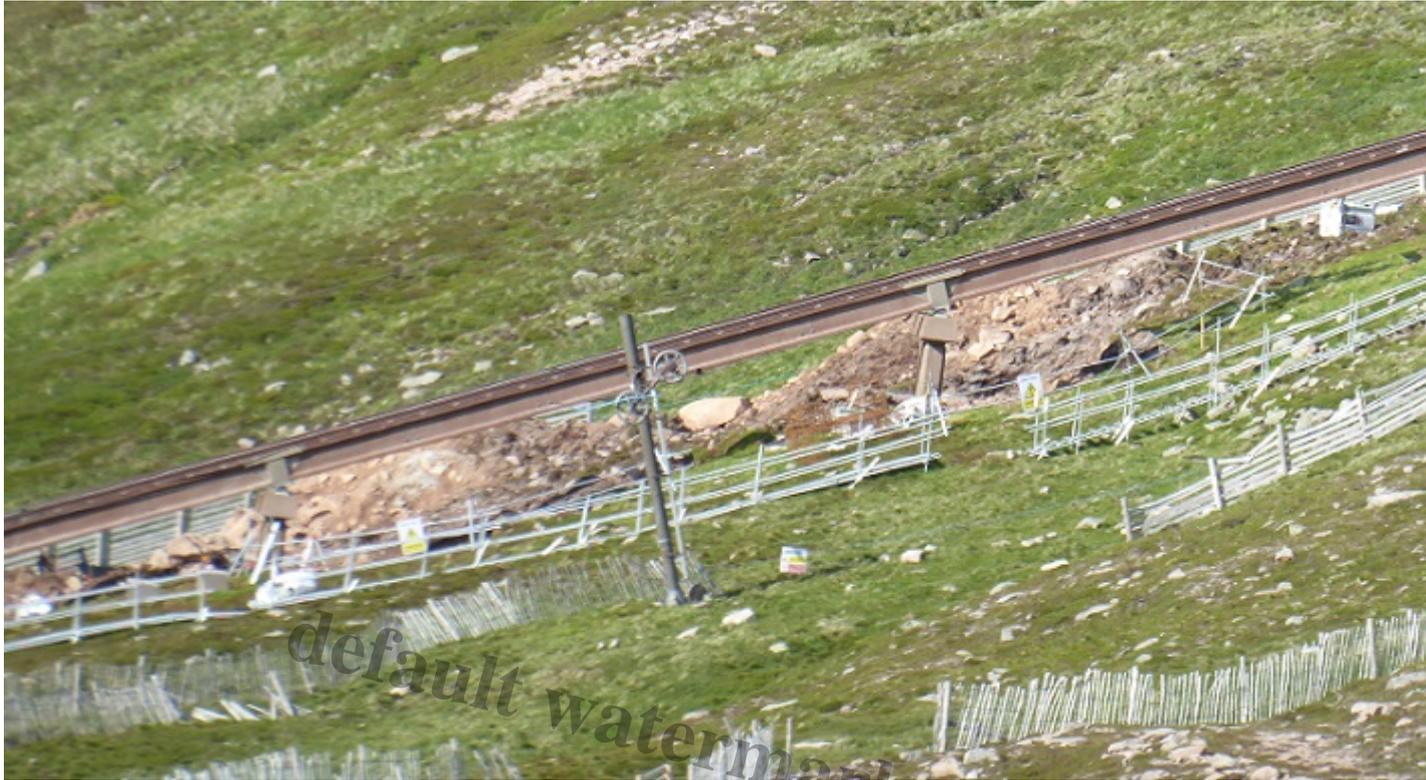
Two weeks ago there were heaps of excavated material all the way up the funicular:

Photo credit Louise Brimelow 14th July.

Whatever the merits of repairing the funicular, heaping piles of excavated material and imported material all the way up the construction site *at the same time* is not a sensible idea in a mountain environment. The work should have been phased. By luck Highlands and Islands Enterprise may get away with itâ?â?â?â?â?â? unlike those developers in Japan.

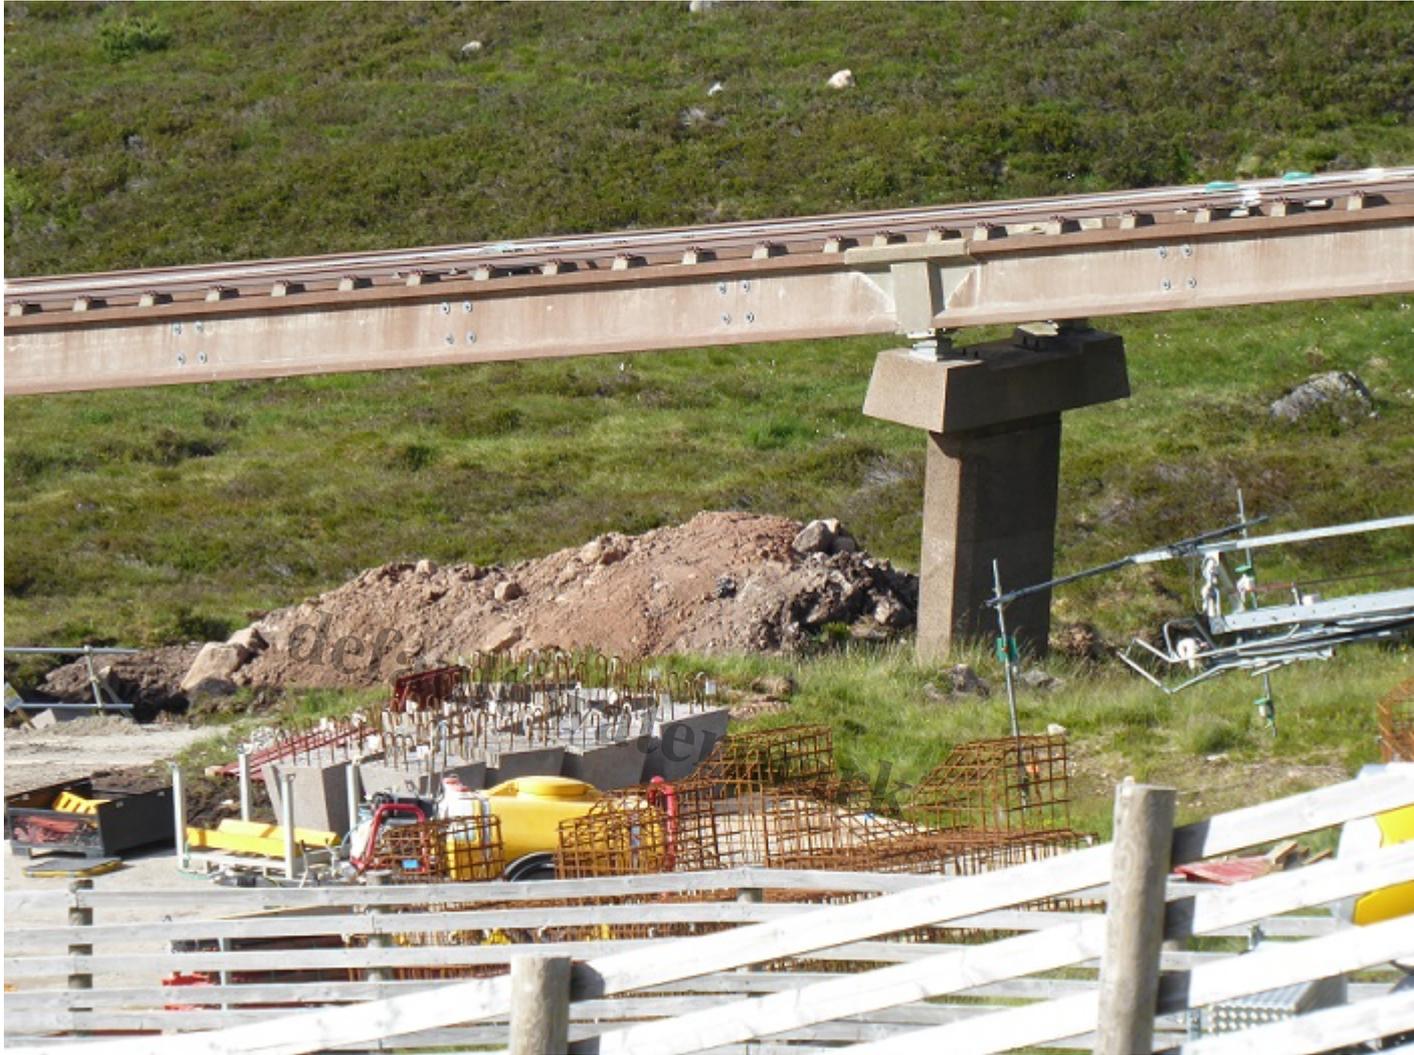
Lower down a heap of excavated material had been placed downhill of a pier and beneath the beams supporting the rails â?? apparently to protect peat â?? where it would have been offered some protection against rain. Photo Credit Louise Brimelow.

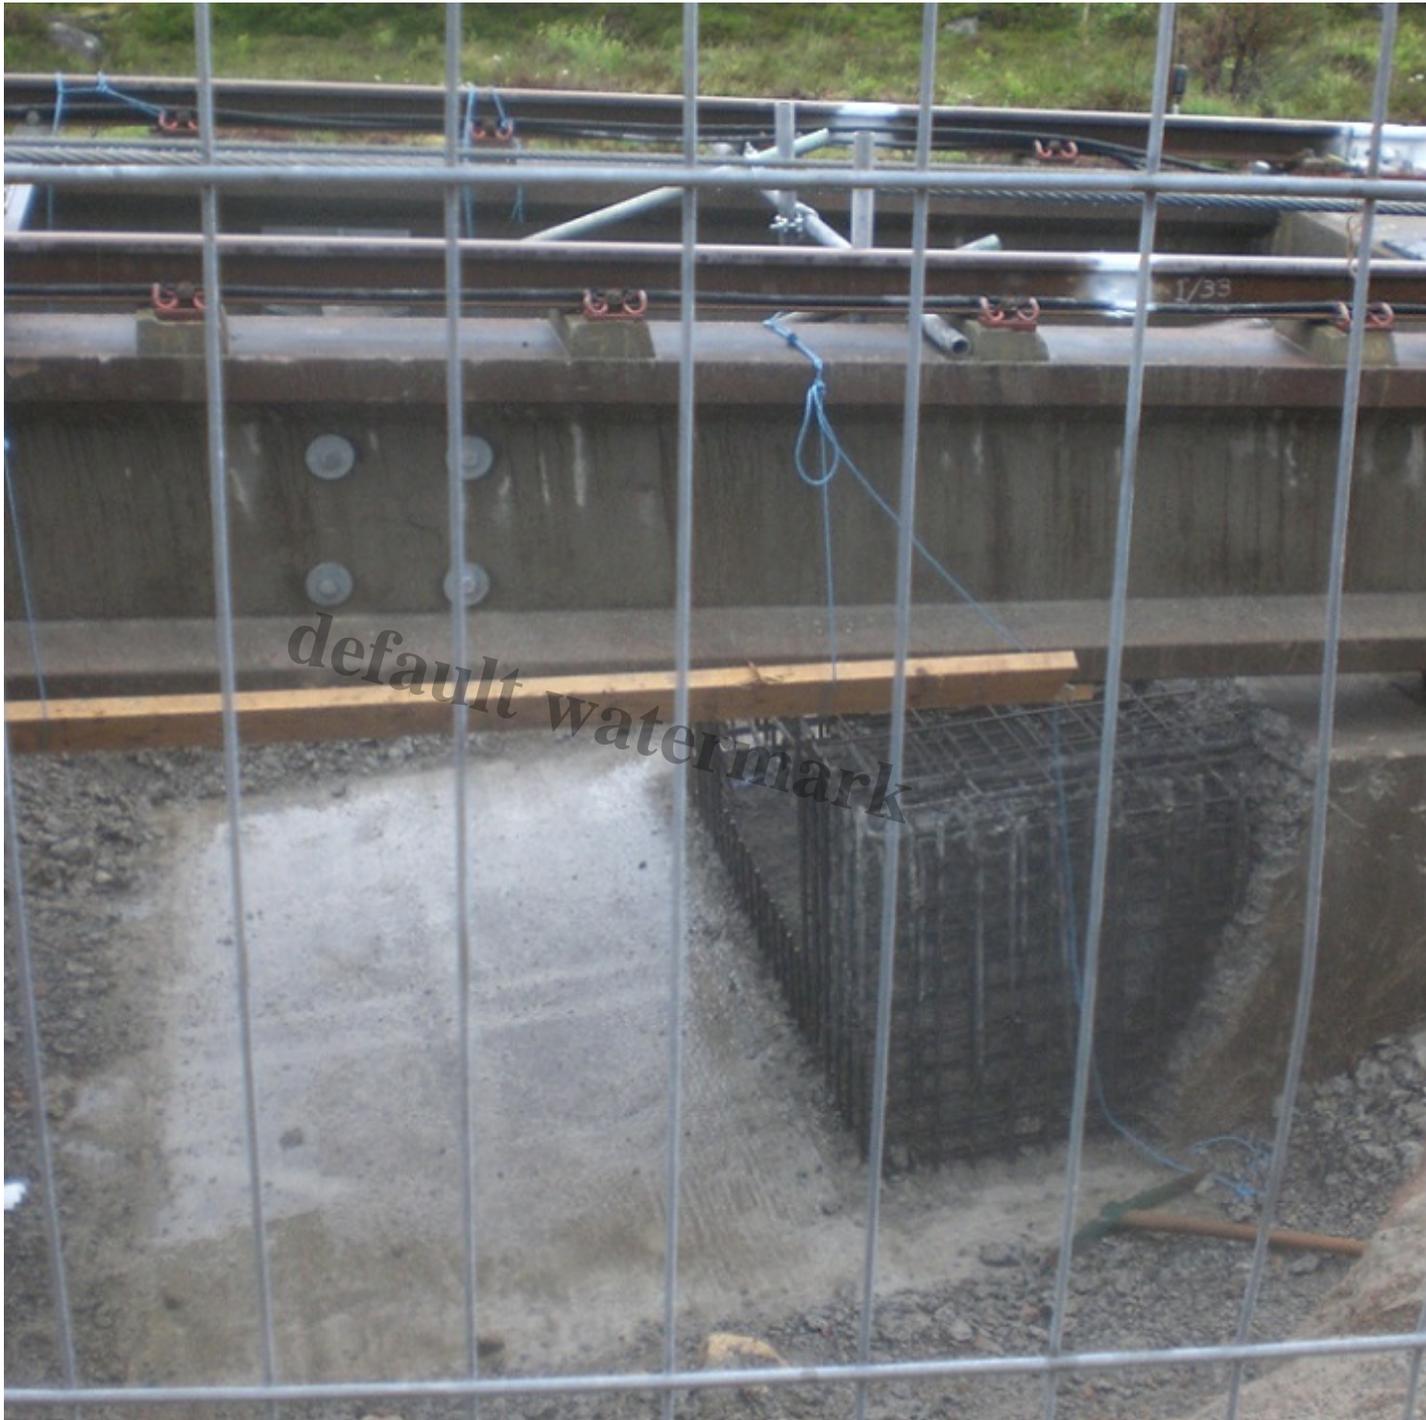
Anchor block extension. Photo credit one of my Cairngorm companions

The amount of concrete â?? 900 kg of CO2 is emitted in the fabrication of every ton of cement â?? being added to the funicular to prop it up and stop it sliding downhill is considerable.

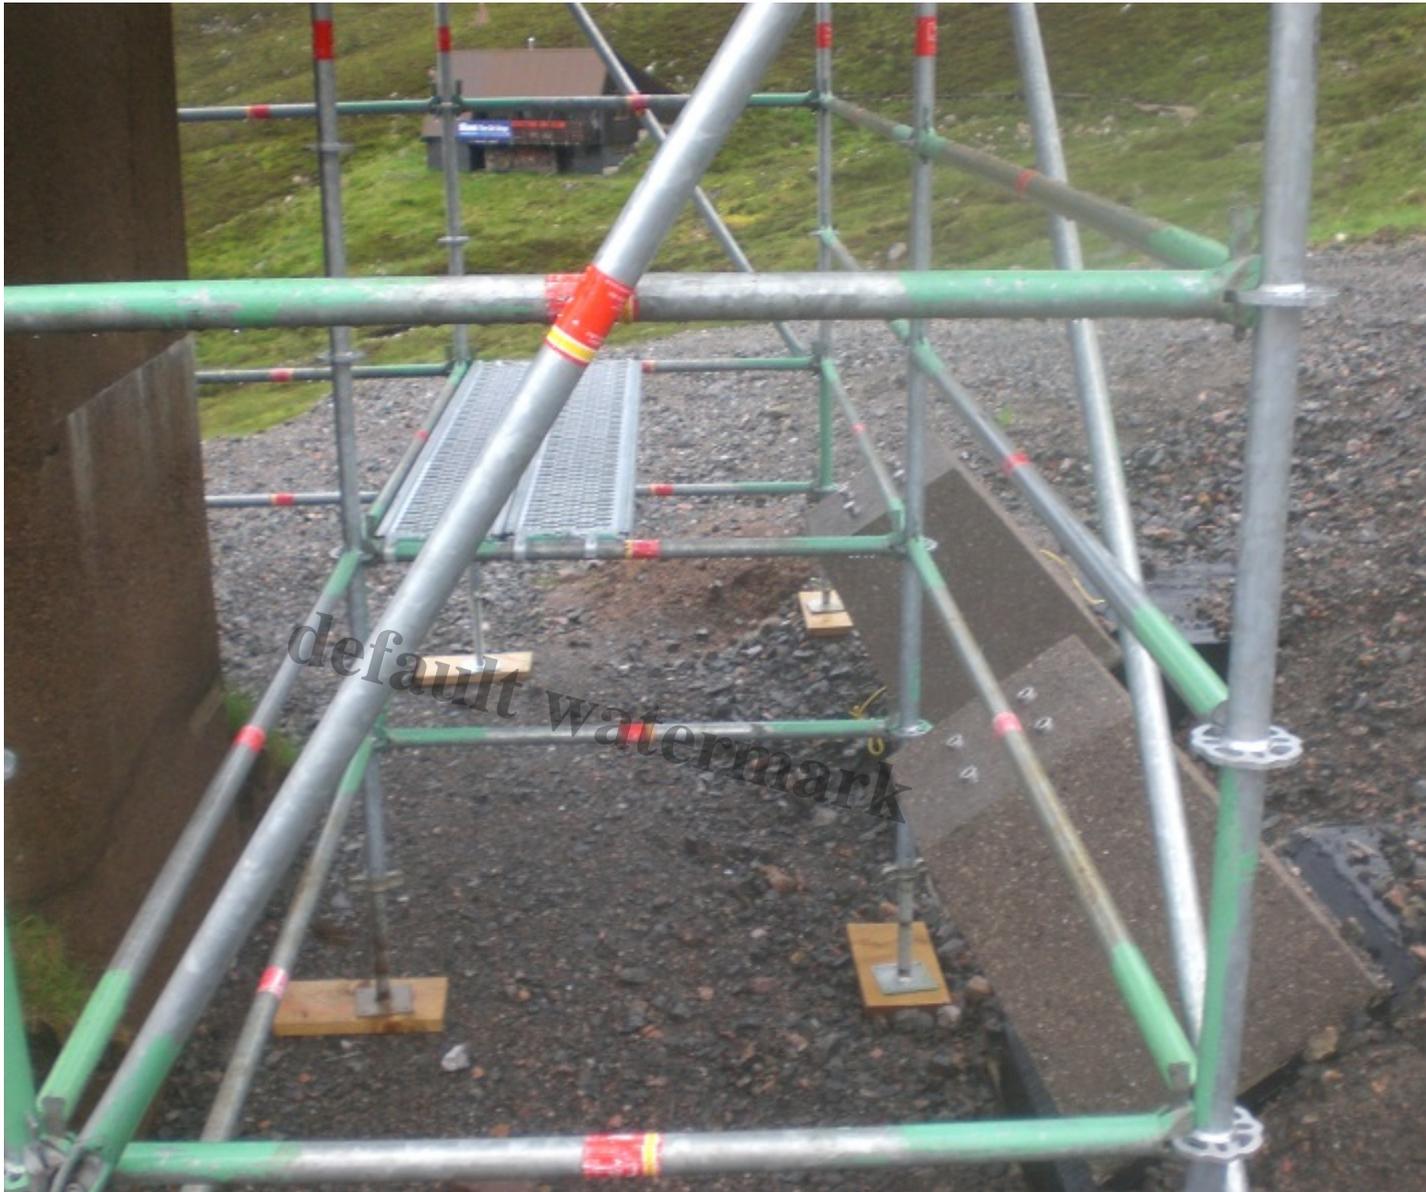
While only the pre-constructed blocks which will support the metal props will be visible once construction is complete, below they are supported by much larger blocks of concrete. Photo credit my Cairngorm companion.

As well as the concrete, significant quantities of imported aggregate have been used in the construction. Together they have altered what remained of the natural granite based soils around the funicular and will change the drainage patterns, with unpredictable consequences.

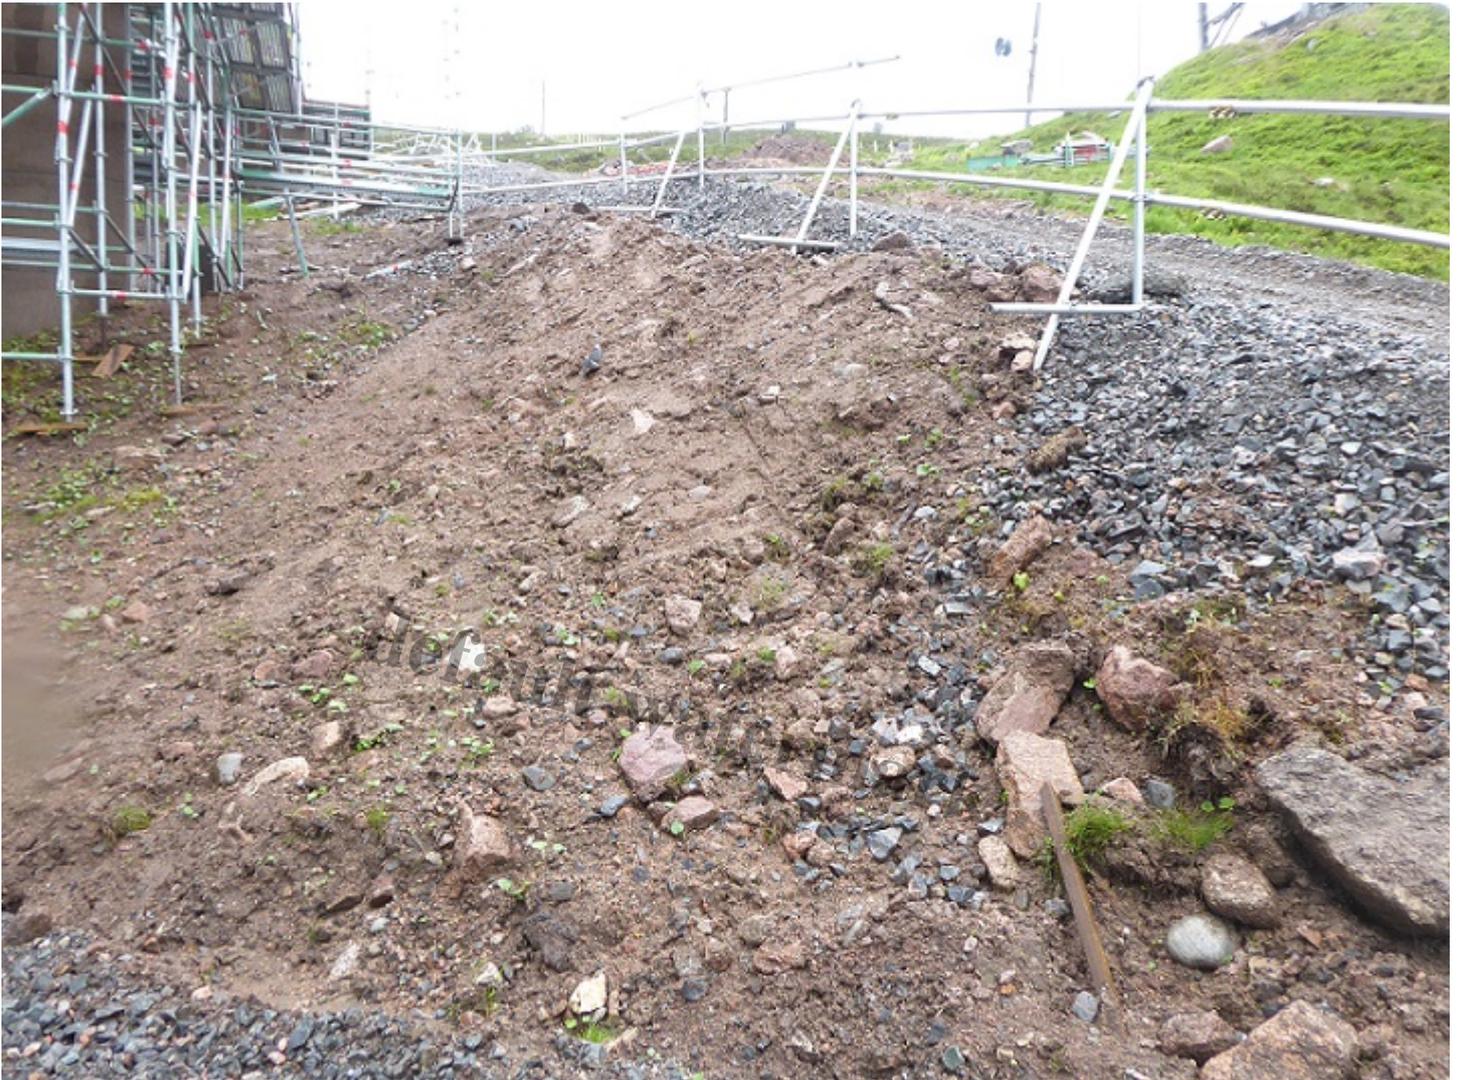
The planning application claimed that the original funicular construction tracks above the mid-station which had been restored would be uncovered and re-used. This always was nonsense. What the photo shows it that Balfour Beatty has been allowed to bring in imported aggregate to surface a new temporary access track. It is hard to see how this can ever be removed it is spilling all over the mountain and its still not clear what will be done with this and all the surplus material displaced from the pits. Spread it around, perhaps, and hope for the best?

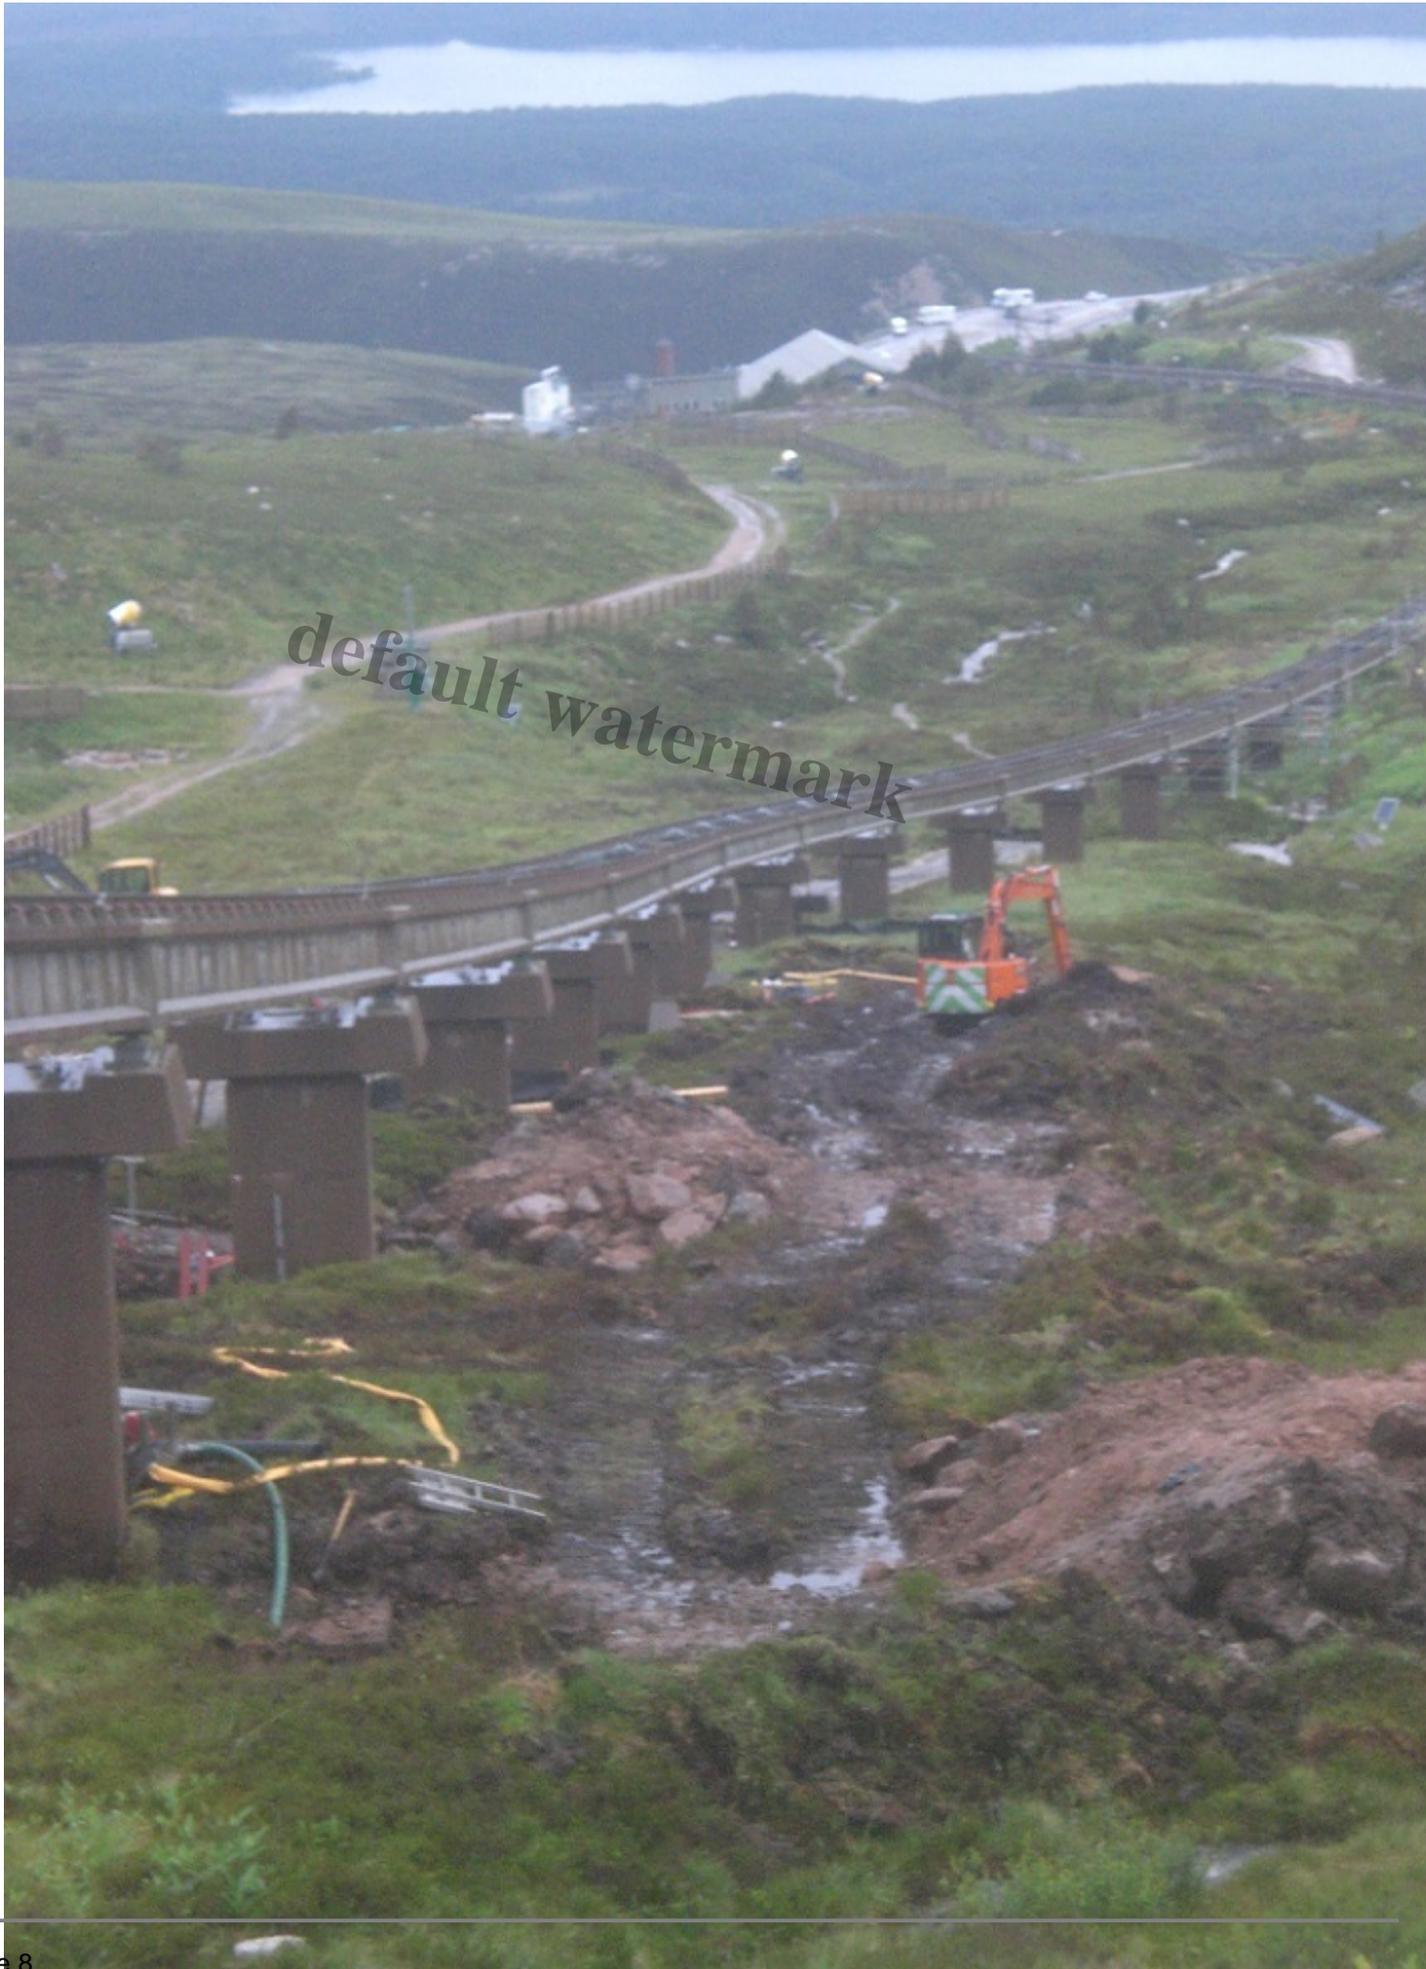
No signs of the ground being protected, the peaty turf (centre foreground) is not being stored properly while large quantities of excavated material have been dumped on peaty vegetation outwith the construction corridor. Photo credit my Cairngorm companion.

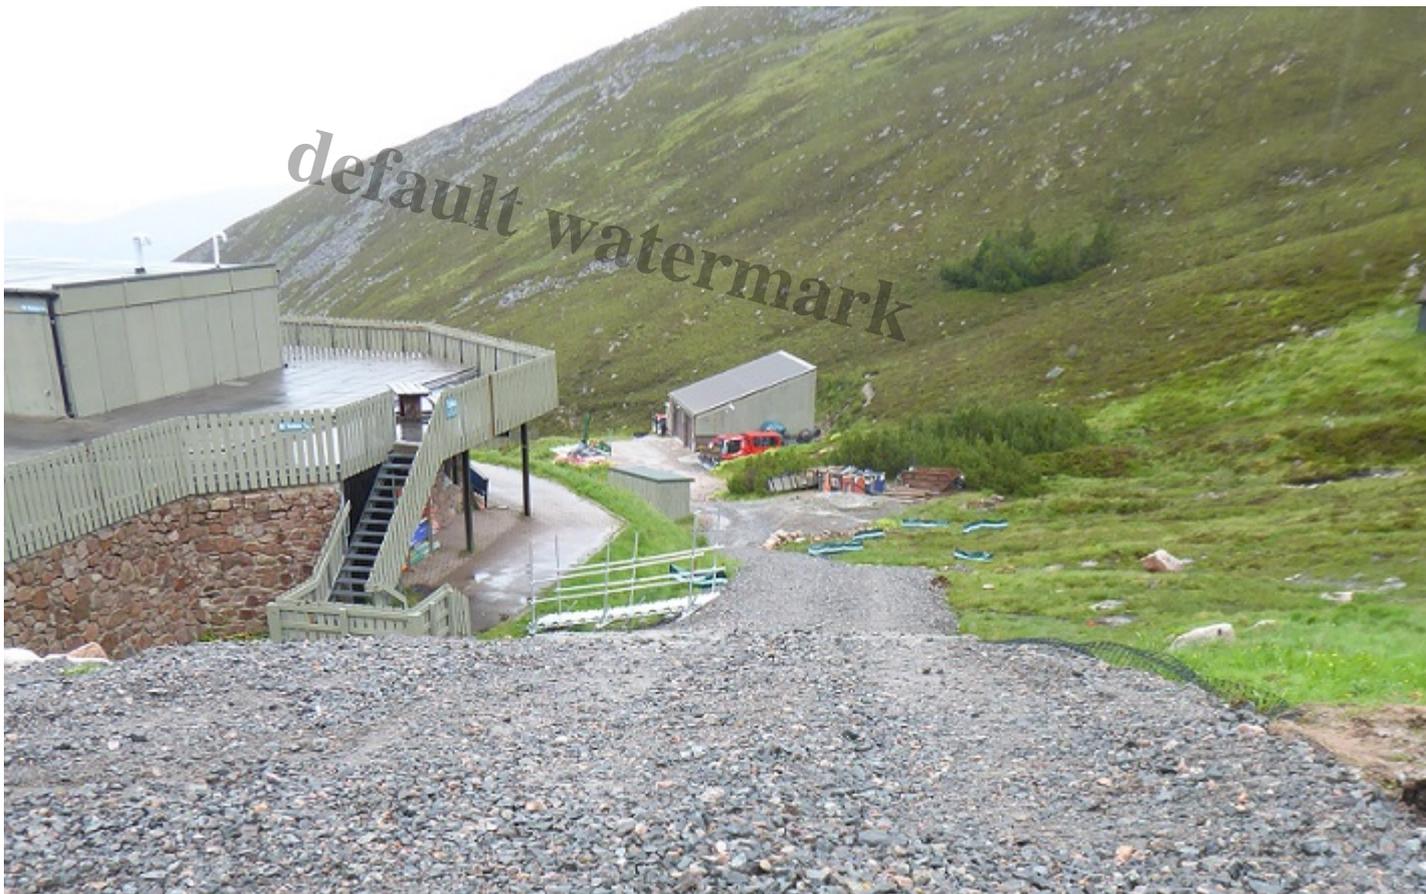
The temporary storage area above the shieling, marked as lying within the construction site appears mostly unused albeit an enormous new track has been constructed..

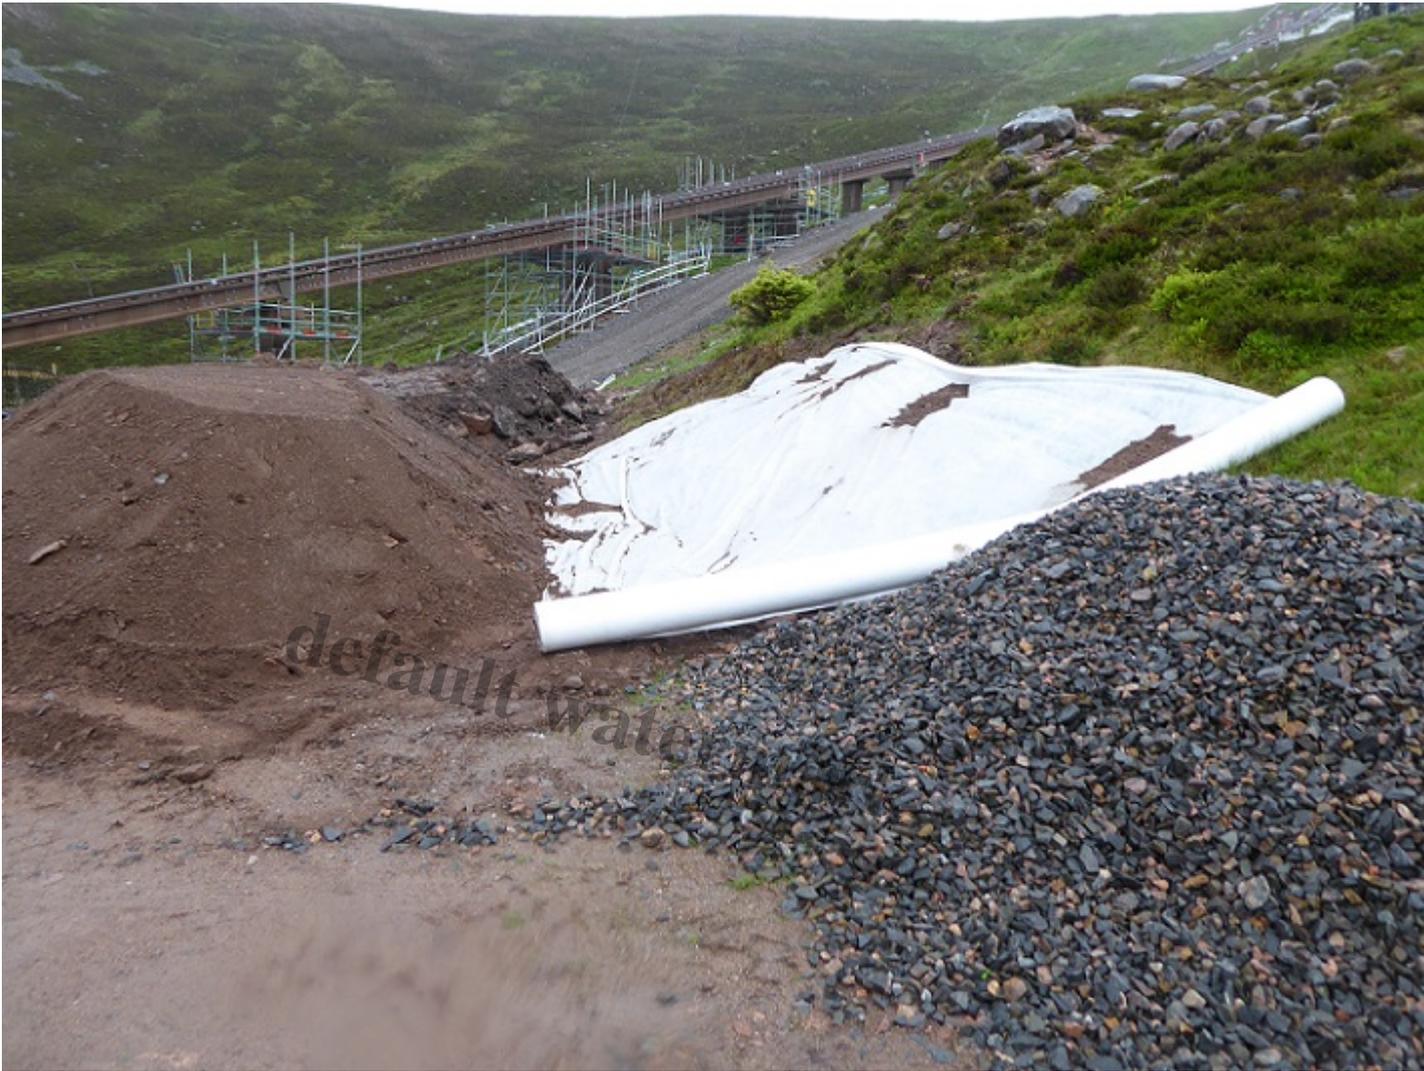
These piles of sand and aggregate, together with the sheeting, lie outwith the construction area, the shaded blue area in the plans above

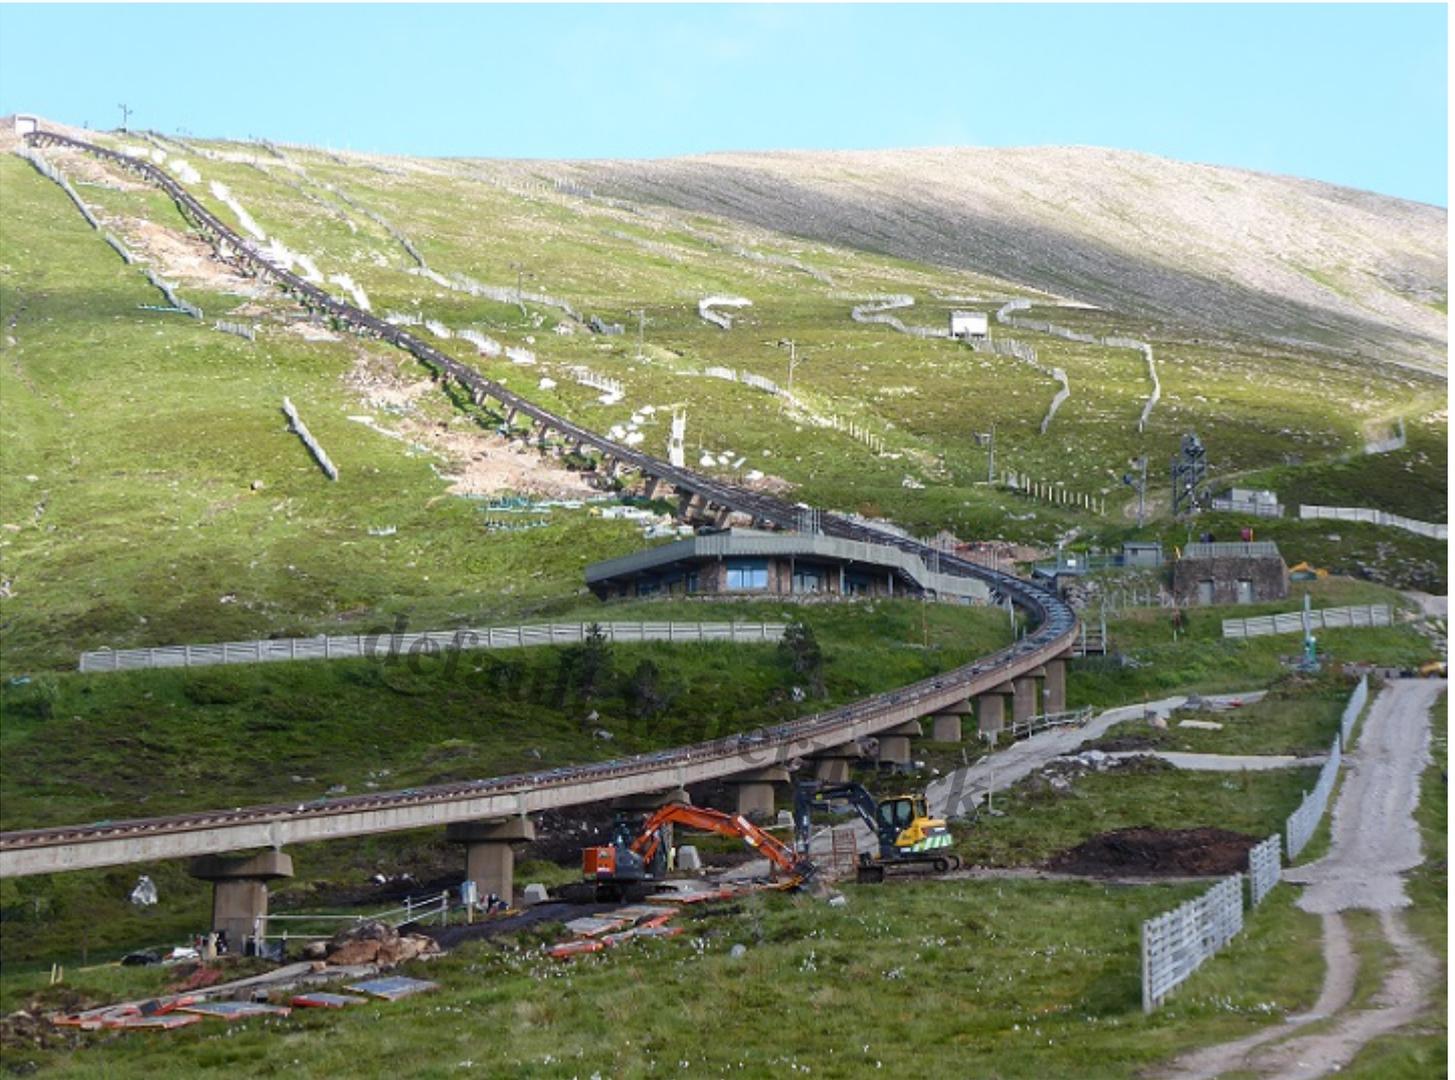
Evidence of work impact on areas outwith the construction corridor, by the heap of soil/peat lower right and higher up the mountain the construction has clearly affected an area more than 30m wide. So why didn't the Cairngorms National Park Authority insist the construction corridor was first sized and then marked out properly? Why has it since not taken enforcement action on this and other issues (like failure to store vegetation)? It was quite predictable that, given their record, HIE and Cairngorm Mountain Scotland Ltd would make little effort to ensure planning conditions were kept, so why weren't CNPA Planning staff out on site each day?
