The state of the Cairngorms (5) – environmental catastrophe and the funicular

Storms and construction work

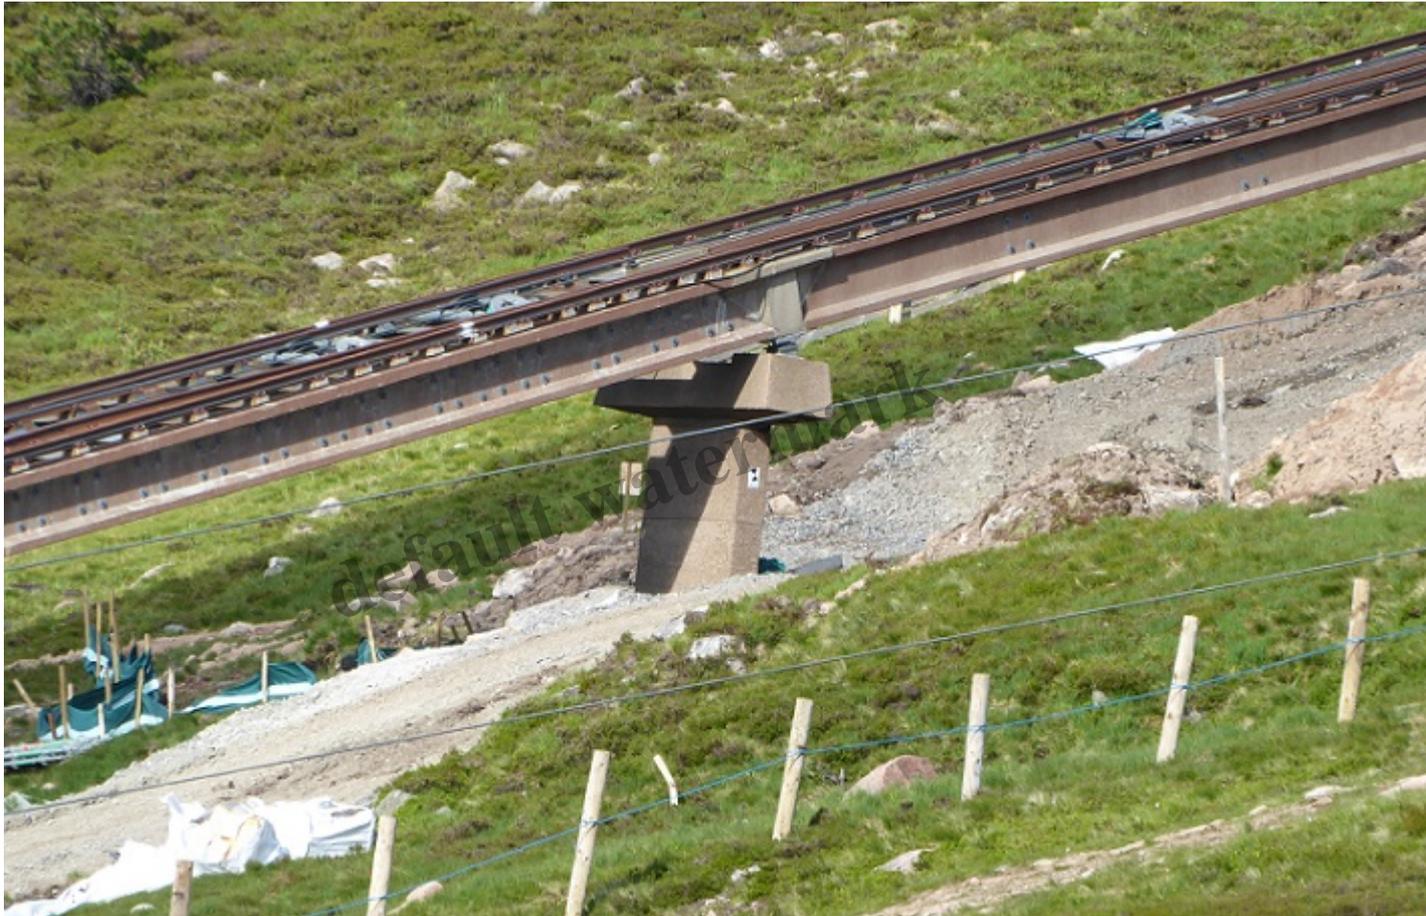
The funicular construction works 14th July, a few days after the intense rainstorms which affected parts of Speyside. Photo credit Louise Brimelow

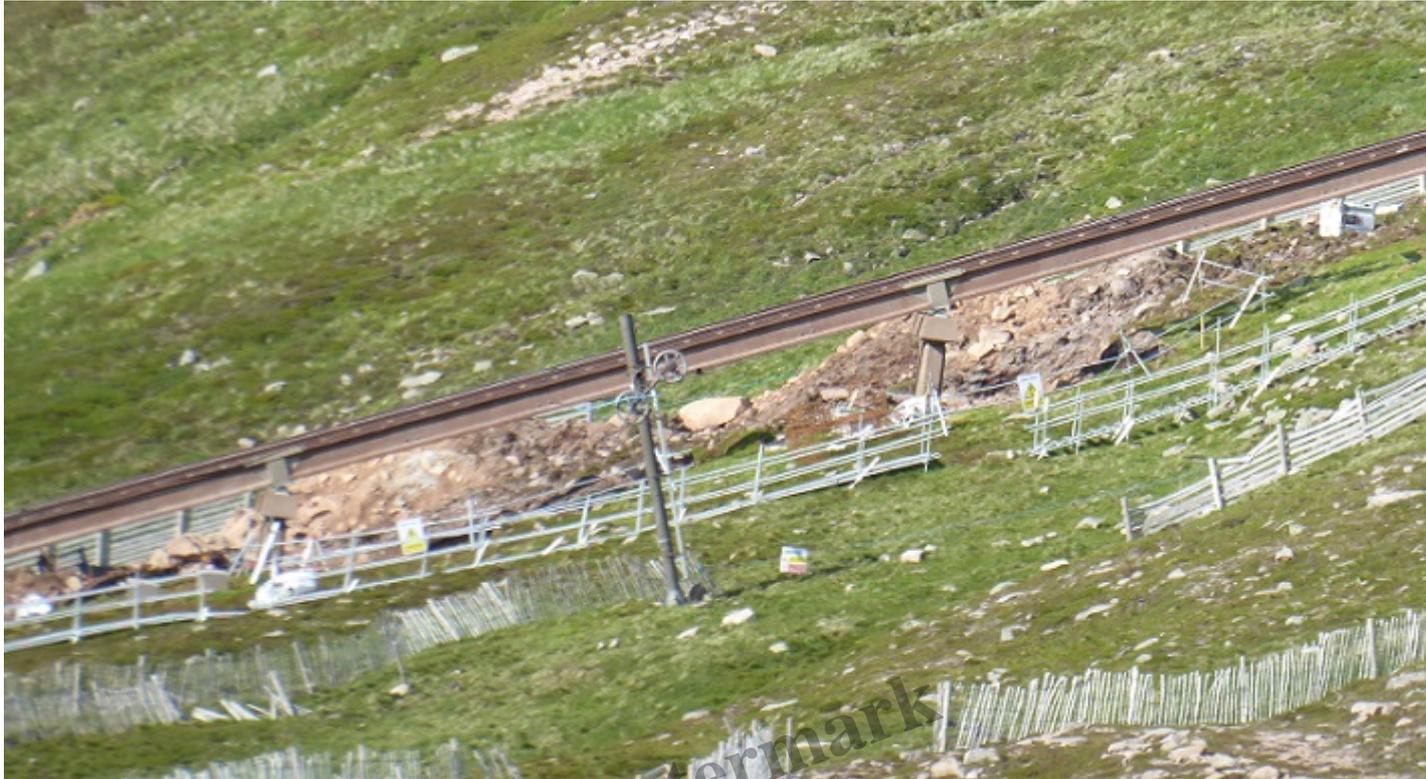
Two weeks ago there were heaps of excavated material all the way up the funicular:

Photo credit Louise Brimelow 14th July.

Whatever the merits of repairing the funicular, heaping piles of excavated material and imported material all the way up the construction site *at the same time* is not a sensible idea in a mountain environment. The work should have been phased. By luck Highlands and Islands Enterprise may get away with it.....unlike those developers in Japan.

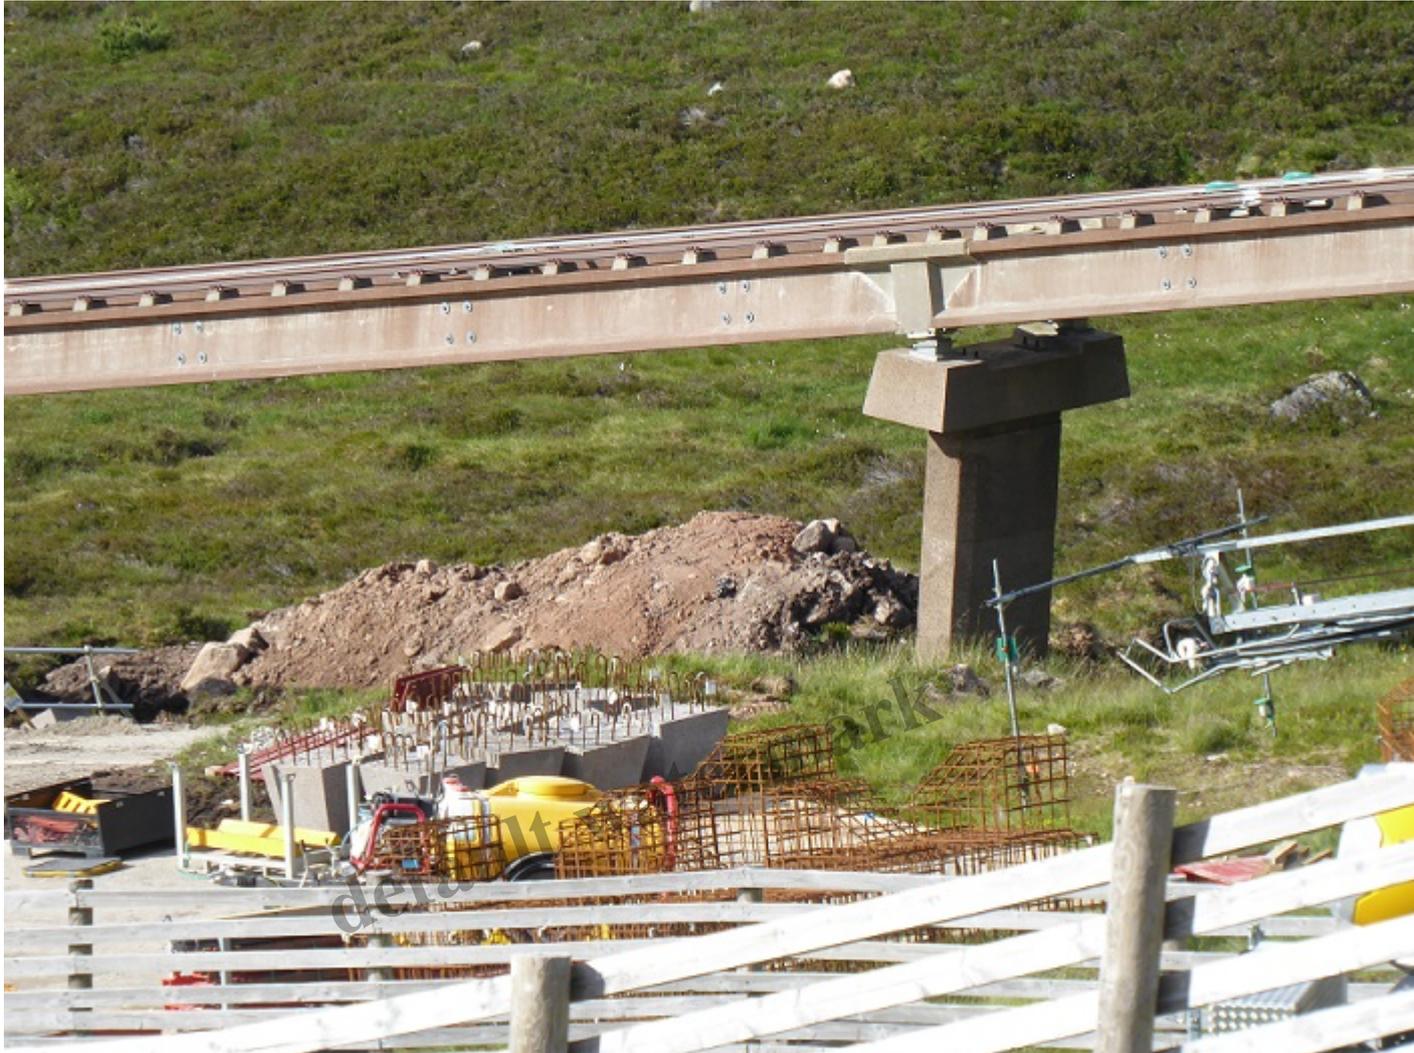
Lower down a heap of excavated material had been placed downhill of a pier and beneath the beams supporting the rails – apparently to protect peat – where it would have been offered some protection against rain. Photo Credit Louise Brimelow.

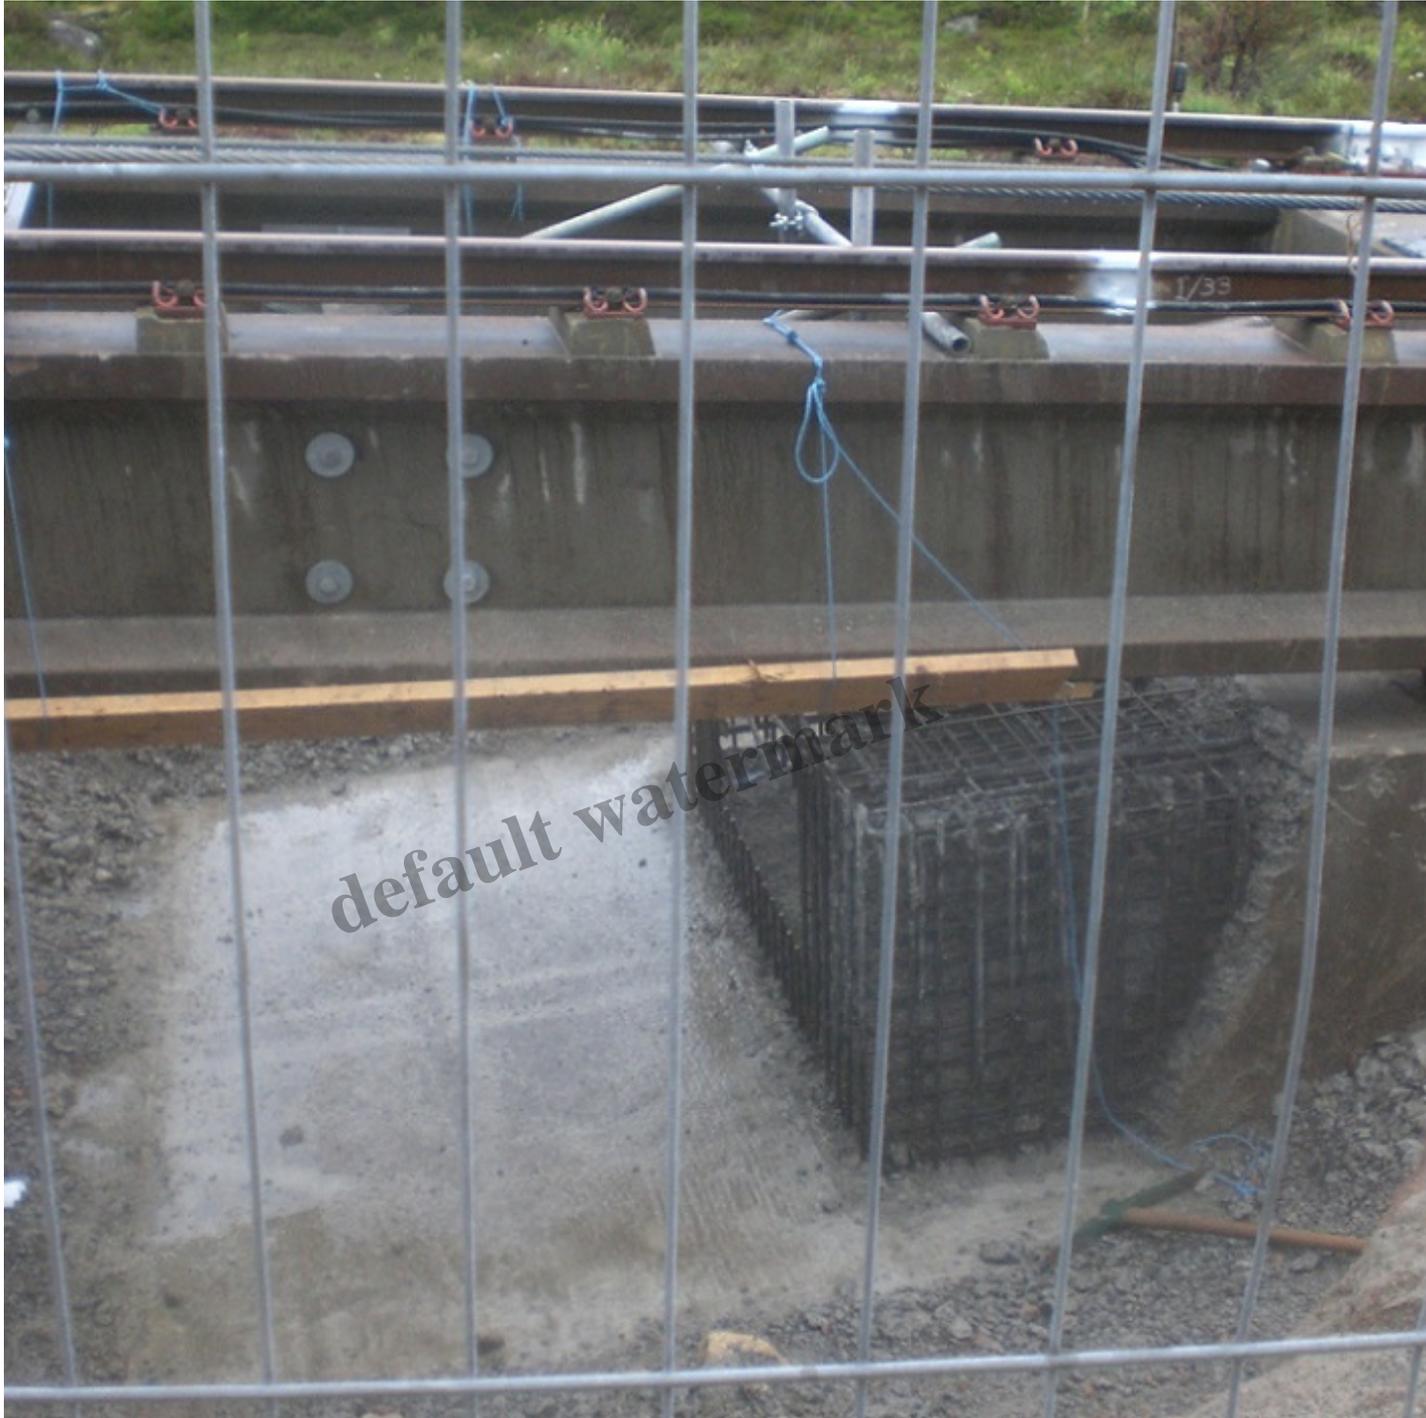
Anchor block extension. Photo credit one of my Cairngorm companions

The amount of concrete – 900 kg of CO₂ is emitted in the fabrication of every ton of cement – being added to the funicular to prop it up and stop it sliding downhill is considerable.

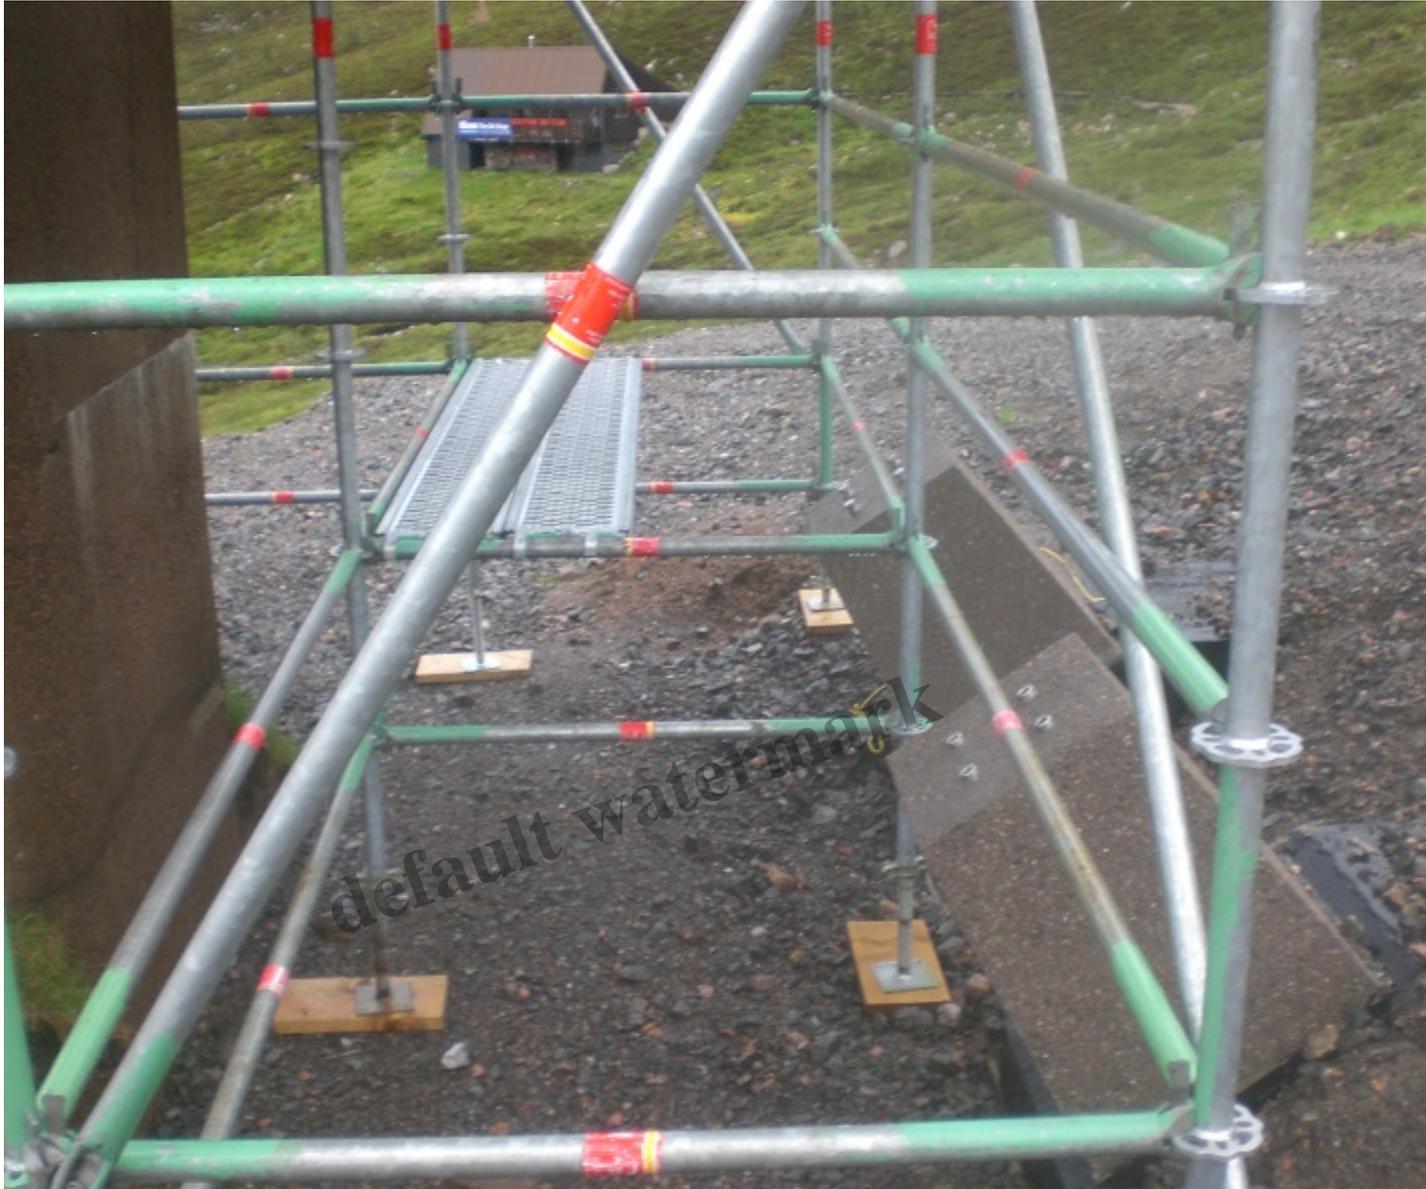
While only the pre-constructed blocks which will support the metal props will be visible once construction is complete, below they are supported by much larger blocks of concrete. Photo credit my Cairngorm companion.

As well as the concrete, significant quantities of imported aggregate have been used in the construction. Together they have altered what remained of the natural granite based soils around the funicular and will change the drainage patterns, with unpredictable consequences.

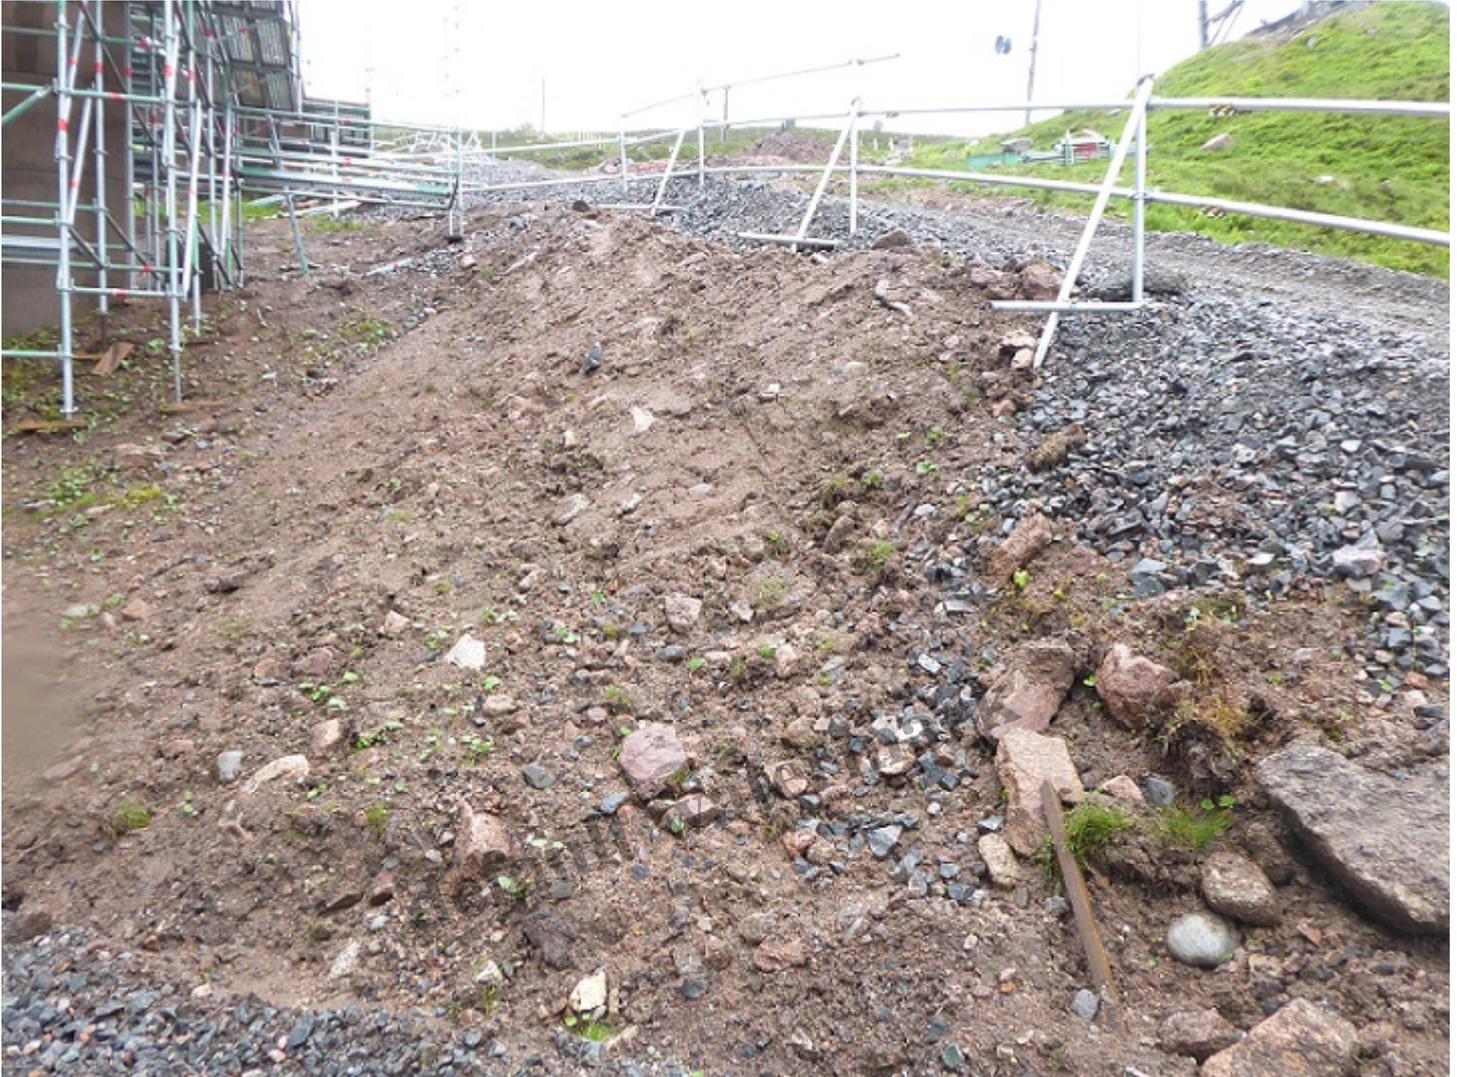
The planning application claimed that the original funicular construction tracks above the mid-station which had been restored would be uncovered and re-used. This always was nonsense. What the photo shows it that Balfour Beatty has been allowed to bring in imported aggregate to surface a new “temporary” access track. It is hard to see how this can ever be removed – it is spilling all over the mountain – and its still not clear what will be done with this and all the surplus material displaced from the pits. Spread it around, perhaps, and hope for the best?

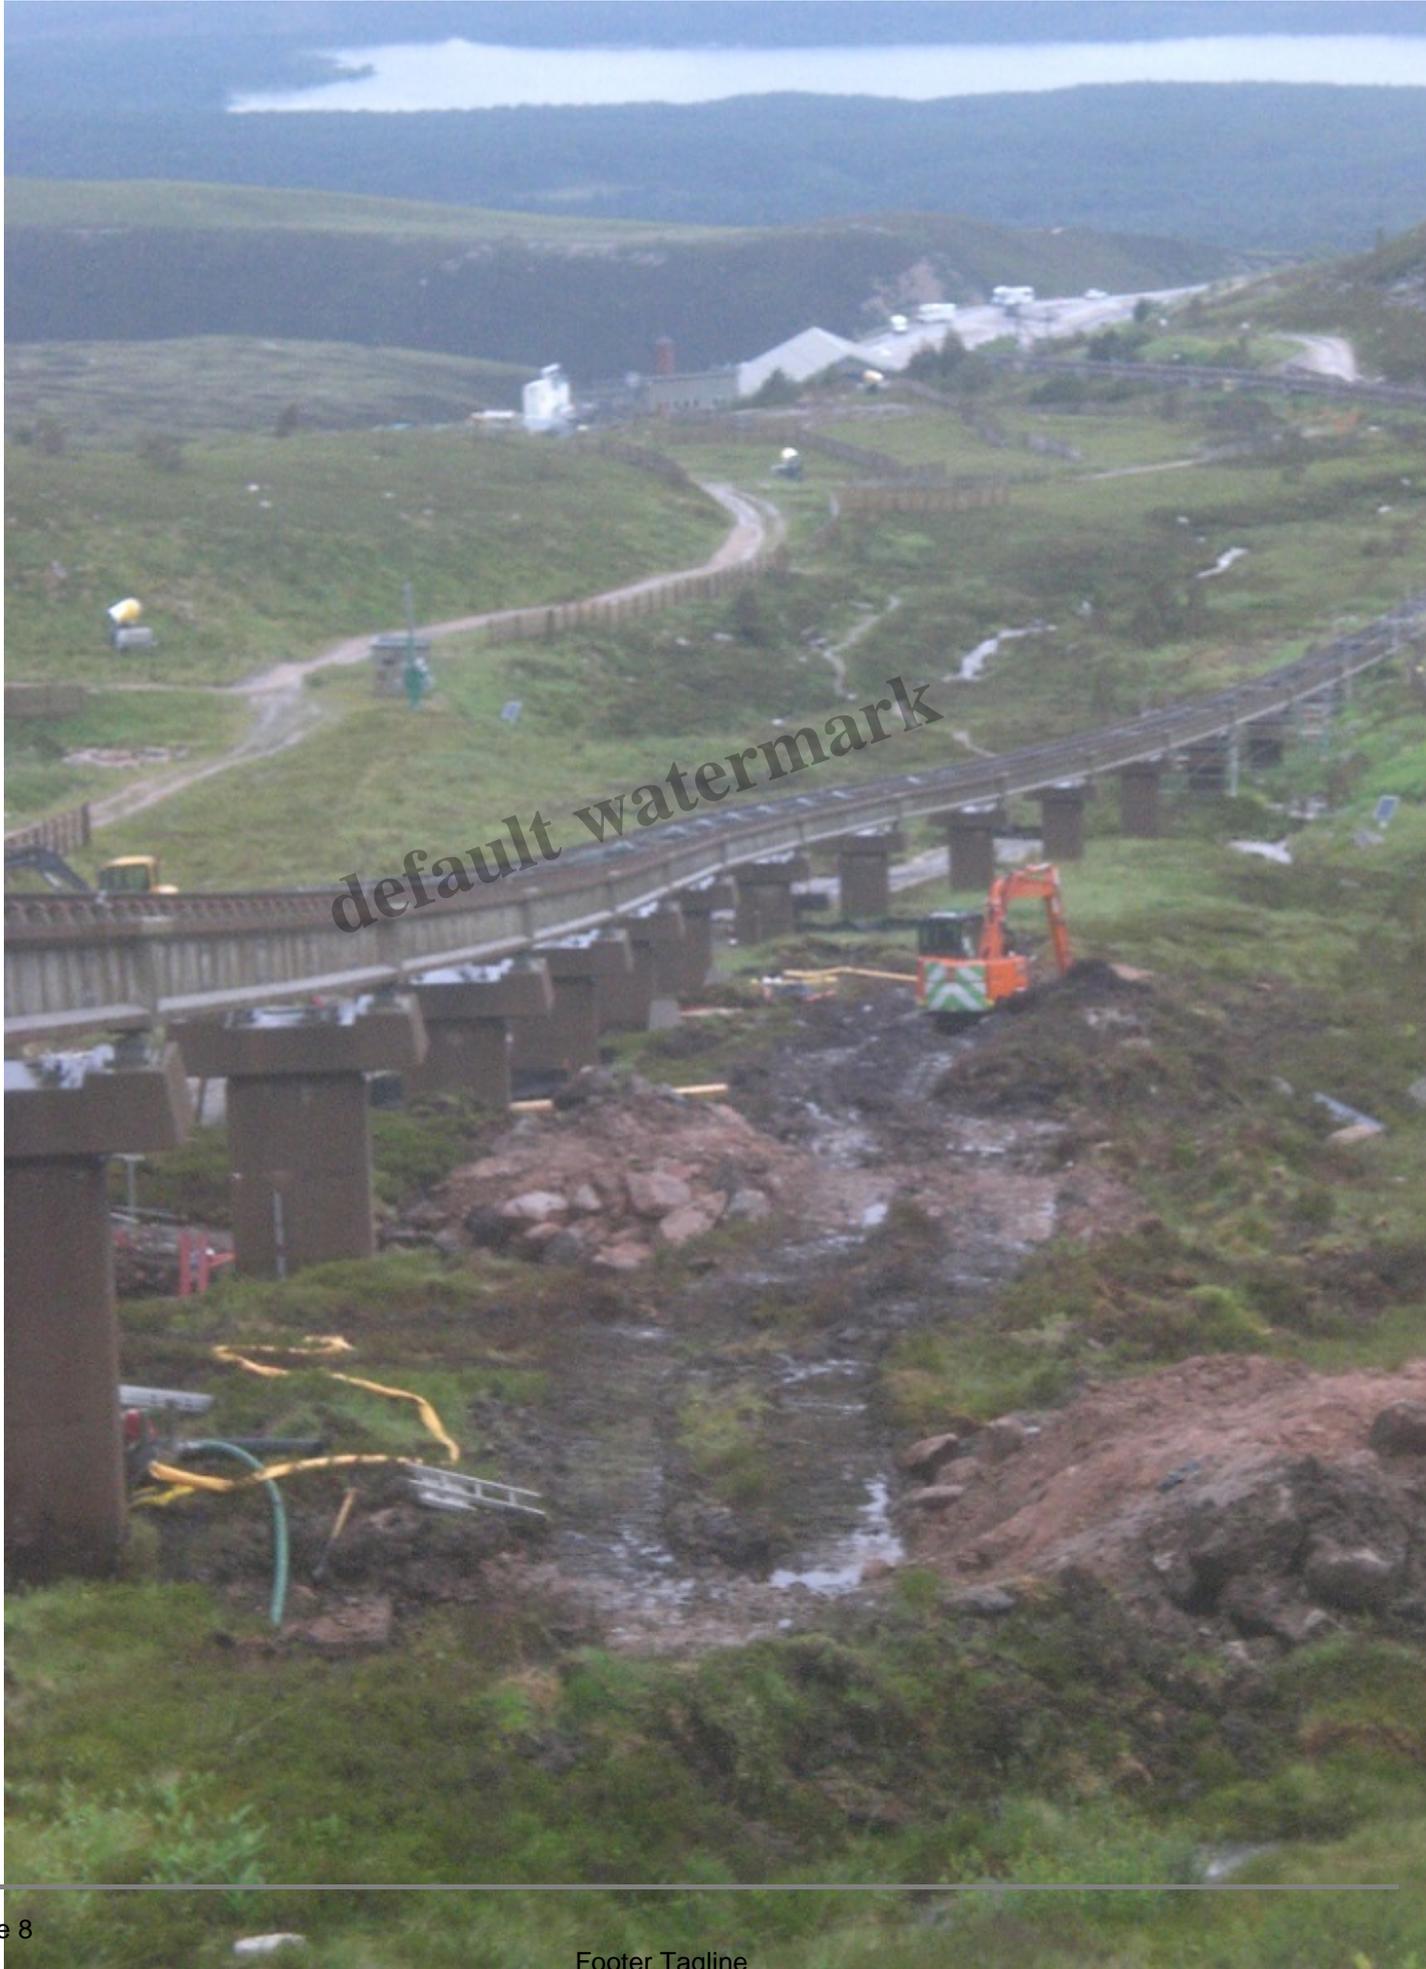
No signs of the ground being protected, the peaty turf (centre foreground) is not being stored properly while large quantities of excavated material have been dumped on peaty vegetation outwith the construction corridor. Photo credit my Cairngorm companion.

“SUSTAINABLE PEAT MANAGEMENT: SEPA welcomes the utilisation of existing tracks where possible and acknowledge that there is little scope for mitigation in terms of reducing volumes of excavated peat with regards to the proposed new pier supports [yet more carbon emissions]. However, there appears to be scope for further mitigation in relation to the new temporary tracks proposed with a significant volume of peat estimated to be excavated for these in table 3 of the Outline Peat Management Plan and SEPA therefore request that all temporary tracks where peat would otherwise be excavated comprise of geotextile or plastic track matting unless there is a significant technical reason why this is not feasible”. (Extract from the CNPA Committee Report on the Planning Application).

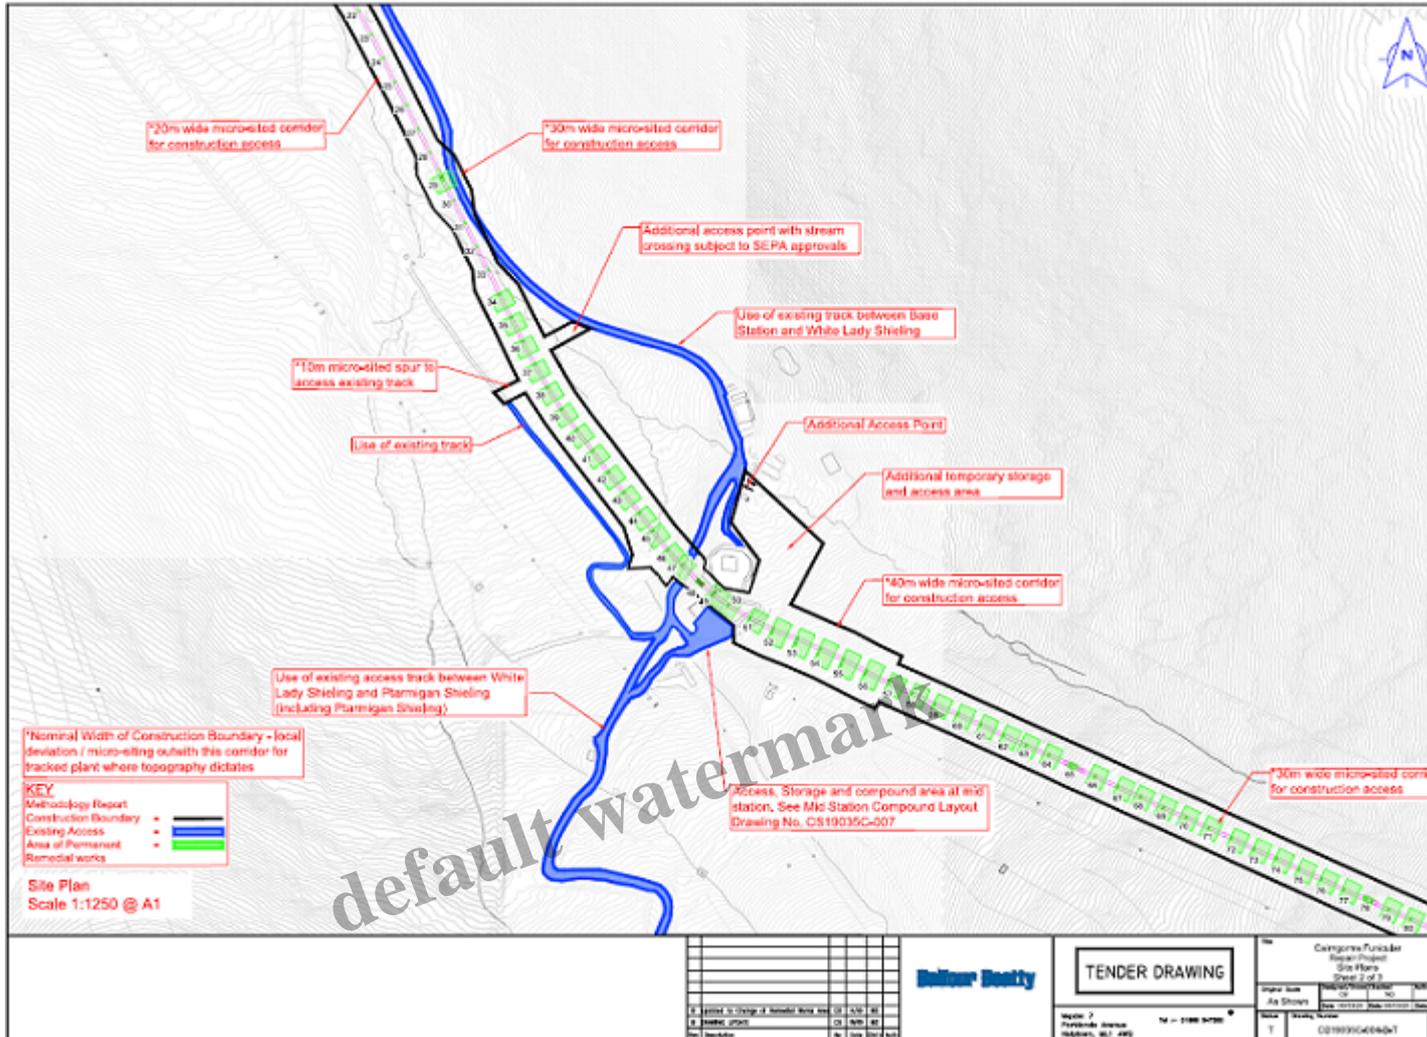
The construction corridor outlined in black, 20m at the top and 30m for the rest, apart from 6 piers above the mid-station. The shieling, outlined in grey, and mid-station are just below centre in the plan.

- 20m where new bearings and pier strengthening was required (generally lower down the hill – top left in map above);
- 30m where new props were required to strengthen the piers which were toppling over (generally from 10 piers below the mid station to the funicular tunnel);
- 40m for the six piers above the mid-station; and
- a few section where there were projecting access spurs and storage areas.

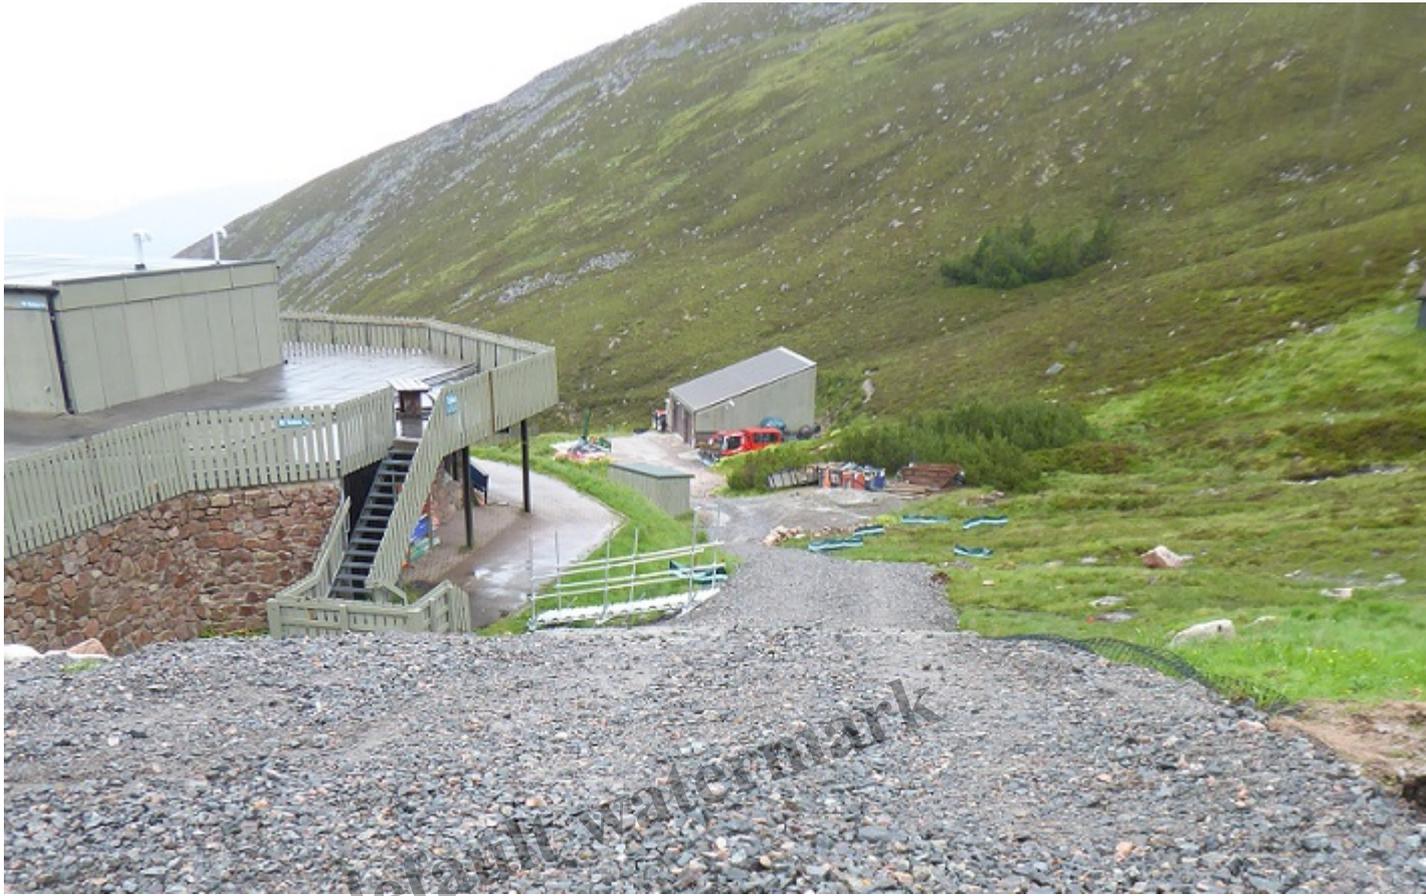
The temporary storage area above the shieling, marked as lying within the construction site appears mostly unused albeit an enormous new track has been constructed..

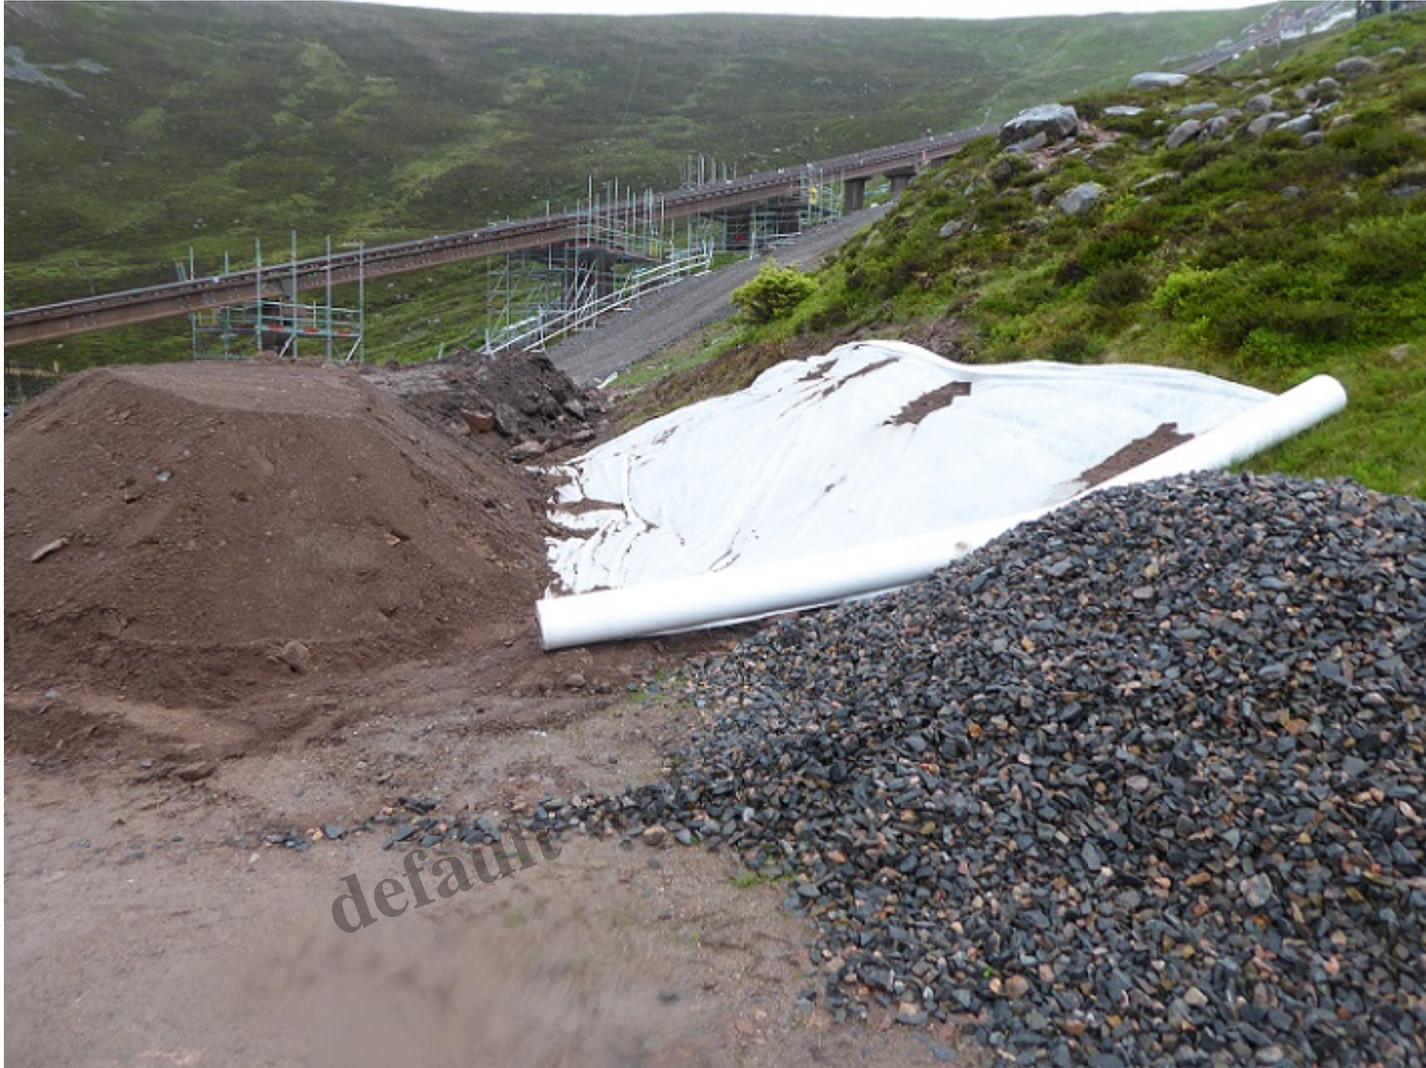
These piles of sand and aggregate, together with the sheeting, lie outwith the construction area, the shaded blue area in the plans above

To their credit, the Scottish Environment Protection Agency in their response to the planning application had queried the construction site area and noted “*that should the construction site area be over 4ha, a Construction Site Licence (CSL) would be required.*” That never appears to have been followed up by the CNPA.

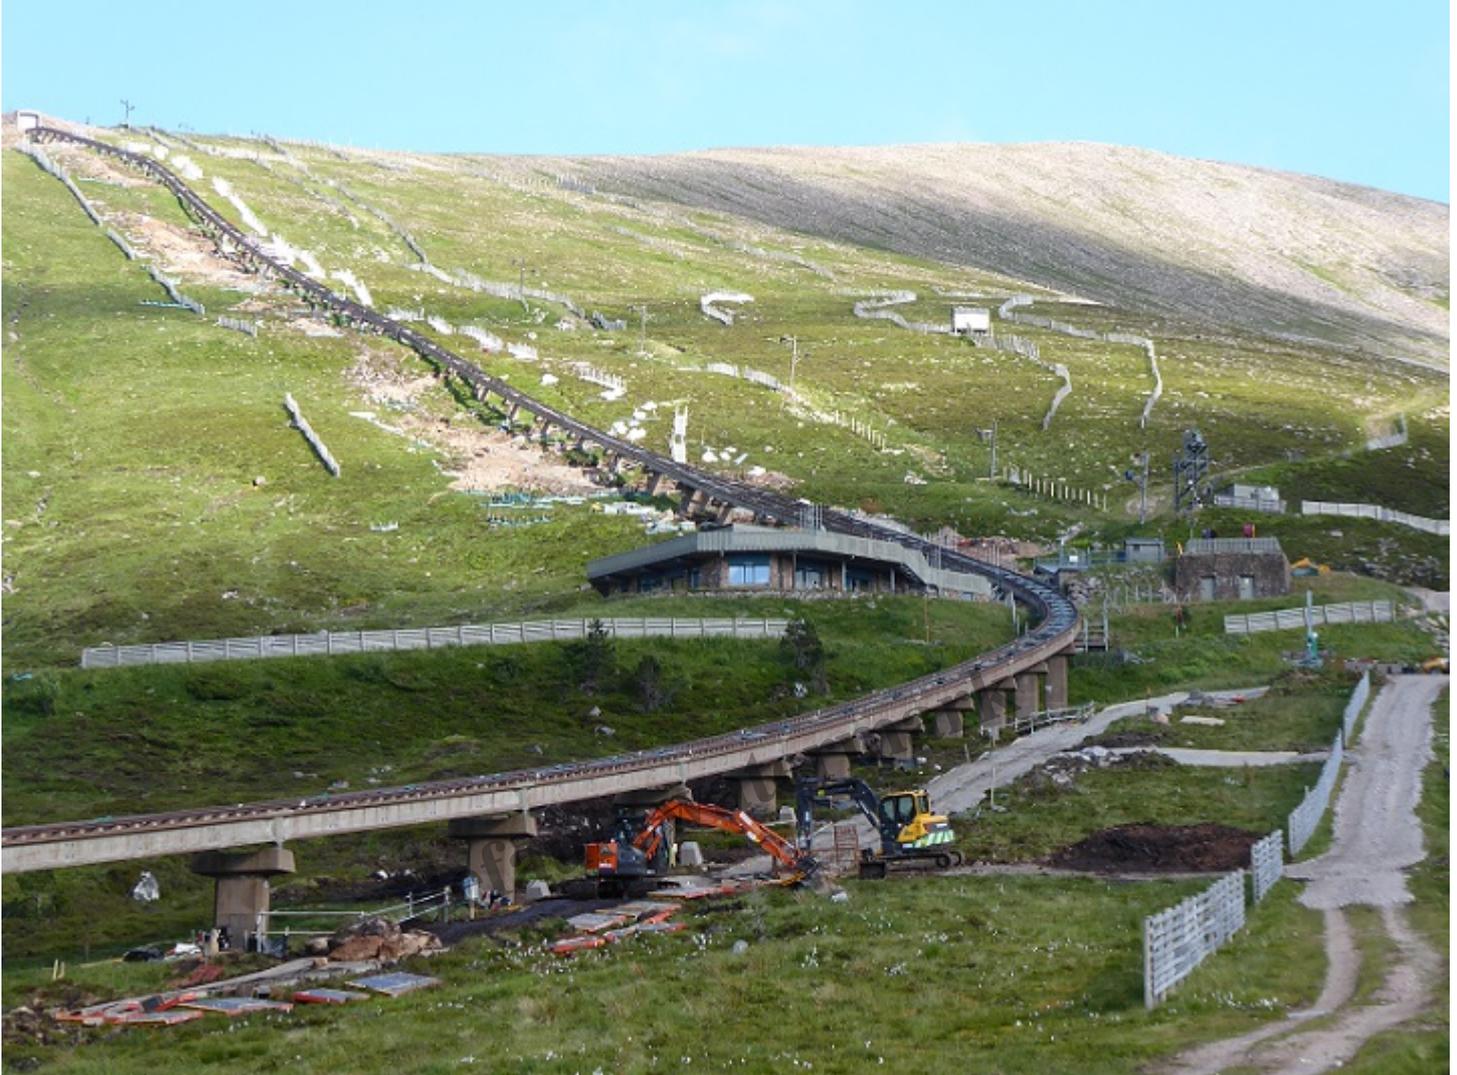
Evidence of work impact on areas outwith the construction corridor, by the heap of soil/peat lower right and higher up the mountain the construction has clearly affected an area more than 30m wide. So why didn't the Cairngorms National Park Authority insist the construction corridor was first sized and then marked out properly? Why has it since not taken enforcement action on this and other issues (like failure to store vegetation)? It was quite predictable that, given their record, HIE and Cairngorm Mountain Scotland Ltd would make little effort to ensure planning conditions were kept, so why weren't CNPA Planning staff out on site each day?
