Contradictory plans for Kinrara – BrewDog needs to get a grip

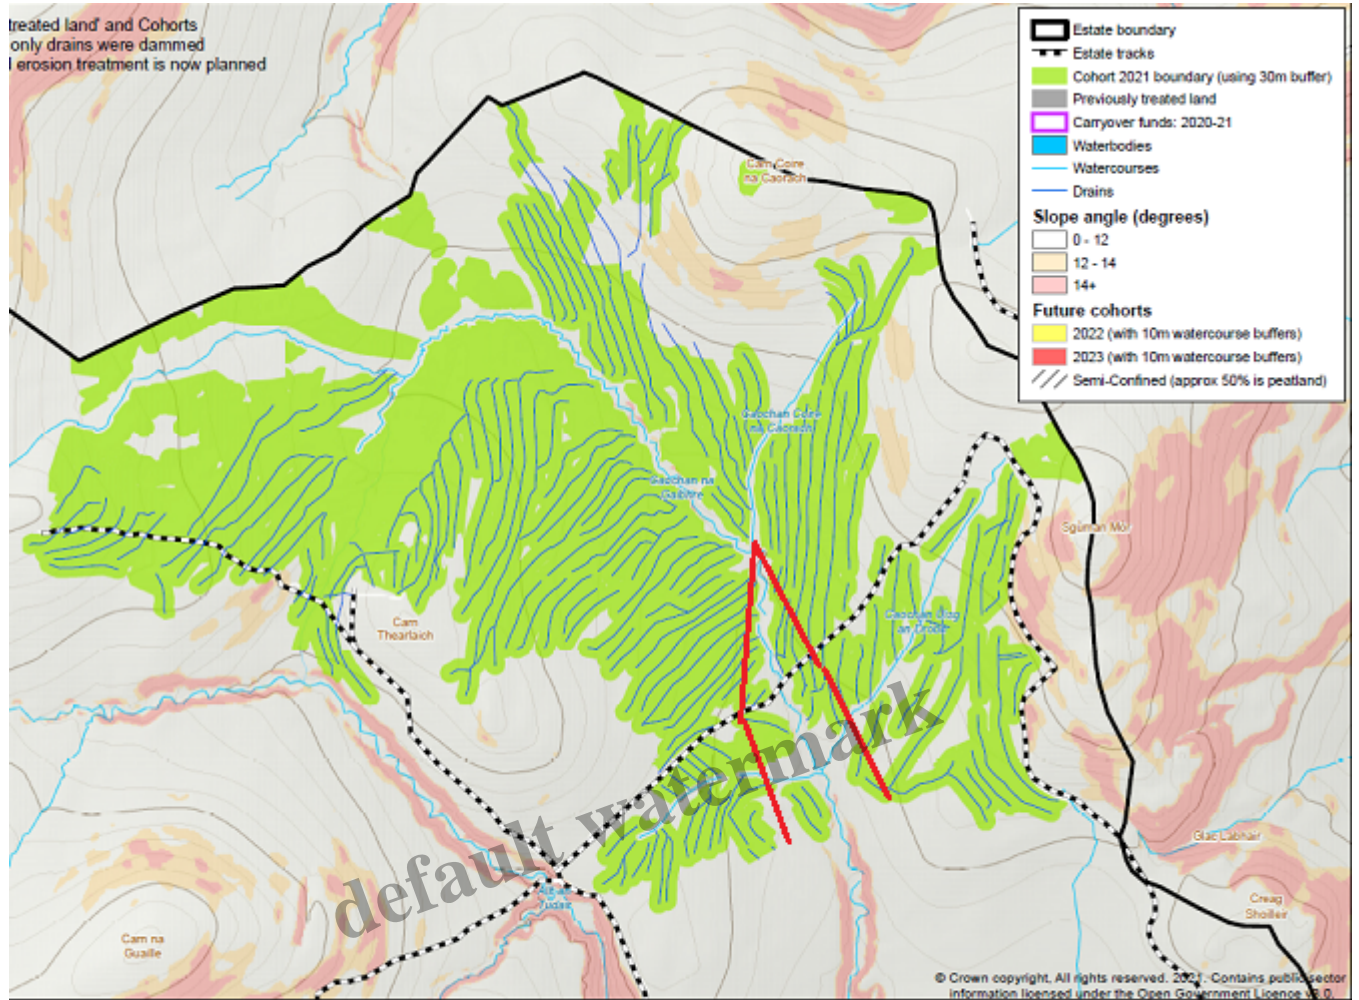
1 Strathalan Bank By Ardargie Finganderry Perth PH2 5PE
14/06/21	FINAL	Planned Restoration Cohorts - KINRARA		
14/06/21		Version: 1	Location: KINRARA	
21/06/21		Scale: 1:12,000

The dark blue lines mark drains/moor grips. The red lines, which I have added, show approximate area of woodland planting on the Lost Forest Plan

The “finger” of woodland restoration alongside the burn, the Caochan na Gaibhre, on either side of the hill track is marked on the Strath Caulaidh map as being an area of proposed peat bog restoration. It should not be both. It could result in NatureScot forking out money to restore peat, while Forestry Scotland fork out other public funds to plant it!

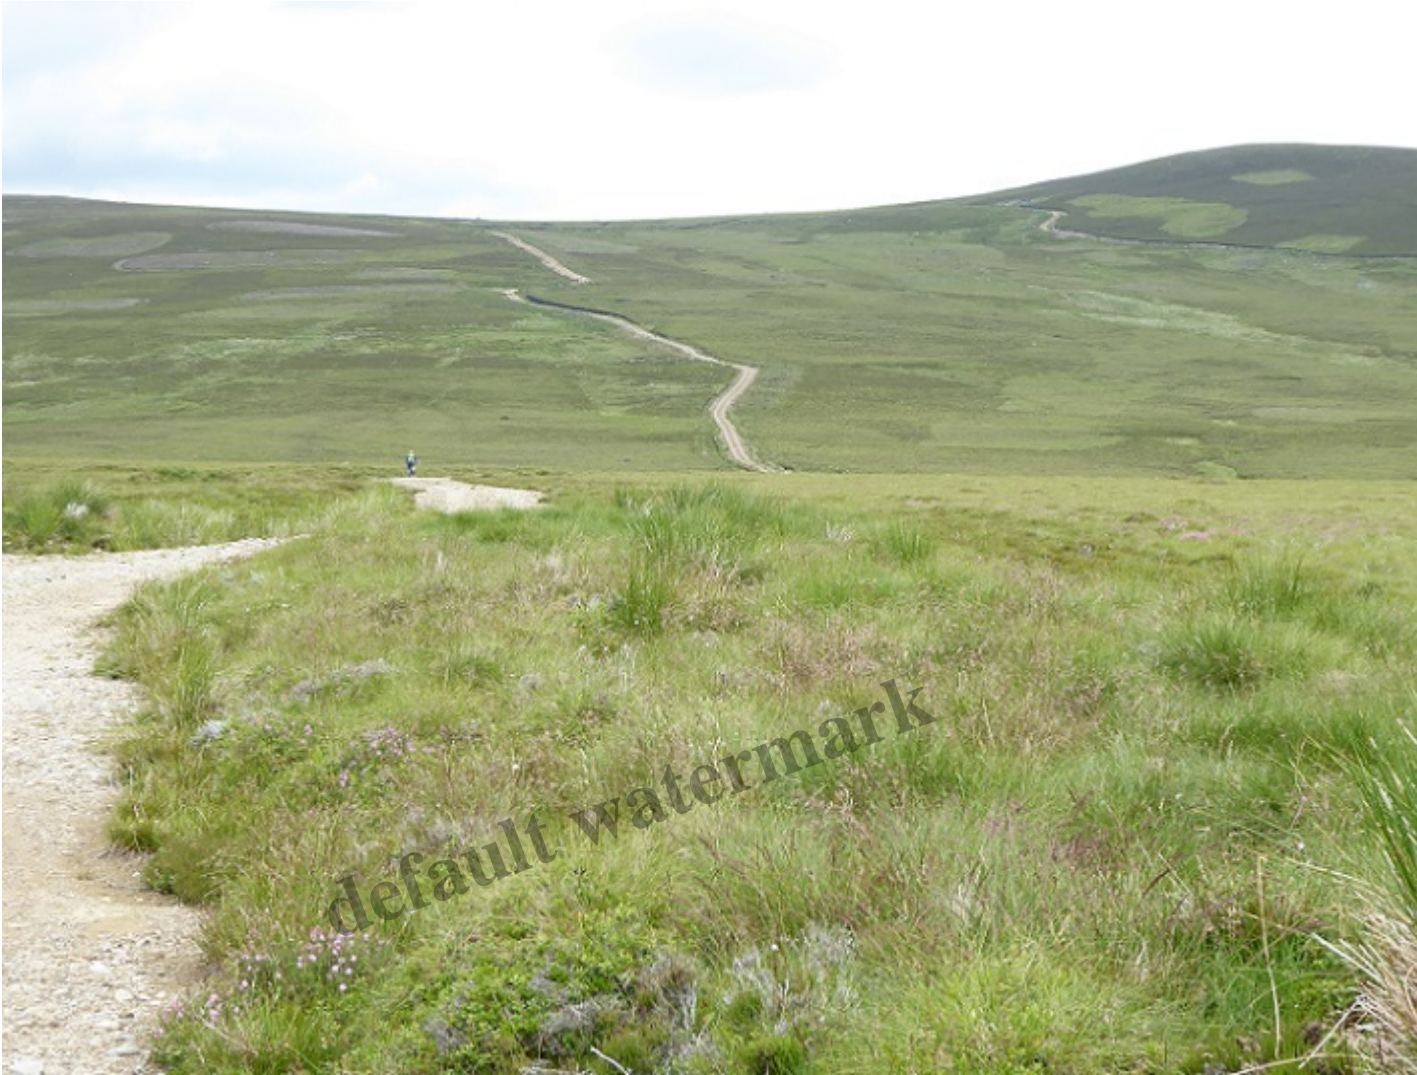
Looking north up the track: the burn, the Caochan na Gaibhre is in dip.

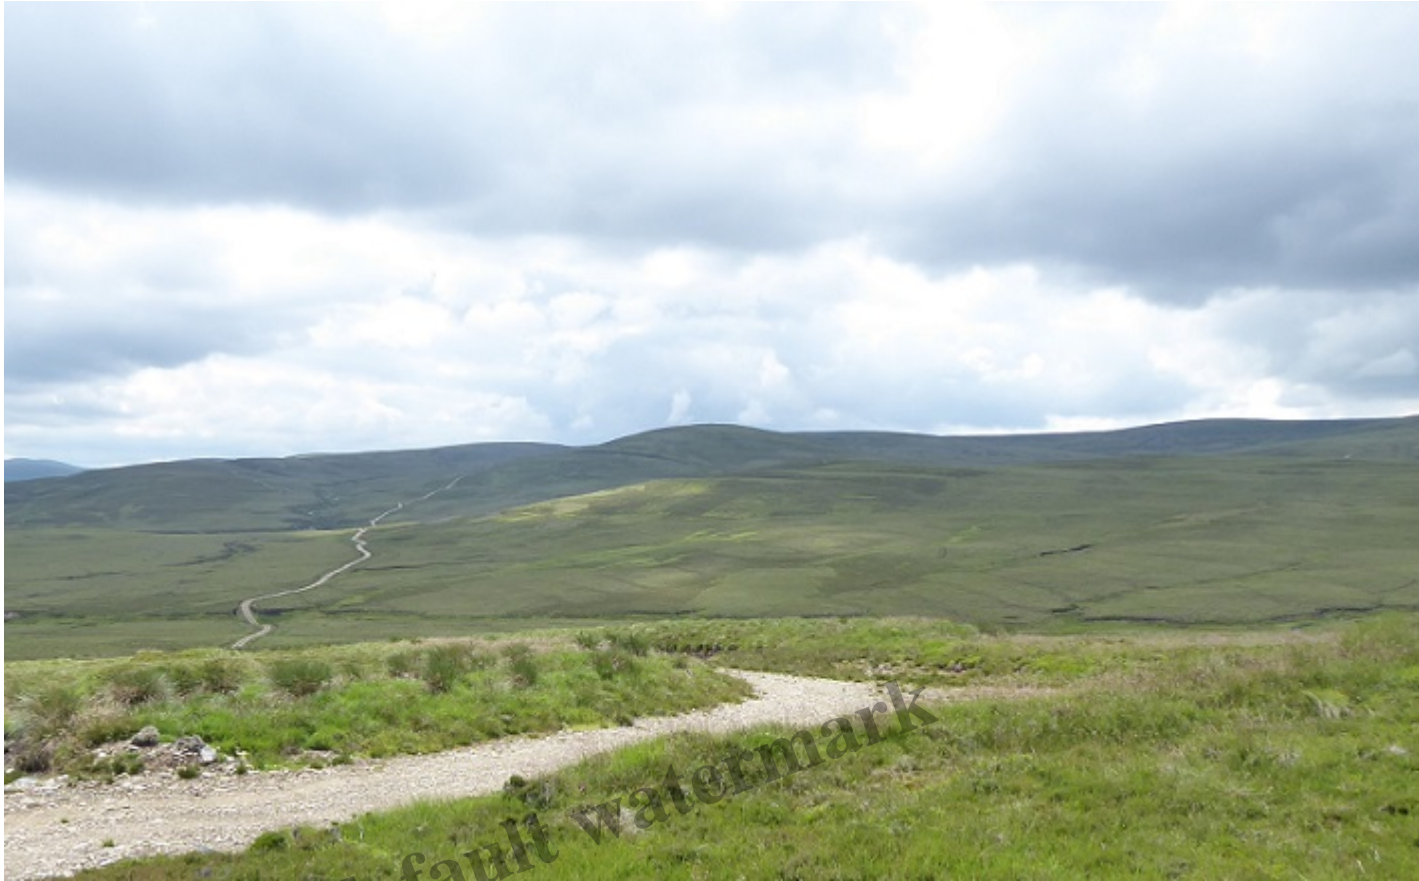
Moor grips are just visible to the right of the track on the far side of the Caochan na Gaibhre burn. They appear as a series of faint parallel lines

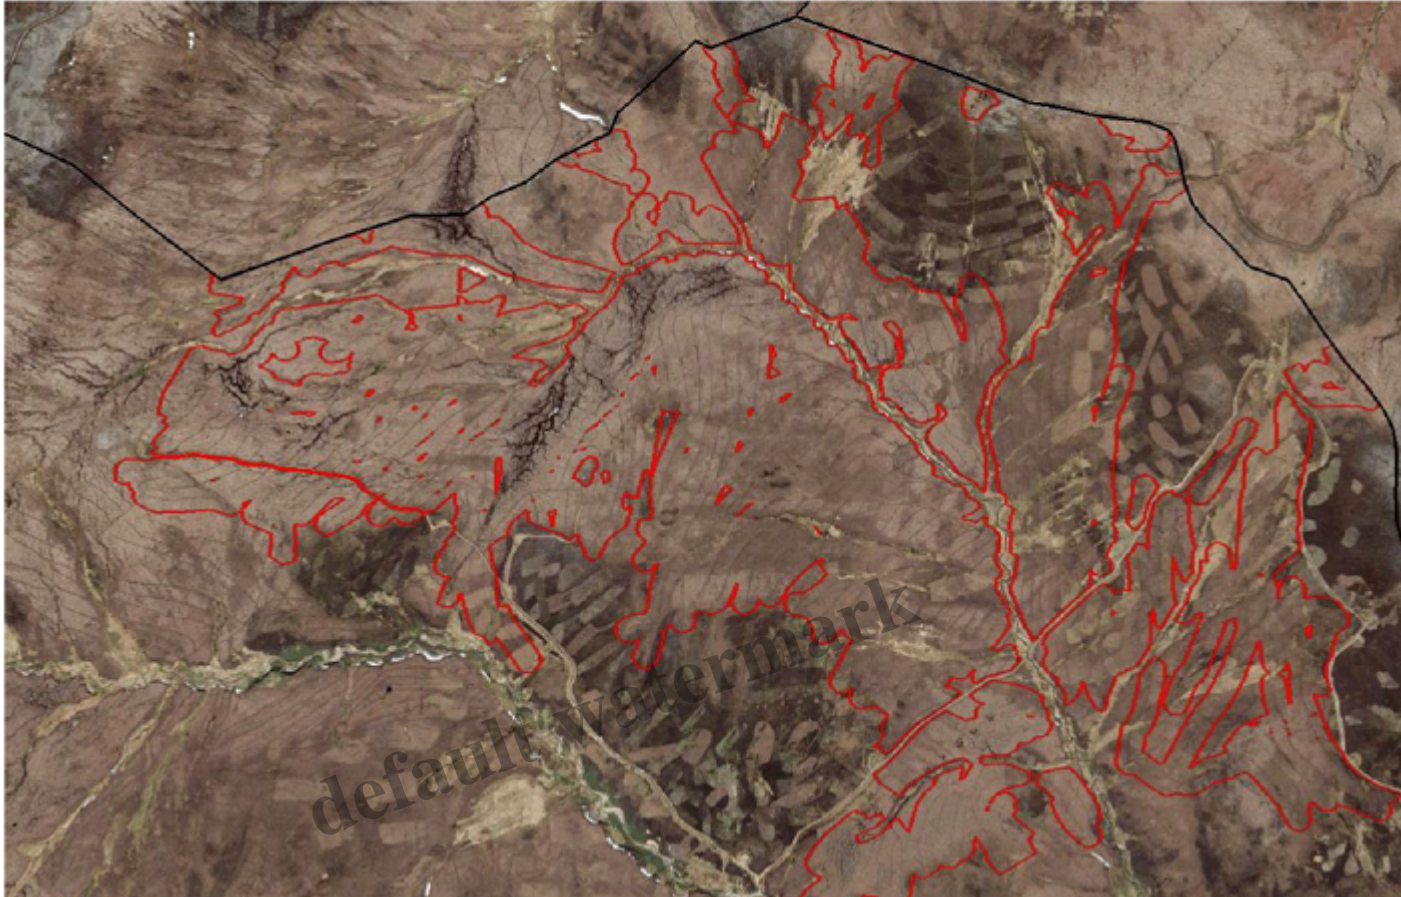
Aerial view of Cohort 2021 (Image copyright of Google Earth ©)

The faint parallel lines show the extent of the moor grips

Clearly in the past a serious attempt was made to drain the bog here. One wonders how much of it was paid for by public money?

Given that the drainage ditches are not obvious on the ground, it is valid to ask how far they are still damaging the peat bog? There was very little sign of exposed peat along the drainage lines and it appears the grips may have filled in with vegetation. I am been informed, however, by Stephen Corcorran – the Cairngorms National Park Authority’s Peatland Officer and a real professional – that people working on peat bog restoration in the Cairngorms have done tests and found that beneath apparently re-vegetated ditches the water may still be flowing. Though concealed, old ditches therefore may still be serving to erode and dry out the bog.

Unfortunately, the Prior Notification does not say whether that is happening in the catching of the Caochan na Gaibhre, the land featured in these photos. The peat bog restoration work seems to have been planned on the basis of what google earth shows, rather than any survey on the ground. If surveys showed the ditches are still draining the bog, work to block them up might be justifiable.

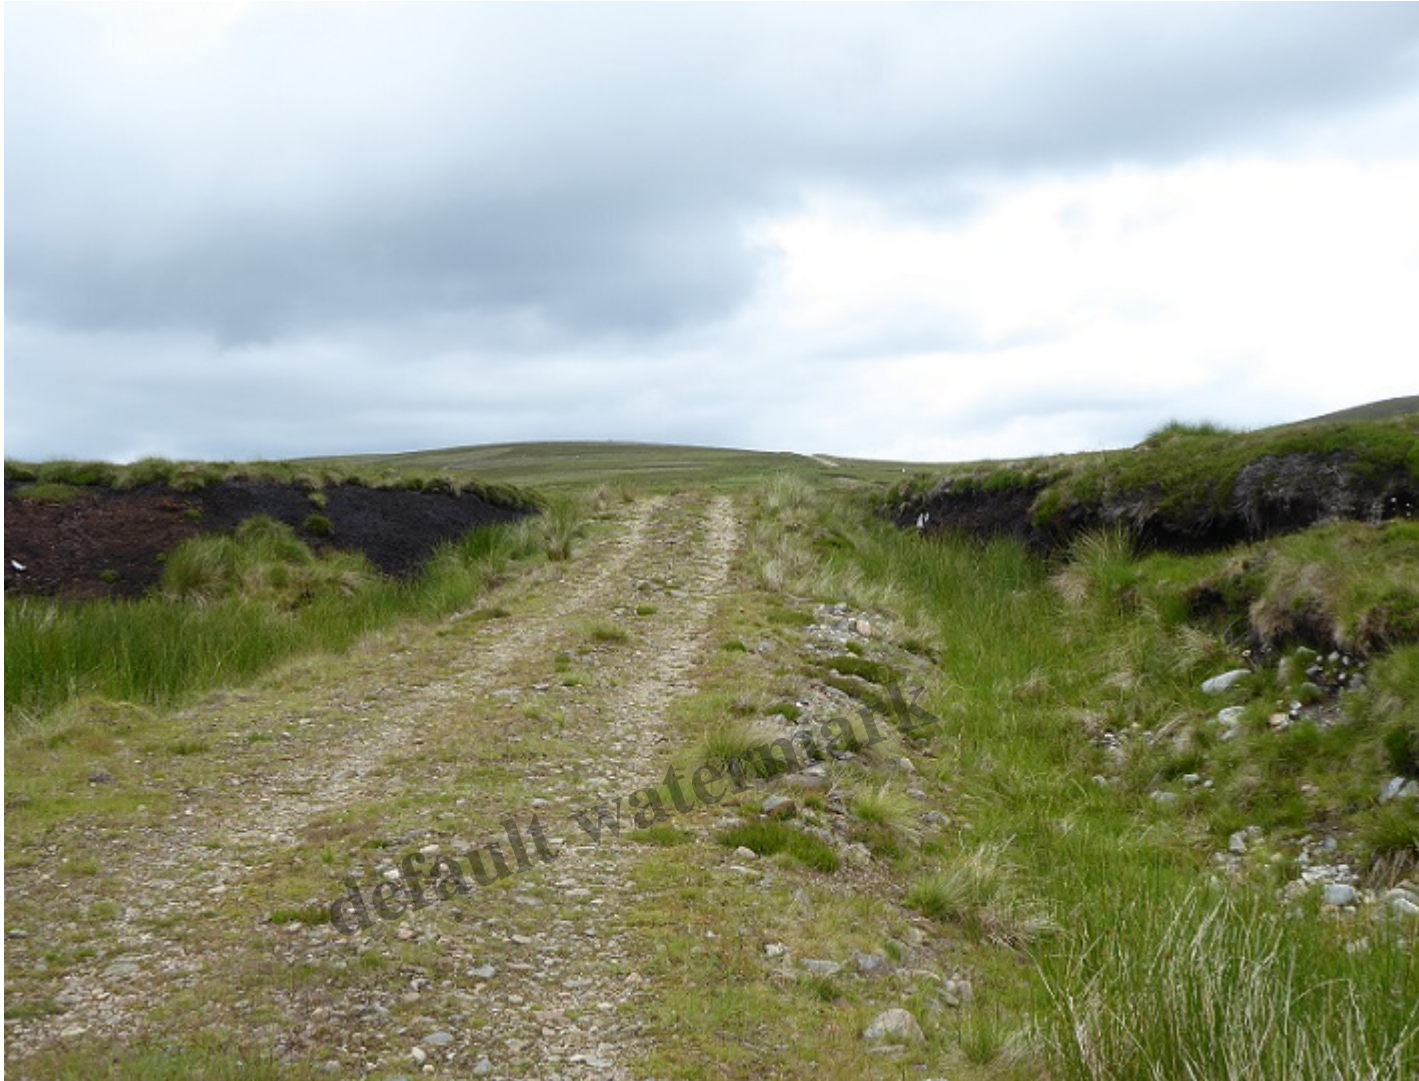
Exposed and eroding areas of peat by the track (location marked by black arrow on map above)

The hill track – used to transport grouse shooters and make intensive management of the moor easier – acts as one enormous drainage line which has been driven through the bog. Etraordinarily, there is no mention of this in the Prior Notification:and no plans to remove it. Why not?

The answer, almost certainly, is that peat bog restoration to date has been driven by the interests of landowners and they have not been prepared to see damaging developments, like hill tracks, removed. If BrewDog is really serious about the need to create carbon sinks on its land at Kinrara, therefore, it should be starting with plans on how to restore the track. Incidentally, one of the reasons Strath Caulaidh may not have included proposals to do this in their plans – despite the change in landowner – is these tracks, which are so damaging to peat and the landscape, make it much easier to drive diggers up the hill!
