Contradictory plans for Kinrara – BrewDog needs to get a grip

Following my two posts on BrewDog’s proposals to create a Lost Forest ([see here](#)) and ([here](#)) at Kinrara, plans for peat bog restoration on the estate appeared on Highland Council’s planning portal ([see here](#)). In April the Scottish Government issued new planning guidance on Permitted Development Rights ([see here](#)) which required peat bog restoration schemes to be notified to the Planning Authority under the Prior Notification Scheme (like Forestry and Agricultural tracks ([see here](#))). While this new requirement appears to have been prompted by a wish to encourage private markets to invest in carbon capture – by assuring investors that they are not investing in a dud – it is welcome as introducing a degree of transparency to peat bog restoration schemes that has not existed up until now.

The Kinrara scheme is one of five notified for the Monadhliath by Strath Caulaidh, an environmental consultancy that undertakes peat bog restoration on behalf of NatureScot. Almost all of the latest proposals are outwith the Cairngorms National Park boundary and the proposed restoration work for Kinrara is on the no

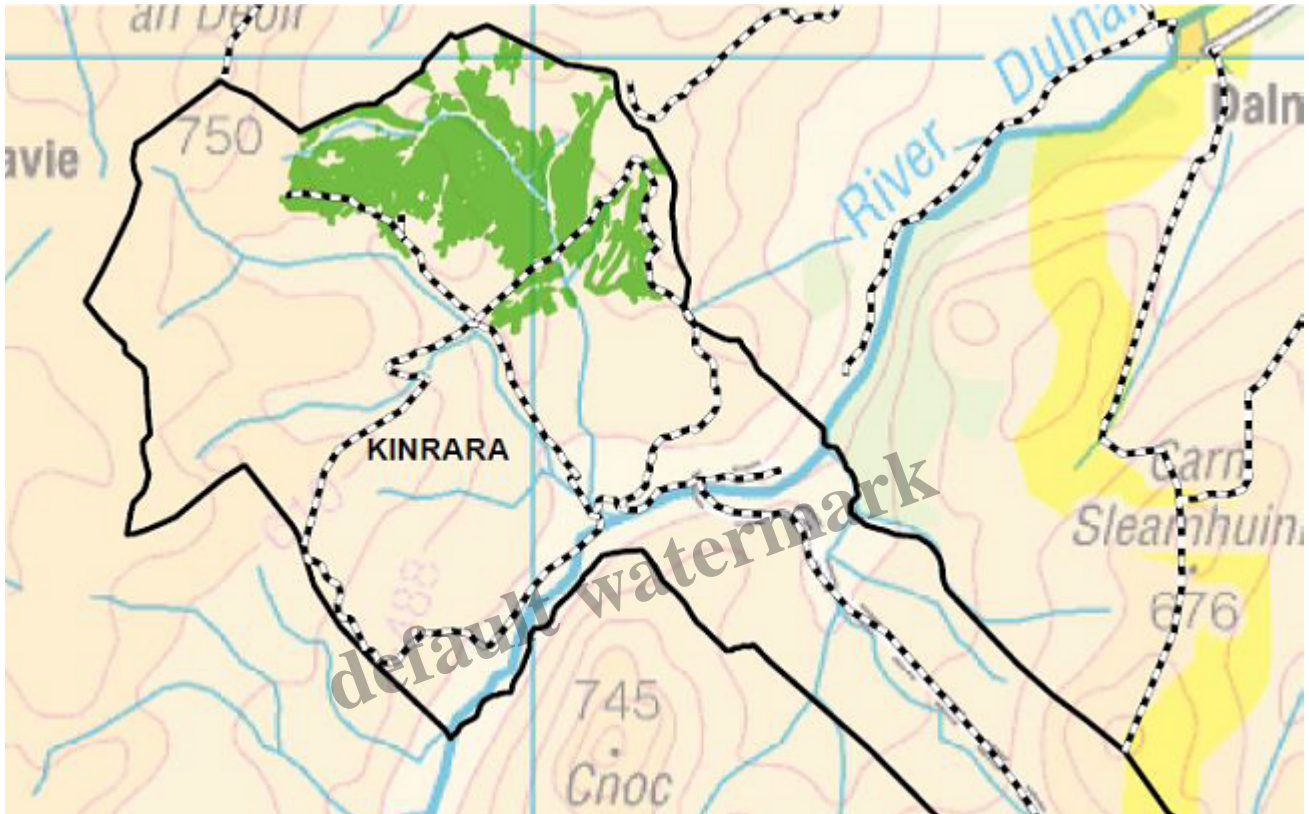
The green shows the proposed “restoration” area, the dotted lines hill tracks and the yellow the Cairngorms National Park boundary

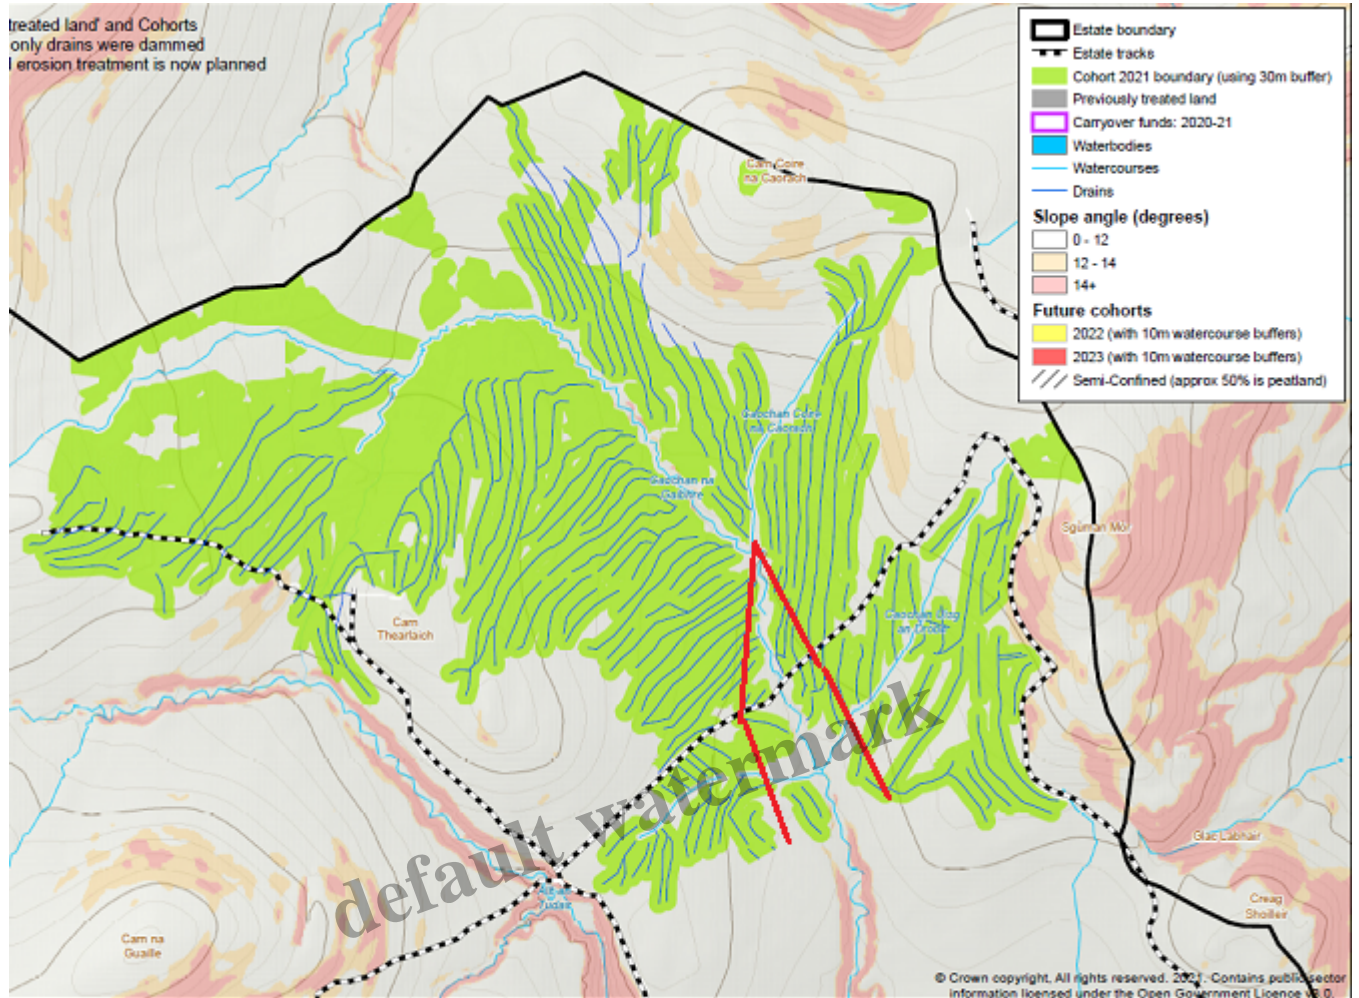
1 Strathalan Bank By Ardargie Finganderry Perth PH2 5PE
14/06/21	FINAL	Planned Restoration Cohorts - KINRARA		
14/06/21		Version: 1	Location: KINRARA	
21/06/21		Scale: 1:12,000

The dark blue lines mark drains/moor grips. The red lines, which I have added, show approximate area of woodland planting on the Lost Forest Plan

The “finger” of woodland restoration alongside the burn, the Caochan na Gaibhre, on either side of the hill track is marked on the Strath Caulaidh map as being an area of proposed peat bog restoration. It should not be both. It could result in NatureScot forking out money to restore peat, while Forestry Scotland fork out other public funds to plant it!

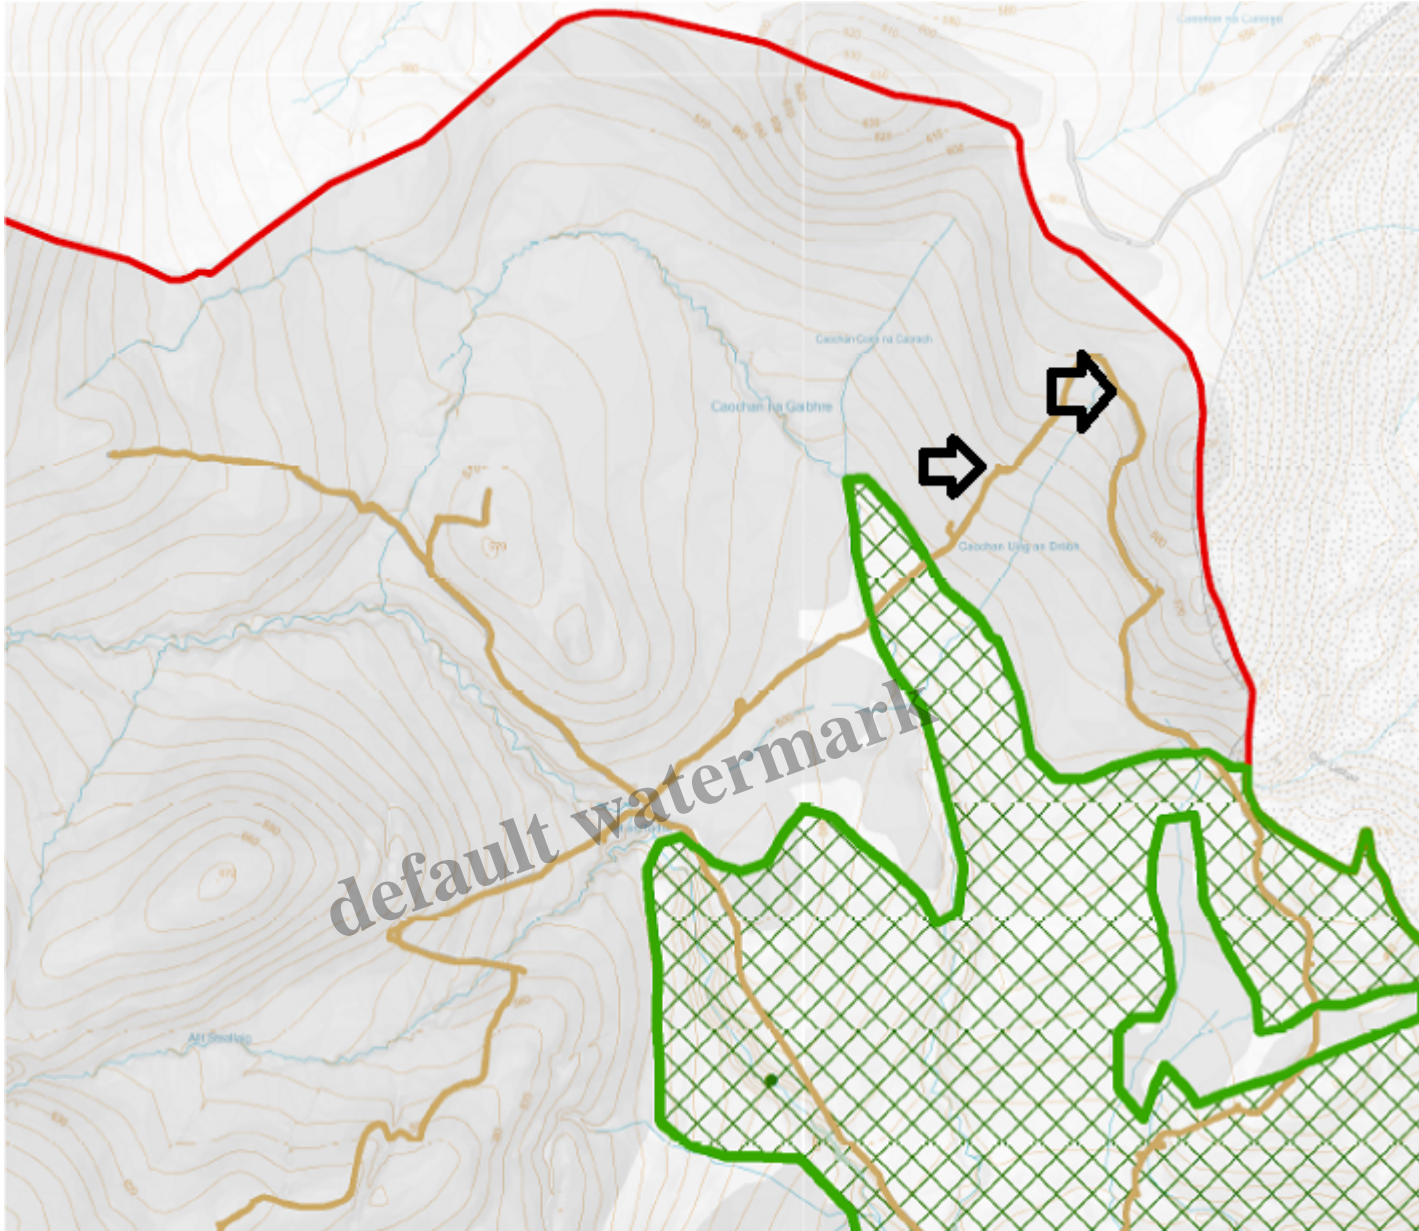
Hatched area marks proposed planting, brown lines the track, and black arrows the photos of the track – annotated extract from plan for Lost Forest North

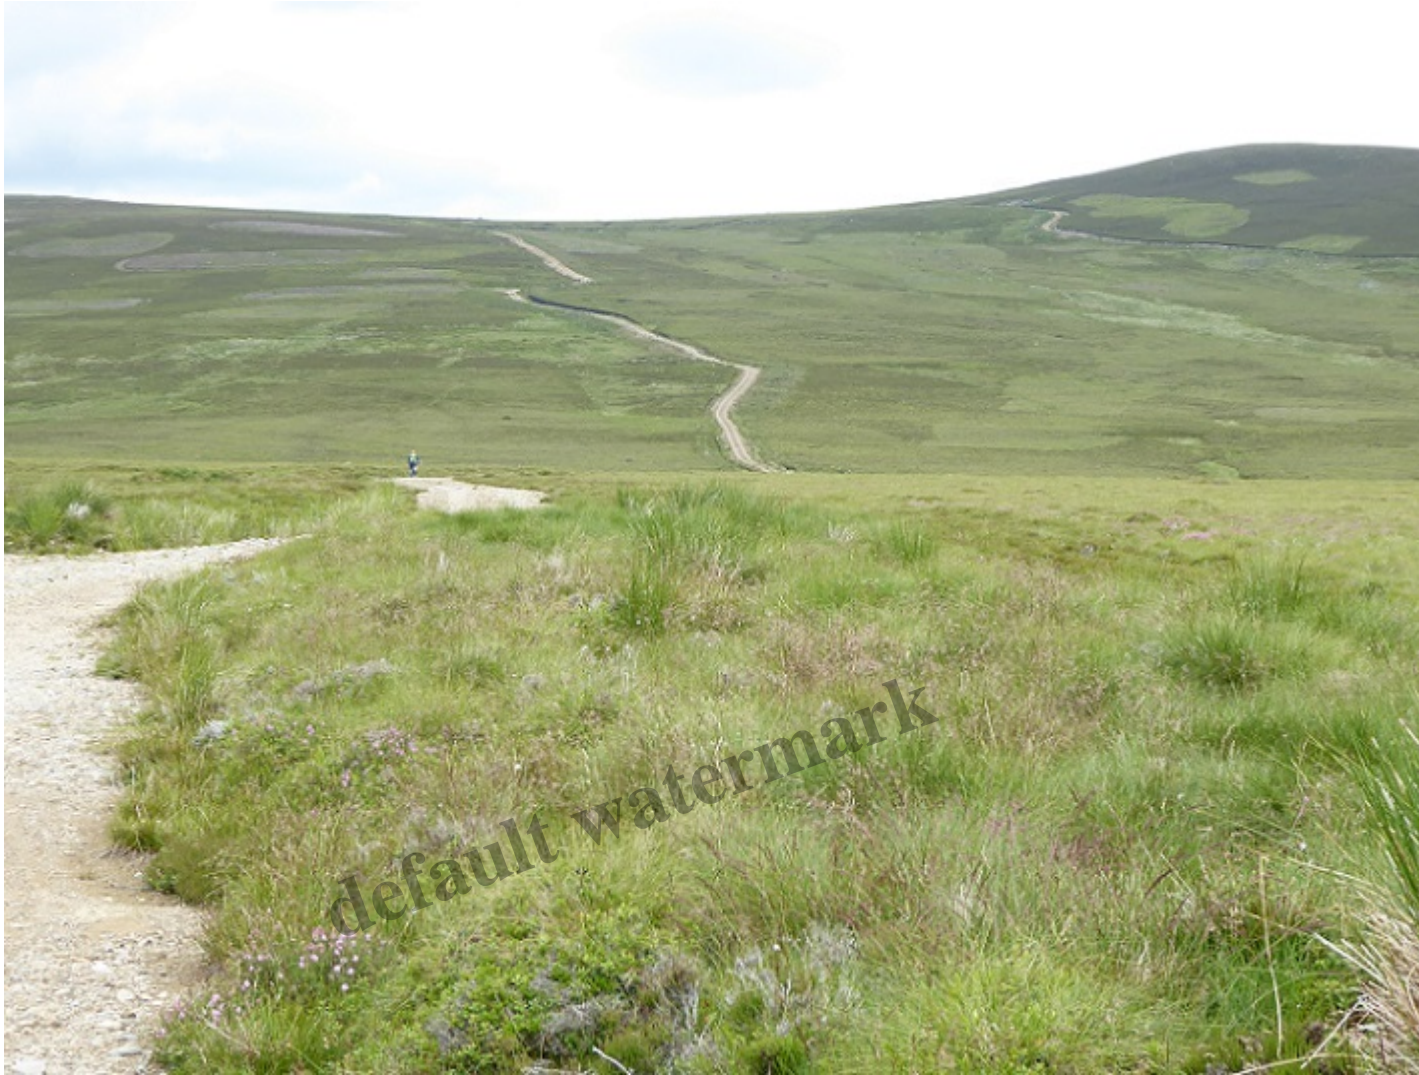
Looking north up the track: the burn, the Caochan na Gaibhre is in dip.

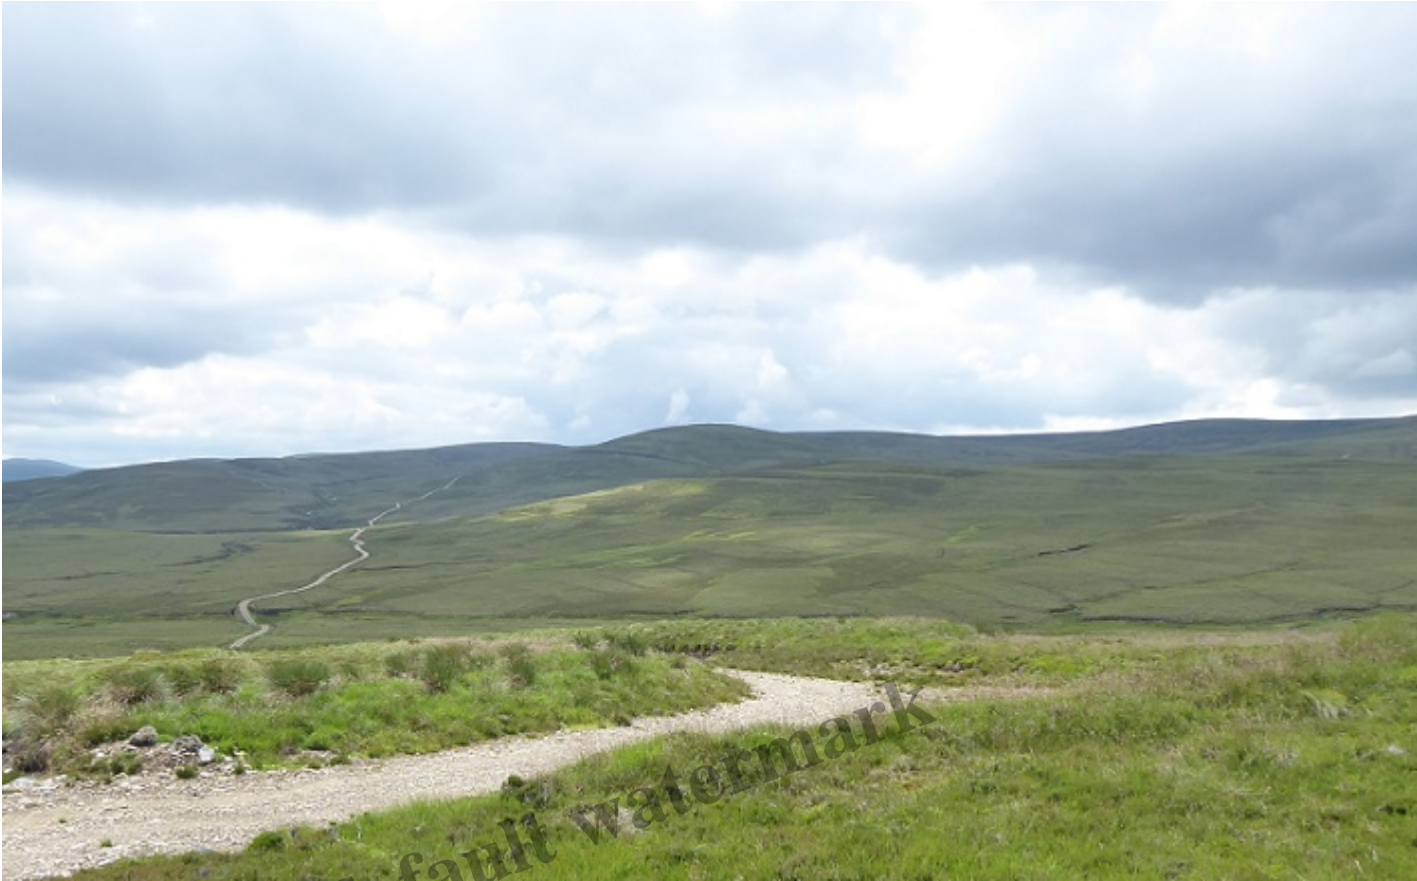
Another type of grip, the moor grips shown on the Strath Caulaidh map, are scarcely visible on the ground. I did not realise there were so many when cycling by in July. The damage down by muirburn is far more obvious the casual observer. The moor grips were, however, were visible from the top of the track looking back:

Moor grips are just visible to the right of the track on the far side of the Caochan na Gaibhre burn. They appear as a series of faint parallel lines

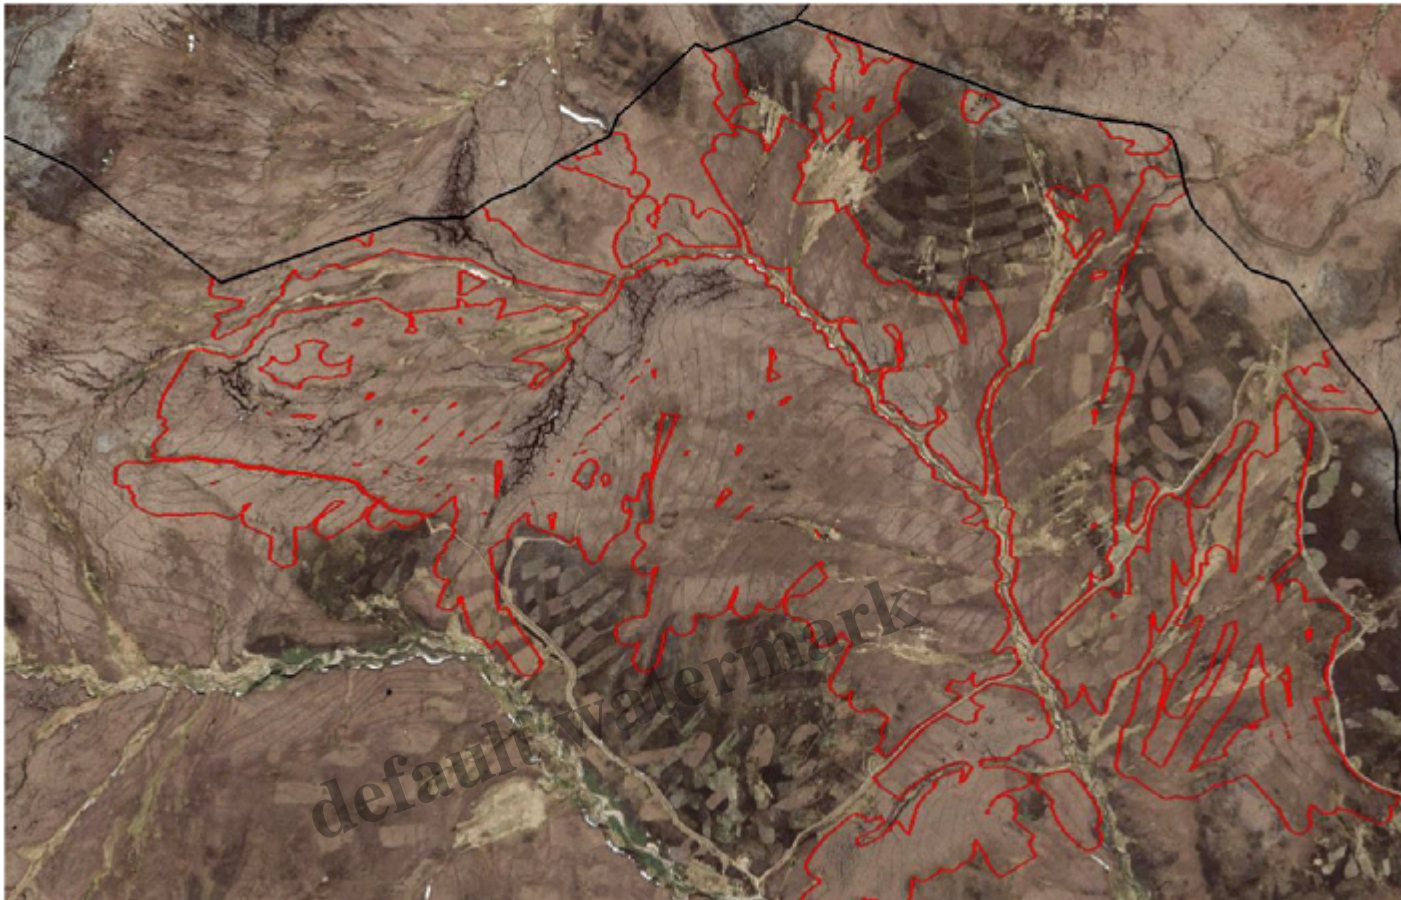
Aerial view of Cohort 2021 (Image copyright of Google Earth ©)

Red outline = cohort boundaries; black line = estate boundaries (note: other estate boundaries and project boundaries may be showing for reference)

The faint parallel lines show the extent of the moor grips

Clearly in the past a serious attempt was made to drain the bog here. One wonders how much of it was paid for by public money?

Given that the drainage ditches are not obvious on the ground, it is valid to ask how far they are still damaging the peat bog? There was very little sign of exposed peat along the drainage lines and it appears the grips may have filled in with vegetation. I am been informed, however, by Stephen Corcorran – the Cairngorms National Park Authority’s Peatland Officer and a real professional – that people working on peat bog restoration in the Cairngorms have done tests and found that beneath apparently re-vegetated ditches the water may still be flowing. Though concealed, old ditches therefore may still be serving to erode and dry out the bog.

Unfortunately, the Prior Notification does not say whether that is happening in the catching of the Caochan na Gaibhre, the land featured in these photos. The peat bog restoration work seems to have been planned on the basis of what google earth shows, rather than any survey on the ground. If surveys showed the ditches are still draining the bog, work to block them up might be justifiable.

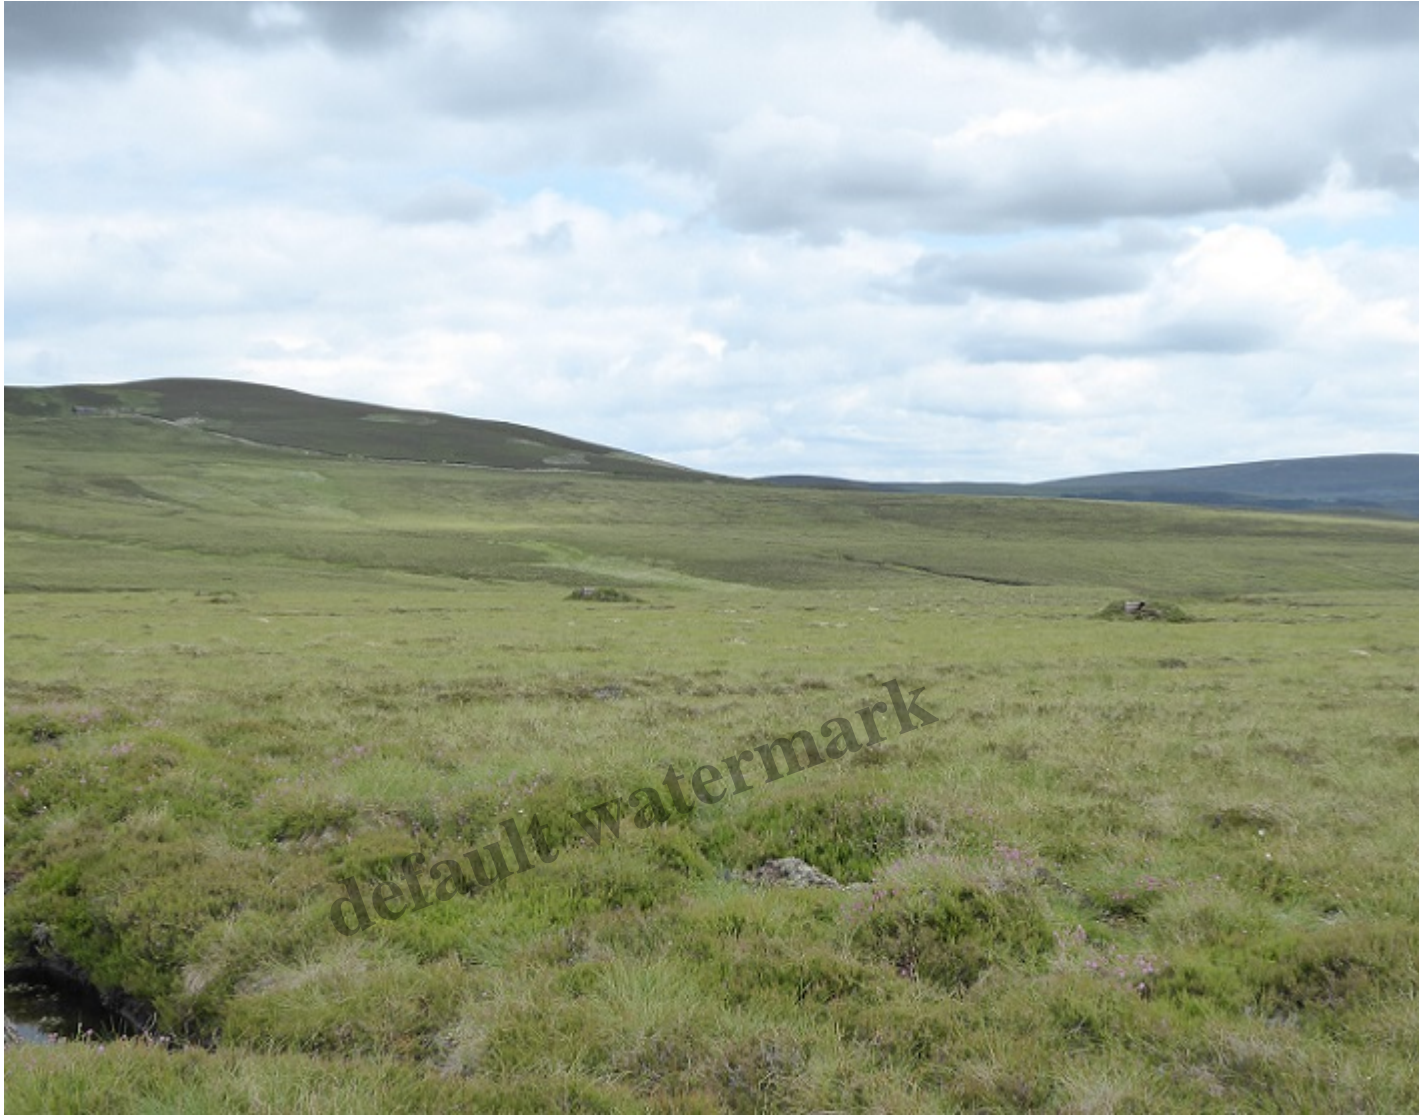
Looking across the bog to the highest part of the track, a shooters hut just visible on the far left. The ditch, bottom left, is drainage for the track

There is certainly some “spare” peat and vegetation, used in the construction of grouse butts, which could be used to fill in ditches, now that driven grouse shooting has stopped on the estate. There is no mention, however, in the plans of whether it’s intended to restore the butts or whether driving a digger over the bog to remove them or to fill in the ditches might cause more damage than it prevents. These are difficult questions but ones which need to be answered if we are to ensure peat bog restoration schemes are worth it.

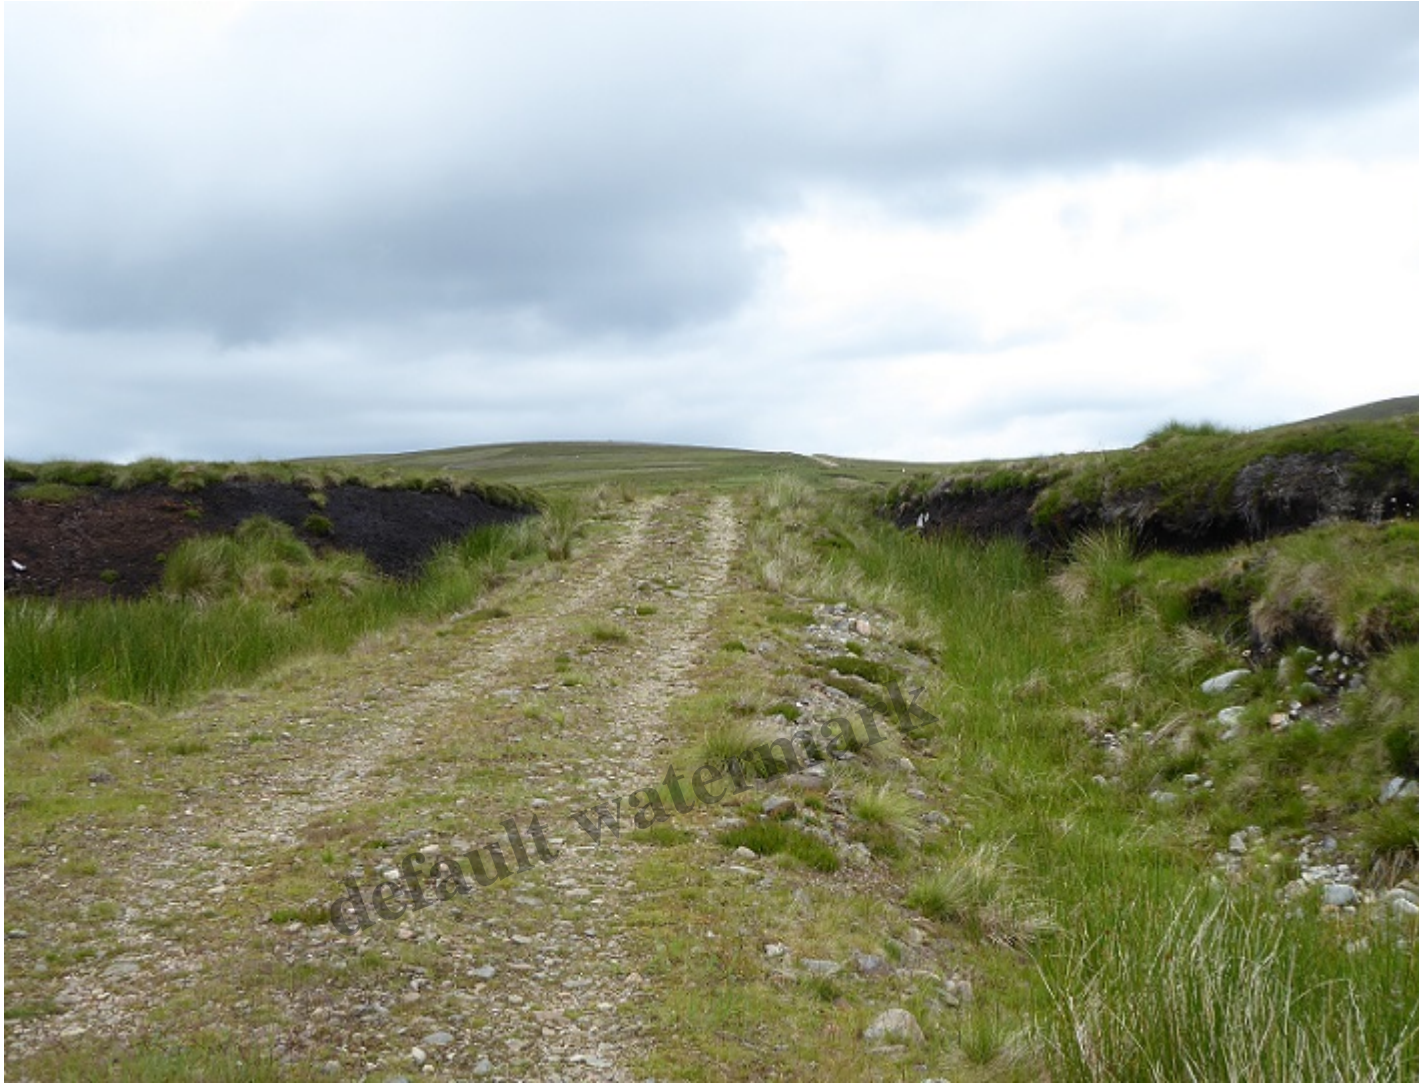
Exposed and eroding areas of peat by the track (location marked by black arrow on map above)

The hill track – used to transport grouse shooters and make intensive management of the moor easier – acts as one enormous drainage line which has been driven through the bog. Etraordinarily, there is no mention of this in the Prior Notification:and no plans to remove it. Why not?

The answer, almost certainly, is that peat bog restoration to date has been driven by the interests of landowners and they have not been prepared to see damaging developments, like hill tracks, removed. If BrewDog is really serious about the need to create carbon sinks on its land at Kinrara, therefore, it should be starting with plans on how to restore the track. Incidentally, one of the reasons Strath Caulaidh may not have included proposals to do this in their plans – despite the change in landowner – is these tracks, which are so damaging to peat and the landscape, make it much easier to drive diggers up the hill!

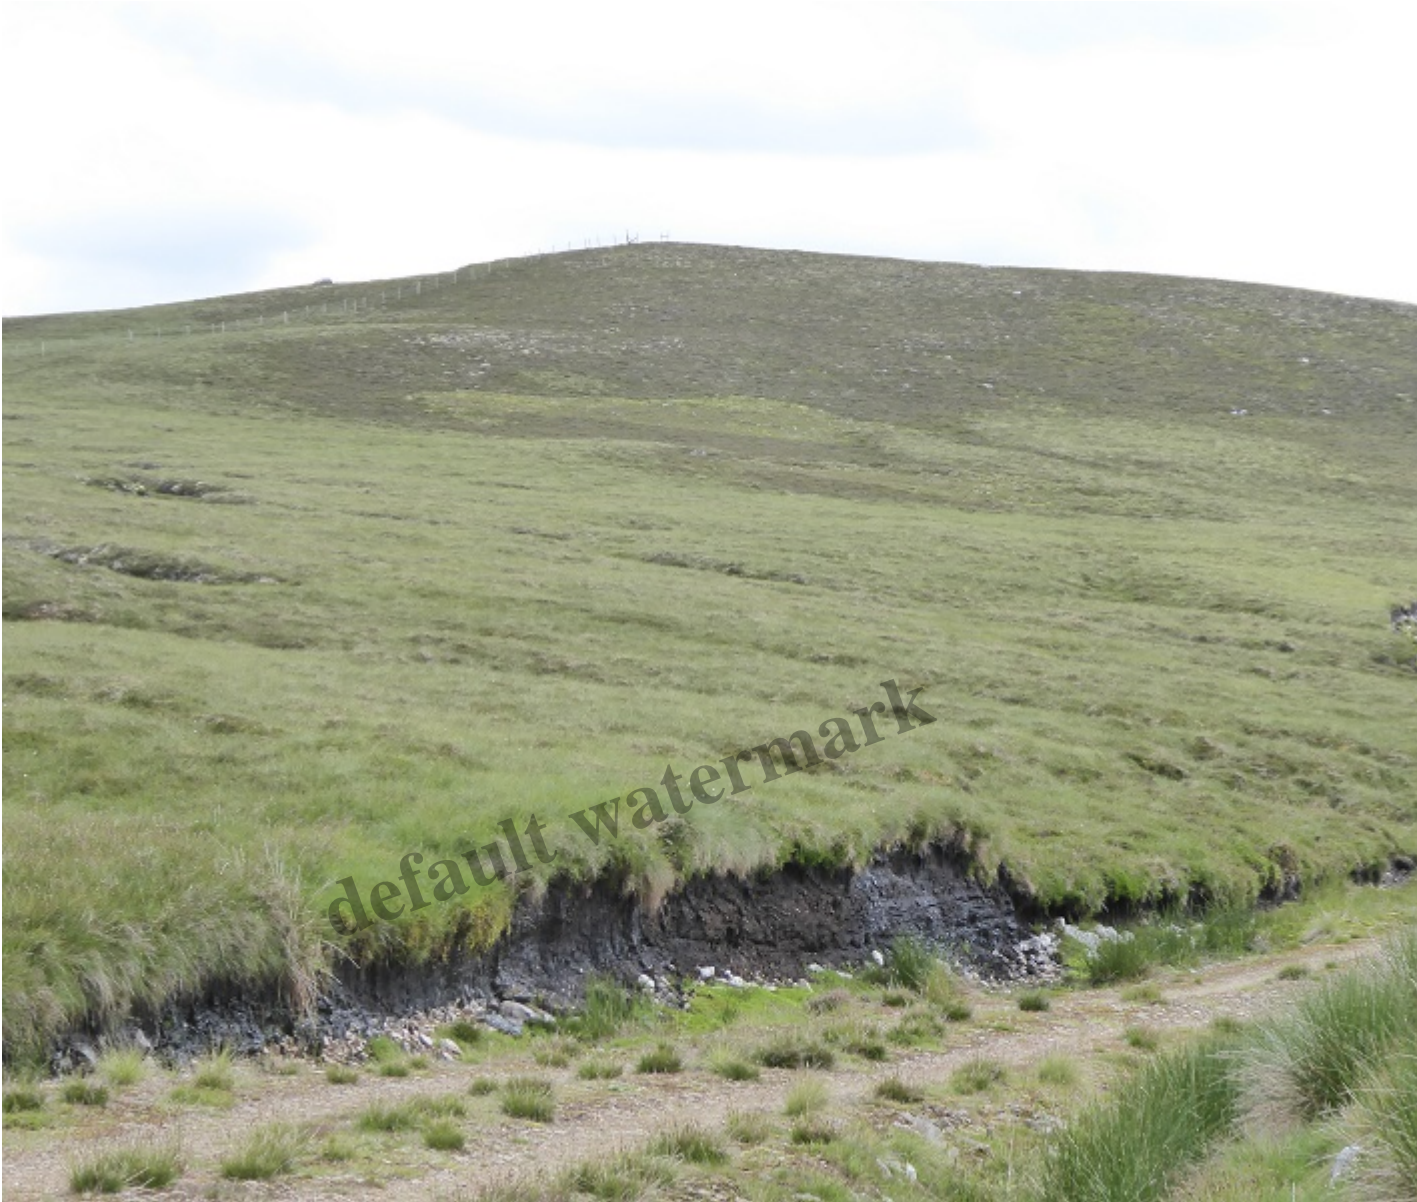
Exposed section of peat along the top section of track, showing how it is drying out, with the lines of visible behind.

Strangely, an area of obviously damaged bog is not included in the restoration plans. Perhaps that is because it is hard to see on google maps?

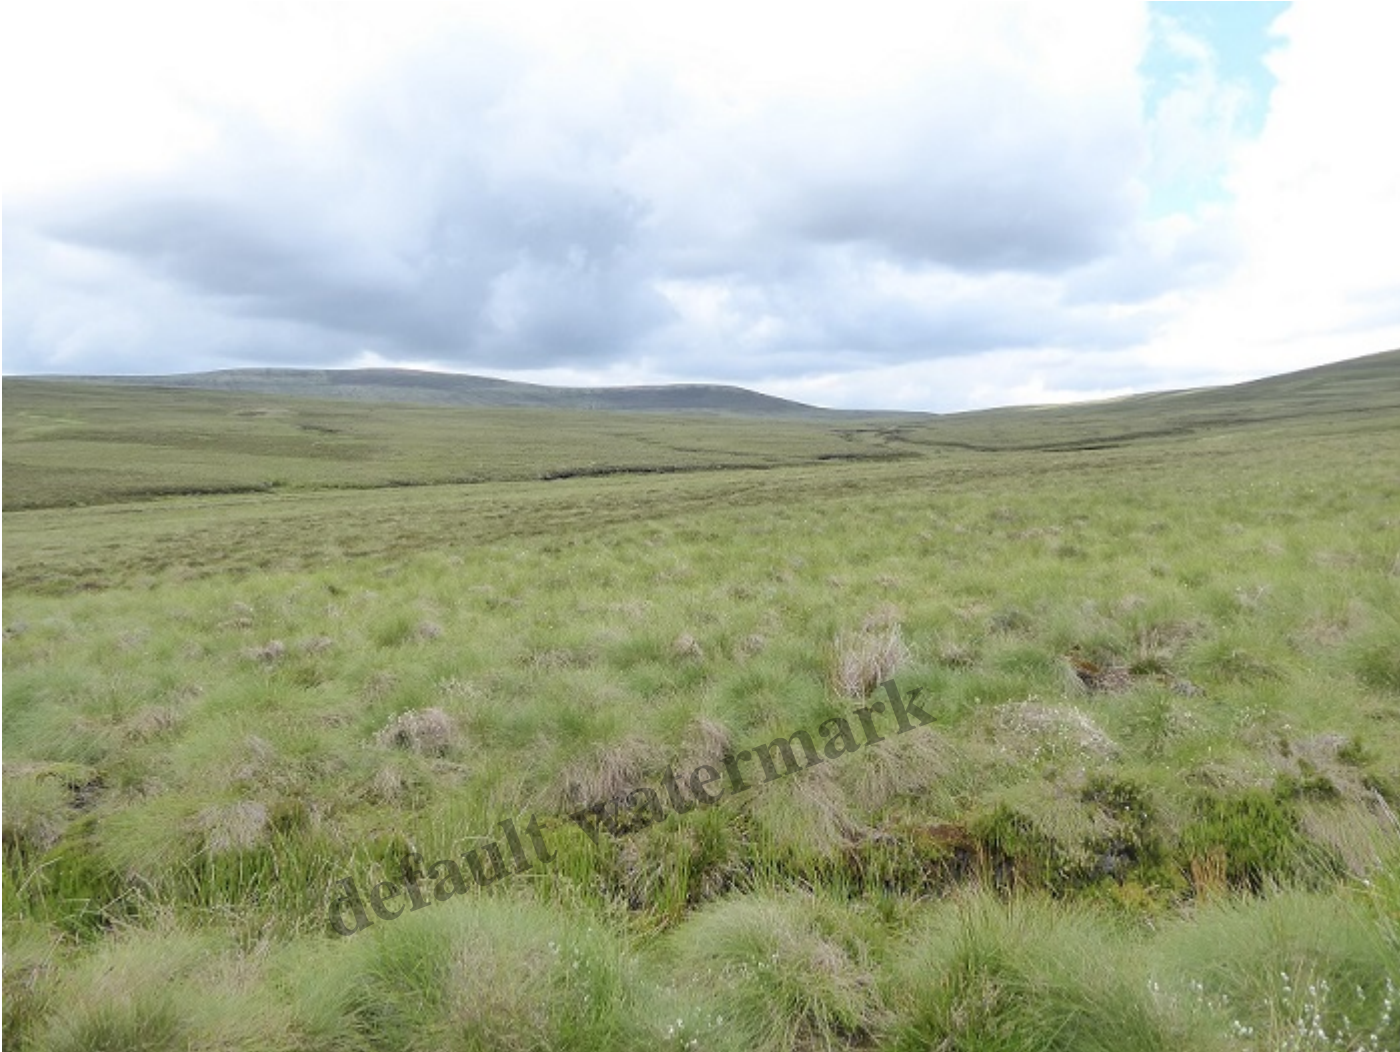
View west along the Caochan na Gaibhre from the track above. Natural drainage lines do erode/prevent peat from forming, marked here by the line of exposed peat alongside the burn. Very few other areas of peat are visible and the moor grips have blended into the landscape.

To the lay person, this is not a peat bog where restoration work is obviously required – apart from the track. In view of this, Highland Council should be asking Strath Caulaidh and BrewDog to demonstrate that the proposals will have a net carbon benefit..
