## On landslides and their impact – lessons from Loch Quoich for the A83 and SSE’s green credentials

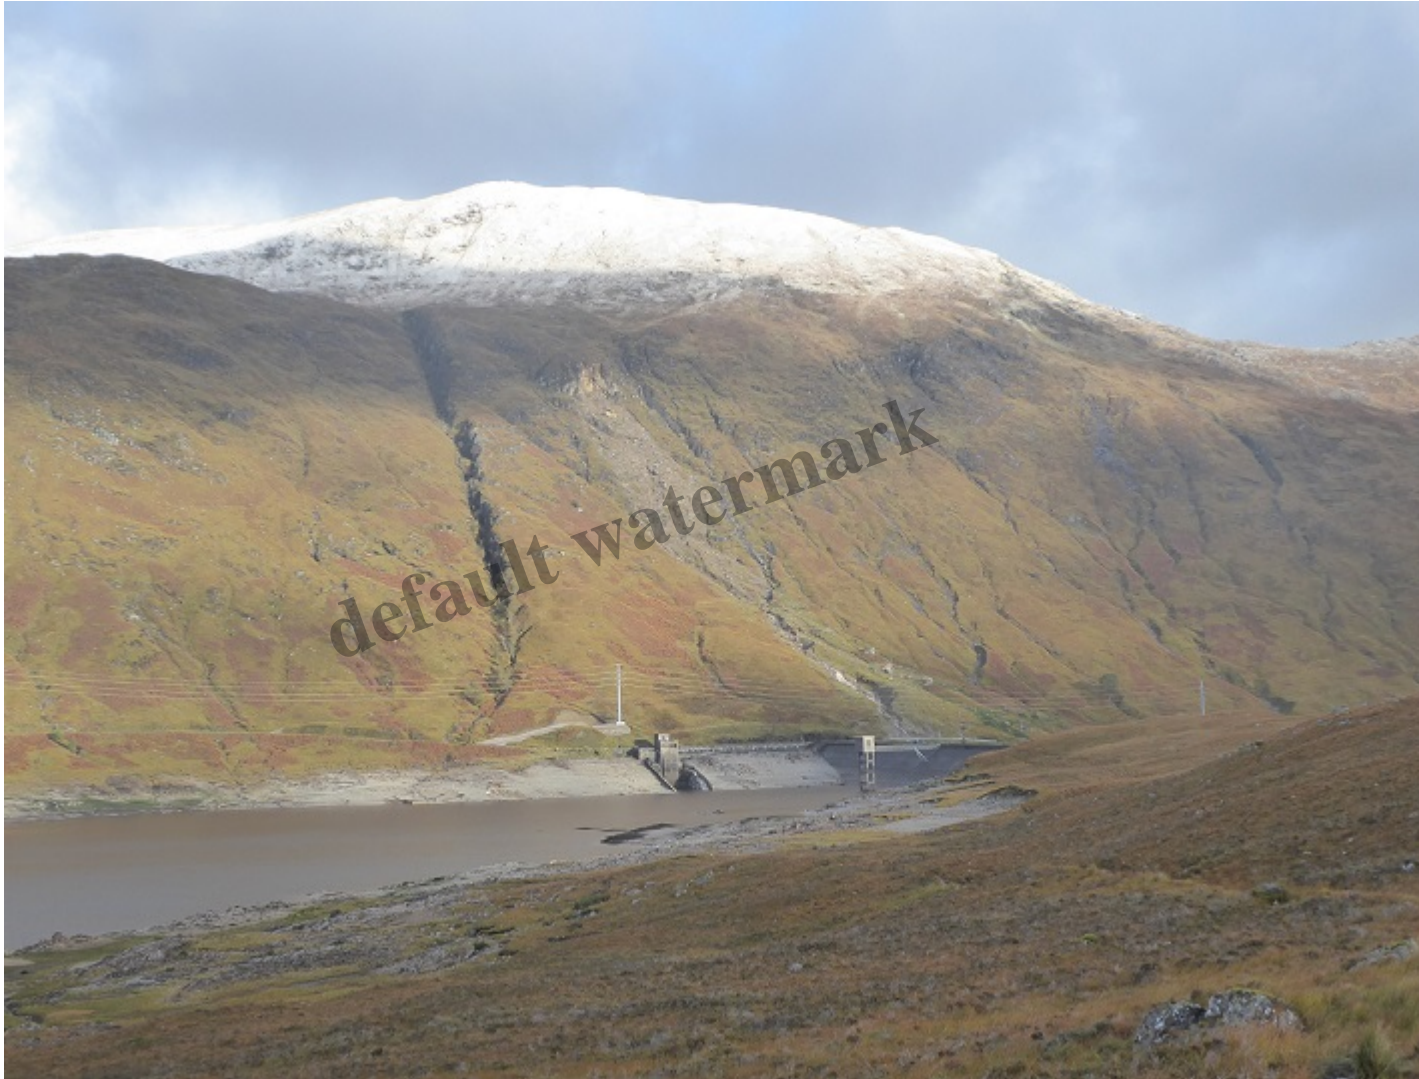
Spidean Mialach from the south with landslide above head of Loch Quoich dam. October 2021

On 10th November 2018 a large landslide took place above the eastern end of Loch Quoich. It was triggered by the collapse of a crag halfway up the steep hillside, demolished an electricity pylon and resulted in the road to Kinloch Hourn being closed for 6 months while the slope was stabilised at an estimated cost of £1m.

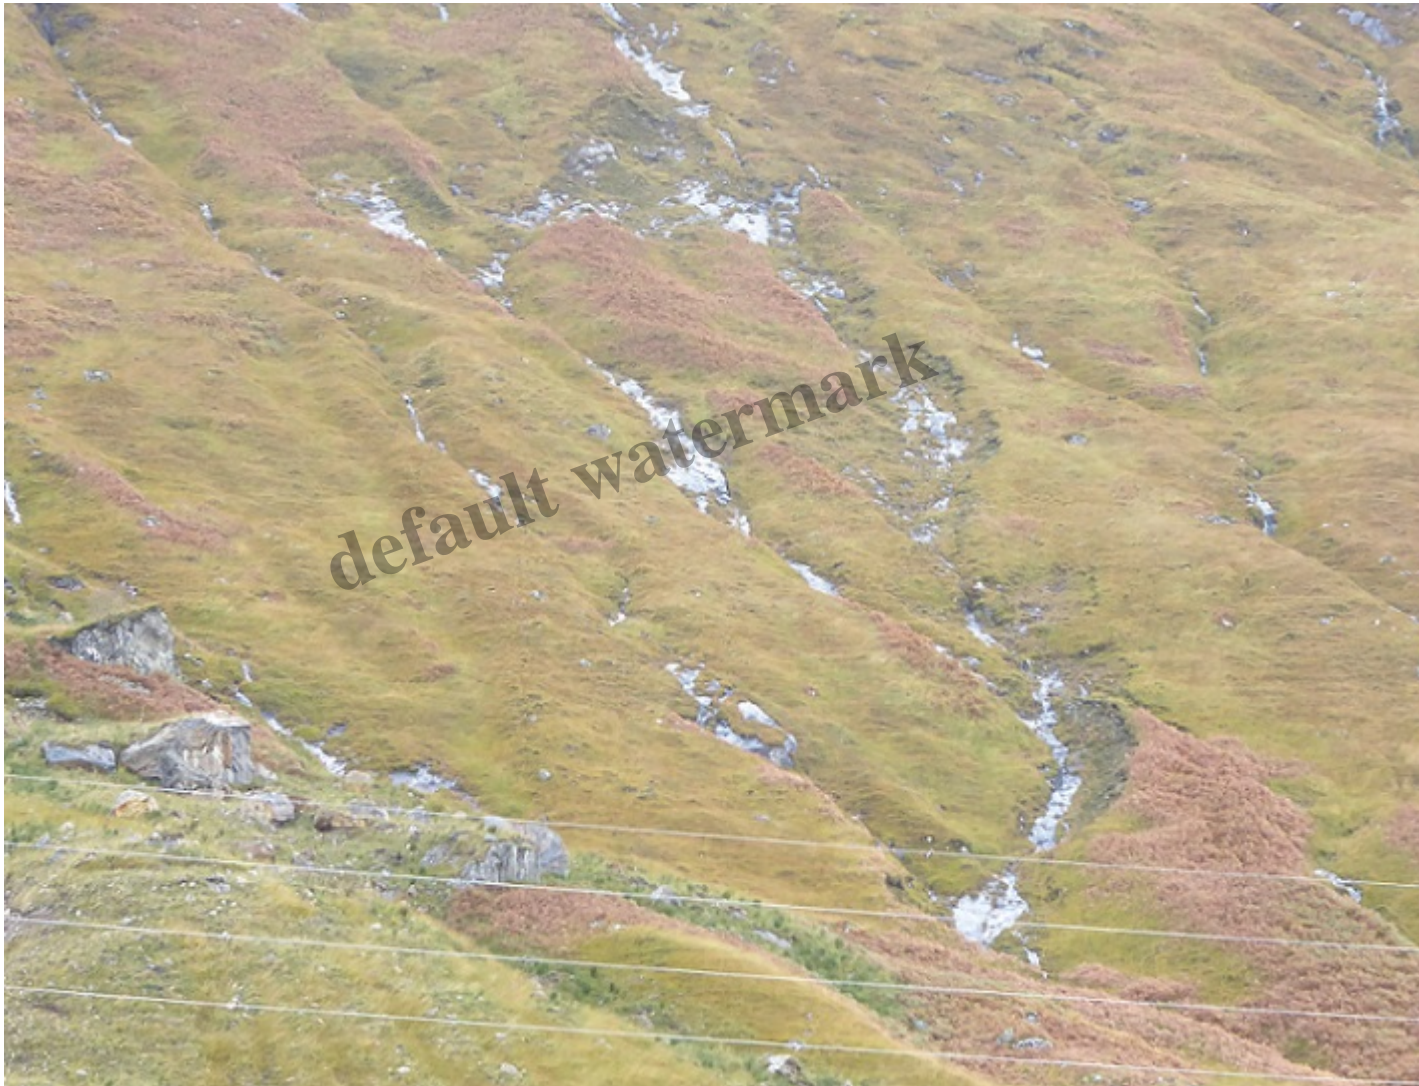
Slope just to the right of the landslide with boulder debris from the recent (and past) rockfall bottom left

The state of the ground to the right of the landslide at Loch Quoich, a skin of glacial debris and earth

lying on top of glacial slabs without a tree or shrub in sight, suggests that this whole slope was/is waiting to go. You can see how water has scoured away the slopes to leave areas of bare rock. Whatever the stability of the crag which partially collapsed, it's not difficult to see how major rainfall might trigger further landslides here. And the western end of Loch Quoich is one of the wettest places in Scotland.....

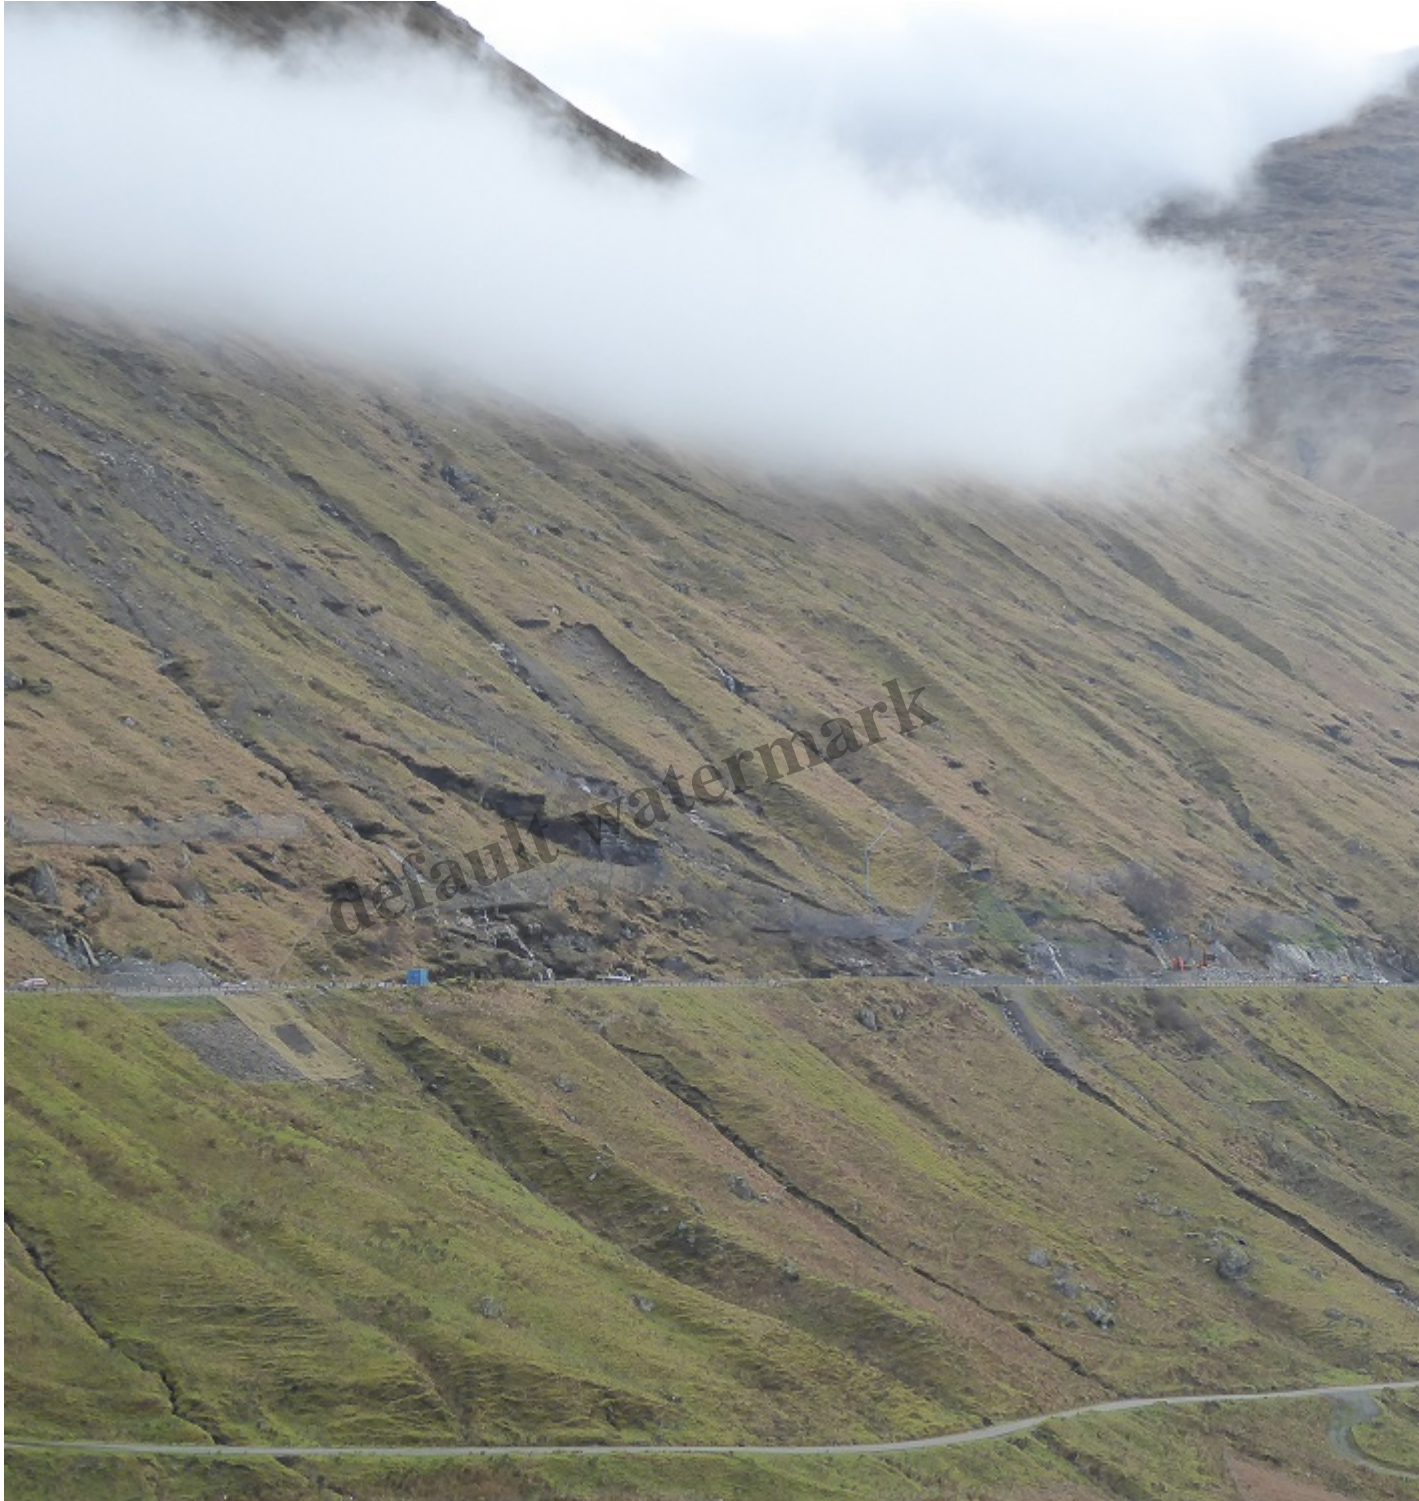
The skin of glacial debris and soils at the Rest and Be Thankful appears to be thicker than at Loch Quoich.Â Â Potentially that might have made it easier for trees to establish themselves on this slope and help stabilise it.

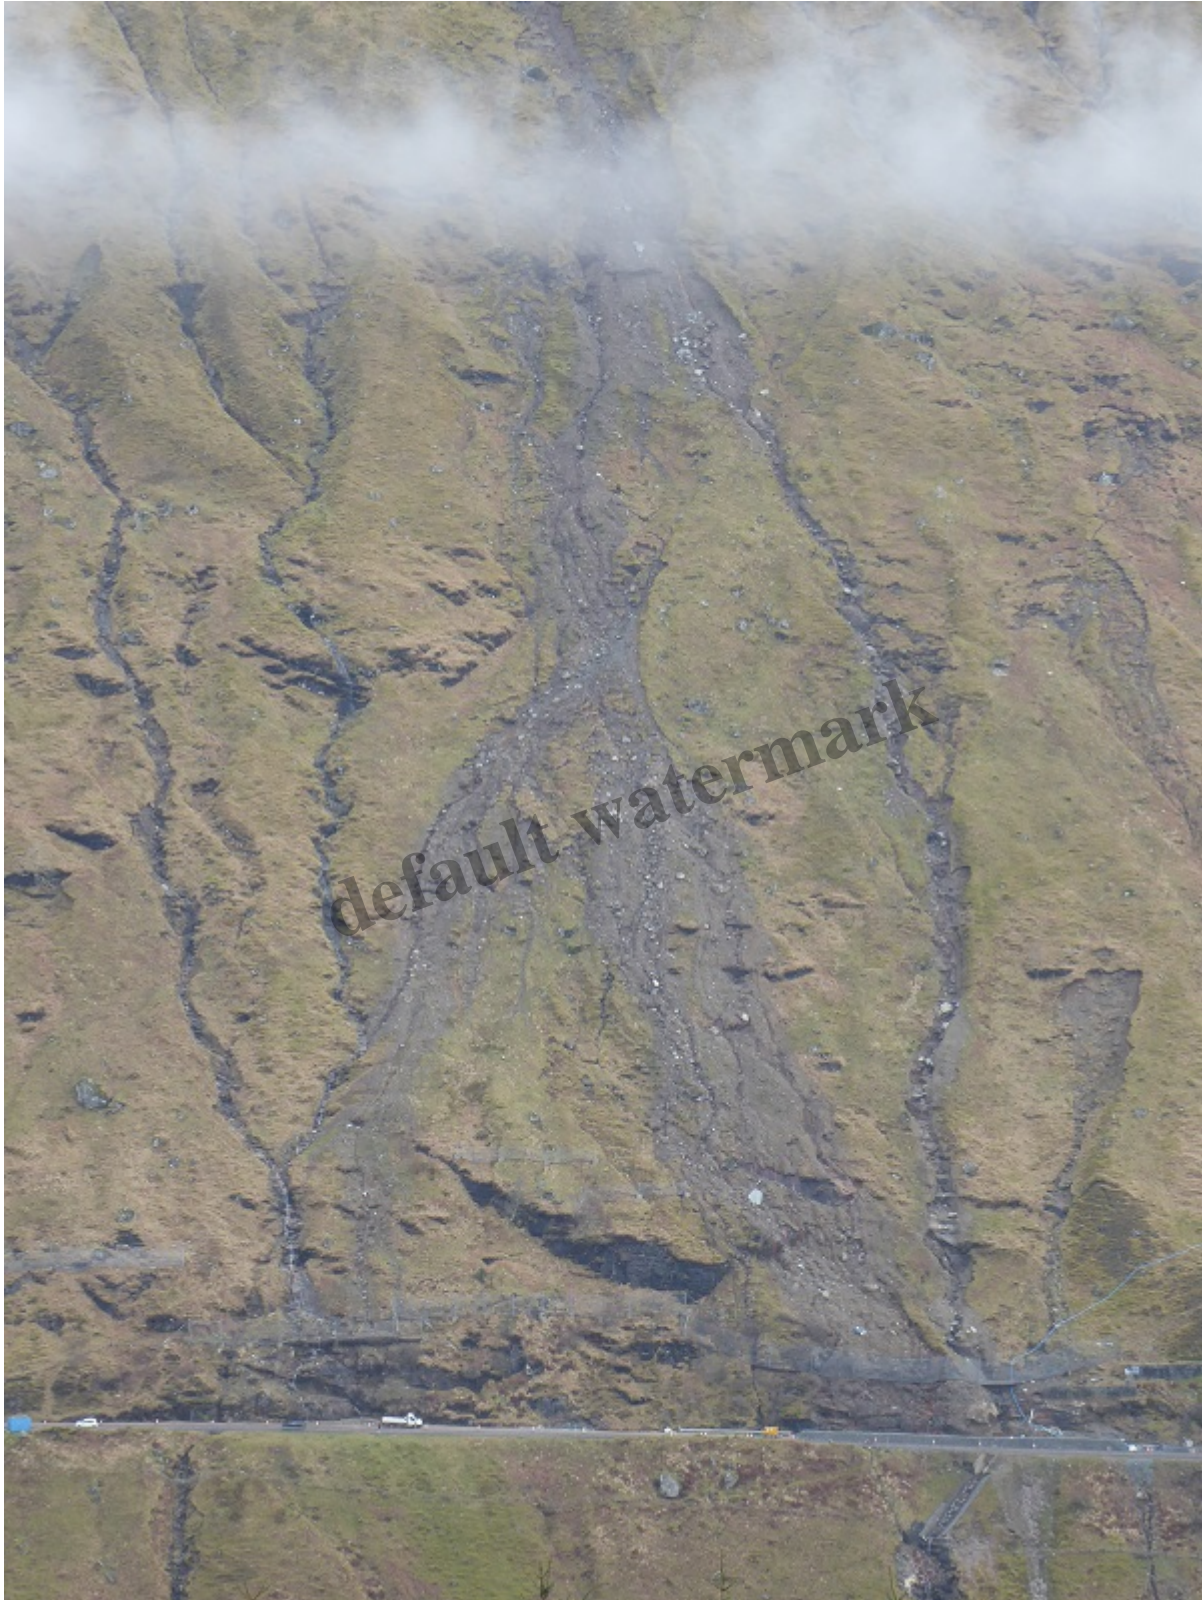
The greater depth of debris and soil at the Rest and Be Thankful has meant that once the slope reached tipping point, it has become even more difficult to stabilise through engineering works. Loch Quoich shows that the problems at the Rest and Be Thankful are far from unique.

Centre part of slope in 2019. Photo credit Louise Brimelow

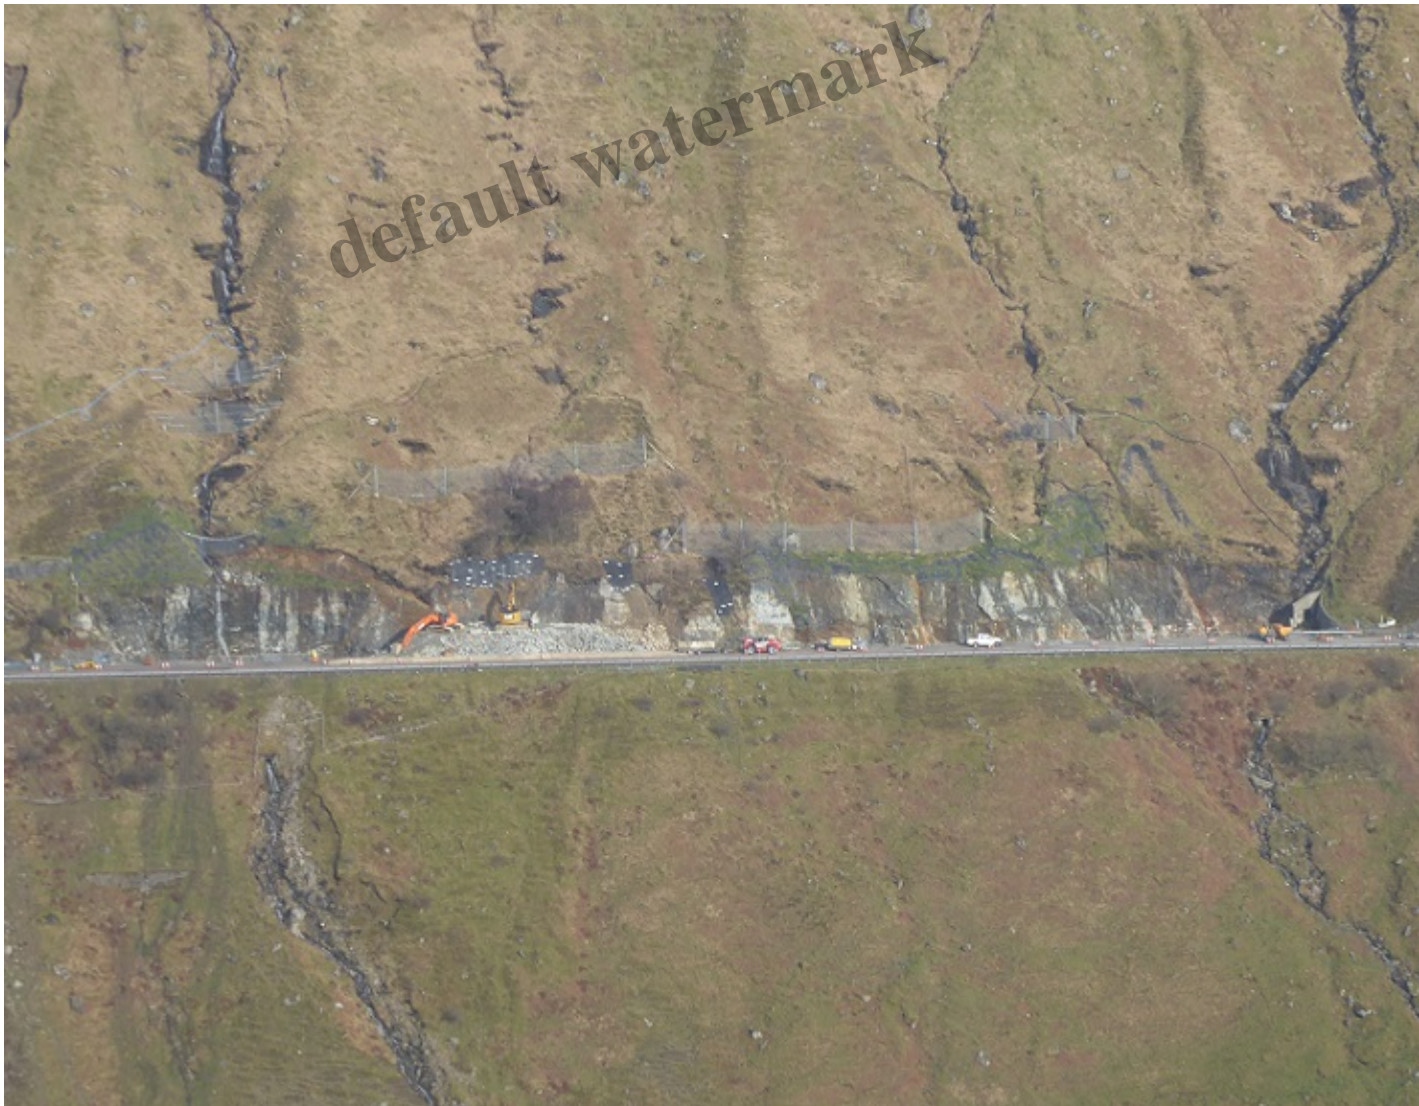
Catch “fences” and catch pits under construction 2019. Photo credit Louise Brimelow

Rather than address the issues created by the construction of A83 across a steep slope that was always high risk and has been allowed to become even more unstable through decades of land mis-management, the Scottish Government’s answer has been to put up fences and dig holes above the road in the hope of catching debris. It hasn’t worked but despite that in September the Scottish Government committed another £3.5m to constructing yet more catchpits. That the Rest and Be Thankful Campaign were right to be criticise the decision ([see here](#)) is demonstrated by what happened at Loch Quoich.

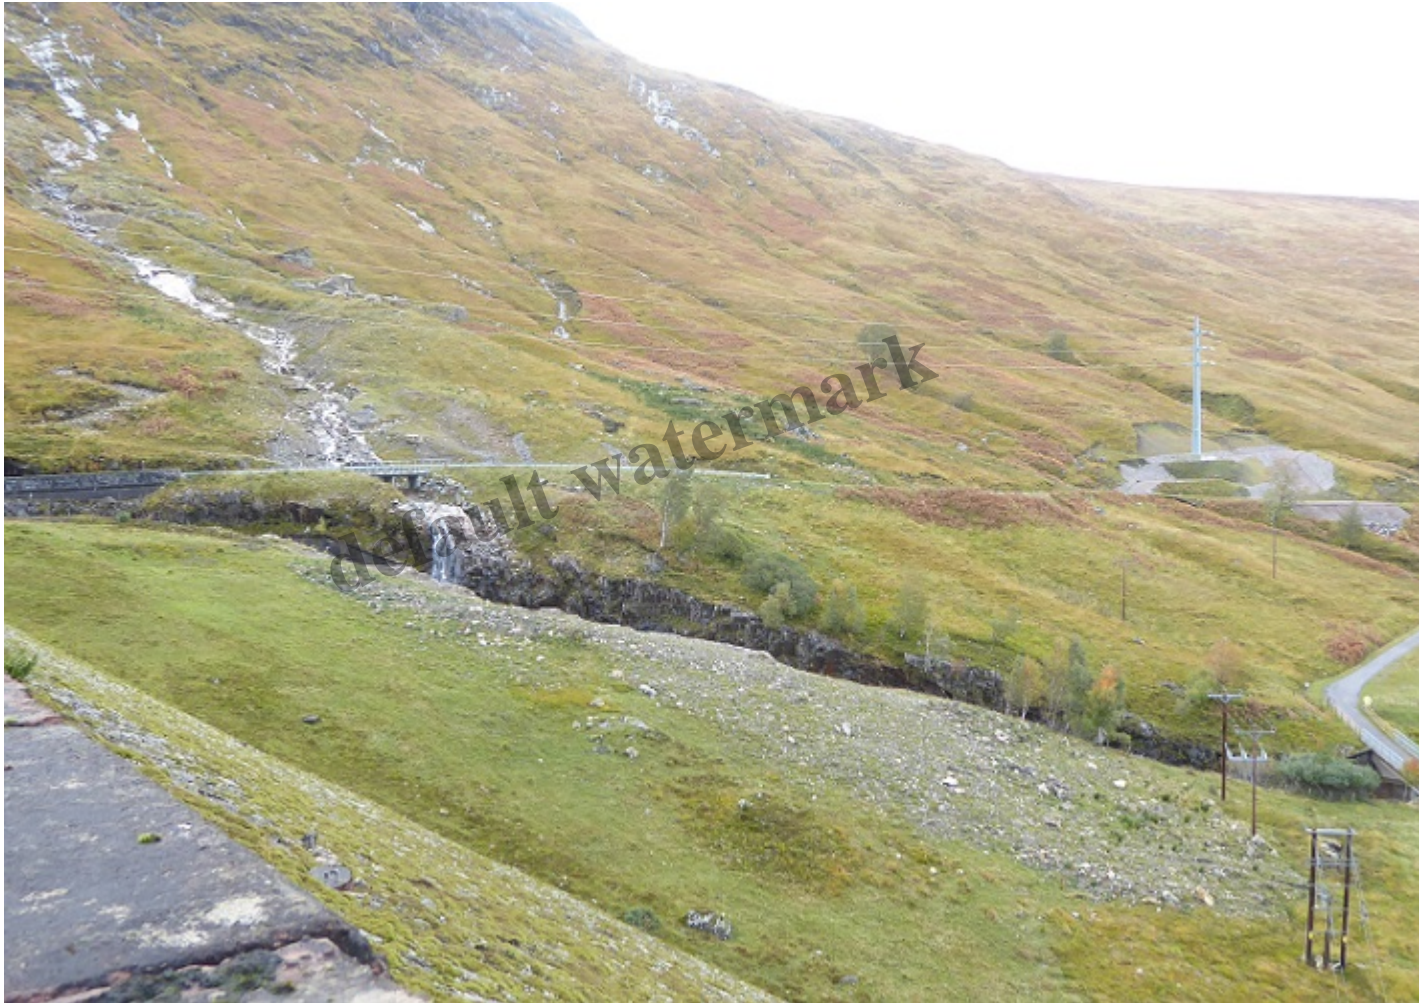
Landslide debris below the Loch Quoich spillway viewed from the dam and easternmost of the 3 new pylons . Note the landscape impact and damage caused by the construction.

A significant part of the landslide jumped the spillway – have you ever seen a larger catchpit?.

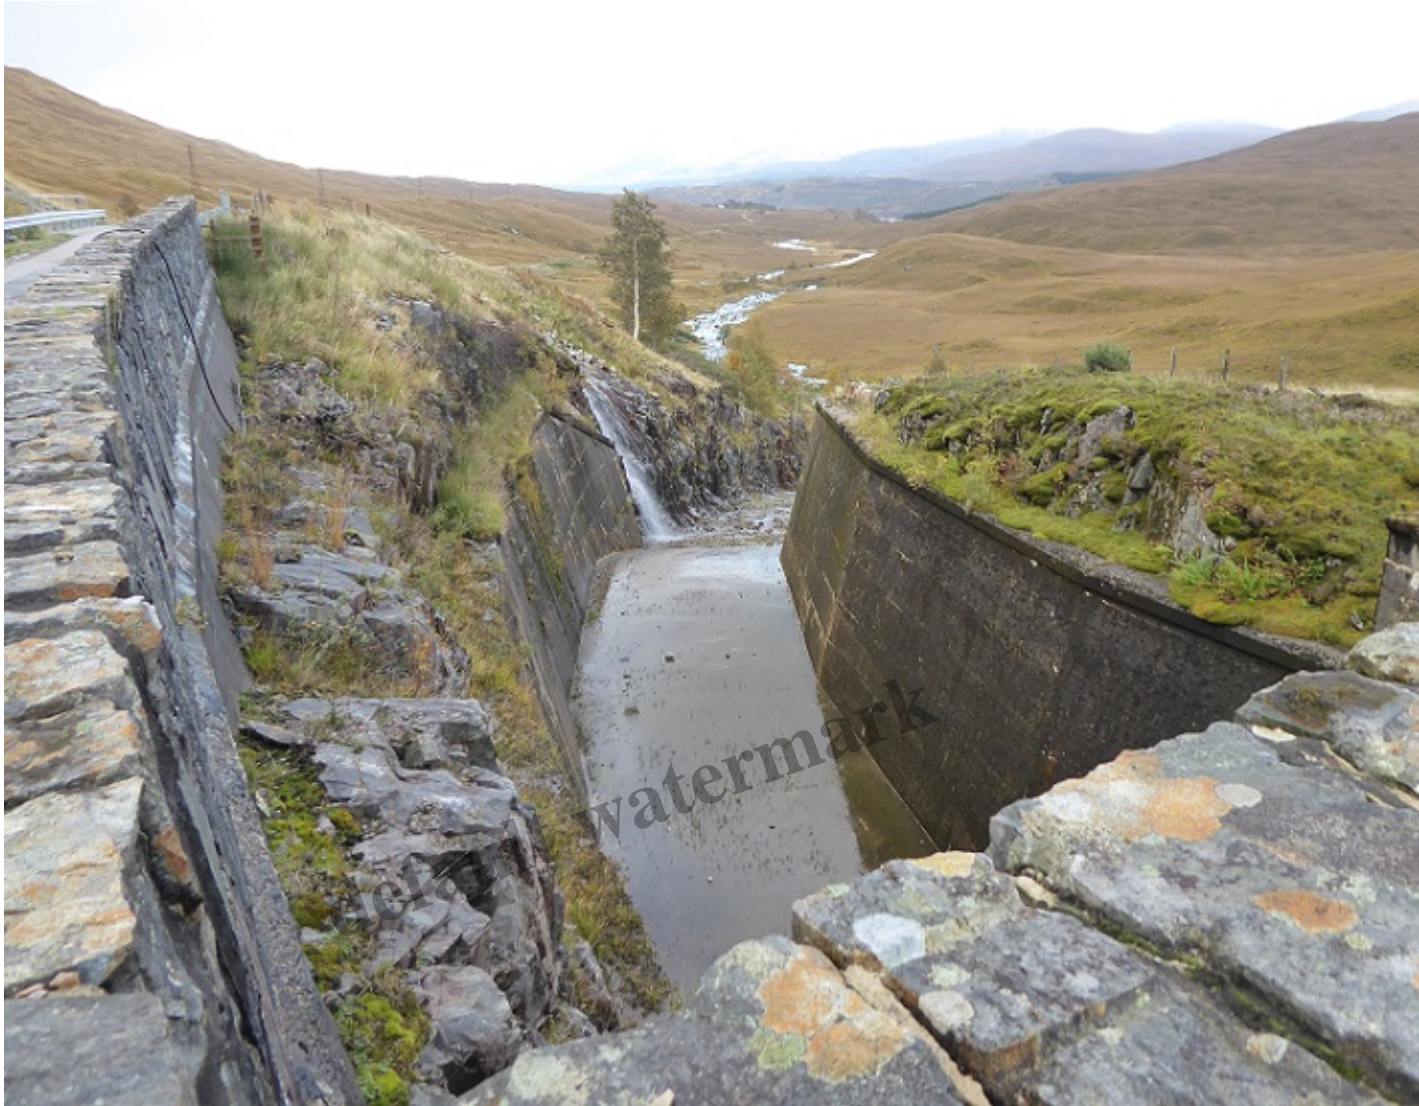
The landslide jumped the spillway by the waterfall. The rocks are a geological Site of Special Scientific Interest designated because of an igneous intrusion which shows the surrounding Moine rocks must be at least 870m years old.

An impressive leap! I haven't been able to find out how much material dropped into the spillway but apparently the hydro electricity operation at the dam was closed until it was cleared – so some did. Clearly, to cross this gap the landslide must have been moving at a significant velocity and the change in angle when it hit the road above may have helped it become airborne. While the catch pits at the Rest and Be Thankful are 6m deep, at least one of the crags above (visible in the photos) appears well placed to serve as a landslide spring board, so it is not just their capacity which is the issue.

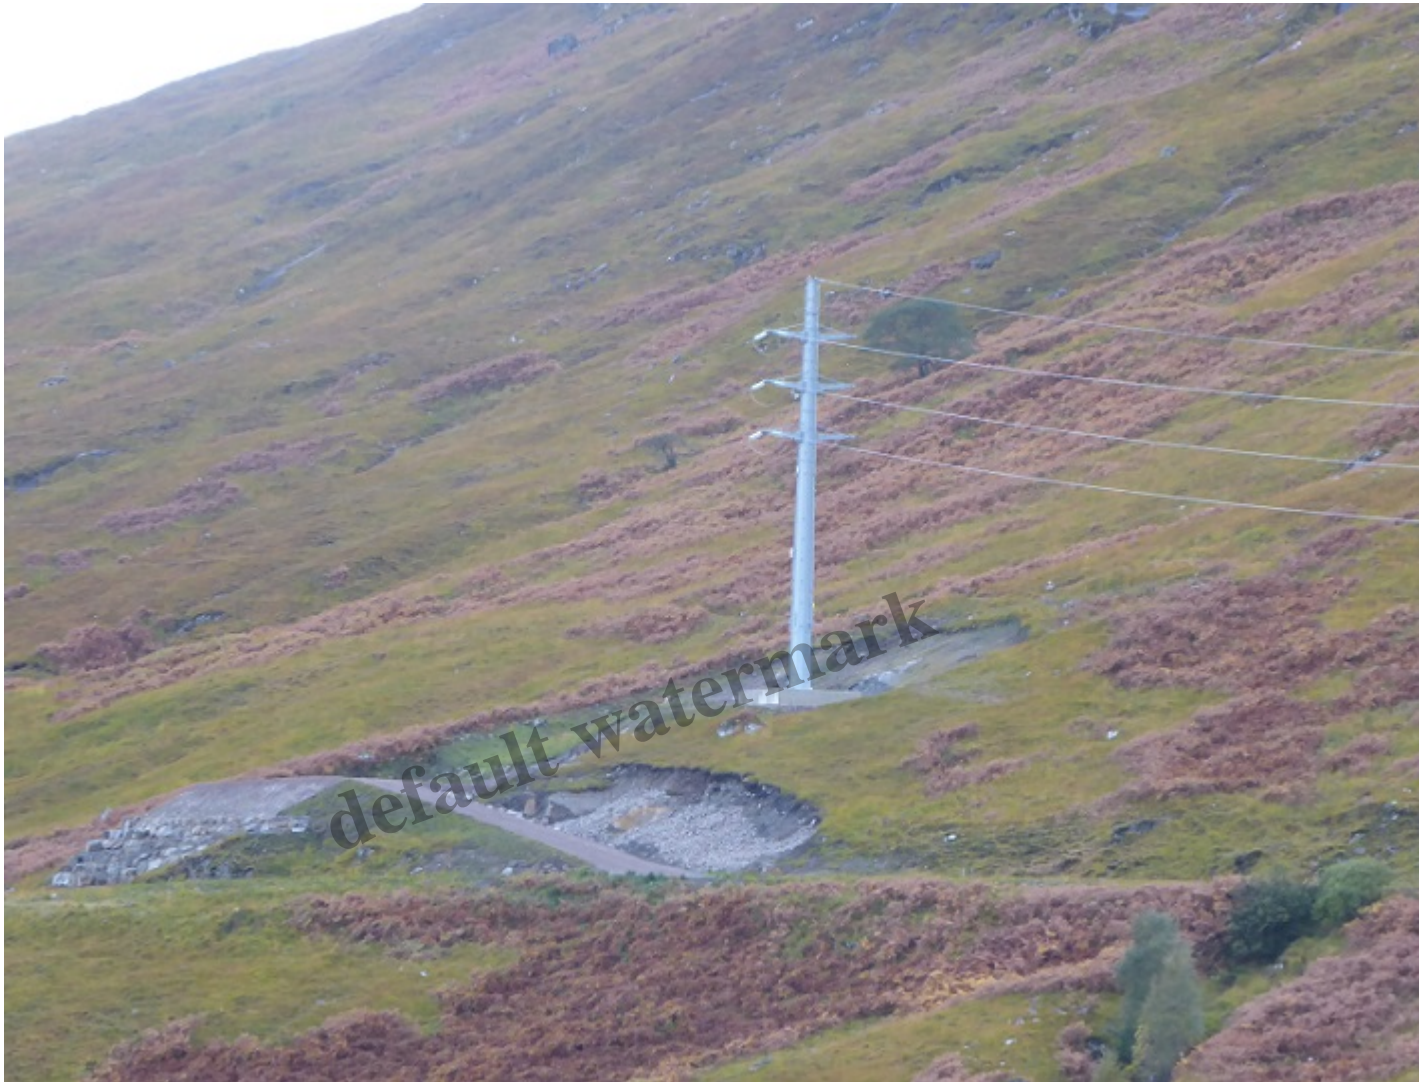
The westernmost of the three new pylons above the Loch Quoich dam

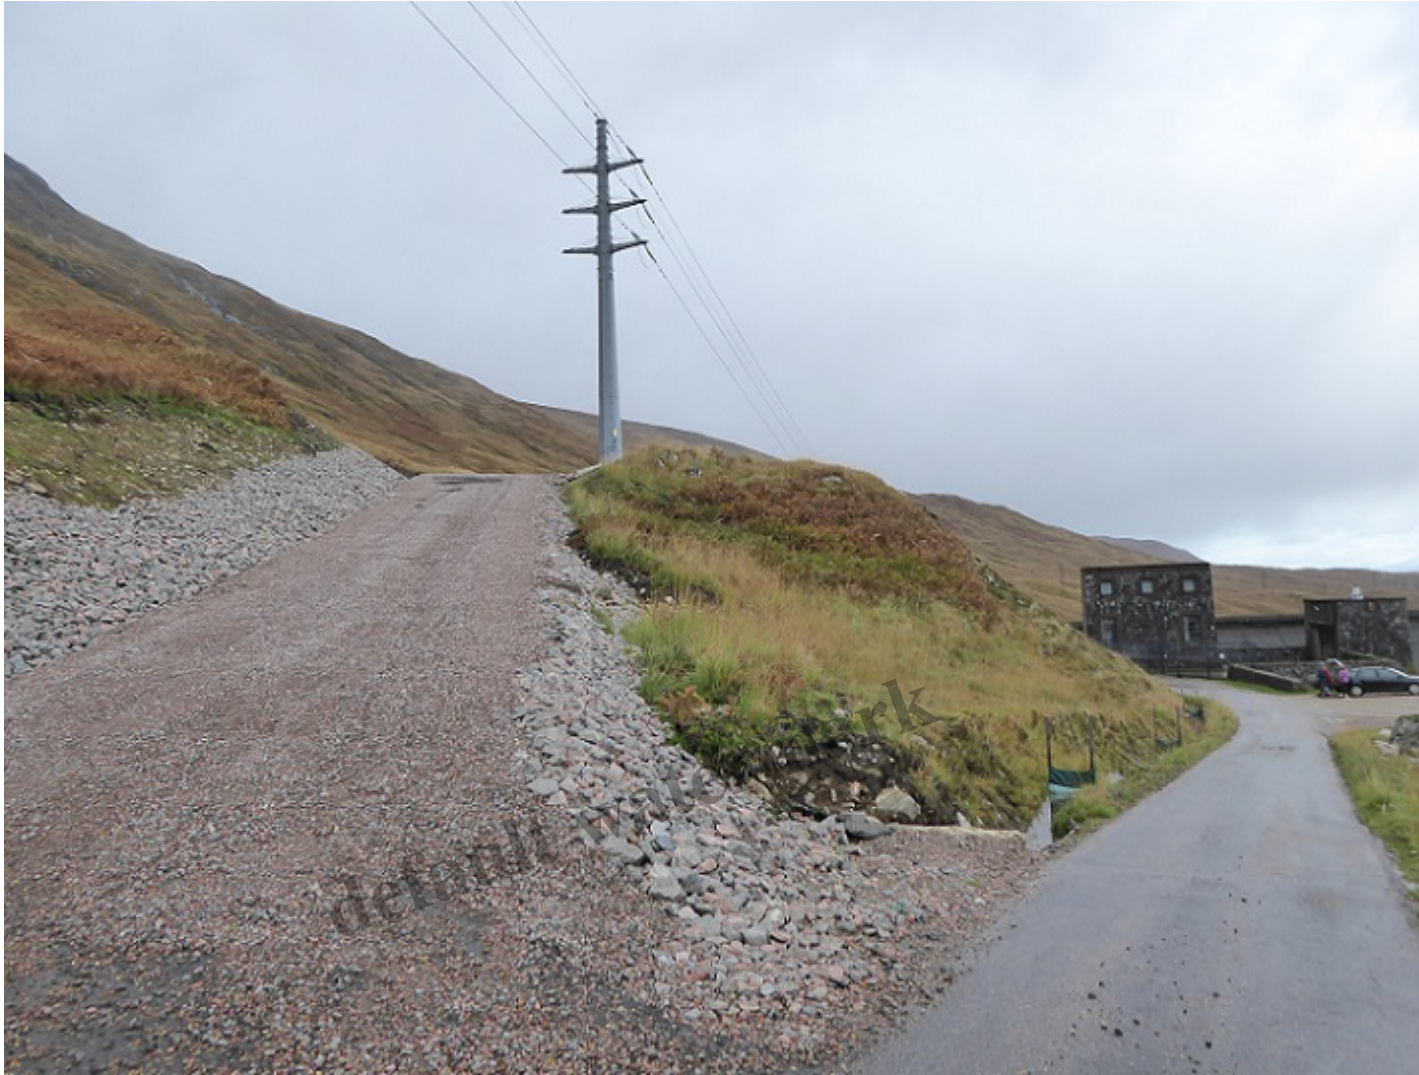
The middle pylon

Large quantities of imported aggregate – at what carbon cost – more hardstanding to drain water off the hill and no attempt at landscape restoration.

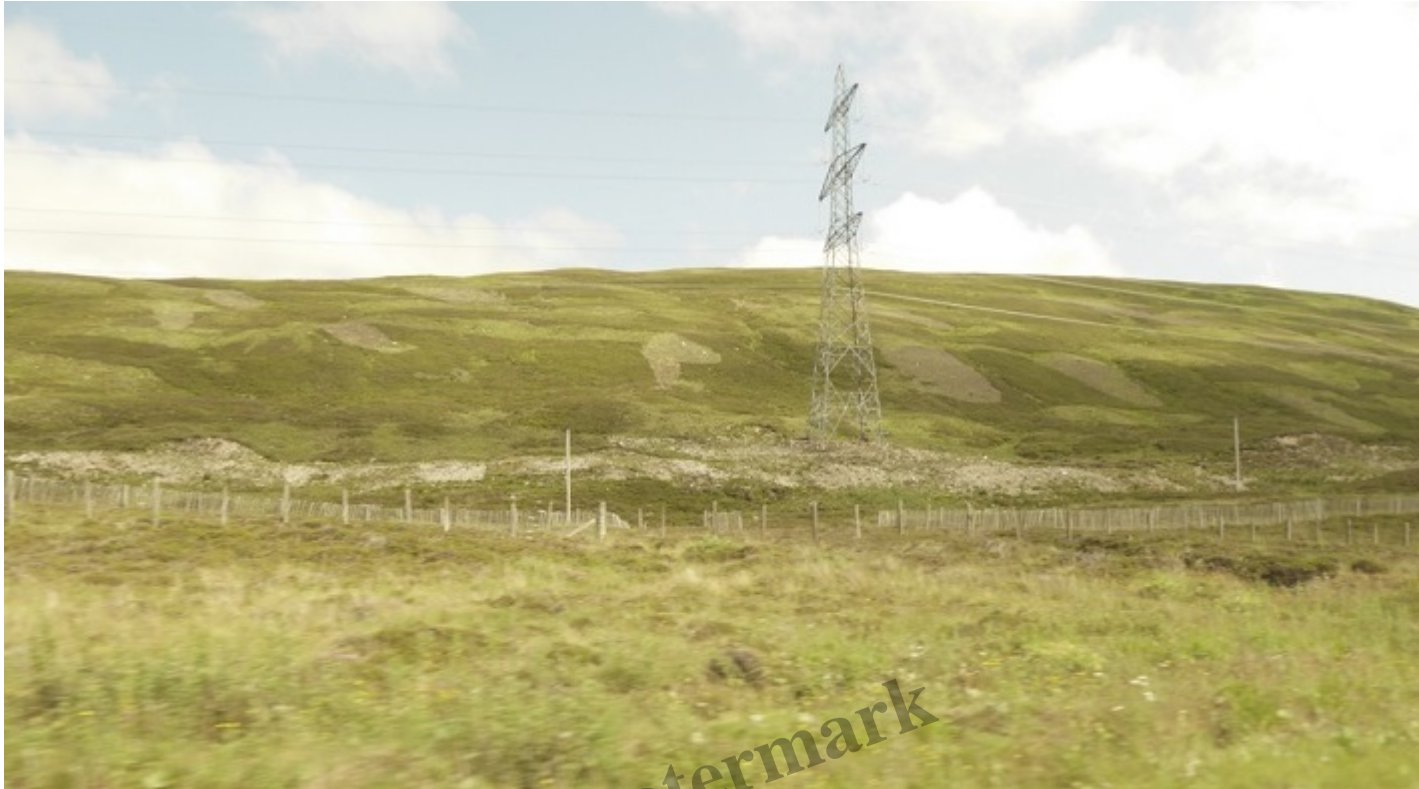
Unrestored ground at Drumochter with destructive muirburn behind, snapped from the passenger window July 2021
