On landslides and their impact – lessons from Loch Quoich for the A83 and SSE’s green credentials

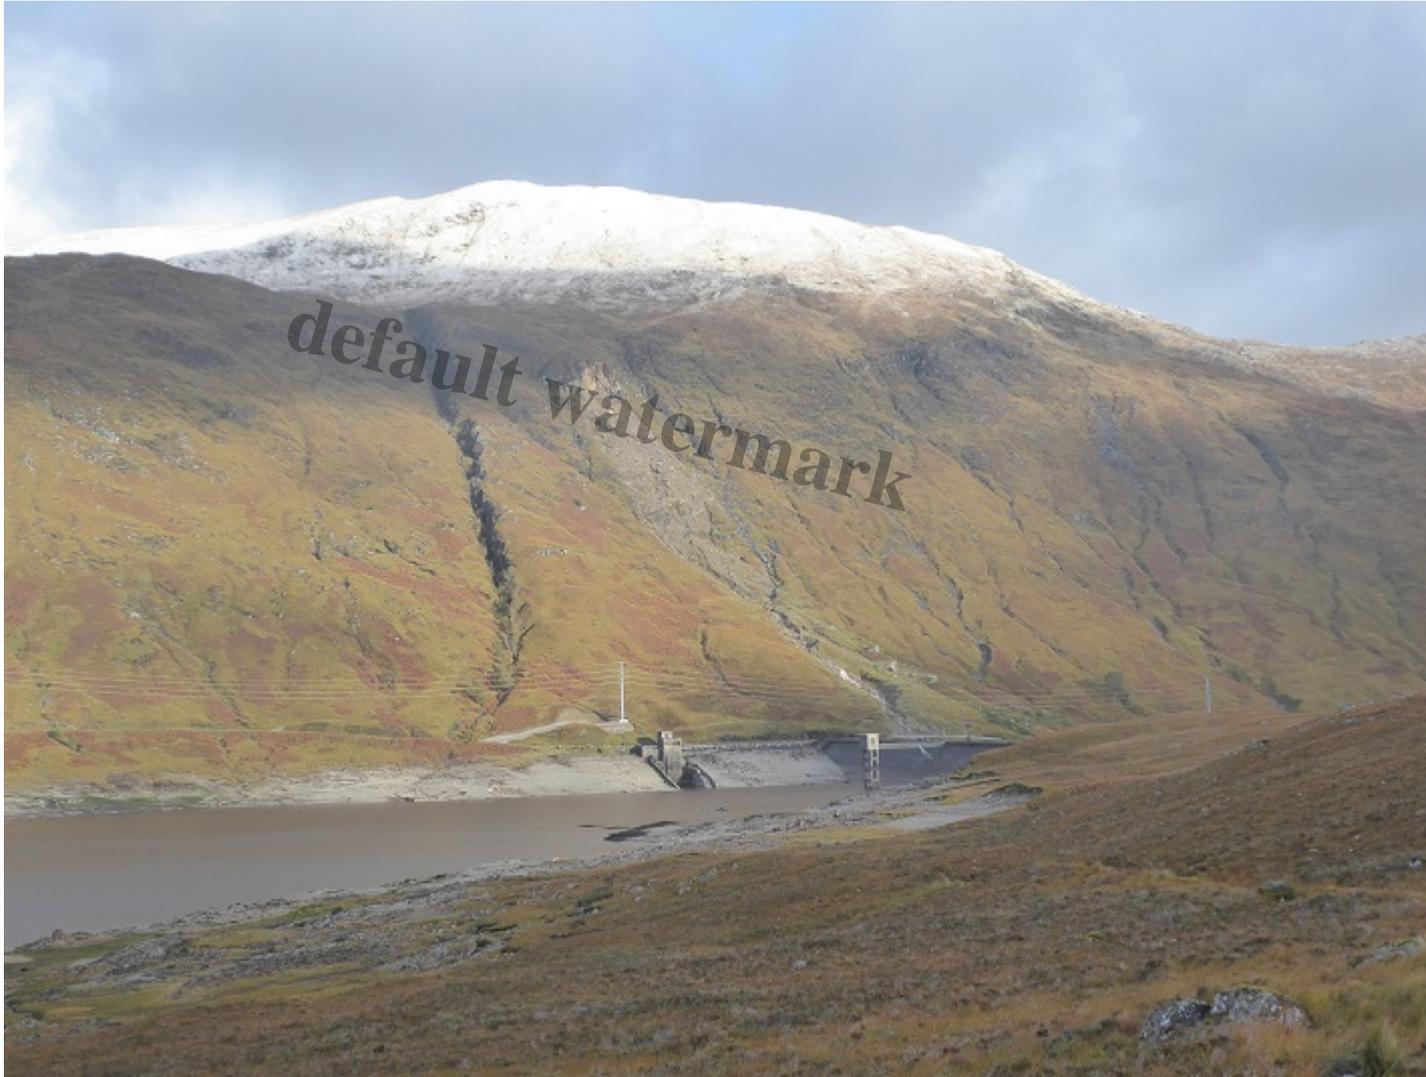
Spidean Mialach from the south with landslide above head of Loch Quoich dam. October 2021

On 10th November 2018 a large landslide took place above the eastern end of Loch Quoich. It was triggered by the collapse of a crag halfway up the steep hillside, demolished an electricity pylon and resulted in the road to Kinloch Hourn being closed for 6 months while the slope was stabilised at an estimated cost of £1m.

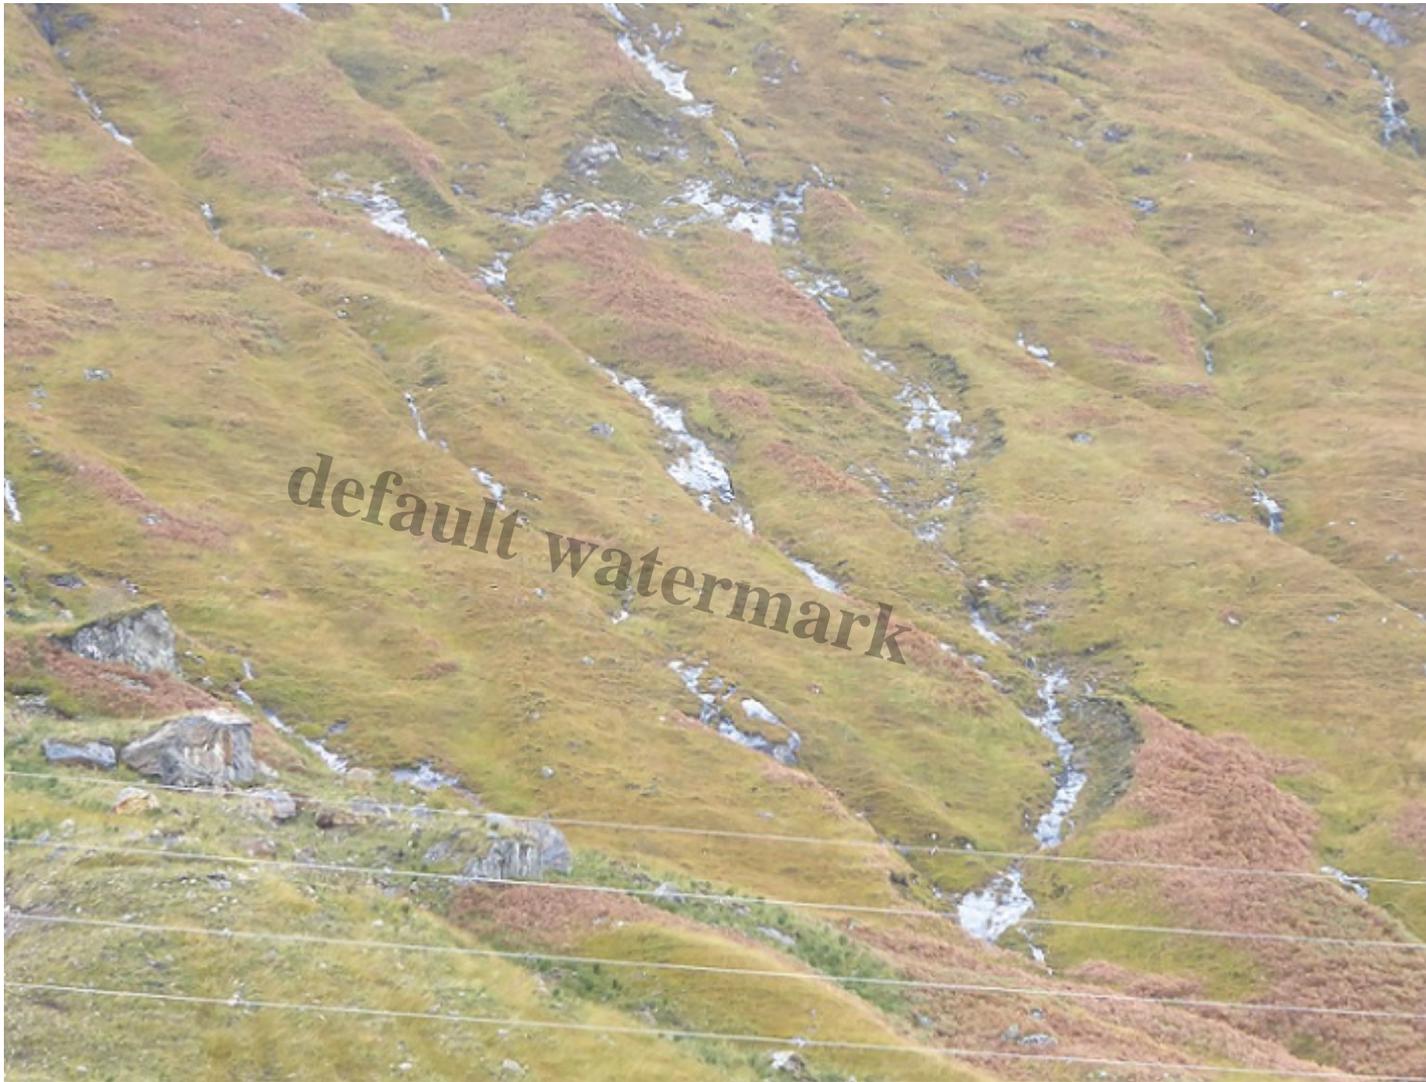
Slope just to the right of the landslide with boulder debris from the recent (and past) rockfall bottom left

The state of the ground to the right of the landslide at Loch Quoich, a skin of glacial debris and earth lying on top of glacial slabs without a tree or shrub in sight, suggests that this whole slope was/is waiting to go. You can see how water has scoured away the slopes to leave areas of bare rock. Whatever the stability of the crag which partially collapsed, it's not difficult to see how major rainfall might trigger further landslides here. And the western end of Loch Quoich is one of the wettest places in Scotland.

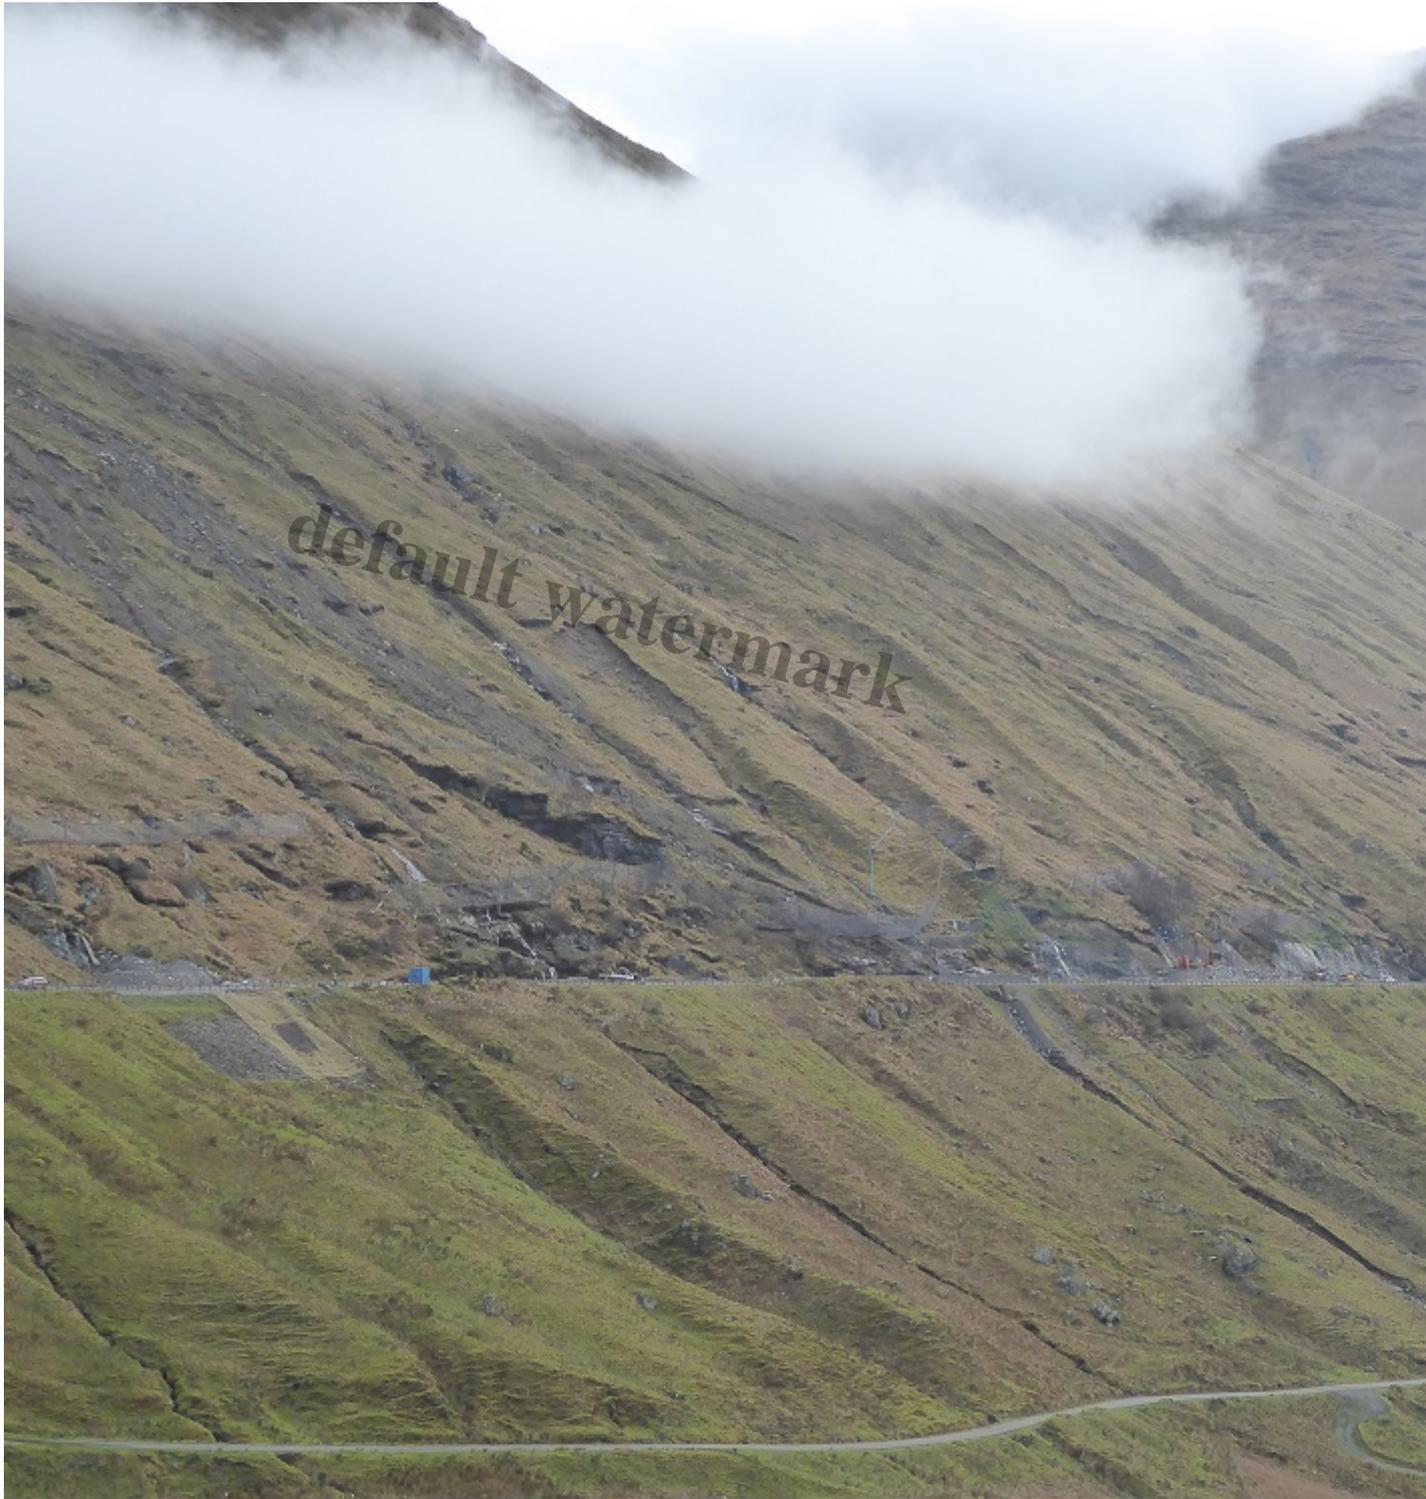
Photo taken 2019, credit Louise Brimelow

The skin of glacial debris and soils at the Rest and Be Thankful appears to be thicker than at Loch Quich. Potentially that might have made it easier for trees to establish themselves on this slope and help stabilise it.

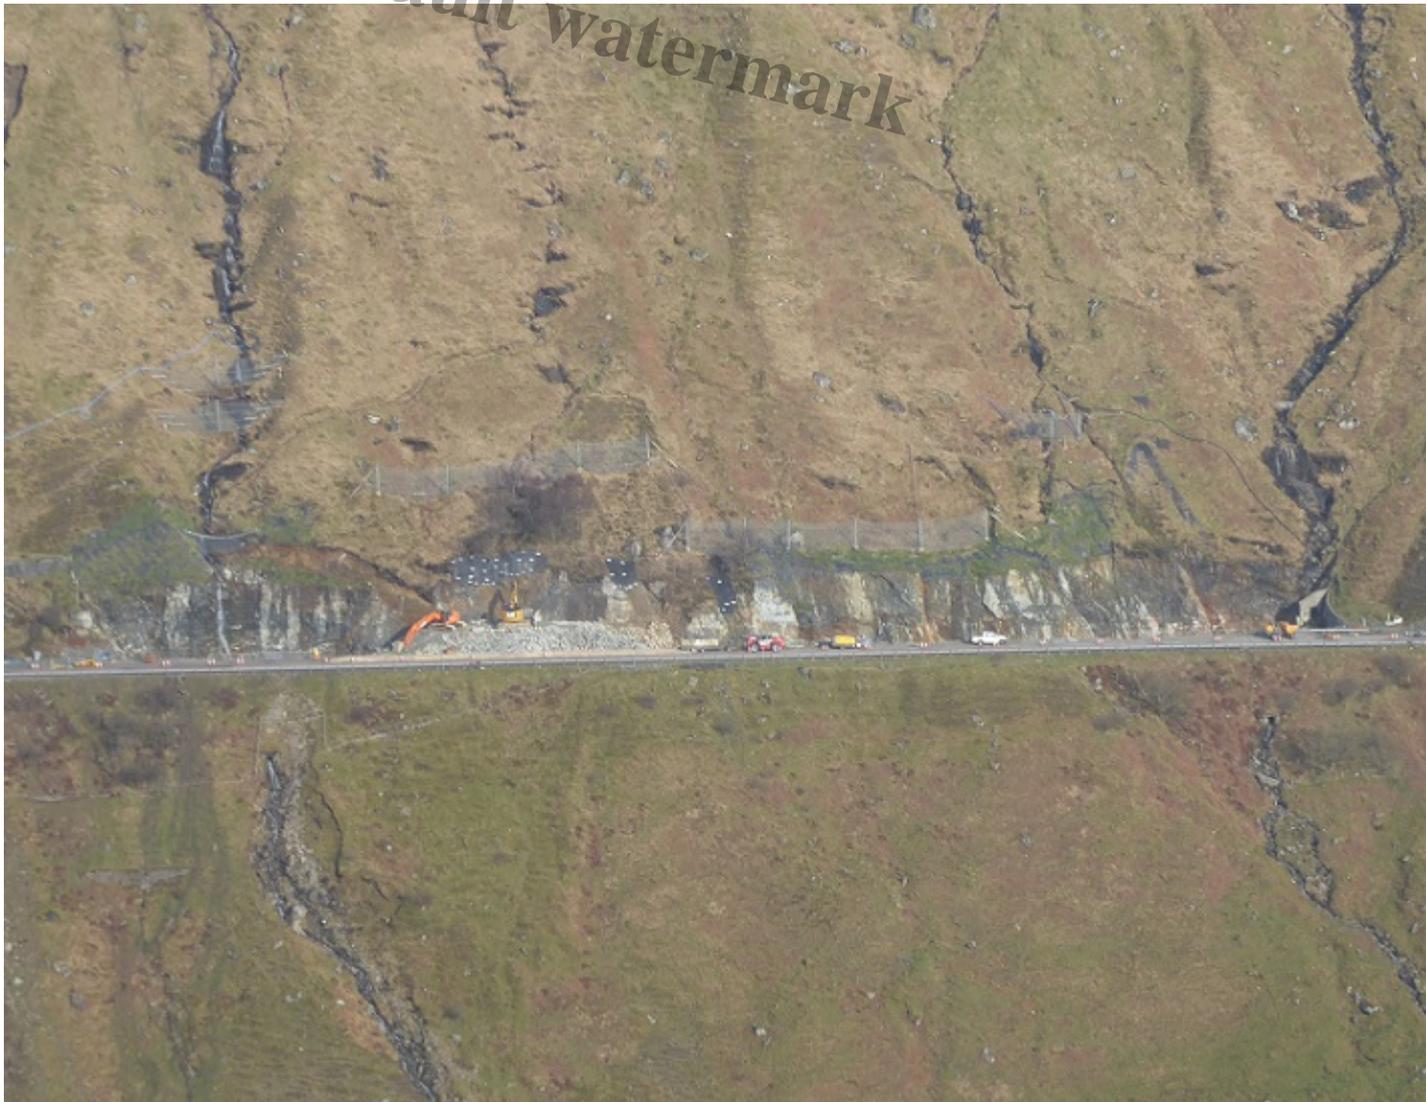
Catch “fences”• and catch pits under construction 2019. Photo credit Louise Brimelow

Rather than address the issues created by the construction of A83 across a steep slope that was always high risk and has been allowed to become even more unstable through decades of land mismanagement, the Scottish Government's answer has been to put up fences and dig holes above the road in the hope of catching debris. It hasn't worked but despite that in September the Scottish Government committed another £3.5m to constructing yet more catchpits. That the Rest and Be Thankful Campaign were right to criticise the decision ([see here](#)) is demonstrated by what happened at Loch Quoich.

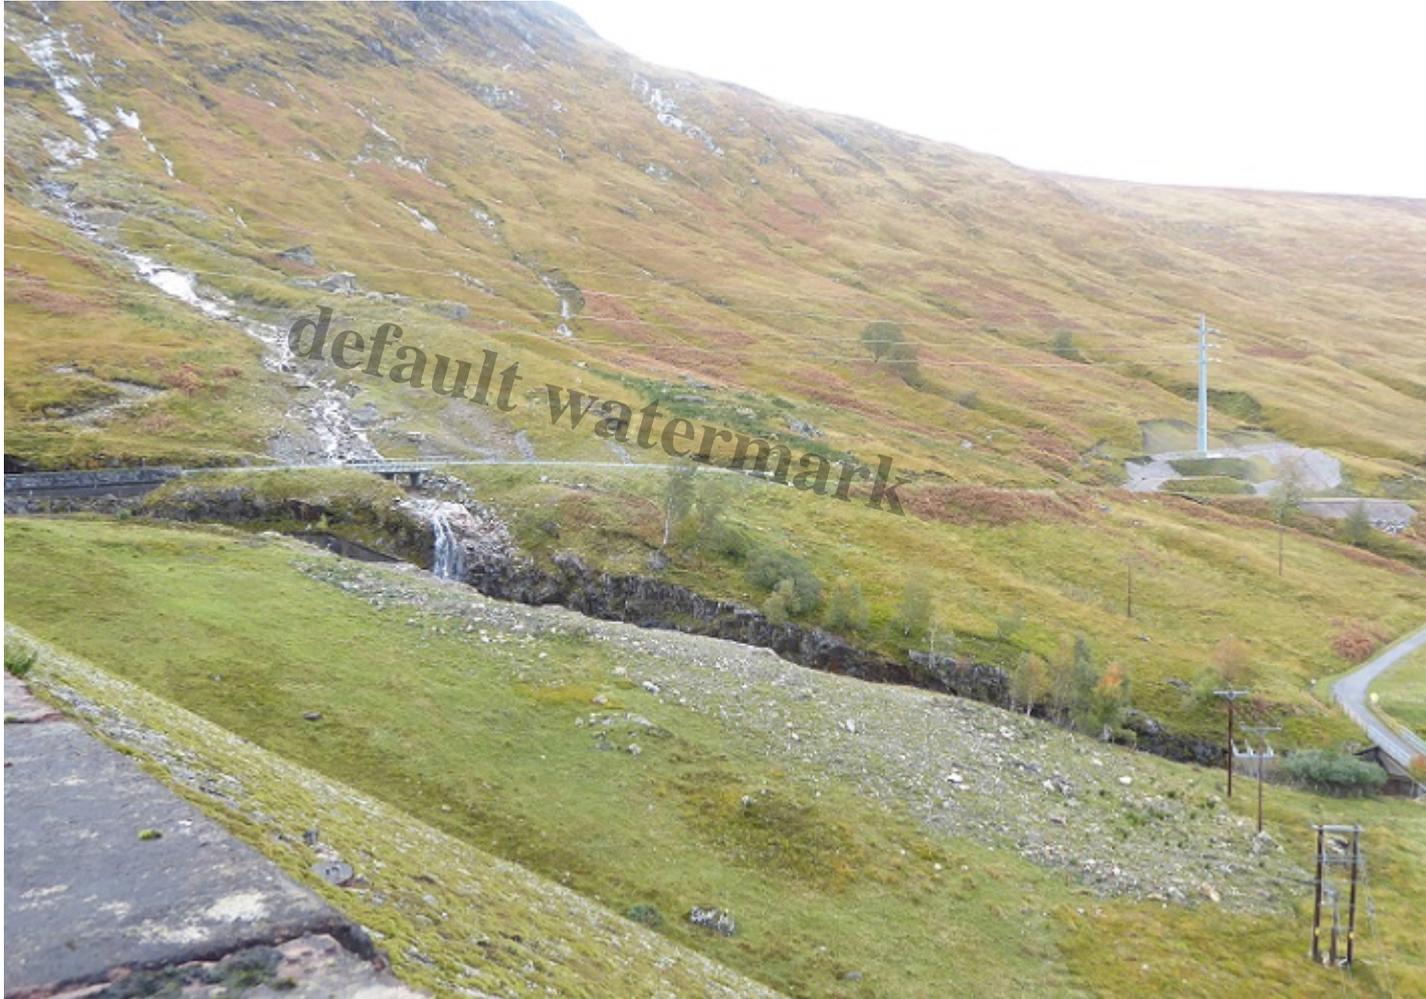
Landslide debris below the Loch Quoich spillway viewed from the dam and easternmost of the 3 new pylons . Note the landscape impact and damage caused by the construction.

A significant part of the landslide jumped the spillway - have you ever seen a larger catchpit?.

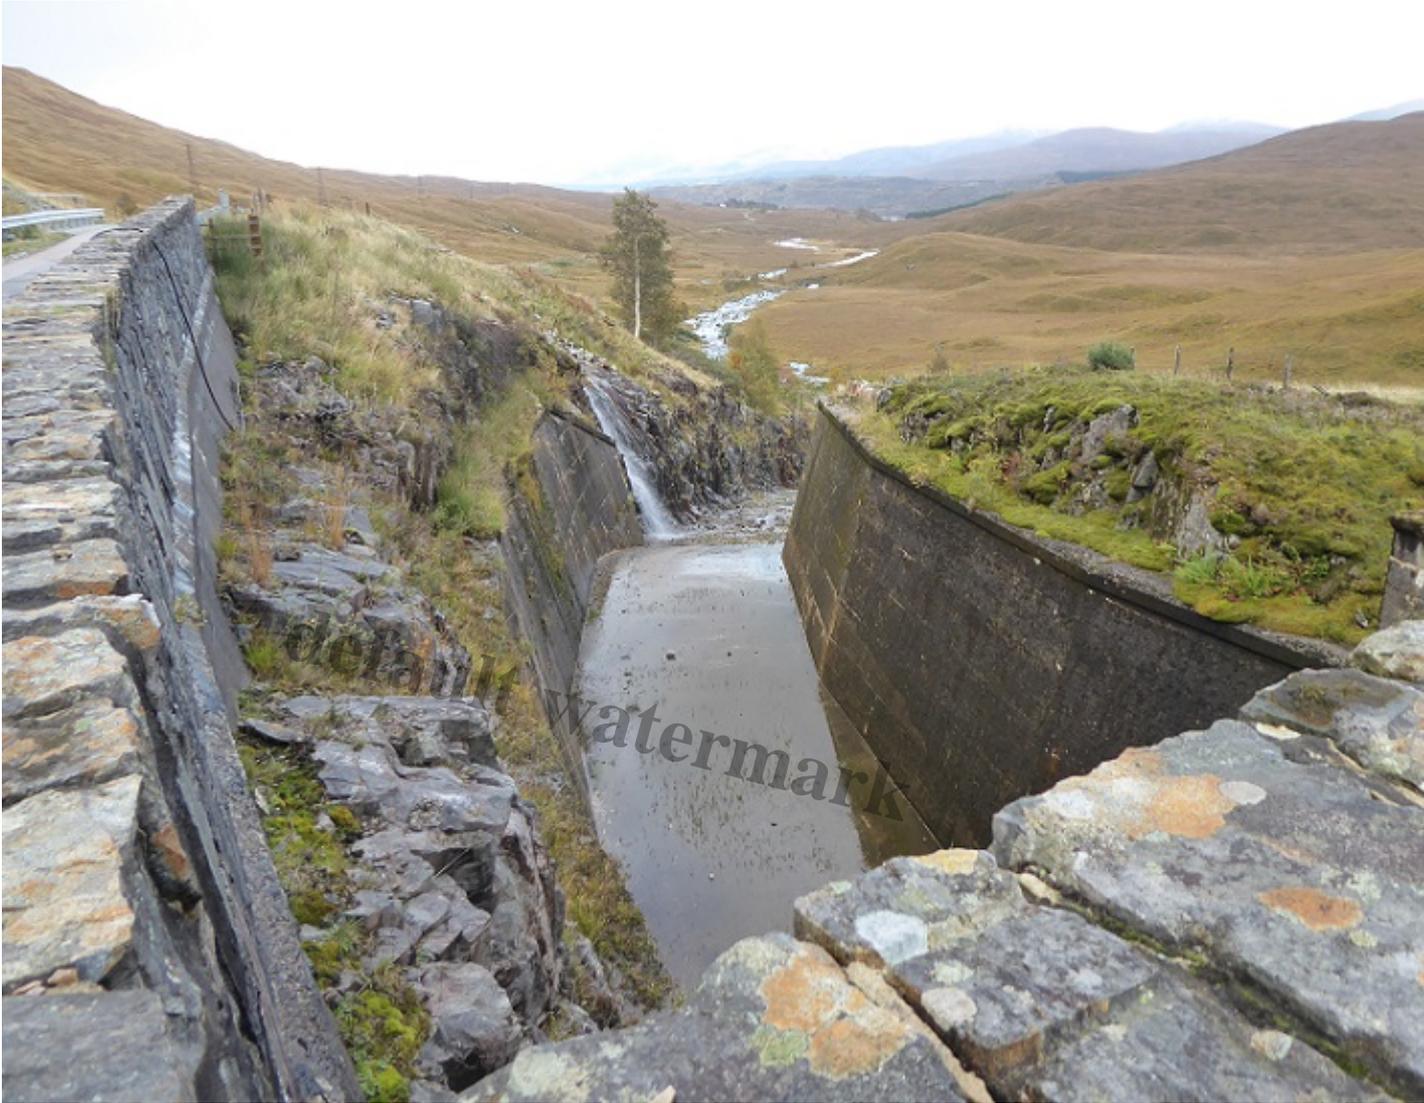
The landslide jumped the spillway by the waterfall. The rocks are a geological Site of Special Scientific Interest designated because of an igneous intrusion which shows the surrounding Moine rocks must be at least 870m years old.

An impressive leap! I haven't been able to find out how much material dropped into the spillway but apparently the hydro electricity operation at the dam was closed until it was cleared so some did. Clearly, to cross this gap the landslide must have been moving at a significant velocity and the change in angle when it hit the road above may have helped it become airborne. While the catch pits at the Rest and Be Thankful are 6m deep, at least one of the crags above (visible in the photos) appears well placed to serve as a landslide spring board, so it is not just their capacity which is the issue.
