The Cairngorms through the lens of Adam Watson (3) - Coire Cas, the long view

Description

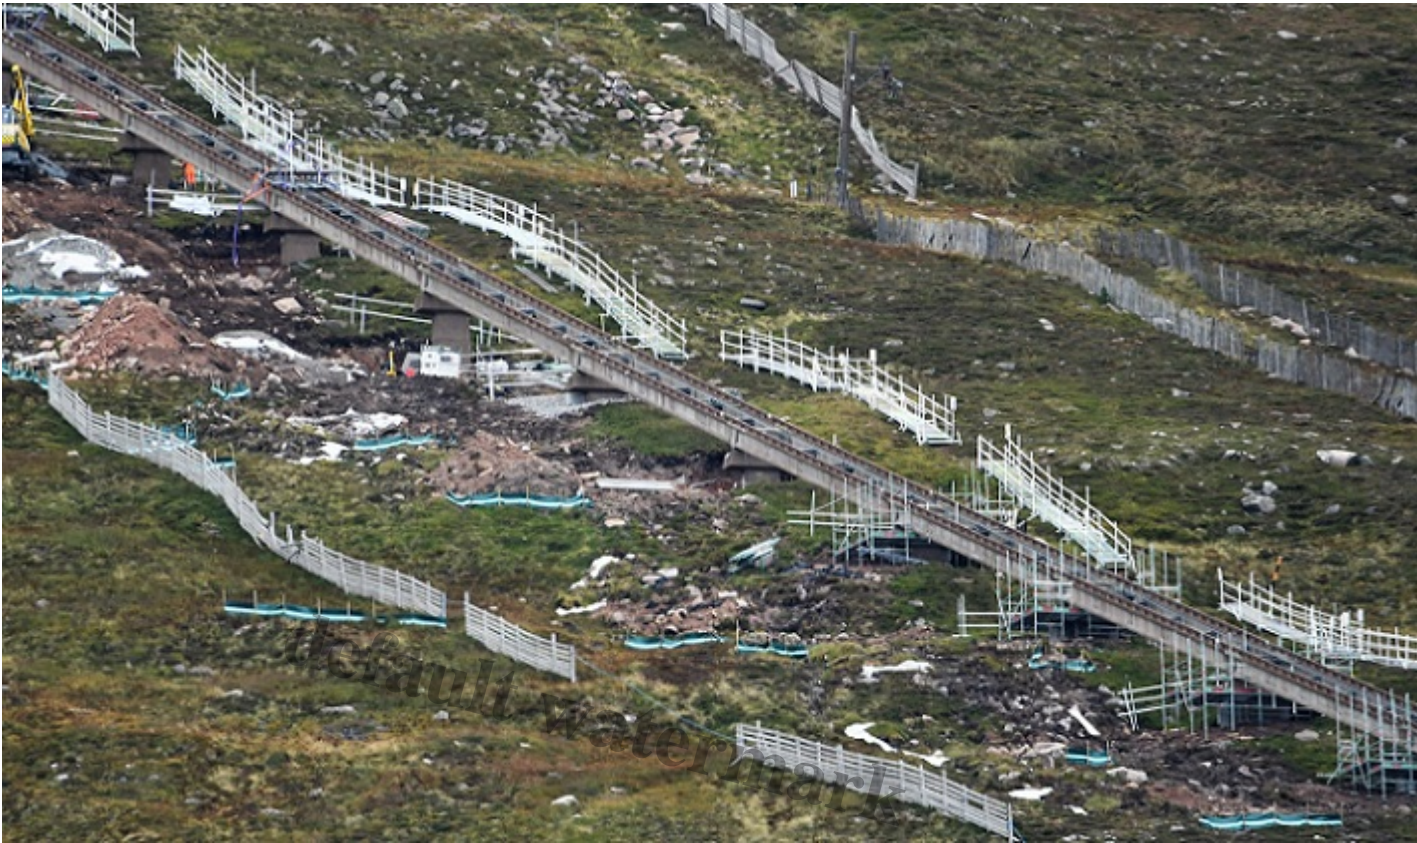
Upper section of funicular repairs prior to "restoration" • 20th September 2021. Photo credit George Paton.

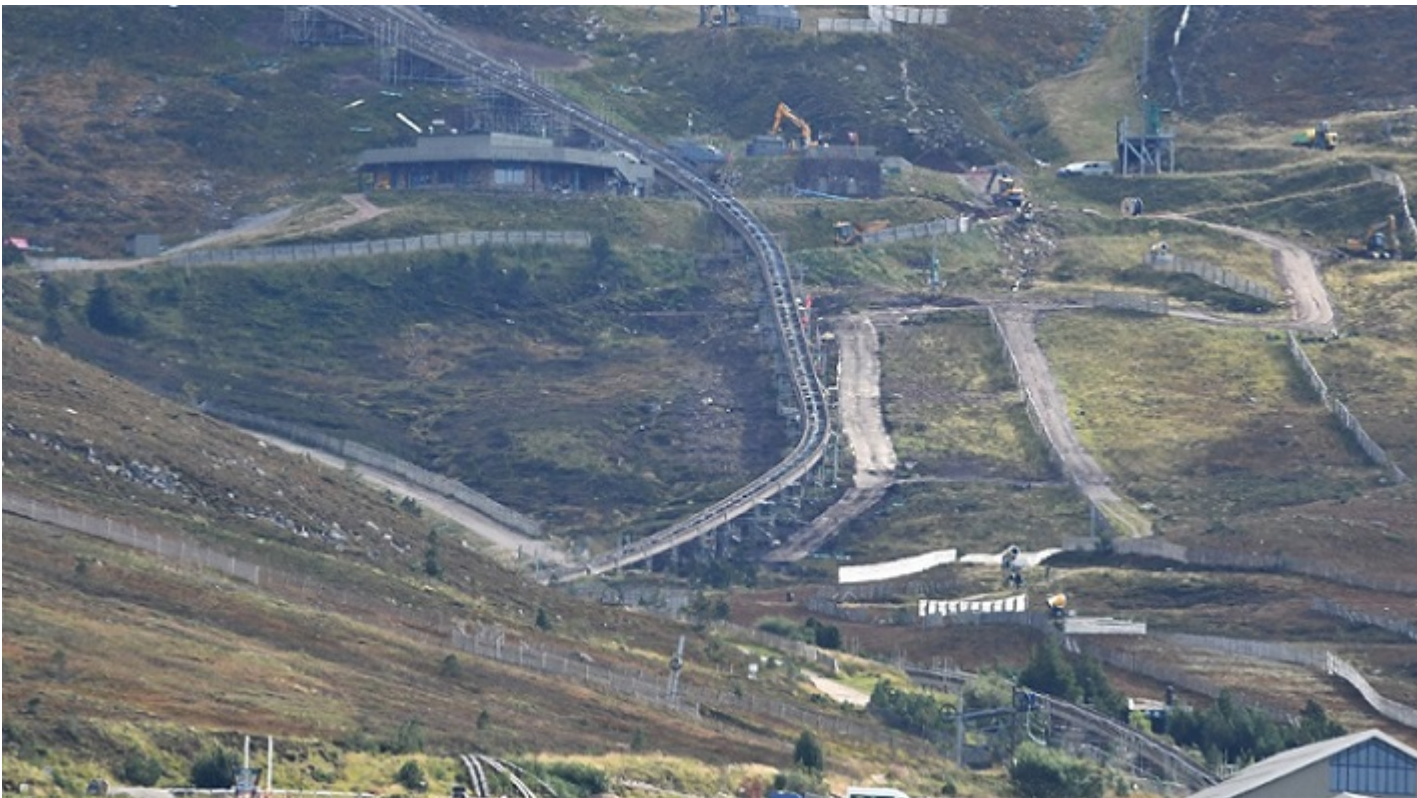
Photo Credit George Paton 20th September 2021 – note the disturbed peat on the left of the funicular.

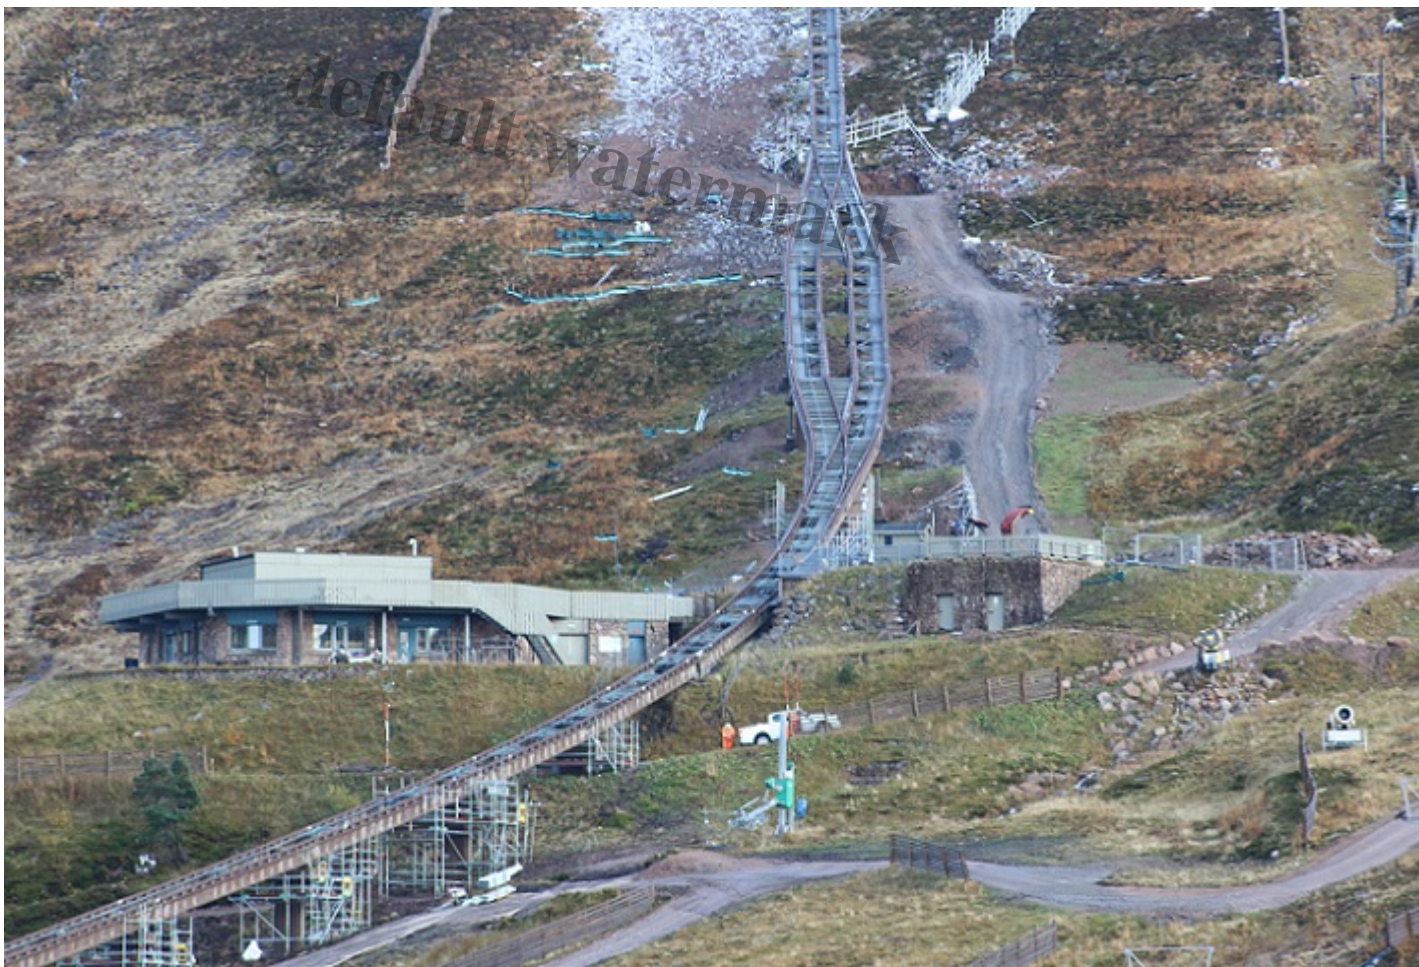
More temporary repair track and restored ground above (on left of funicular). Photo credit Gordon Bulloch 4th November 2021
