When are SSE and the Scottish Government going to take responsibility for the damage at Drumochter?

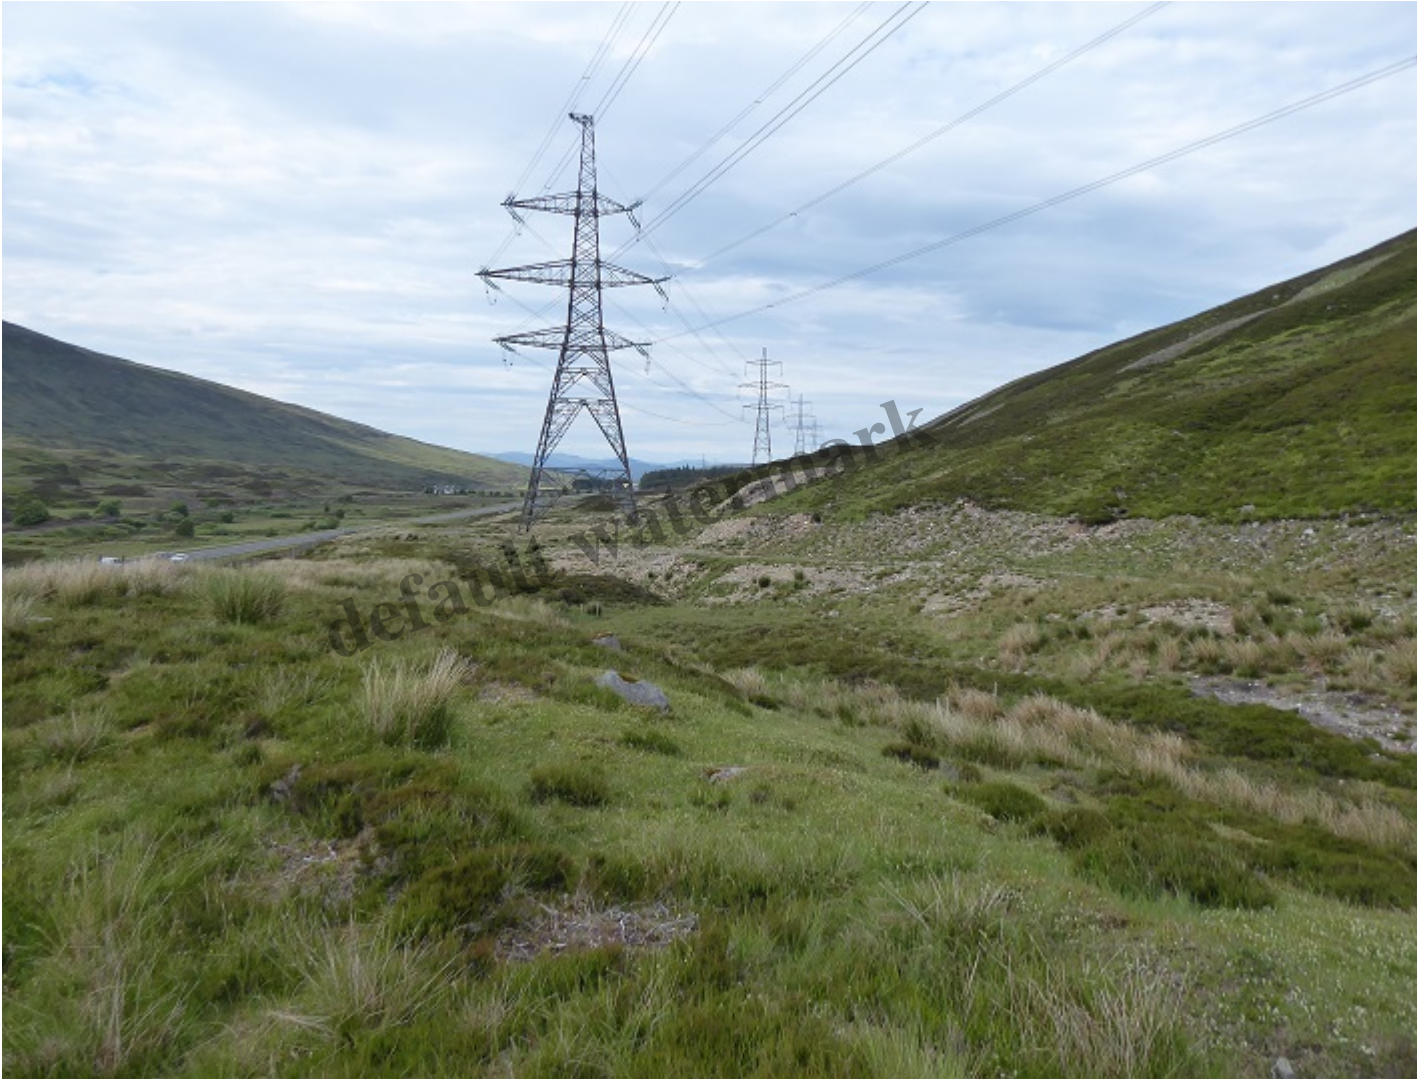
Looking north towards tower compound 141 on the Beauly Denny powerline at Drumochter. Balsporran Cottages, with their car park popular with hill walkers, is visible in the distance on the other side of the A9.

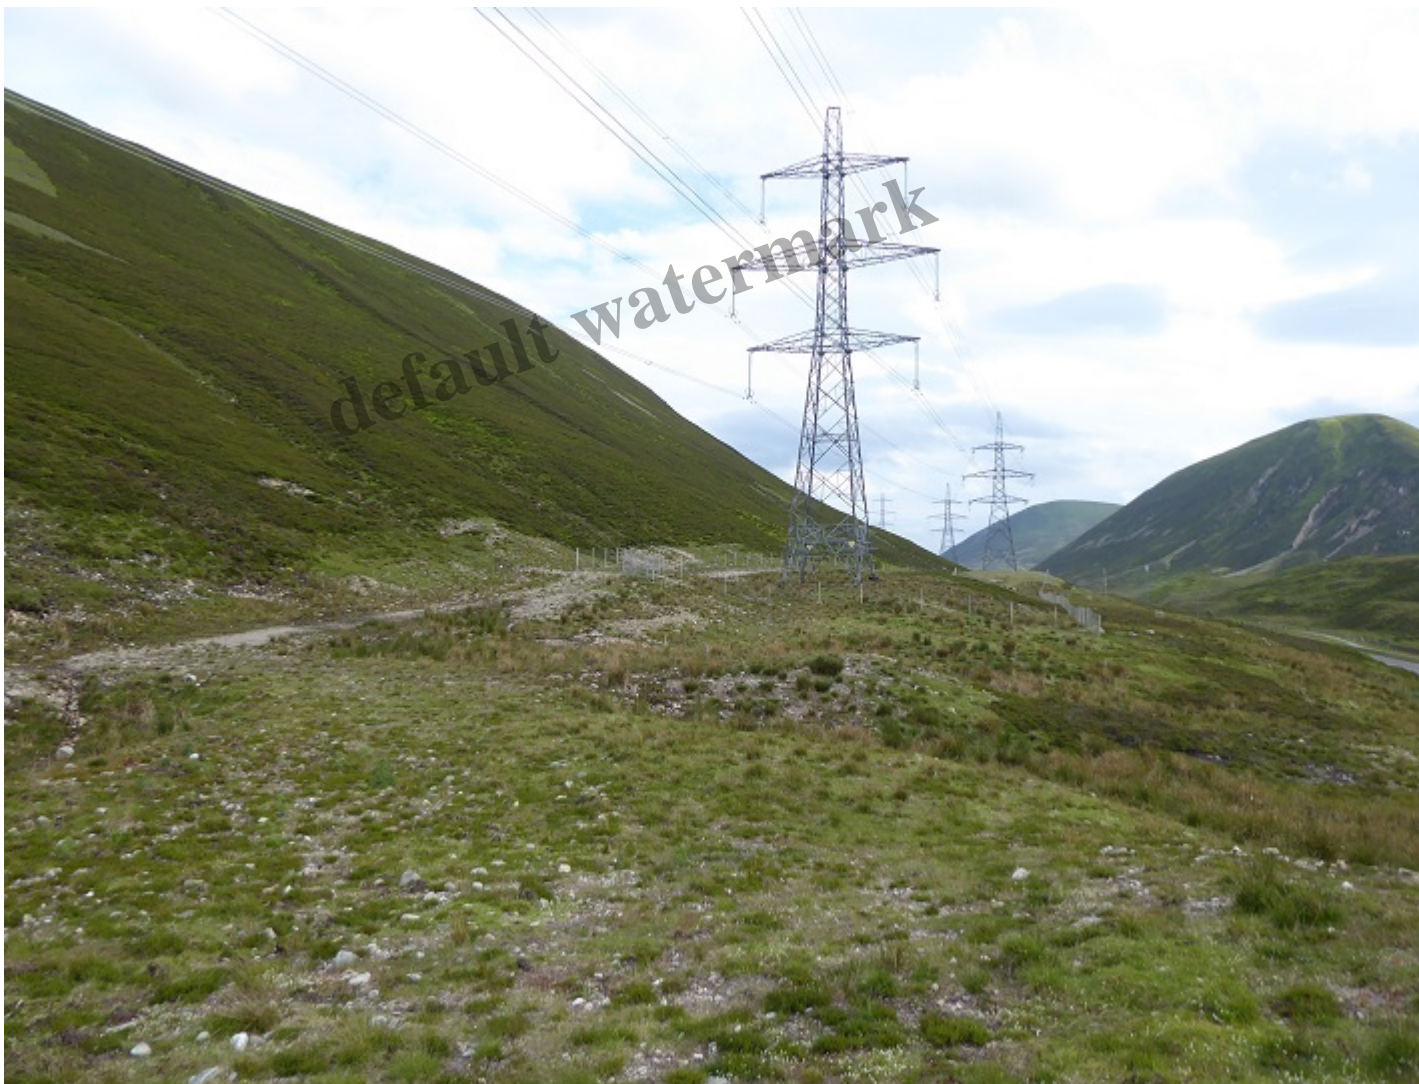
The view south towards towers 142, 143, 144 and 145 and the trial restoration area, almost all out of sight from the A9, where deer were to be excluded by fencing.

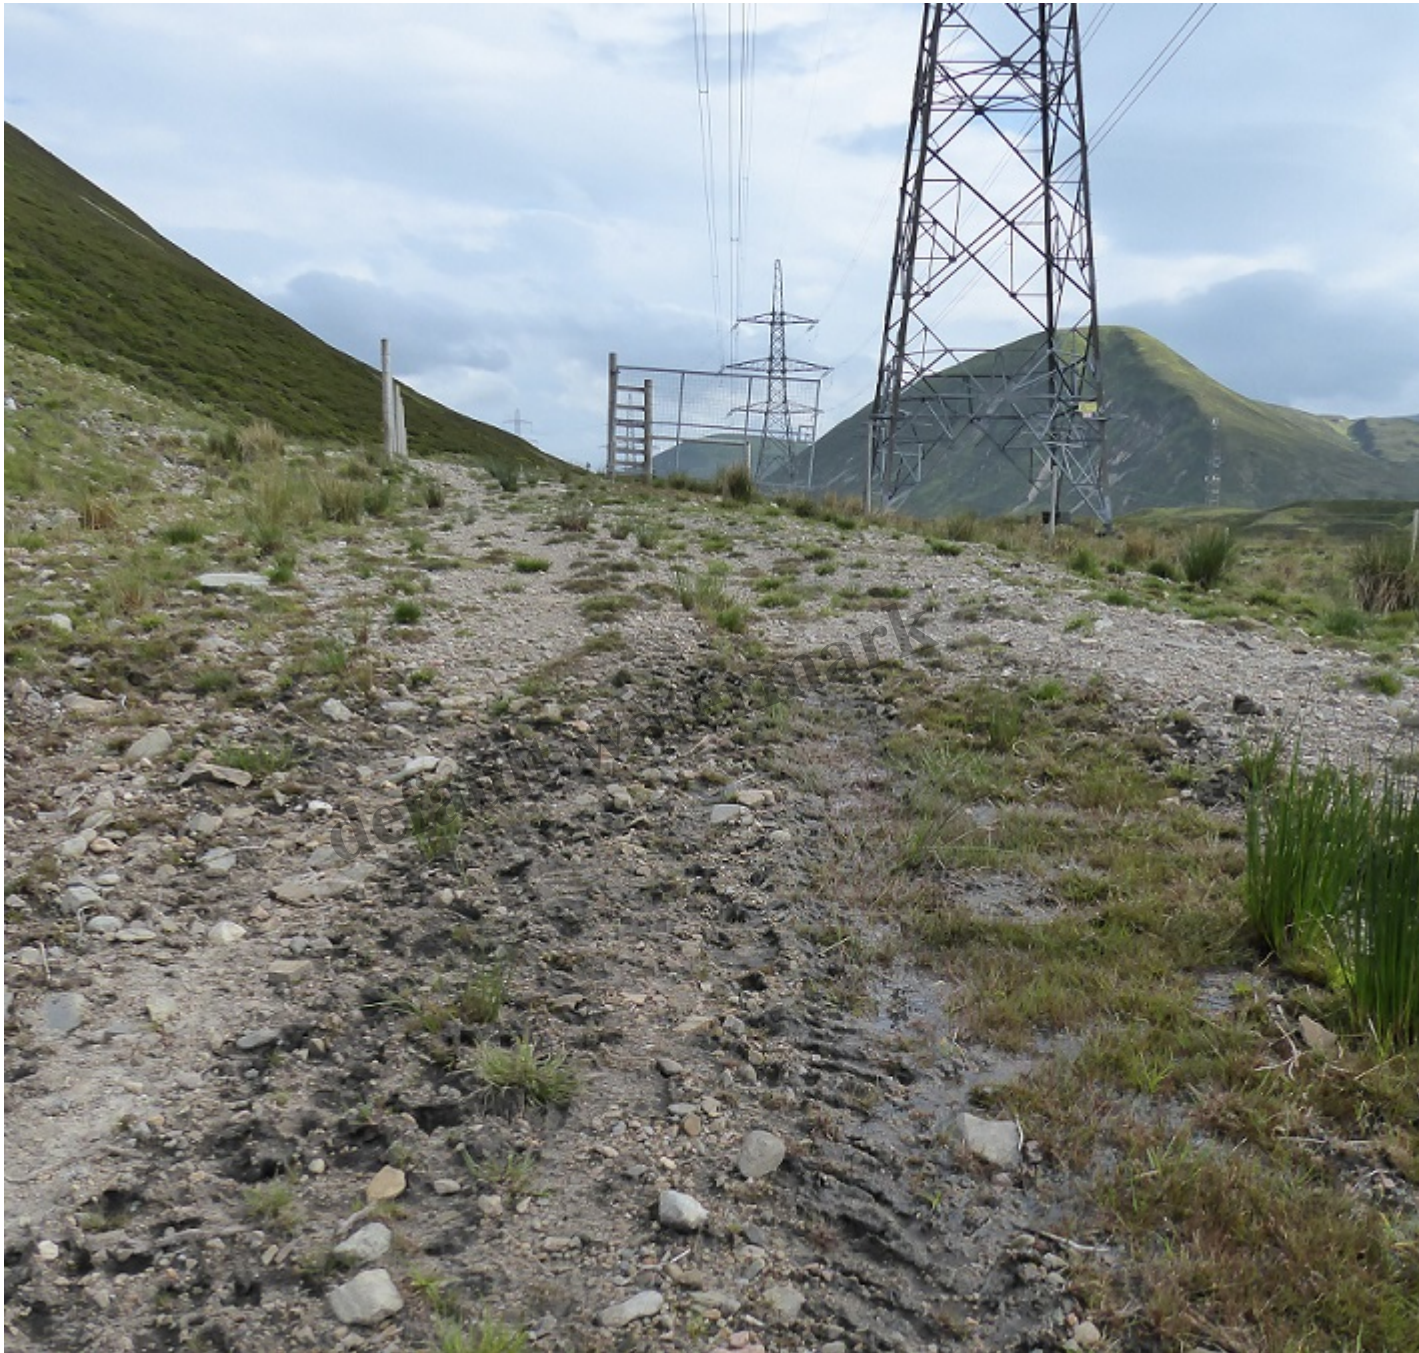
Towers 142 and 143

I was somewhat taken aback therefore to find that vehicles are still being driven into the deer-fenced area, that the gate had been left open and that judging by the profusion of footprints that grazing animals are making a beeline for it.....or perhaps sheep were herded here by an estate worker on an ATV?.

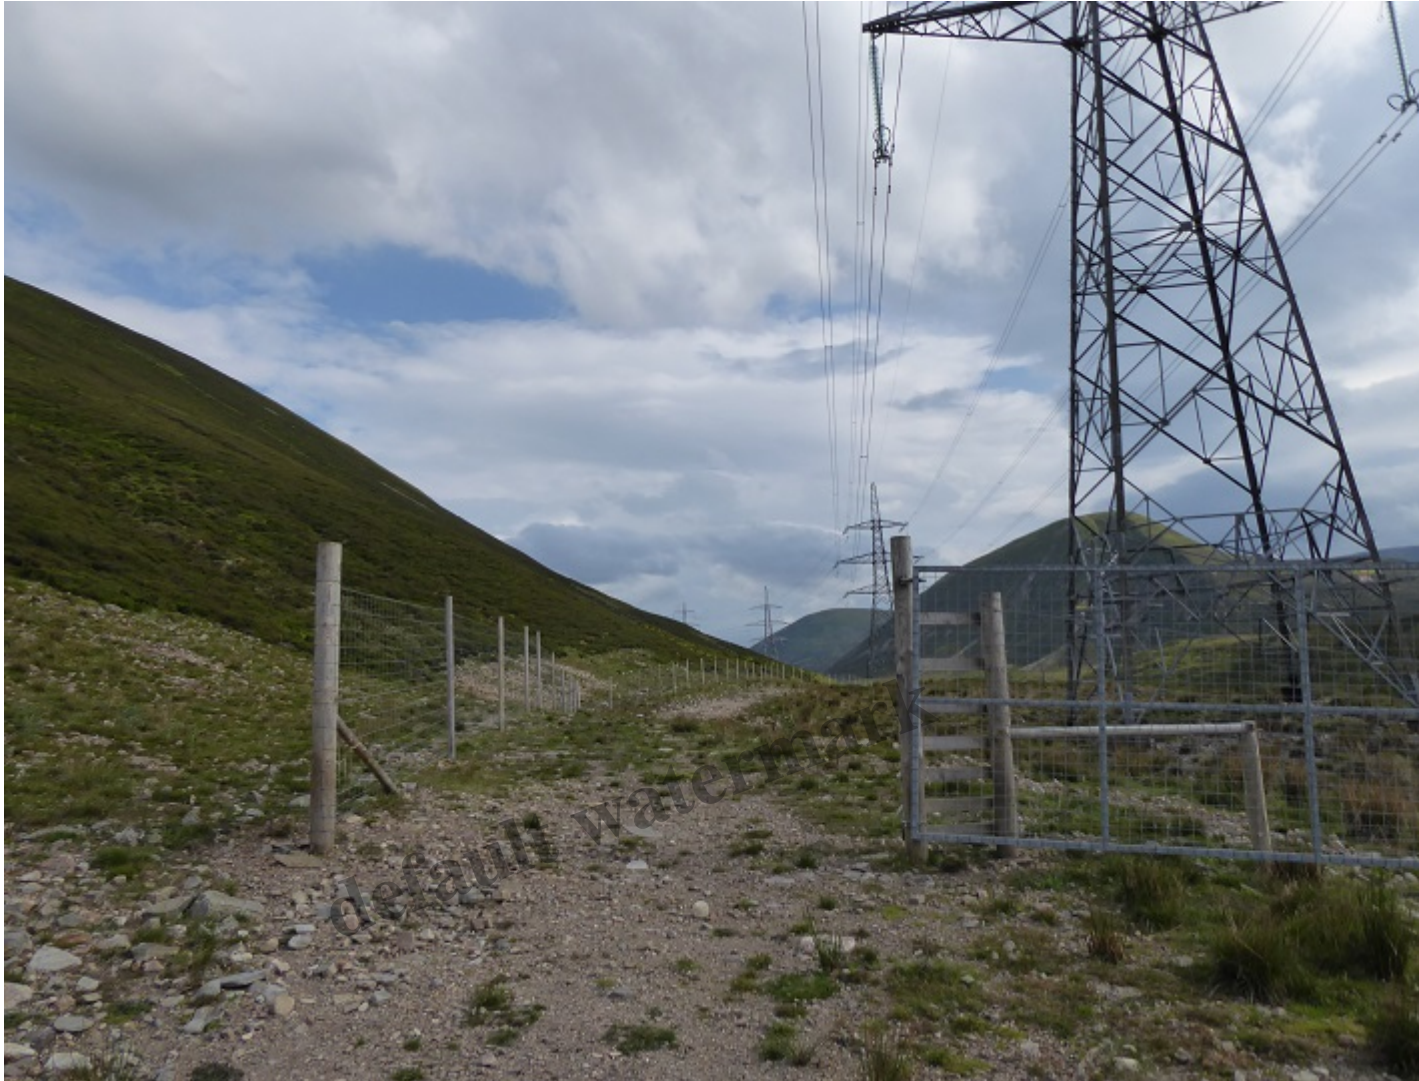
A senseless exclusion area

SSE are possibly unaware of that the gate is now being left open since they have failed to provide any monitoring reports to the CNPA since well before Covid – as I was told when I requested copies. It does appear, however, they were aware that the north Drumochter Estate might not co-operate with keeping deer and sheep out of the enclosure as their last monitoring report that is available refers to a site visit to check whether the gates were closed!

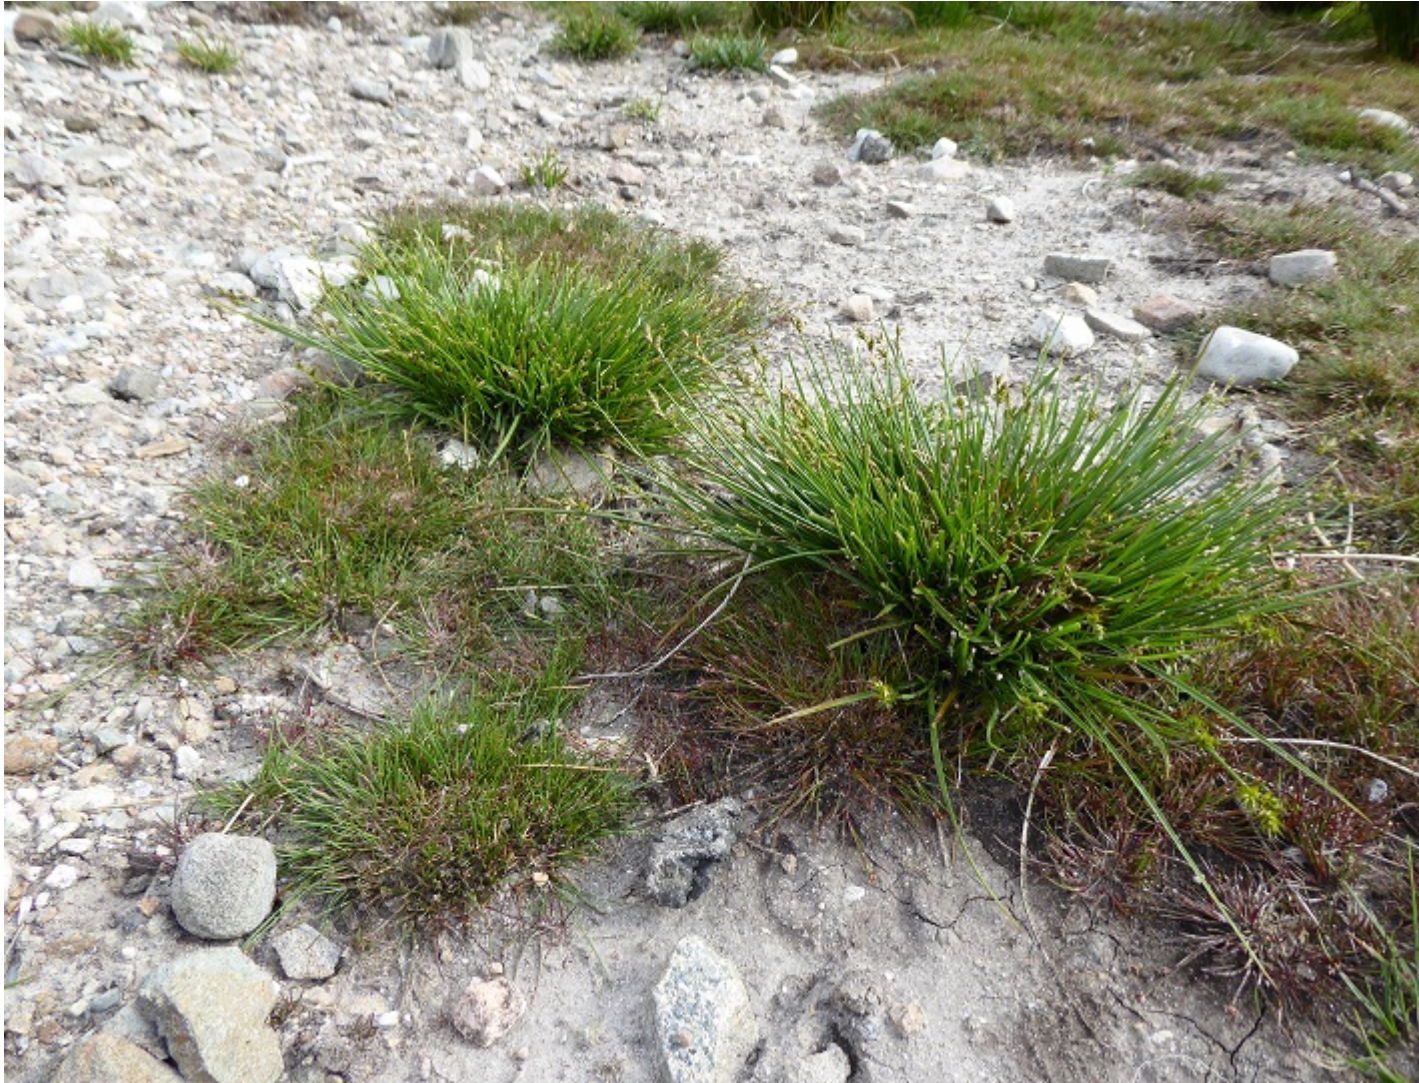
Heavily browsed sedges and grasses with nipped off stems clearly visible

Inside the fenced area the impact of grazing was obvious. This is not a recent issue, it would appear the gate has been left open for some time, possibly several years.

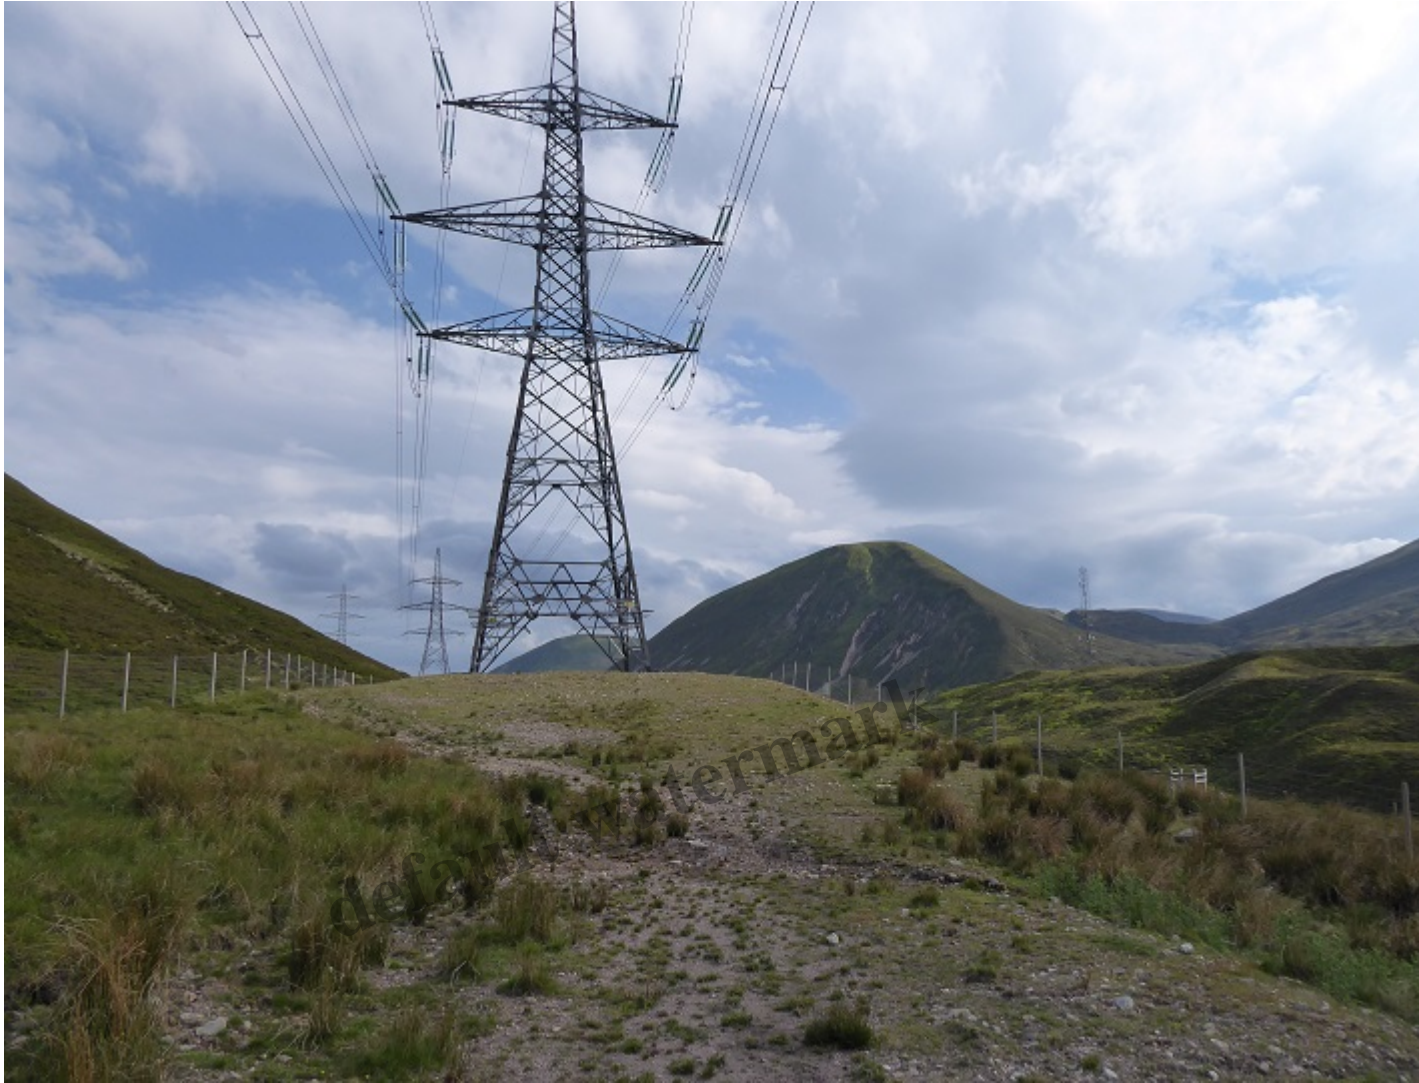
The main vegetation is soft rush, a plant which flourishes where there is high grazing pressure

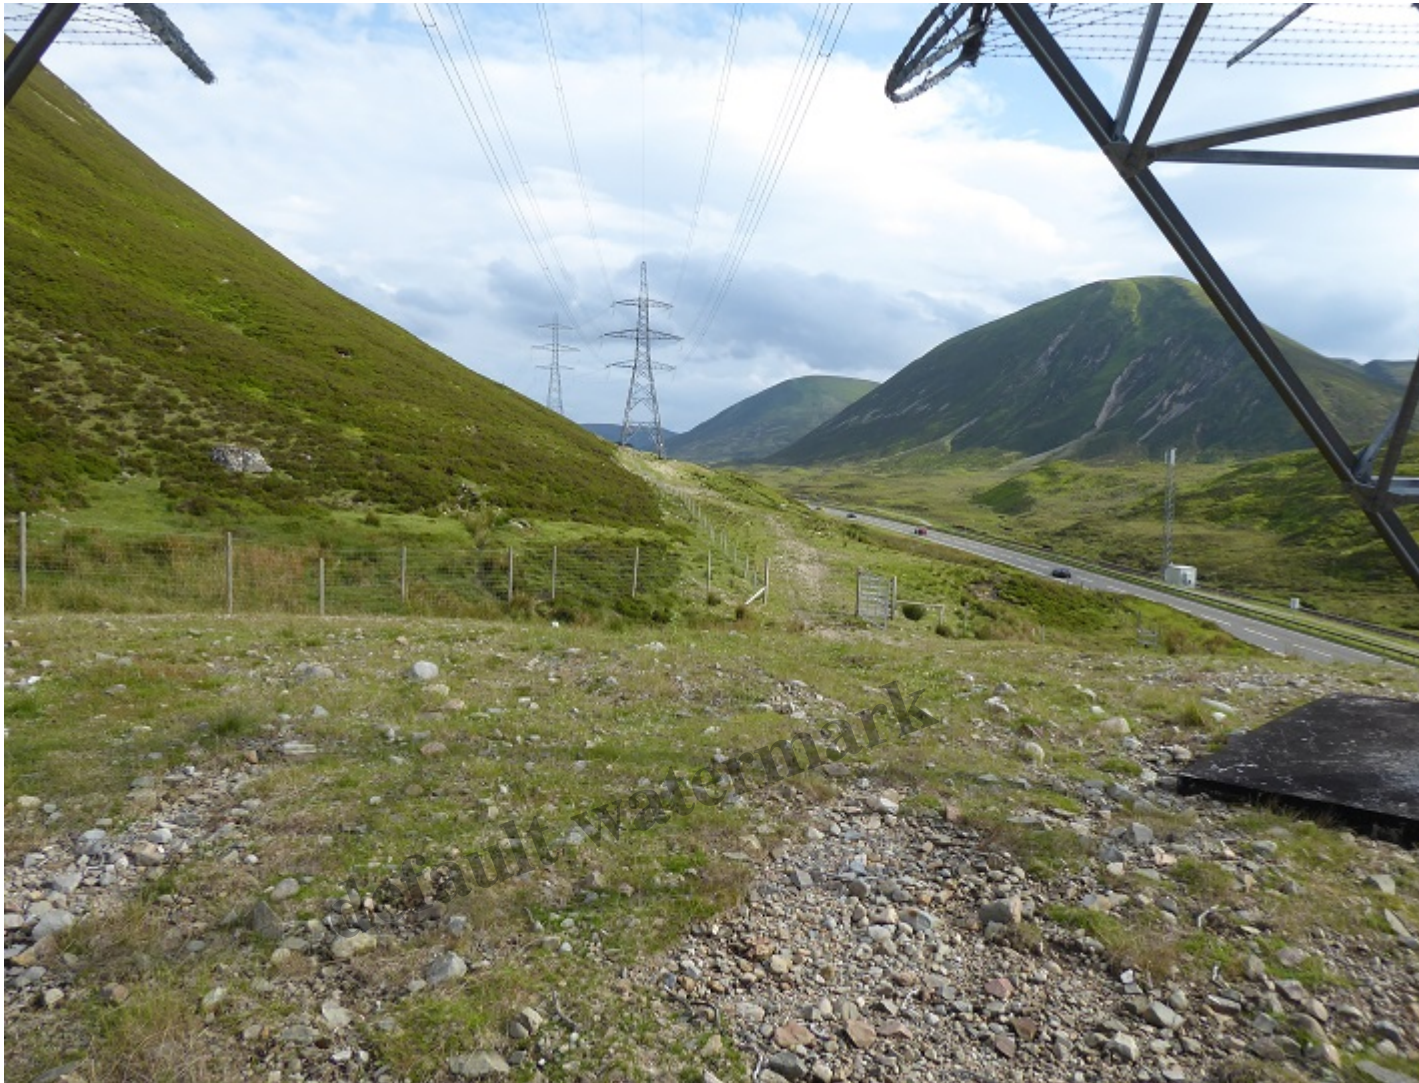
View south from beneath tower 143, the Sow of Atholl on the right. You can just see the open gate

Just beyond tower 143 the area protected by deer fencing ends with another gate which opens onto a further strip of land which is only “protected” by stock fencing.

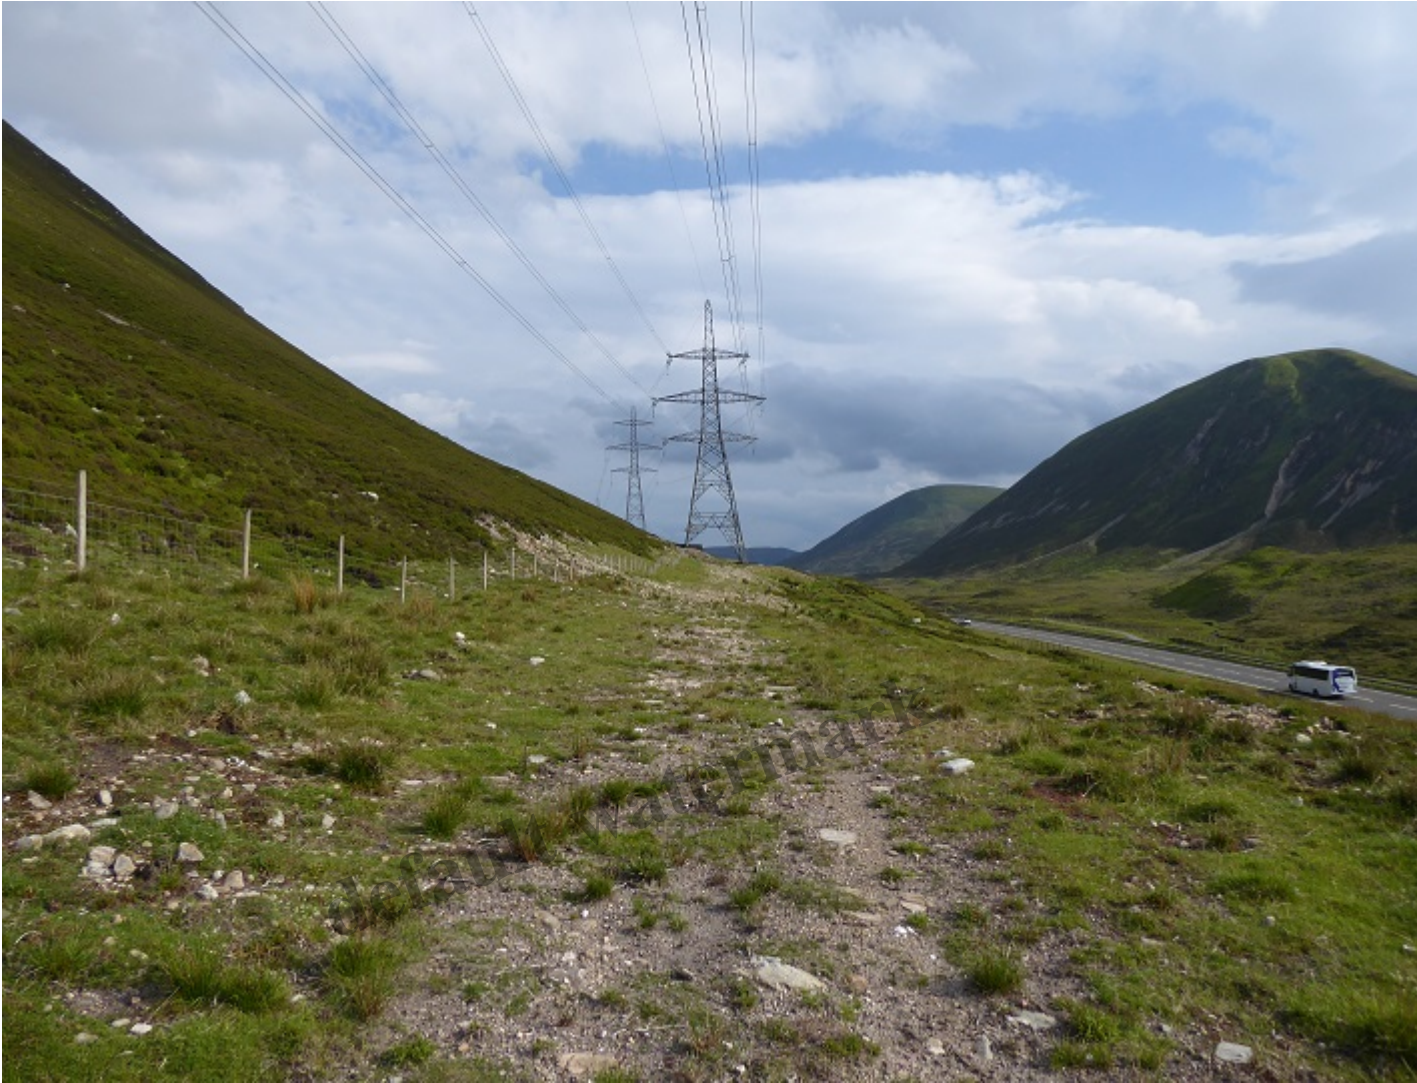
ATV track line running along the Beauldy Denny construction track towards tower 144

The theory behind the trial appears to have been that by comparing vegetation recovery in areas where only sheep were excluded with those where deer were too, that this would show which were causing the most problems. Much of any potential value of the trial has been undermined by the continued use of the Beauldy Denny construction tracks by vehicles. Had the track been properly restored it would have been much harder and less tempting to drive along it on All Terrain Vehicles.

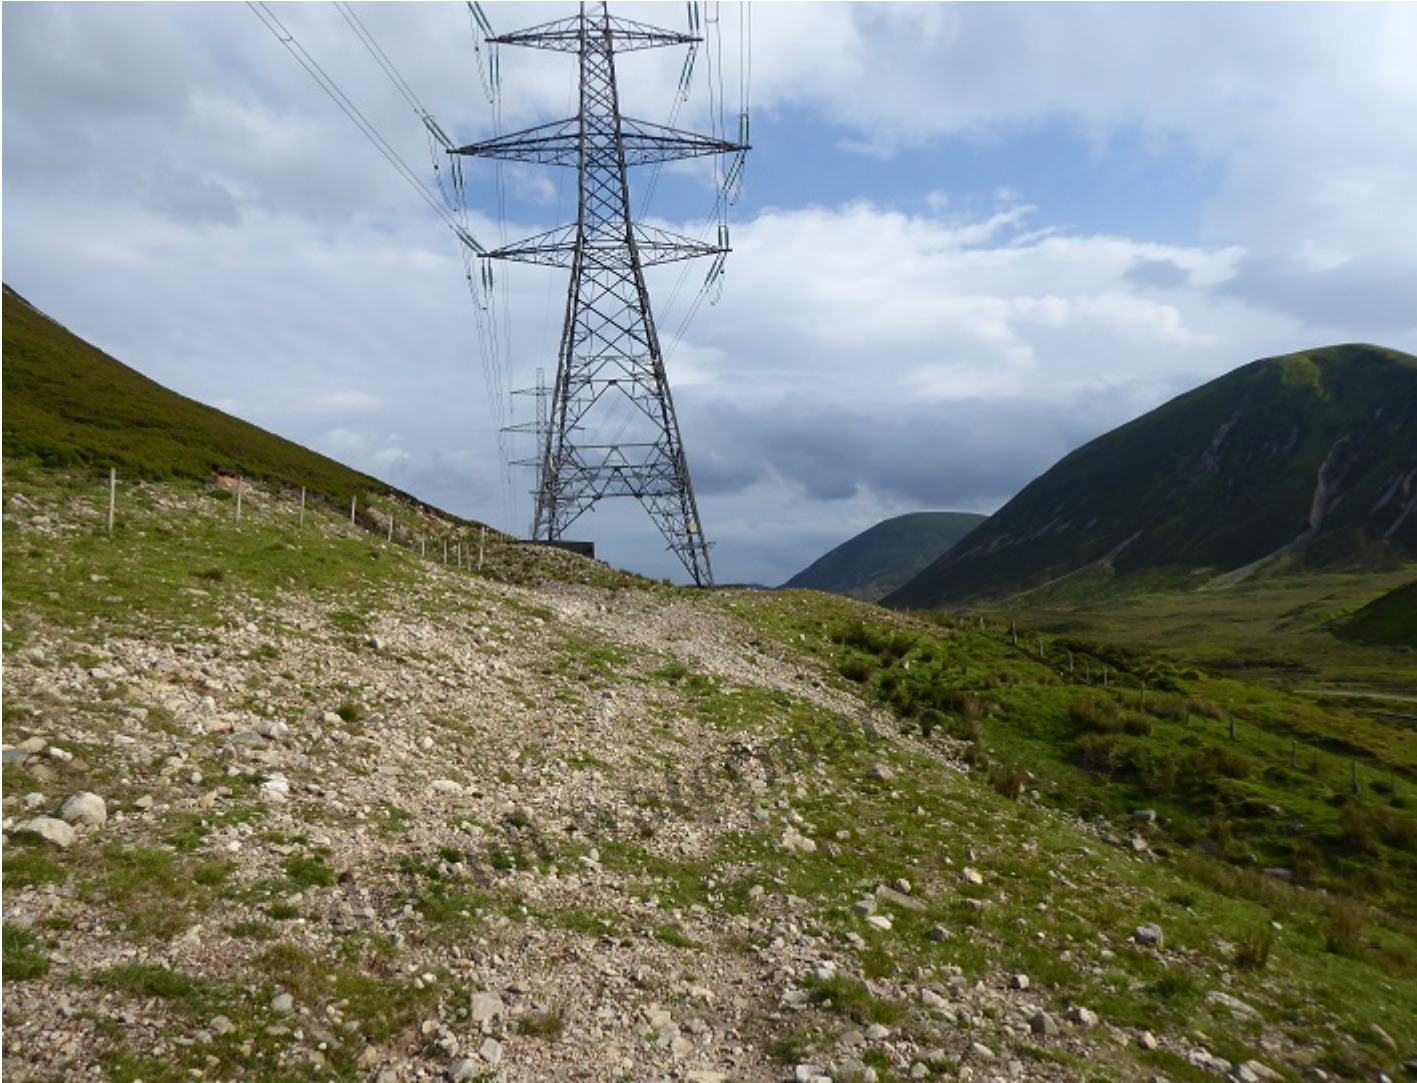
Approaching tower 144 with the line vehicles have driven still visible.

Only at the end of the flat section does ATV use become a little more challenging albeit still not enough to stop a skillful driver.

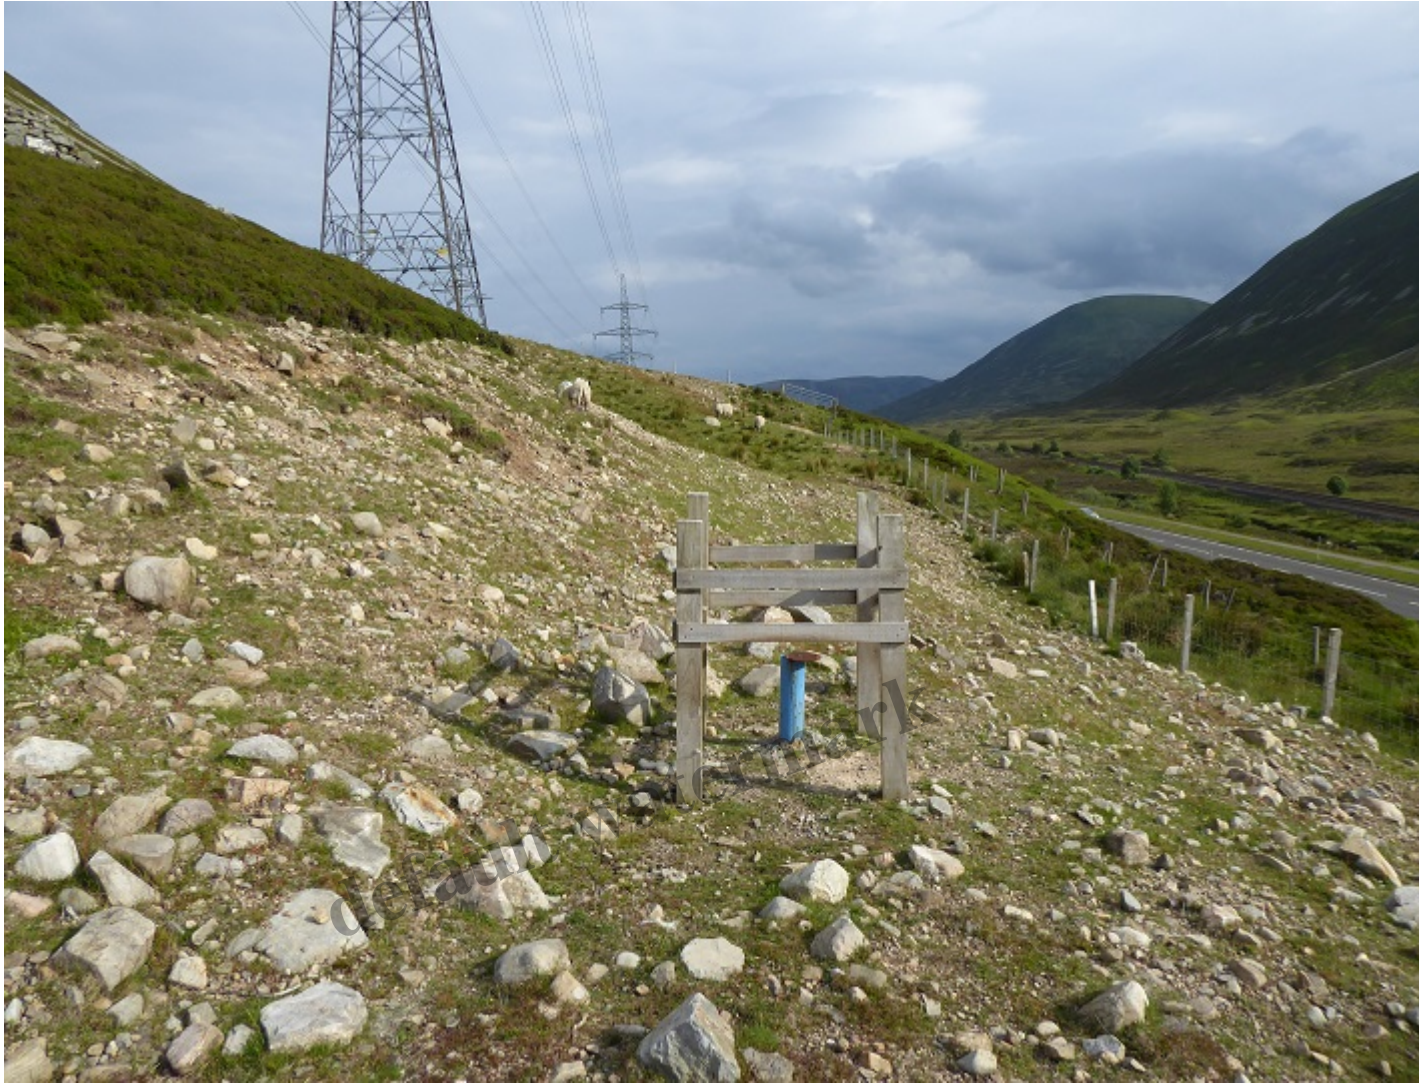
Tower 145. The blue pipe is part of the site investigations work for the A9 but it was construction of the Beaully Denny, not the sinking of this bore hole, which created the swathe of destruction visible in the photo.

The ATV tracks disappeared approaching tower 145 but at the end and inside the stock fence was a small herd of sheep!

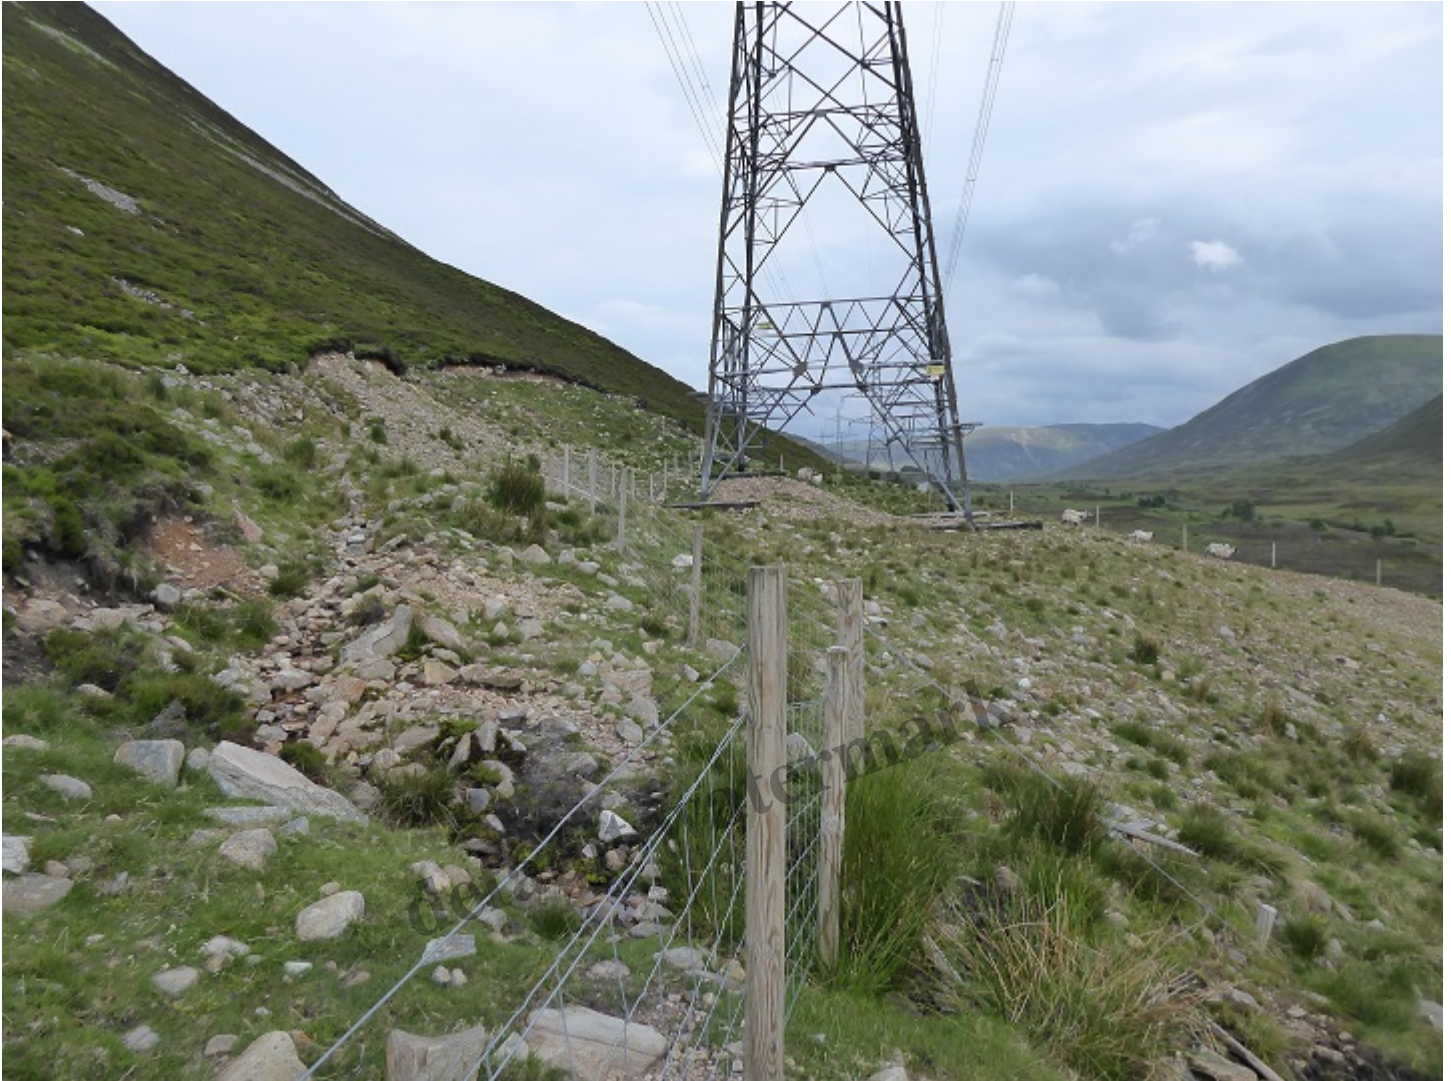
After my last post on the Beaully Denny Ron Greer commented that he had seen lots of sheep grazing along the landscape scar and this was impacting on the restoration. I then also saw a large herd on the section visible from the road but in the pouring rain, so I was unable to take any photos. Judging by the photographic evidence grazing pressure now appears as great inside the enclosure intended to exclude stock as out!

One of the planning conditions that should have applied to the Beaully Denny – and all other developments like hydro schemes that result in extensive ground disturbance – is that the developer should have to enter a legally binding agreement with the landowner to control grazing until vegetation has recovered. Instead, in the aftermath of the Beaully Denny construction the North Drumochter Estate has been provided with a new field for sheep courtesy of SSE.

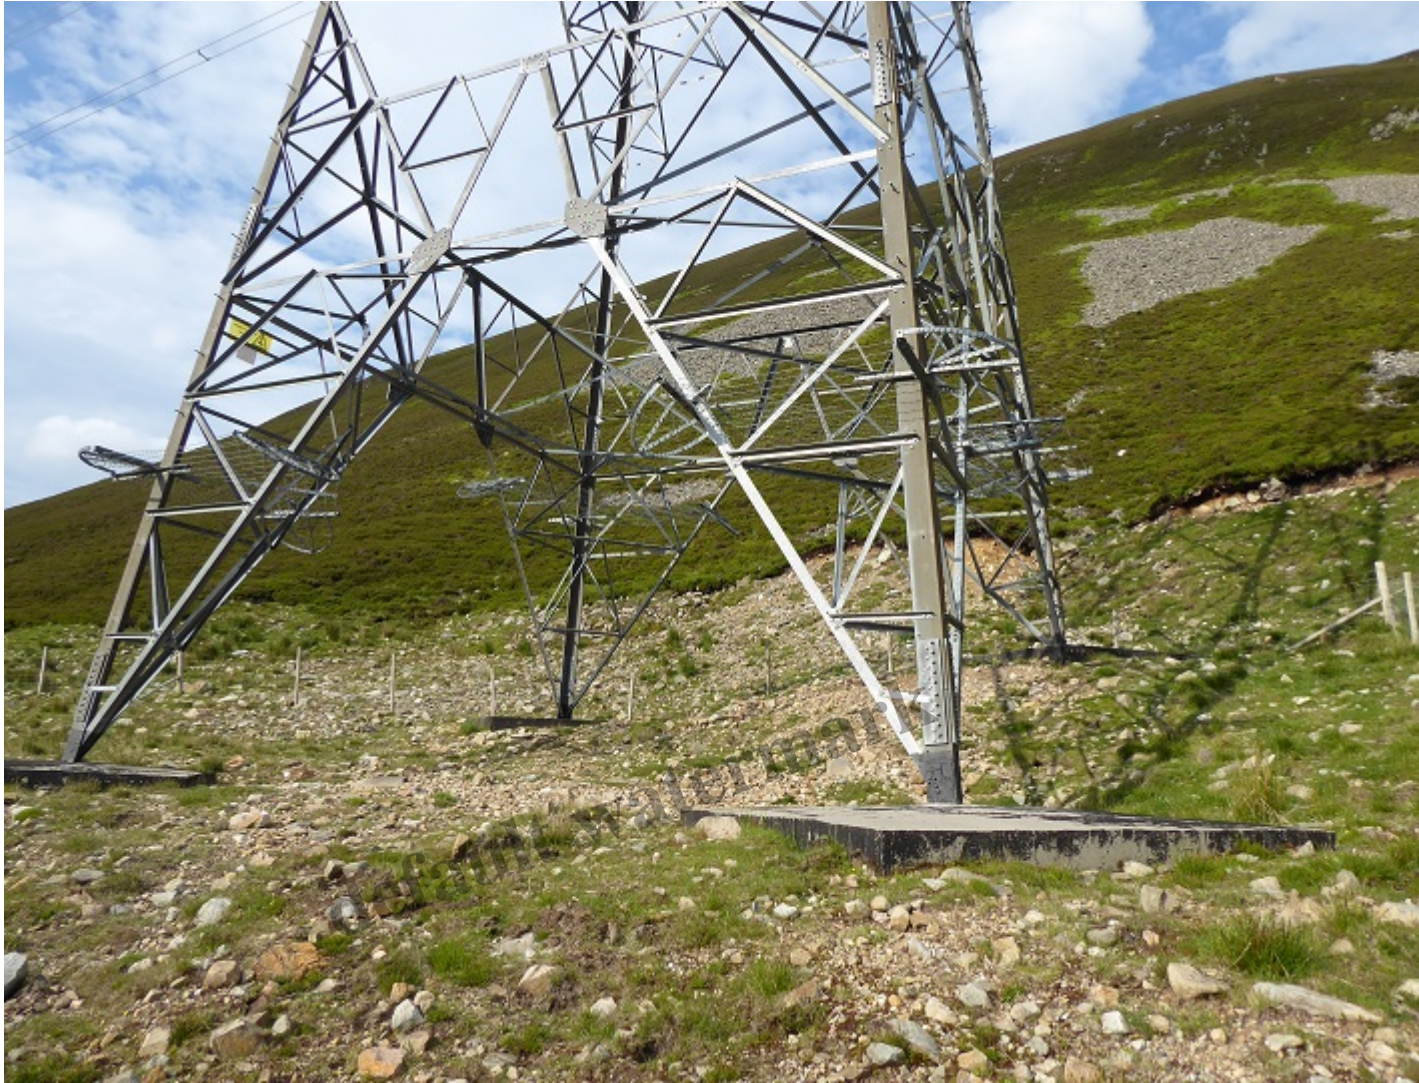
Beneath tower 145. There is little appreciable difference between the vegetation recover in the disturbed ground areas inside and outside the stock fence.

The exposed edge of peat along the edge of heather illustrates how the peaty soils that used to cover much of the area used to construct the powerline have been lost, releasing carbon into the atmosphere. What does this say about SSE's attempts to re-invent itself as a green energy company?

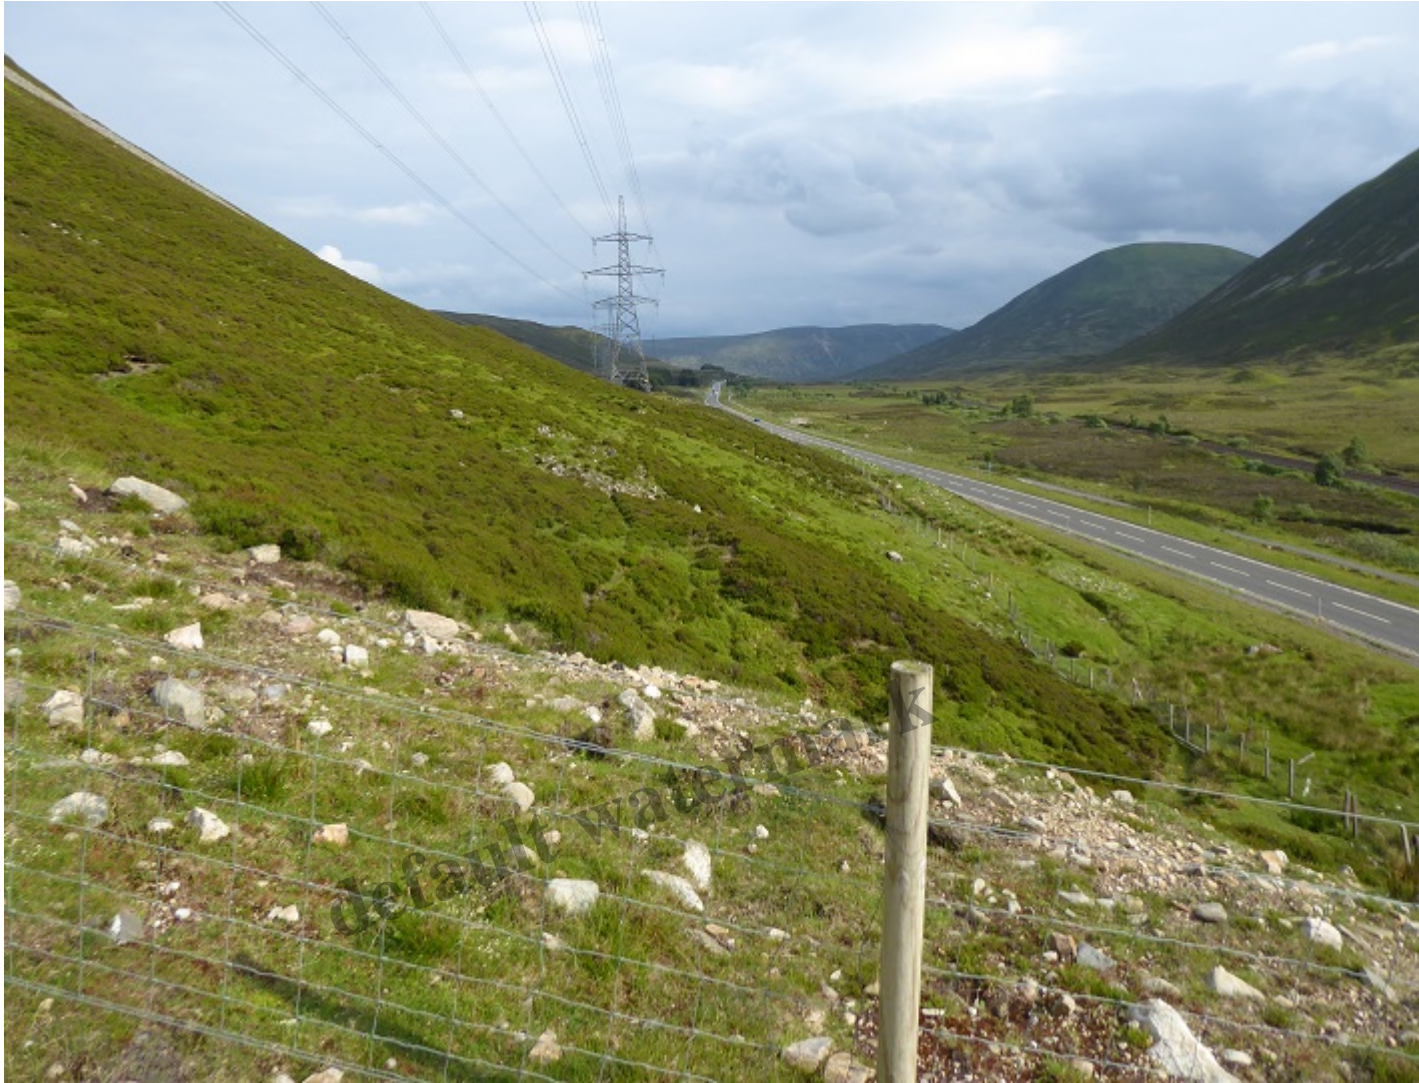
View from edge of stock fence and tower 145 to tower 146

It came as a relief and a contrast to reach tower 145. There was no construction track between towers 145 and 146 since both were erected using tracks coming from the other direction. This view shows how the land might look if it were restored properly.
