When are SSE and the Scottish Government going to take responsibility for the damage at Drumochter?

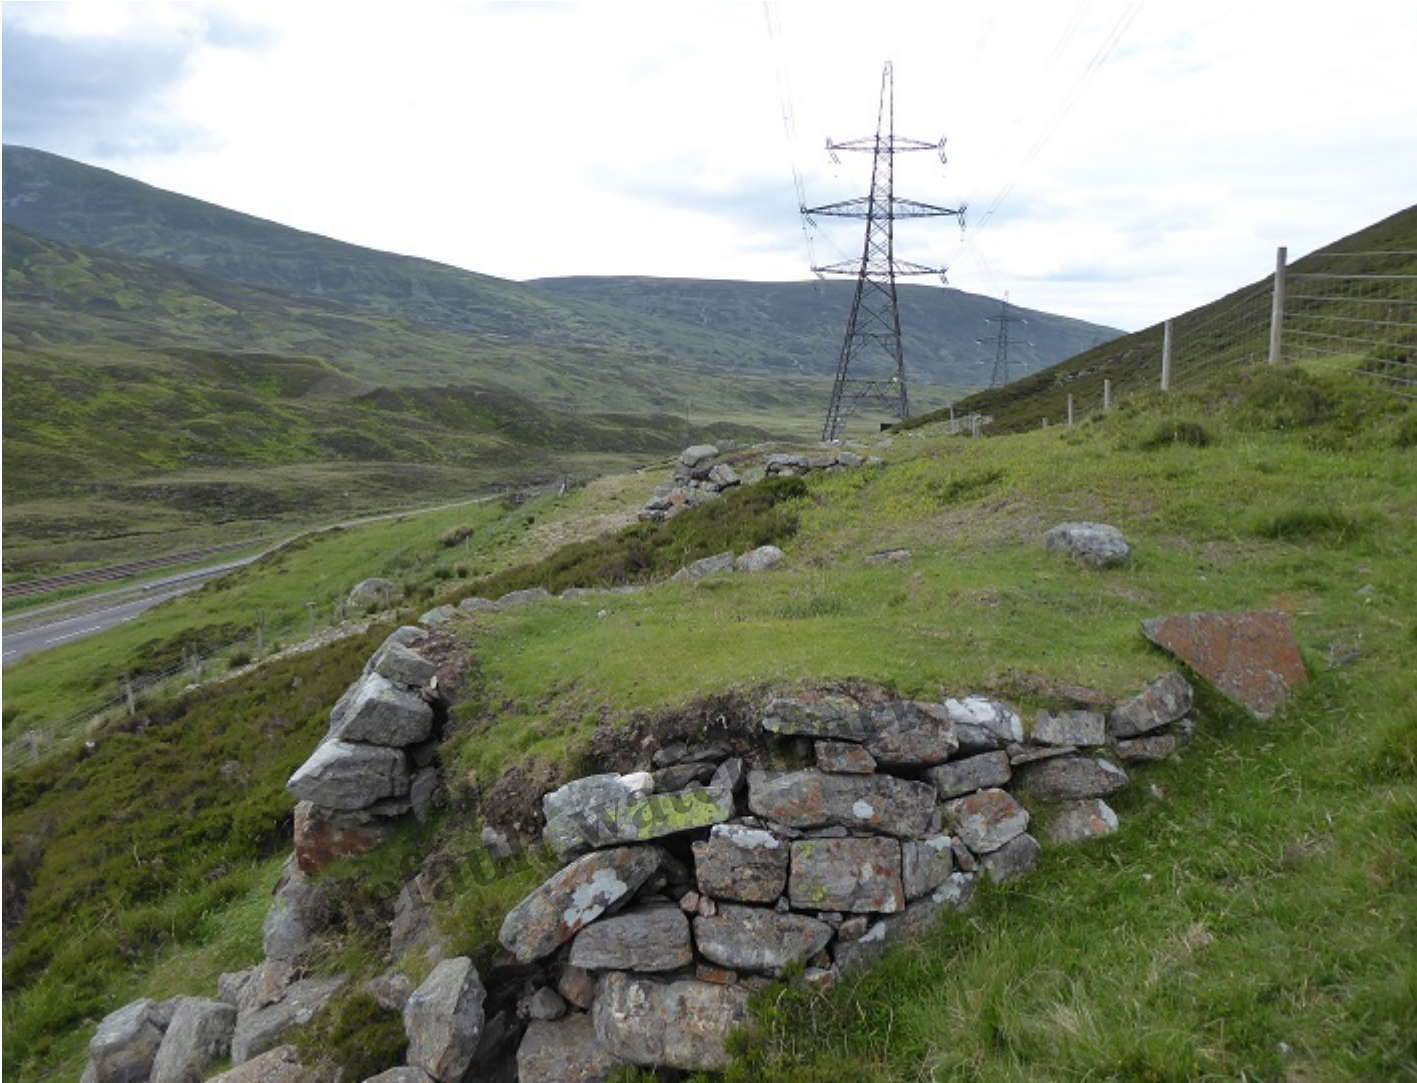
View back towards tower 144 with the footings for the old powerline towers in the foreground

While the construction of the former powerline through the Drumochter appears to have caused far less damage than that of the Beaully Denny and used local materials, it also impacted on the natural environment, altering the drainage and bringing mineral soils to the surface. That helps explain why, years later, there is a sward of of bright green grass around this former footing. The photo helps illustrate that talk of restoring land to its original state after construction may be esay but it's very difficult in practice. Still this looks far better than the Beaully Denny construction is ever likely to do as the construction footprint was much less.

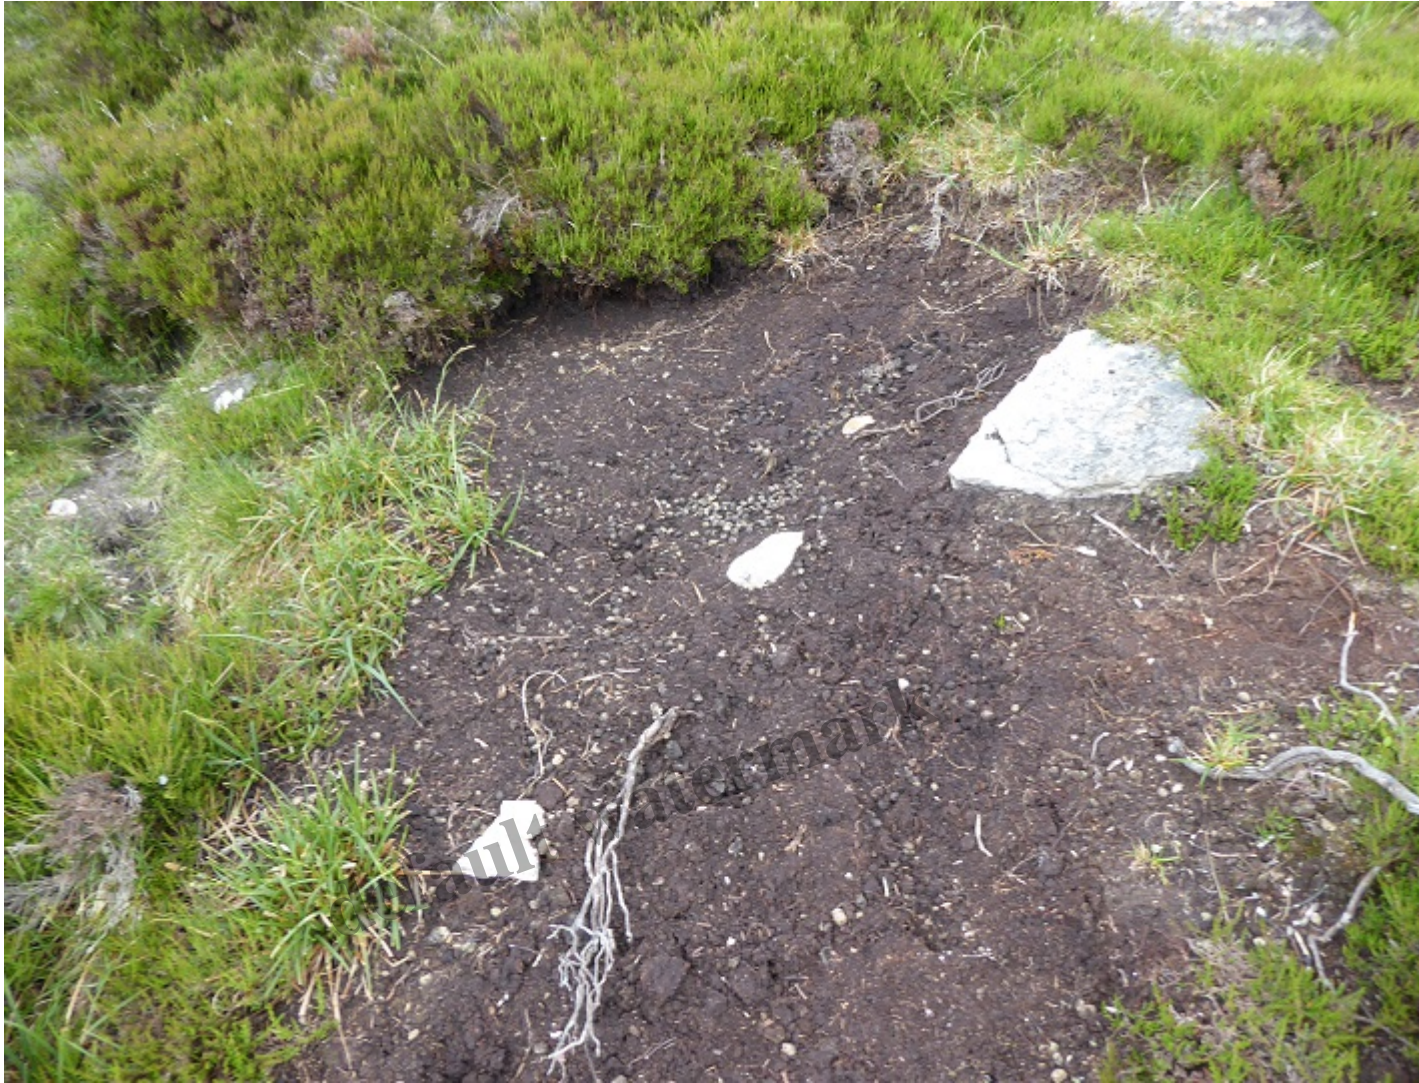
Rabbit poo, with a burrow just to the left

Walking through the stock enclosure, I saw several rabbits and their burrows. Rabbits too help prevent moorland vegetation from recovering and appear to be flourishing. Part of the explanation may be an absence of predators, with the powerline making it very dangerous for raptors to hunt here.

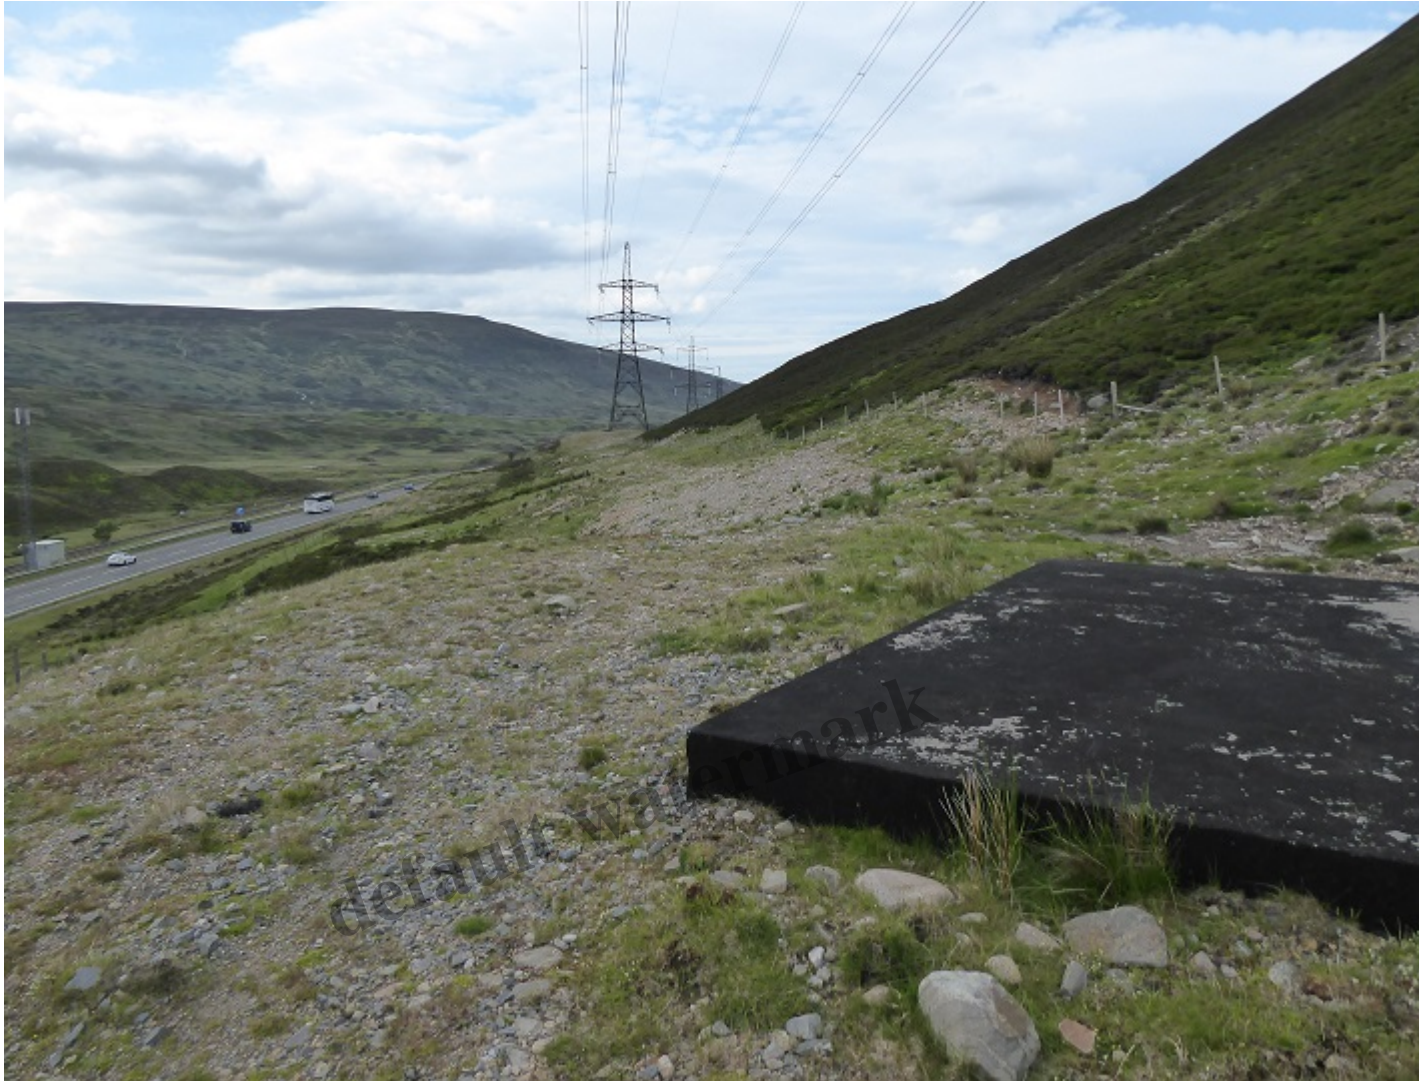
View back from tower 144 to tower 143. The extent of the construction impact here is hidden from the A9 below because of shape of the slope

It is not just vegetation that is the issue. SSE and Balfour Beatty never restored the form of the land but instead left a benchline across the hillside, which has altered drainage patterns and is an invitation to estate staff to drive along it. While the CNPA has rightly in the past highlighted the failures to restore vegetation, they have never tried to address the more fundamental which is about the failure to restore the landscape. Only the Scottish Government has the power to do that.

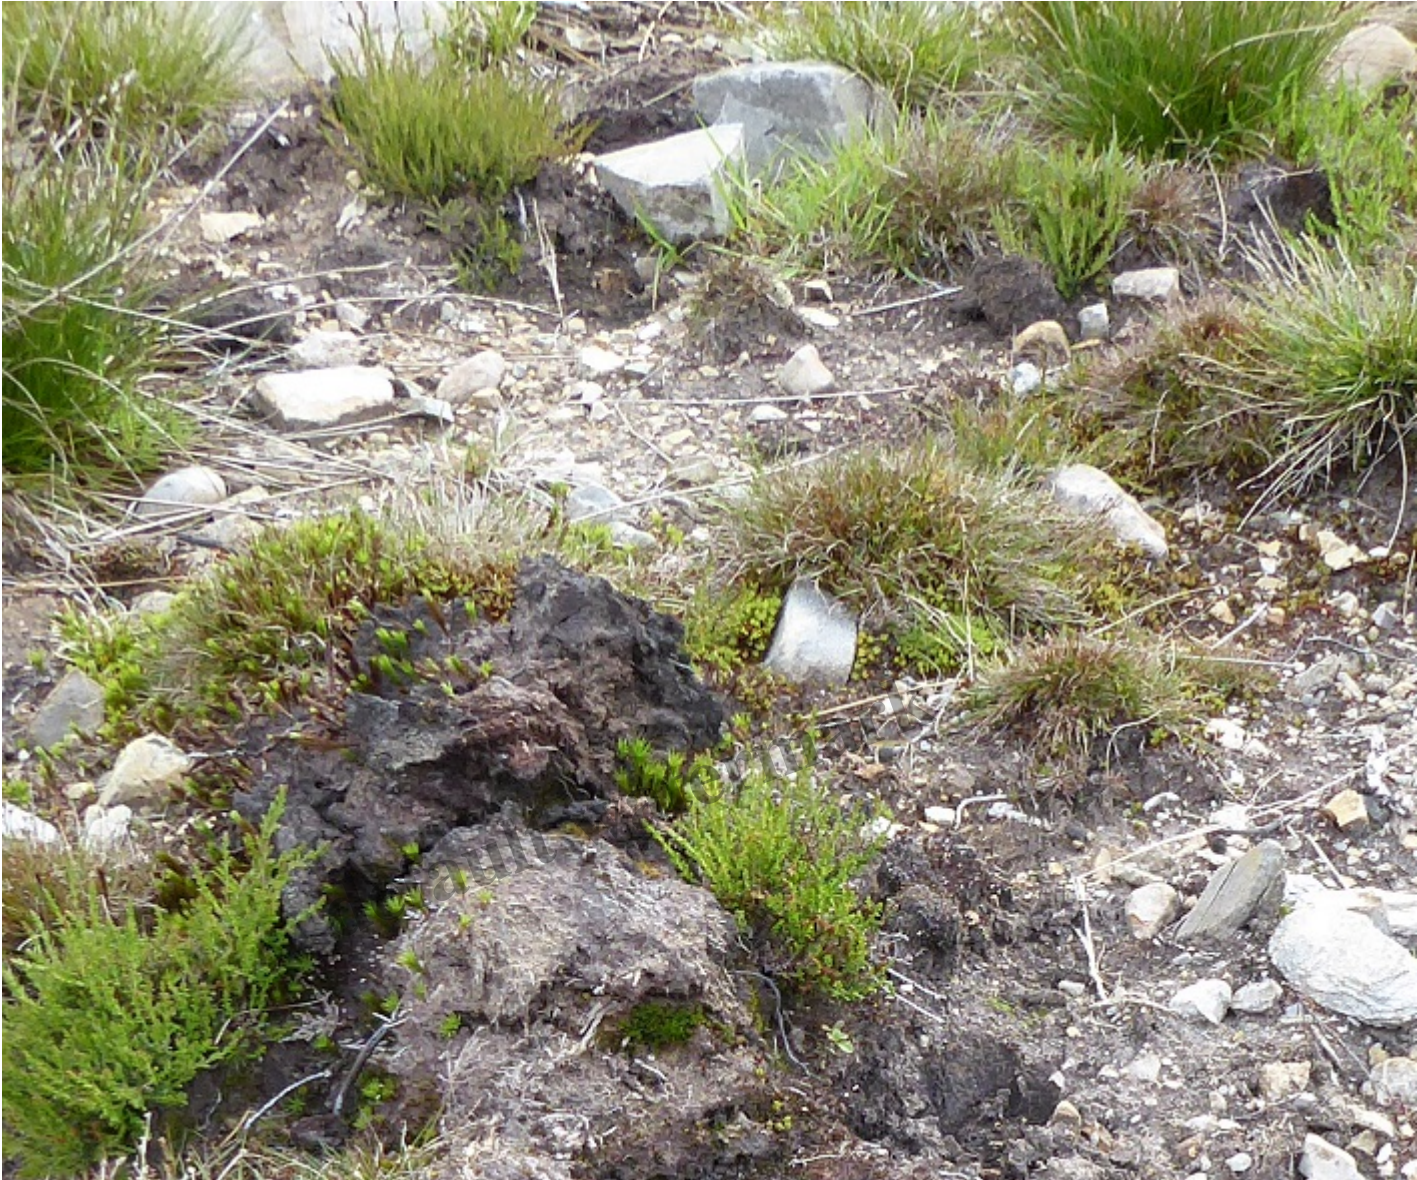
Another example of restoration greenwash

Instead of storing the shallow peat during the construction and replacing it once the landforms had been restored, SSE and Balfour Beatty allowed what little peat was left to be placed in clumps back on top of the disturbed ground. This has exposed the peat to the atmosphere and to oxidation and as a result there is significantly less peat now than there was five years ago and it is almost inevitable that any remaining peat will soon be lost.

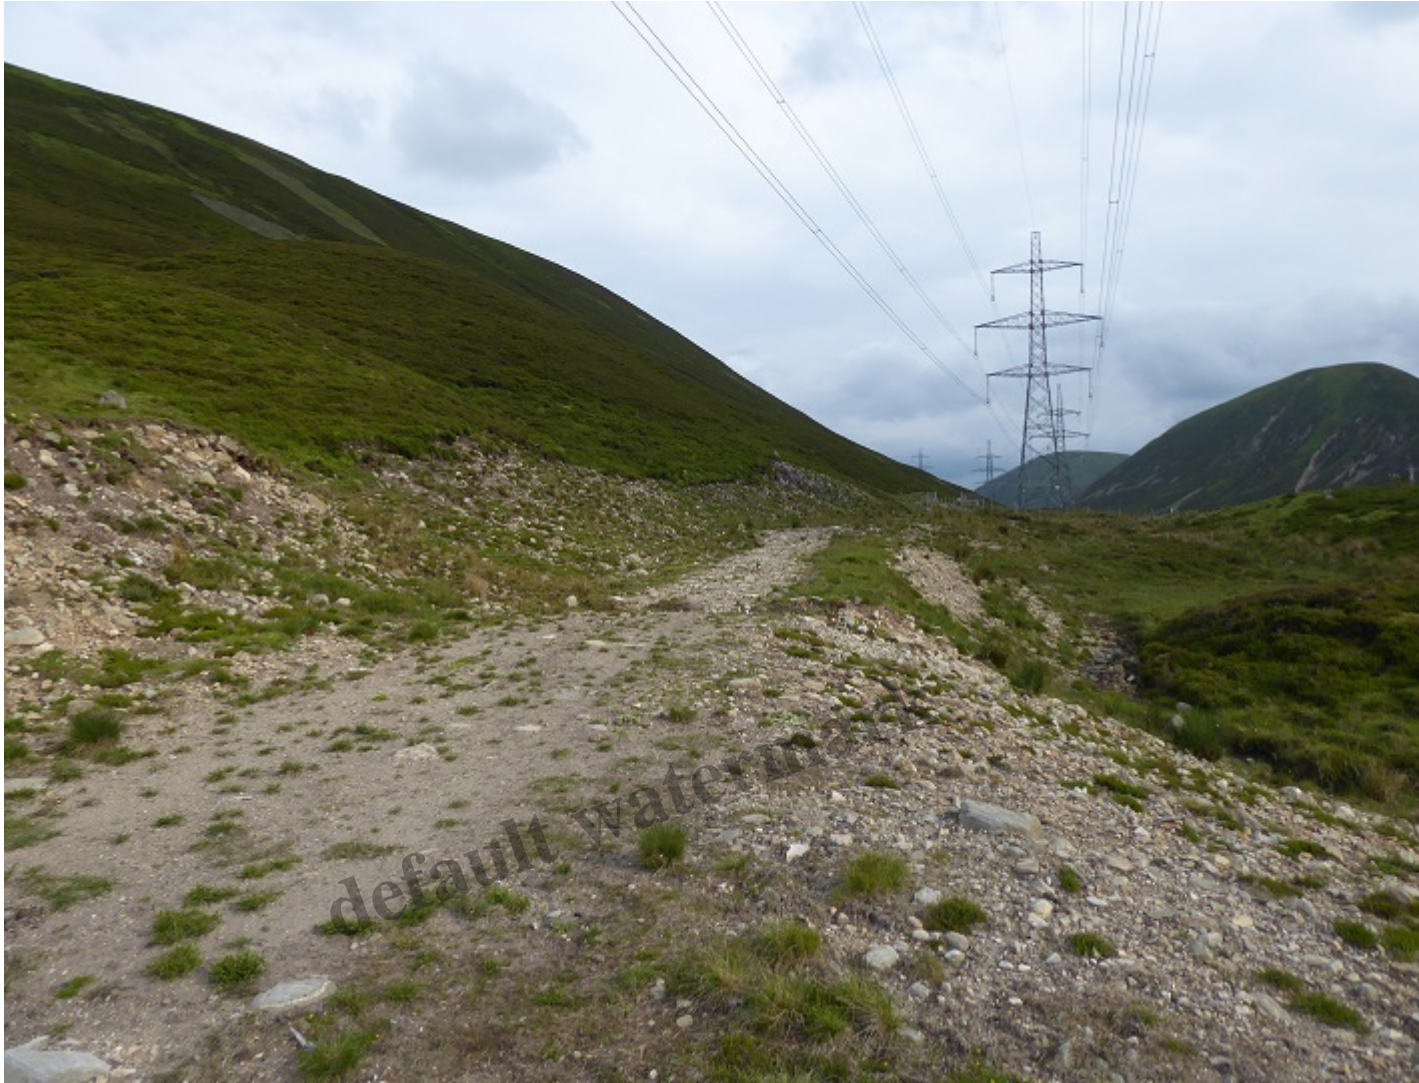
View from near tower 140 south towards tower 141 along a section of unfenced track

Large sections of the construction track within the trial restoration areas are still in situ, the landforms altered and disturbed areas now almost completely devoid of peat or heather. The vegetation is unlikely to change back to what is once was by natural regeneration – SSE’s preferred restoration methodology which happens to cost them nothing – until the minerals leach out of the new surface soil but even then the altered drainage may result in different vegetation.

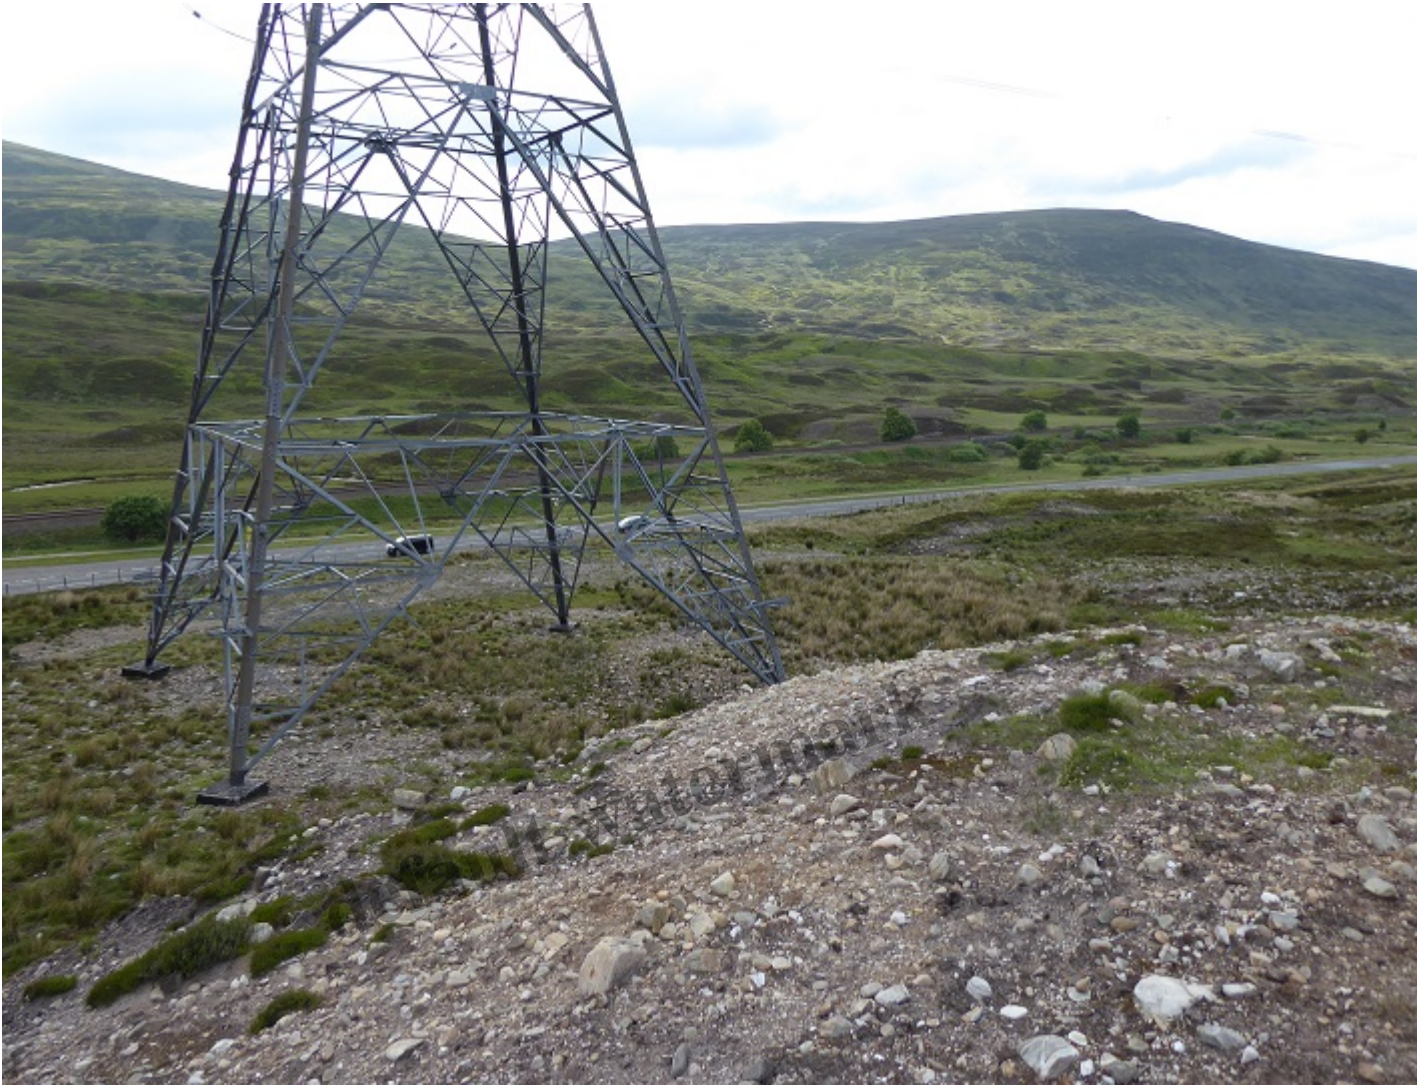
The area around tower 141

This area by tower 141 was supposed to have been re-seeded under the trial restoration project but there is little evidence of that now. Whatever seed was sown either failed or has been eaten!

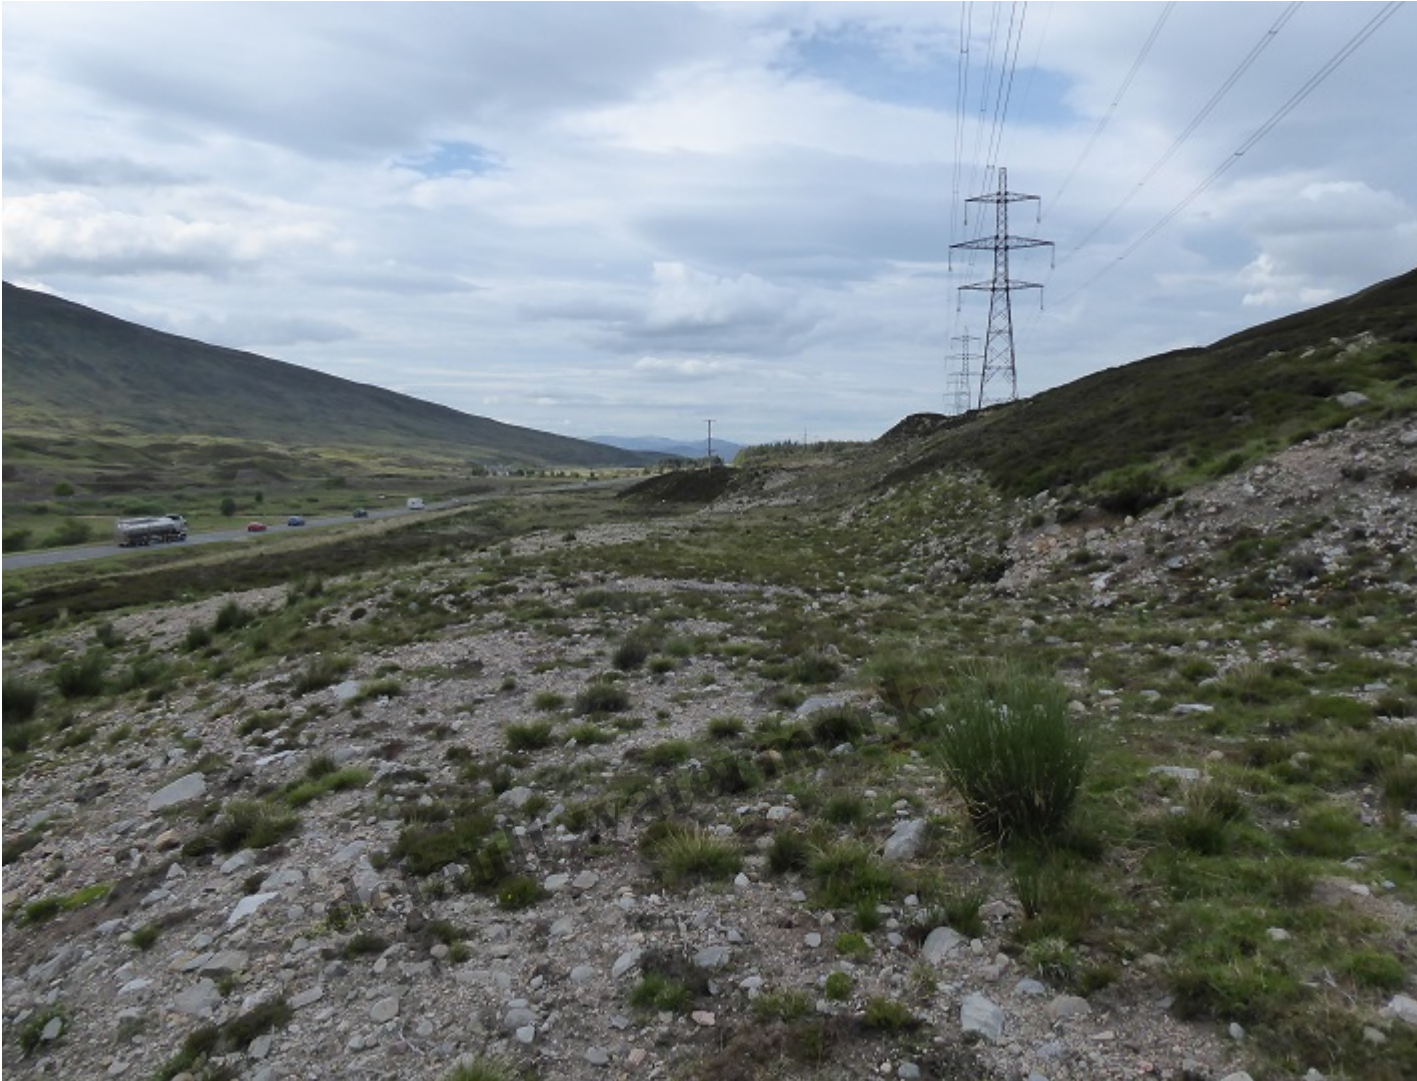
View from tower 141 to 140. This part of the trial restoration area is visible from the A9 and forms the start of the long landscape scar that runs to the policy woodlands around North Drumochter Lodge
