SSE and powerlines – another landscape disaster in the Cairngorms National Park above Dava Moor

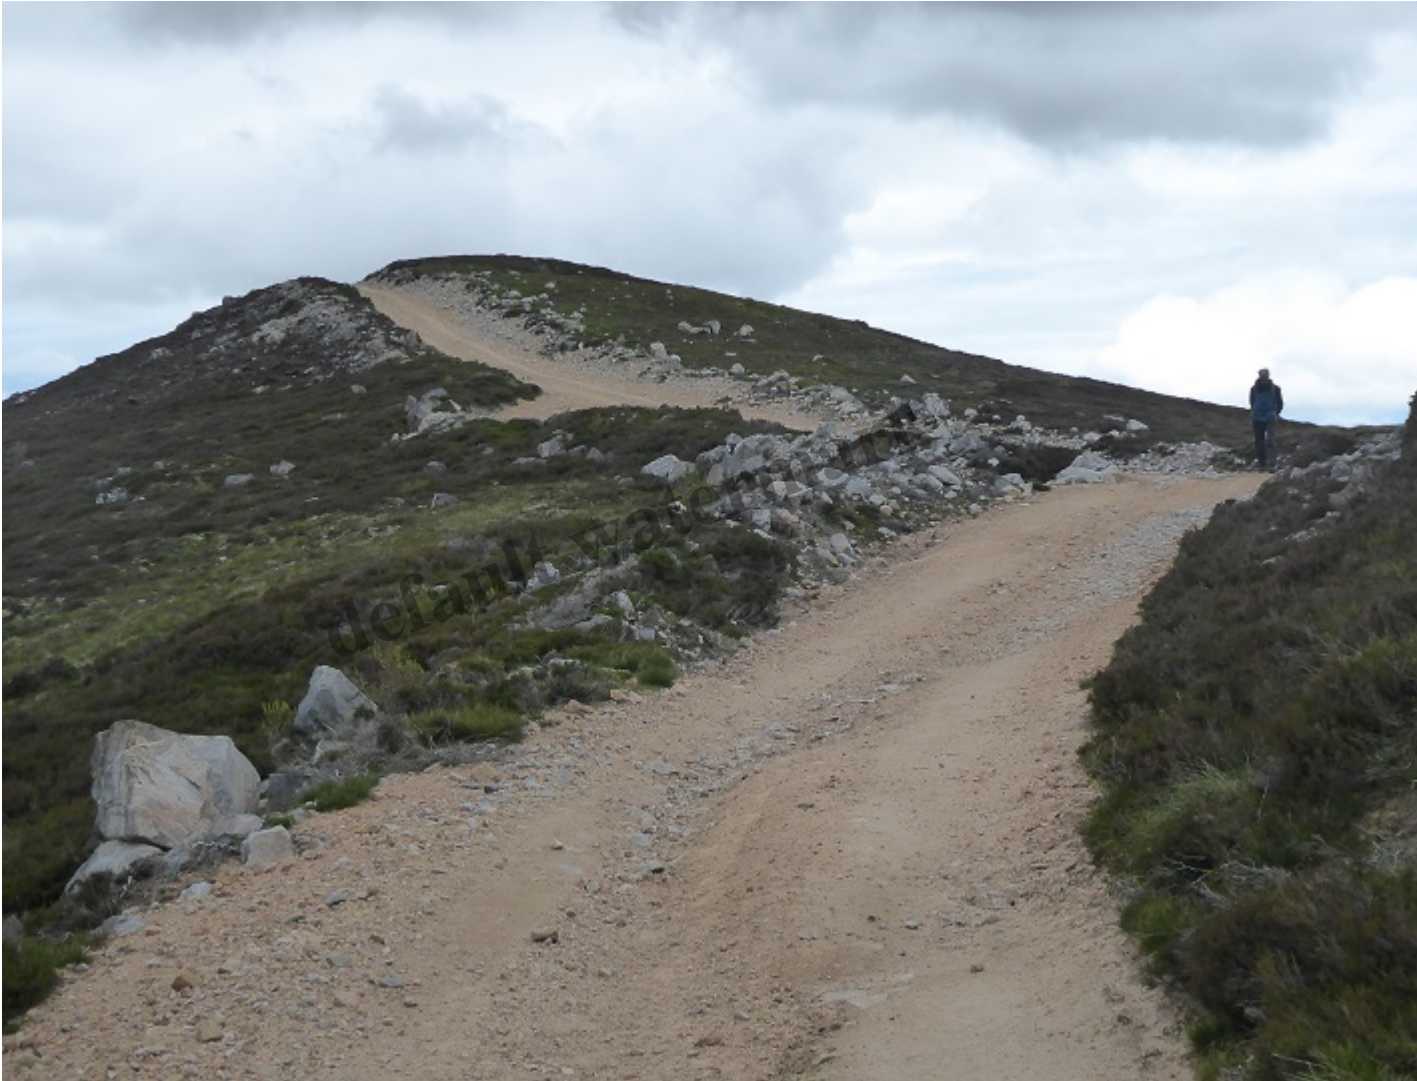
The upgraded road over the knoll north of Creag n'h Iolaire within the National park boundary

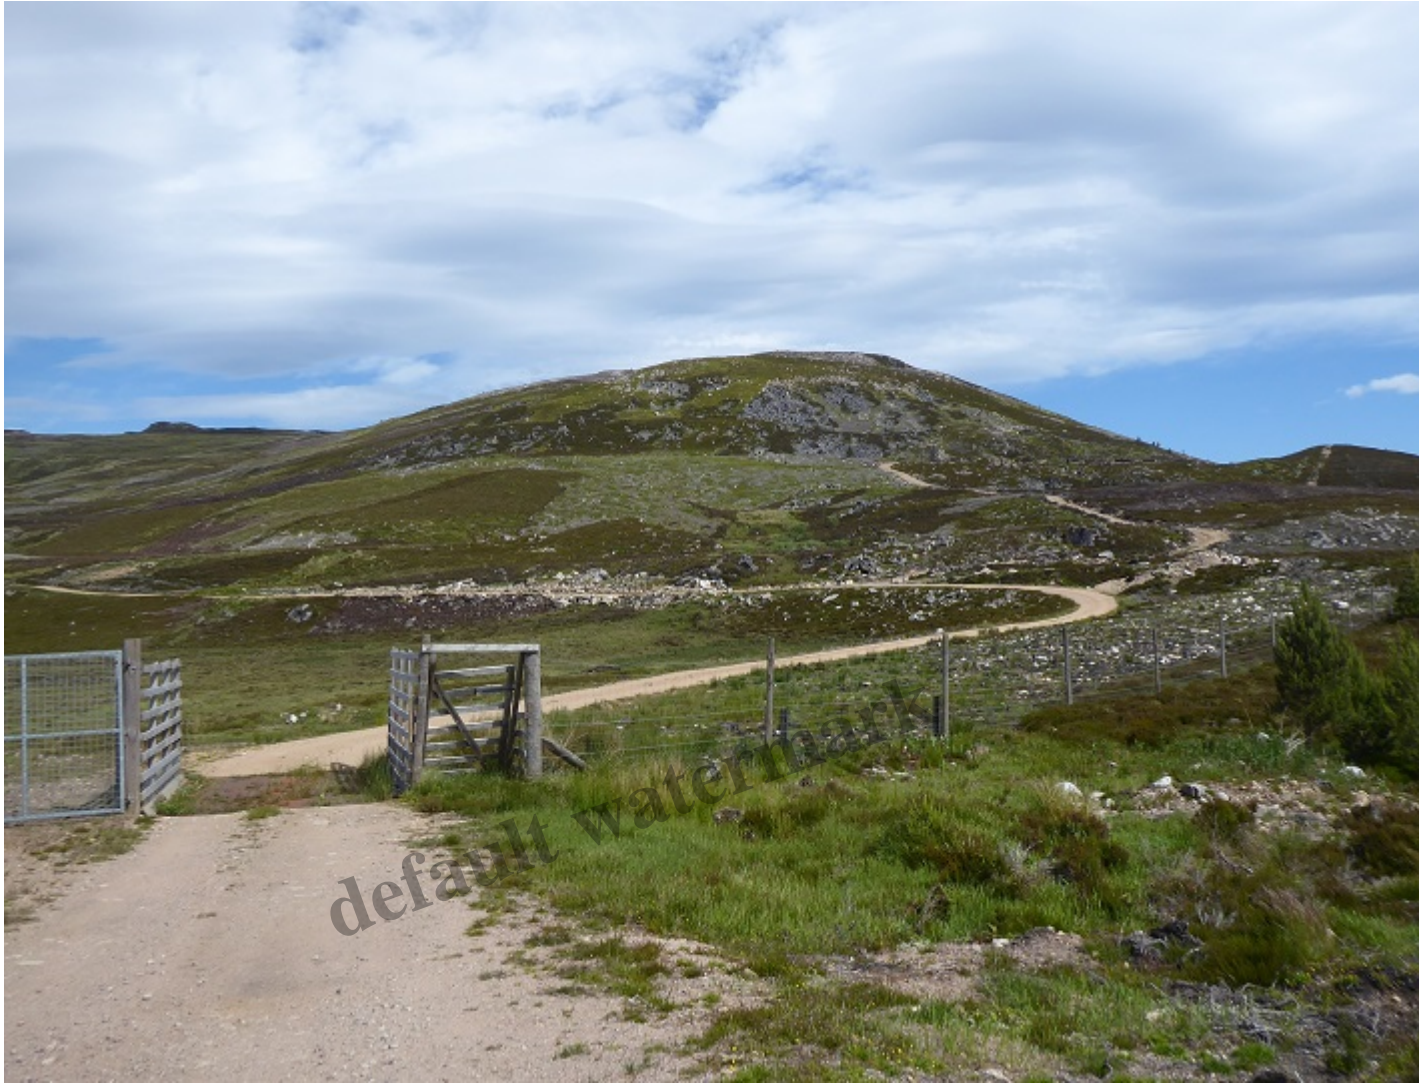
Note the two plastic powerline markers by the posts to the right of the gate

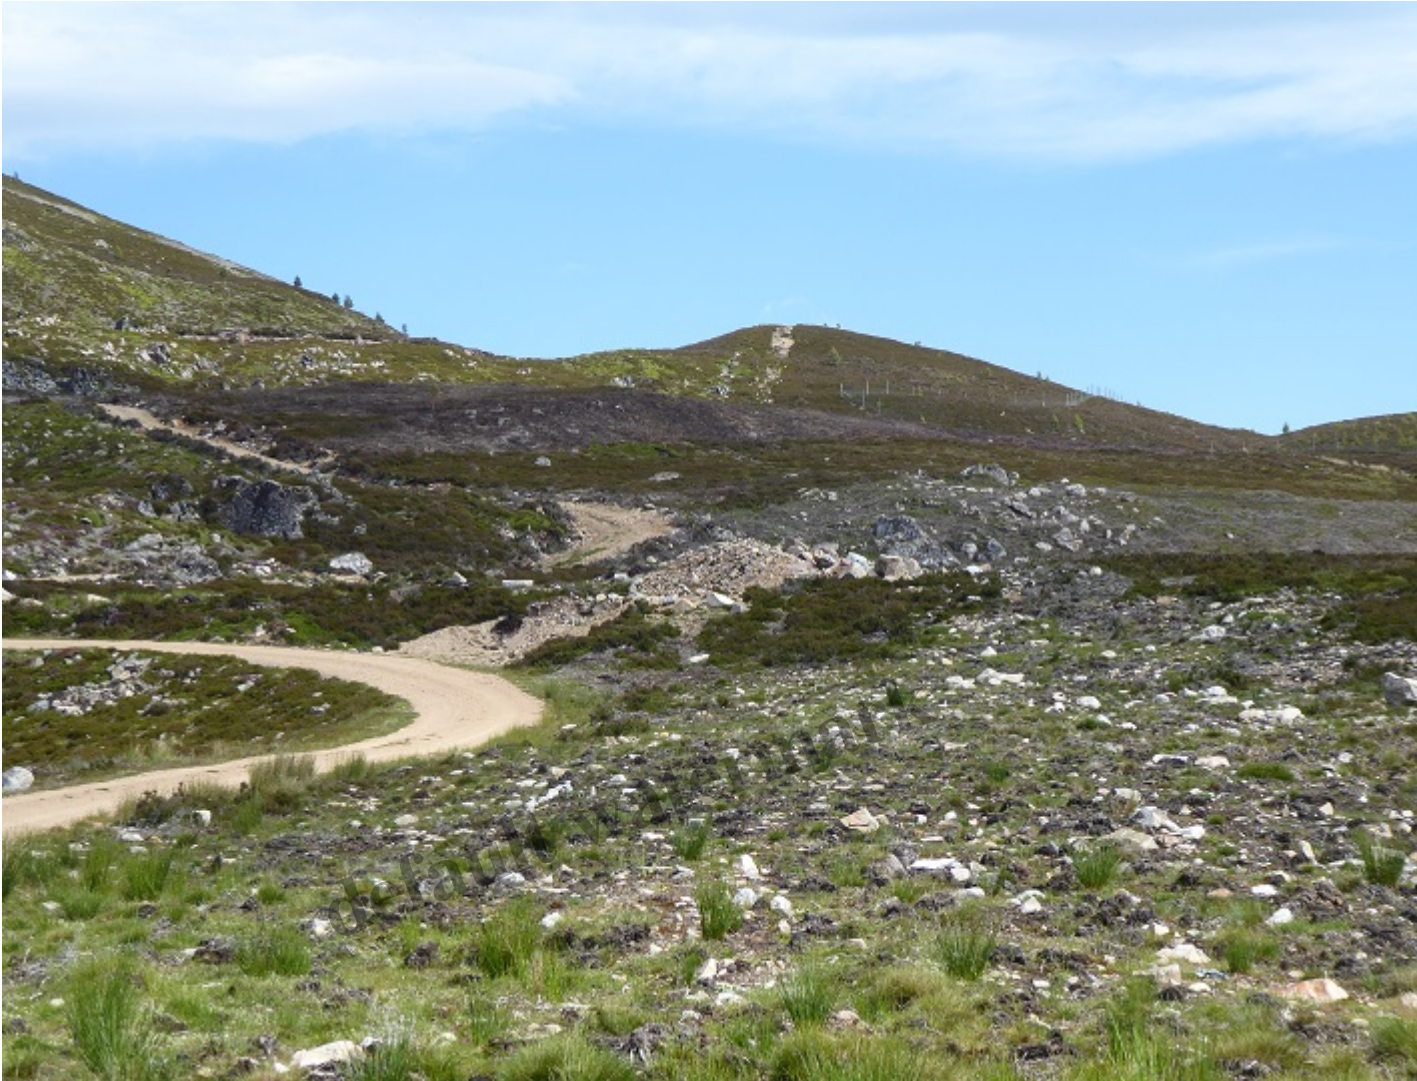
The powerline runs beneath the disturbed ground in the foreground and then curves to the left rather than follow the track directly up the hill.

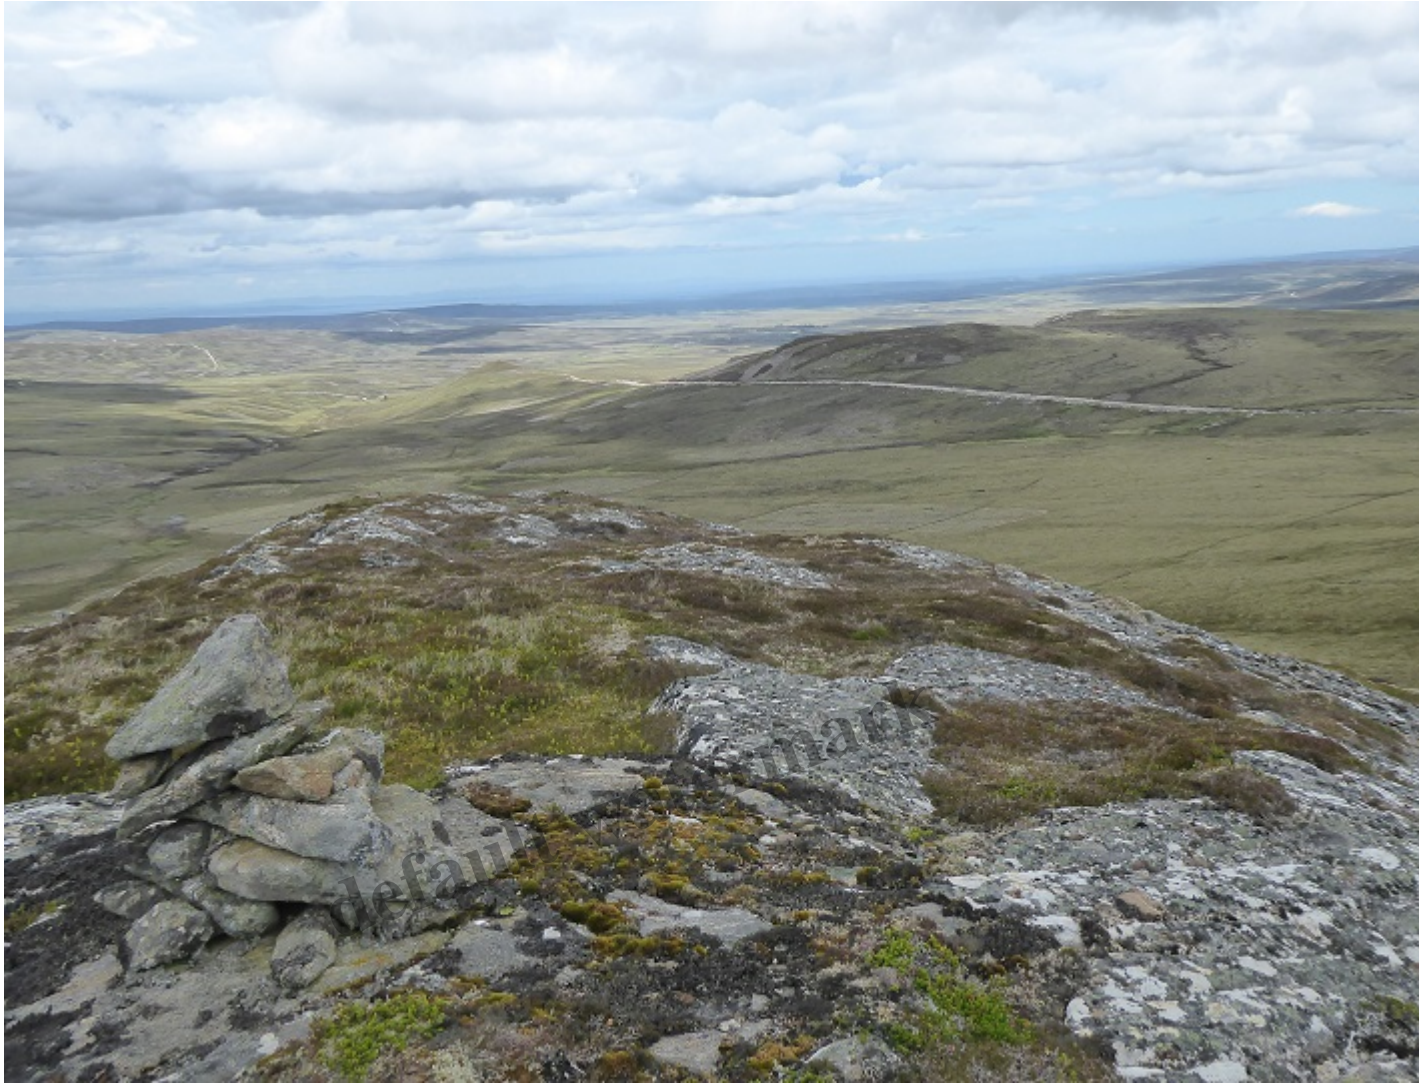
The upgraded road appears to split near where it meets the watercourse left of centre, with the branch that bends left (only just visible) connecting with the windfarm in the previous photo.

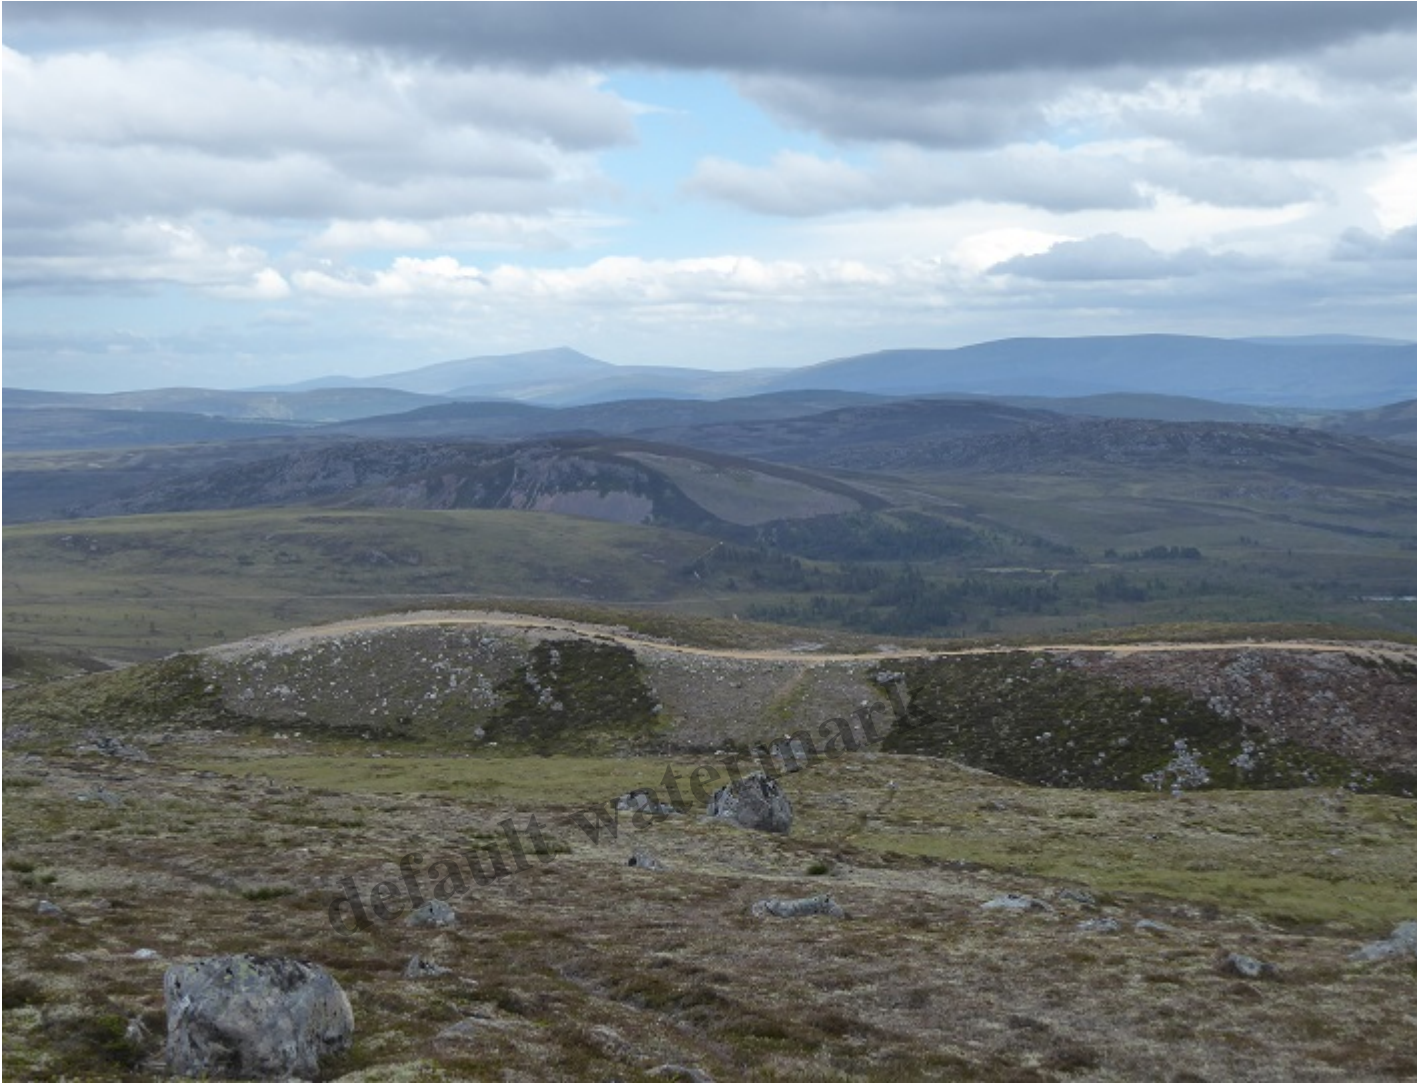
The road over the knoll north of Creag na'h Iolaire, which lies just inside the National Park boundary, with Ben Rinnes behind

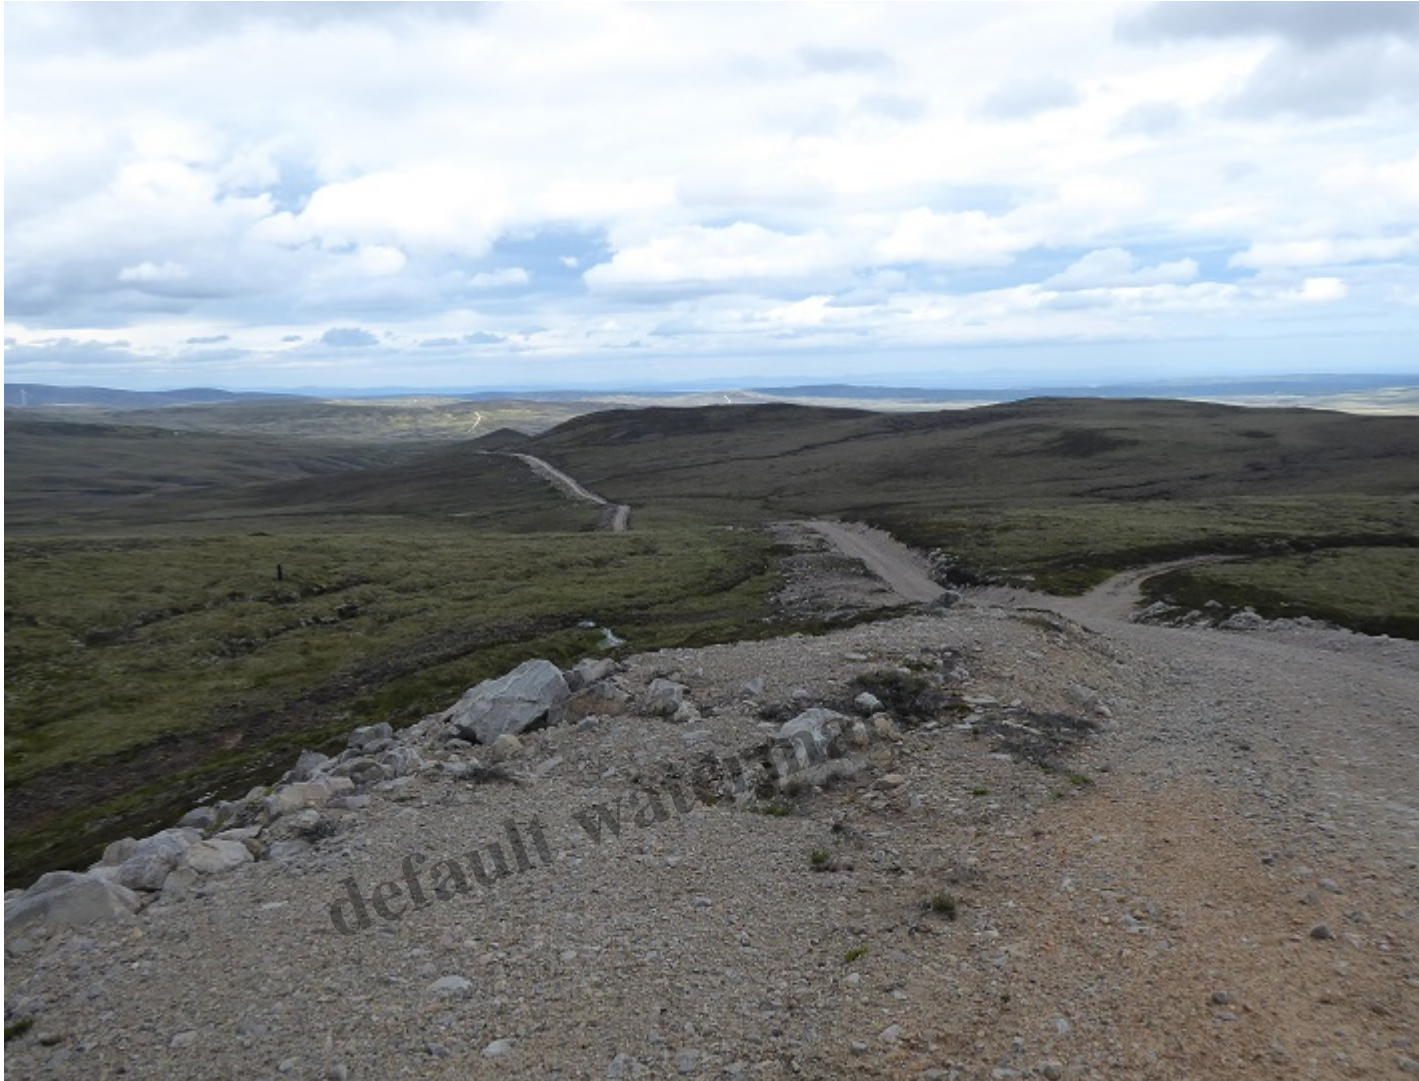
View north from the National Park boundary towards the Moray firth. Note the wind turbine visible in the distance on the far left. The power cable is buried on the left hand side of the road.

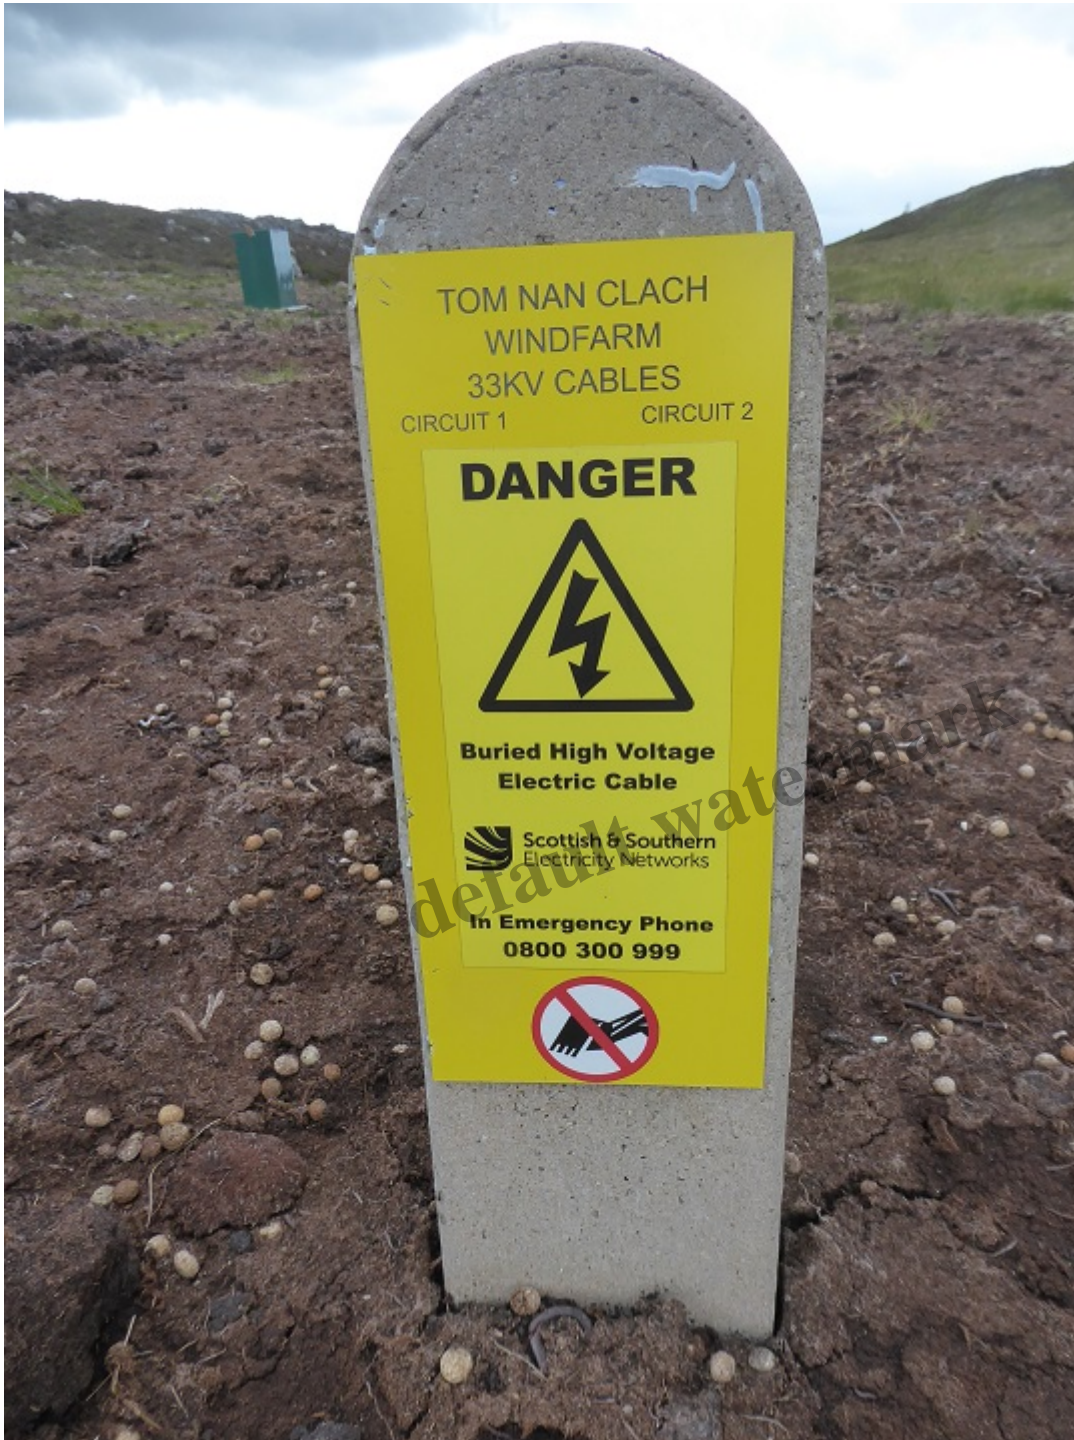
That the work was associated with a windfarm and the responsibility of SSE was confirmed by this marker post close to the road.

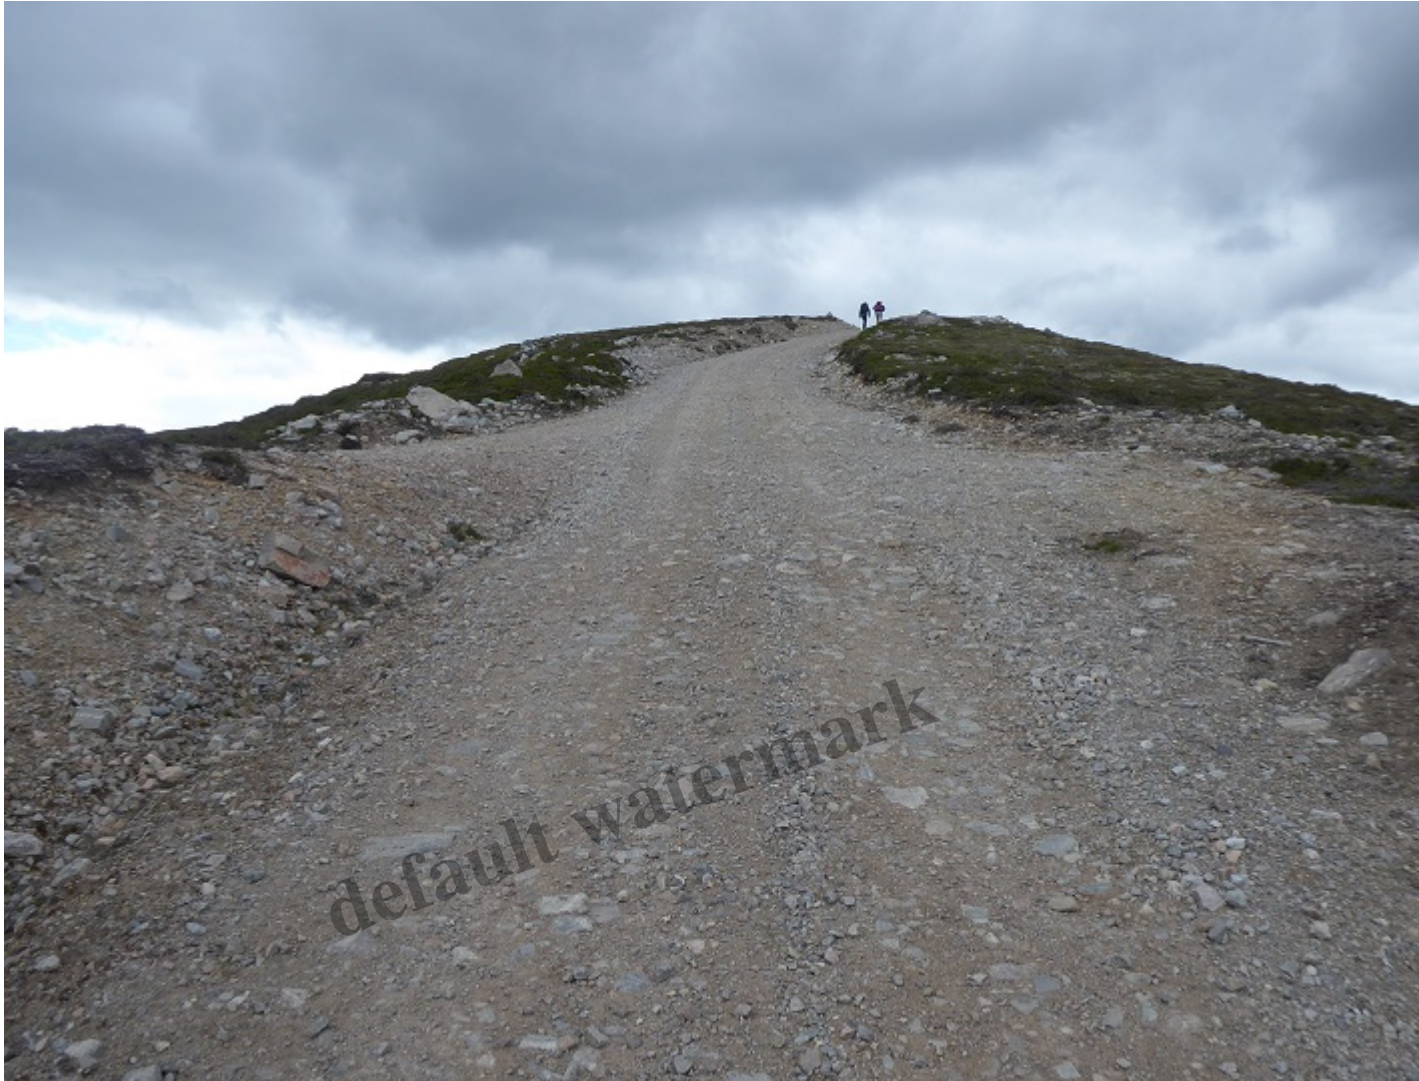
View back into the National Park from near the boundary, the opposite side of the knoll from the top photo.

My 2011 edition of the 1:50,000 OS map shows that there was a road here at that time but it has clearly been “upgraded” recently. On returning home, there was nothing on either the CNPA or Highland Planning portals about this road being upgraded which should have happened if Cawdor Estates was responsible. It appears therefore that either this road work has been classed as a permitted development by a utility company or else dealt with by the Scottish Government Energy Consents Unit as part of the Tom nan Clach windfarm development. It appears almost certain, therefore, that SSE are responsible for both the burial of the powerline and the road upgrade.

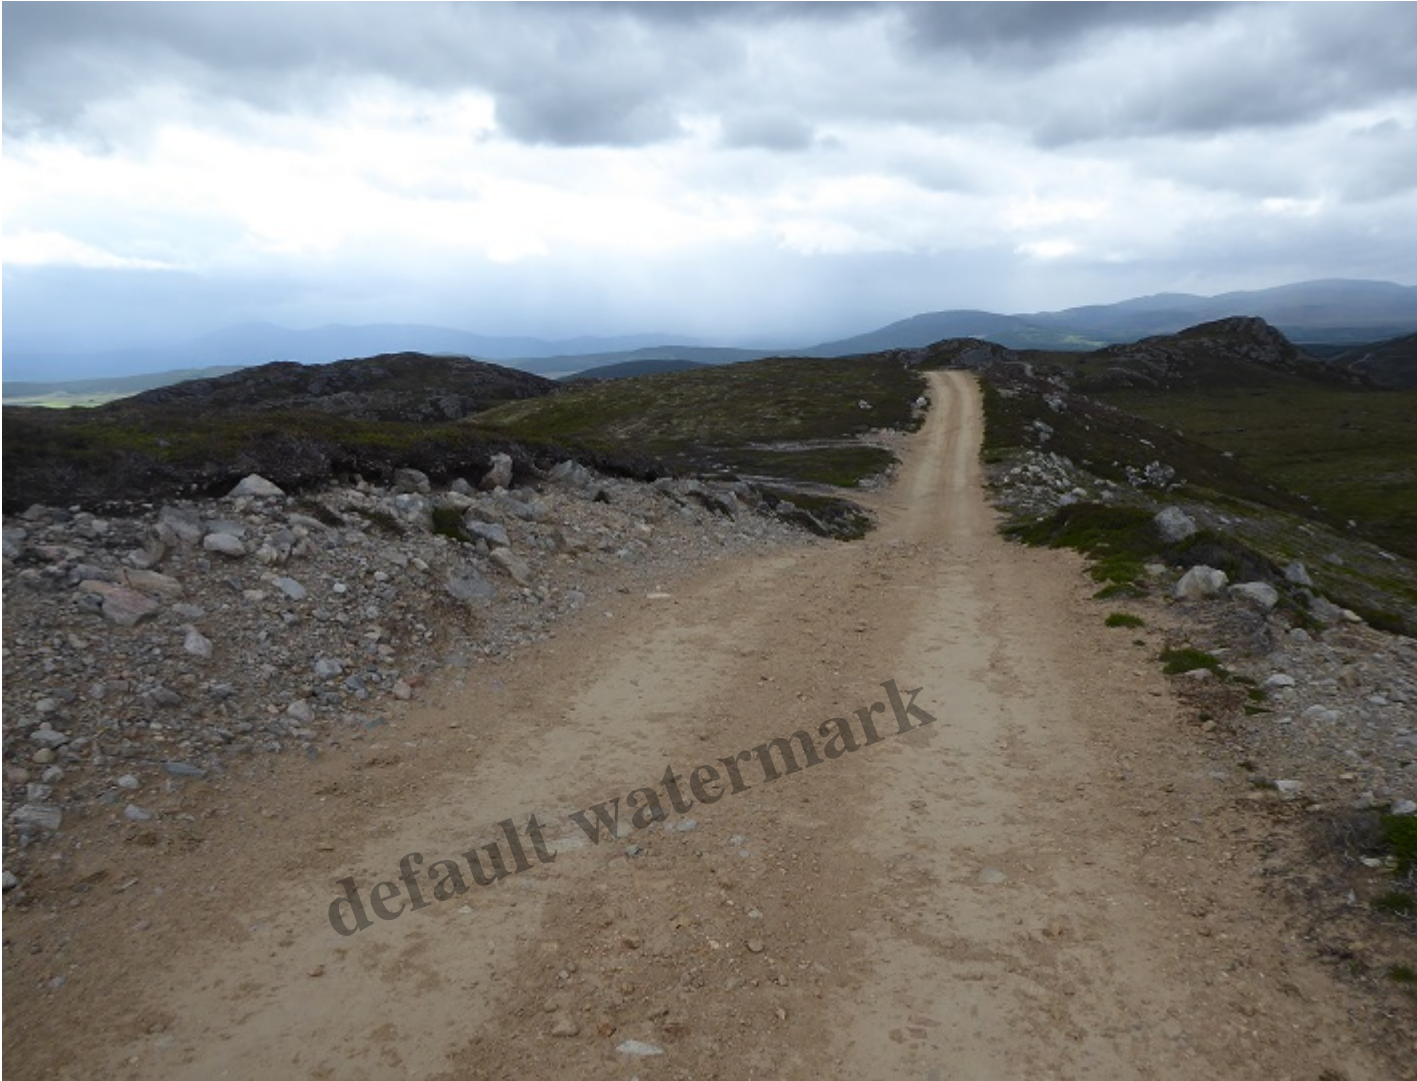
Looking south along the road as it runs across the top of the ridgy knoll

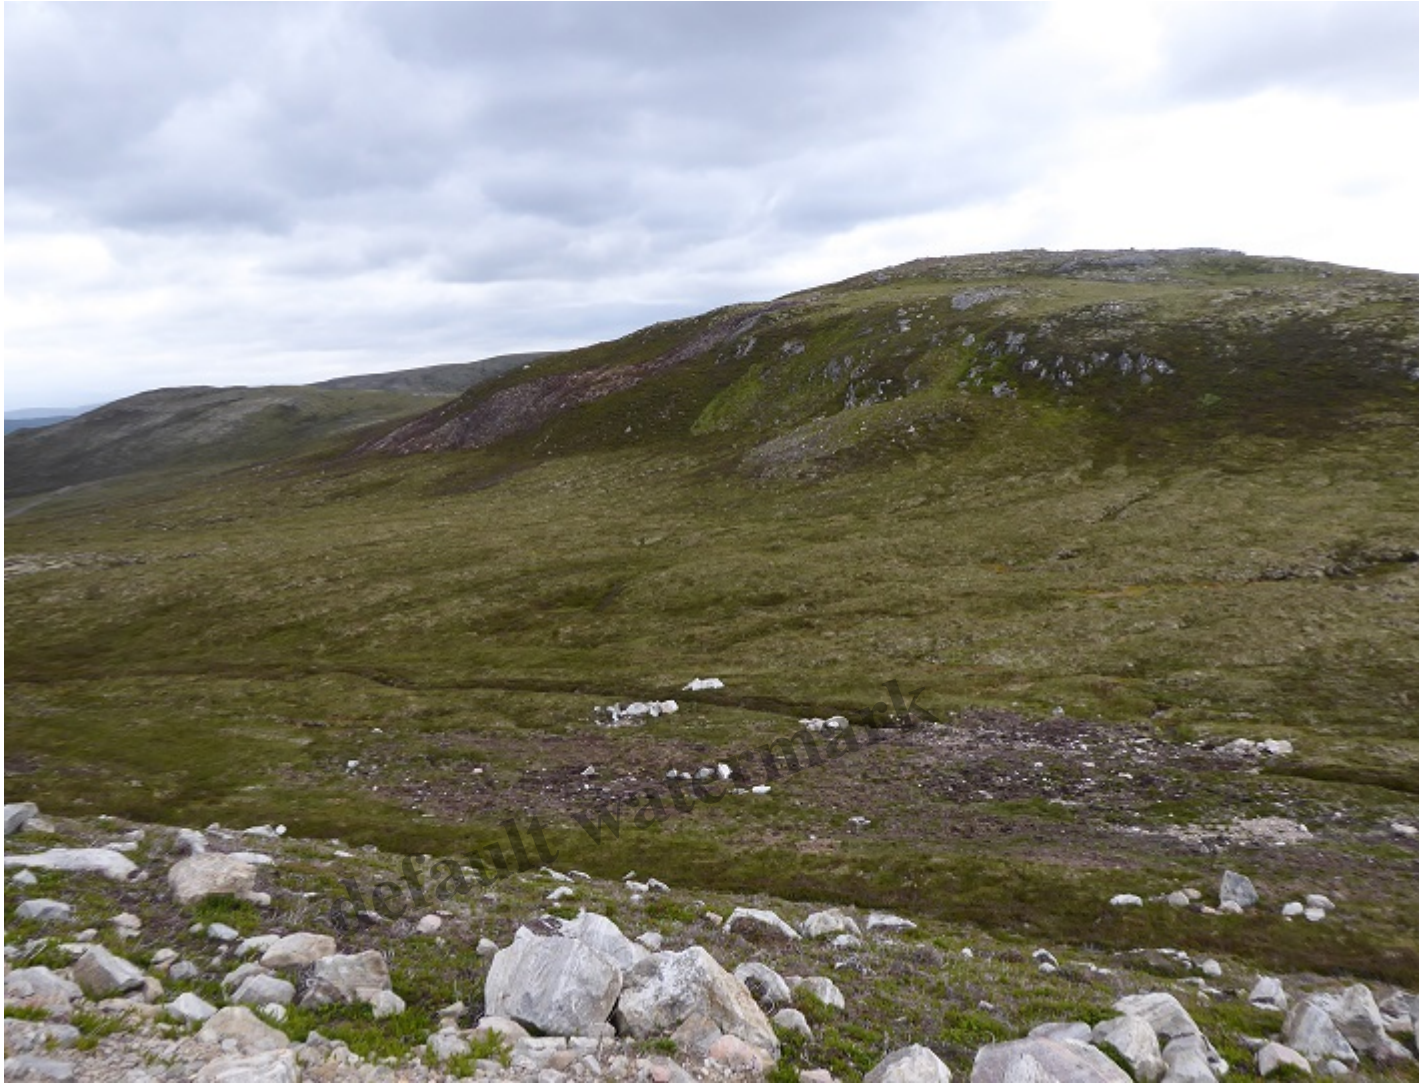
View from the upgraded road down onto the route of the powerline and across to the hillside from where we had walked.

Similar to the case of buried hydro pipelines, the visual impact of the buried powerline was less than the associated construction tracks. Even so, the lack of care taken during the construction was all too apparent, as illustrated above where newly exposed rocks have been dumped on peat.

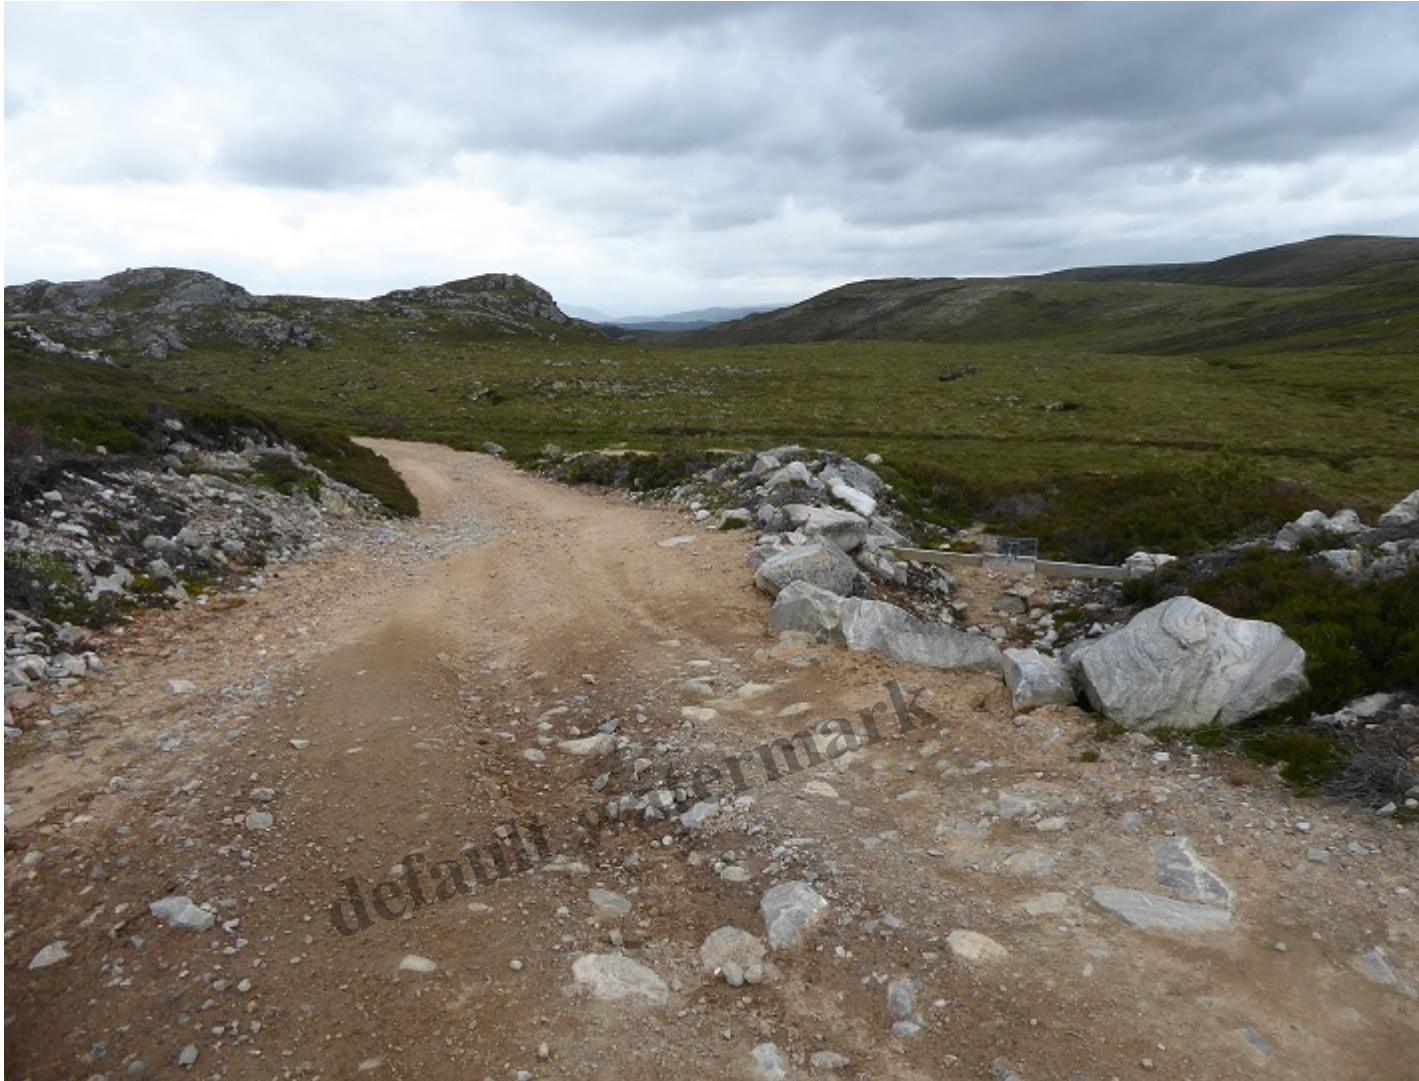
Erosion on the south side of the ridgy knoll with trap visible on the right

Traps had been sited among the new rubble created by the upgrading work. This helped confirm my suspicions that the large number of licenses issued to shoot mountain hares in the Auchtertipper woodland was linked to the intensive management of the moorland above. Meddle with nature and there are always consequences. Creag na h-lolaire, round which the upgraded road winds, means eagle crag, an indication that in the past there was more wildlife here. These roads are good for neither landscape nor wildlife and play a major role in undermining the CNPA's statutory purpose to put conservation first.

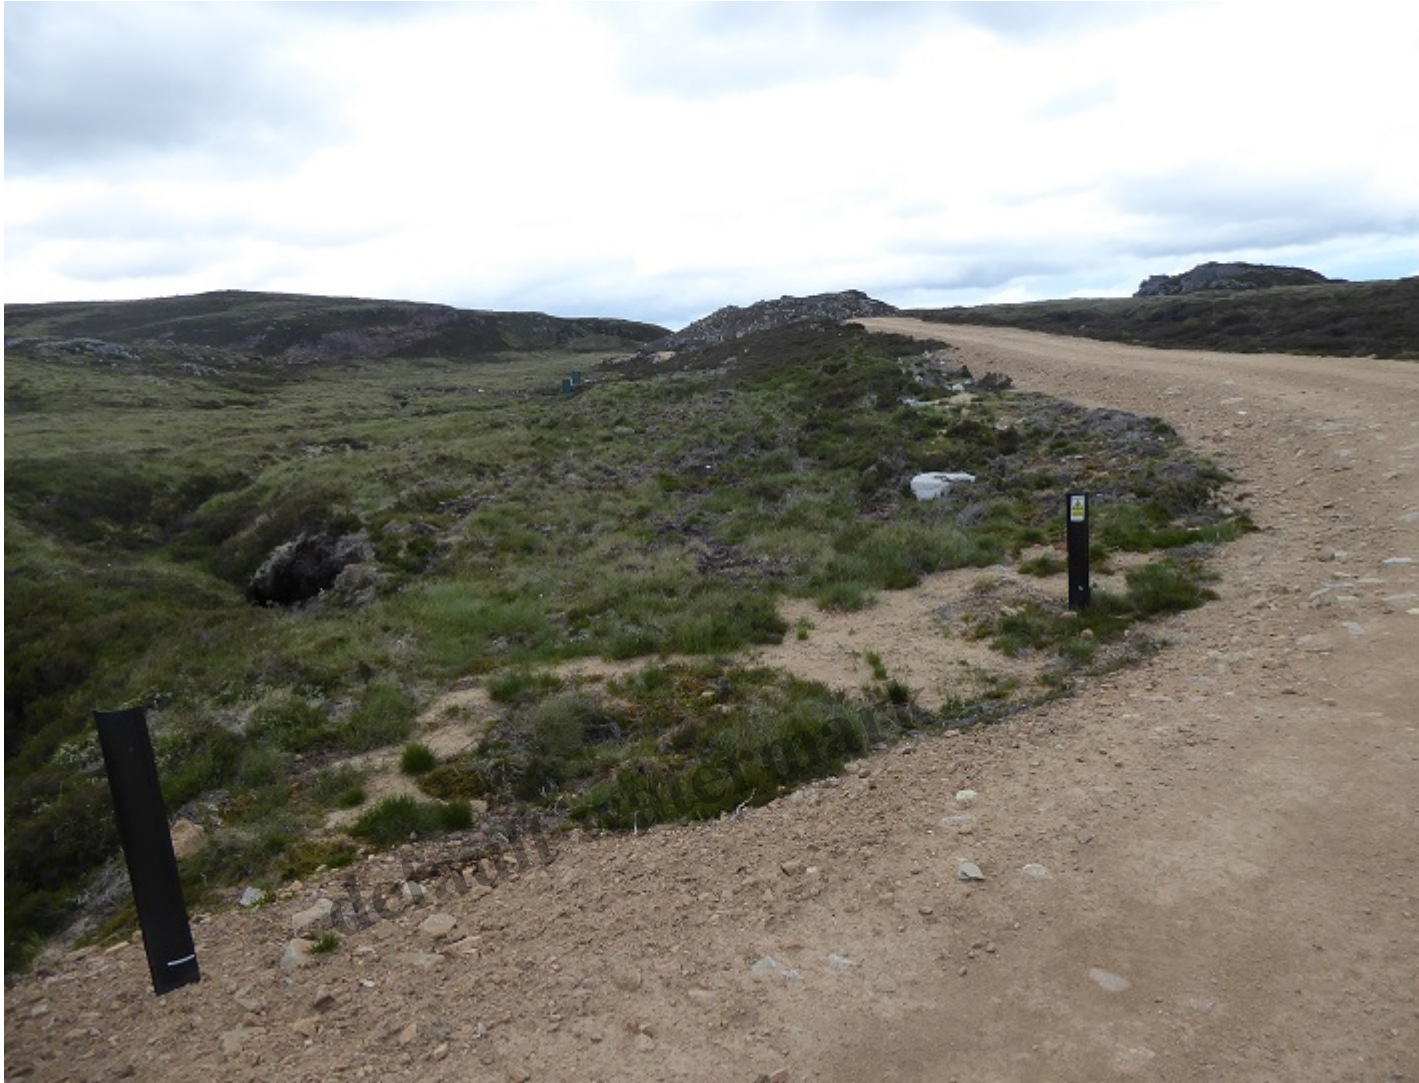
Two electricity boxes are just visible in the middle distance beyond the plastic line markers. Note how silt and grit from the road is being washed down onto the peat.

Generally the work that had been undertaken to restore the ground above the pipeline was better than that to restore the ground by the road. It made me wonder if different contractors were involved?

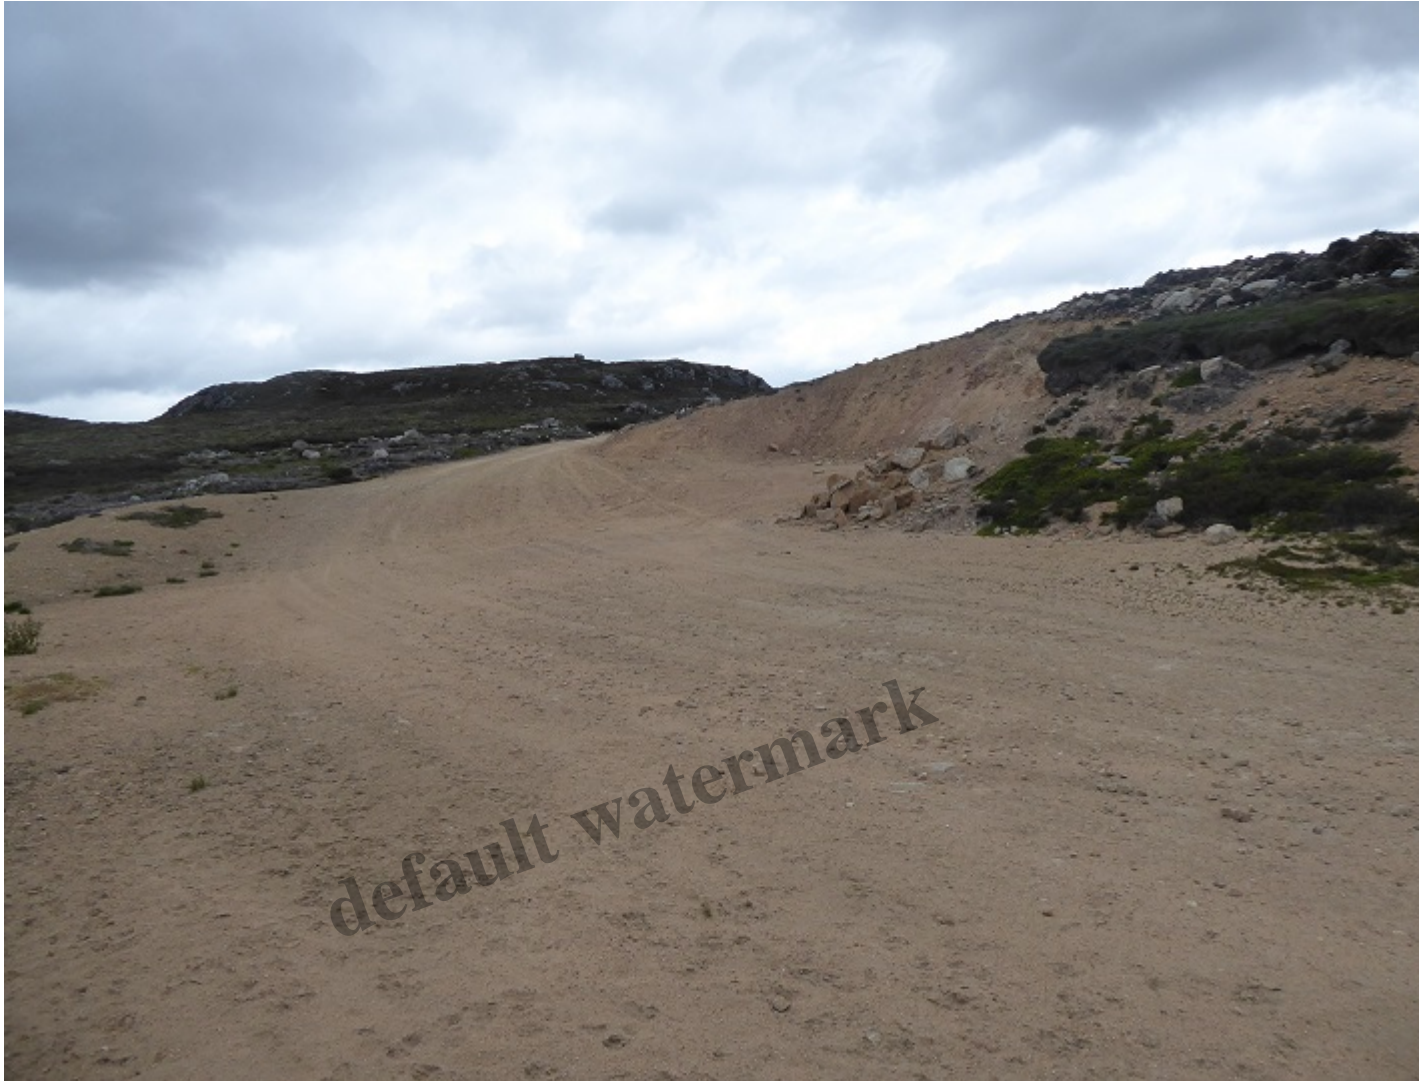
Motorway and borrow pit

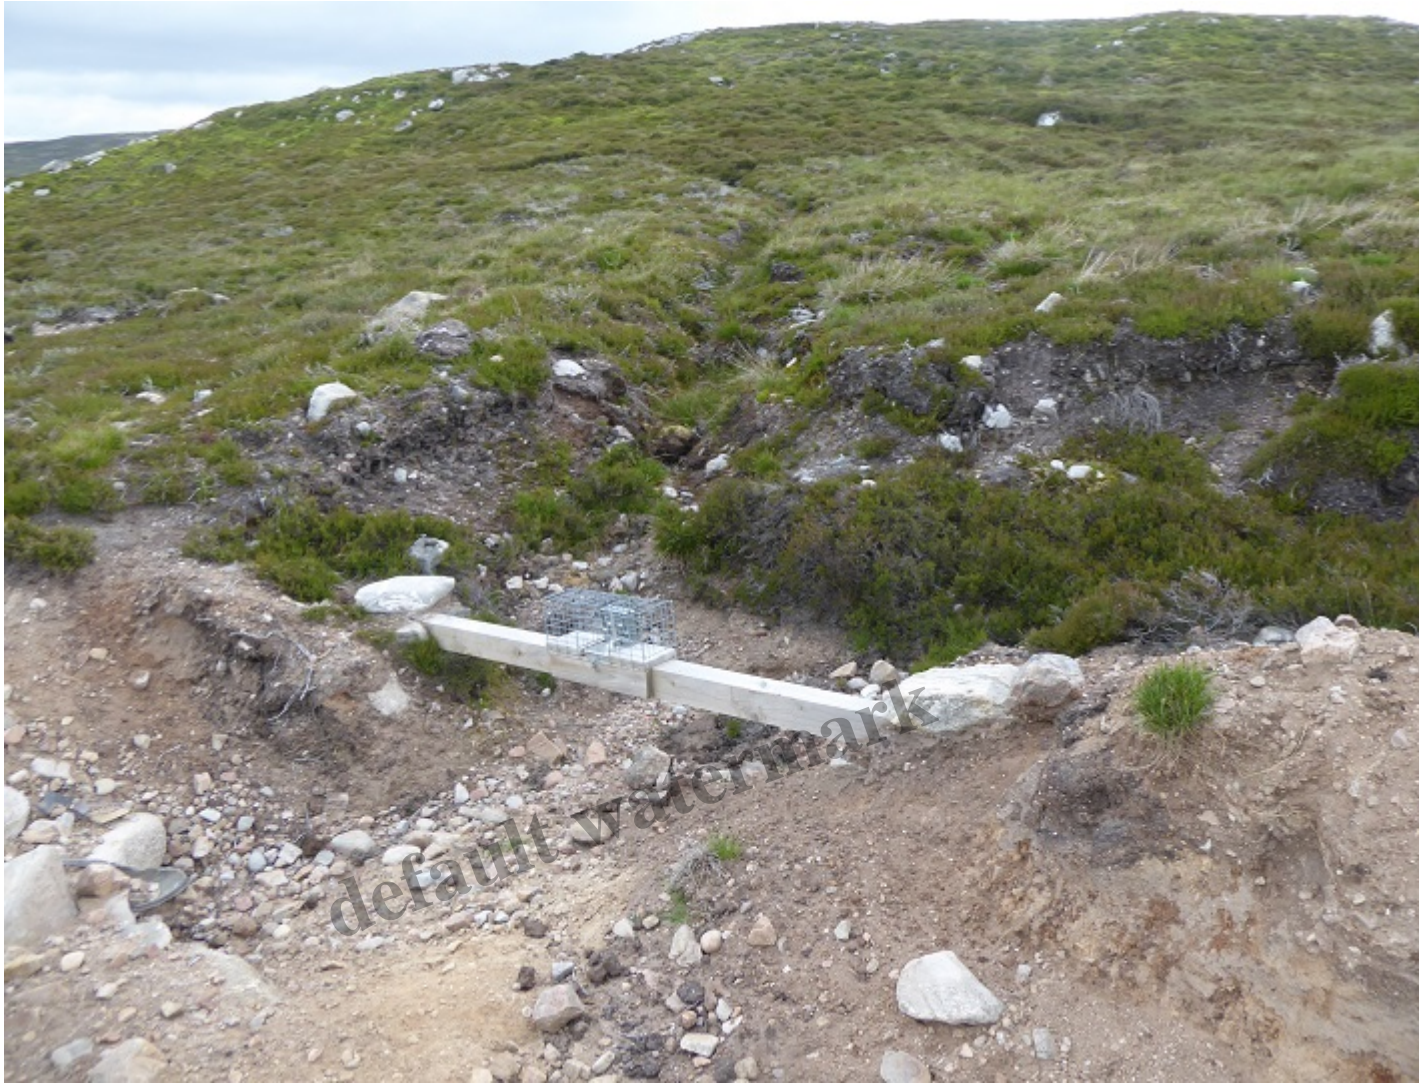
An example of the quality of the drainage work alongside the track together with one of the other traps we saw

We followed the upgraded road back down the hill. All along there were signs of poor construction and that it is already eroding away.
