SSE and powerlines – another landscape disaster in the Cairngorms National Park above Dava Moor

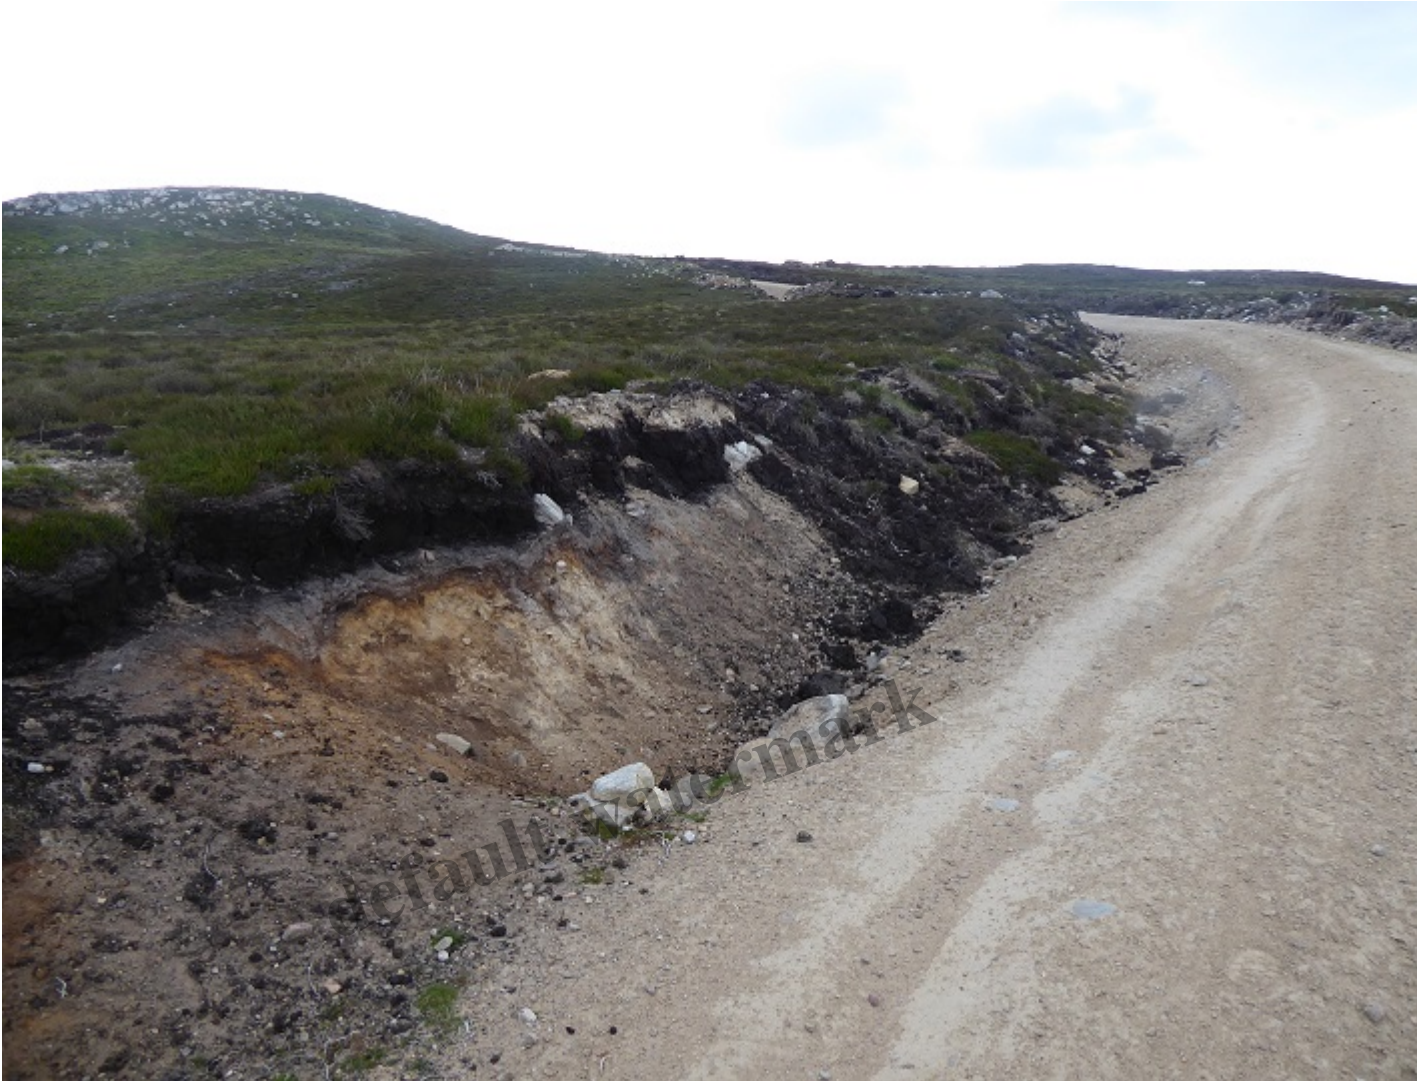
Section of edge of track that had been restored with vegetation above an unrestored section below

While there were places where some attempt had been made to restore the vegetation alongside the road this helps highlight how poor the rest of the work was and how much unnecessary damage has been done.
