Landslips, flooding and riverside tree planting in Balquhiddar – tackling the source of the problems

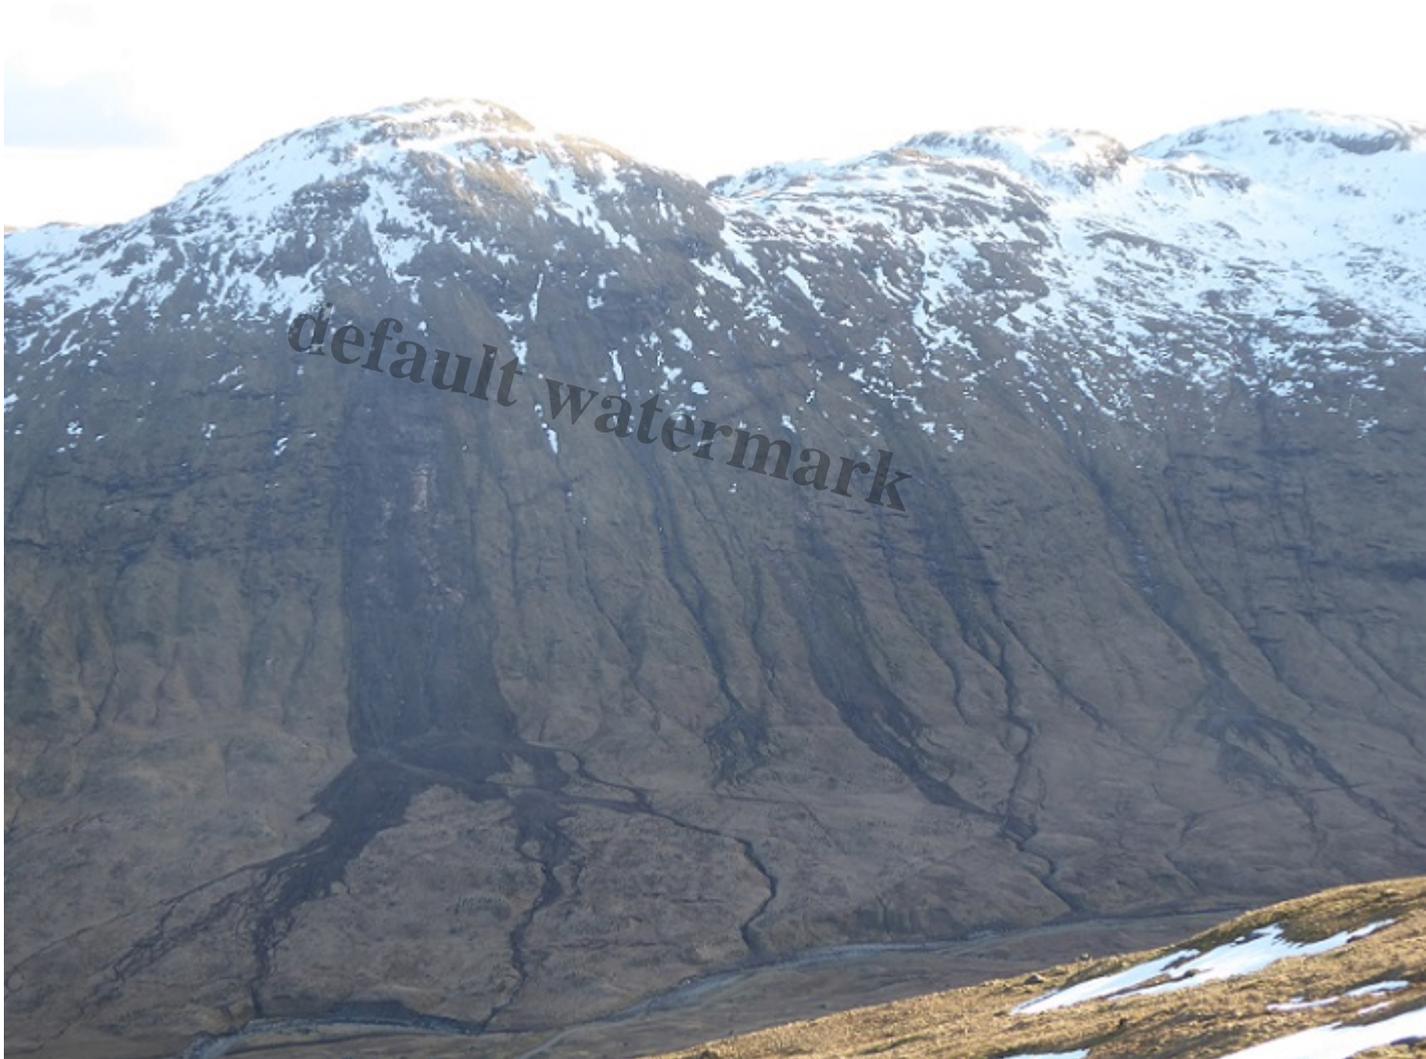
Landslips on Stob an Duibhe March 2020

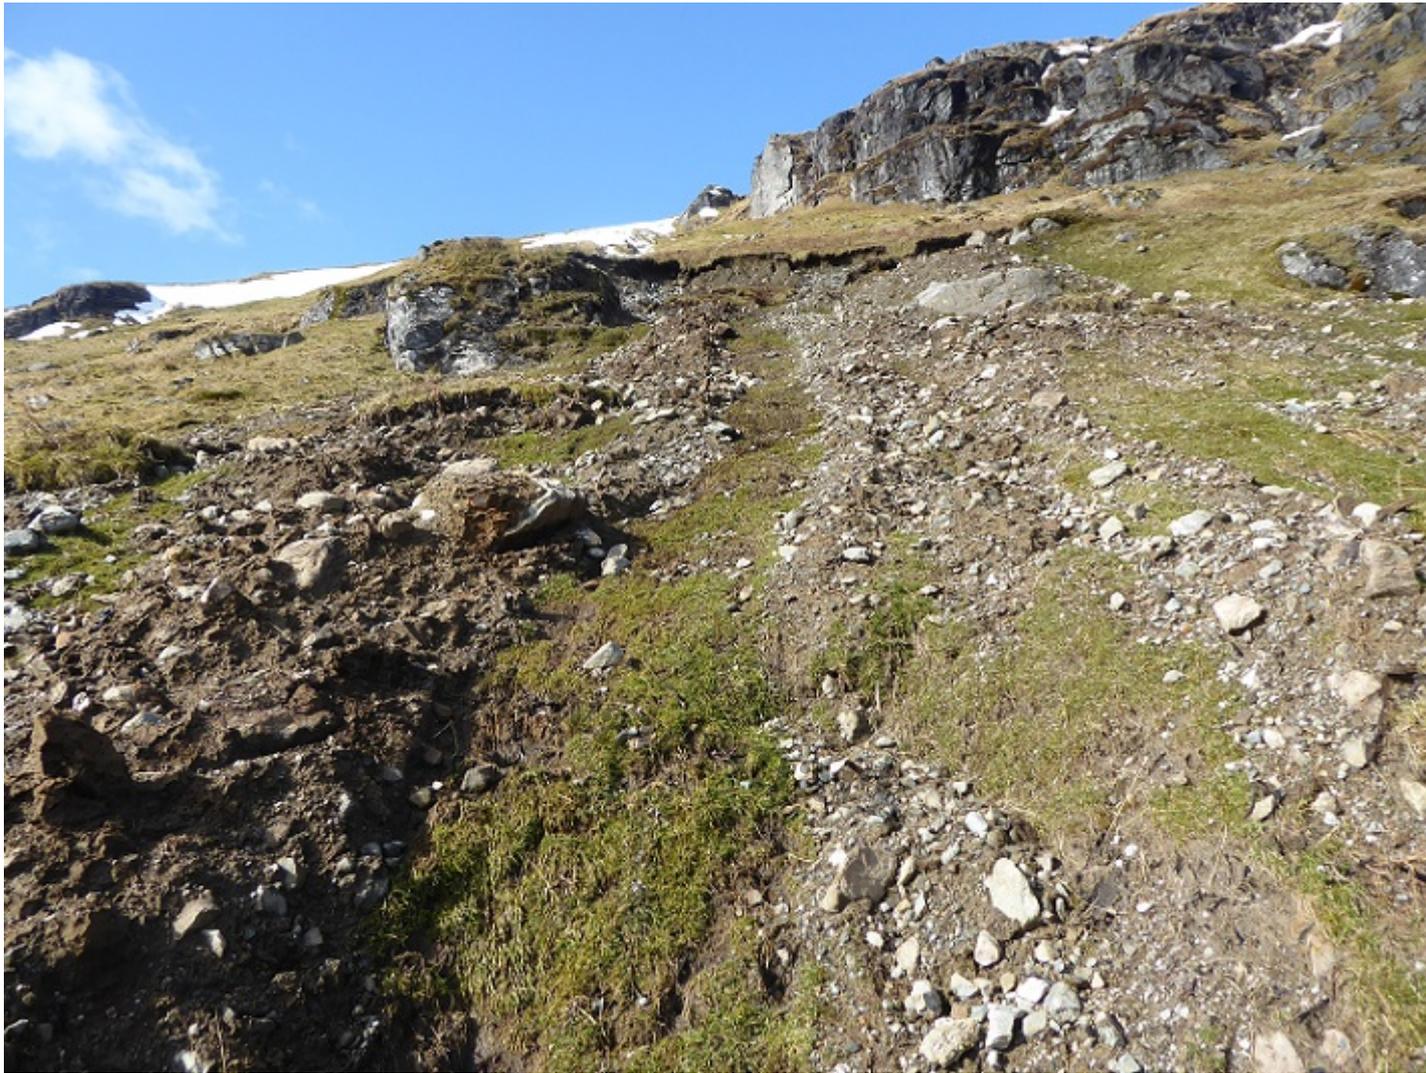
Landslip on south slope of Beinn a Chroin. Note how the volume of water has washed clean a strip down the centre of the landslip. March 2020.

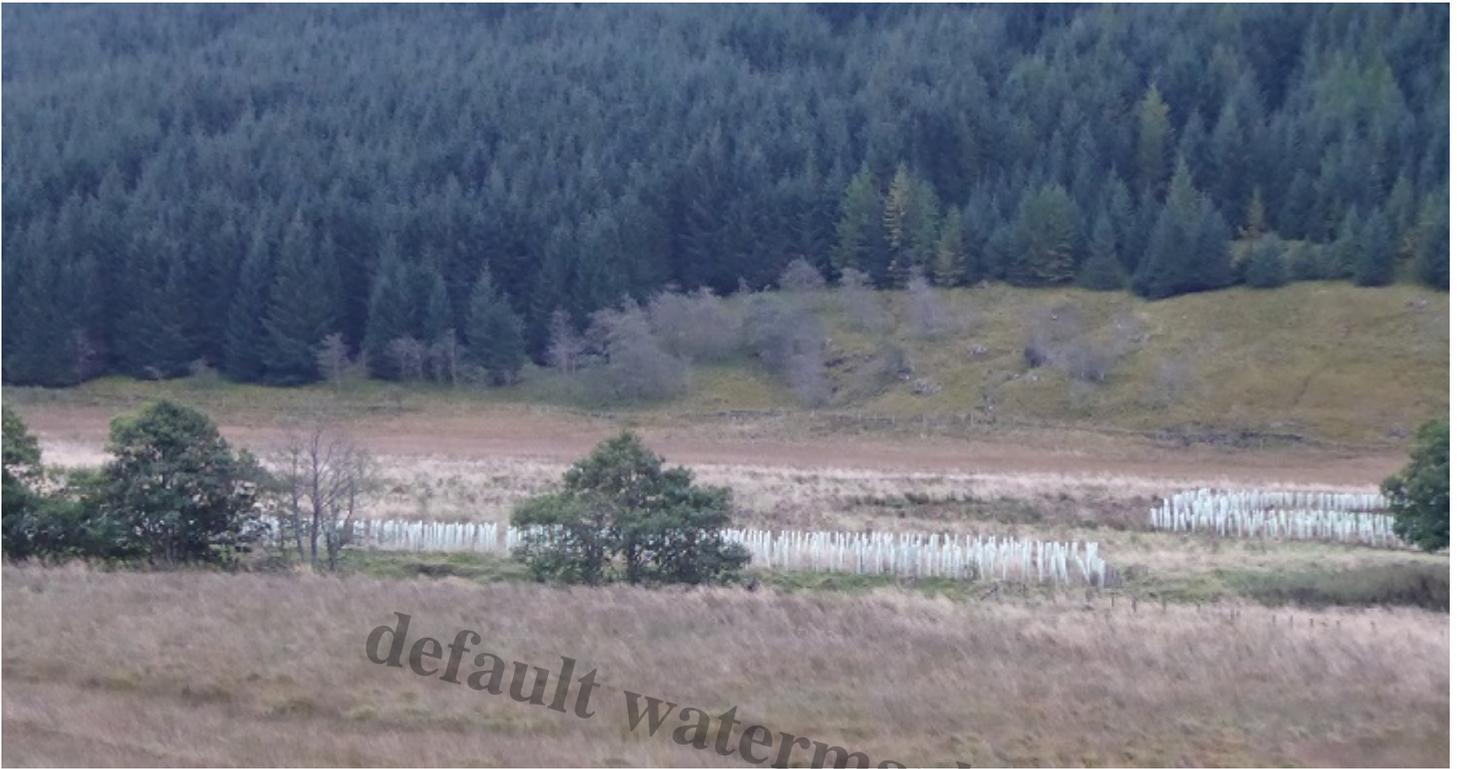
We were greeted by a forest of plastic tree tubes on the flood plain just before the road end at Inverlochlarig which the Loch Lomond and Trossachs National Park Authority (LLTNPA) had boasted about back in March ([see here](#)). The photo illustrates how the LLTNPA has paid no regard to the landscape, carbon emissions – plastic is derived from oil – or how it is killing wildlife in our rivers and seas.

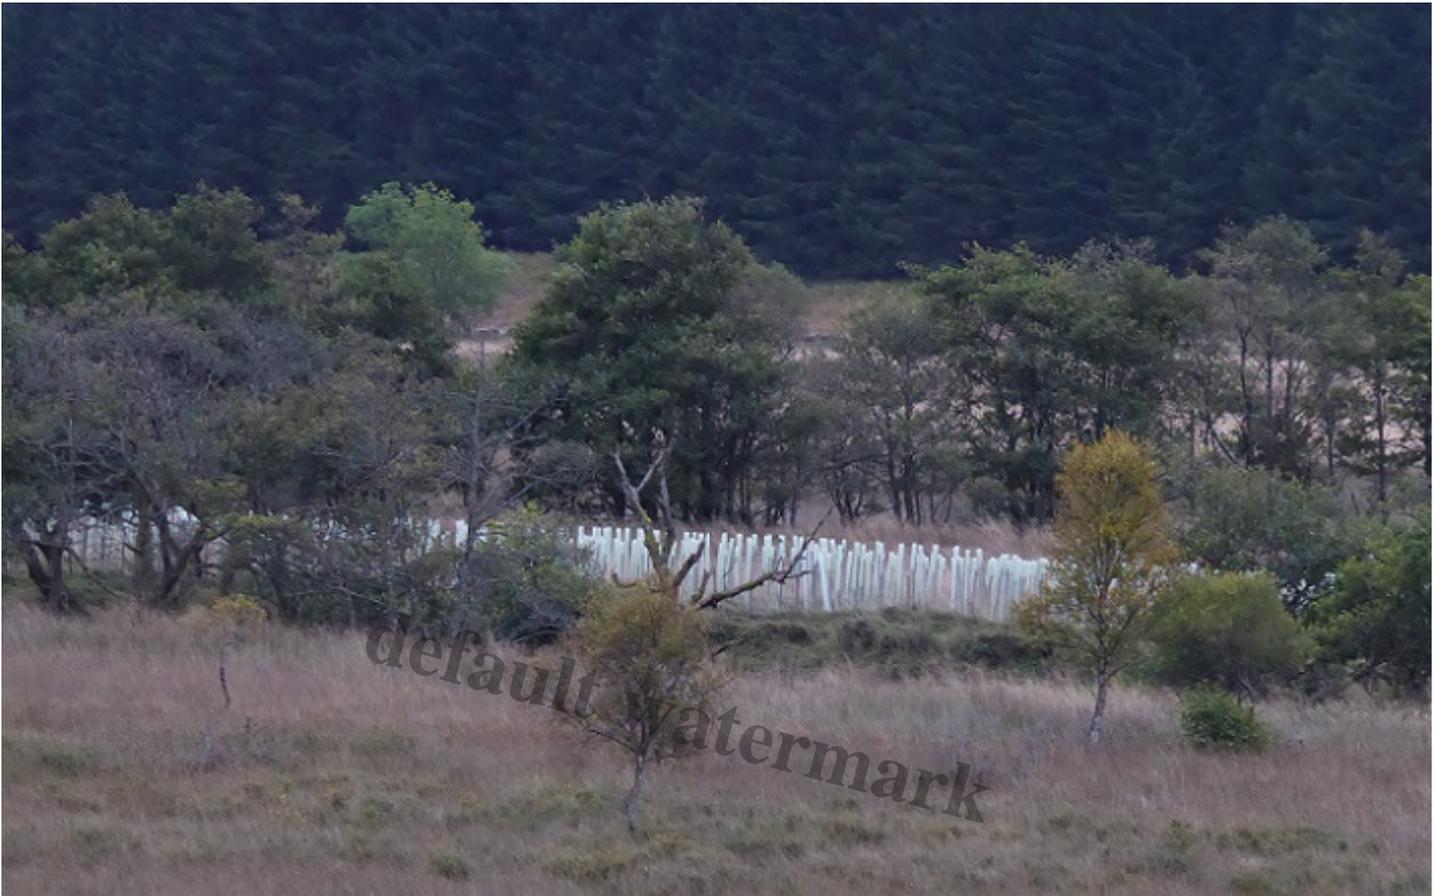
The LLTNPA stated the purpose of this tree planting was to improve river habitats by creating riparian tree cover. This photo shows it was completely unnecessary and a waste of public funds. There are already lots of trees along this section of the River Larig and these would regenerate naturally if given a chance. .

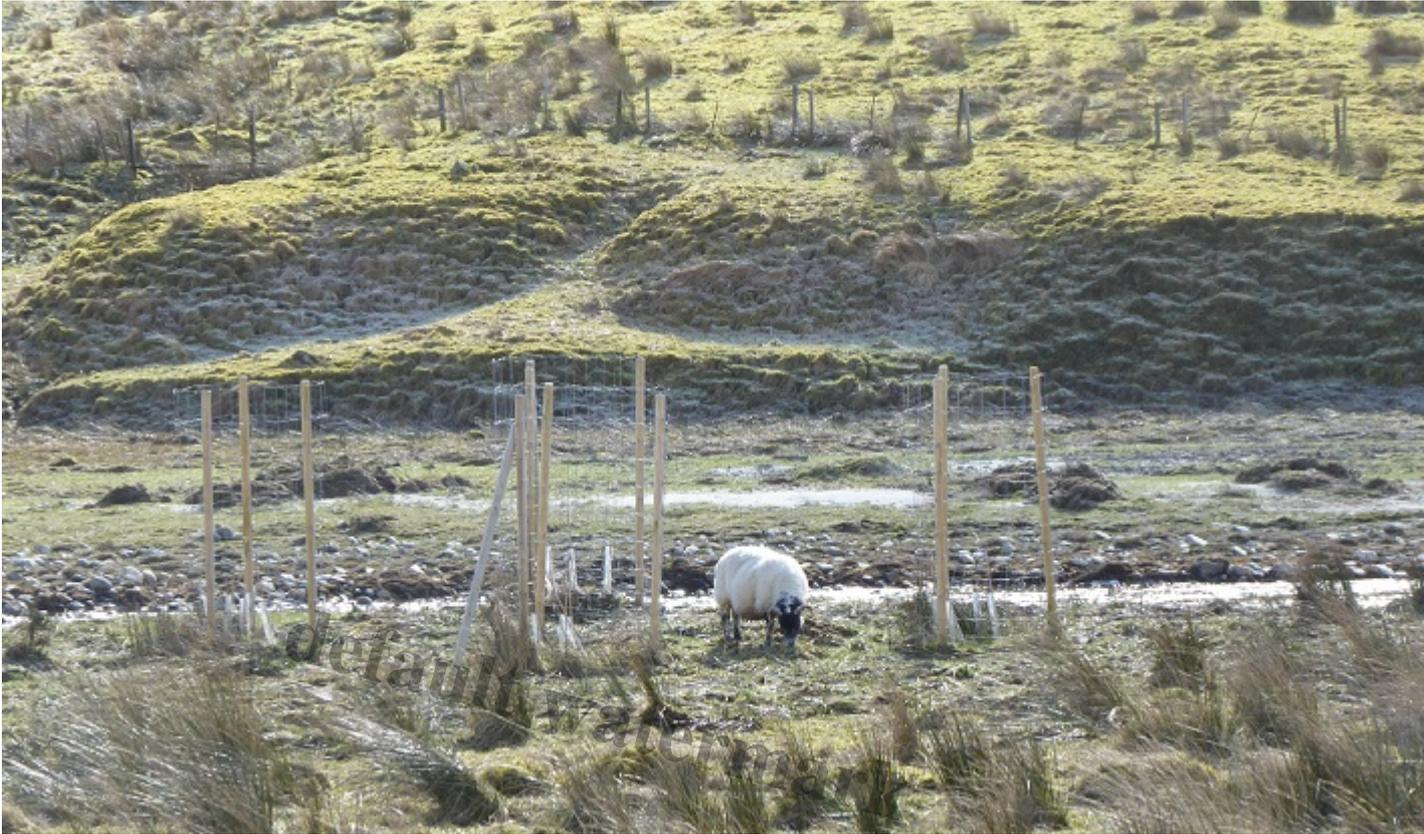
Trees enclosures above Inverlochlarig, March 2020.

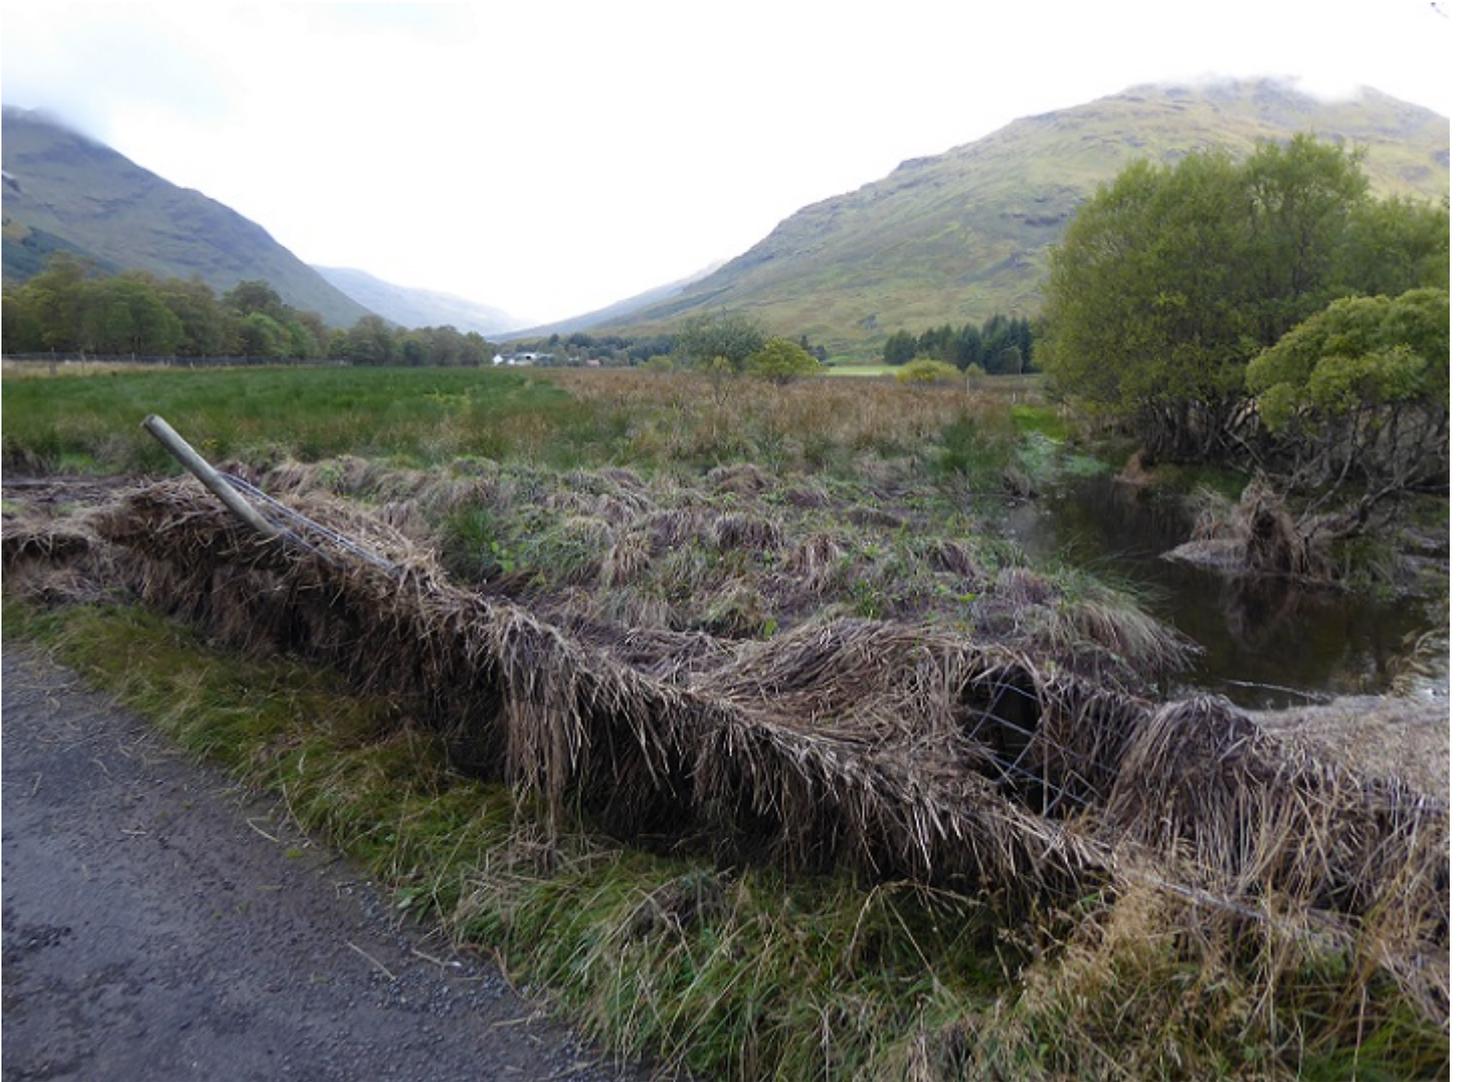
Just 50m beyond the car park, we came across evidence that the rain on Friday had been sufficient to cause significant flooding

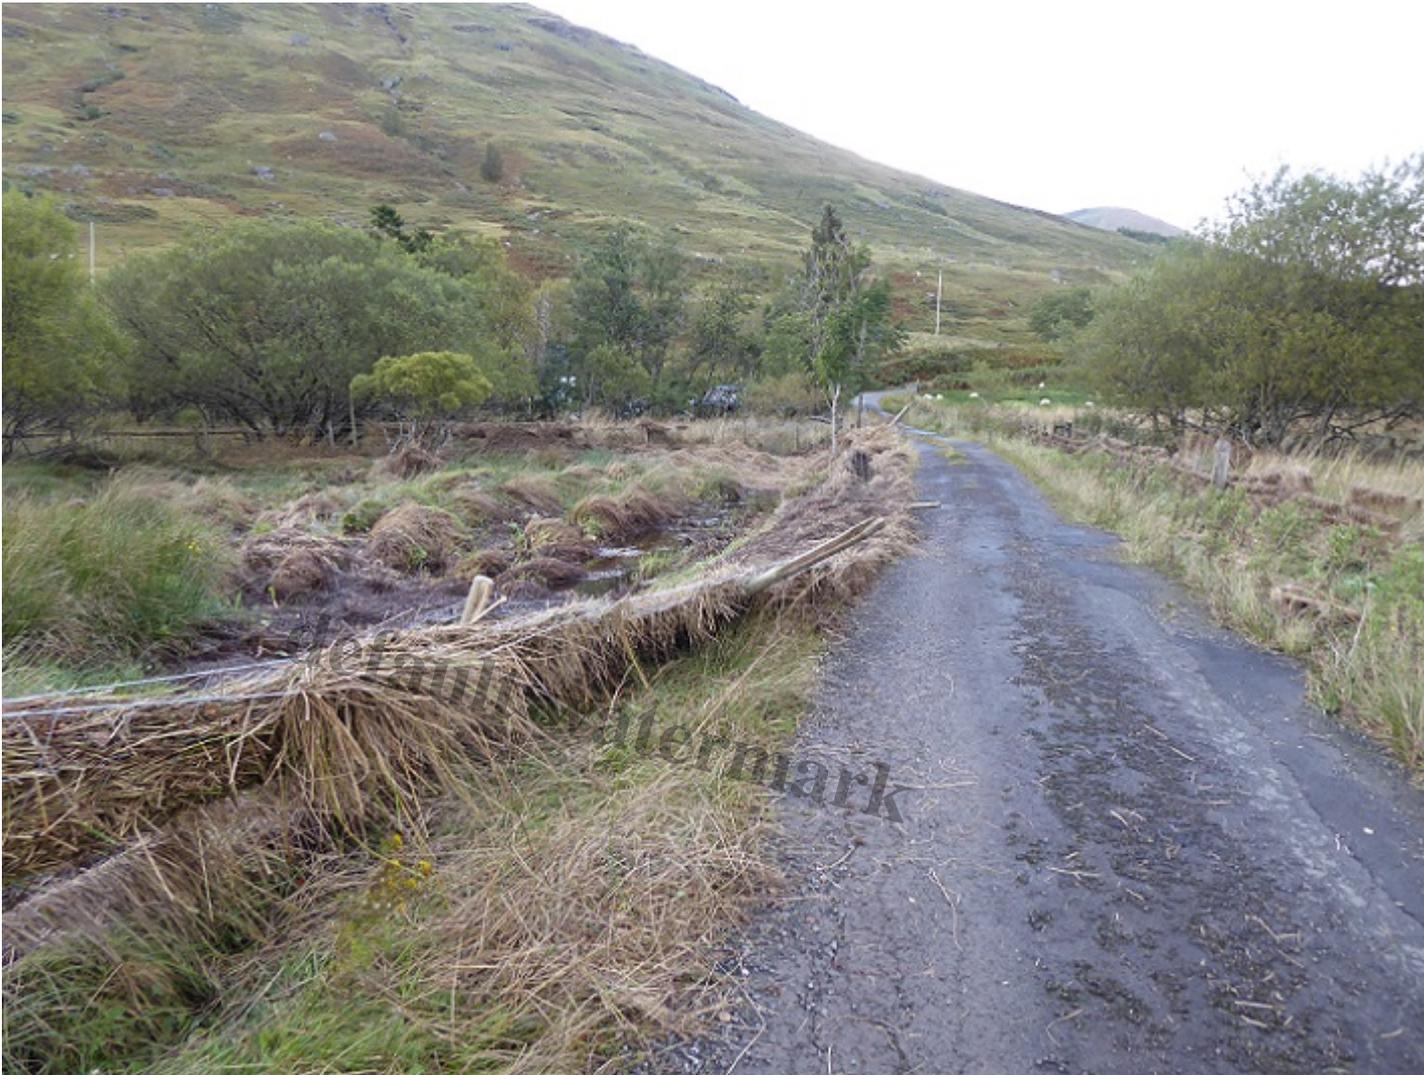
Looking back towards the car park. You can just see some of the sheep which were scattered over the hillside beyond in significant numbers.

Even small scale damage like this will have caused significant cost to the landowner

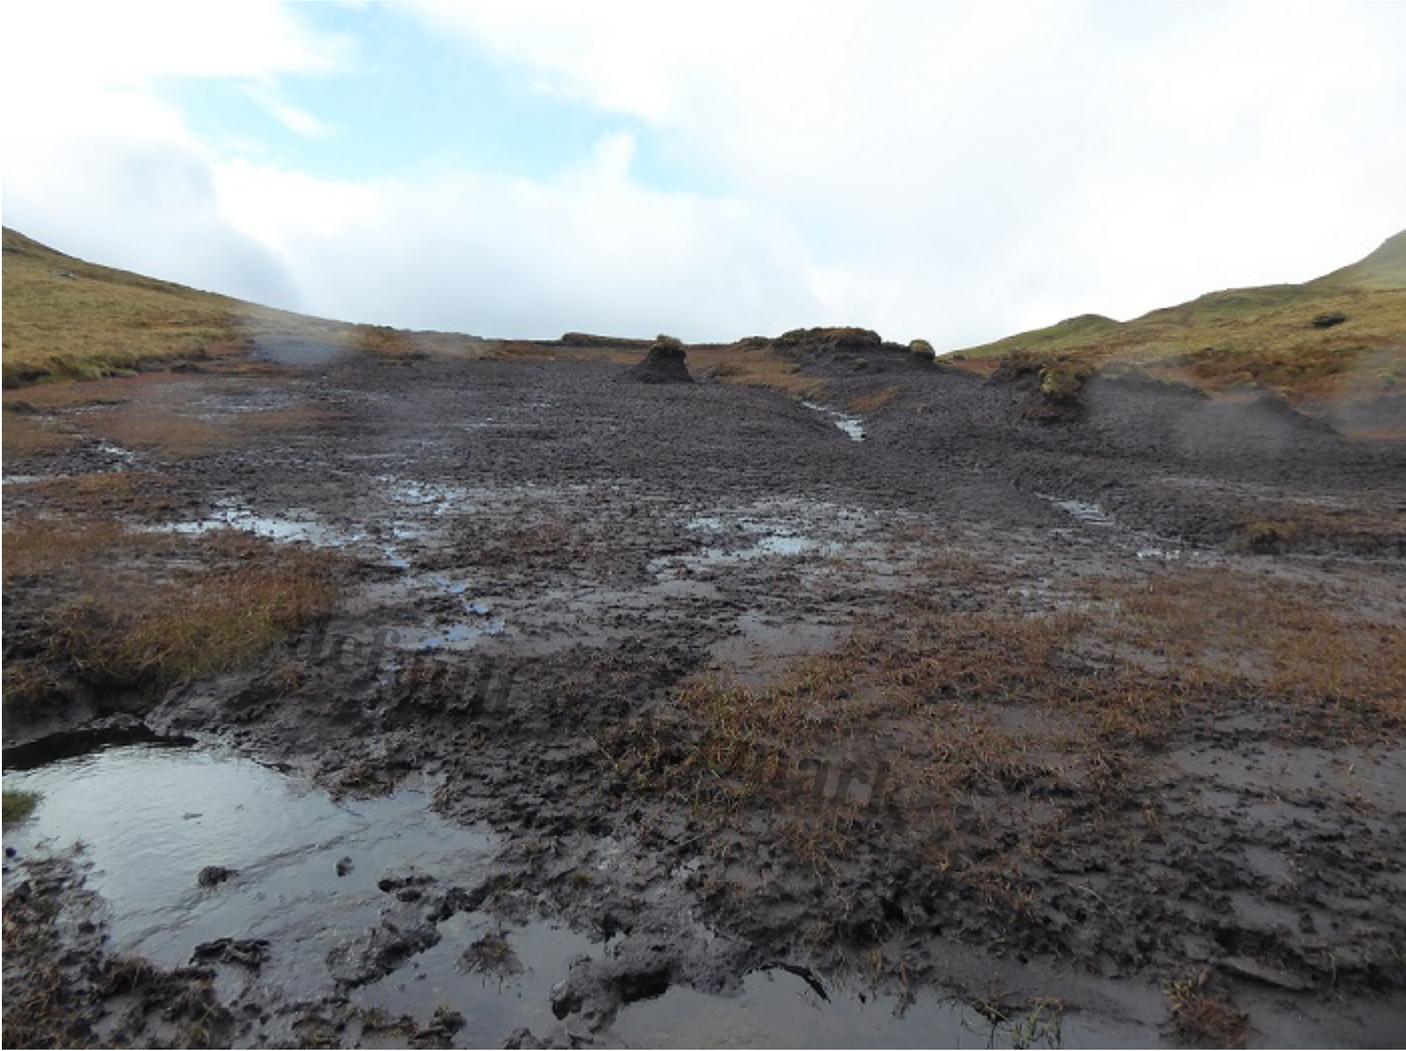
Eroded peat on the undulating south east ridge of Stob à?? Choin. The height of the hag in the distance is an indication of the former height of the bog and how much carbon was stored here. Note the animal hoof marks visible in the foreground and the watercourse on the right, both of which are causing the erosion.

This and other areas of degraded peatland between Balquhidder and Loch Katrine could be helping to absorb rainfall which has been triggering landslips on both sides of the watershed. This particular area would appear need very little restoration work to start functioning again as a bog. If grazing levels were reduced, the flat areas would quickly re-vegetate with cotton grass. The other main intervention that would be required would be to block up the water course and create bog pools.

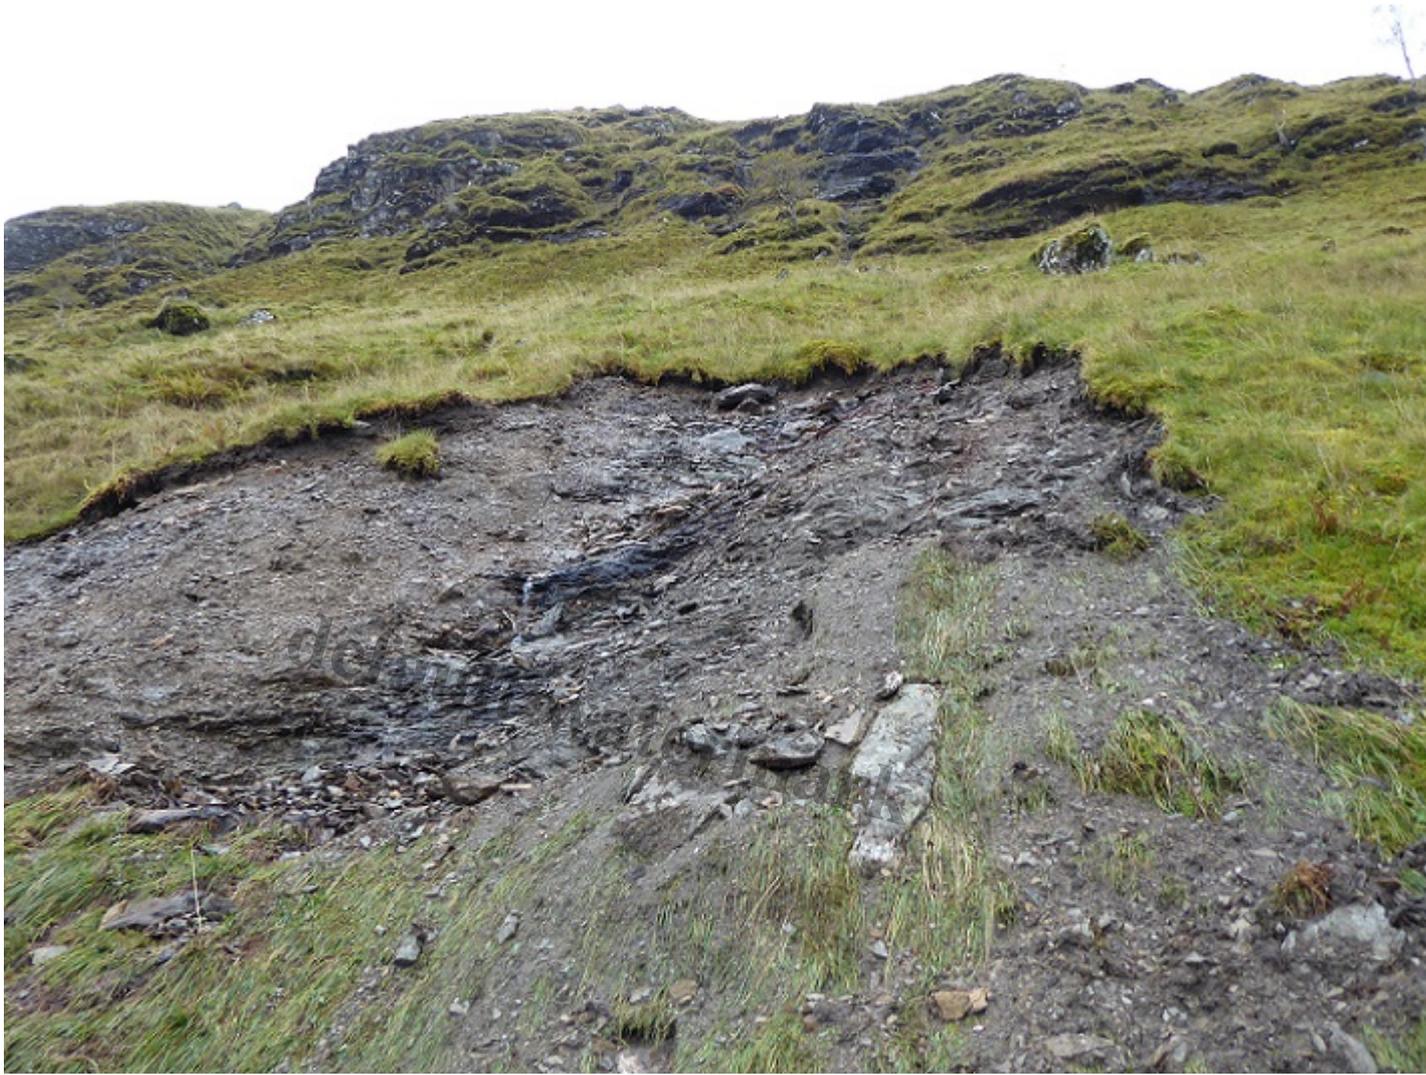
The flattened vegetation and smaller debris, which was soft and unconsolidated, indicates that this landslide was only days old.

A small watercourse was visible below the crag above the landslide which then disappeared under the vegetation. It appears that the volume of water flowing down this underground burn triggered the landslide exposing the burn once more.

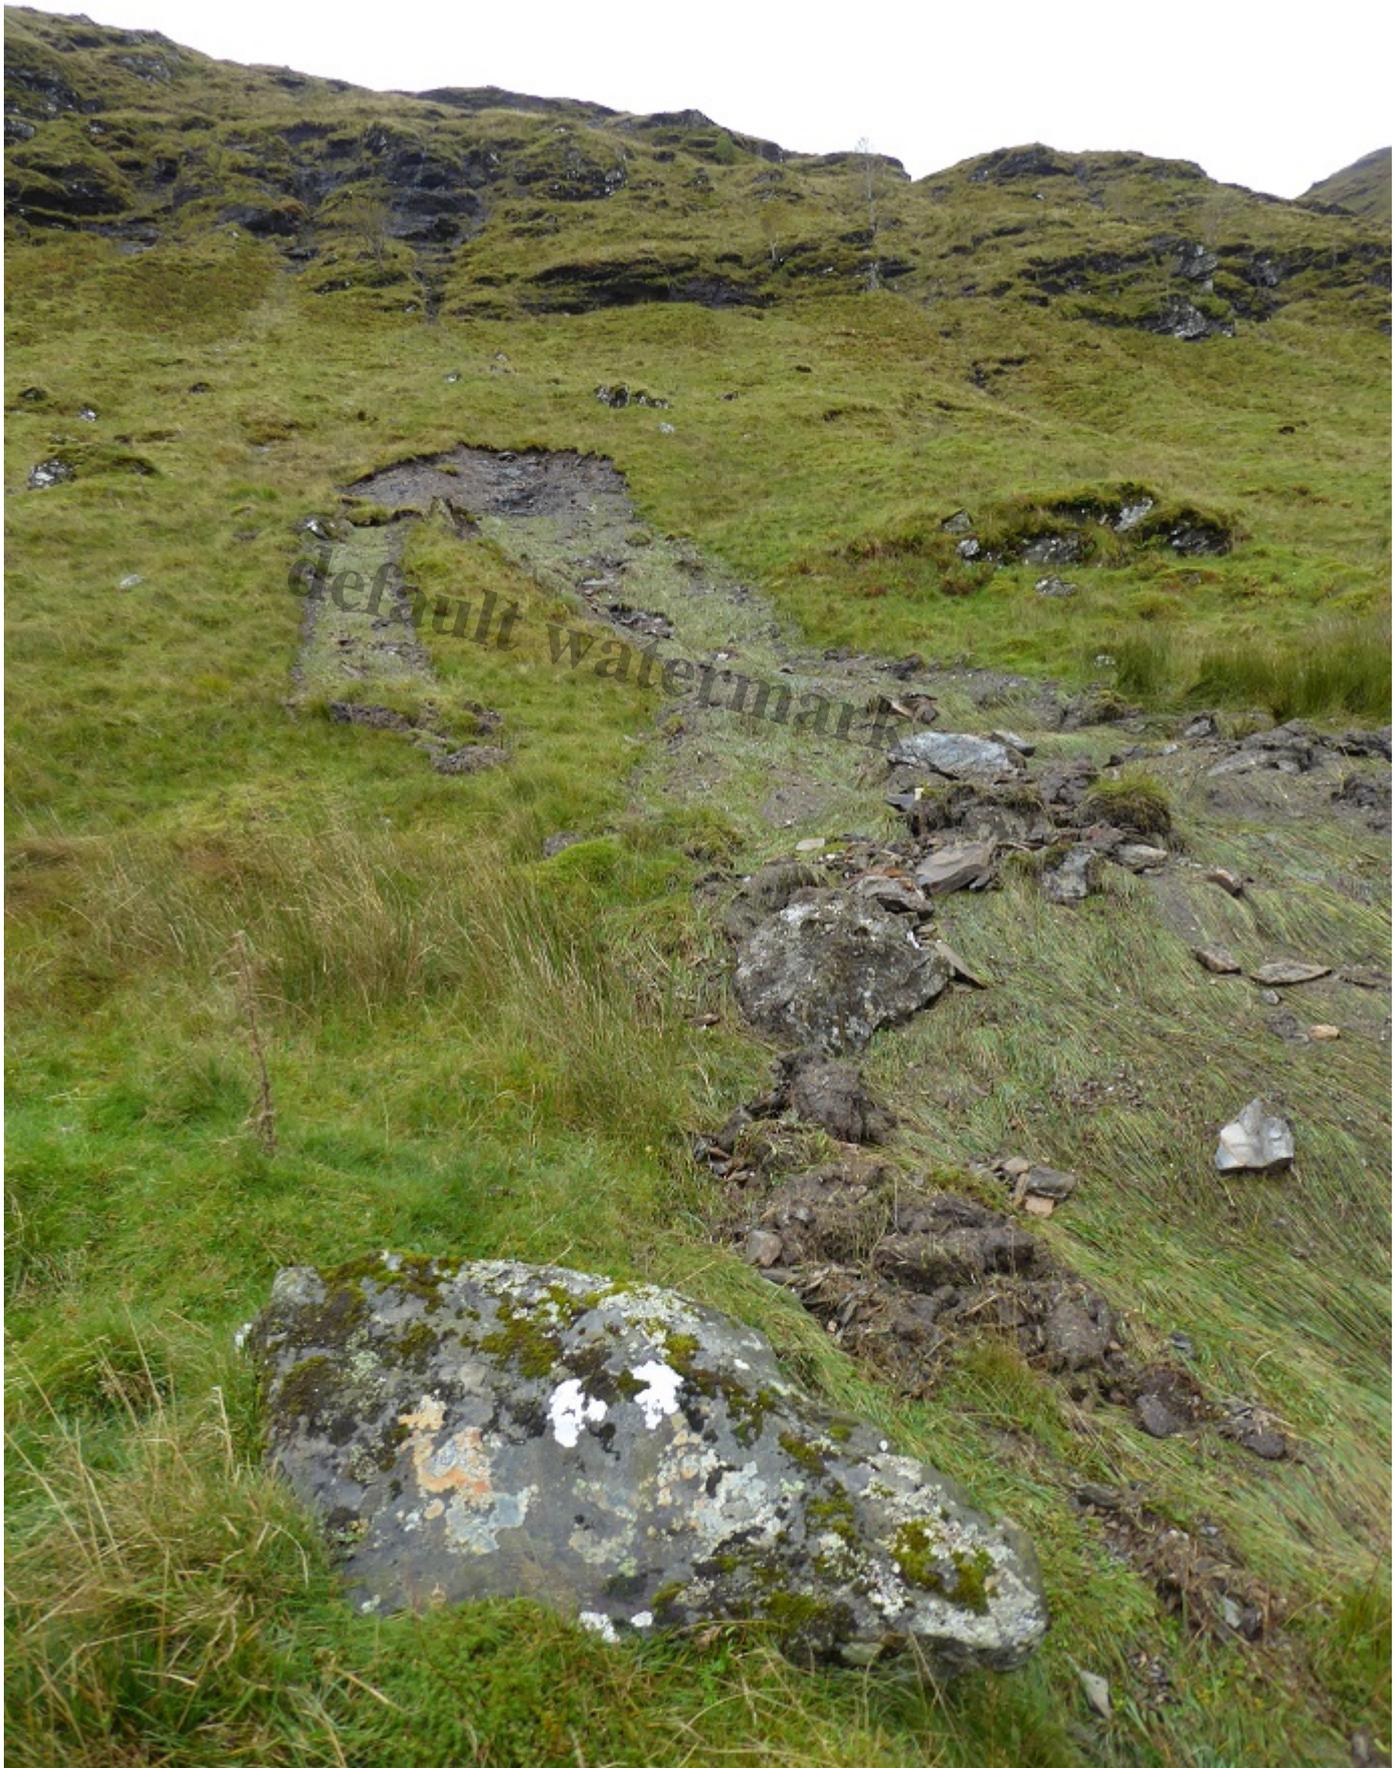
Top section of landslip.

There was also enough water running down the hill to allow these blocks to slide over the vegetation without causing it significant damage

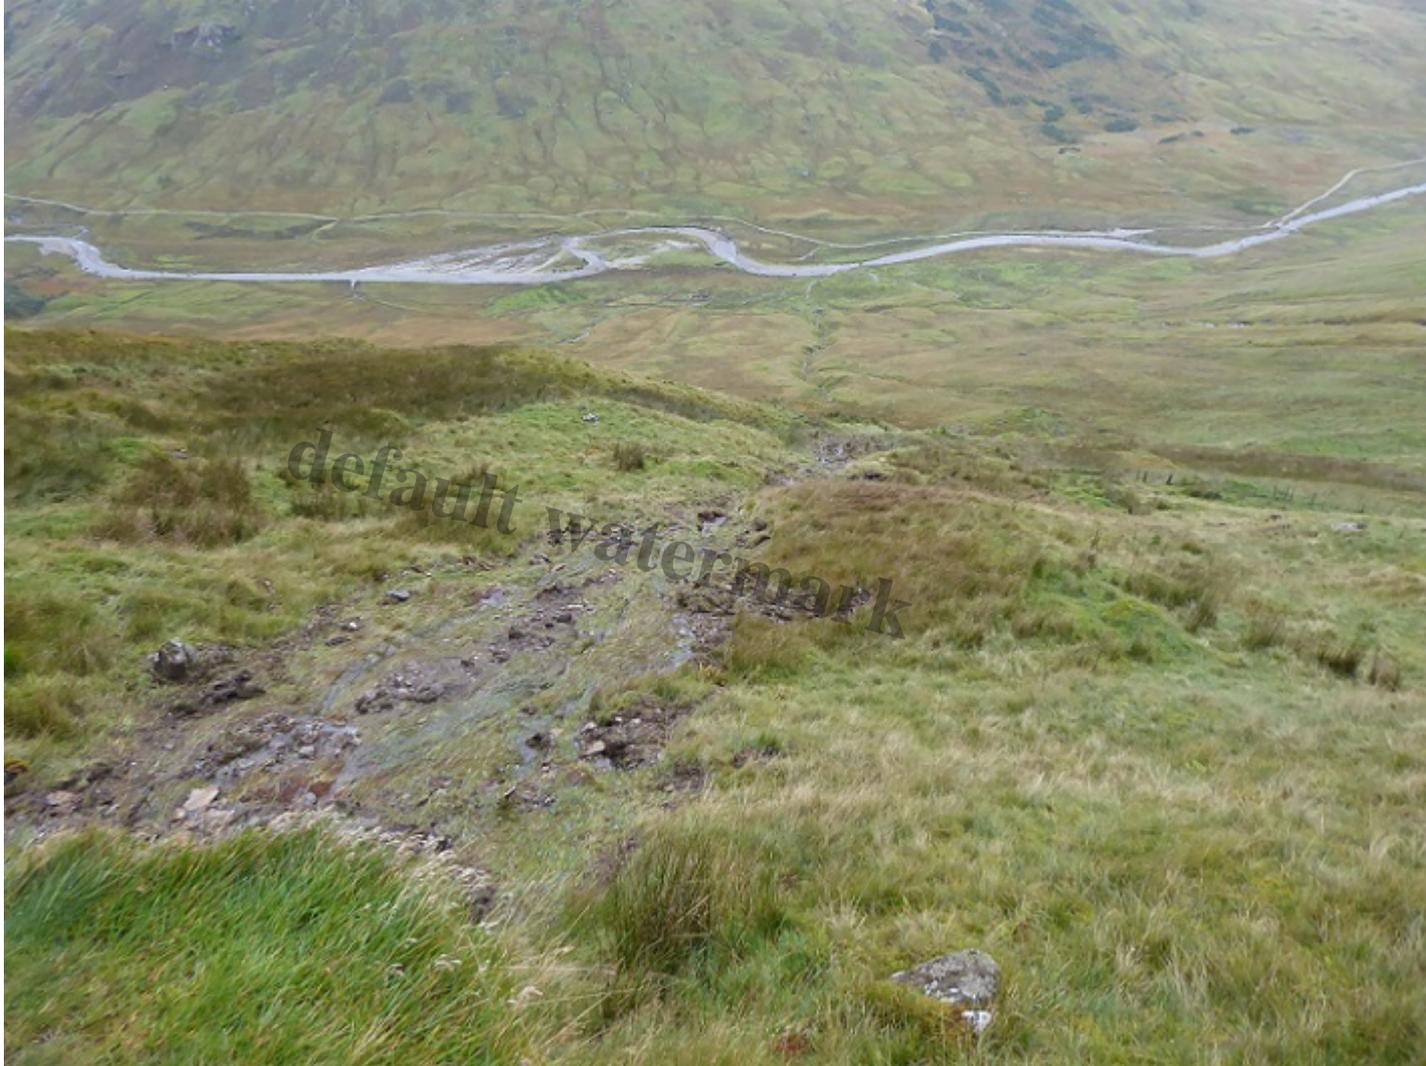
Looking down from near the point where the previous photo was taken

The landslip continued scattering debris for several hundred metres down the hillside

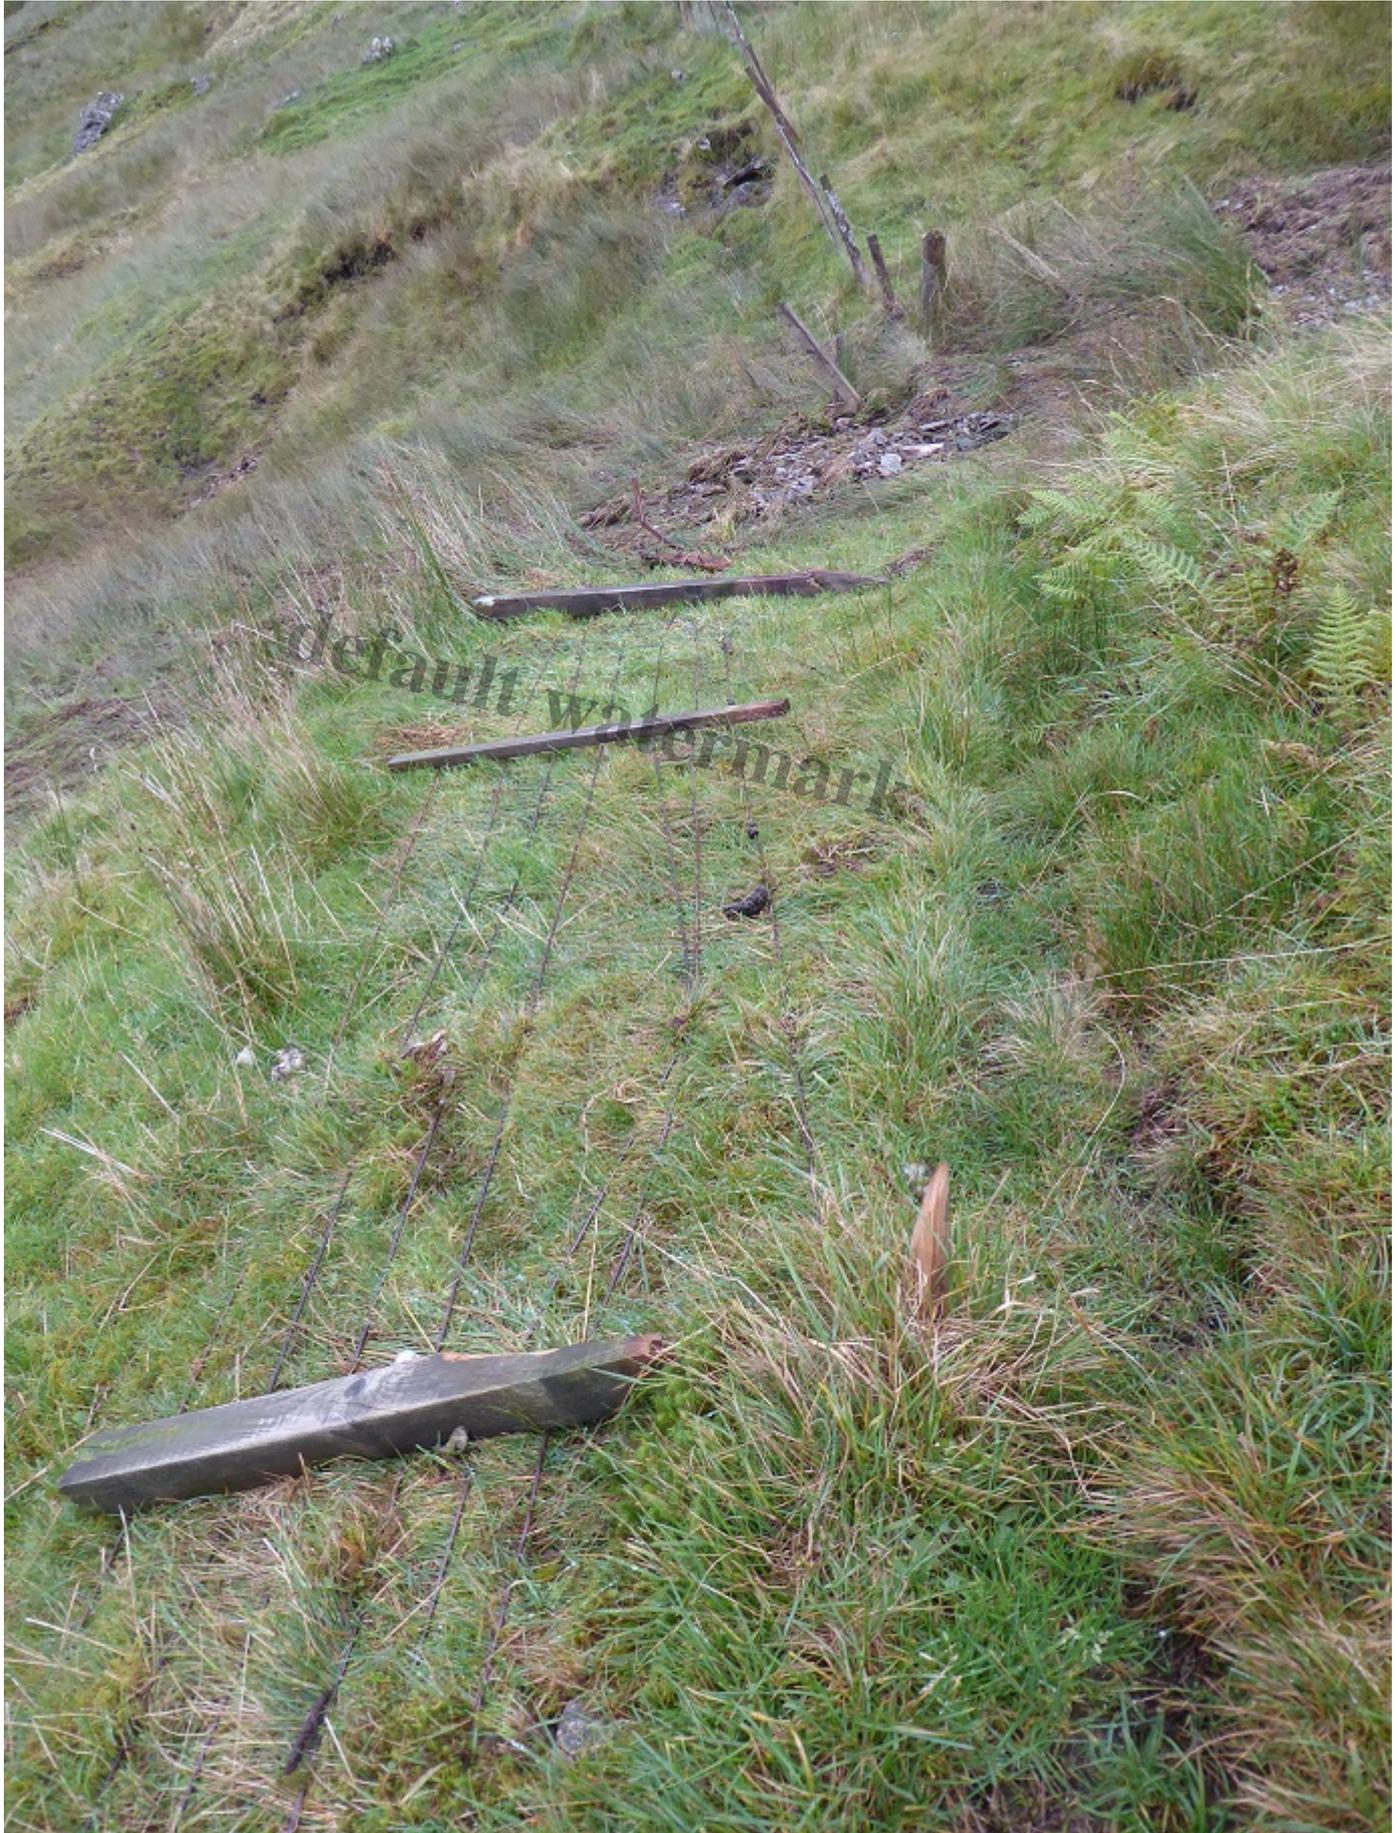
Note the projecting spear of wood to the right of the post in the foreground

The force of the water and the debris it was carrying was sufficient to flatten this stock fence well below and snap one its posts in two - more costs for the estate

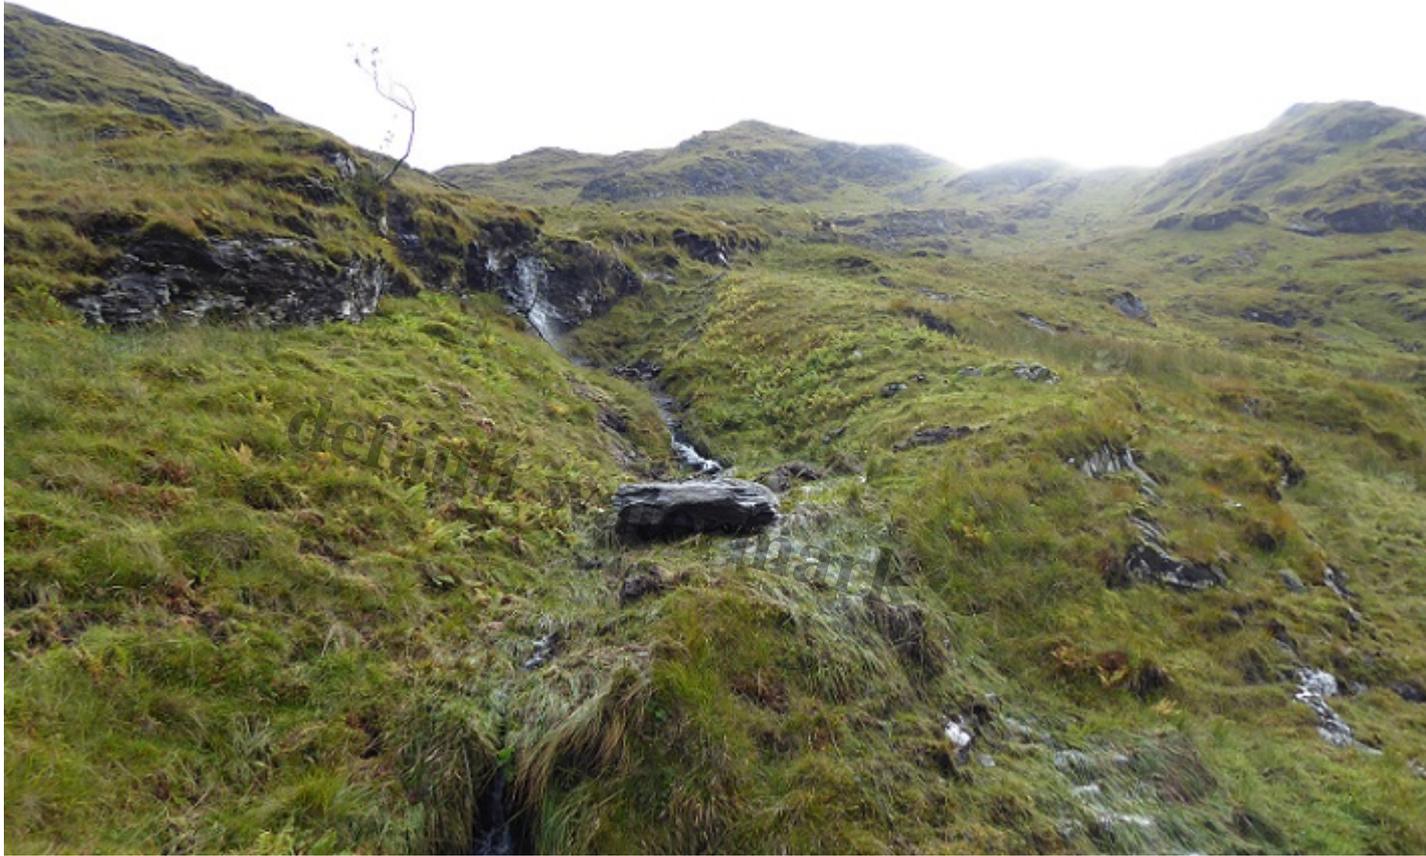
The course of the landslip is visible to the right of what is now a small waterfall.

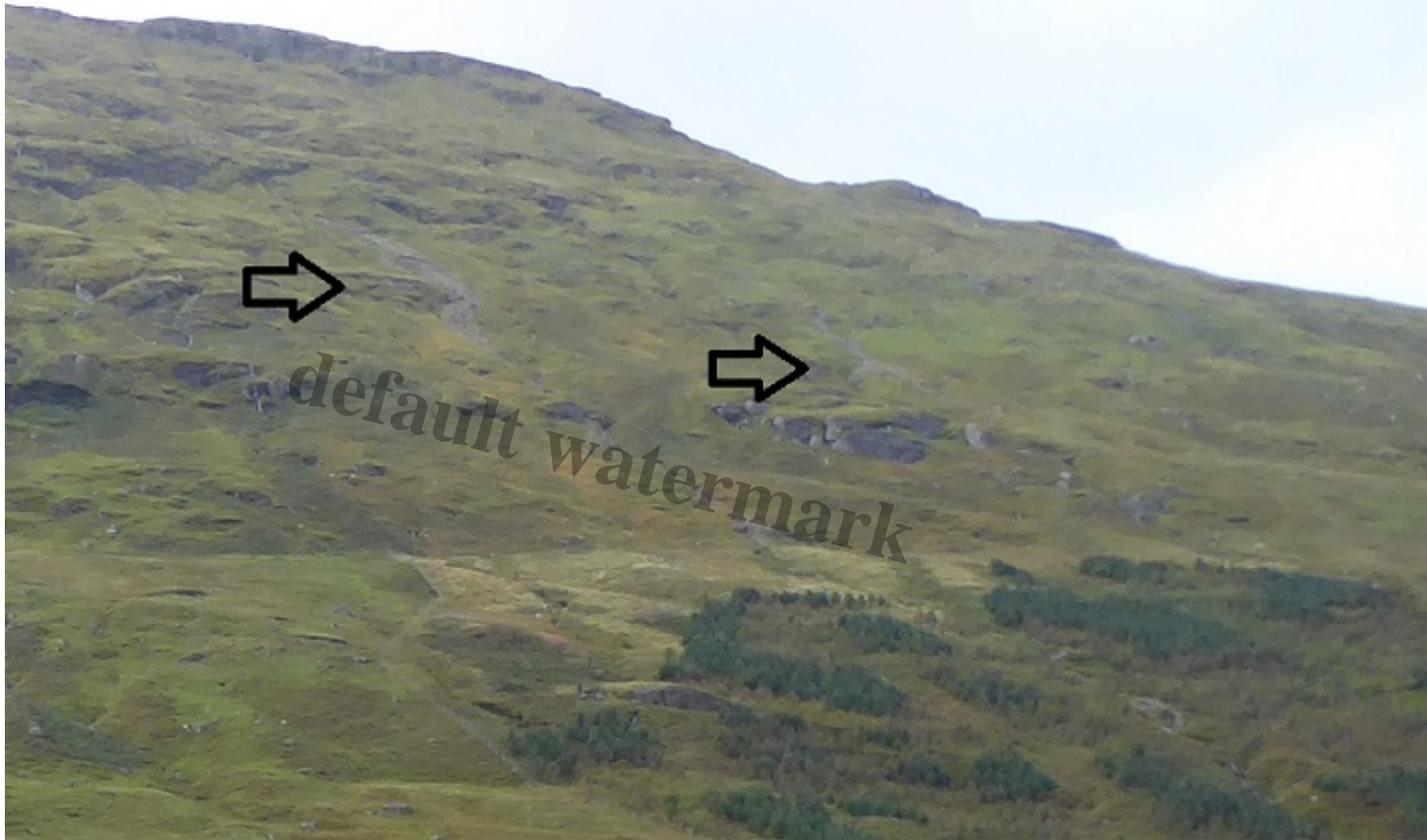
Note how the landslips are above the native woodland plantation, an illustration that we need to stem flow of water much higher up the hill
