Landslips, flooding and riverside tree planting in Balquhiddar – tackling the source of the problems

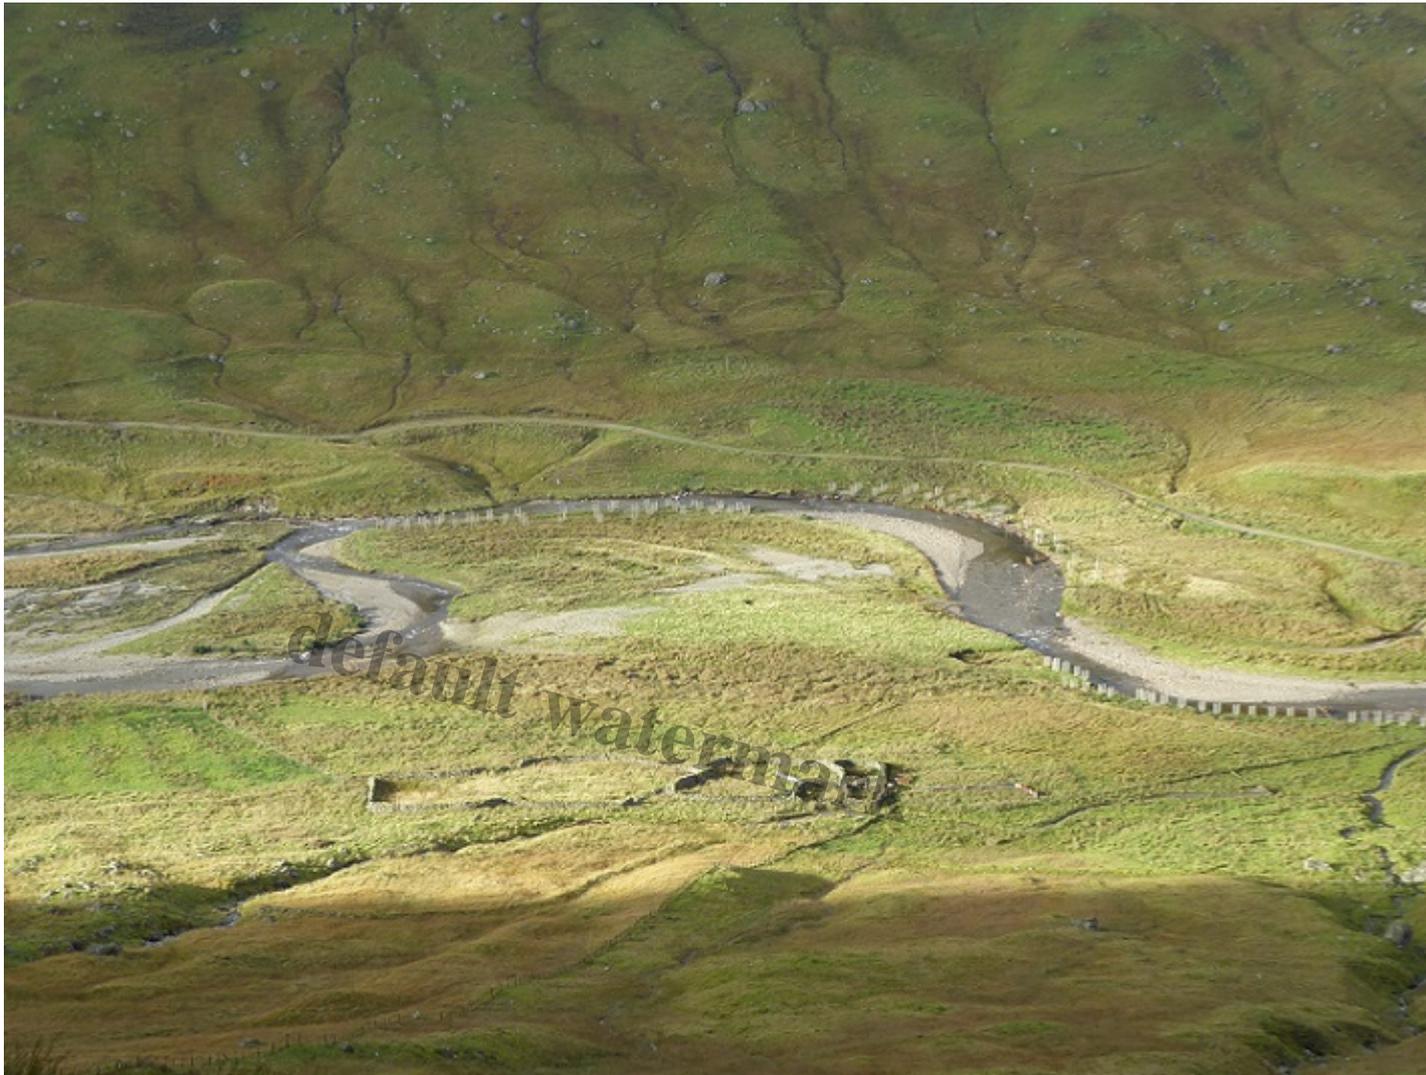
Part of the postage sized planting above Inverlochlarig Farm. Note the many watercourses on the far side of the glen. Once rainfall gets into these the water flows rapidly down the hill

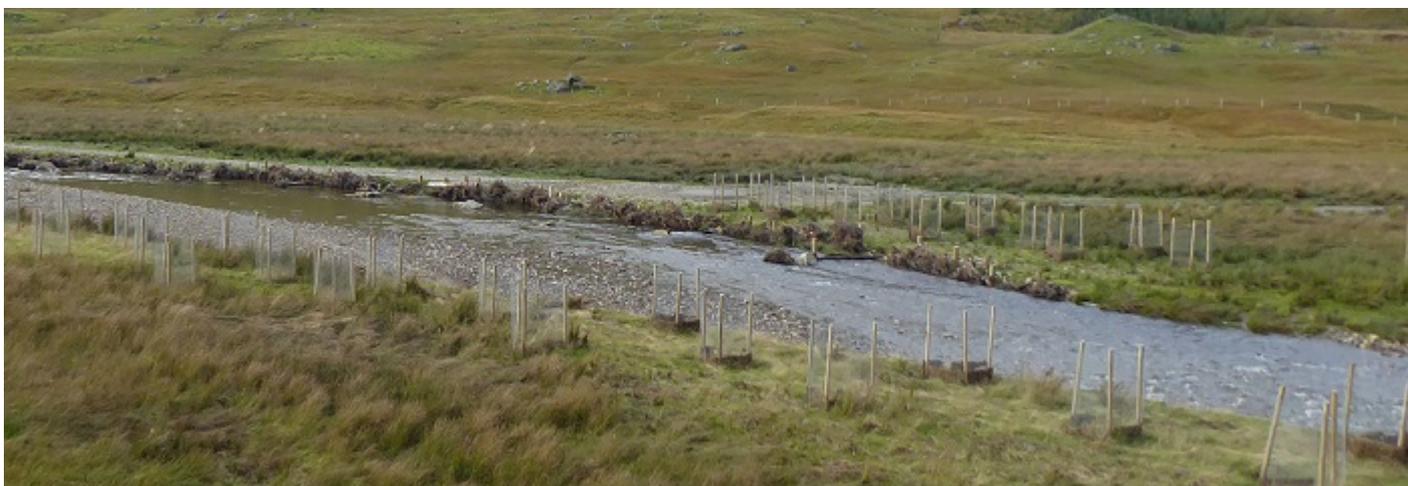
Works to stabilise the river bank visible left of centre

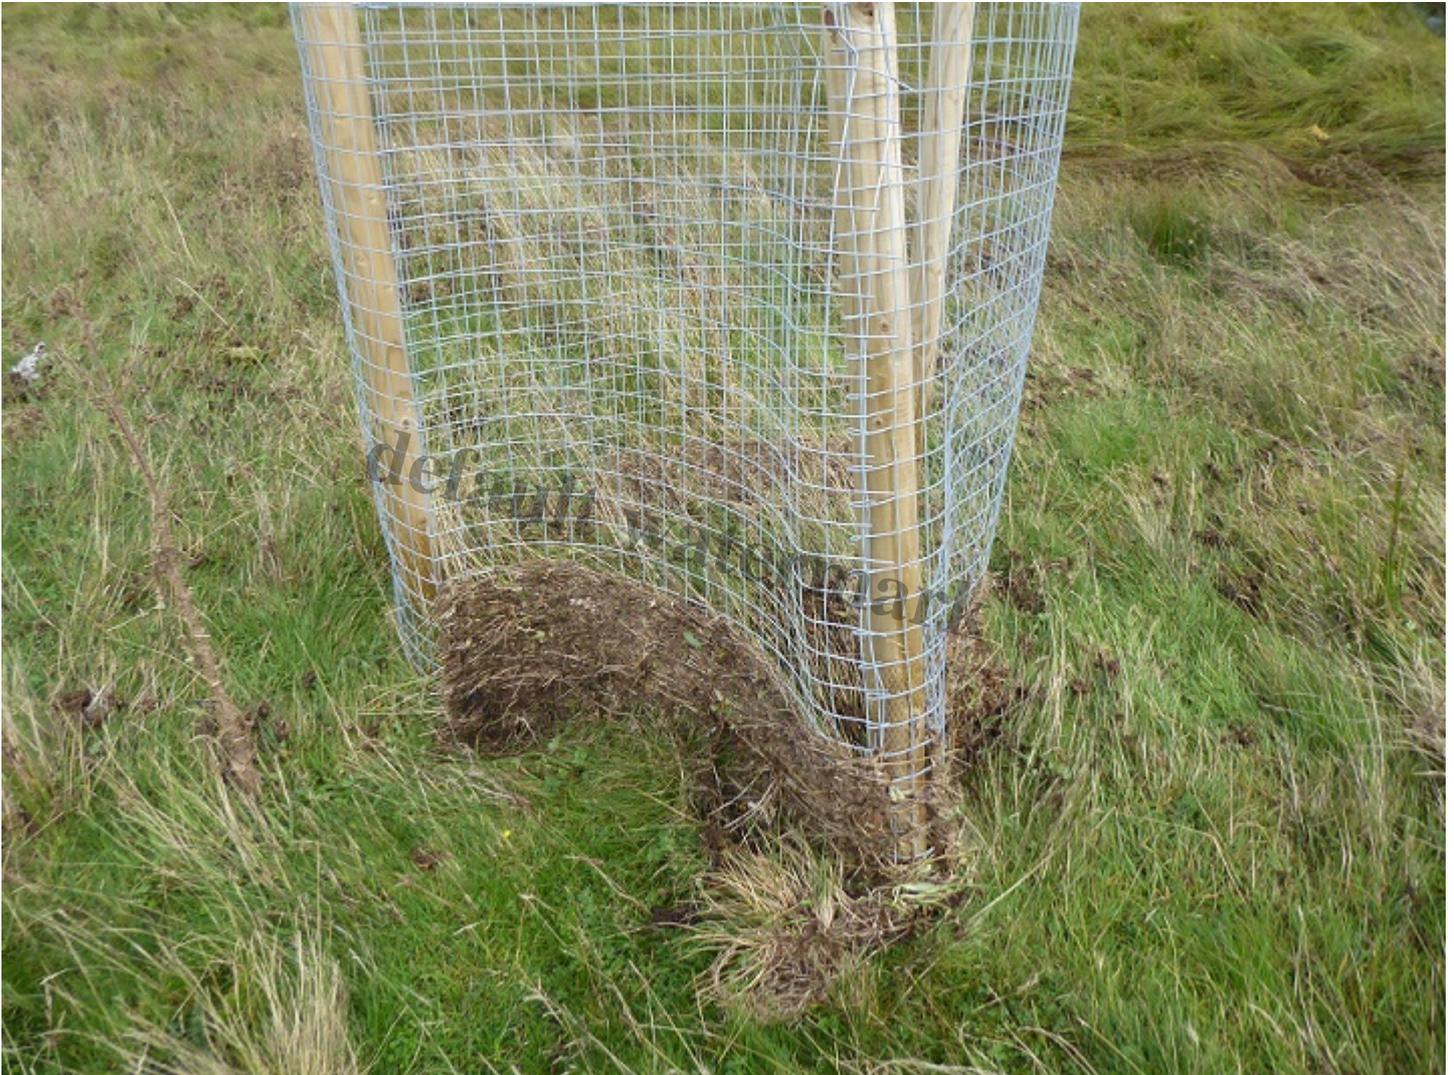
Some of the enclosures, particularly where broadside on to the flow of water, had taken quite a battering in the flood.

While there was no tree surviving in this enclosure, the way the wire serves to catch the vegetation probably helps to protect the trees and reduce the chances that they will be uprooted by the force of water or chopped or crushed by flood debris (though alder have evolved to survive such challenges). A larger flood, however, might destroy the enclosures and the trees with it.

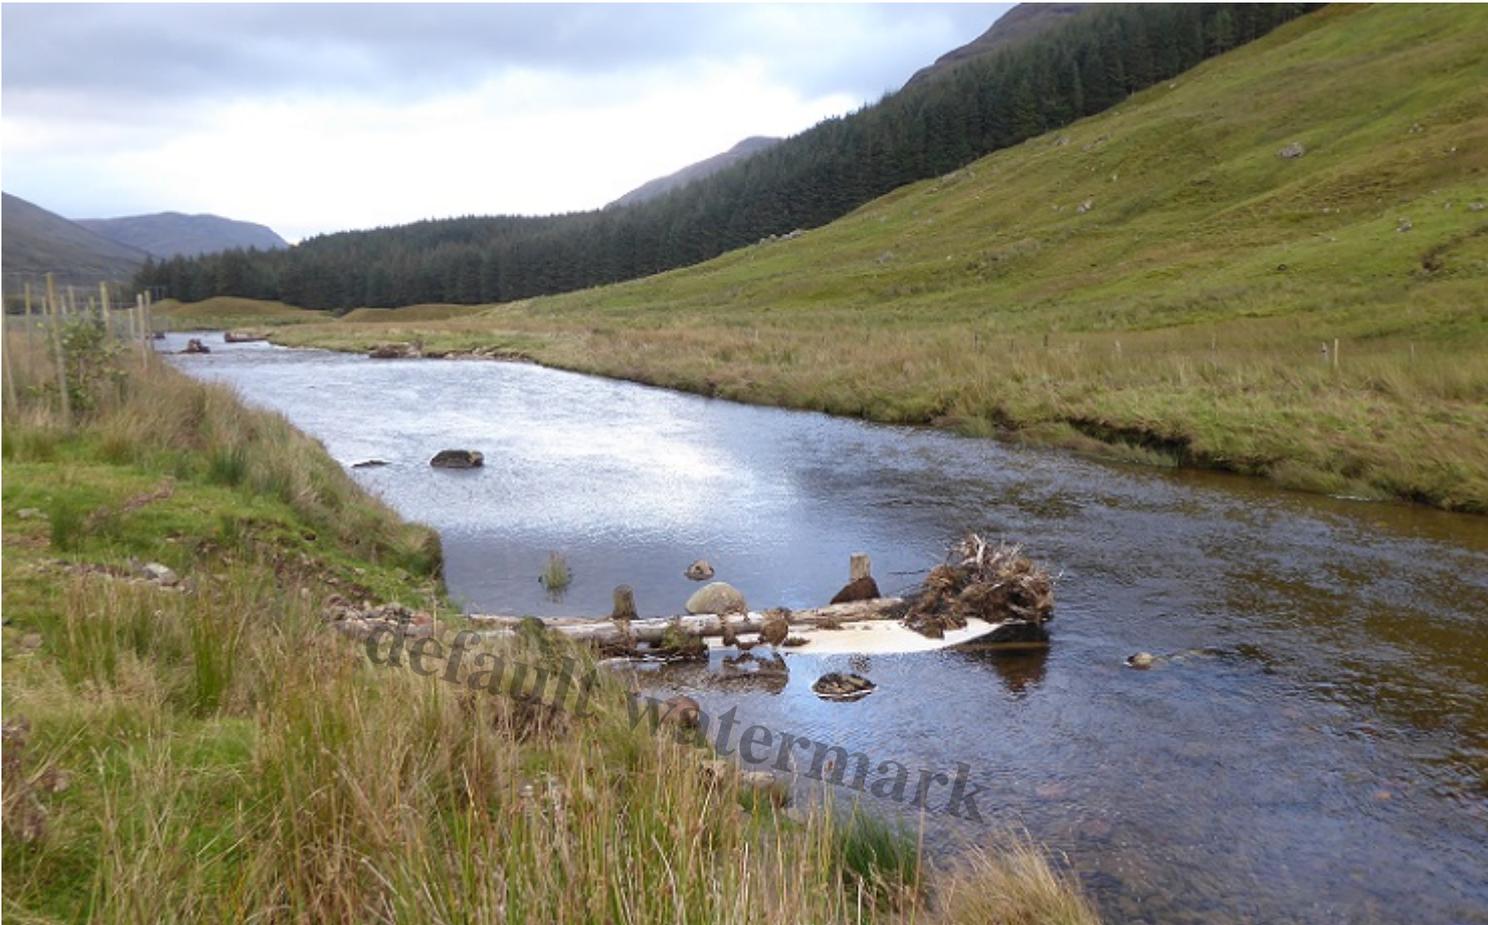
Placing tree trunks across rivers is now quite fashionable in conservation circles. While it serves to hold back some debris, potentially creating spawning beds for fish, in a flood it is likely to quickly bank out so that water and debris flow over the top. Neither in-river works like this nor planting trees is likely to reduce flood flow significantly.

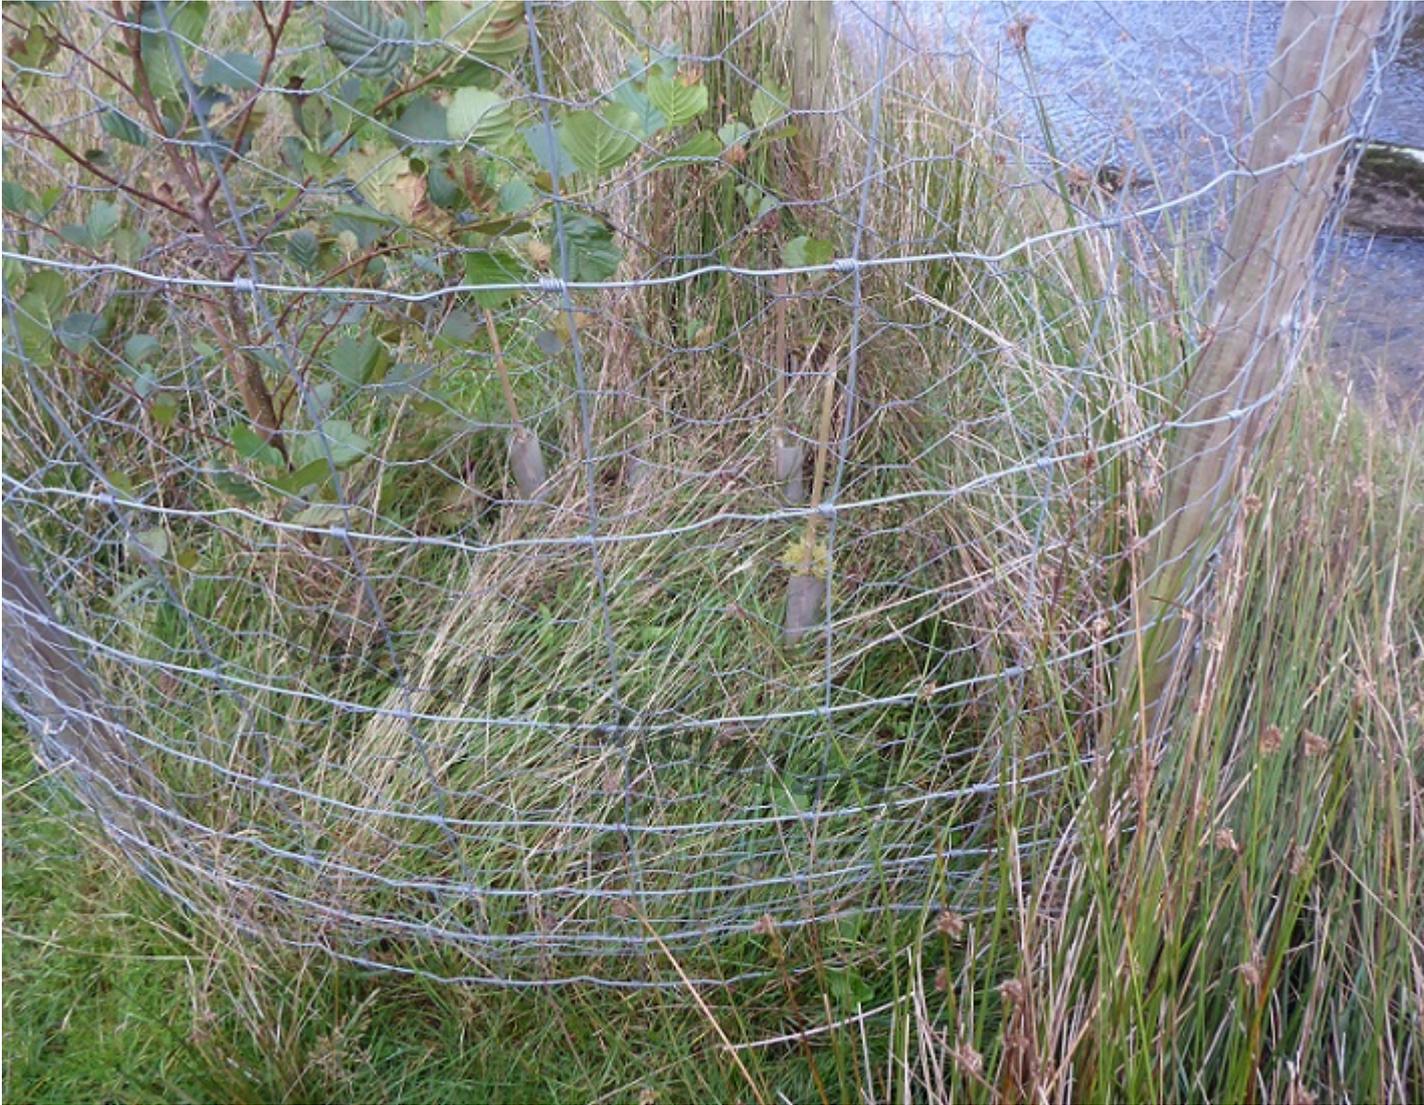
The trees in about half the tubes in this enclosure had taken â?? note the moss filled tube on the right. The wire netting makes it very difficult for anyone to remove the redundant tubes and reduce the amount of plastic that may end up in the river.
