## Landslips, flooding and riverside tree planting in Balquhiddar – tackling the source of the problems

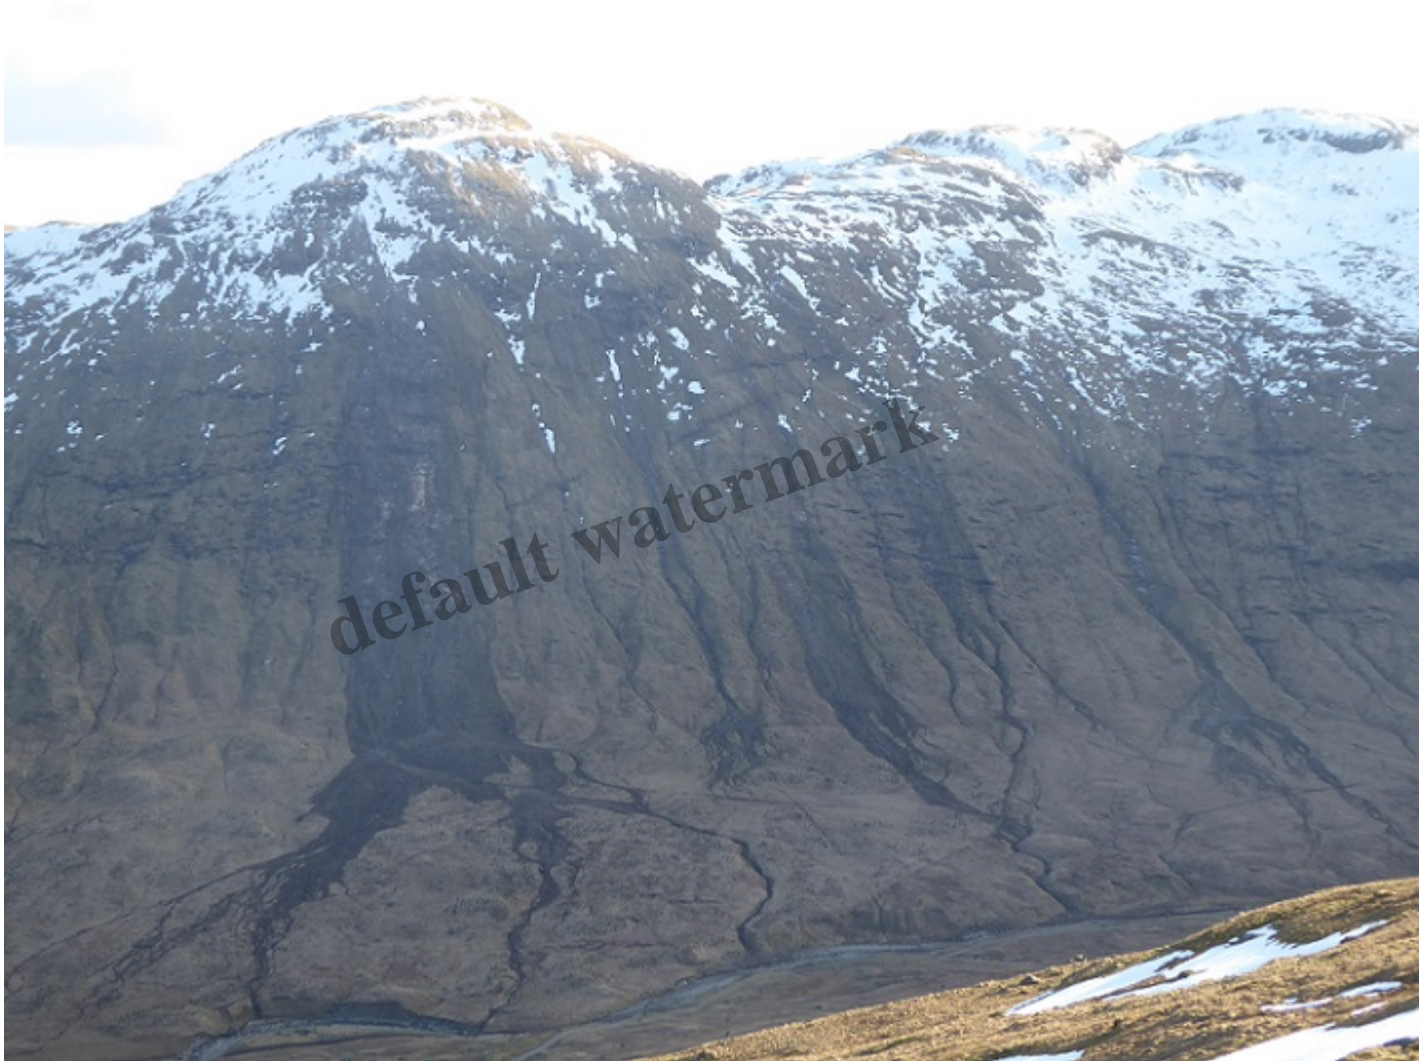
Landslips on Stob an Duibhe March 2020

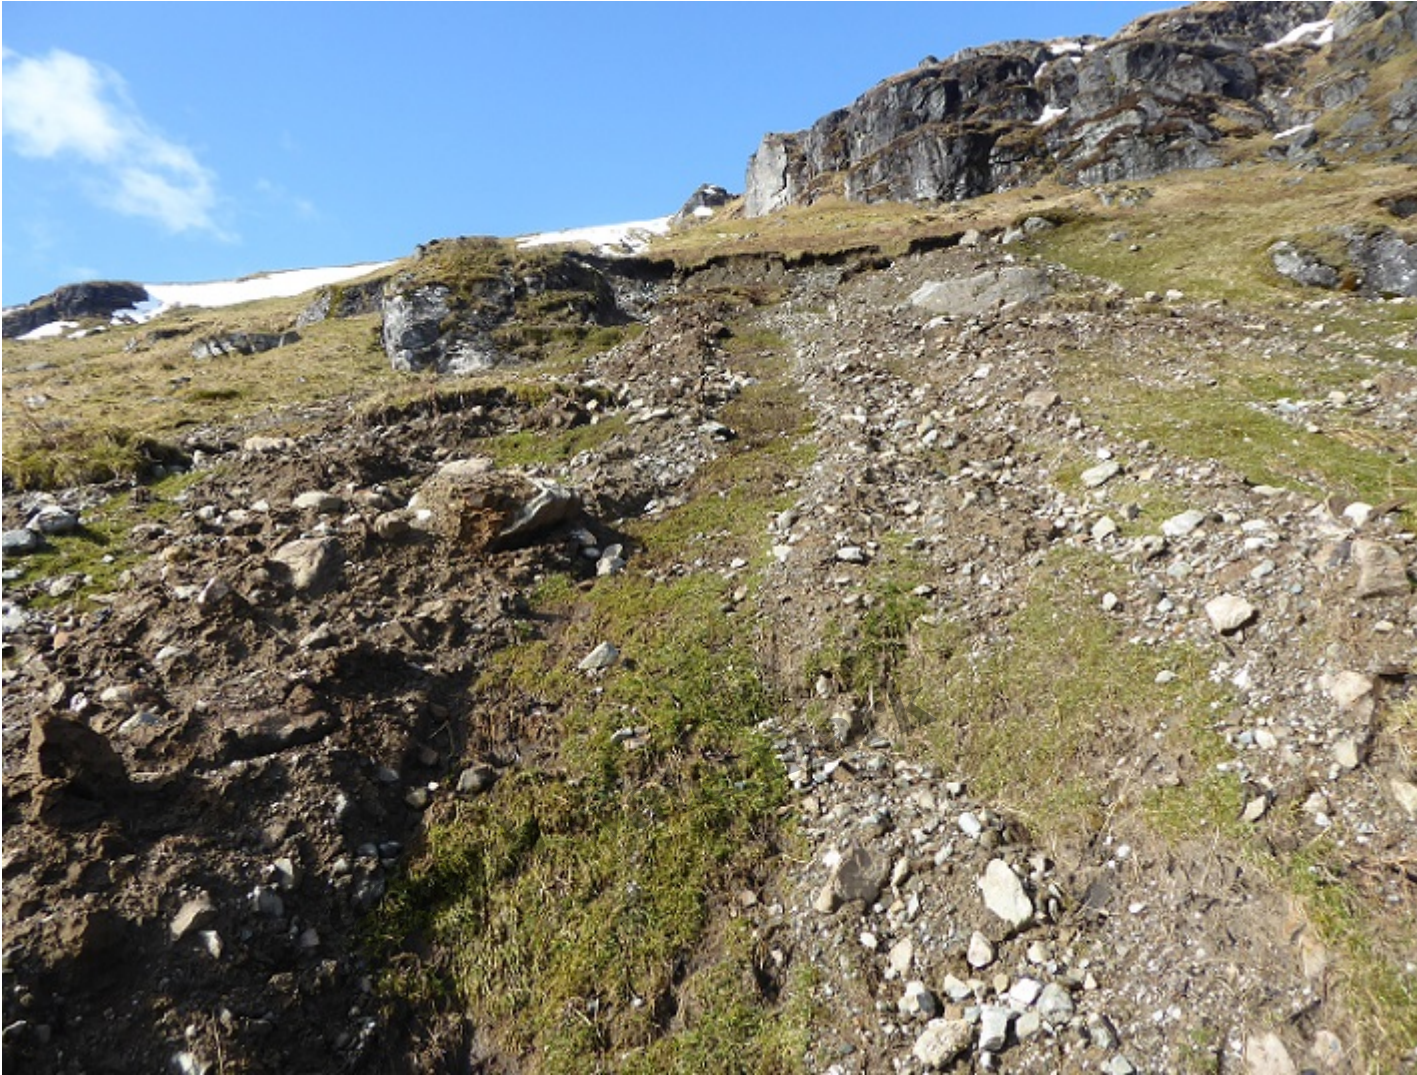
Landslip on south slope of Beinn a Chroin. Note how the volume of water has washed clean a strip down the centre of the landslip. March 2020.

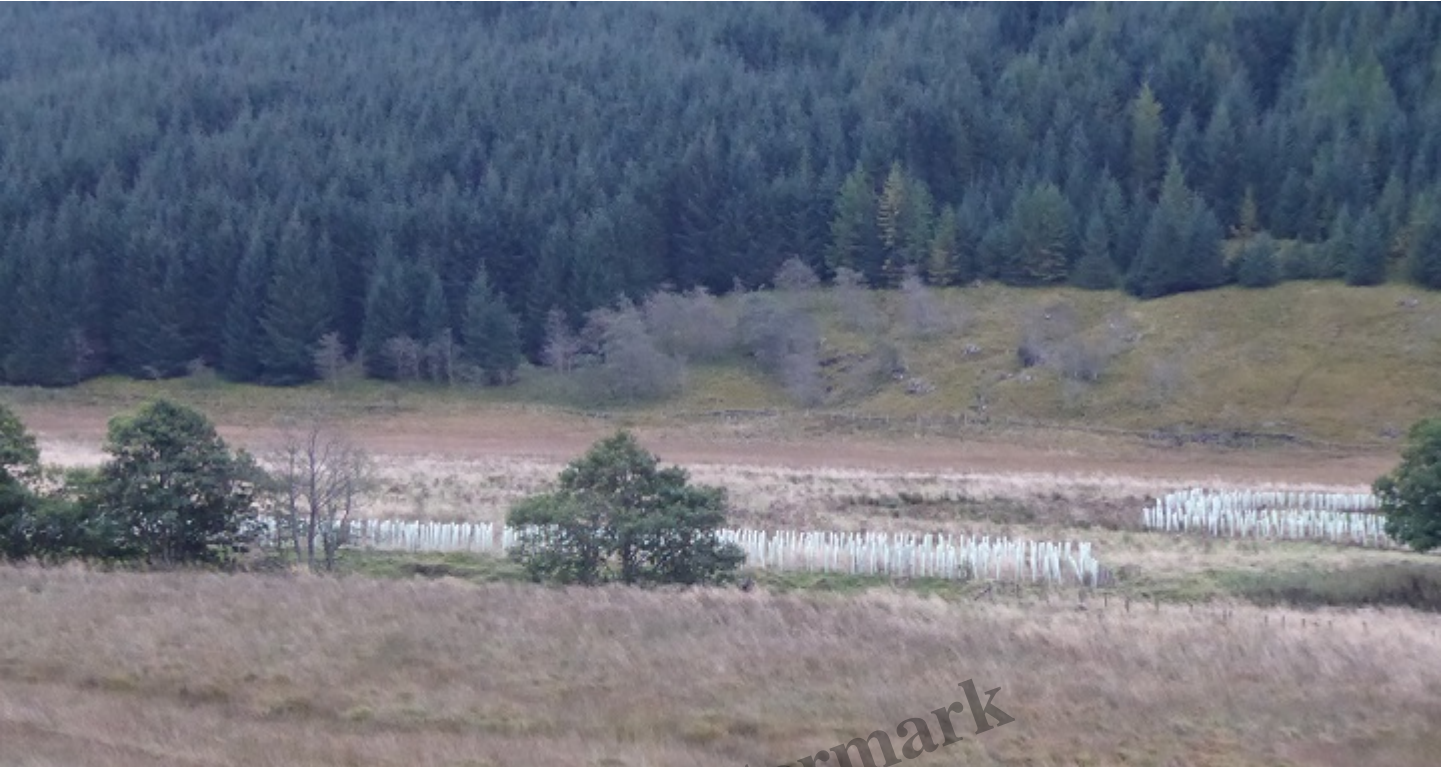
We were greeted by a forest of plastic tree tubes on the flood plain just before the road end at Inverlochlarig which the Loch Lomond and Trossachs National Park Authority (LLTNPA) had boasted about back in March ([see here](#)). The photo illustrates how the LLTNPA has paid no regard to the landscape, carbon emissions – plastic is derived from oil – or how it is killing wildlife in our rivers and seas.

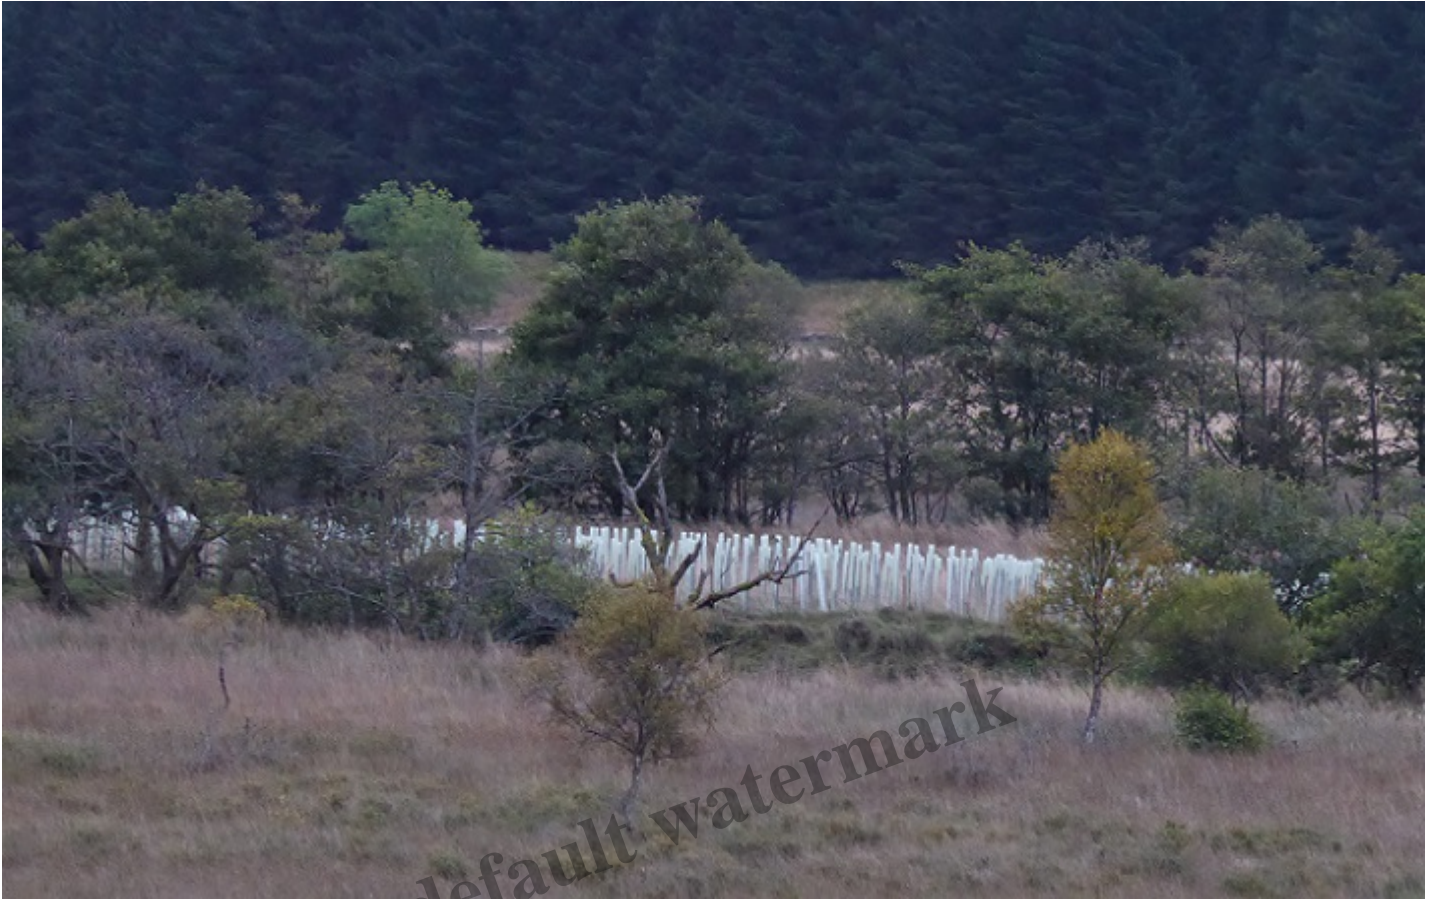
The LLTNPA stated the purpose of this tree planting was to improve river habitats by creating riparian tree cover. This photo shows it was completely unnecessary and a waste of public funds. There are already lots of trees along this section of the River Larig and these would regenerate naturally if given a chance. .

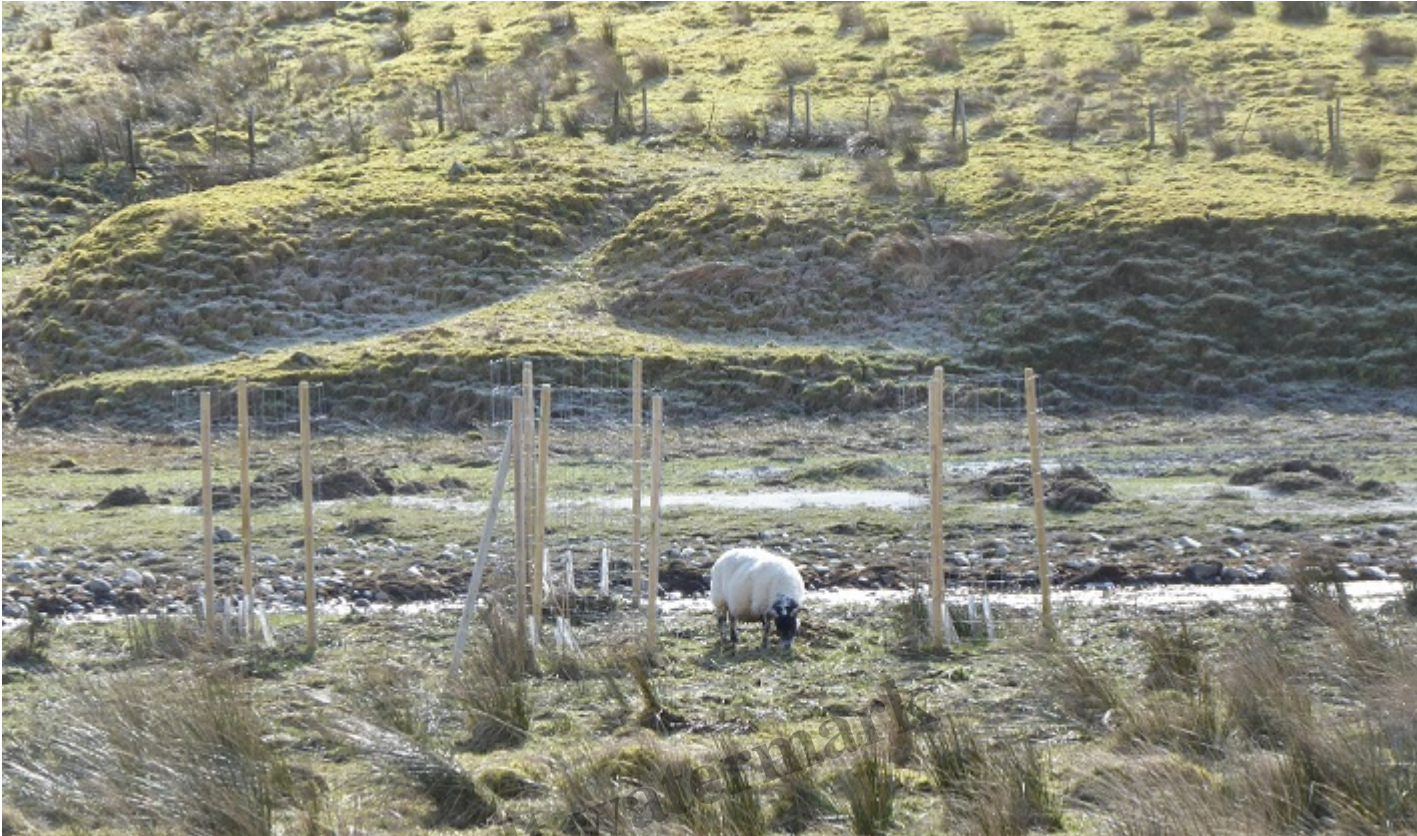
Trees enclosures above Inverlochlarig, March 2020.

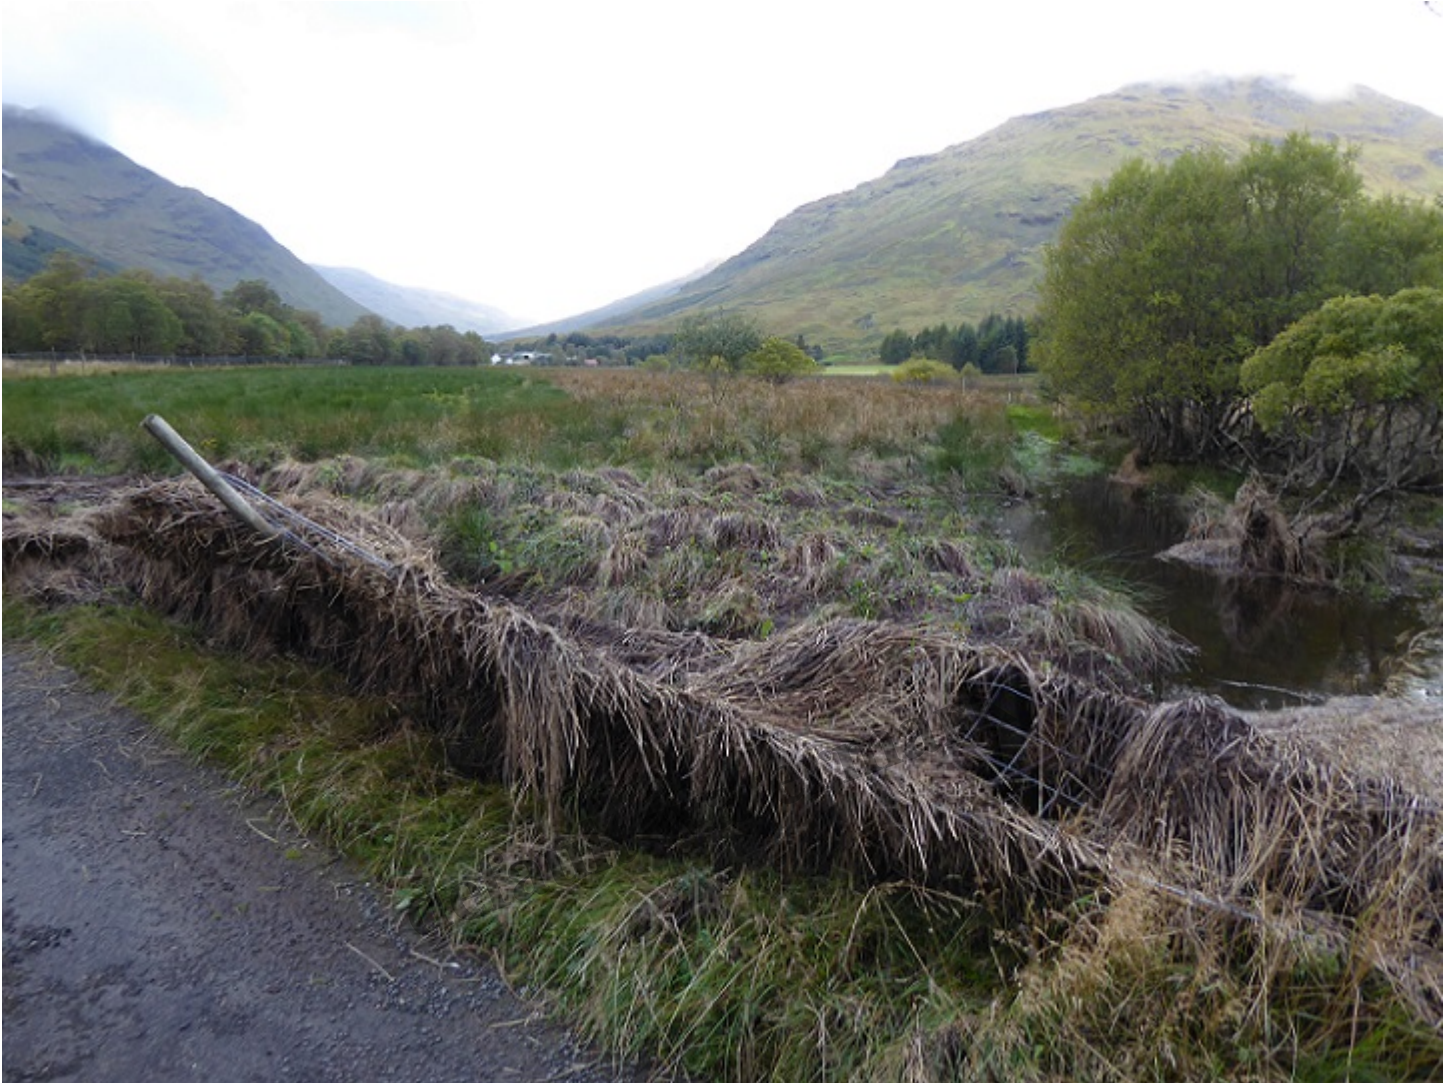
Just 50m beyond the car park, we came across evidence that the rain on Friday had been sufficient to cause significant flooding

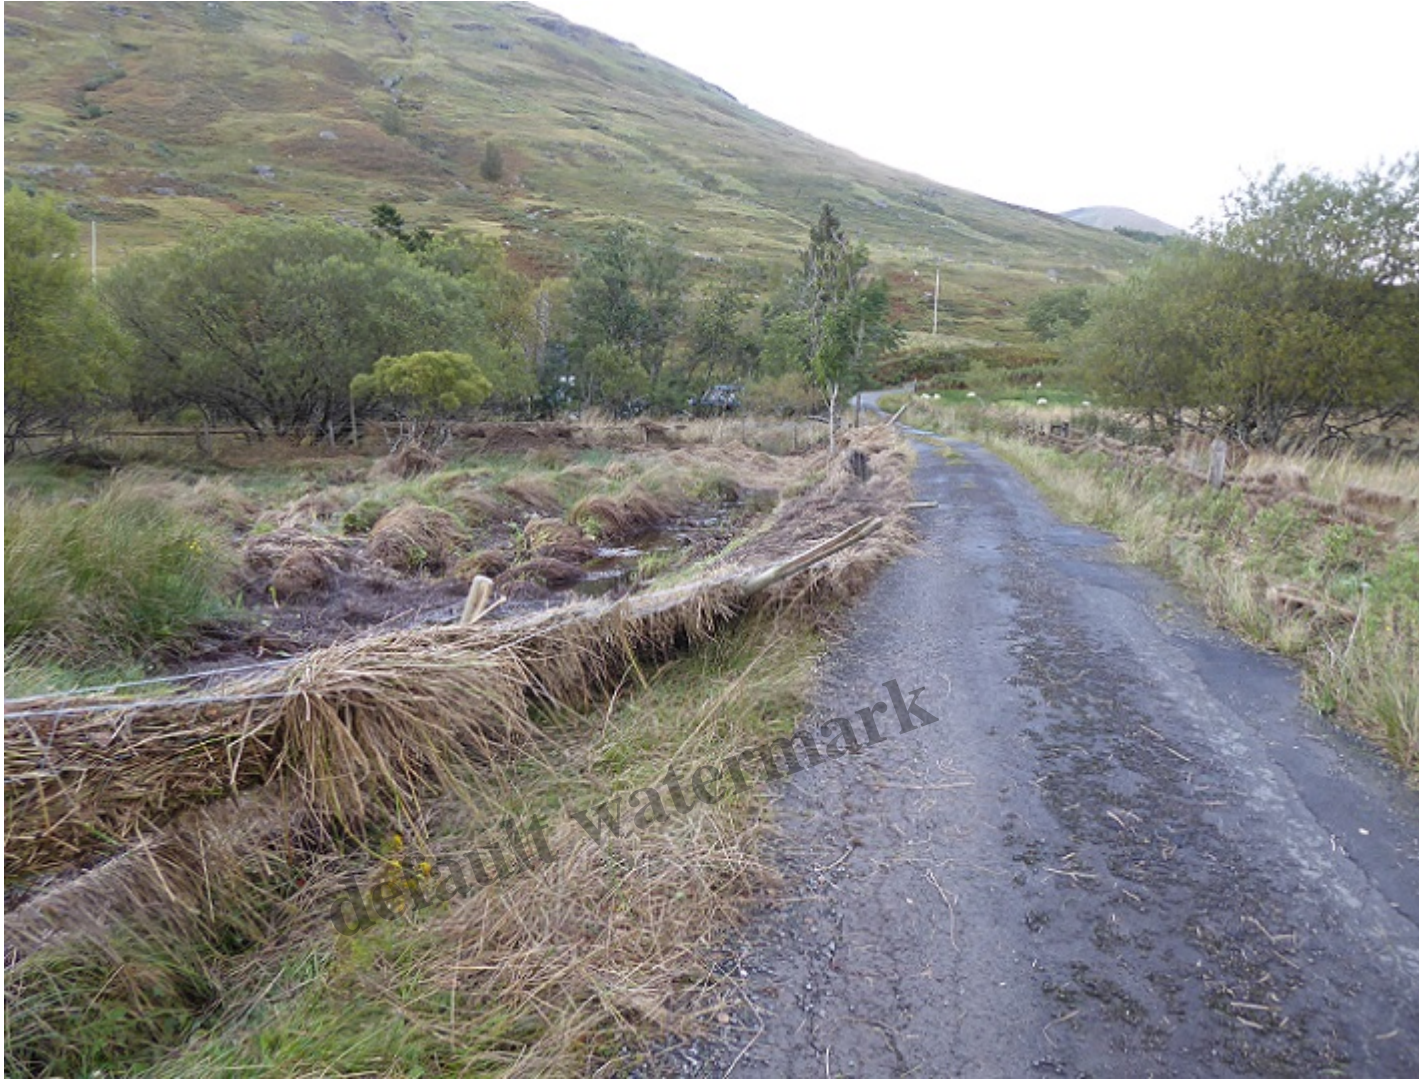
Looking back towards the car park. You can just see some of the sheep which were scattered over the hillside beyond in significant numbers.

Even small scale damage like this will have caused significant cost to the landowner

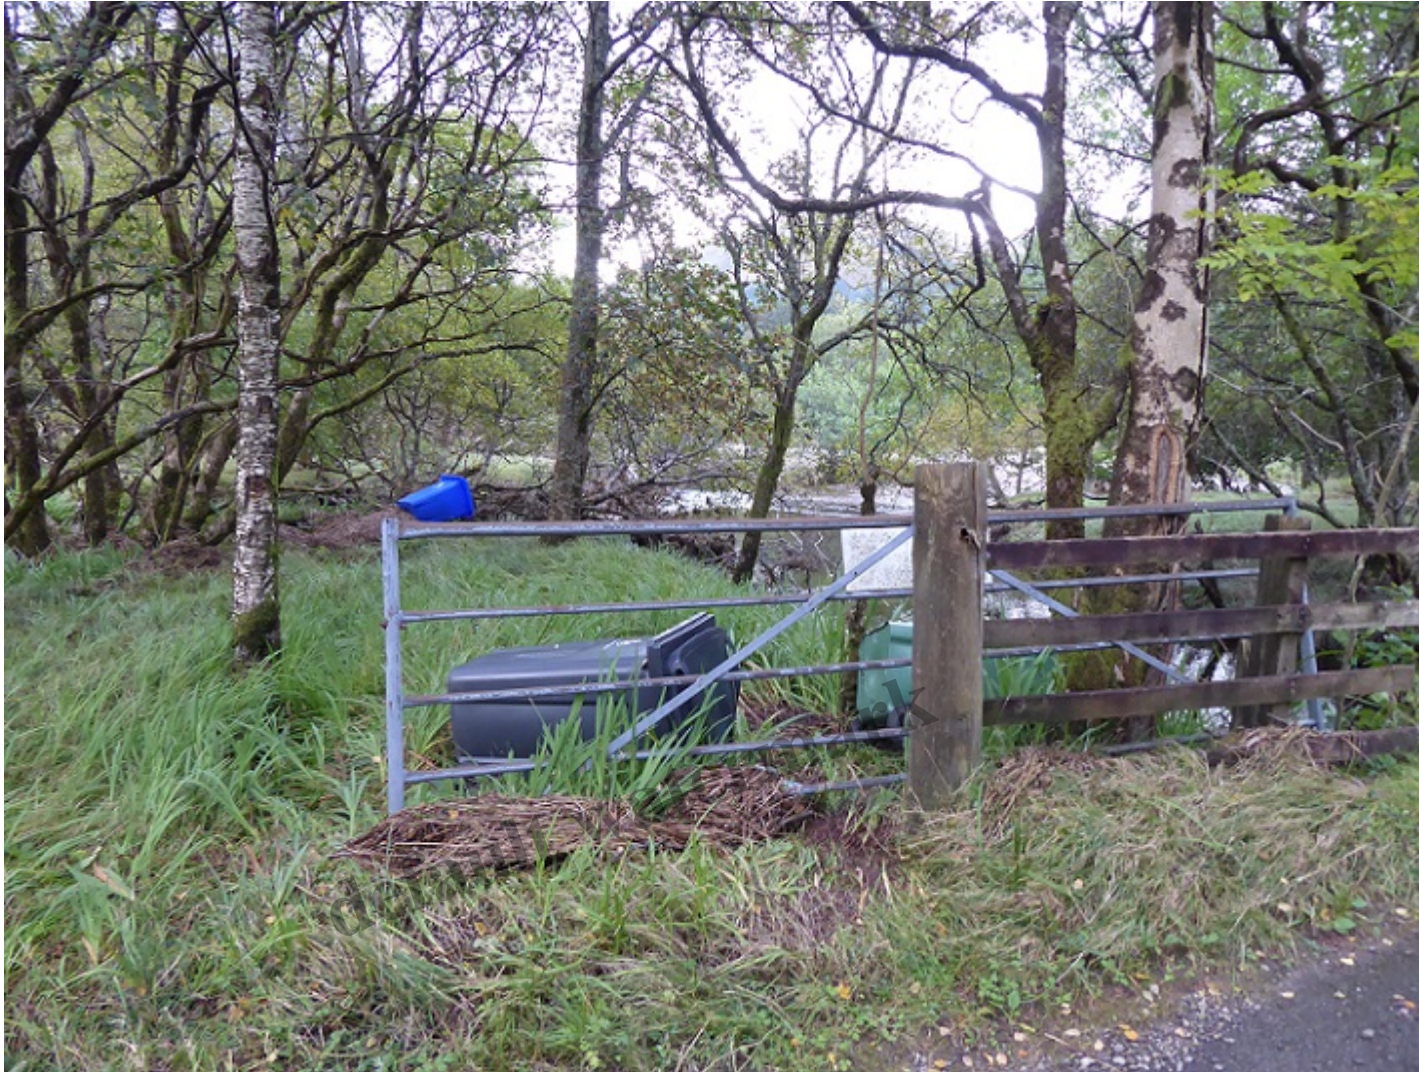
It looked like not everyone locally was prepared for the rainfall

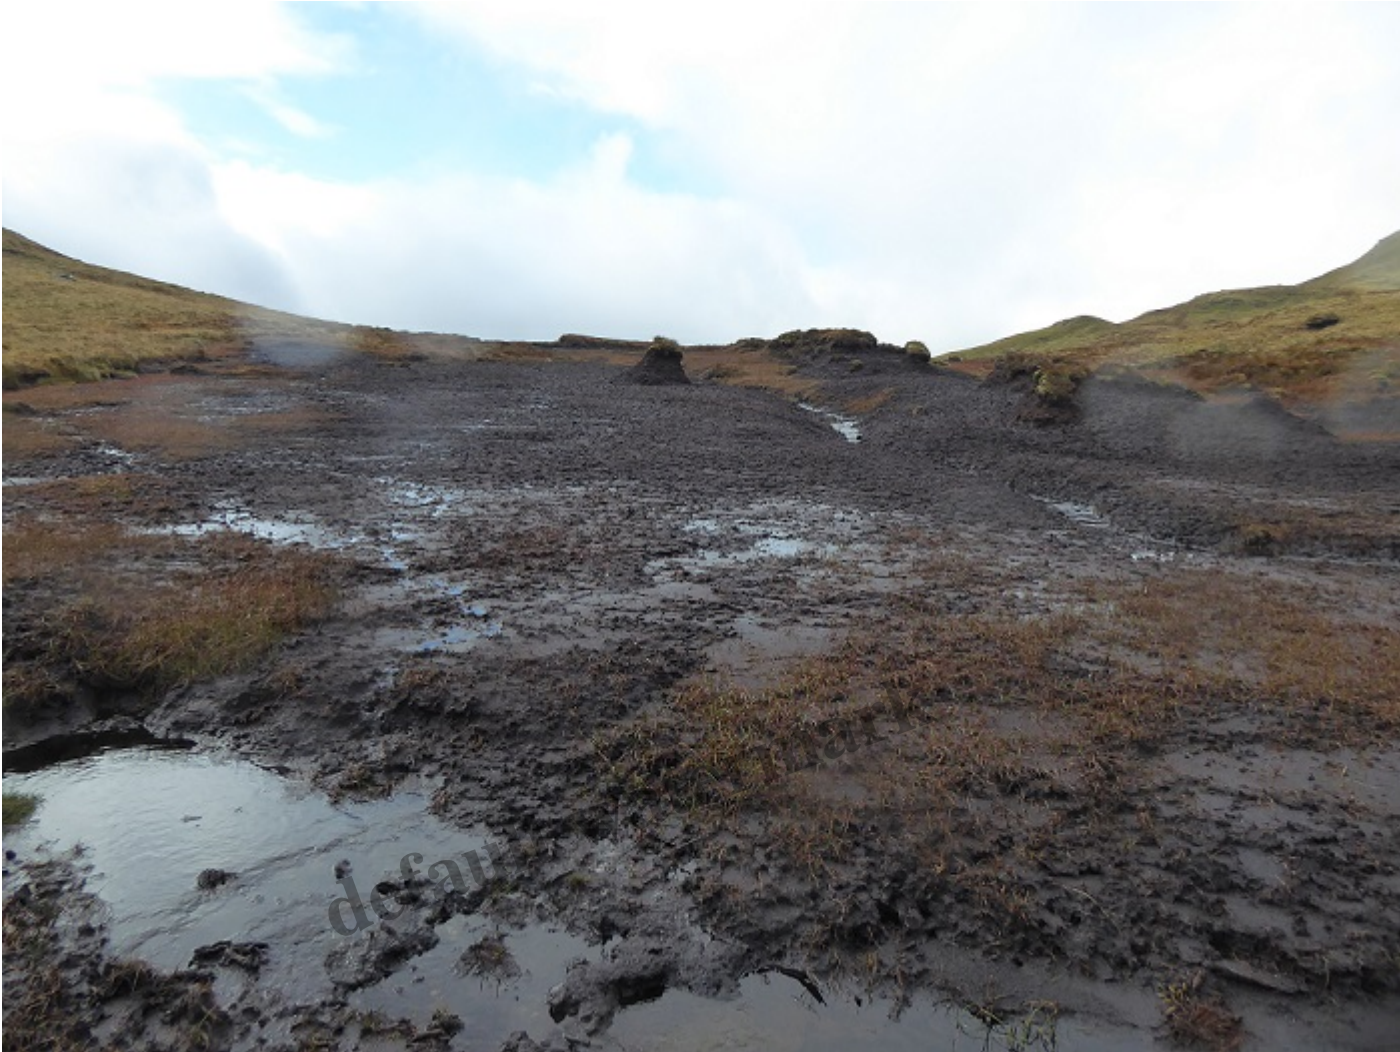
Eroded peat on the undulating south east ridge of Stob a' Choin. The height of the hag in the distance is an indication of the former height of the bog and how much carbon was stored here. Note the animal hoof marks visible in the foreground and the watercourse on the right, both of which are causing the erosion.

This and other areas of degraded peatland between Balquhidder and Loch Katrine could be helping to absorb rainfall which has been triggering landslips on both sides of the watershed. This particular area would appear need very little restoration work to start functioning again as a bog. If grazing levels were reduced, the flat areas would quickly re-vegetate with cotton grass. The other main intervention that would be required would be to block up the water course and create bog pools.

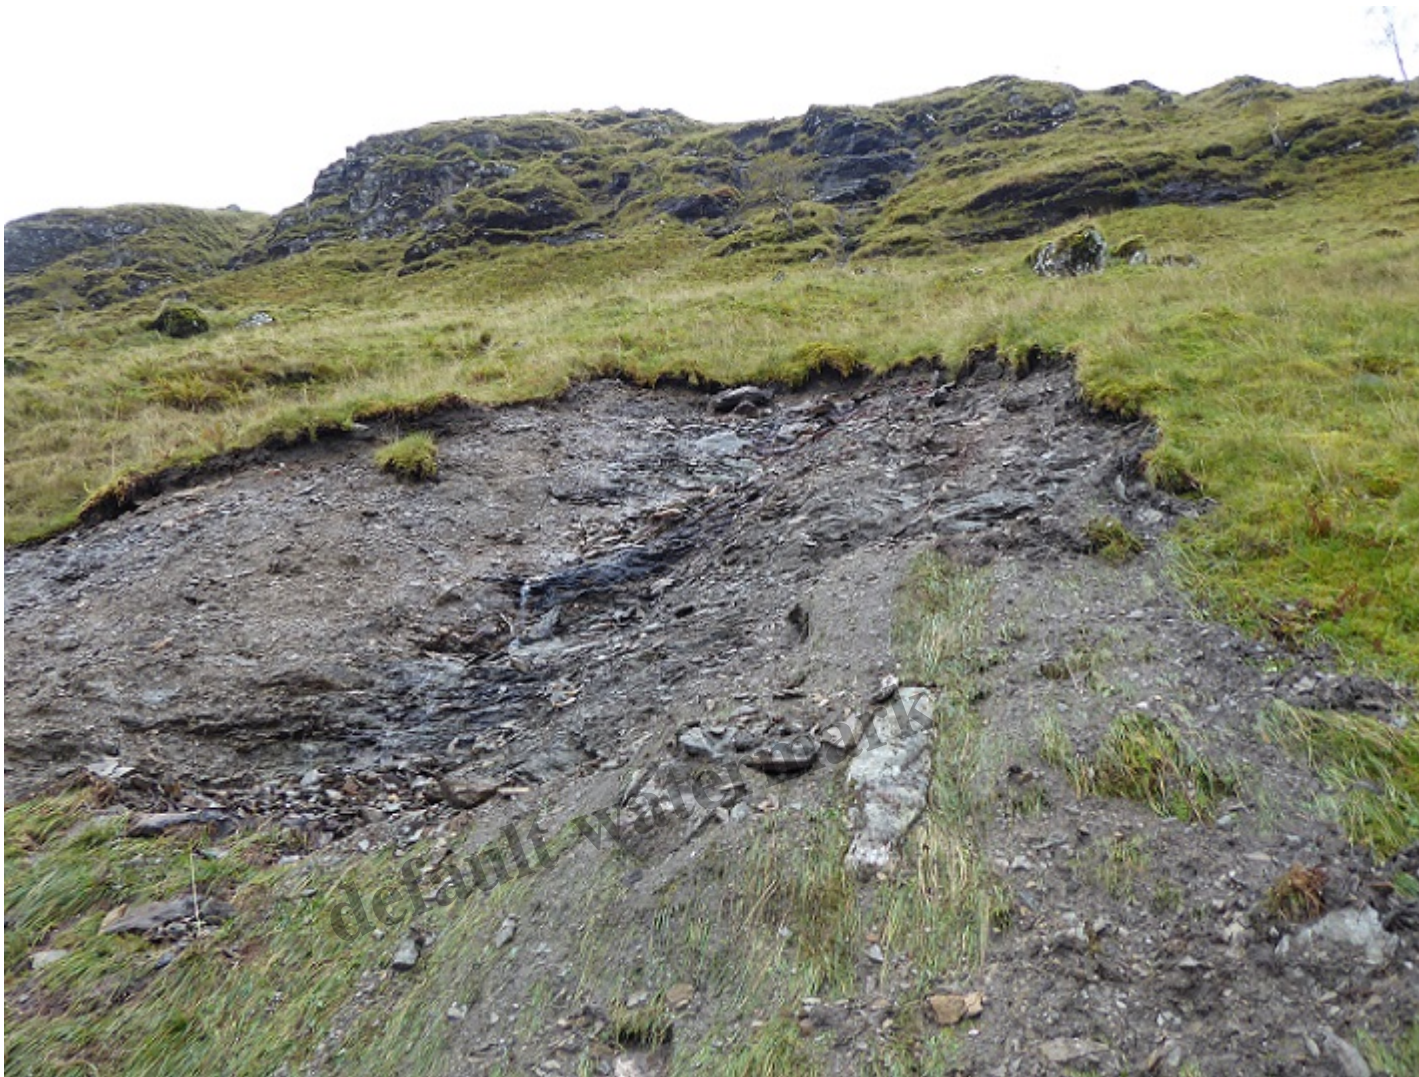
The flattened vegetation and smaller debris, which was soft and unconsolidated, indicates that this landslide was only days old.

A small watercourse was visible below the crag above the landslide which then disappeared under the vegetation. It appears that the volume of water flowing down this underground burn triggered the landslide exposing the burn once more.

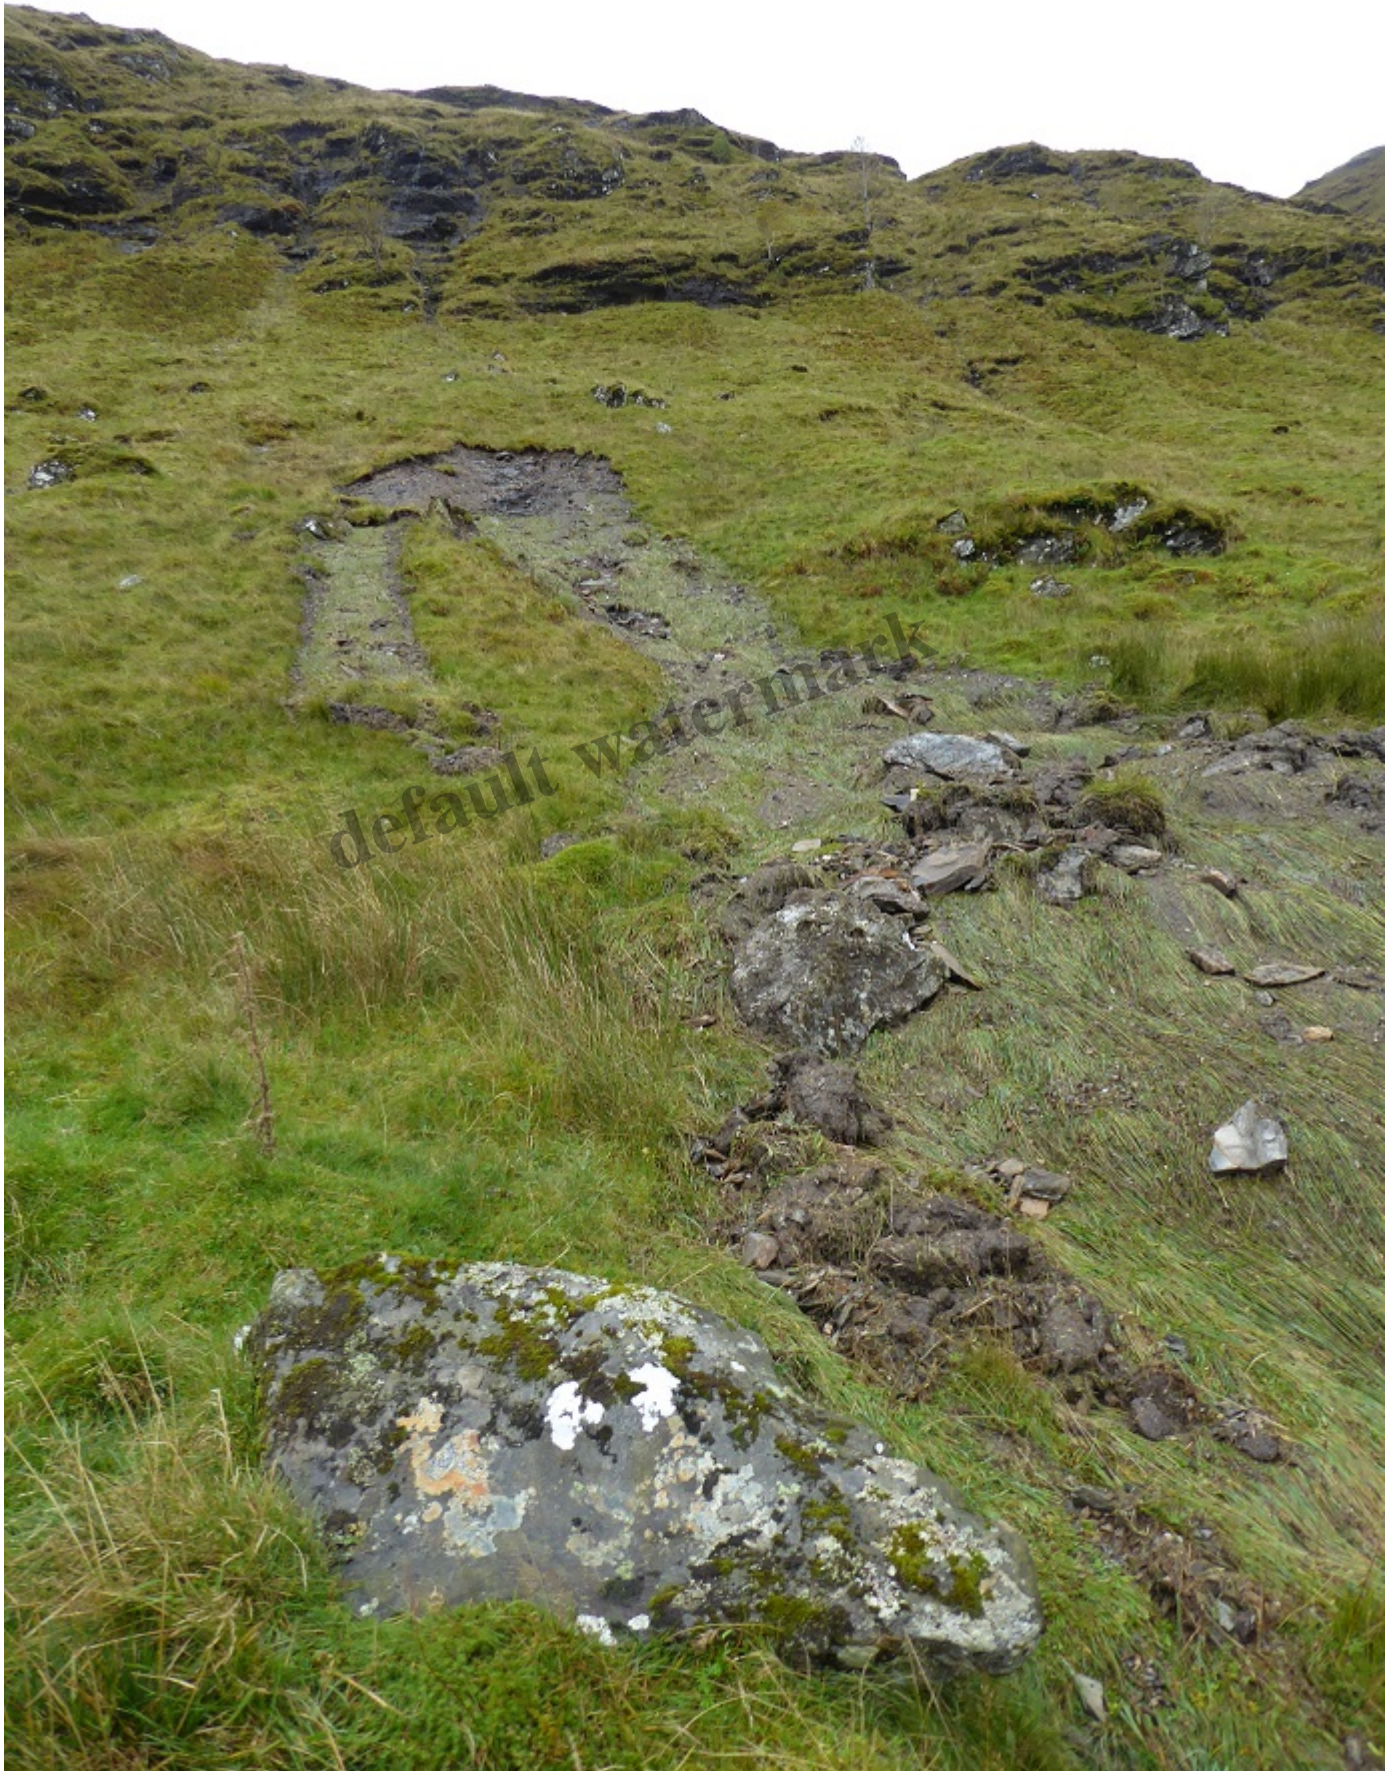
Top section of landslip.

There was also enough water running down the hill to allow these blocks to slide over the vegetation without causing it significant damage

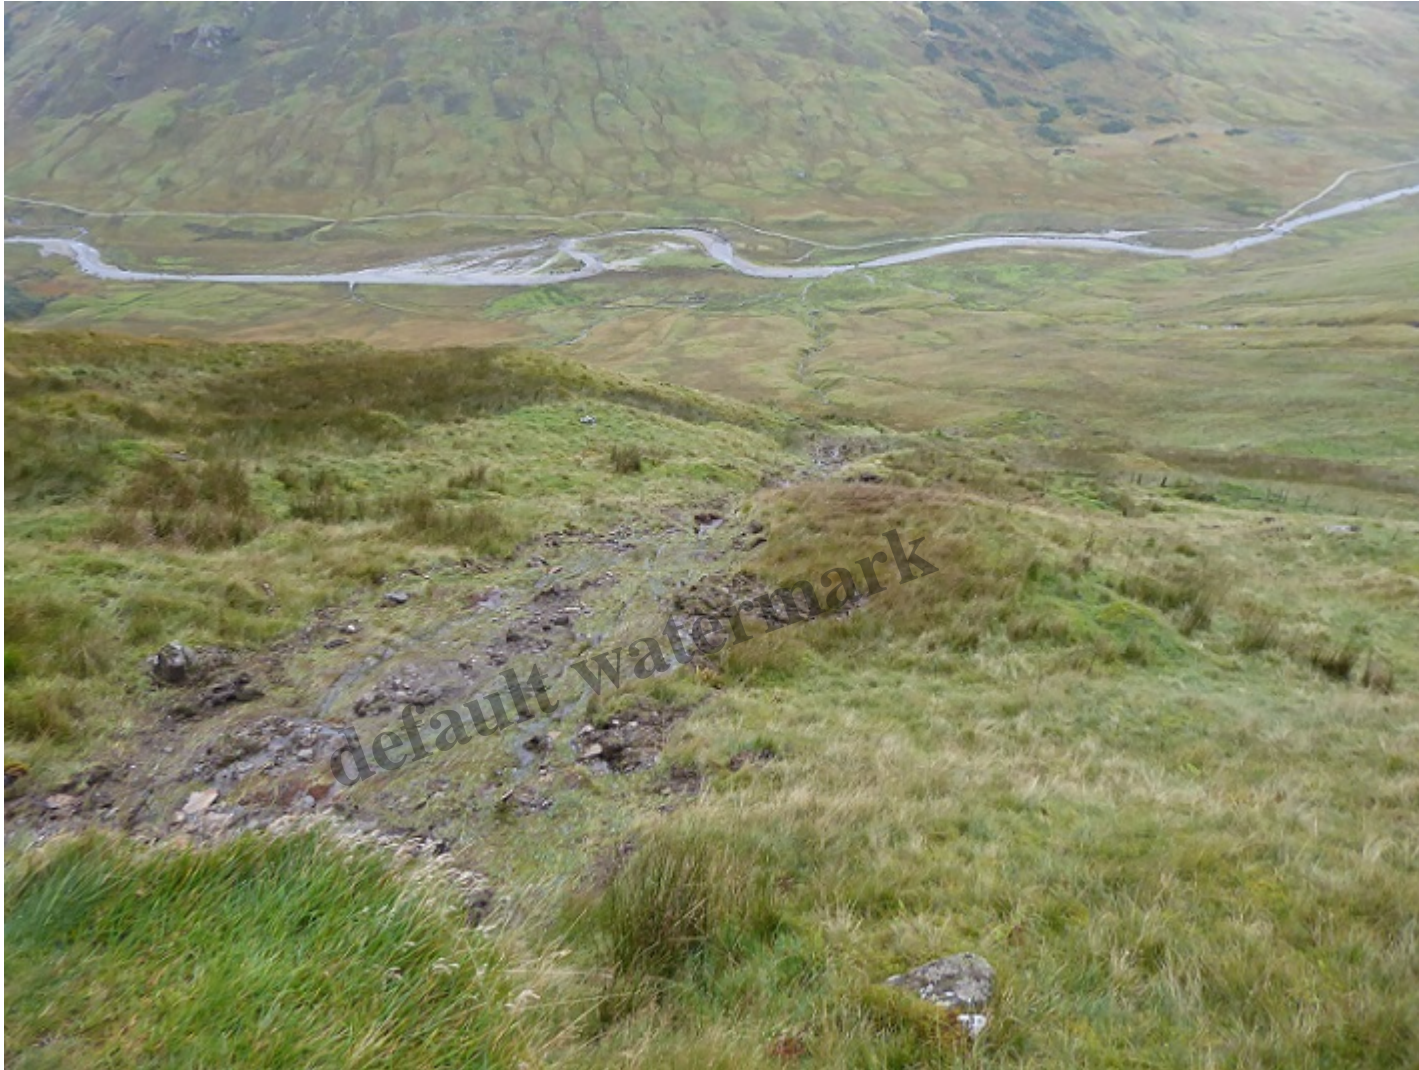
Looking down from near the point where the previous photo was taken

The landslip continued scattering debris for several hundred metres down the hillside

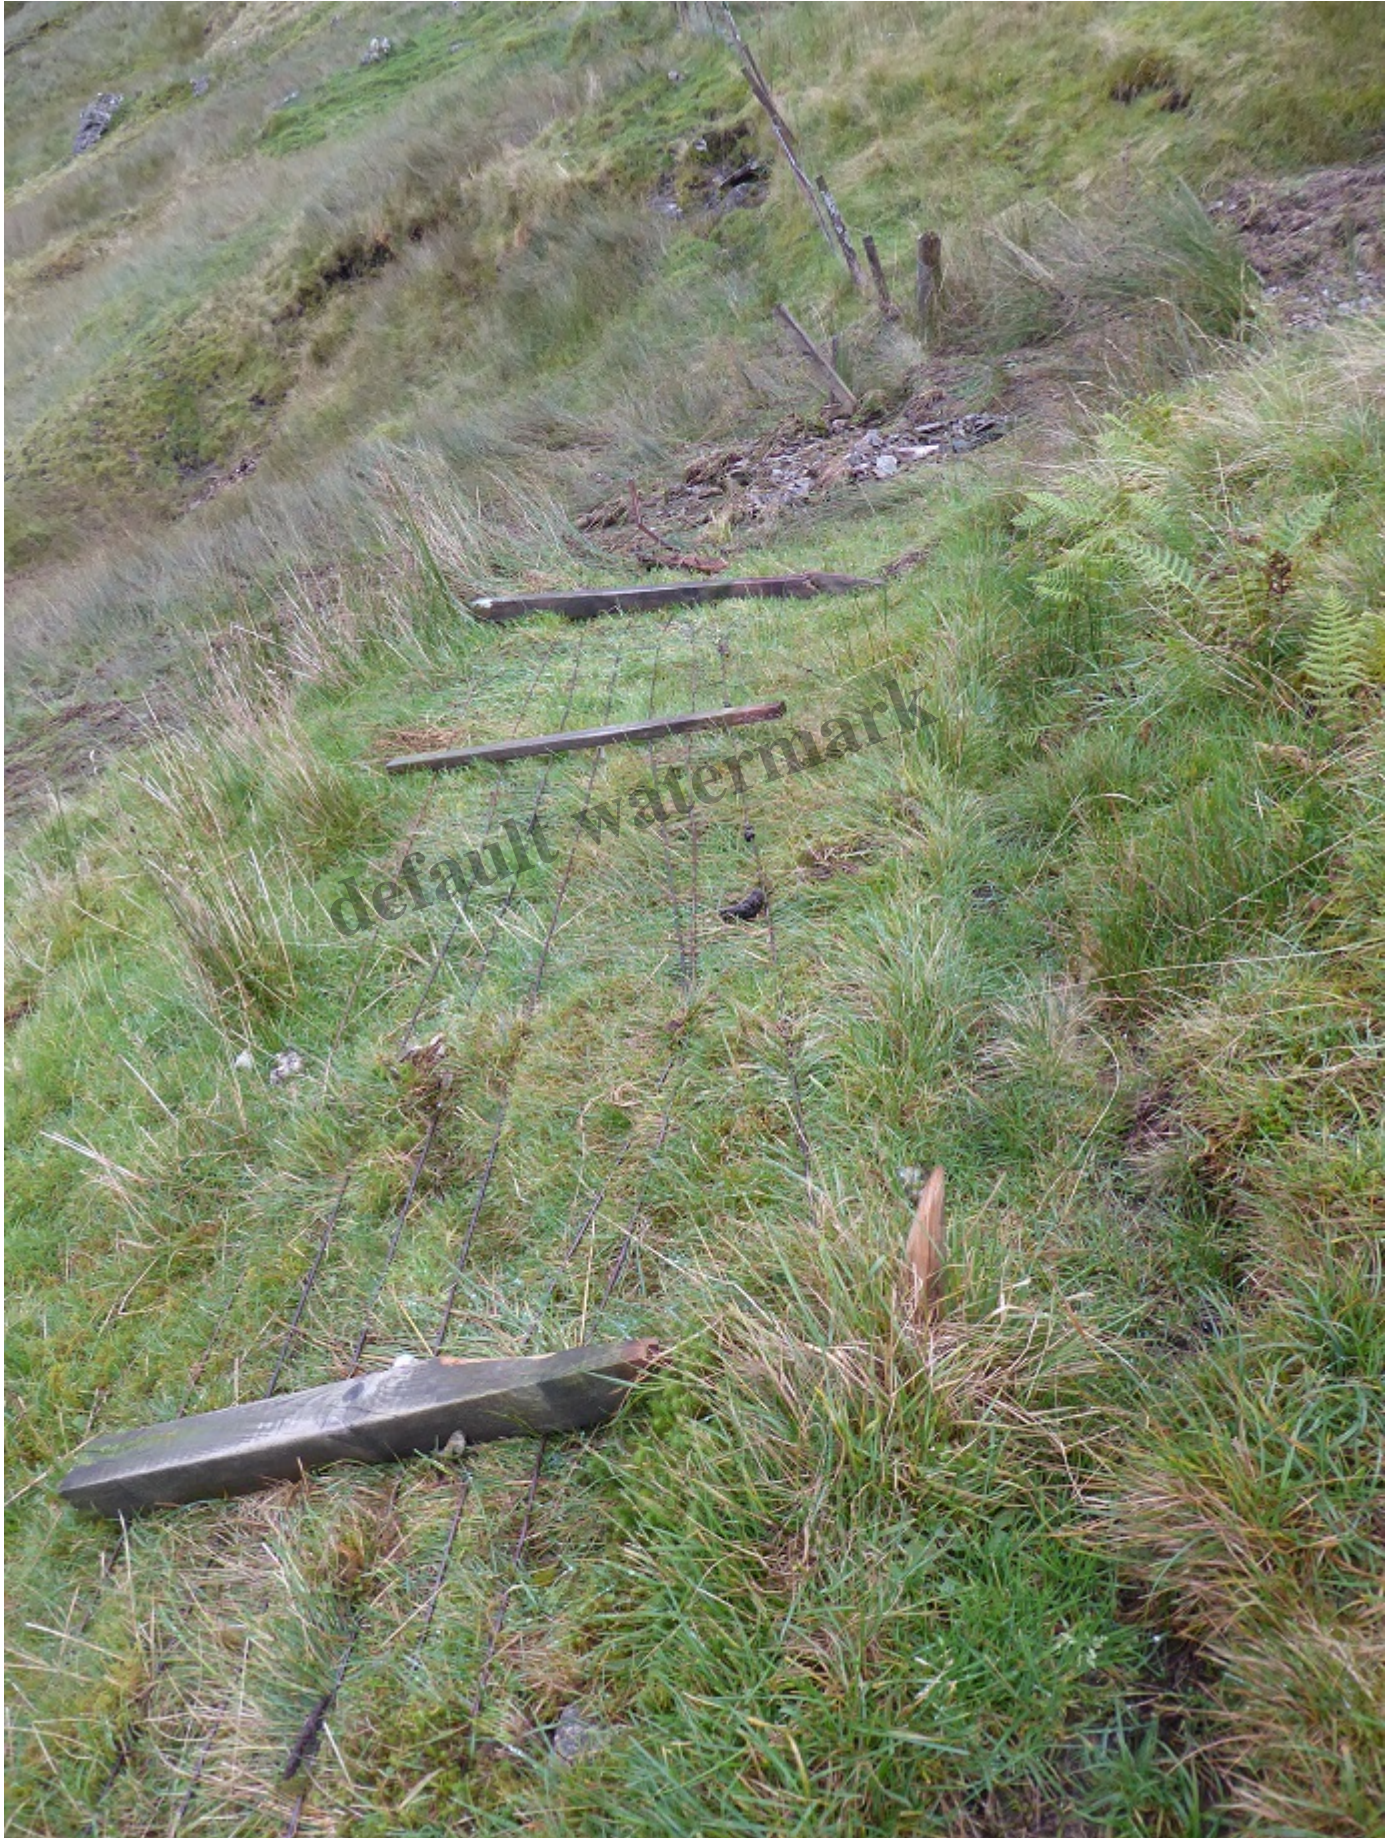
Note the projecting spear of wood to the right of the post in the foreground

The force of the water and the debris it was carrying was sufficient to flatten this stock fence well below and snap one its posts in two – more costs for the estate

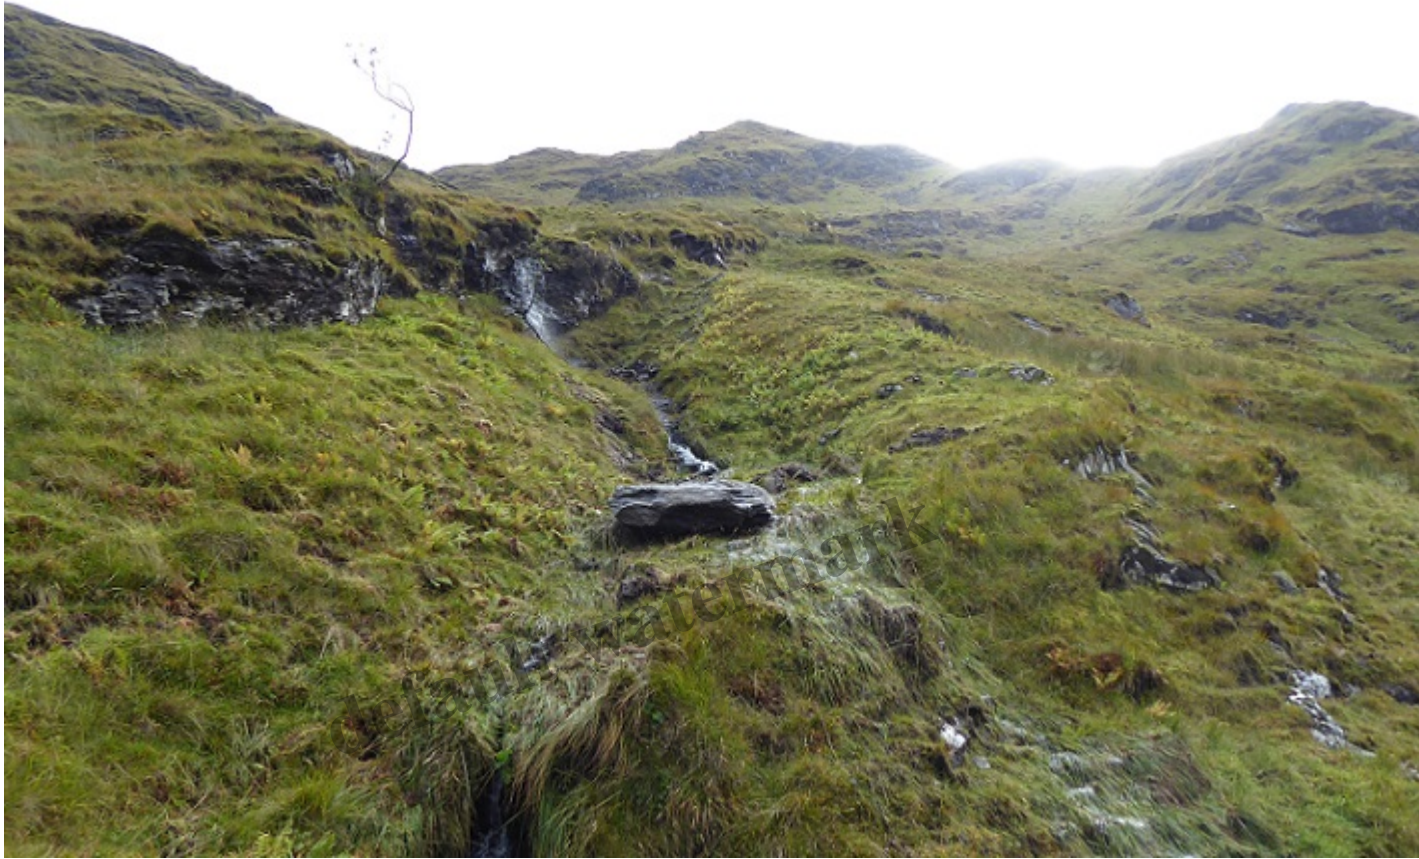
The course of the landslip is visible to the right of what is now a small waterfall.
