## Landslips, flooding and riverside tree planting in Balquhiddar – tackling the source of the problems

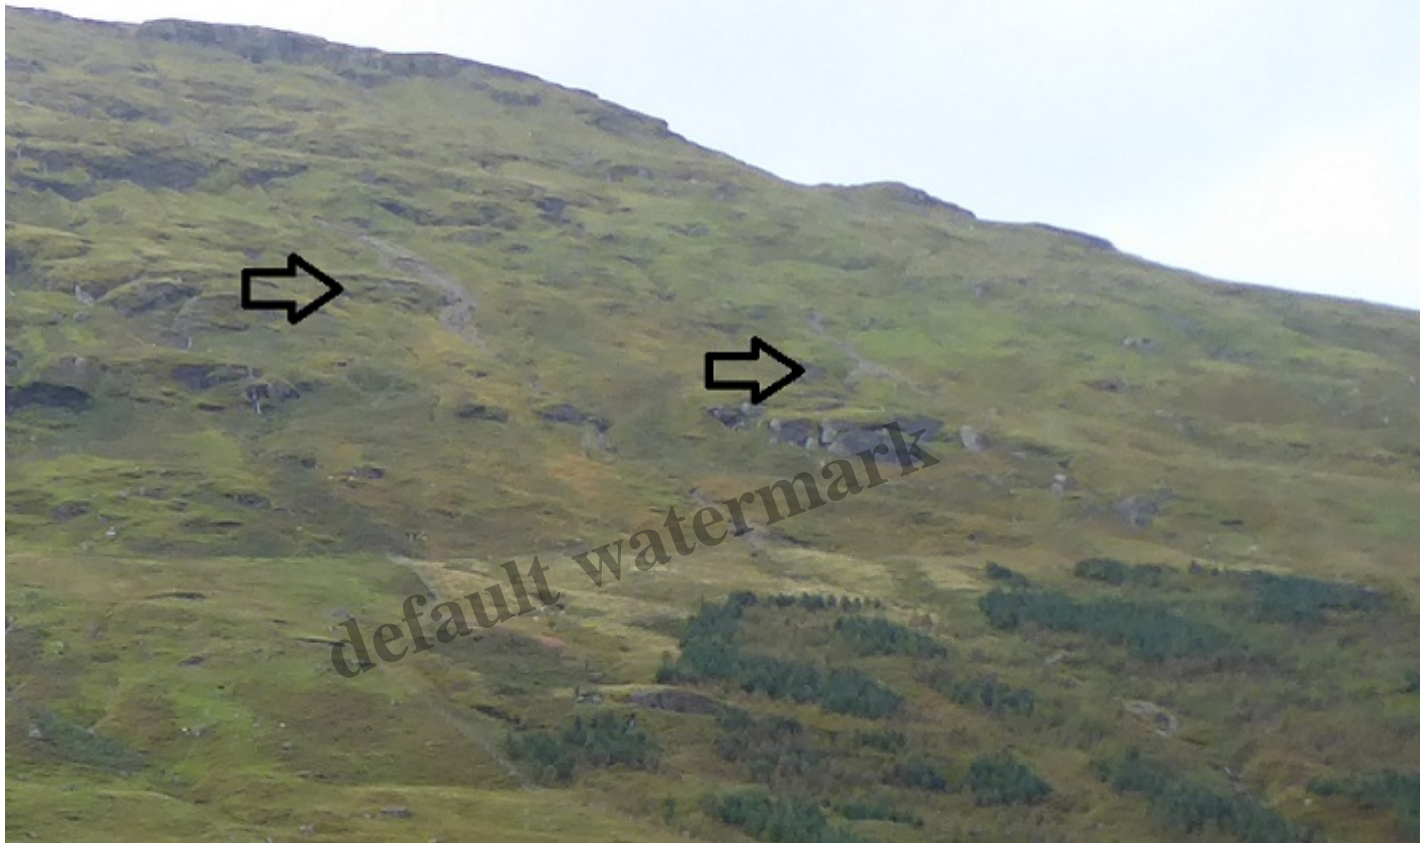
Note how the landslips are above the native woodland plantation, an illustration that we need to stem the flow of water much higher up the hill

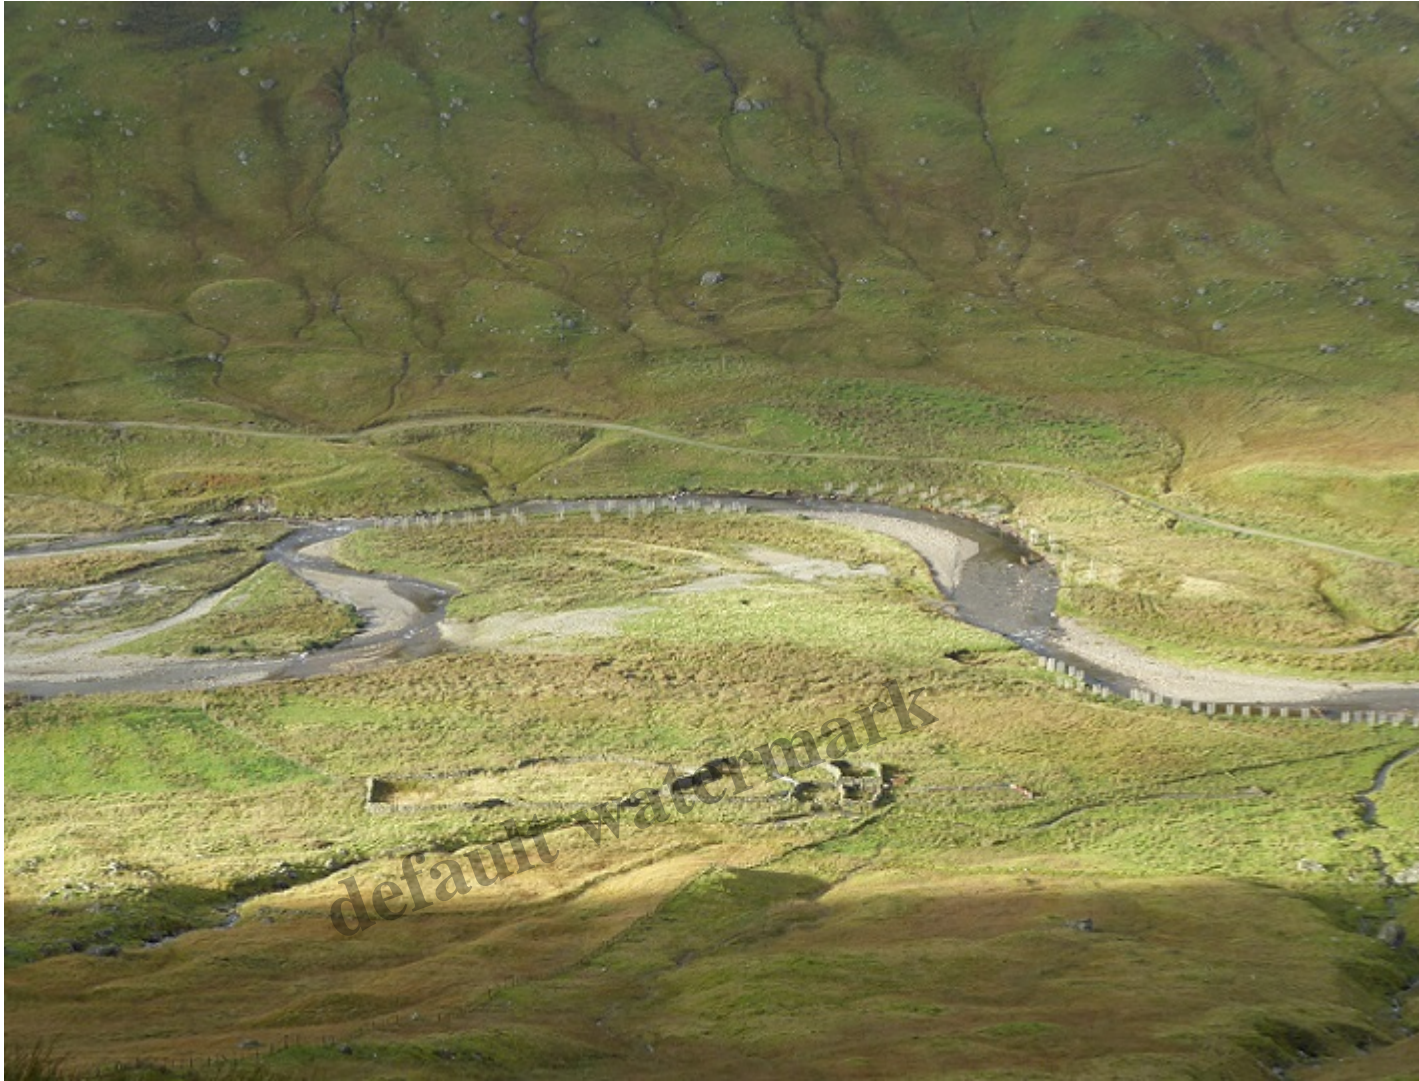
Part of the postage sized planting above Inverlochlarig Farm. Note the many watercourses on the far side of the glen. Once rainfall gets into these the water flows rapidly down the hill

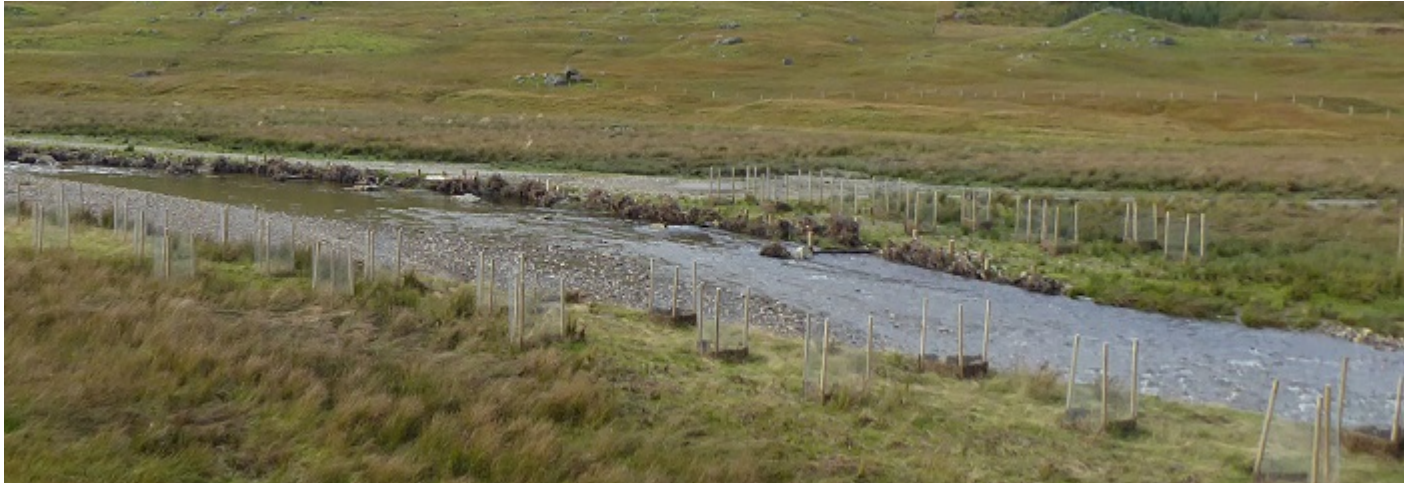
Works to stabilise the river bank visible left of centre

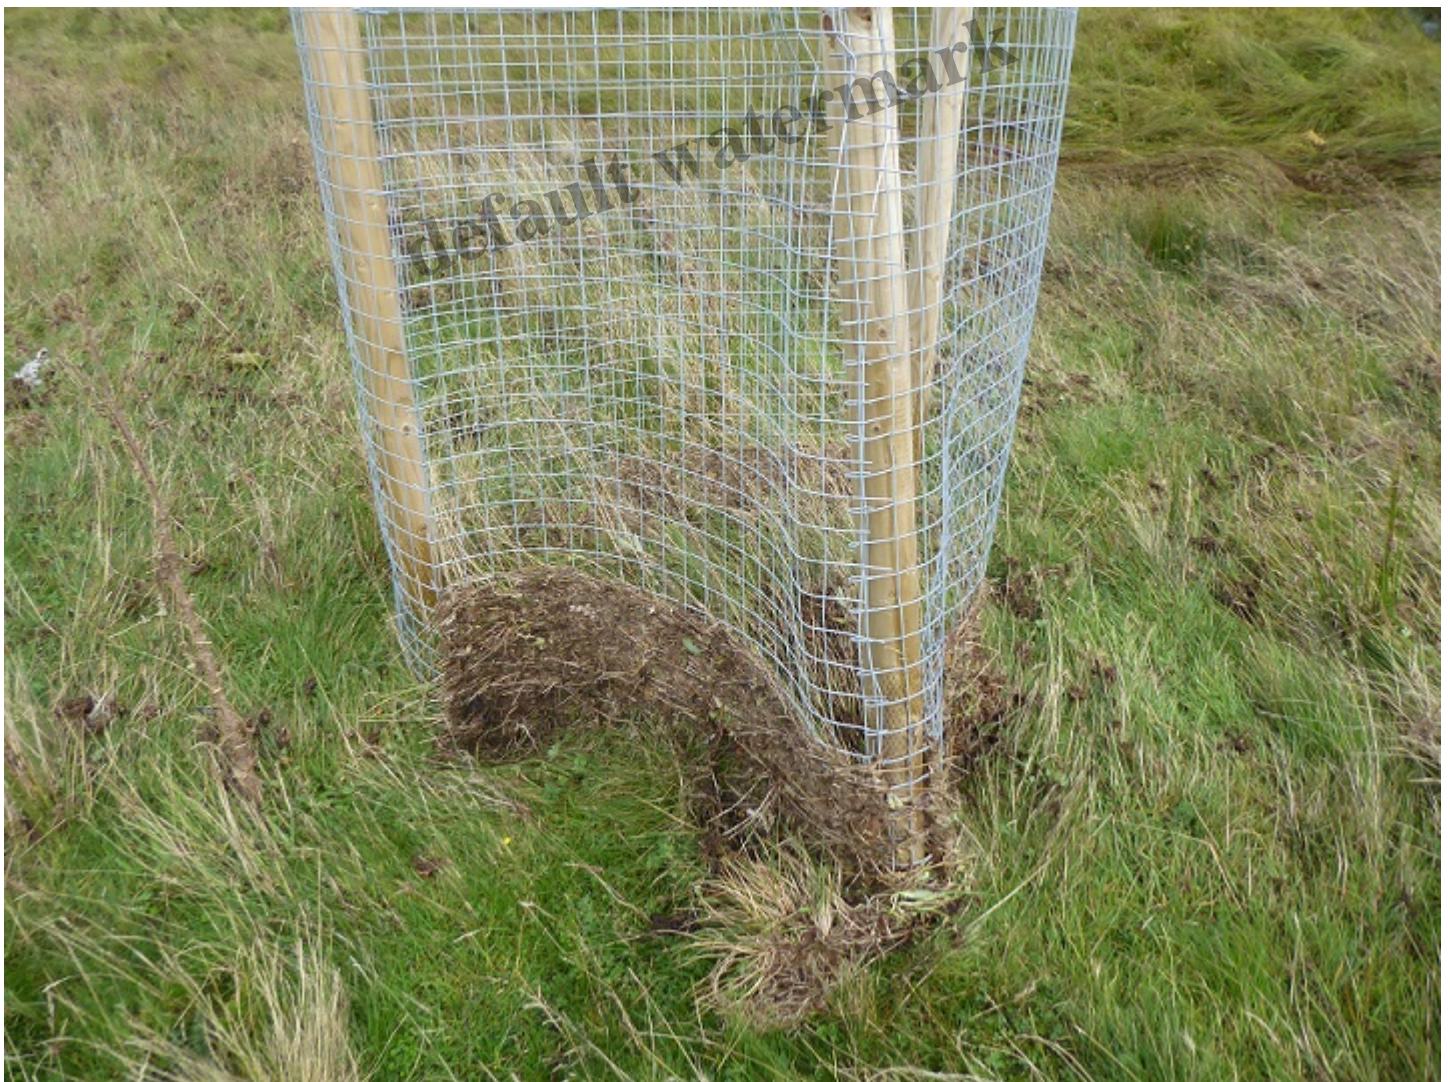
While there was no tree surviving in this enclosure, the way the wire serves to catch the vegetation probably helps to protect the trees and reduce the chances that they will be uprooted by the force of water or chopped or crushed by flood debris (though alder have evolved to survive such challenges). A larger flood, however, might destroy the enclosures and the trees with it.

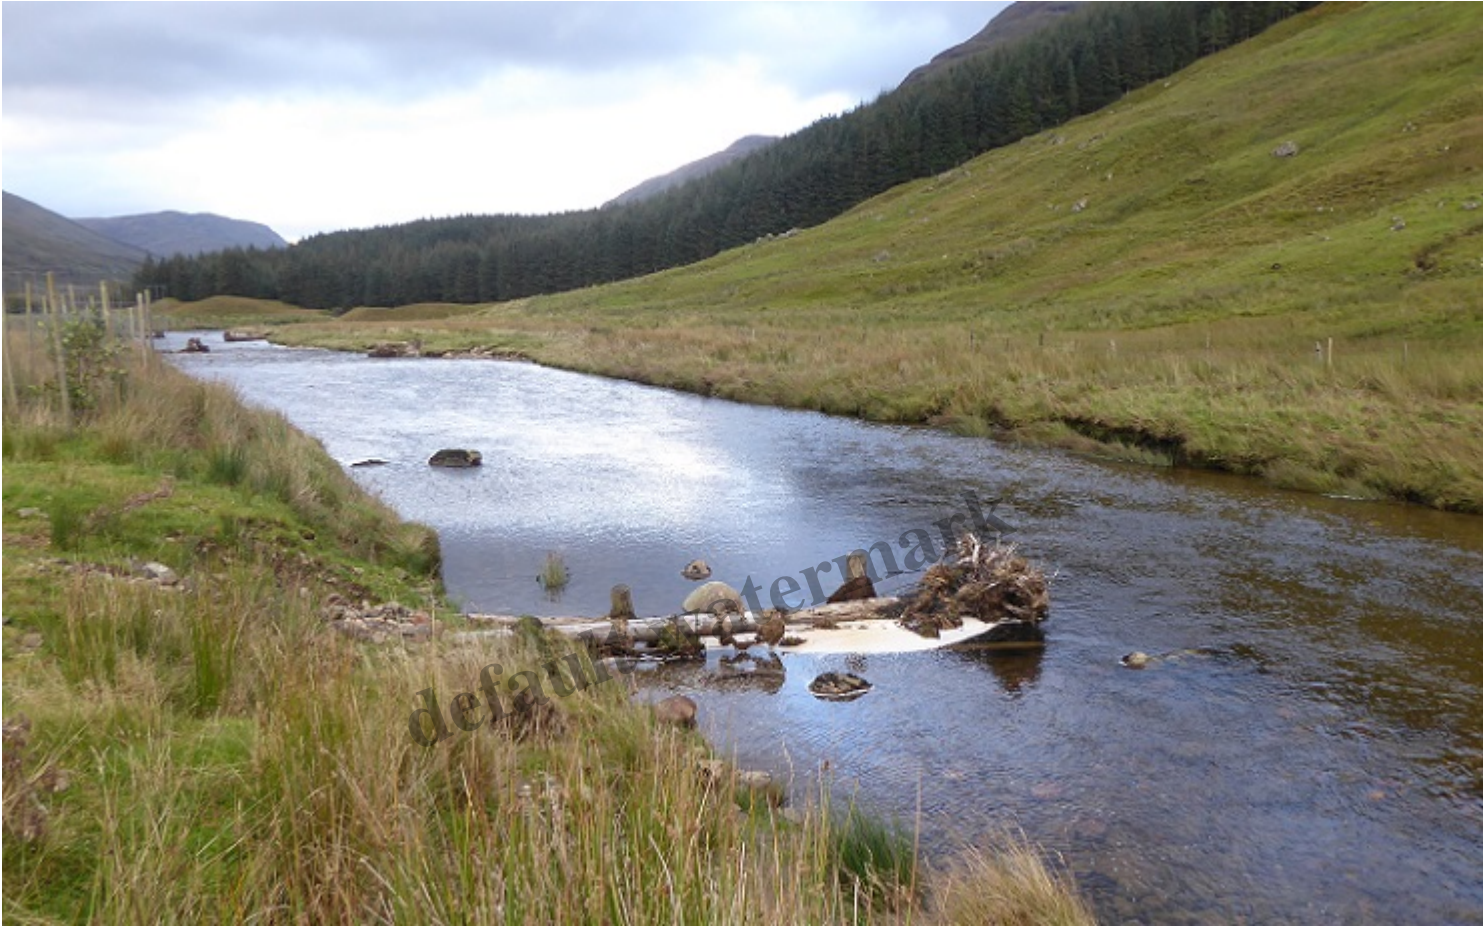
Placing tree trunks across rivers is now quite fashionable in conservation circles. While it serves to hold back some debris, potentially creating spawning beds for fish, in a flood it is likely to quickly bank out so that water and debris flow over the top. Neither in-river works like this nor planting trees is likely to reduce flood flow significantly.

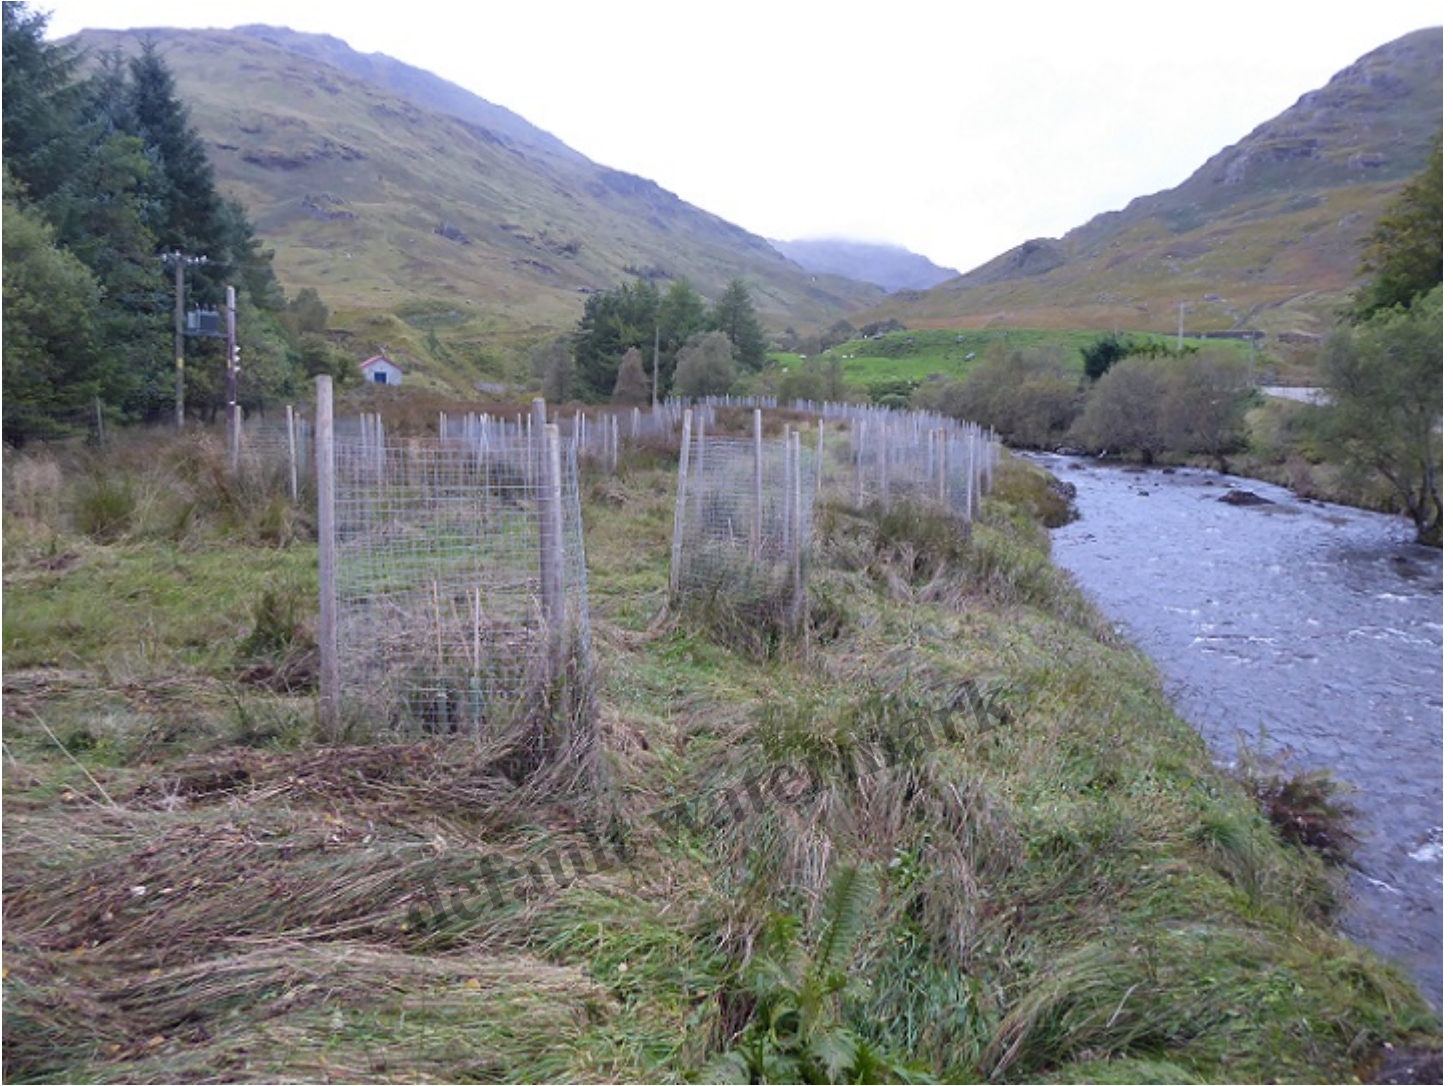
Once water is in the river its too late and the only real option in terms of natural flood prevention is to let the water spread out over flood plains.

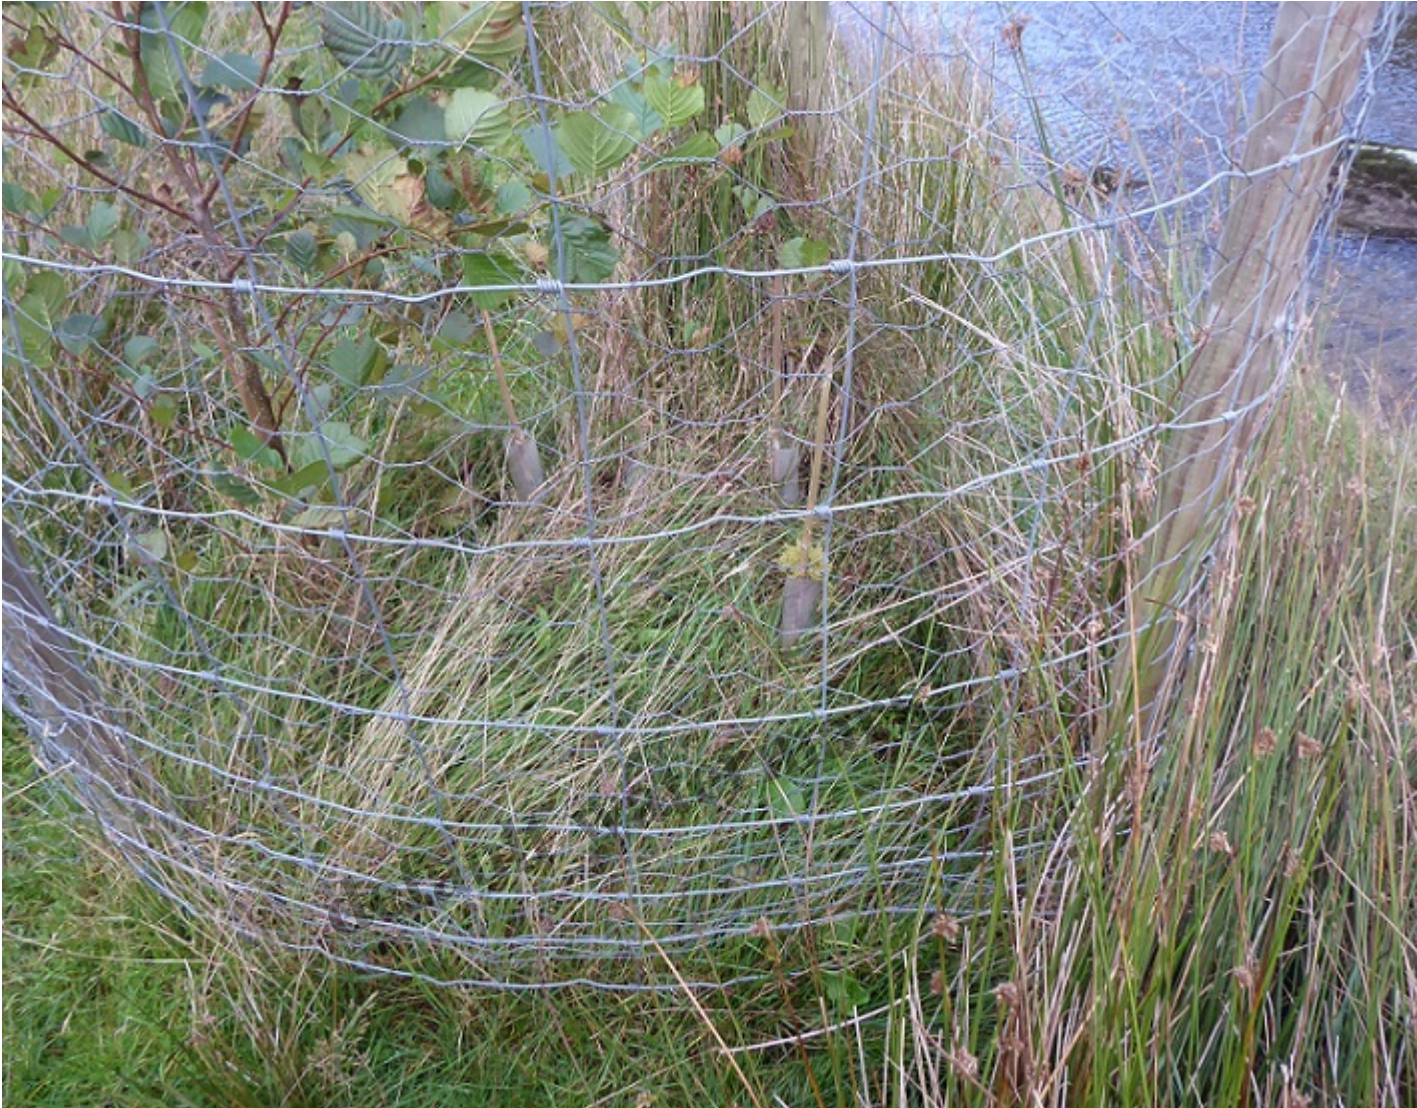
The trees in about half the tubes in this enclosure had taken – note the moss filled tube on the right. The wire netting makes it very difficult for anyone to remove the redundant tubes and reduce the amount of plastic that may end up in the river.
