Landslips, flooding and riverside tree planting in Balquhiddar – tackling the source of the problems

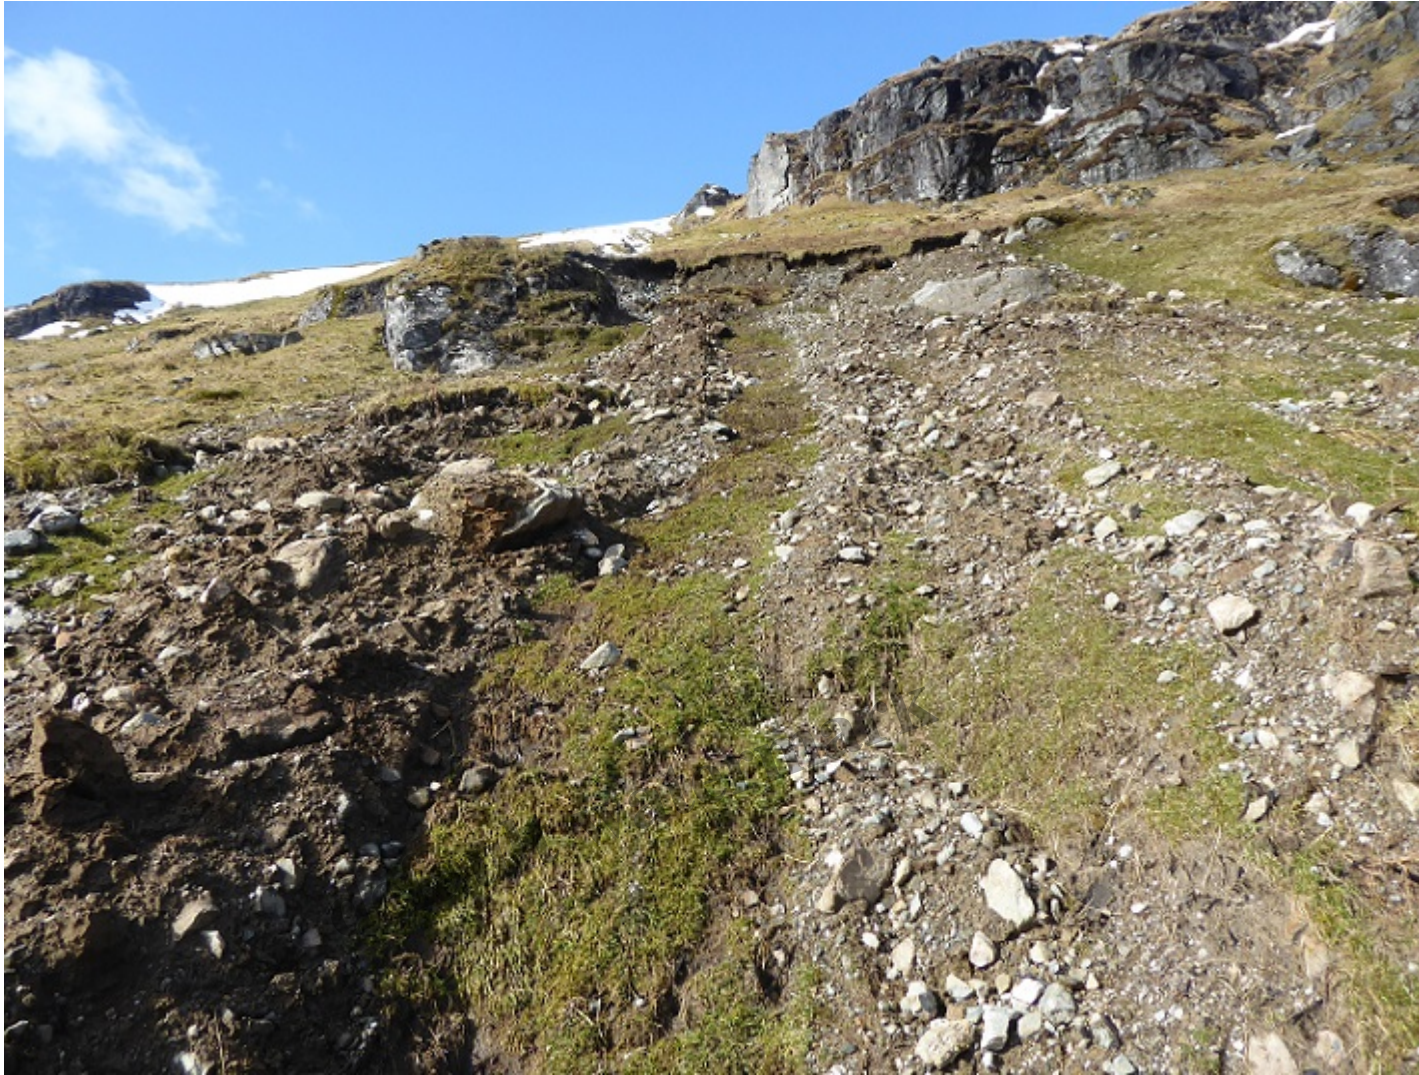
Landslip on south slope of Beinn a Chroin. Note how the volume of water has washed clean a strip down the centre of the landslip. March 2020.

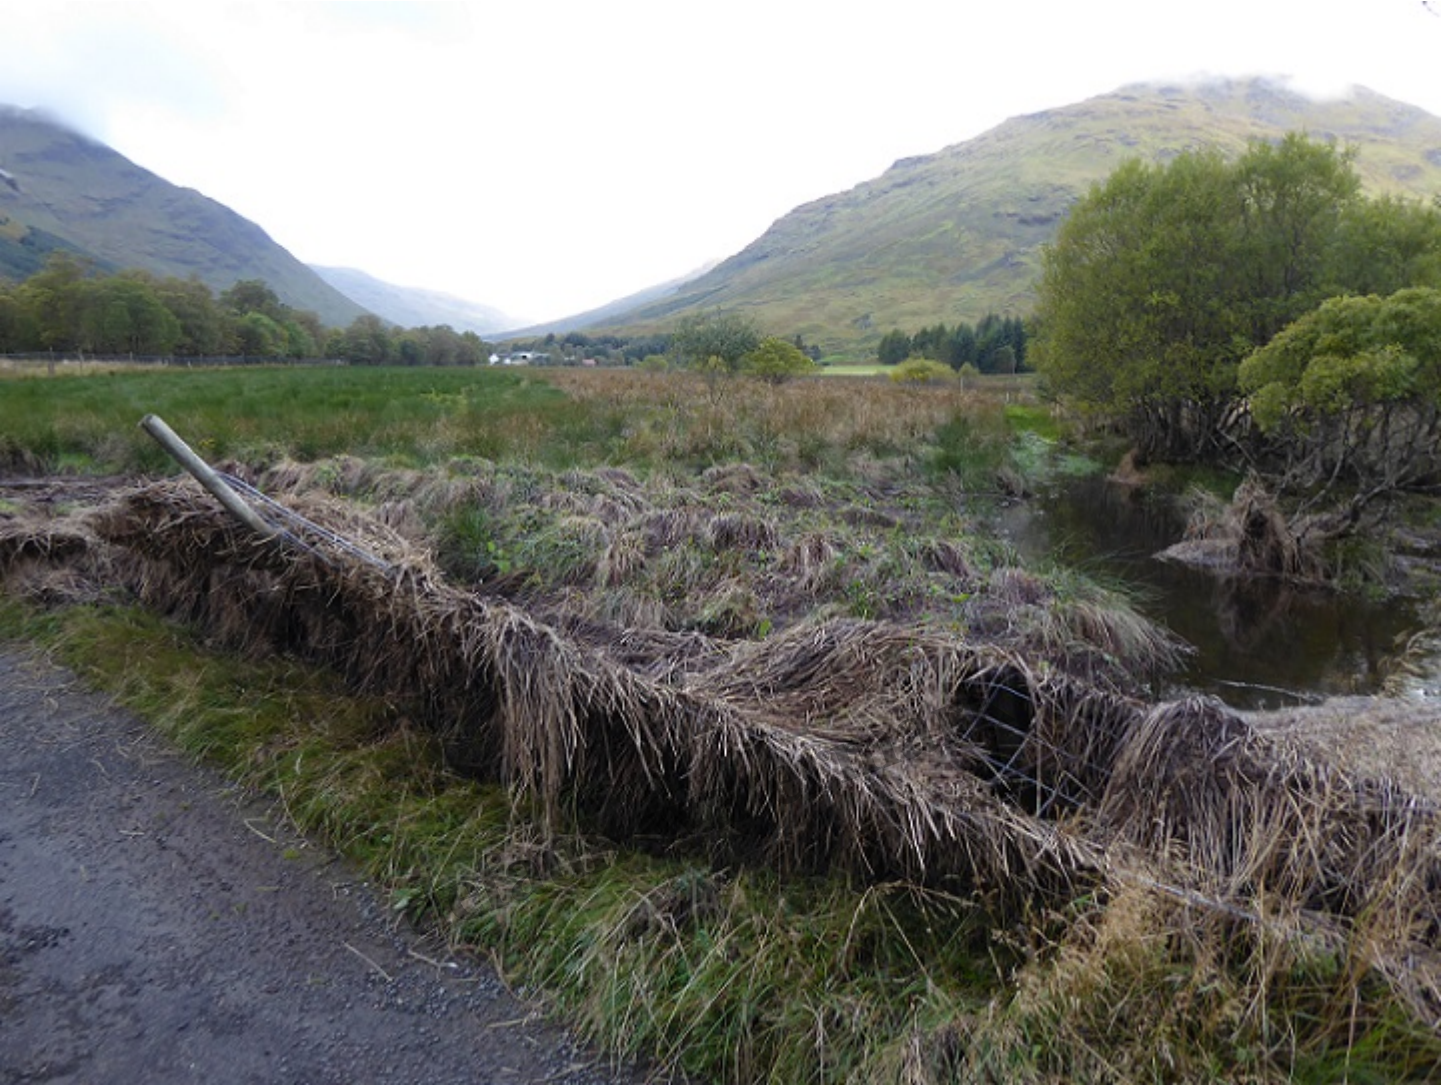
Just 50m beyond the car park, we came across evidence that the rain on Friday had been sufficient to cause significant flooding

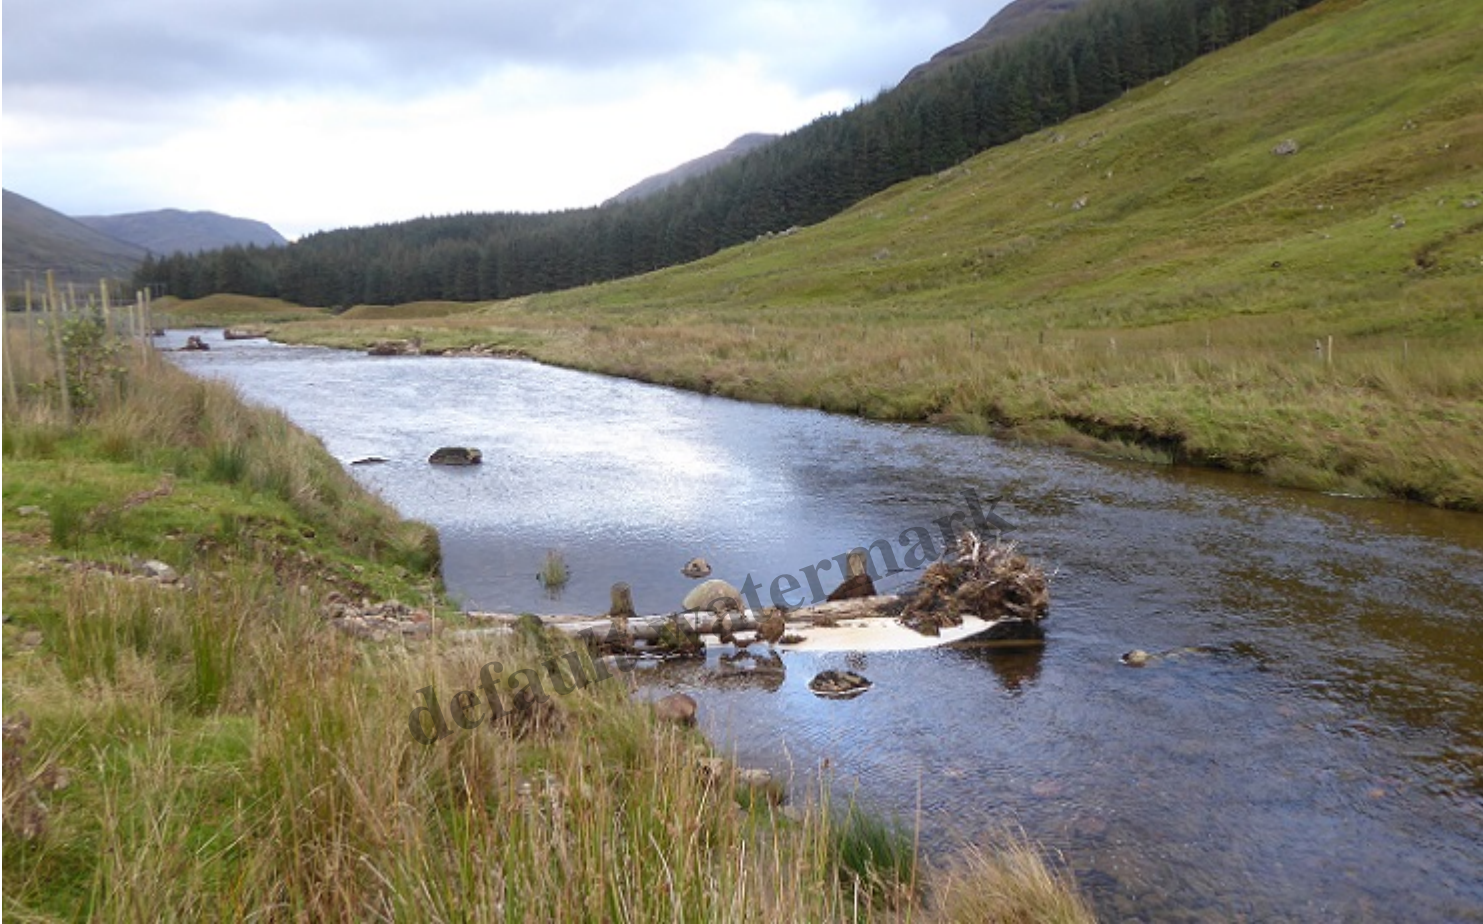
Placing tree trunks across rivers is now quite fashionable in conservation circles. While it serves to hold back some debris, potentially creating spawning beds for fish, in a flood it is likely to quickly bank out so that water and debris flow over the top. Neither in-river works like this nor planting trees is likely to reduce flood flow significantly.

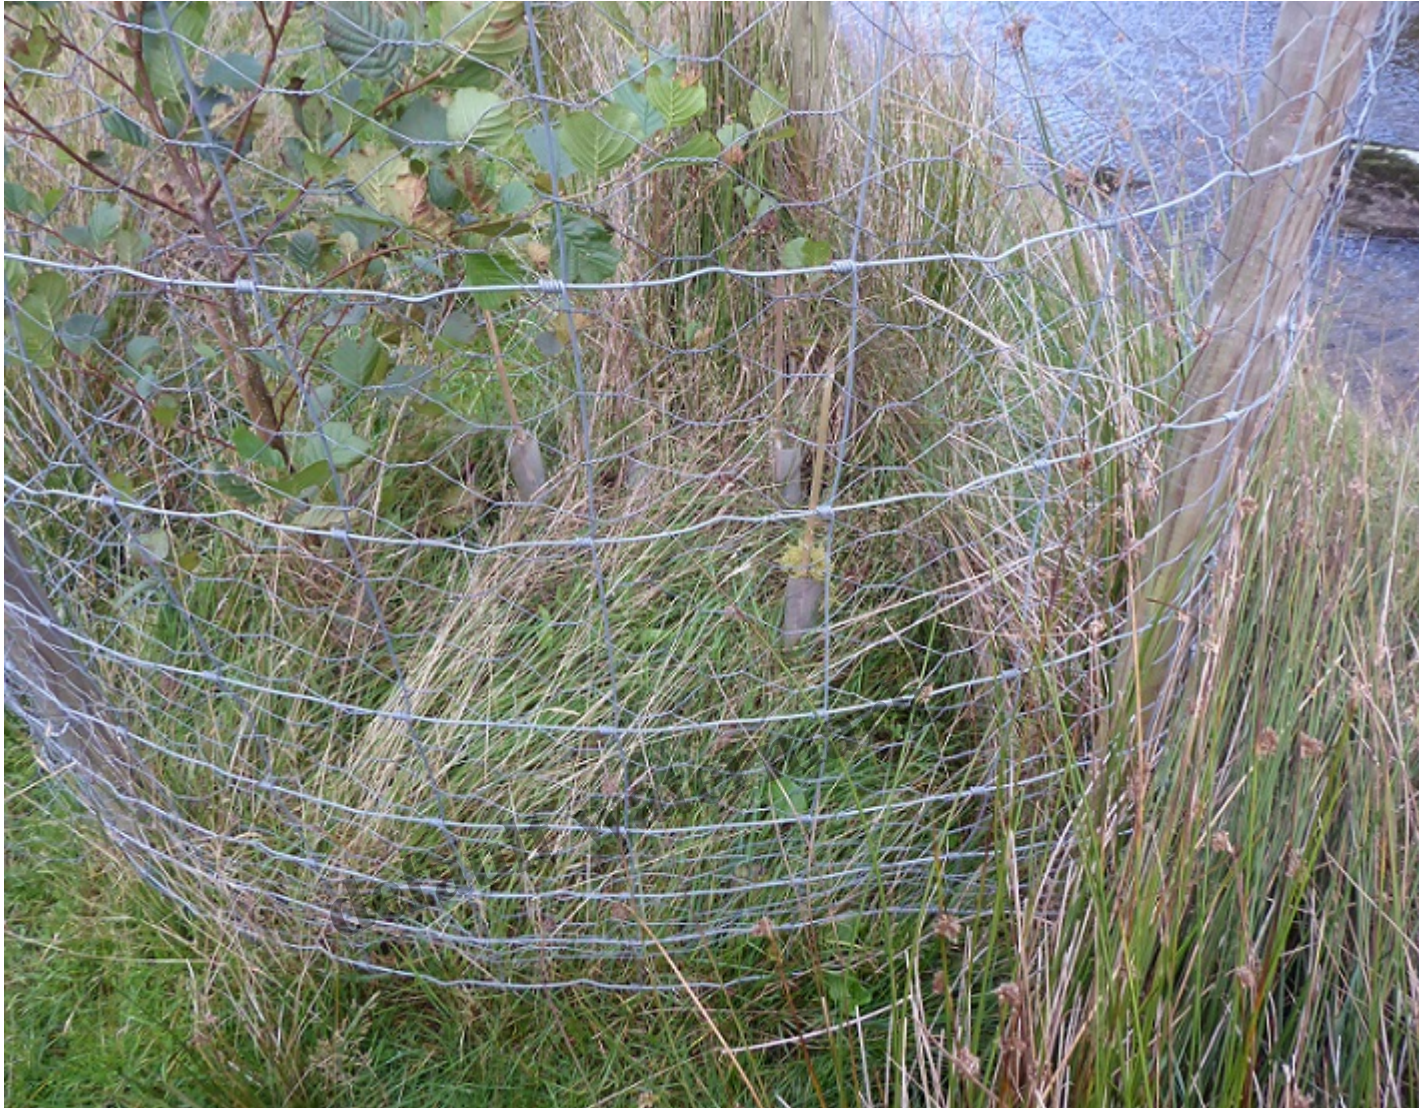
The trees in about half the tubes in this enclosure had taken – note the moss filled tube on the right. The wire netting makes it very difficult for anyone to remove the redundant tubes and reduce the amount of plastic that may end up in the river.
