## **Deer numbers and peat bog restoration in Glen Banchor**

## Peat bog restoration and sporting land-use in Glen Banchor

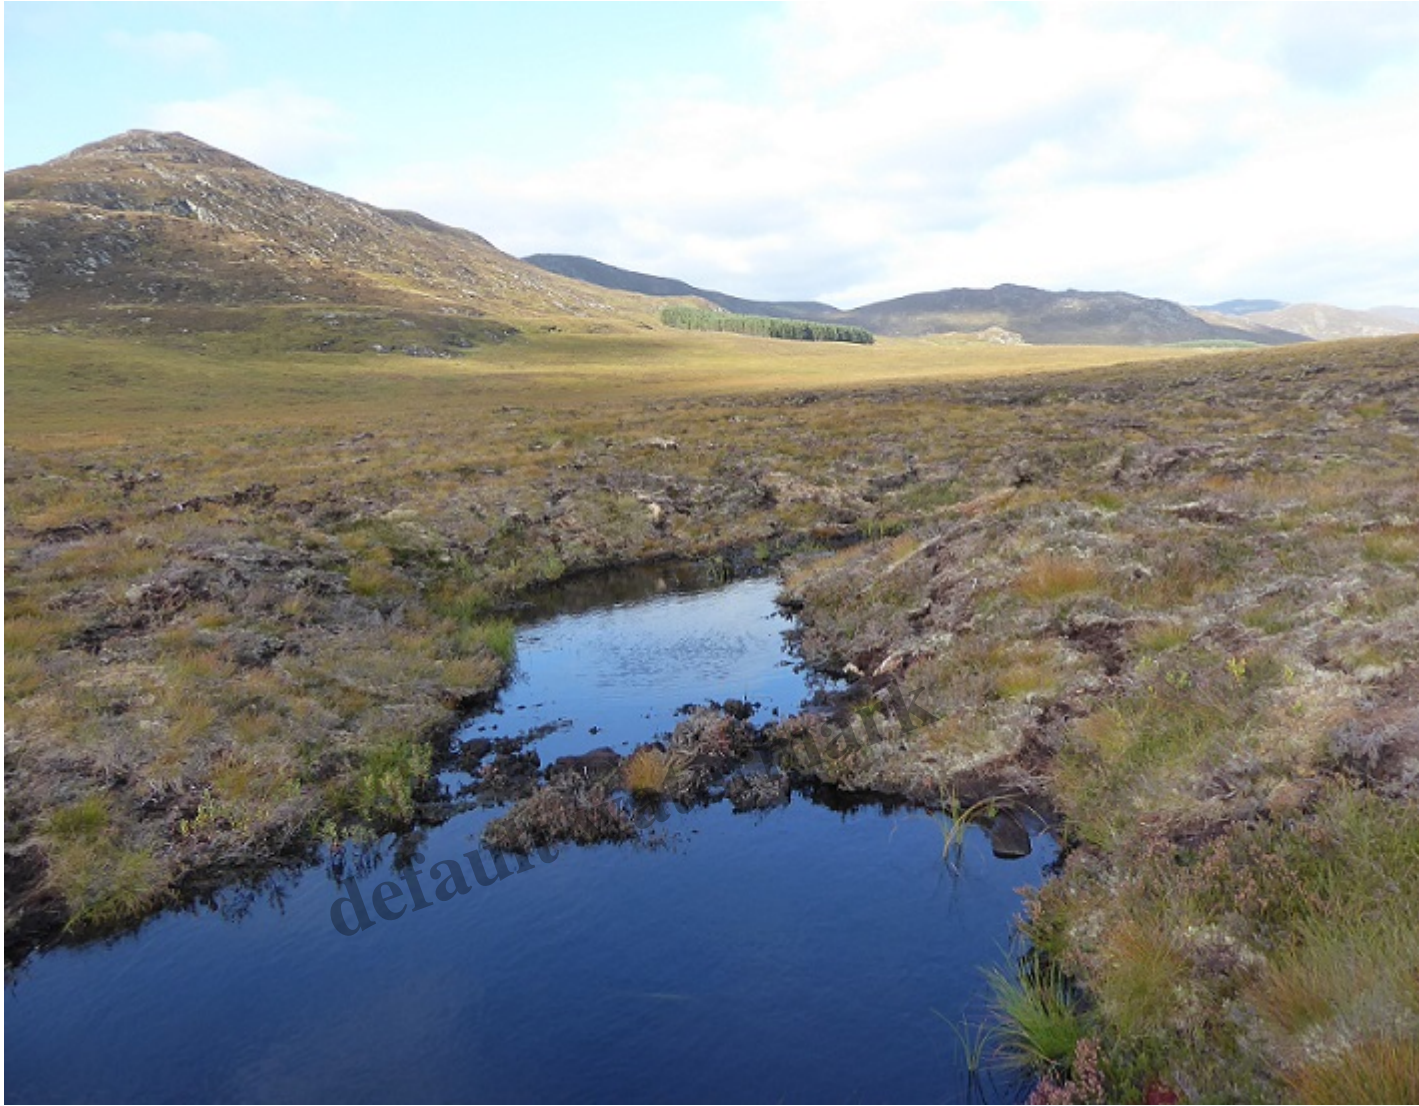
The gaps between the vegetation, leaving narrow jagged lines of bare peat, show that it has been lifted and redistributed over the area and that some of the peat below may have been “re-profiled”.

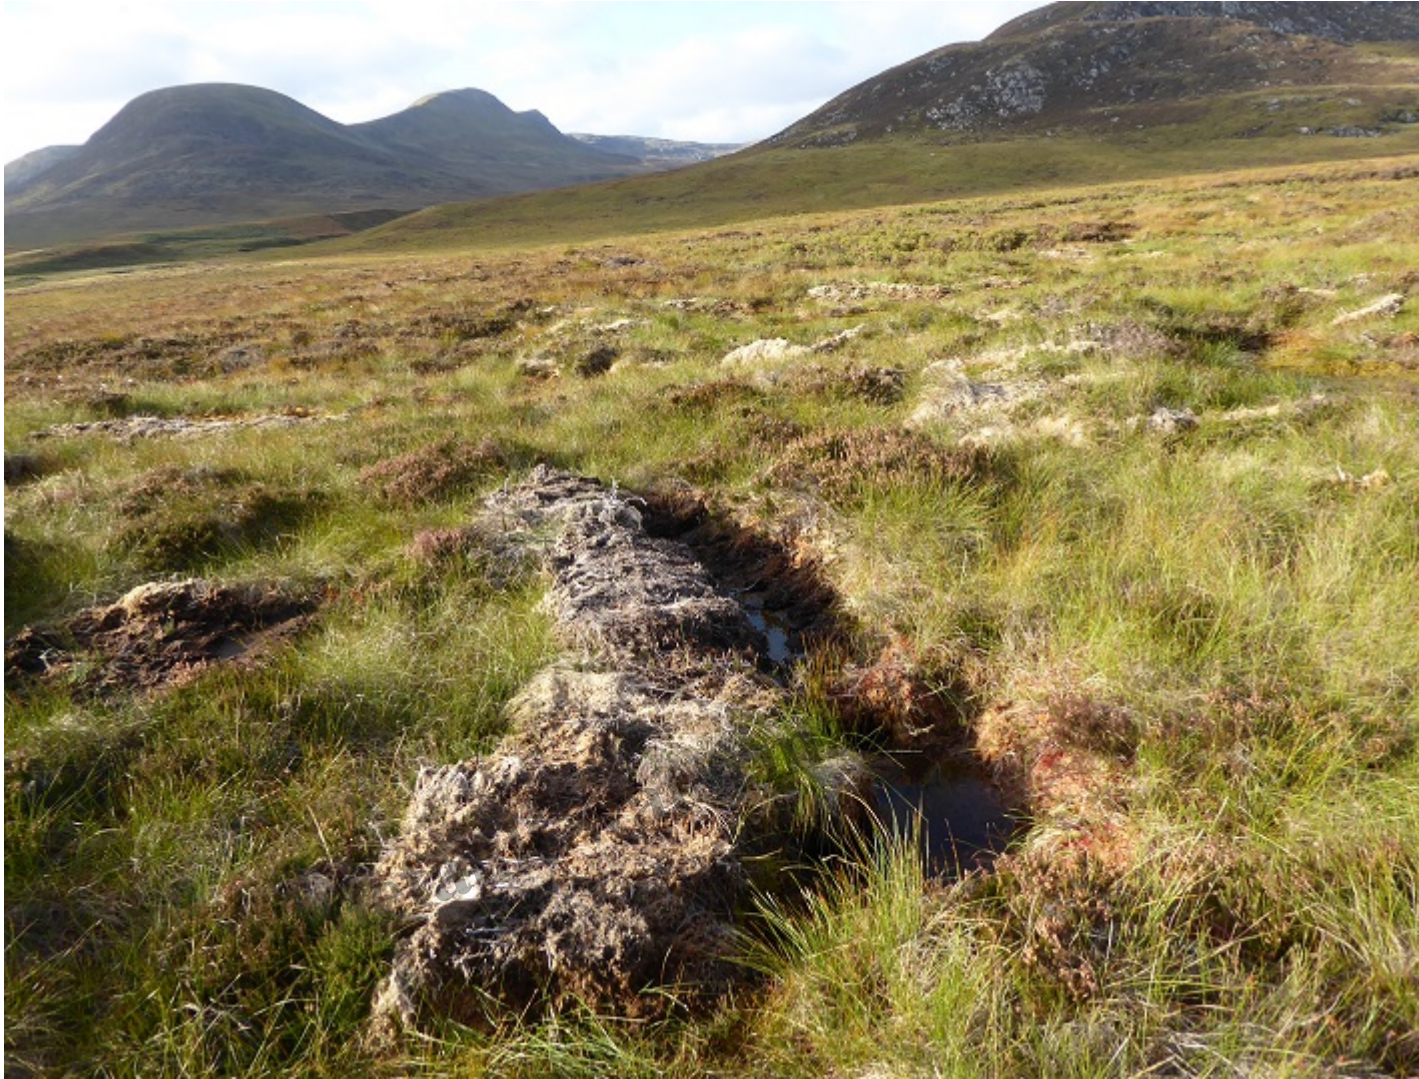
A trench pool, excavated by a digger, with further pools marked by heaps of sphagnum behind

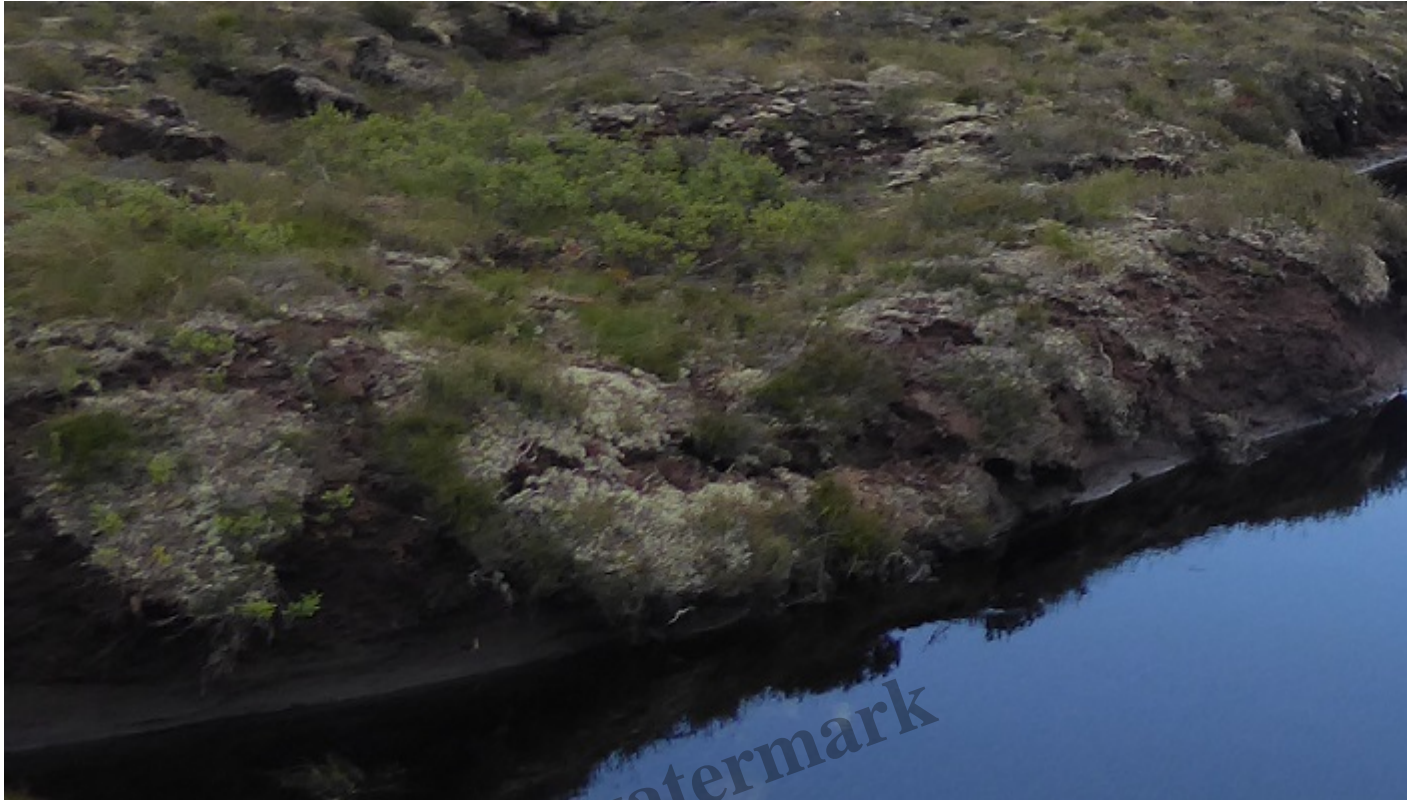
Collapsing section of bank centre. Just to the right is another slab vegetation covered peat that is sliding down into the hill.

One possible explanation for this particular restoration failure is that deer legs slipped through the gaps between the “restored” clumps of vegetation prising them away from the slope (you don’t have to look far in most restoration schemes to see deer hoof marks in the open spaces). Another is that the water in the bog pool has eroded the peat from underneath.

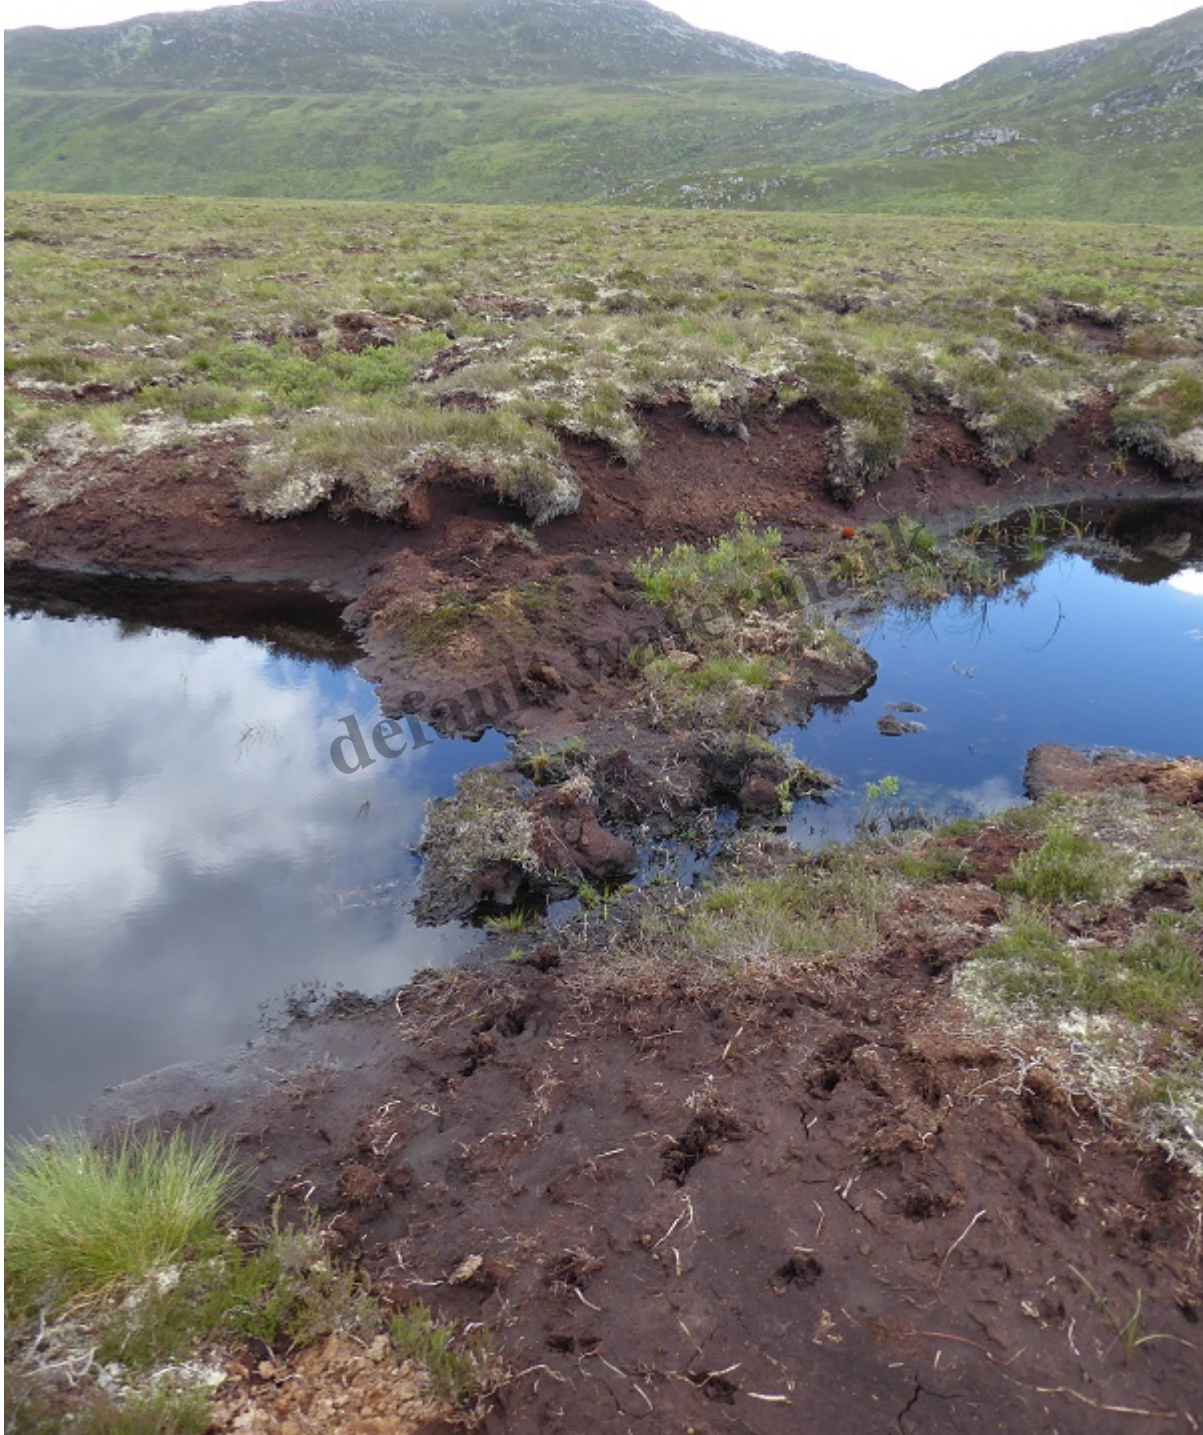
Deer hoof marks were highly visible on the low vegetated areas that had been created between the pools.

The trampling has left bare peat which will be quickly eroded away by the new stream and further trampling

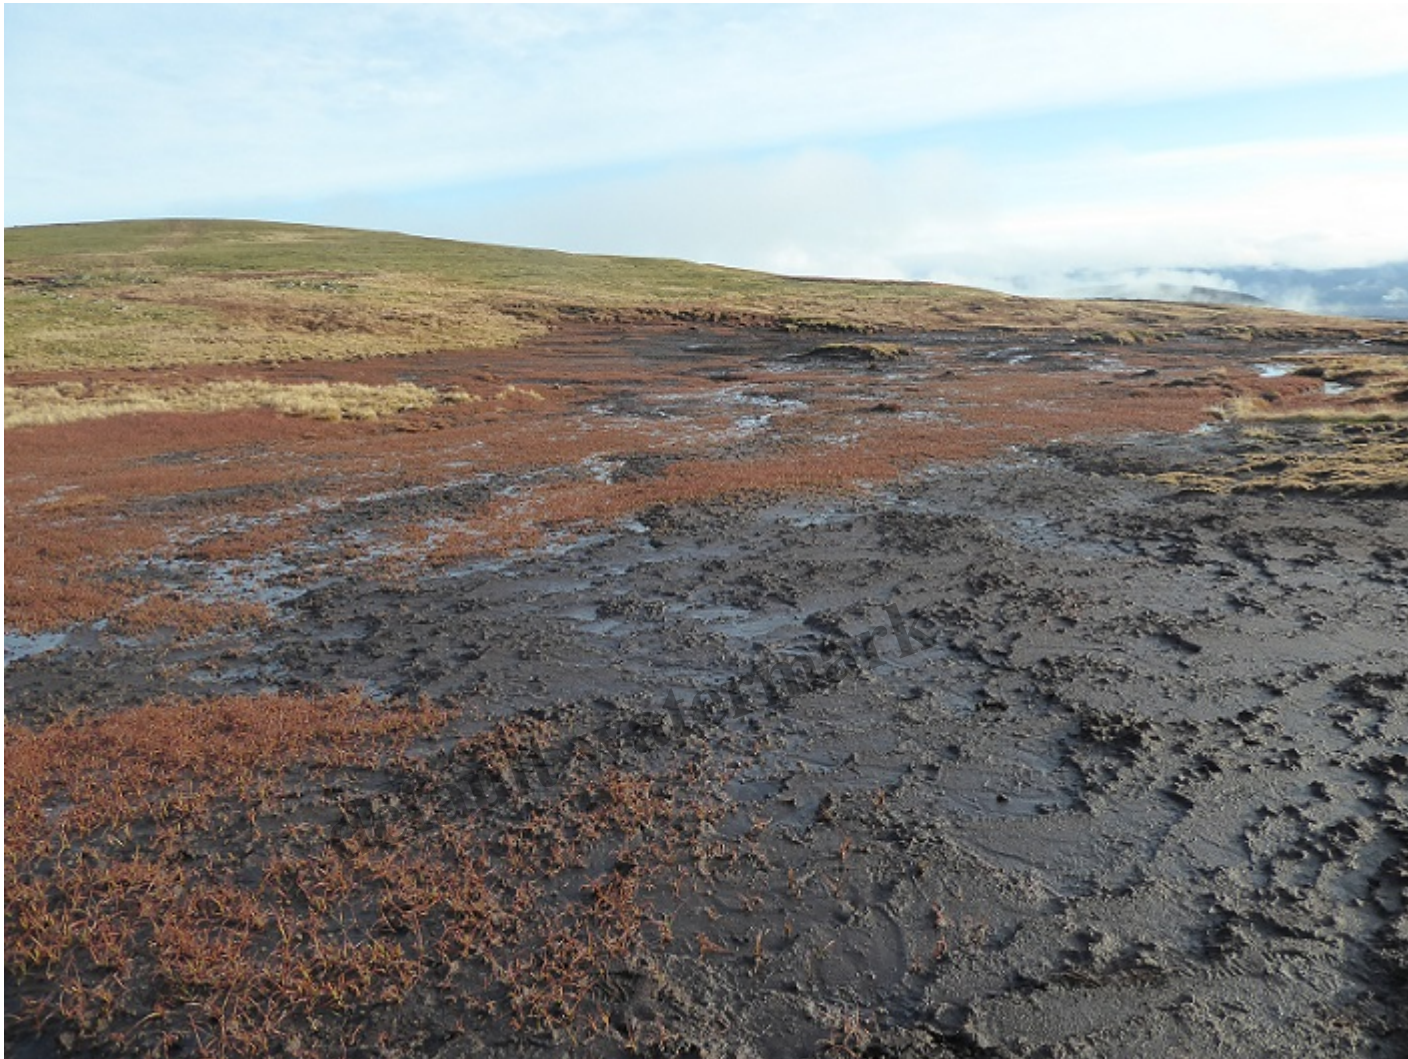
Peat erosion (and partial recolonisation by plants) on ridge between Carn Sgulain and Carn Ballach, Glen Banchor Estate. Photo Credit Louise Brimelow Nov 2021

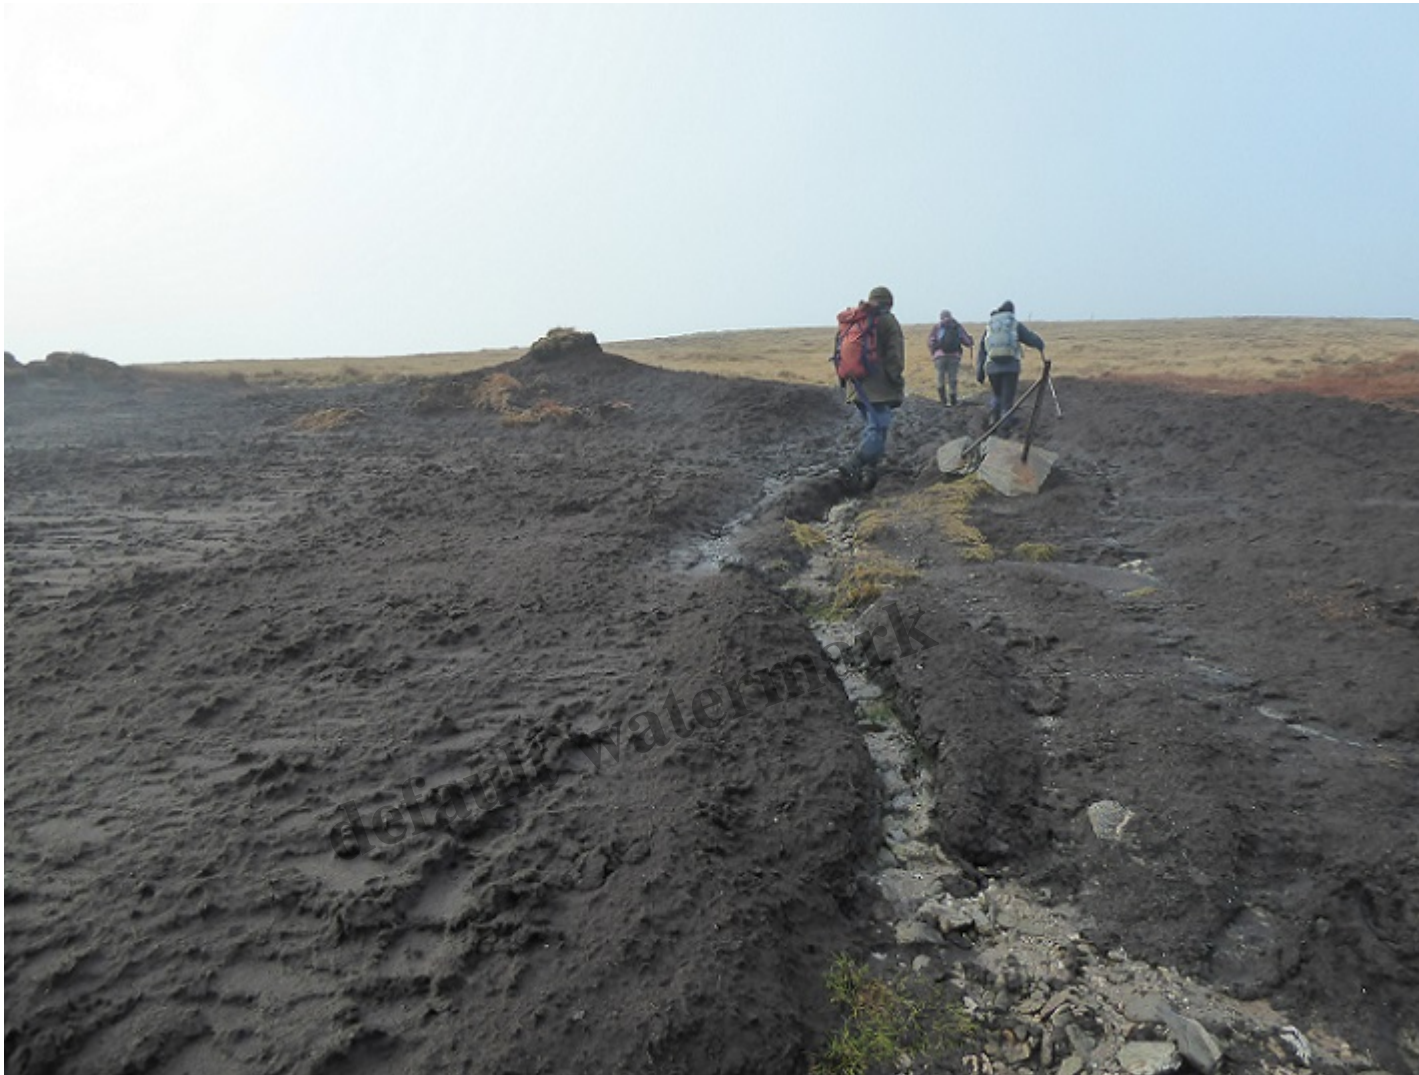
Walkers clearly account for this eroded line across the peat but can't explain the eroded peat hags behind or the sheer extent of the eroded area. Carn Balloch, November 2021. Photo credit Louise Brimelow

Some erosion is as a result of natural processes while both All Terrain Vehicles and walkers play a role. But none of this can explain the 1000s of hectares of damaged peat bog in Scotland or deer wallows.

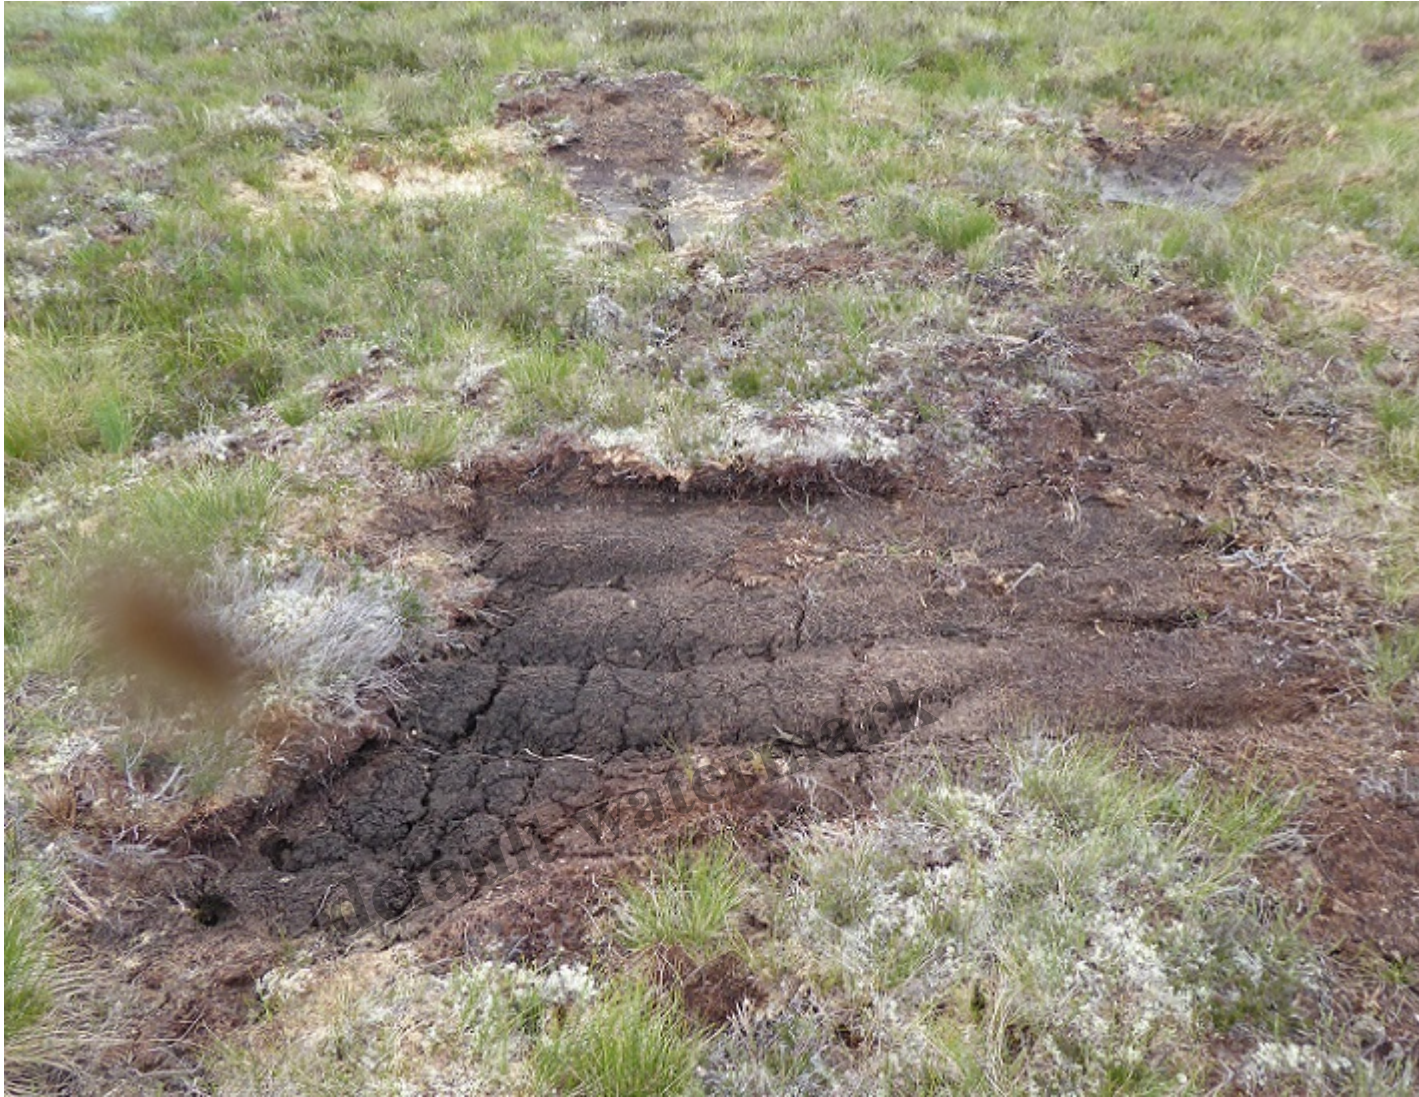
Removal of vegetation to cover areas of bare peat is useless if new areas of peat are left open to the air and sunlight.

The contractor has clearly not be sent back to repair the damage. But much of the failure also appears attributable to trampling and grazing pressure:

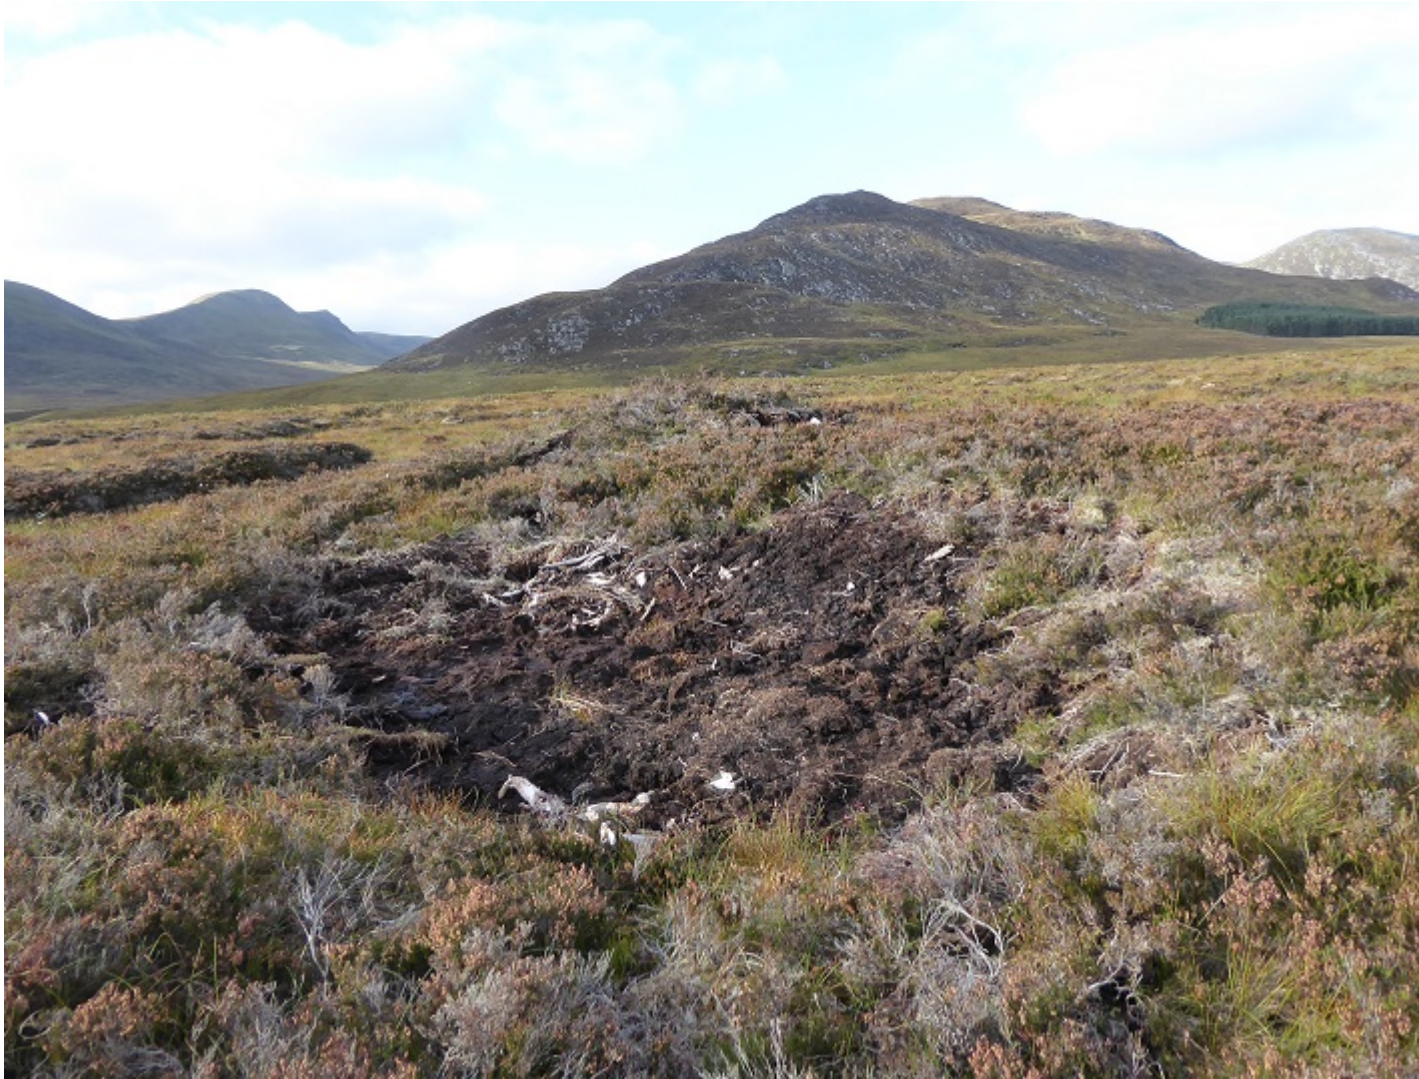
Patch which may have been excavated and not restored, although there were plentiful signs of trampling in 2020

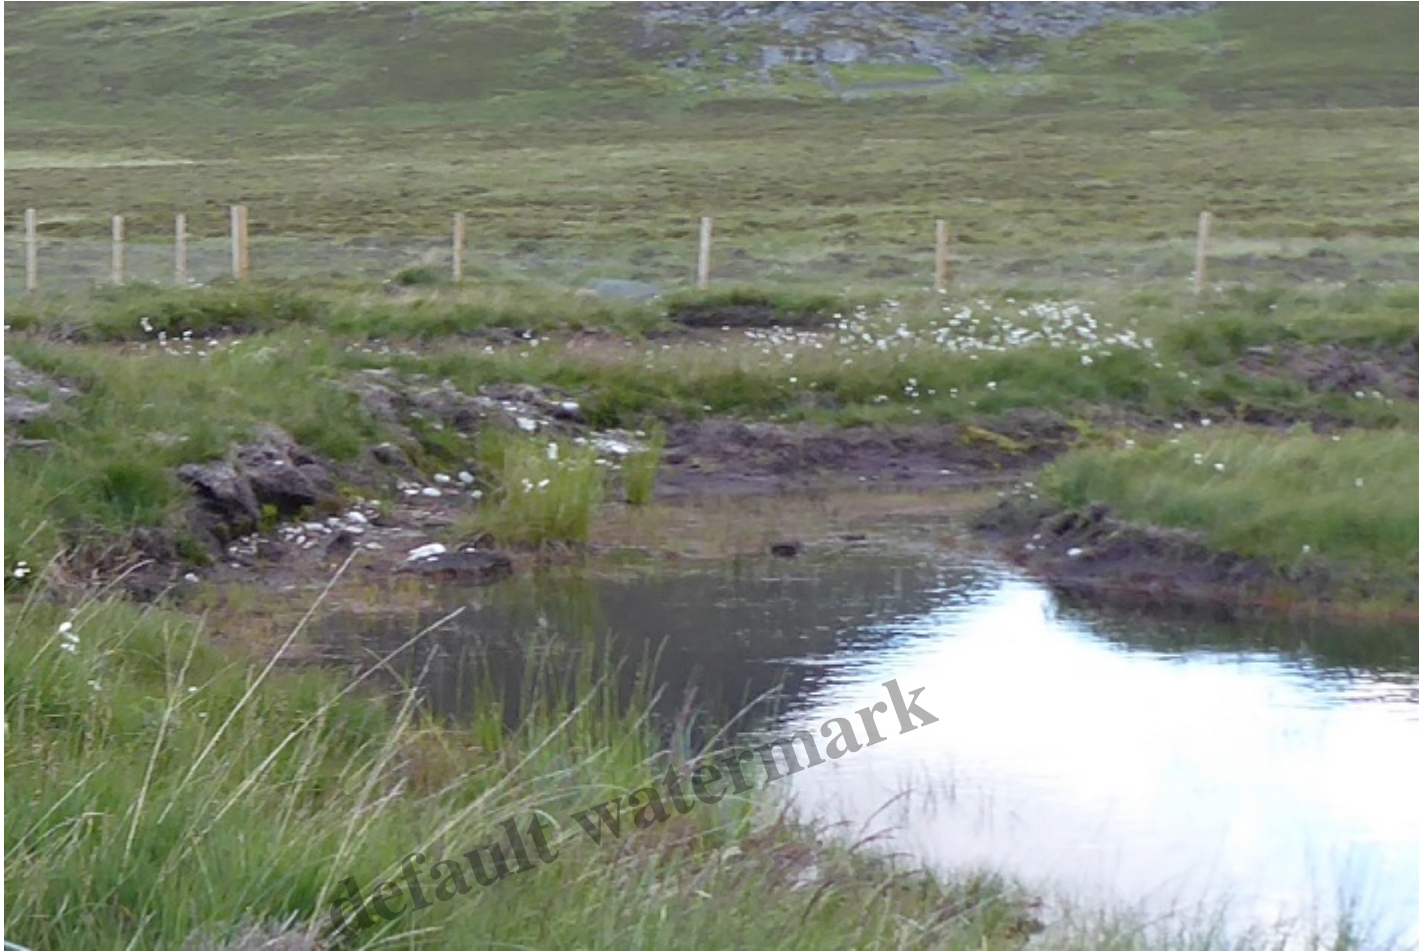
Close up of pool

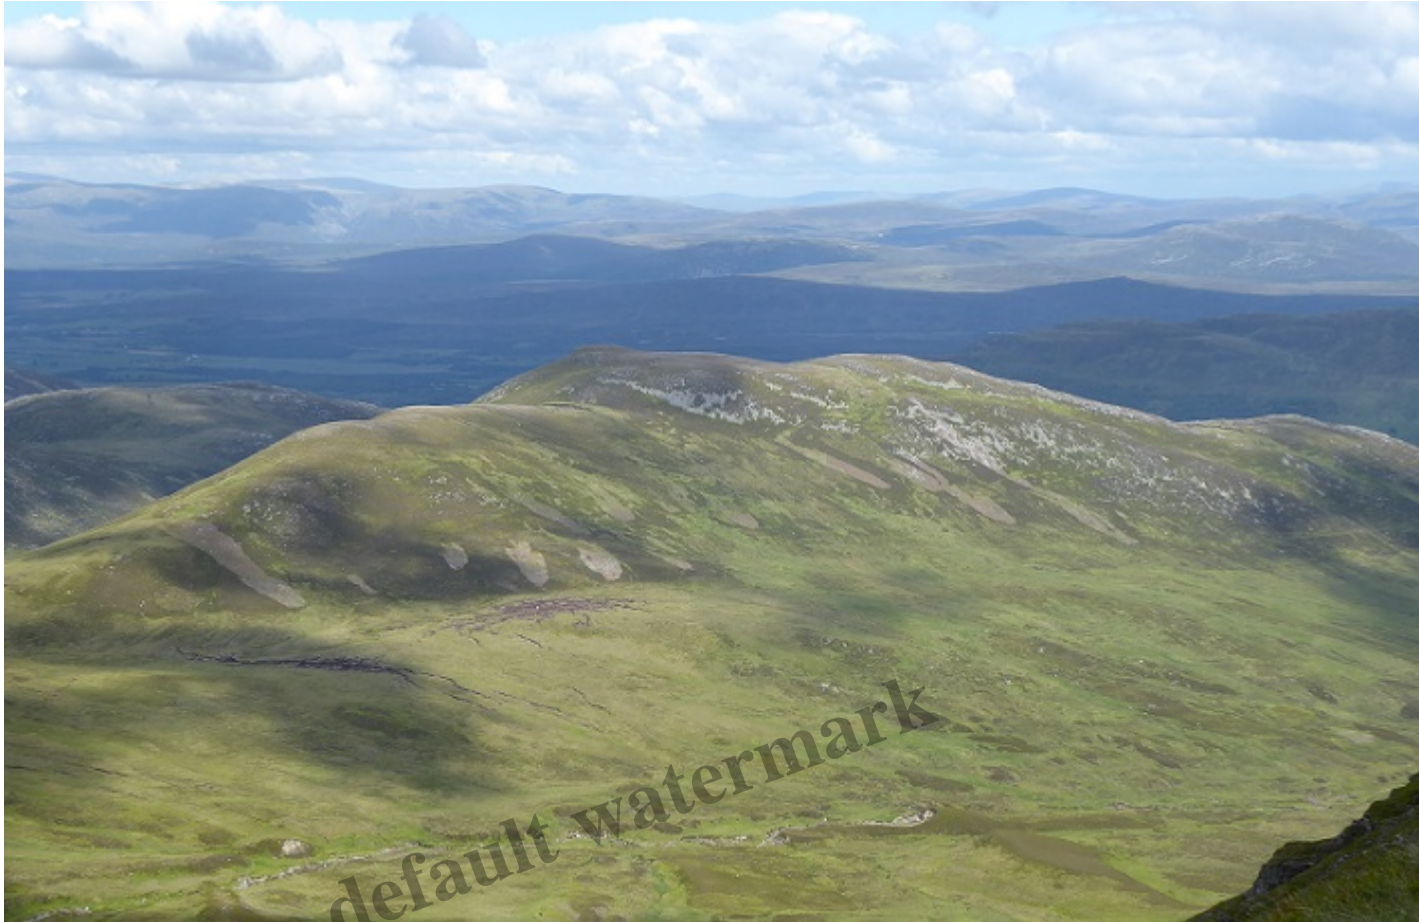
Muirburn on the slopes of Creag Liath viewed from Carn Dearg. Noted the eroded peat below the muirburn on the left.

Muirburn not only prevents peat from developing, it promotes water run off. While peat bogs generally absorb water, if water starts flowing into or over a peat bog it will start to create erosion gullies and can precipitate peat slides. Such phenomena occur naturally but become unnatural and their effects accentuated where there is muirburn.
