Conservation in Glen Banchor? Peat bog and woodland restoration (1)

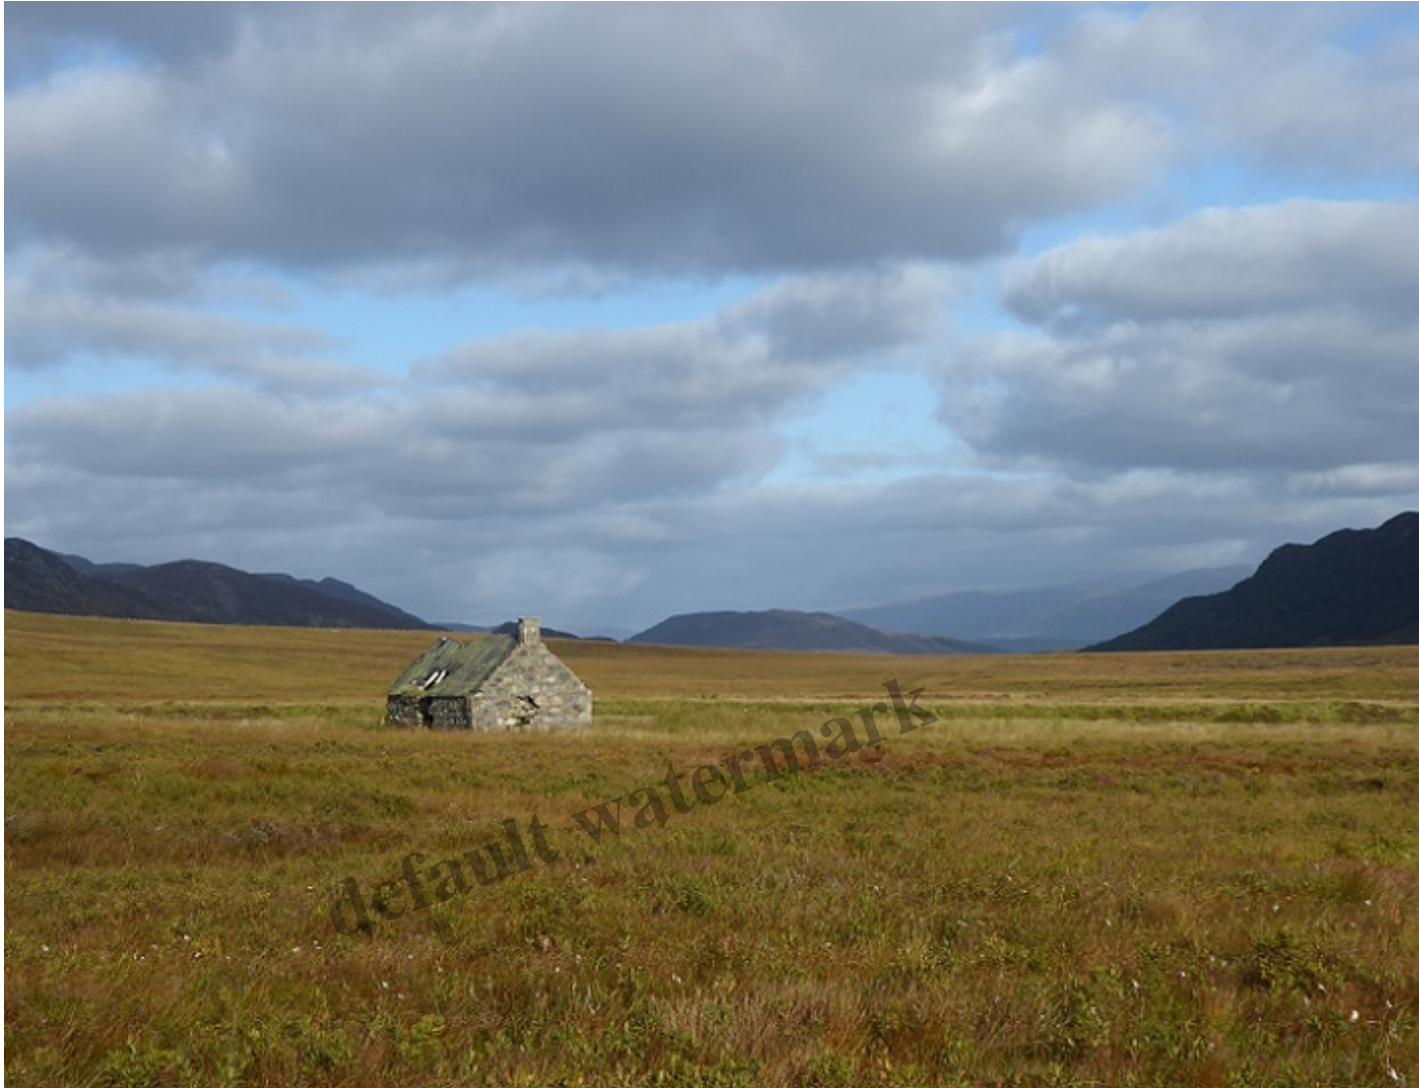
Looking east to the ruin at Dalballoch along the floor of Glen Banchor 2020. Note the bog cotton and bog myrtle in the foreground.

The western half of the lower ground in Glen Banchor is now predominantly peat bog, although some of it was farmed in the past. In 2018 it appears the Pitmain Estate was proposing to convert the area east of the Allt Balloch (on the far side of Dalballoch in the photo and the large green area at the top left of the map above) into new native woodlands for purposes that included “sporting” and “fishing”. I was surprised by the woodland plan not just because I knew the area was bog but because when I passed by two years later there was evidence of recent peat bog restoration work:

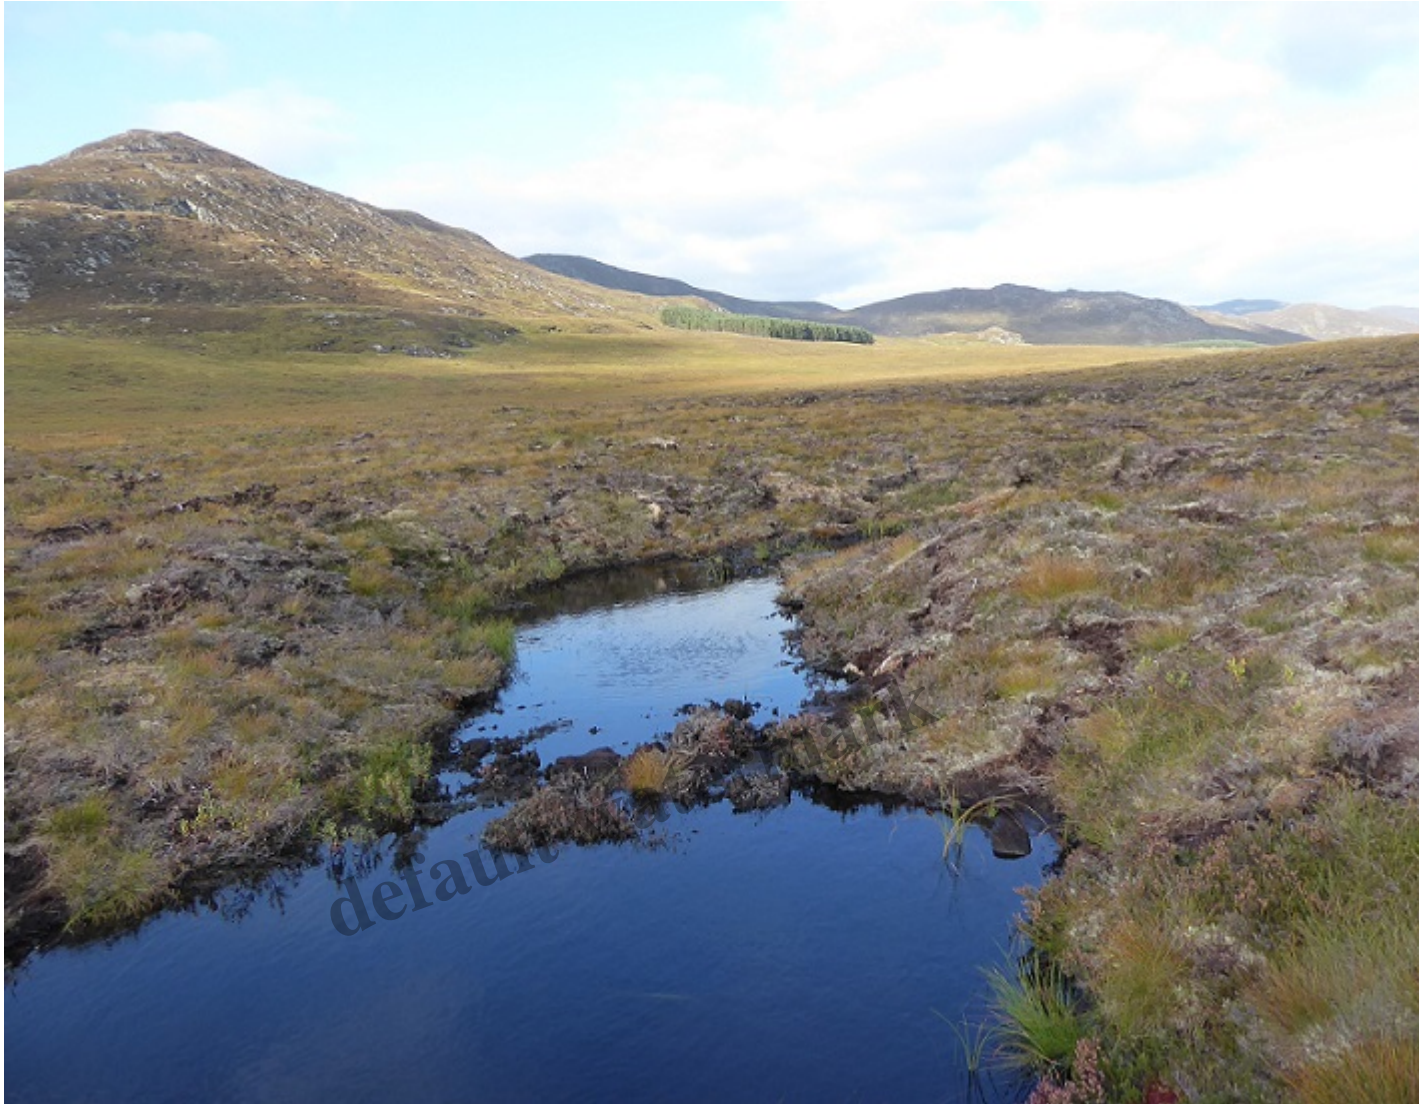
The gaps between the vegetation, leaving narrow jagged lines of bare peat, show that it has been lifted and redistributed over the area and that some of the peat below may have been “re-profiled”.

The restoration included a significant amount of water engineering, with peaty clumps of vegetation being used to split larger pools in two (as above) and in other places new pools created:

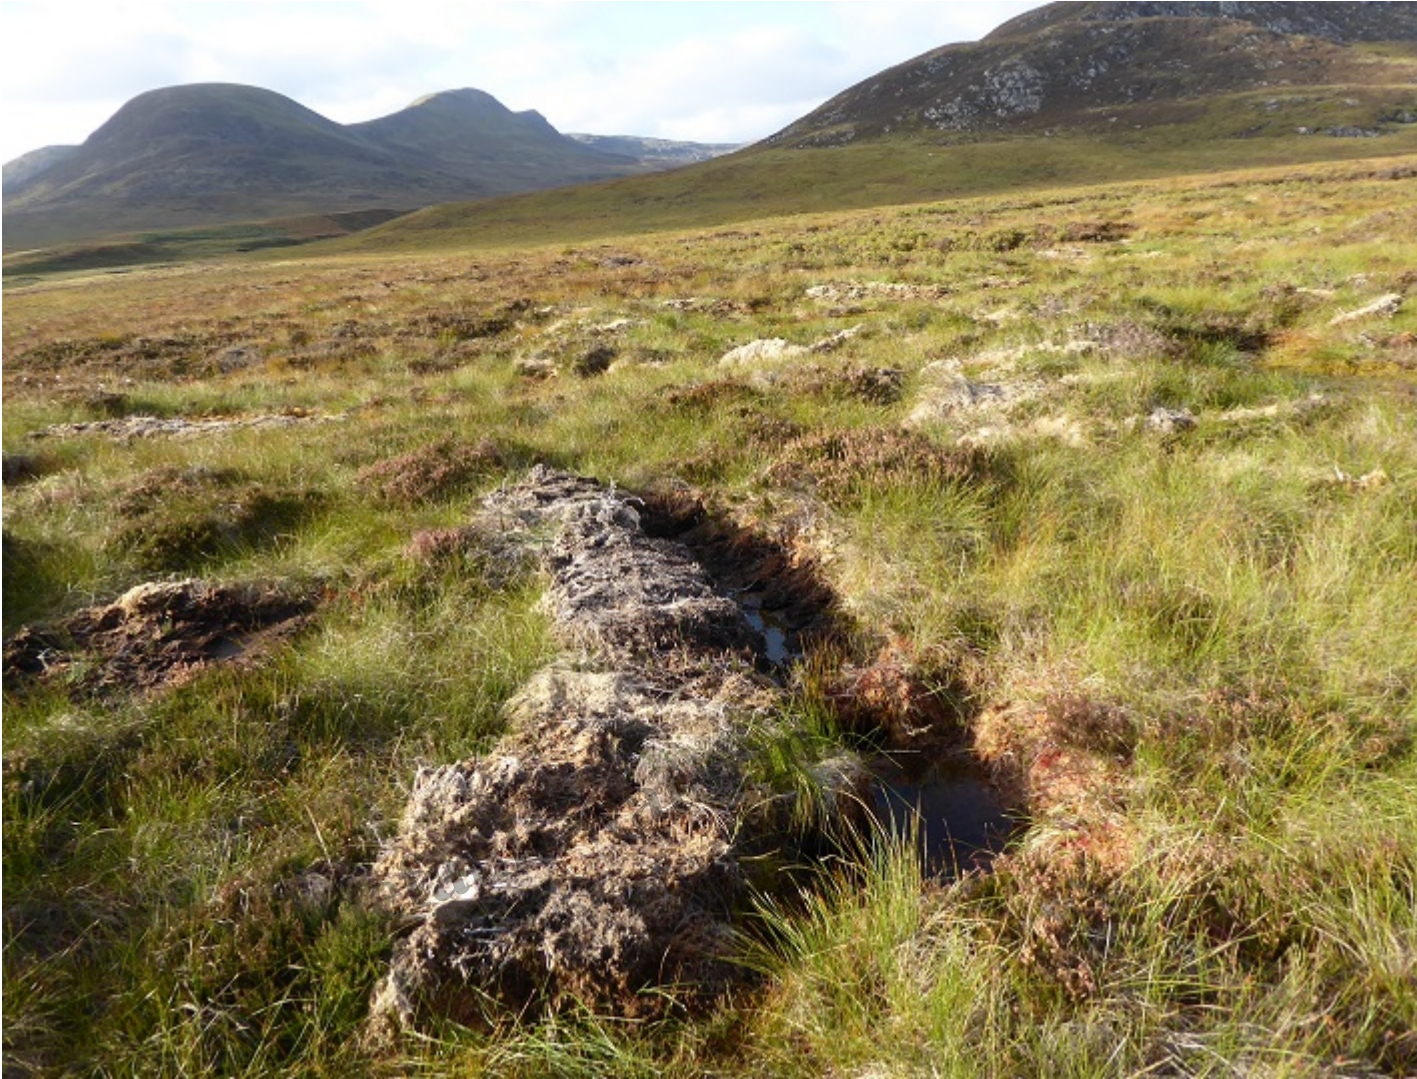
A trench pool, excavated by a digger, with further pools marked by heaps of sphagnum behind

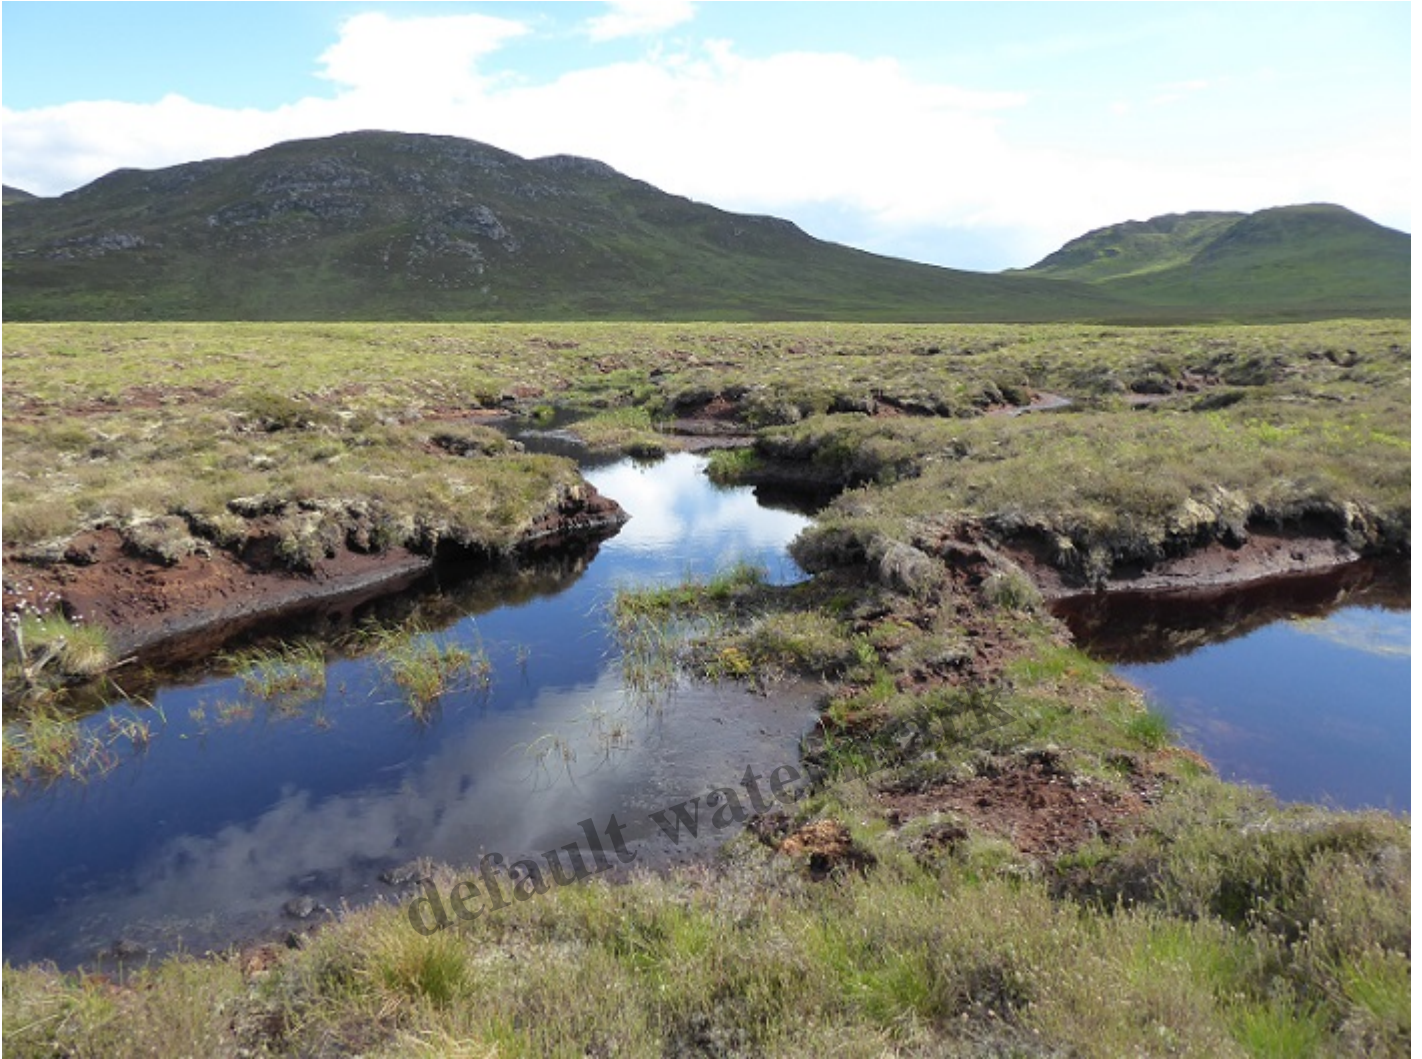
It was worse than I had anticipated. The edges of pools had in places already been eroded, perhaps by deer going for a drink, while elsewhere banks were in the process of breaking down:

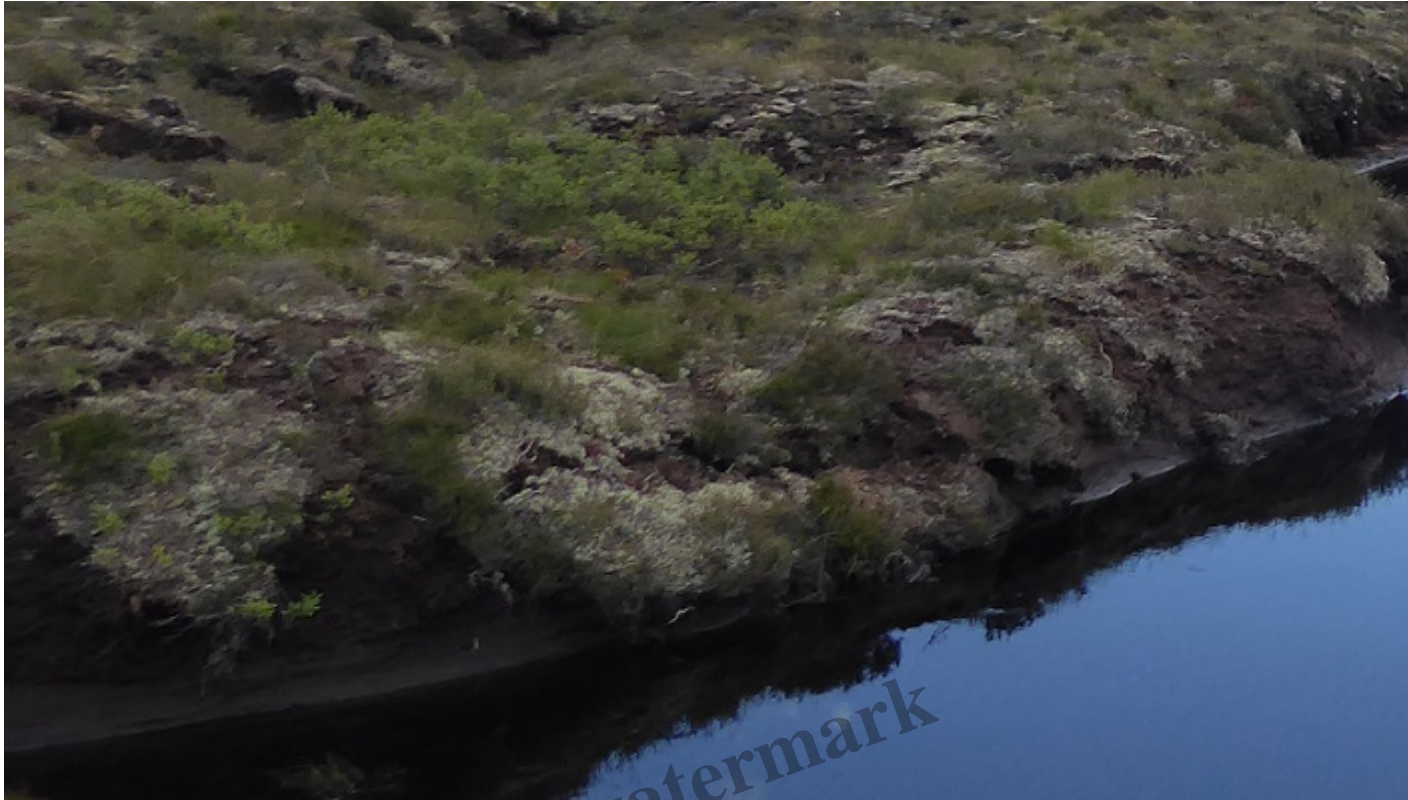
Collapsing section of bank centre. Just to the right is another slab vegetation covered peat that is sliding down into the hill.

One possible explanation for this particular restoration failure is that deer legs slipped through the gaps between the “restored” clumps of vegetation prising them away from the slope (you don’t have to look far in most restoration schemes to see deer hoof marks in the open spaces). Another is that the water in the bog pool has eroded the peat from underneath.

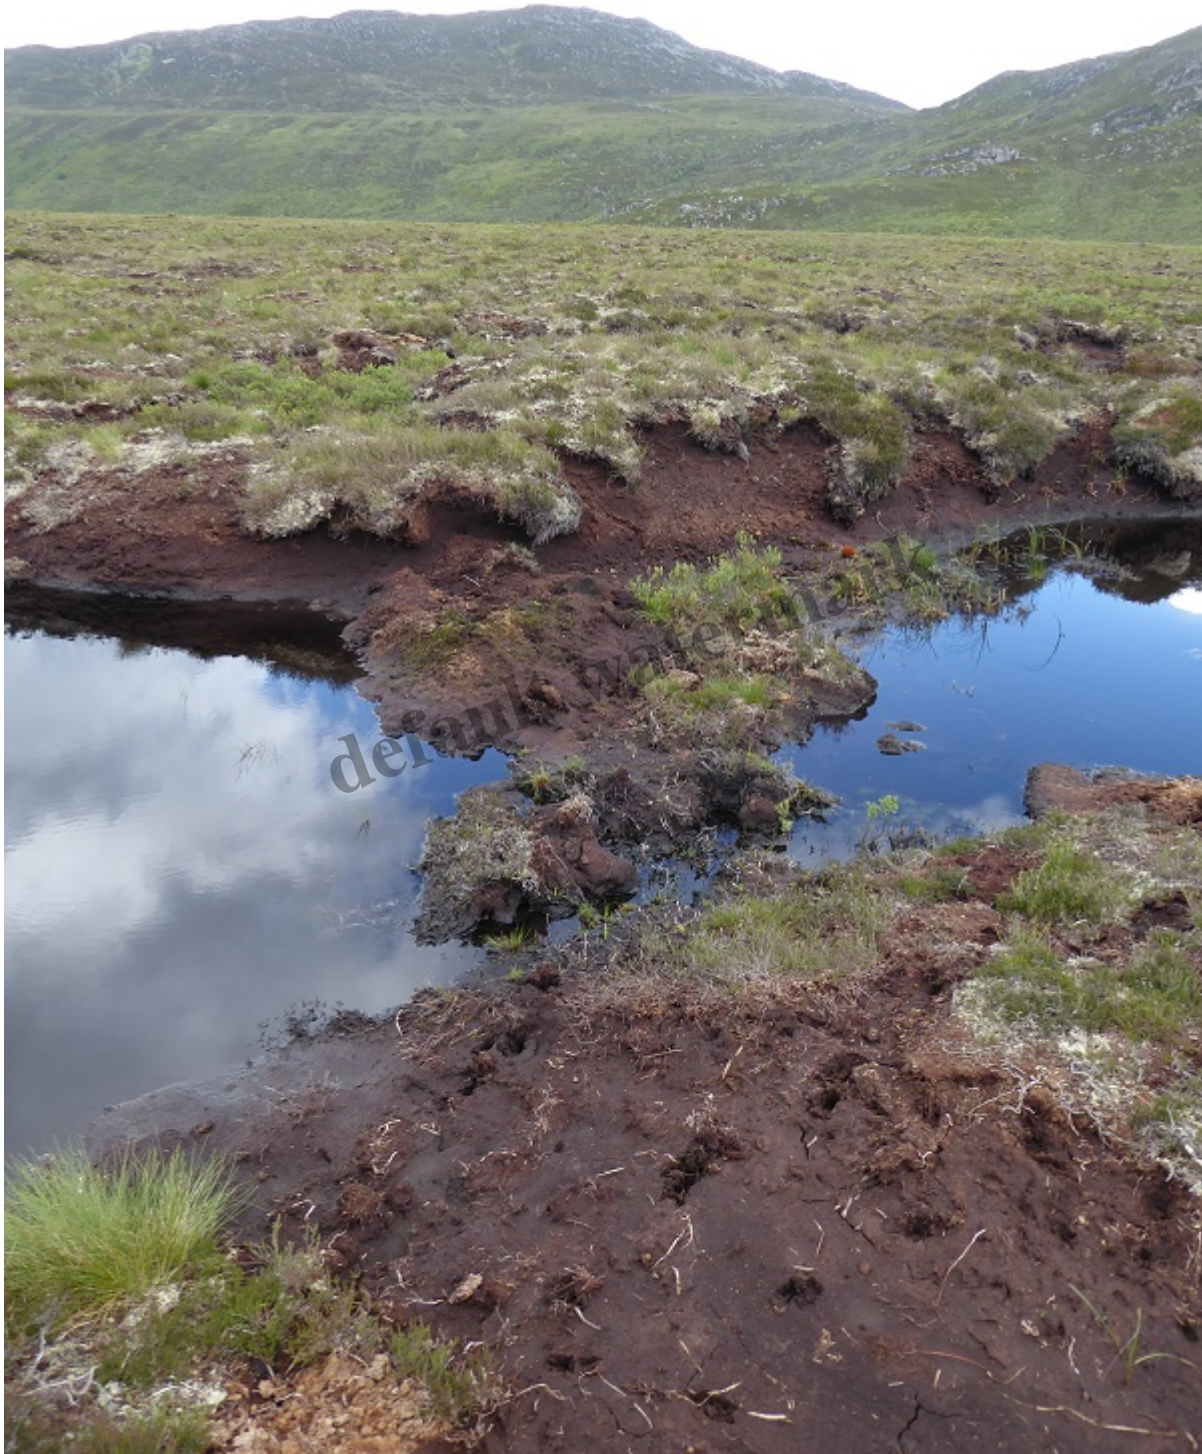
Deer hoof marks were highly visible on the low vegetated areas that had been created between the pools.

The trampling has left bare peat which will be quickly eroded away by the new stream and further trampling

Whoever paid for this restoration work, it appears to have been a waste of money because the main reason why the bog is likely to have degraded in the first place, trampling and grazing by animals, has

not been addressed.

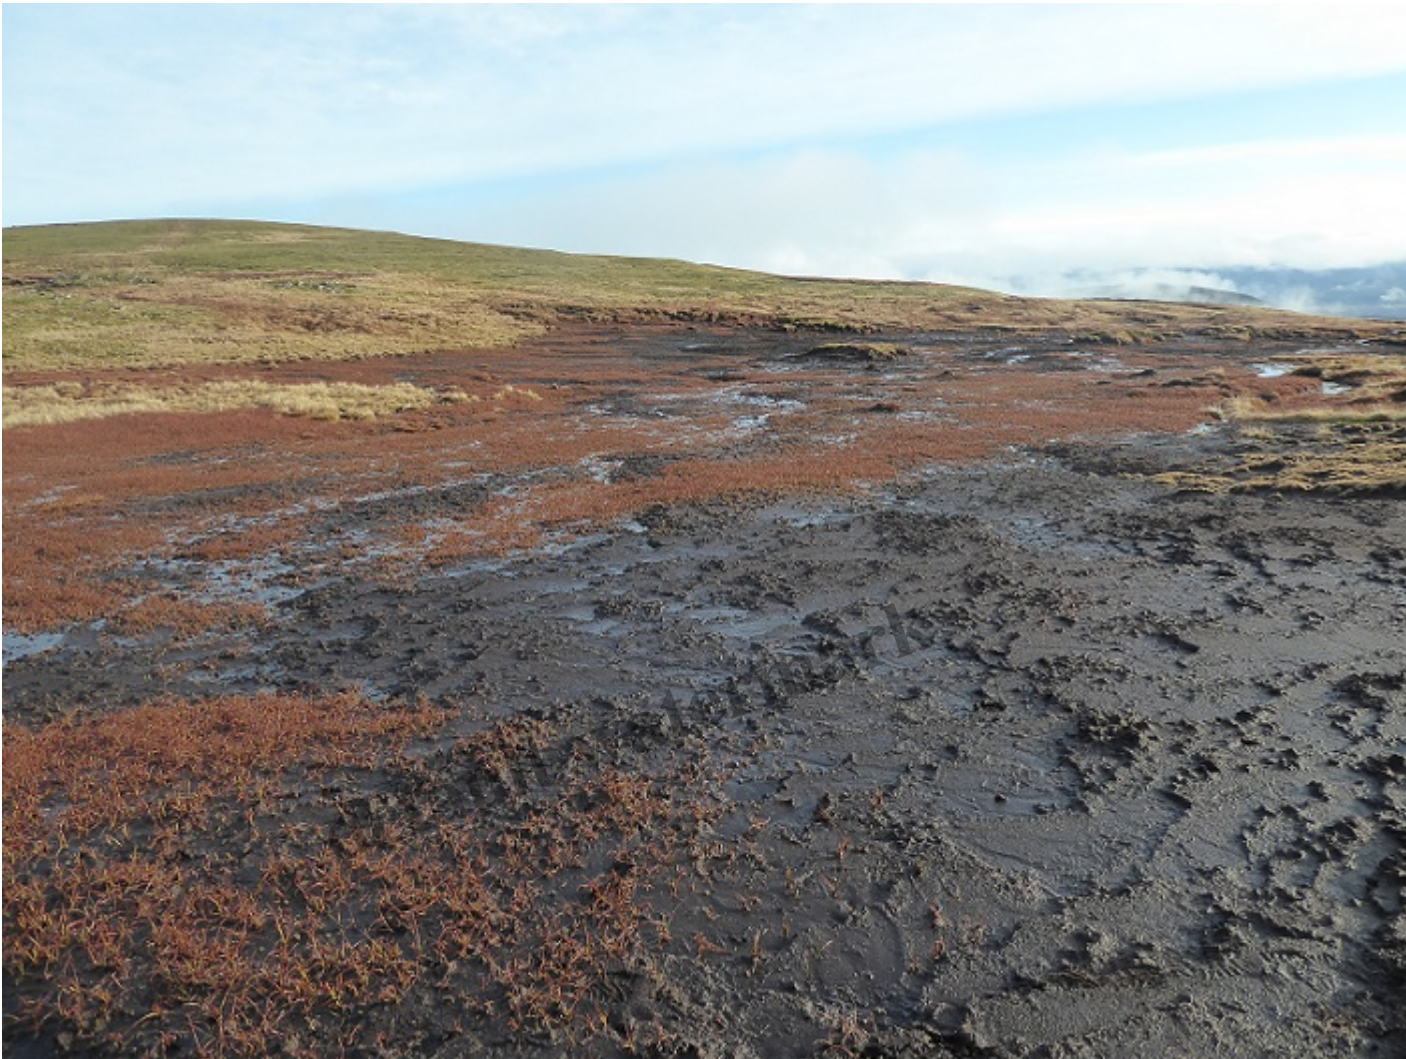
Peat erosion (and partial recolonisation by plants) on ridge between Carn Sgulain and Carn Ballach, Glen Banchor Estate. Photo Credit Louise Brimelow Nov 2021

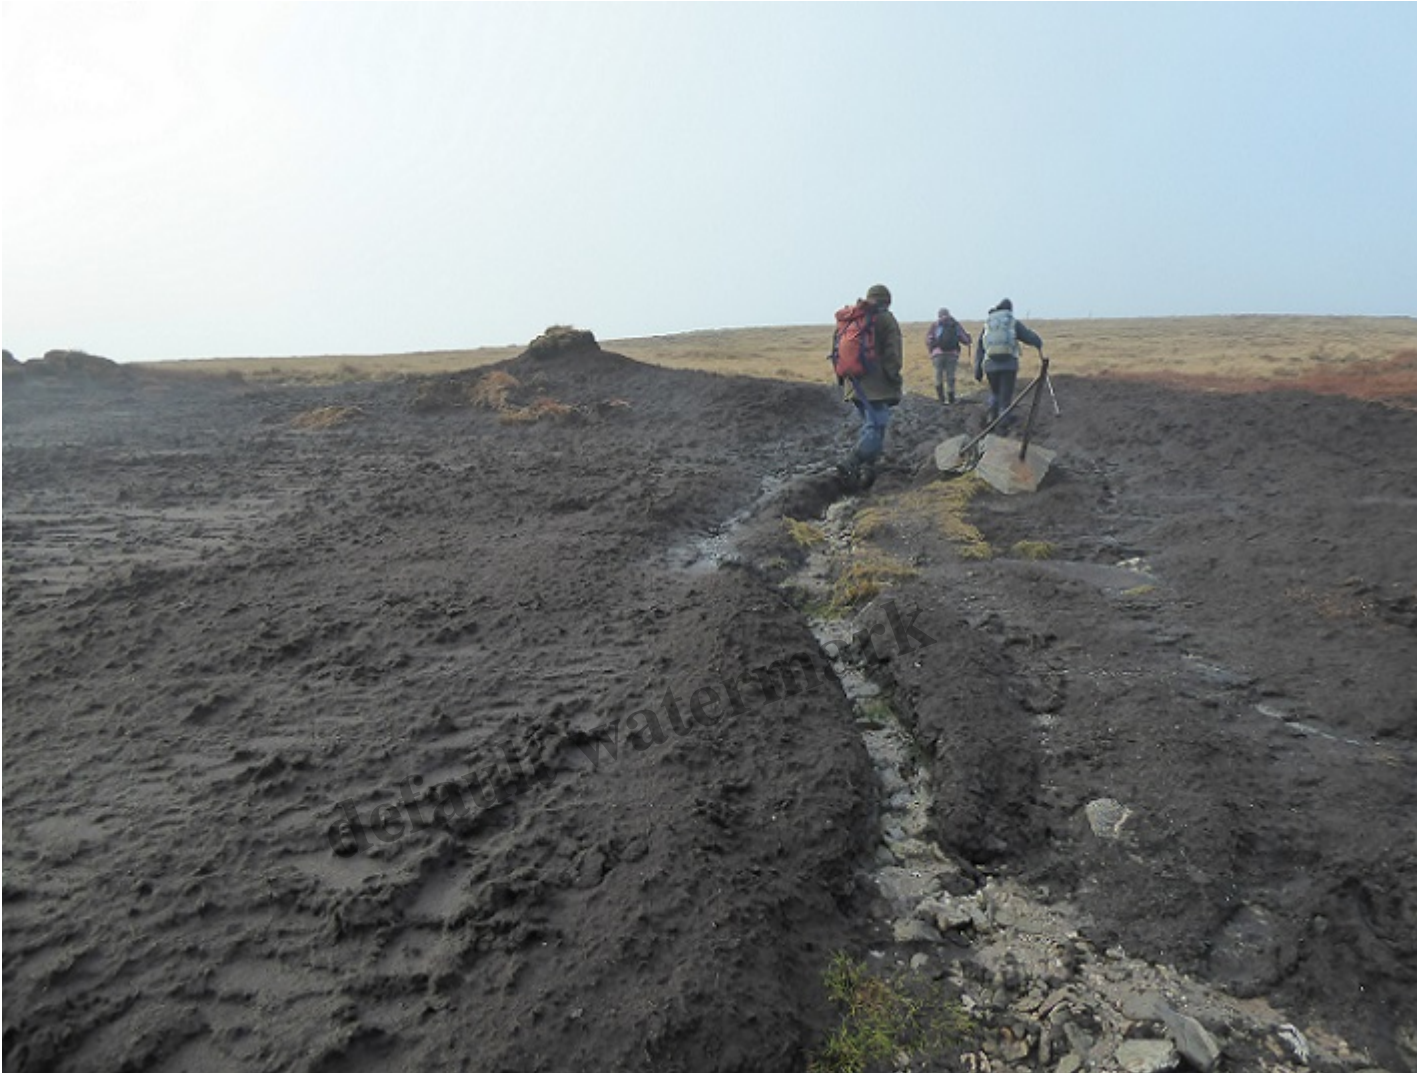
Walkers clearly account for this eroded line across the peat but can't explain the eroded peat hags behind or the sheer extent of the eroded area. Carn Balloch, November 2021. Photo credit Louise Brimelow

Some erosion is as a result of natural processes while both All Terrain Vehicles and walkers play a role. But none of this is can explain the 1000s of hectares of damaged peat bog in Scotland or deer wallows.

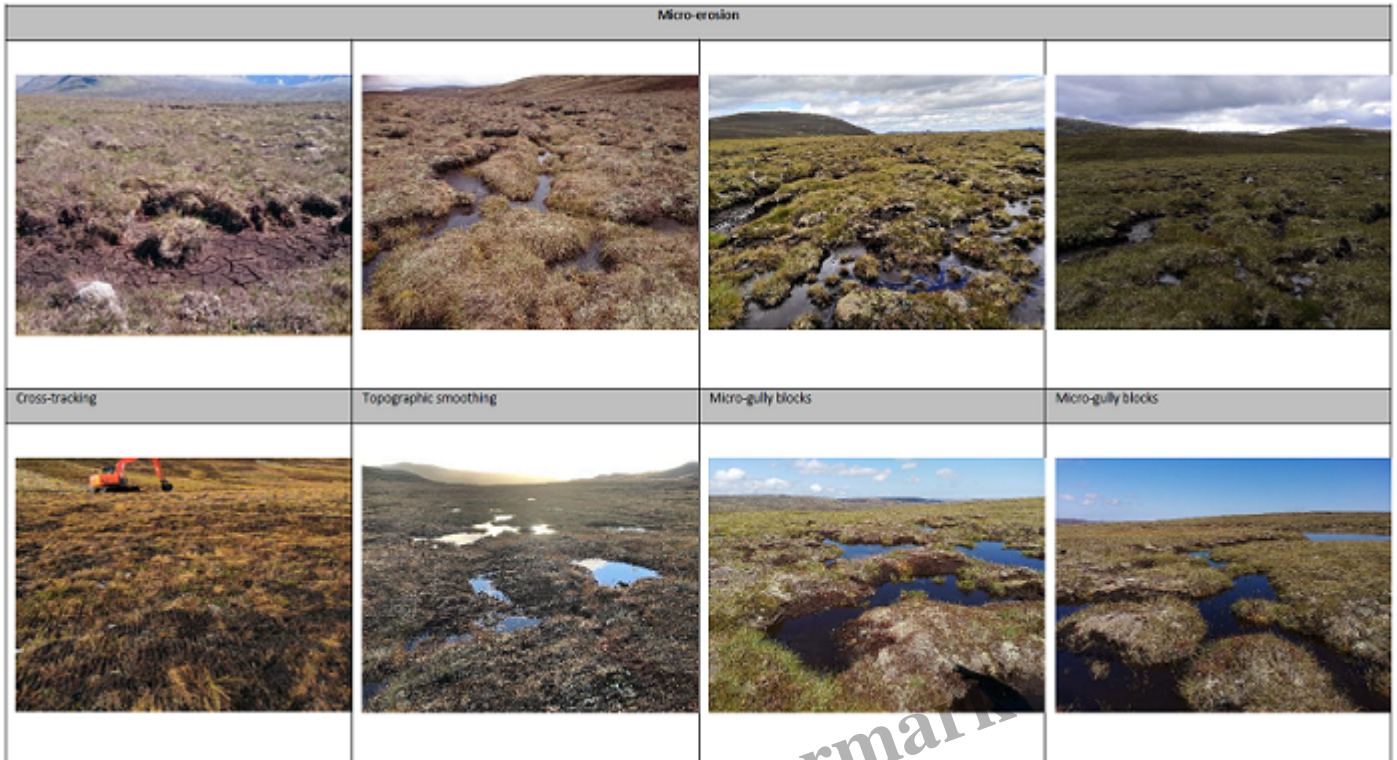
In the Pitmain Prior Notification there are some photos of peat bog restoration techniques, before and after:

Now Strathcauldih may have had nothing to do with the peat bog restoration in Glen Banchor – most of their work appears to be on higher ground. But the photos of how the Glen Banchor bog appeared last year were more like the top line of photos than the bottom: evidence that the restoration work has failed.

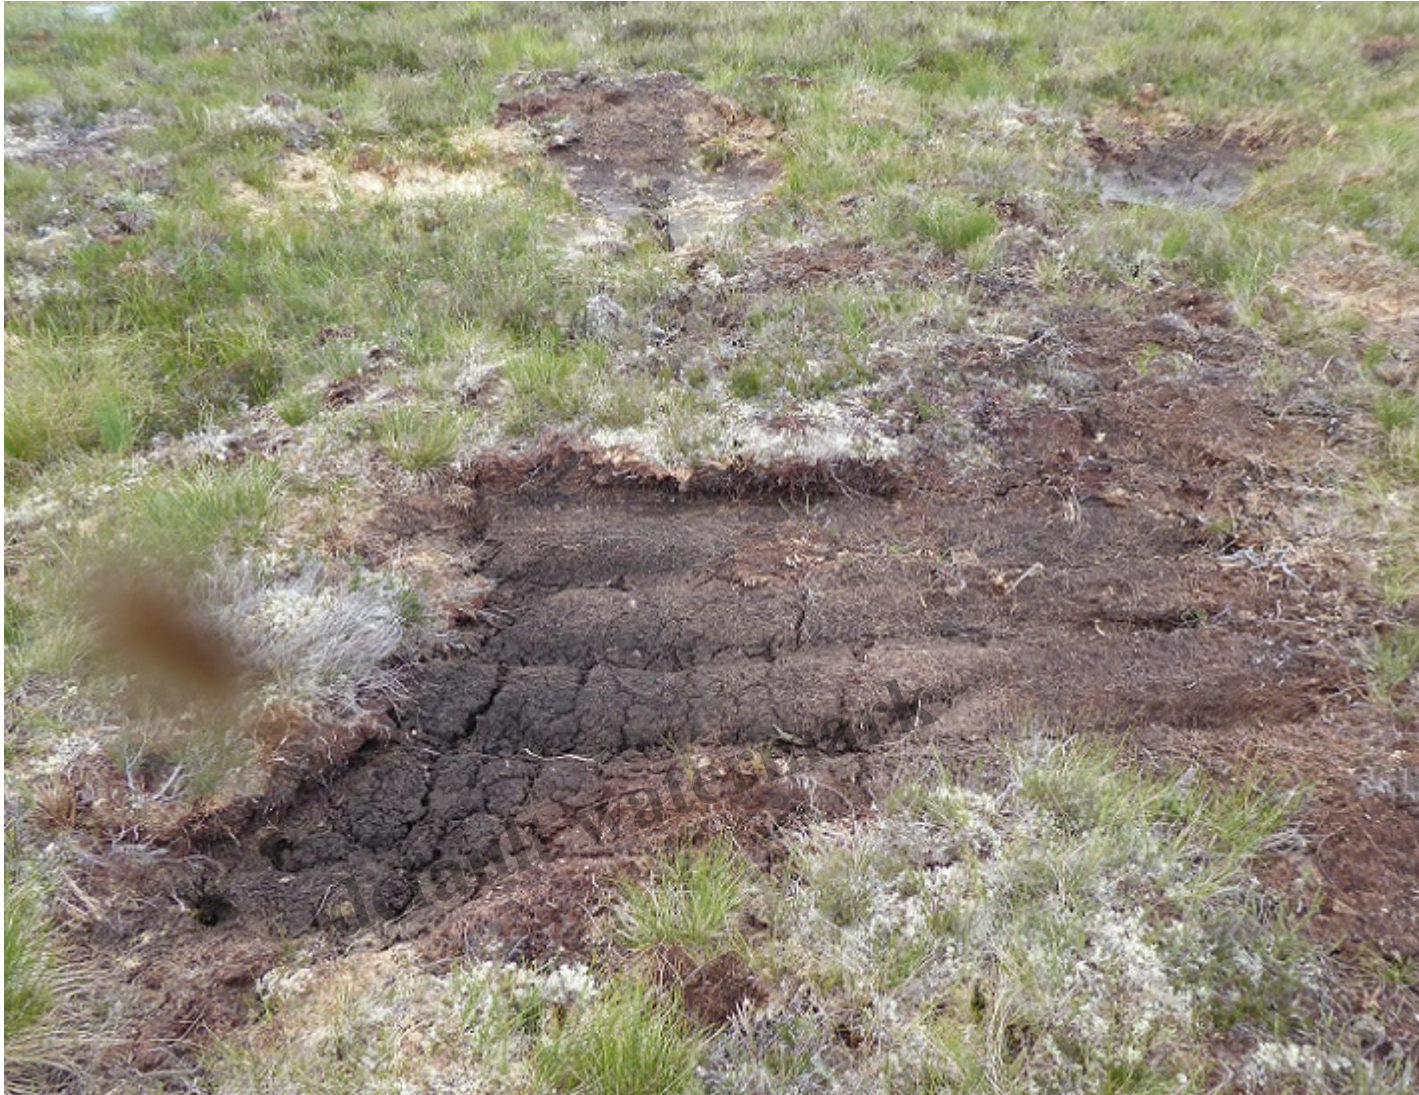
Removal of vegetation to cover areas of bare peat is useless if new areas of peat are left open to the air and sunlight.

The contractor has clearly not be sent back to repair the damage. But much of the failure also appears attributable to trampling and grazing pressure:

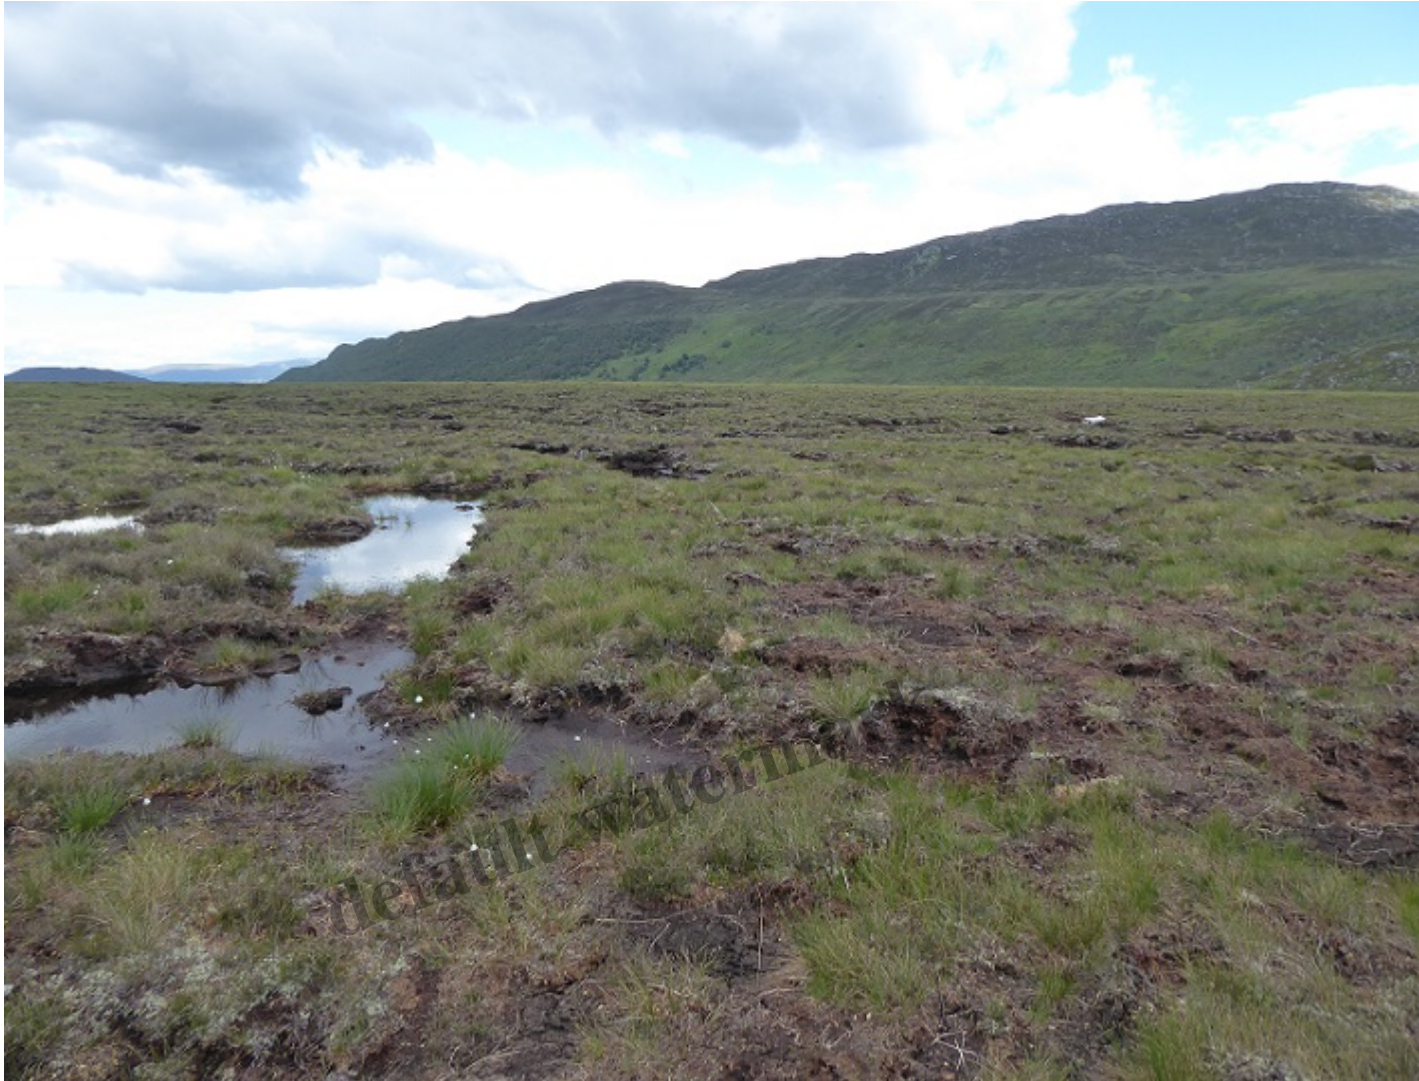
Why has vegetation failed to relonise bare areas of peat two years after restoration if not because of grazing and trampling? Photo 2022

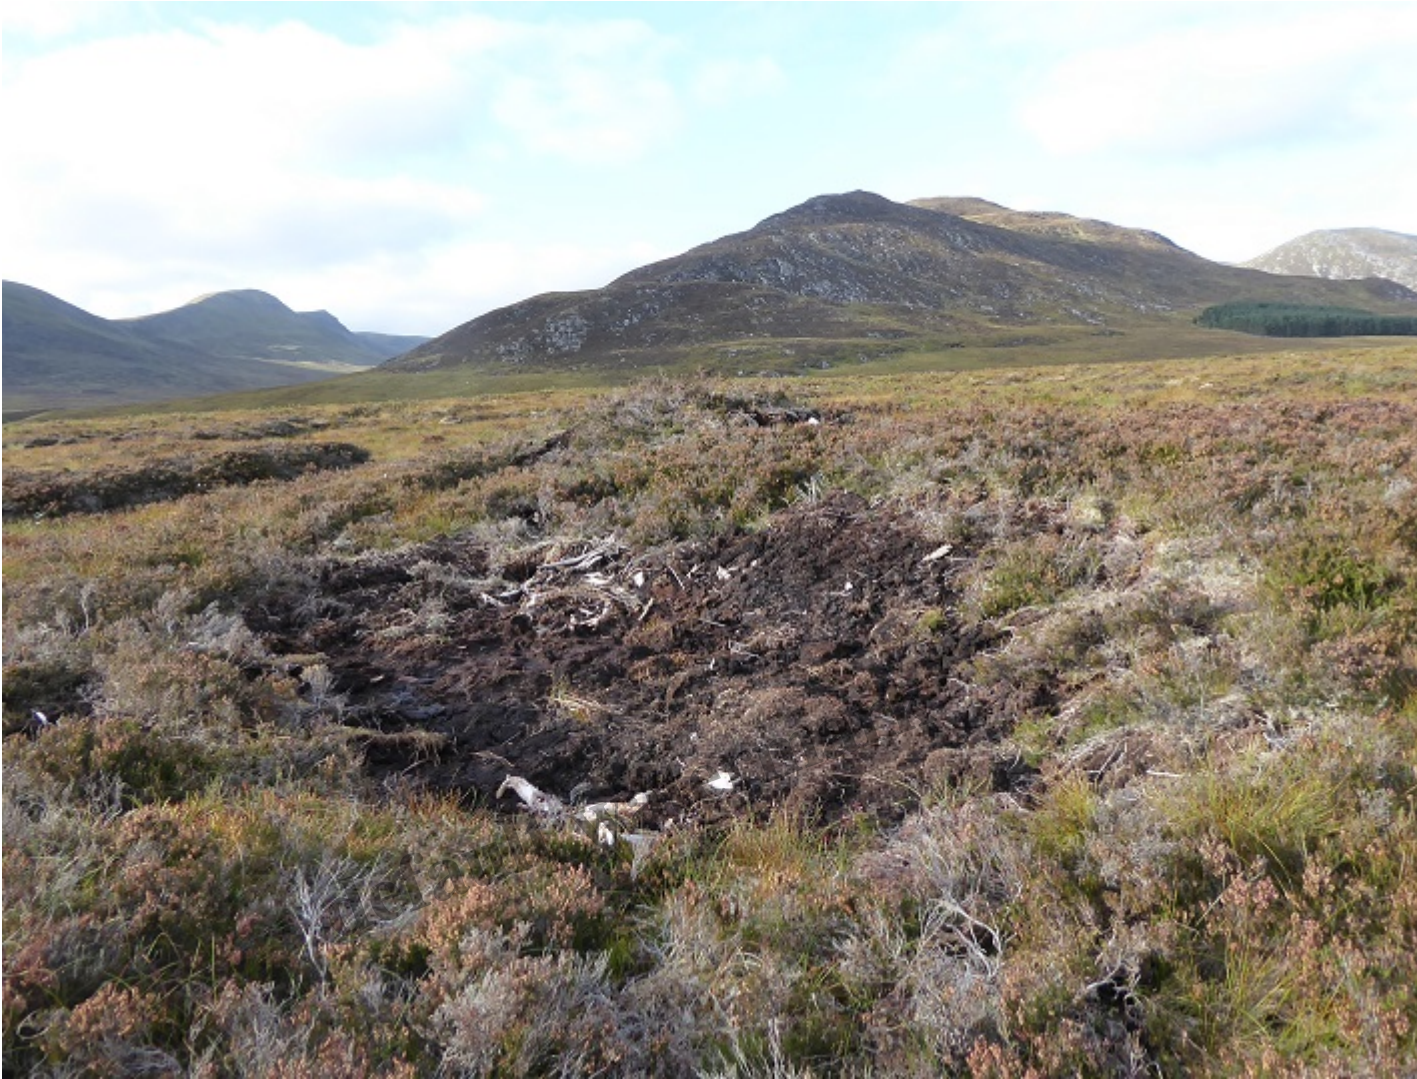
Patch which may have been excavated and not restored, although there were plentiful signs of trampling in 2020

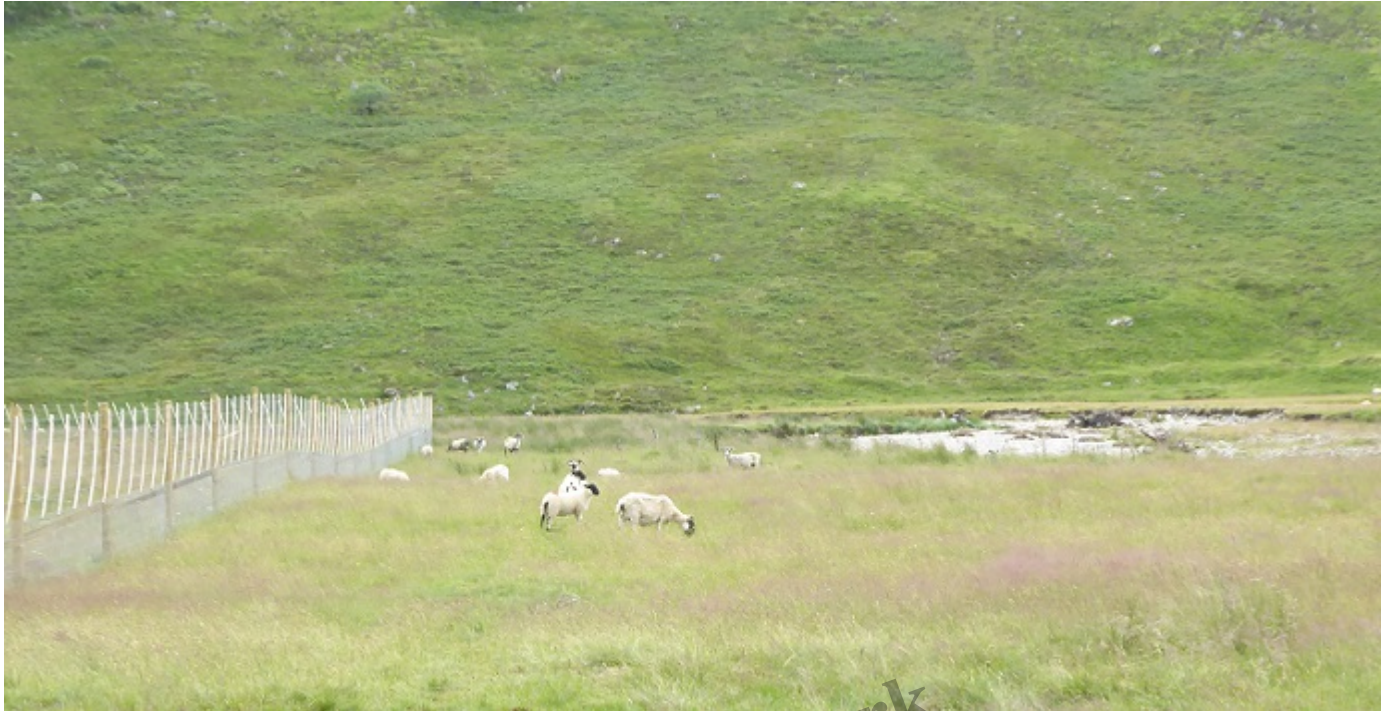
Photo July 2021

At times significant numbers of sheep are still grazing in upper Glen Banchor on the more fertile ground by the river. They are free to wander onto to the bog and although I have not seen them there they may be responsible some of the damage.

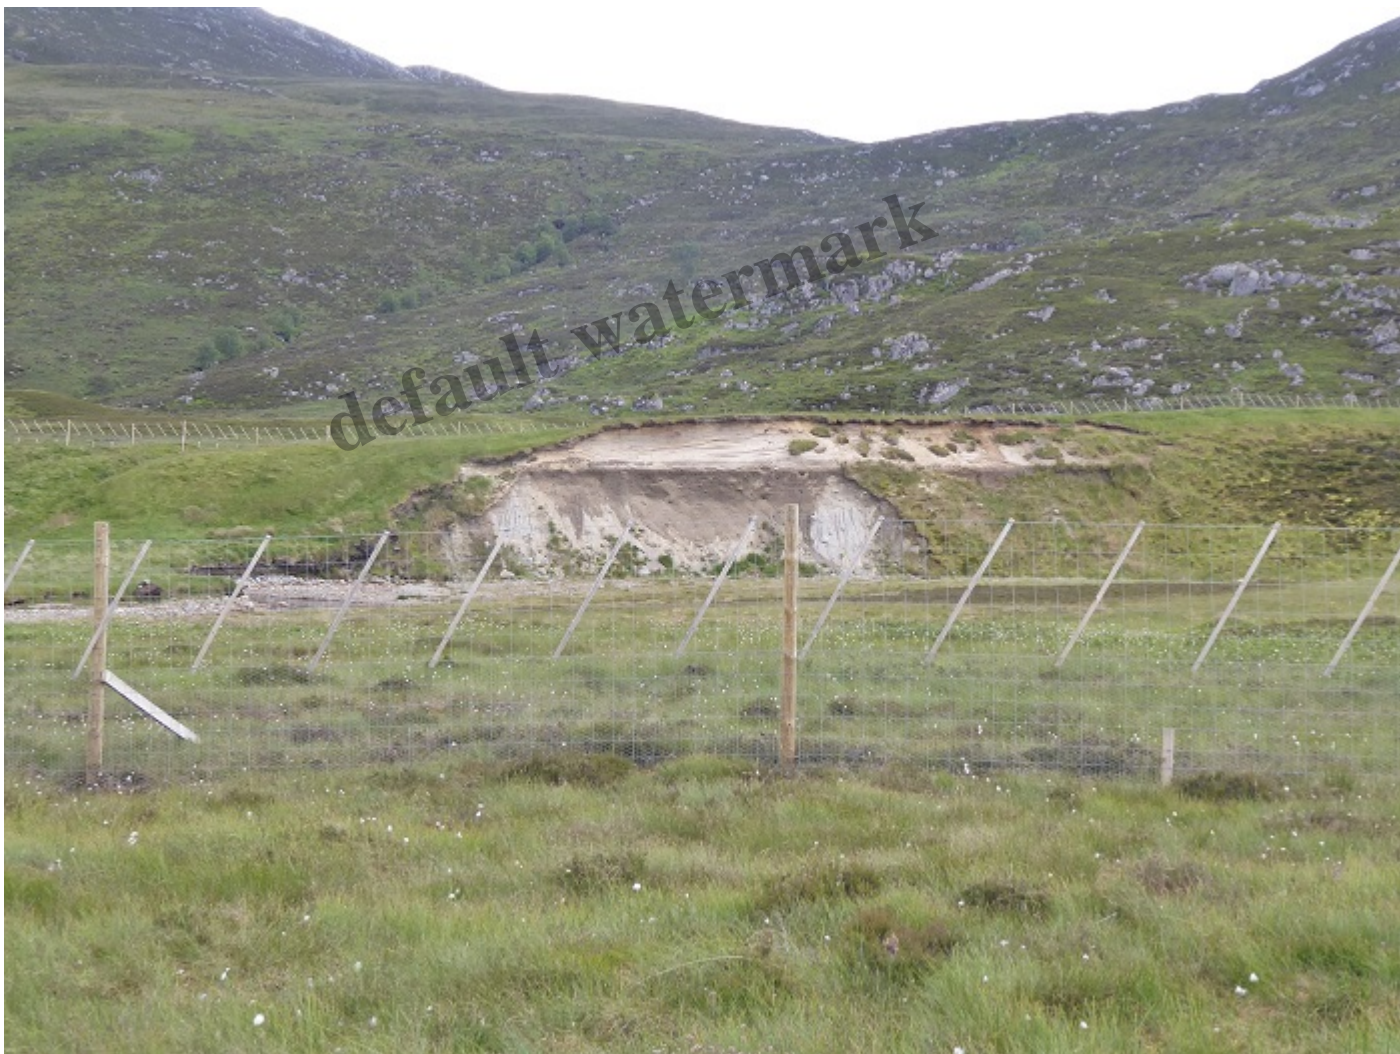
The topmost enclosure includes areas of bog, as evidenced by the cotton grass, although when I visited in 2020 I could not see evidence of tree planting there.

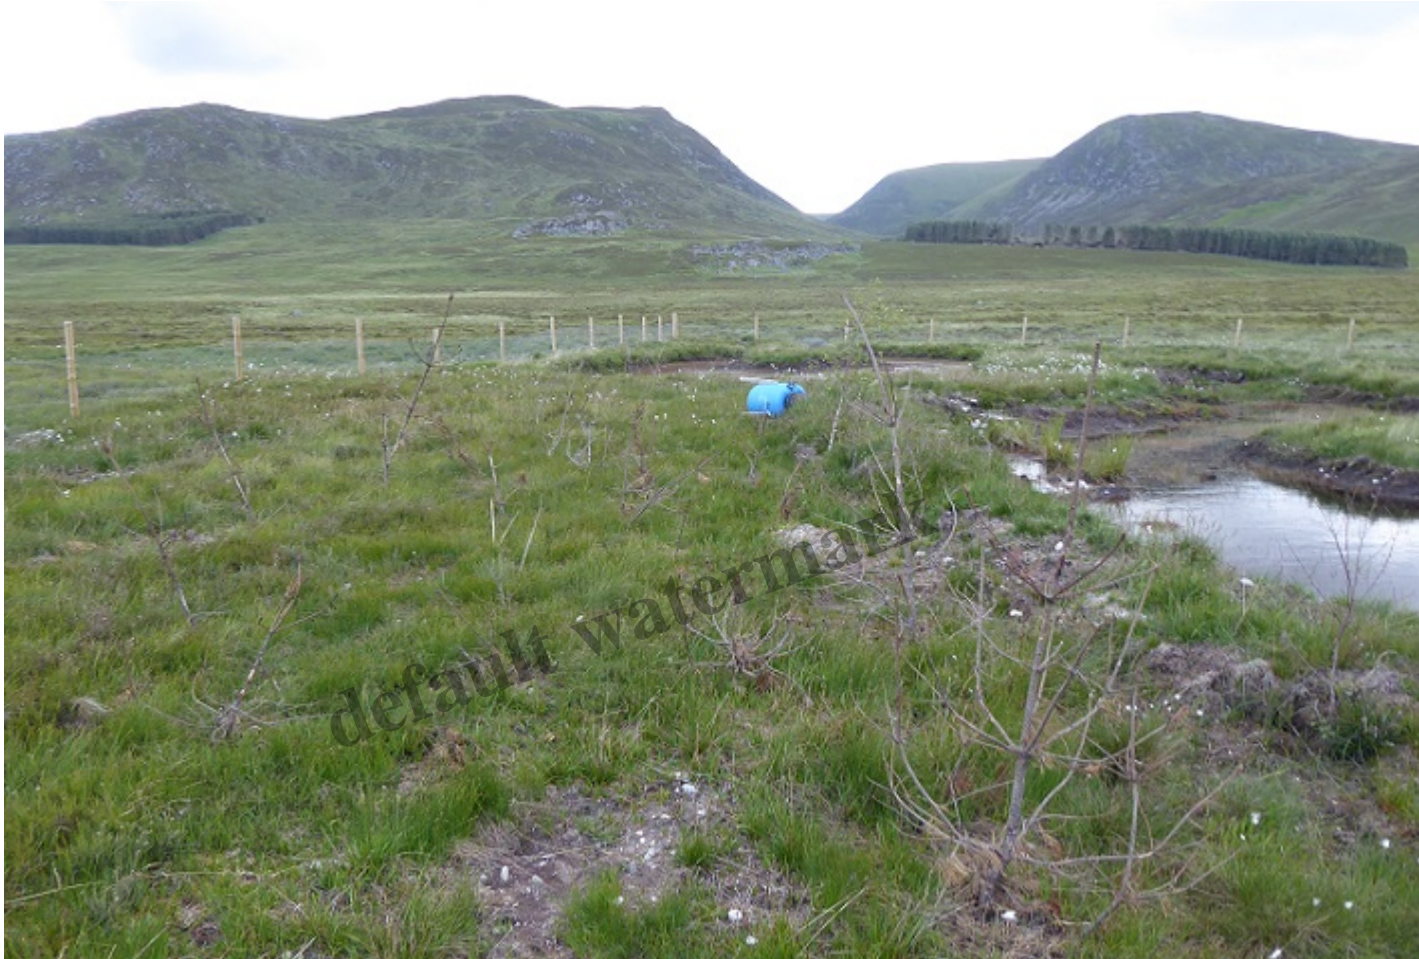
New “sporting pen” enclosure – note the blue game bird feeder – near enclosures 1 and 2

This sporting pen is consistent with the Pitmain Estate’s Woodland Management Plan of 2018 which described the woodland that was proposed here as being partly for sporting use. The peat bog restoration nearby didn’t prevent the estate from trying to plant trees, all of which have died, or from excavating a pool in the bog for sporting purposes.
