Conservation in Glen Banchor? Peat bog and woodland restoration (1)

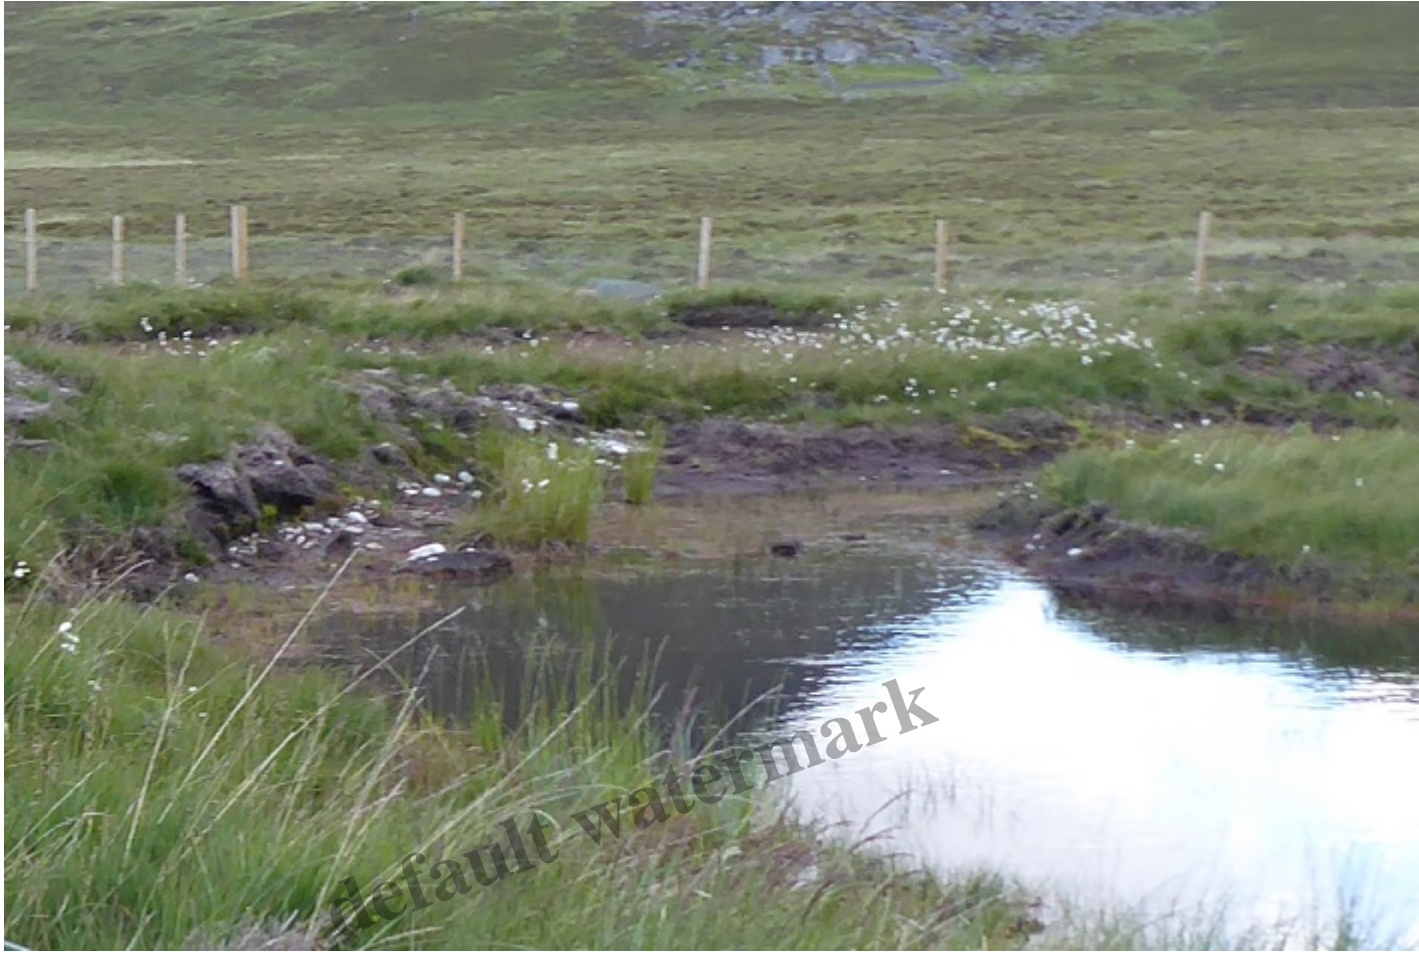
Close up of pool

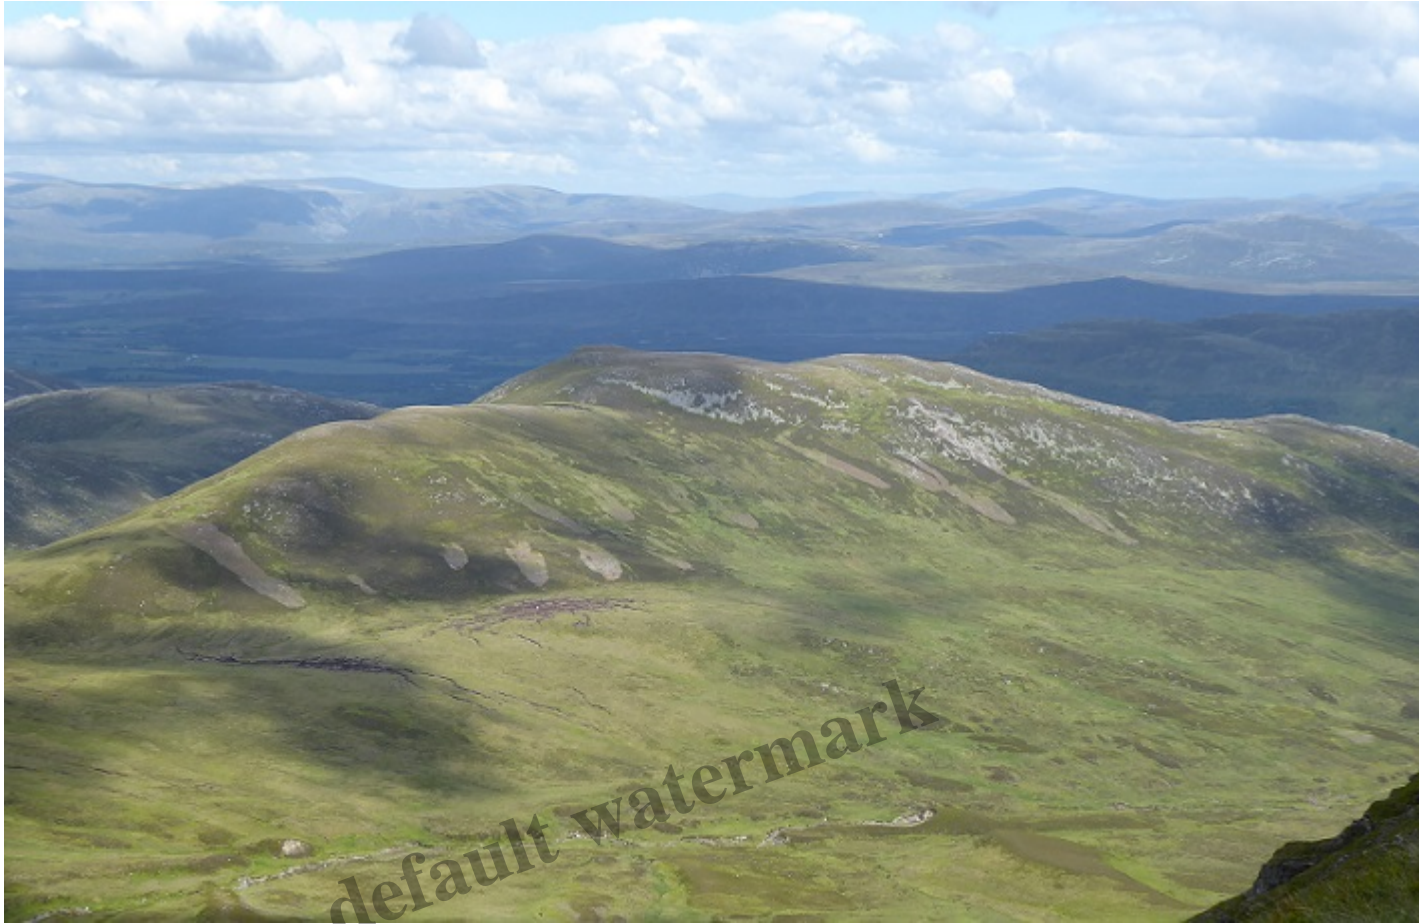
Muirburn on the slopes of Creag Liath viewed from Carn Dearg. Noted the eroded peat below the muirburn on the left.

Muirburn not only prevents peat from developing, it promotes water run off. While peat bogs generally absorb water, if water starts flowing into or over a peat bog it will start to create erosion gullies and can precipitate peat slides. Such phenomena occur naturally but become unnatural and their effects accentuated where there is muirburn.
