Is the funicular at Cairn Gorm safe?

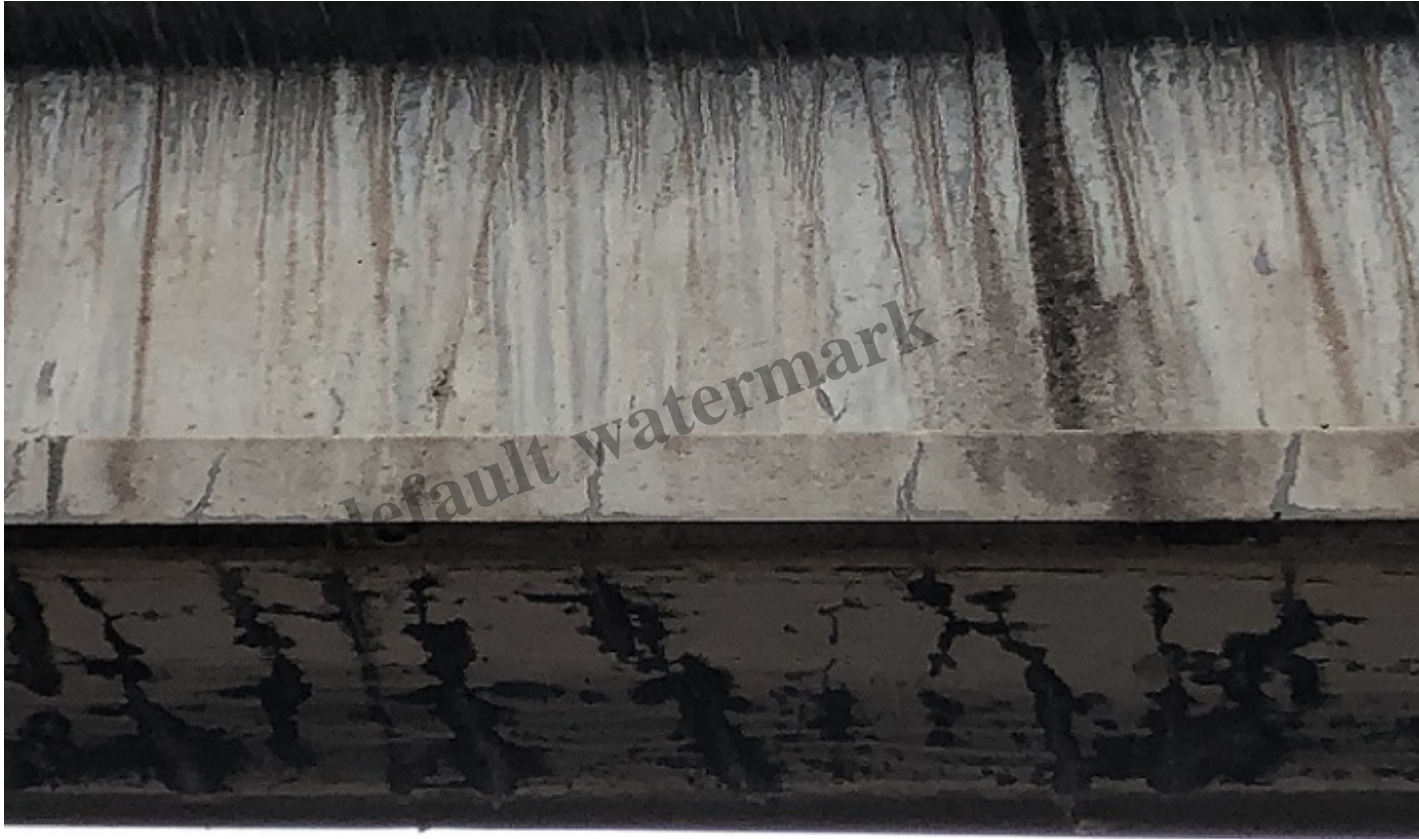
"I finally made it up the hill to the Cairngorm Ski Area. I think it would be fair to say I was appalled by the so called 'repairs' to the Funicular. More of a bodge than anything else, held together by screwed rods which I doubt are high tensile."

It was the end of operations when I was there and the last car came down as I watched. The support beam above me visibly flexed as the empty car passed over it, moving perhaps 5cm, the other side did not.

Closer inspection revealed what appeared to be numerous cracks in the underside of the beam flange, marked by lines of moisture. That is bad enough but what happens when this moisture freezes and expands making the crack worse? It can only further degrade the integrity of the beam and hence its strength. All the other beams I could see seemed to have the same problem. Also moisture entering a reinforced concrete beam will corrode the reinforcing leading to premature failure.
