Is the funicular at Cairn Gorm safe?

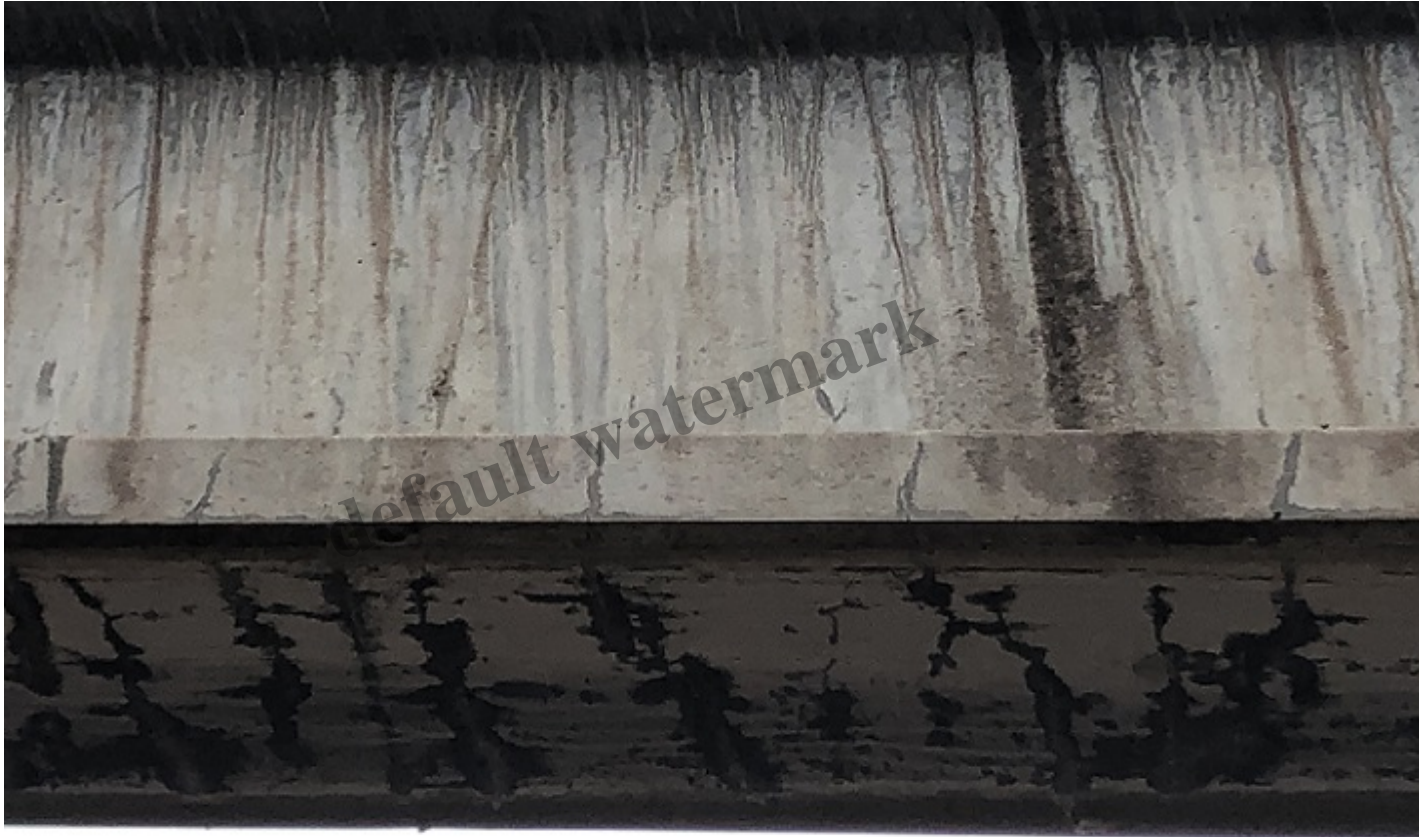
*“I finally made it up the hill to the Cairngorm Ski Area. I think it would be fair to say I was appalled by the so called ‘repairs’ to the Funicular. More of a bodge than anything else, held together by screwed rods which I doubt are high tensile.*”

*It was the end of operations when I was there and the last car came down as I watched. The support beam above me visibly flexed as the empty car passed over it, moving perhaps 5cm, the other side did not.*

*Closer inspection revealed what appeared to be numerous cracks in the underside of the beam flange, marked by lines of moisture. That is bad enough but what happens when this moisture freezes and expands making the crack worse? It can only further degrade the integrity of the beam and hence its strength. All the other beams I could see seemed to have the same problem. Also moisture entering a reinforced concrete beam will corrode the reinforcing leading to premature failure.*

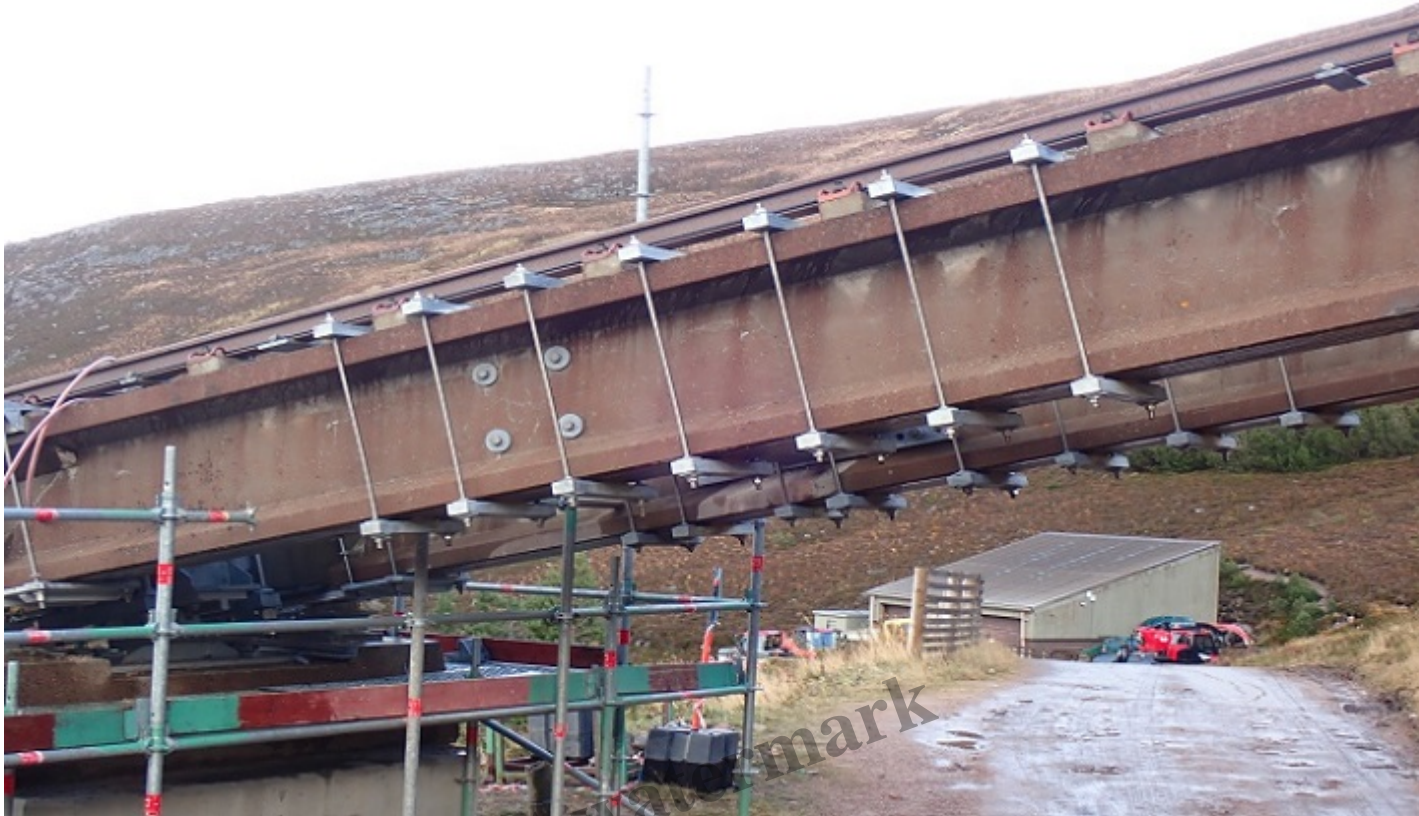
The steel rods as previously featured on parkswatch

*It would be interesting to see the stress calculations for these and how they are affected by extremes of temperature. Did they actually do stress calculations?*
