Forest and Land Scotland's failed path but flourishing woodland – Ben A'an revisited

The state of the tourist path up Ben A'An

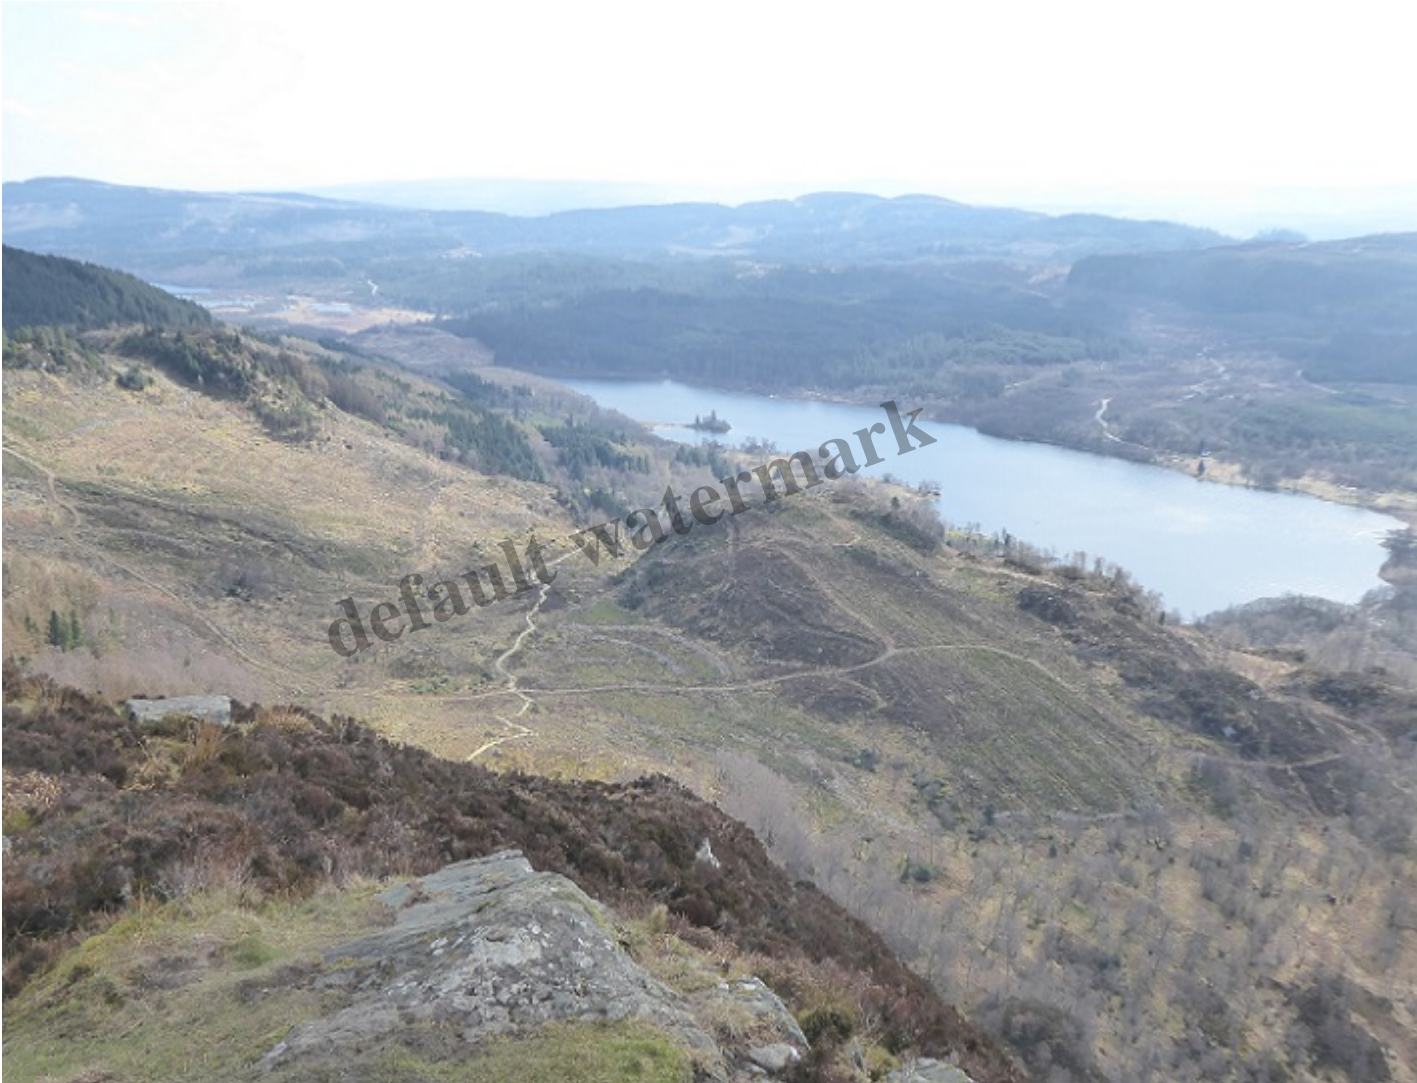
View down the middle and flatter section of the tourist path up Ben A'an – there is potential to promote other paths to help spread the load

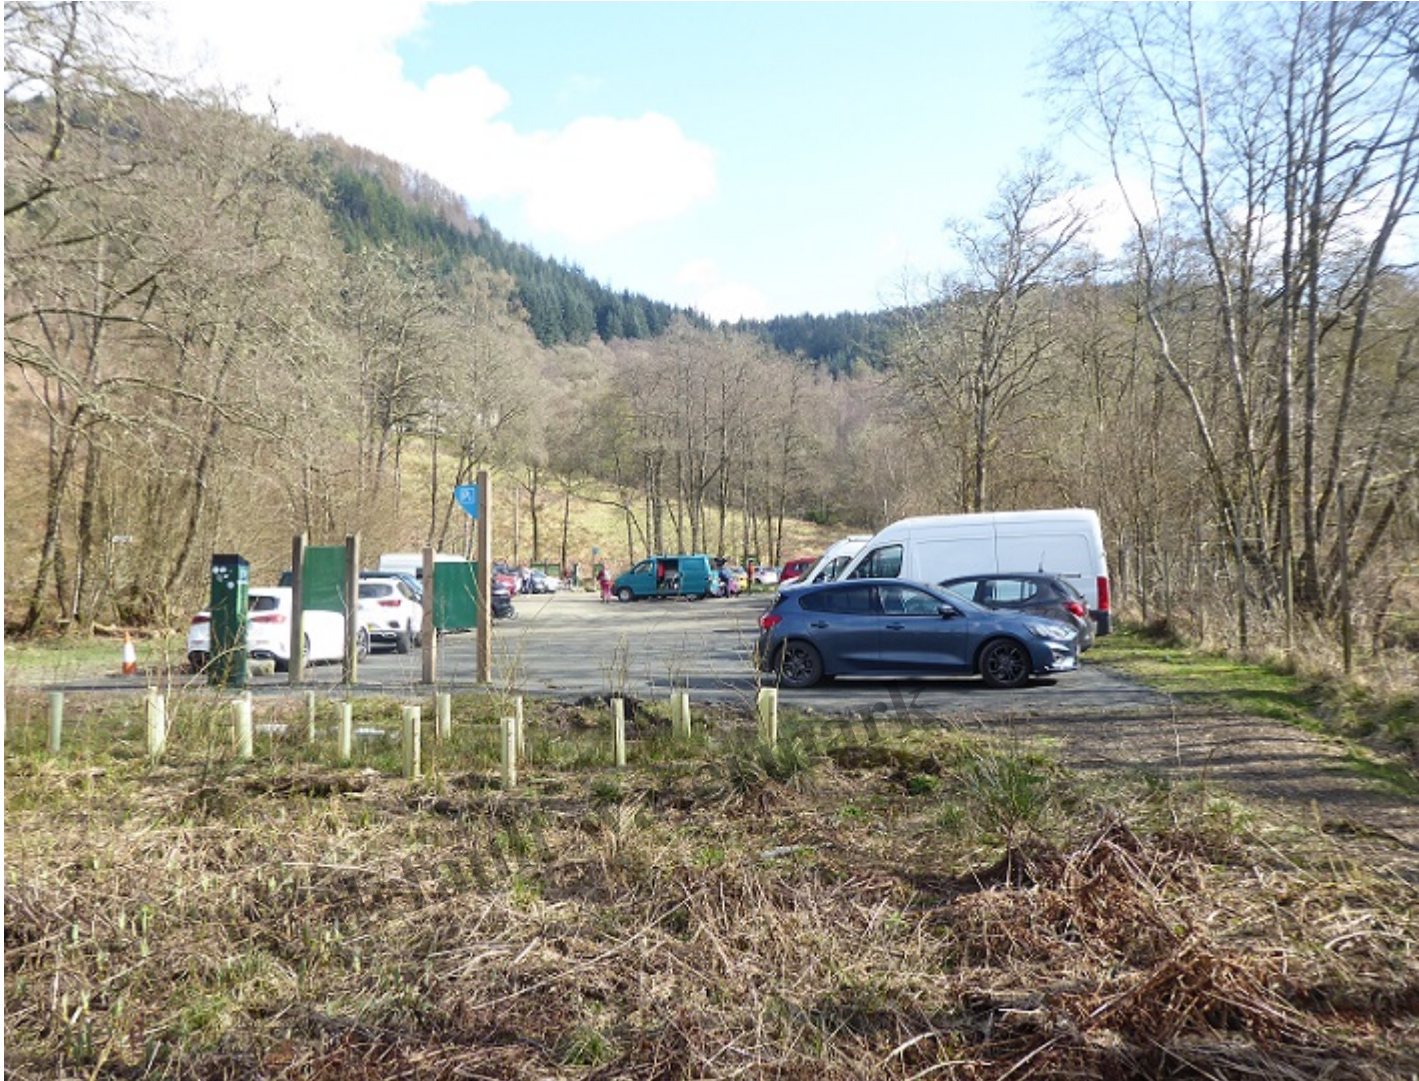
The car park has been extended by 26 places onto what was marshy ground (foreground) on the shore of Loch Achray, part of the River Teith Special Area of Conservation. Note the sapling in front (left) of the plastic tree tubes.

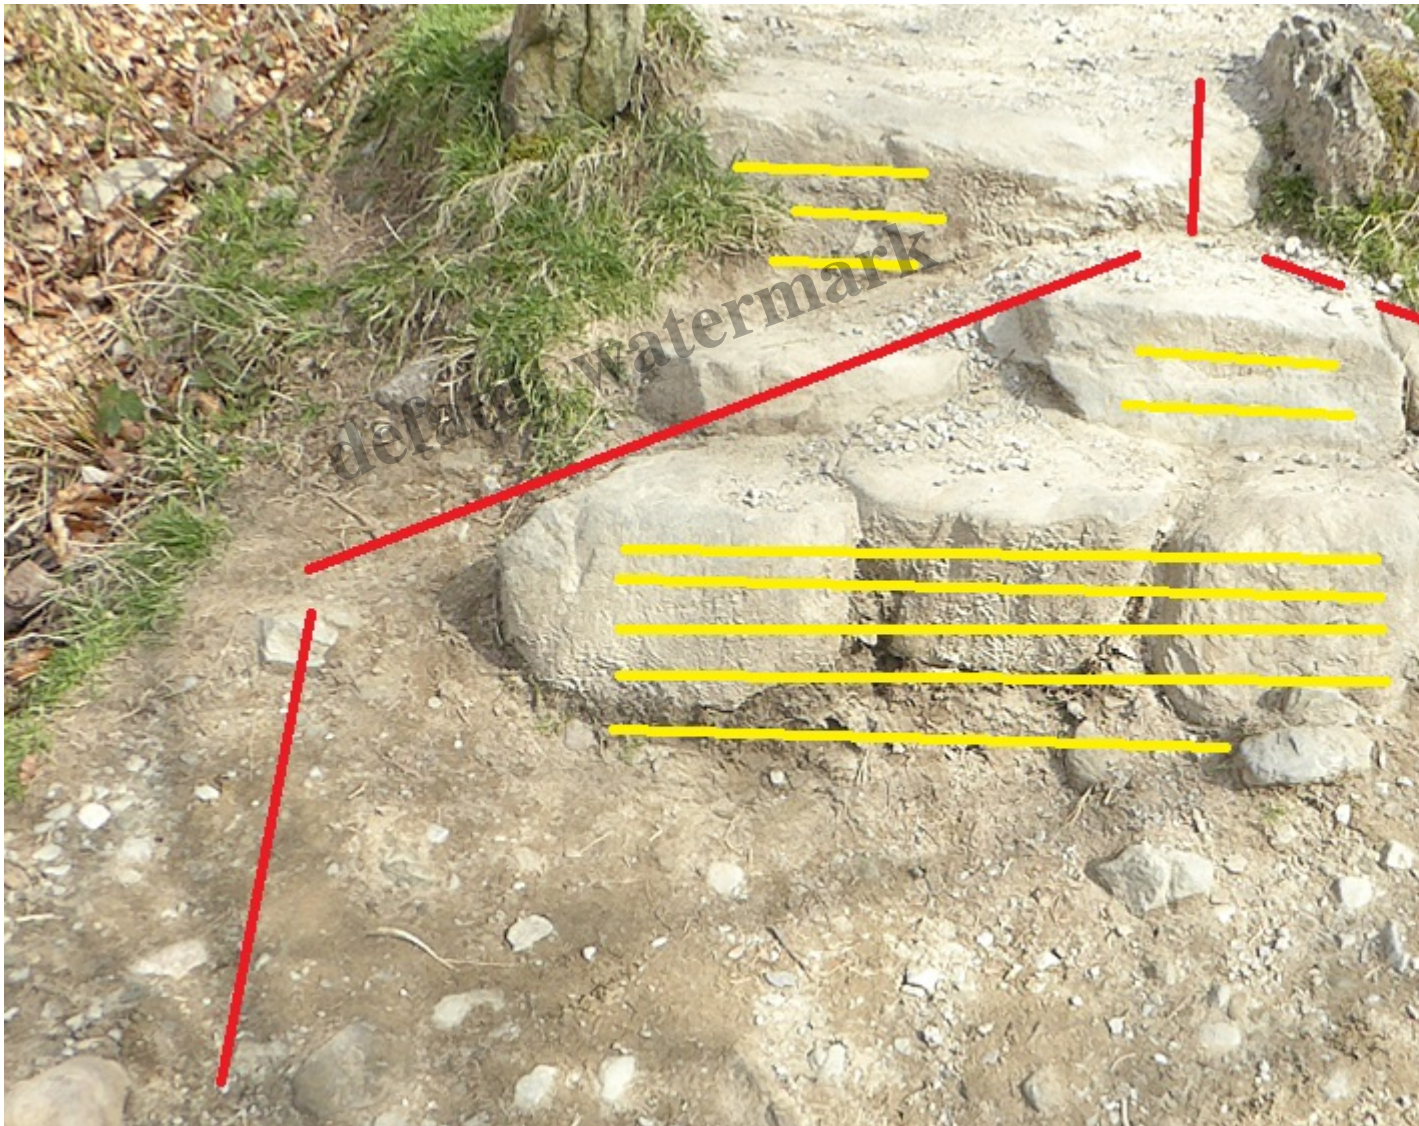
The yellow lines highlight the barriers, the red lines show the ways around them.

The main problems are the stepped sections, most of which were never fit for purpose, as illustrated by the photo above. Instead of making it easier for people to walk up the hill, the steps have served to form barriers, making it more difficult to use the path.

Most people avoid using steps over 20cms high both because of the effort this involves walking up and because they jar the knees going down. In this case, the height of the lowest step has increased since construction because the path surface below has been eroded away – more poor design! The consequence is that people try and walk round even where this is awkward. While the “Devil’s Ears” on either side of the top step have in this case been partially successful in keeping people to the top step, you can see how routes around them are gradually forming. When those routes become easier than taking the steps, most people will abandon the constructed path entirely.

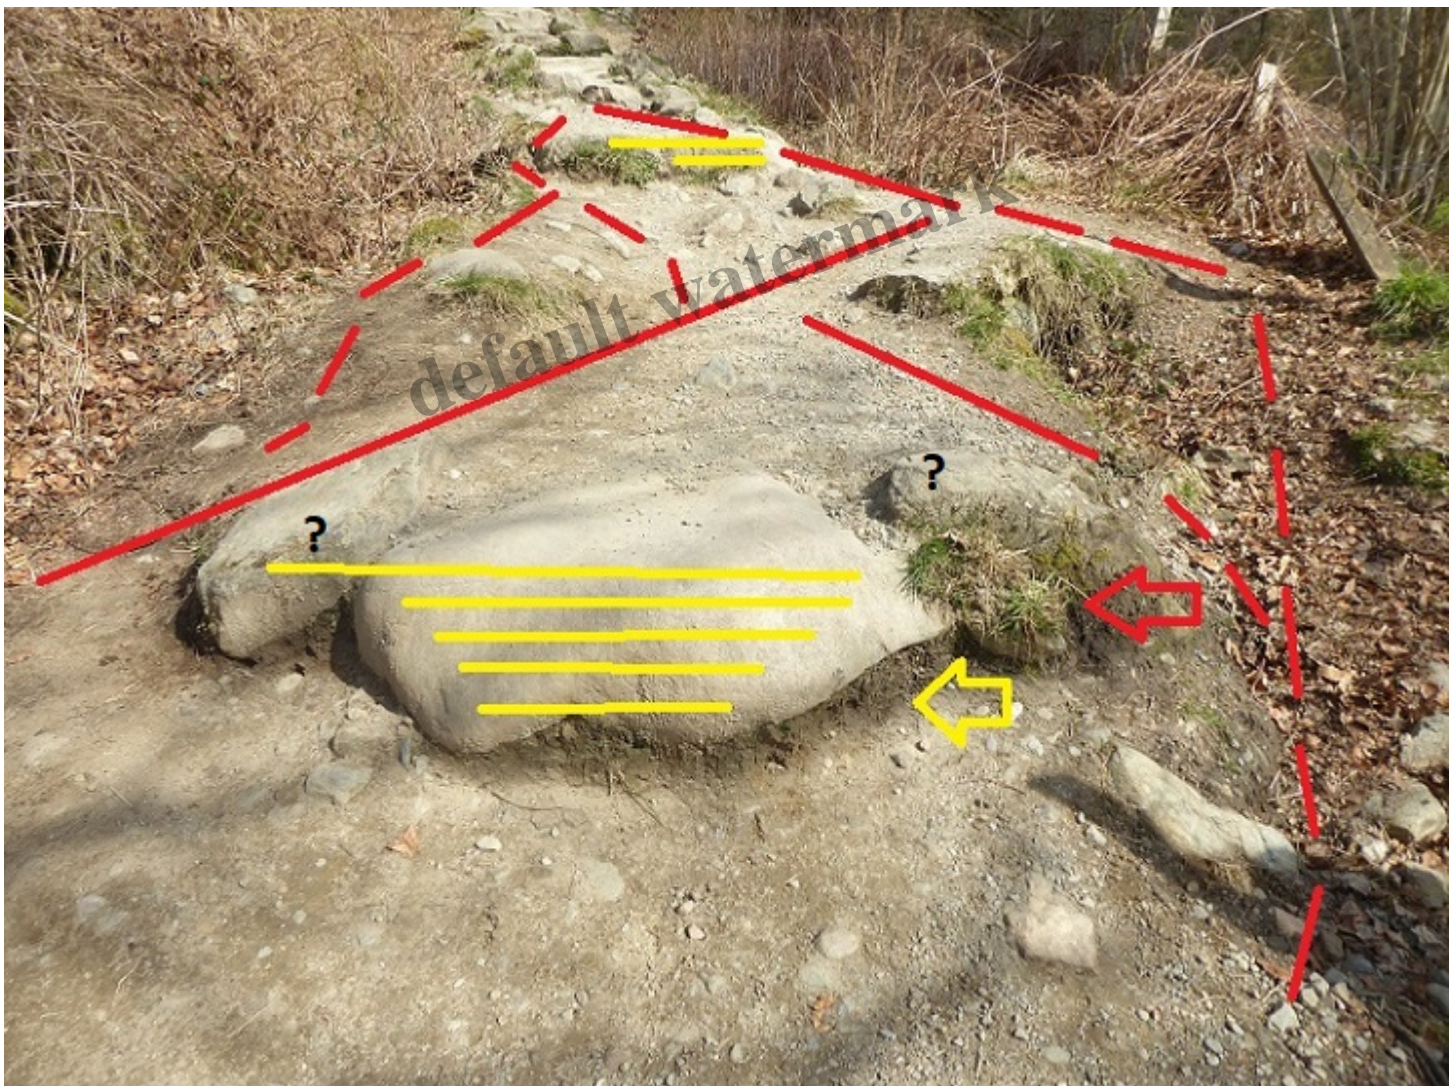
In the example above, further design and construction flaws are apparent. The rounded nature of the large bottom step means that people have to stretch up even further to get a secure footing and in the wet few are likely to trust the smooth surface. If the rocks on either side, highlighted with a question mark, were intended to direct people to the step, they have failed completely: they are clearly worn by

boots and some people are now walking over them in preference to taking the main step.

The damp earth below the boulder, marked by the yellow arrow, suggests it has only recently been exposed to the air by erosion of the ground below as it has not yet dried out. When it does, it is likely to crumble away gradually, a process which will in time leave the boulder unsupported. The red arrow shows where people have stepped on a clod of grass in preference to the step and how it too is gradually eroding away: once it does there will be nothing to stop the pebbles above from being washed over the step speeding up the erosion process further.

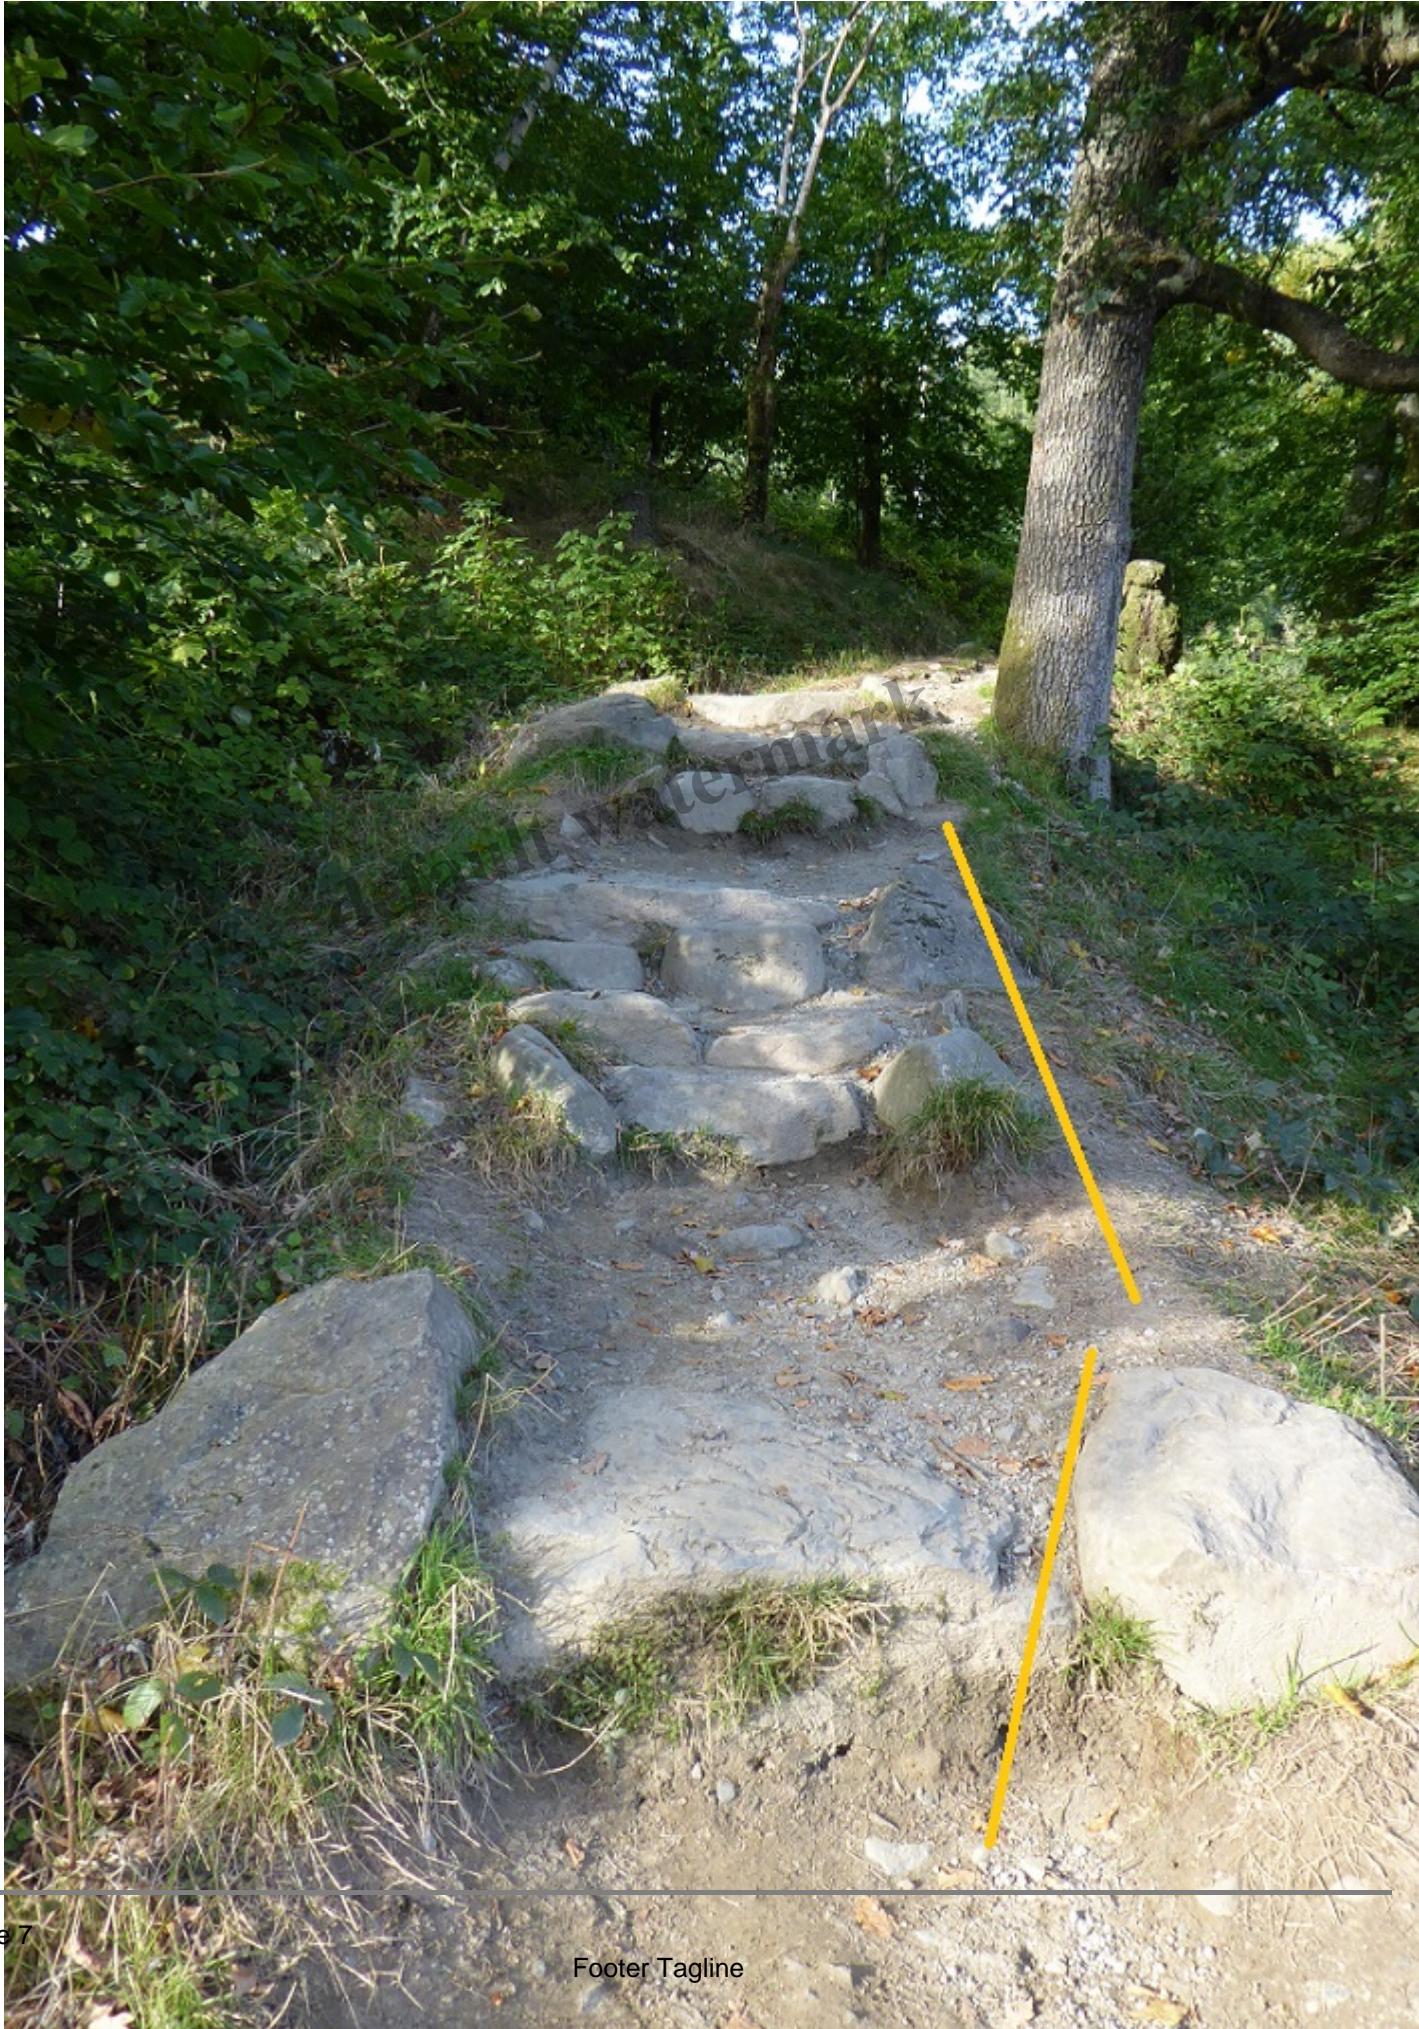
October 2020

The speed with which the new path has failed to serve its intended purpose is illustrated by comparing the photo above with that below. Two and a half years ago some people were taking the rather awkward route marked by the yellow lines to avoid the step.

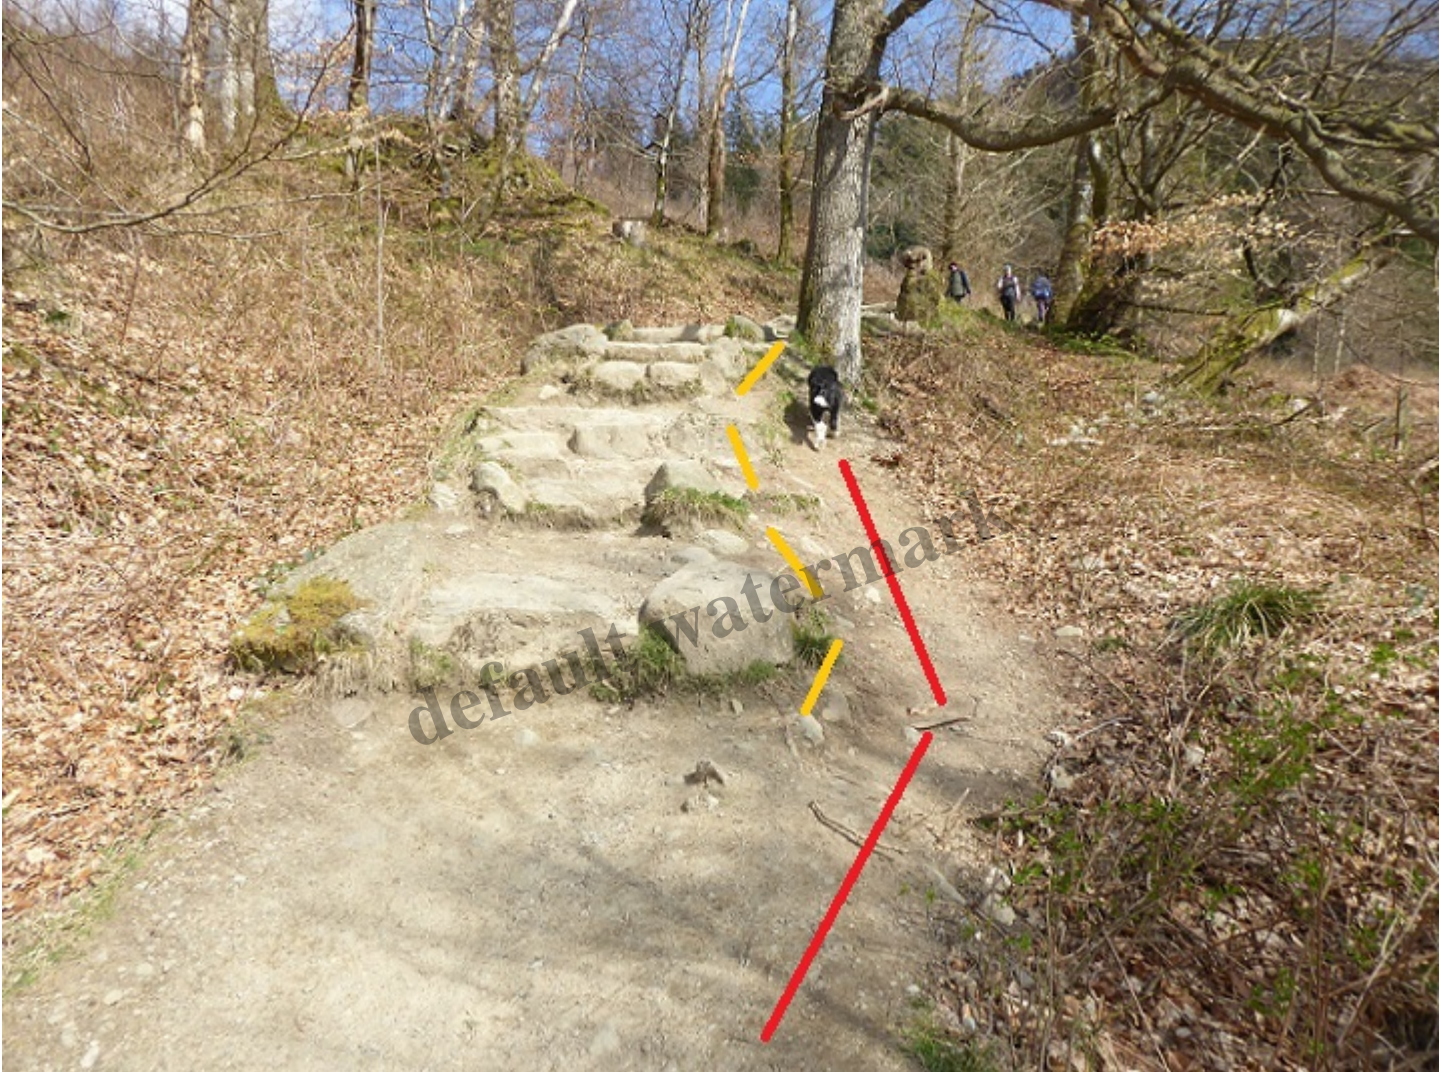
Since then that route, which I have marked with the dashed yellow line, has been more or less abandoned and replaced by a new path below taken by the dog and marked by the red line. Humans are like animals and tend to take the easiest route! Looking at the first photo, this might have seemed an unlikely line but once people started trampling over vegetation to avoid the steps, the red line quickly developed into the preferred route.

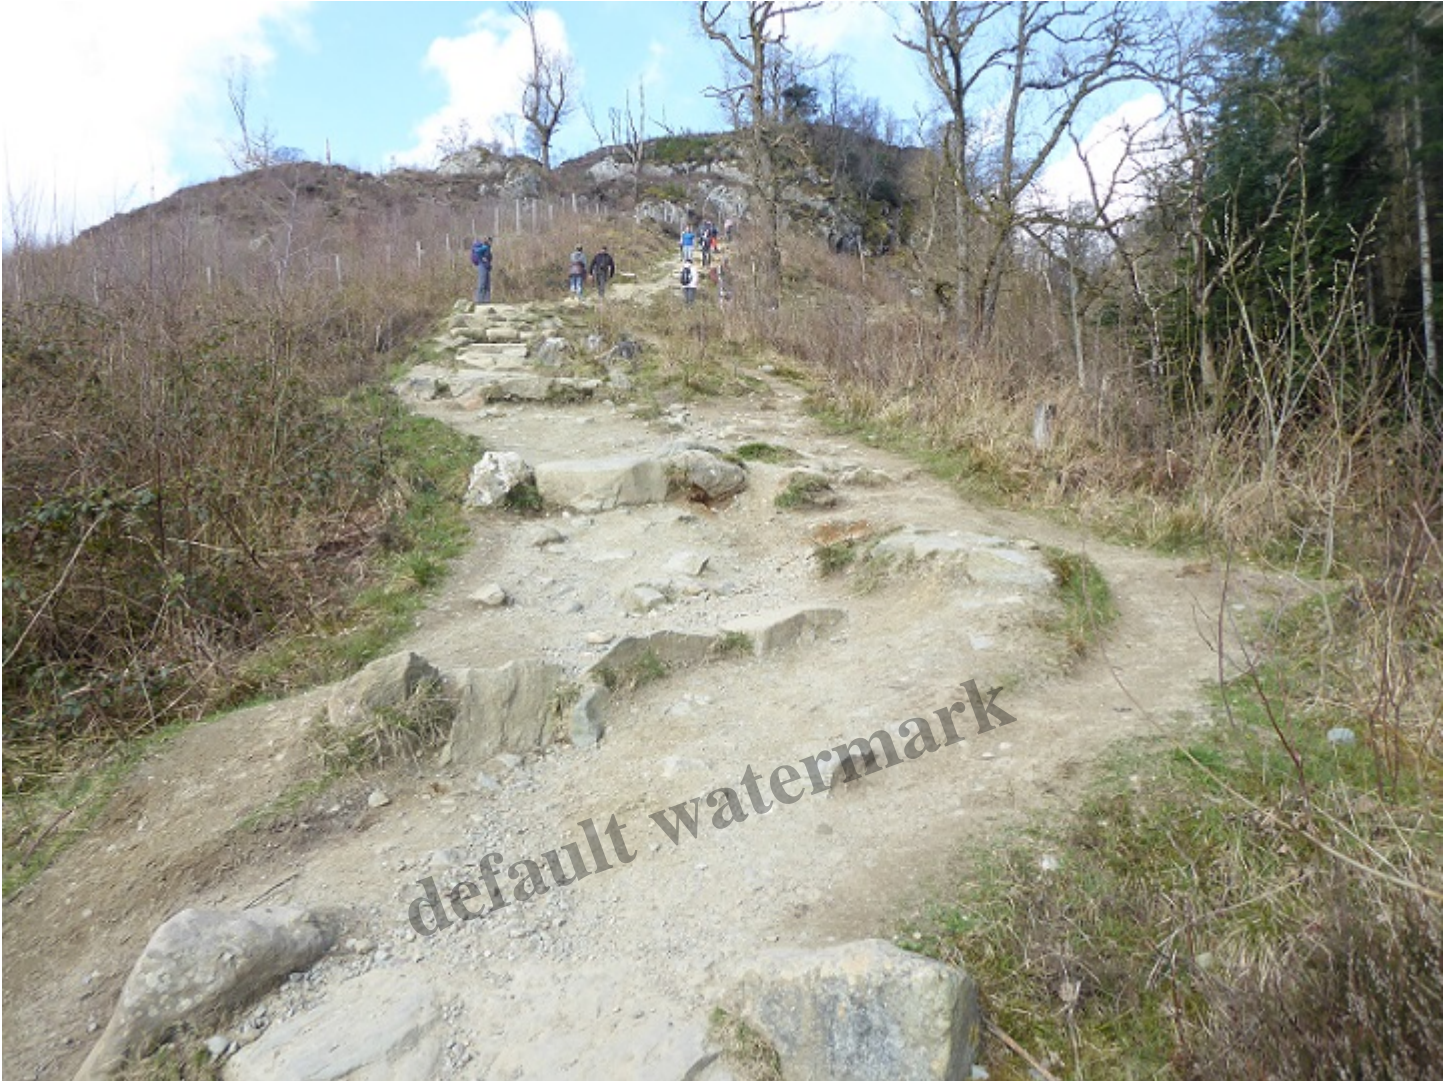
Higher up the hill, where the route is less constrained, people have been able to take longer diversions to avoid the steps spreading the erosion further.

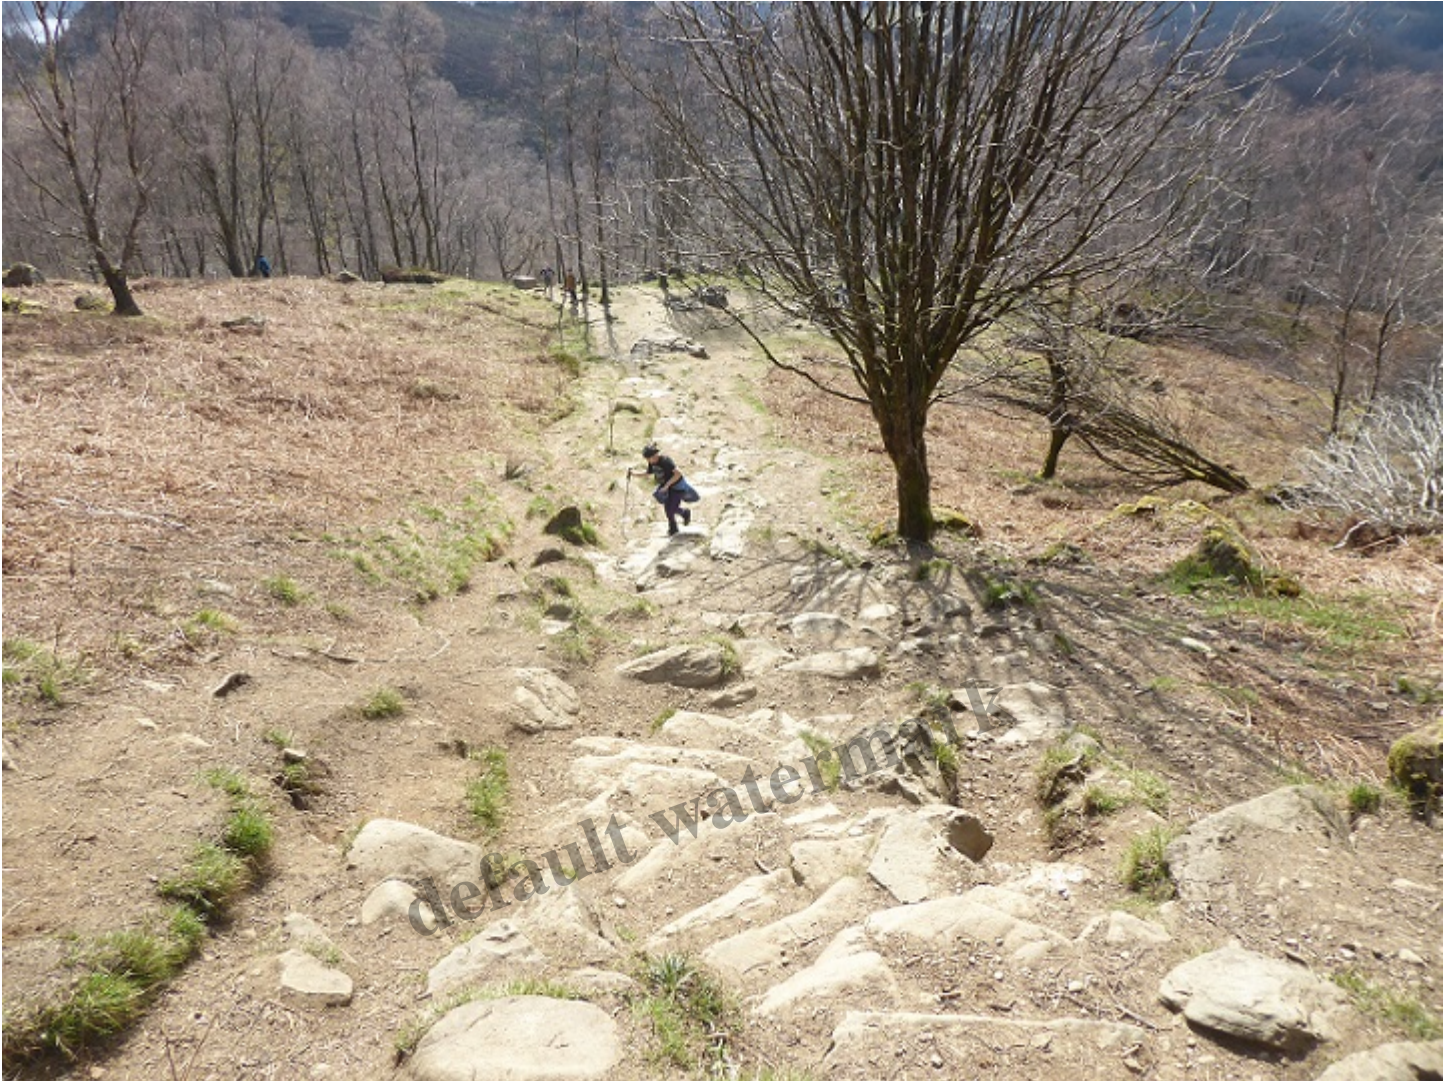
Even on the final third of the path, which ascends a fairly steep slope, people have been avoiding the steps where possible. This illustrates that designing and building a path that people will use on such ground is a skilled process. Unfortunately it appears that neither FLS nor the contractor had the skills necessary. A wasted opportunity and a wasted investment.

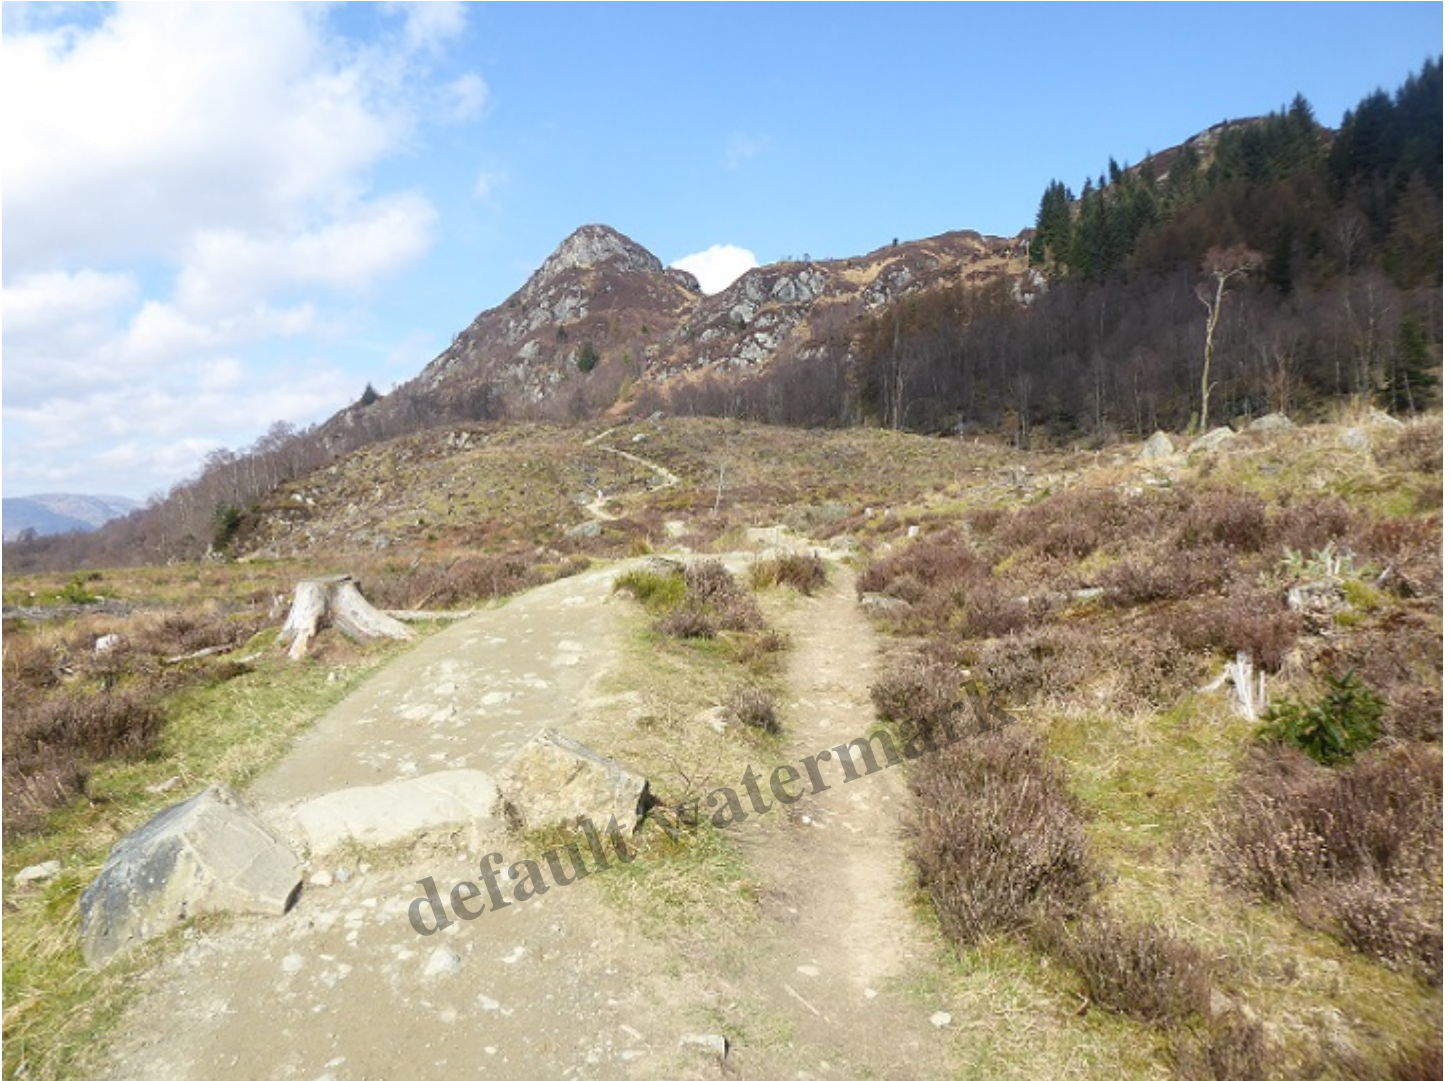
The problems are also apparent on the middle section of the path, which is gently rolling and has relatively few steps. Put them in the wrong place, however, leave a short cut and people will stop using what is otherwise a reasonably designed section of path.

These design problems are being made worse as a result of a lack of maintenance by FLS. There is no point having drains across the path if water is able to flow over them. I could see no signs of maintenance, let alone of any remedial action to fix some of the design flaws. It would be easy enough, for example, to place a couple of felled tree trunks across the shortcut in the photo (two) above.

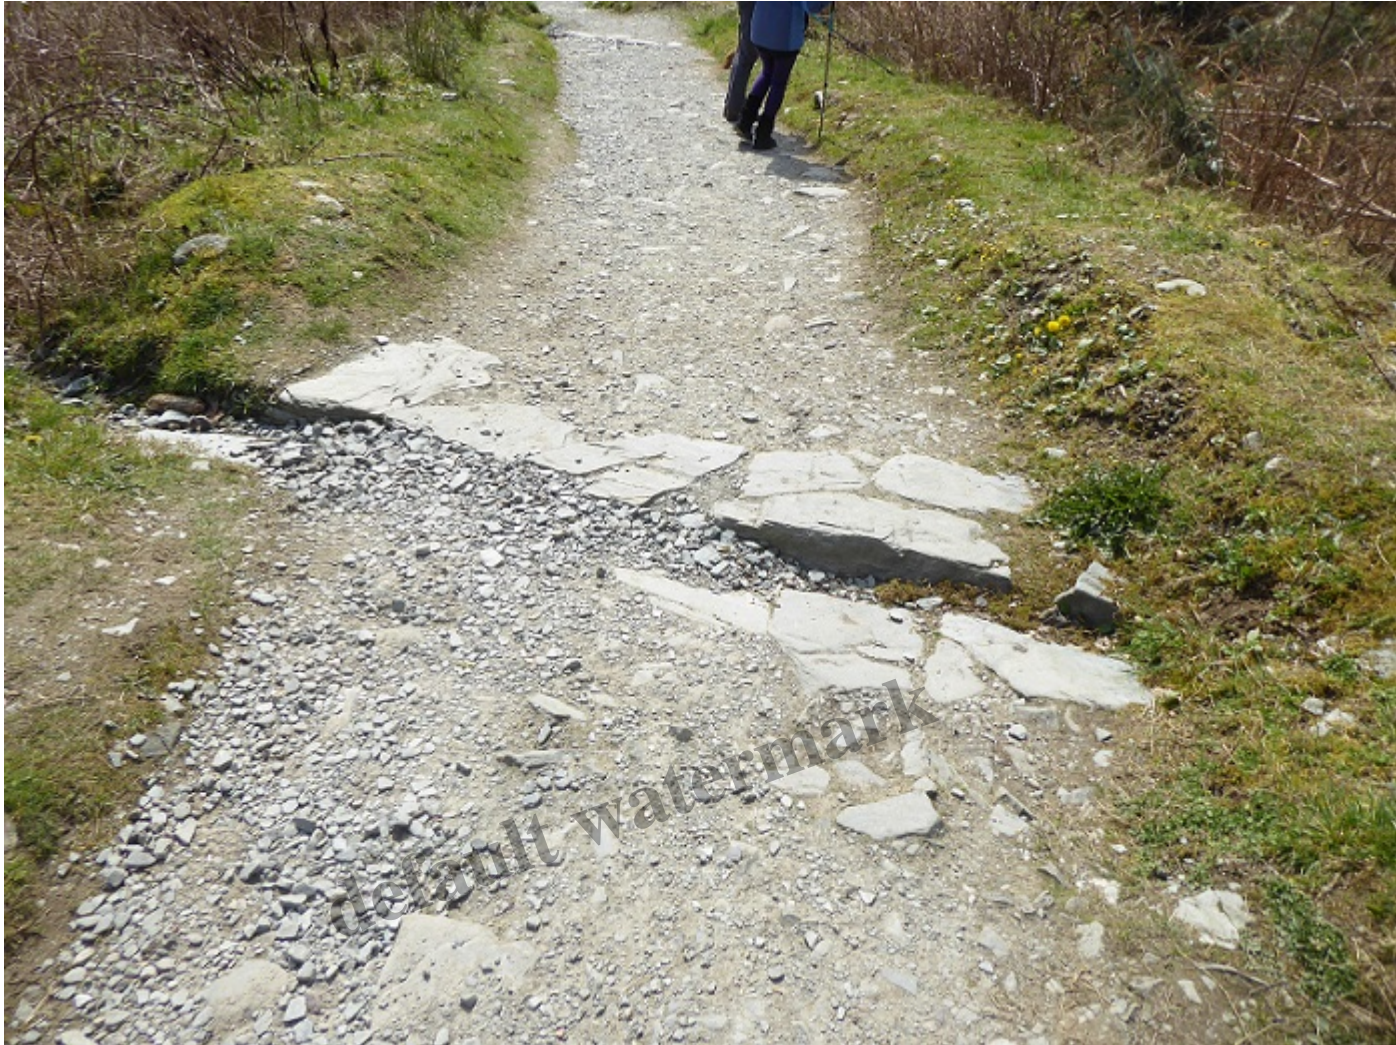
Cross drain clogged up with eroded material

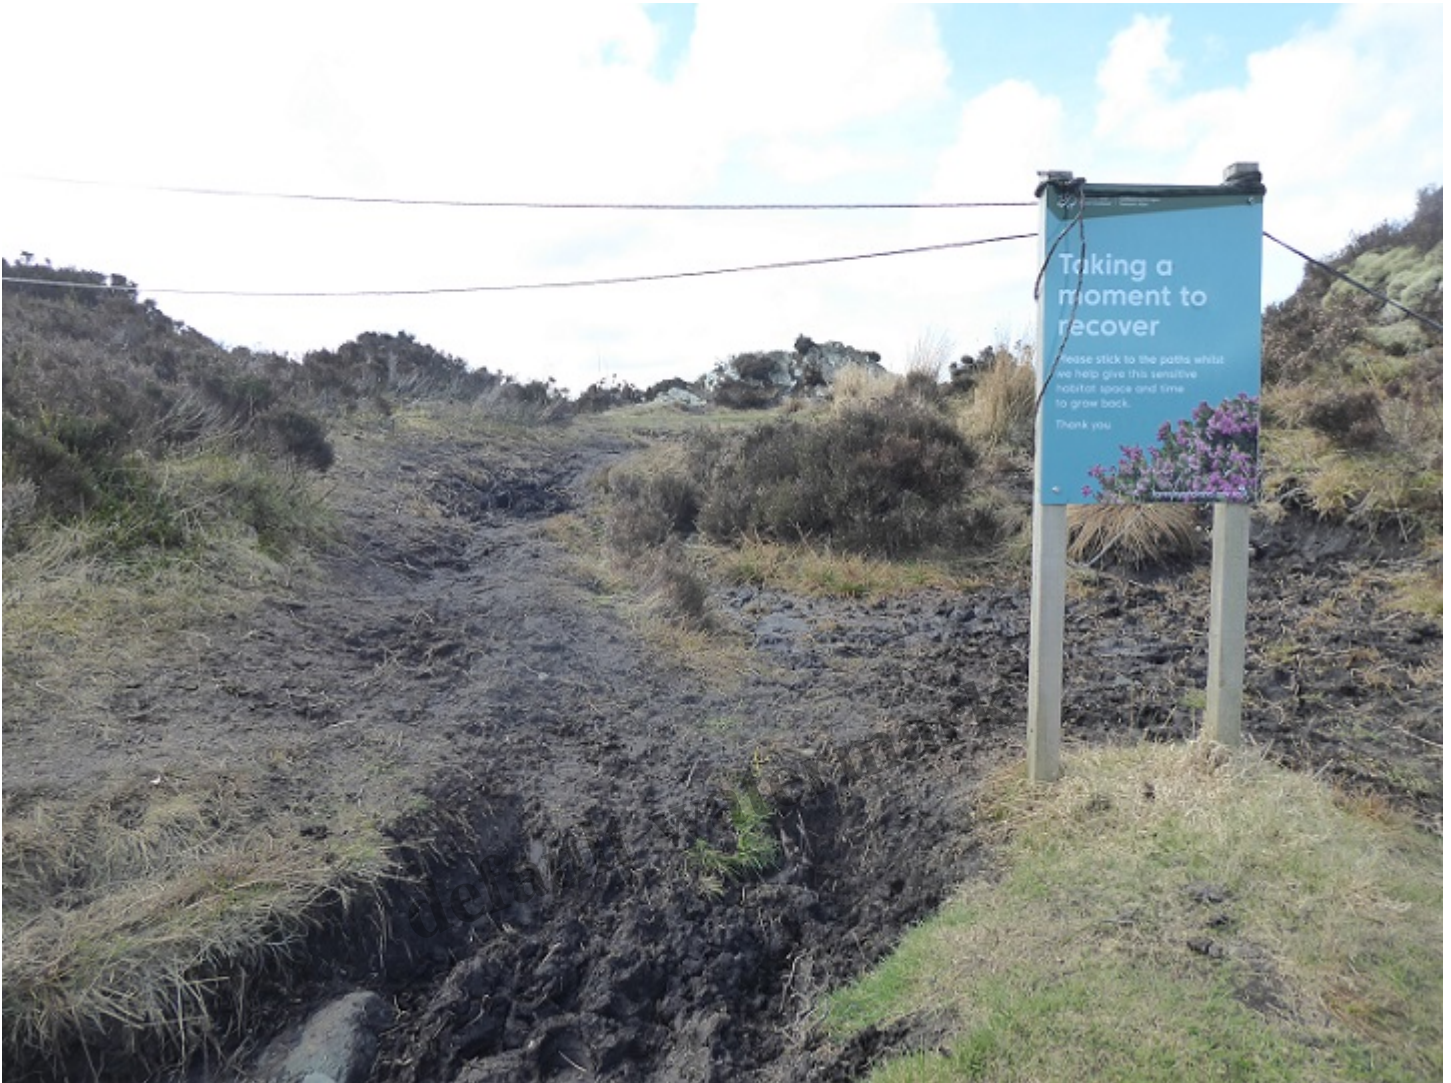
Near the summit of Ben A'An was this sign asking people to keep off what it described as "sensitive habitat". One could question whether this heathery habitat is any more sensitive than that being eroded below, where there were no such signs. But the message wasn't working and for good reason: 20m beyond the sign are fantastic views out across Loch Katrine and people want to enjoy these.

If FLS wanted to reduce the area of ground that is being eroded they could do so quite easily with a bit of judicious path work funded by some of the £1000s they are collecting from the Ben A'An car park. It is cheaper, however, to virtue signal with an occasional sign. That appears to be about as redundant as much of the path below.
