## Forest and Land Scotland's failed path but flourishing woodland at Ben A'an revisited

## The state of the tourist path up Ben Aân

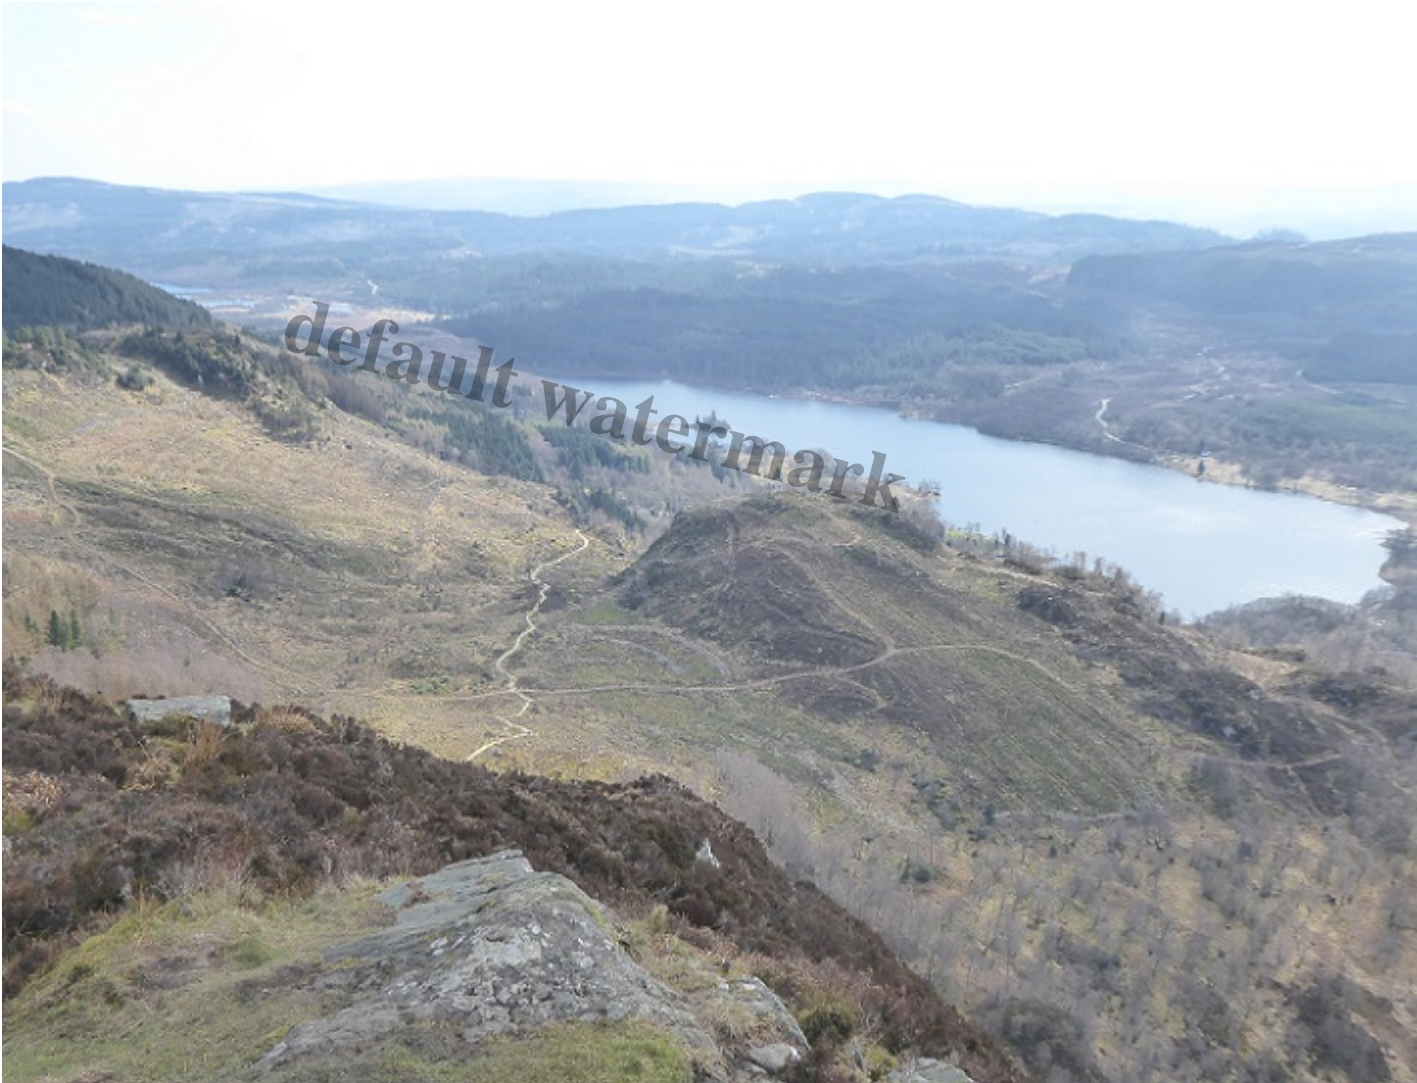
View down the middle and flatter section of the tourist path up Ben A'an where there is potential to promote other paths to help spread the load

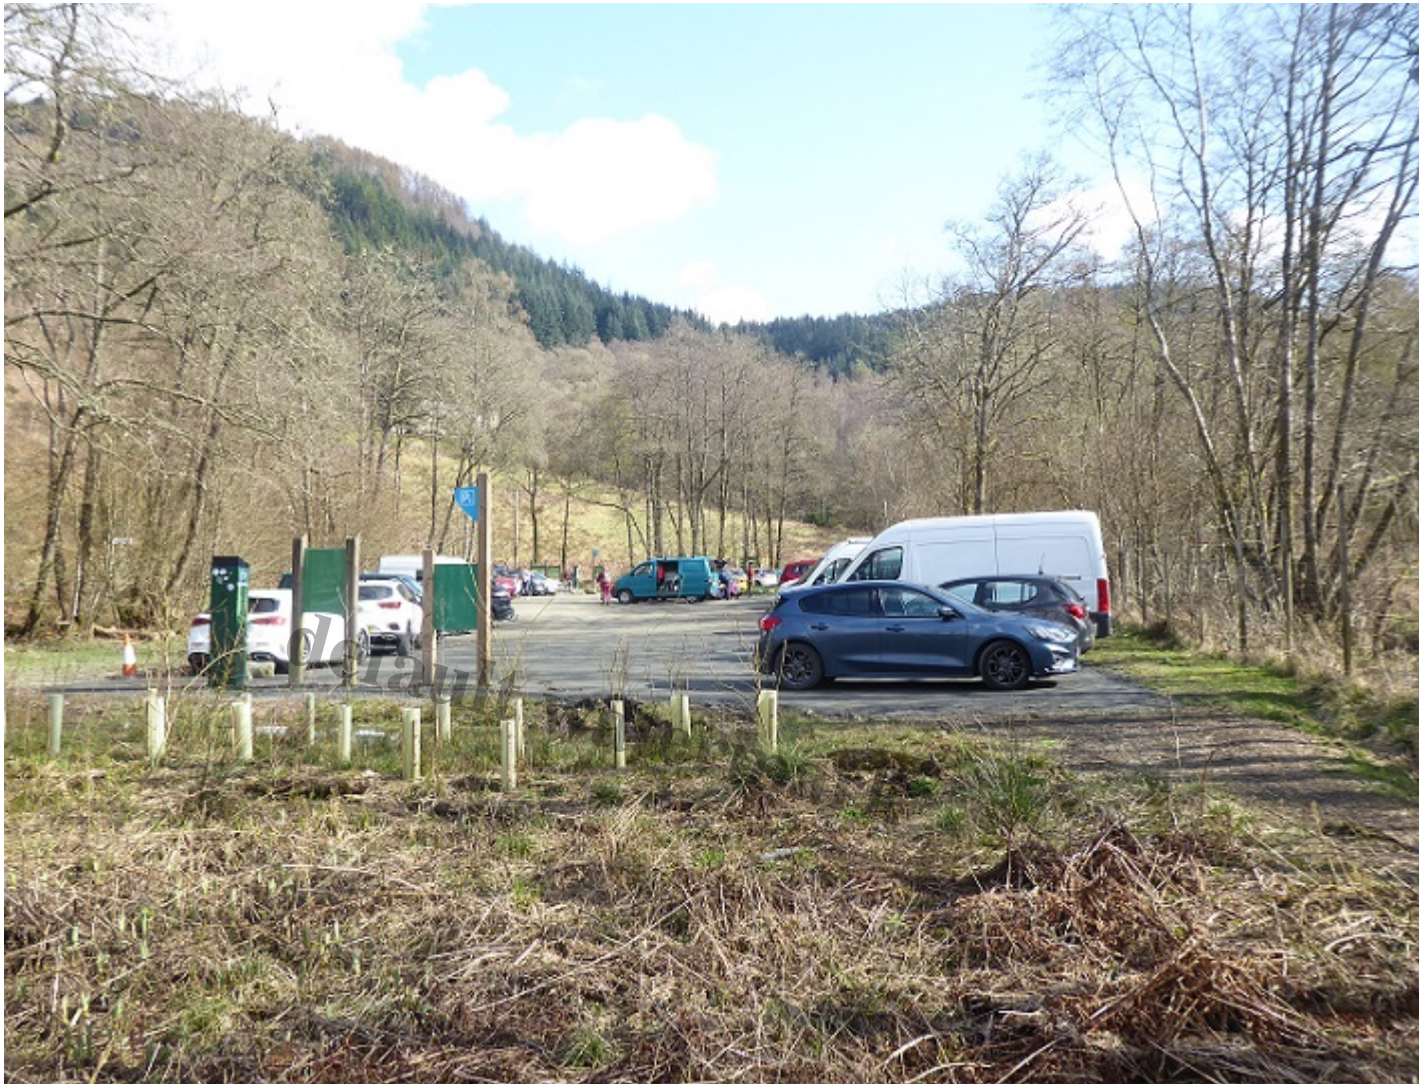
The car park has been extended by 26 places onto what was marshy ground (foreground) on the shore of Loch Achray, part of the River Teith Special Area of Conservation. Note the sapling in front (left) of the plastic tree tubes.

Having required an assessment of the impacts that an expanded car park might have on the Special Area of Conservation (SAC) and concluded these could be mitigated (the car park has been expanded onto an area of rank vegetation - photo in my previous post), Loch Lomond and Trossachs National Park Authority (LLTNPA) planning staff allowed FLS to use polluting plastic tree tubes right next to what is supposed to be a highly protected freshwater system. The photo above and the regenerating scrub on either side of the car park shows that was completely unnecessary.

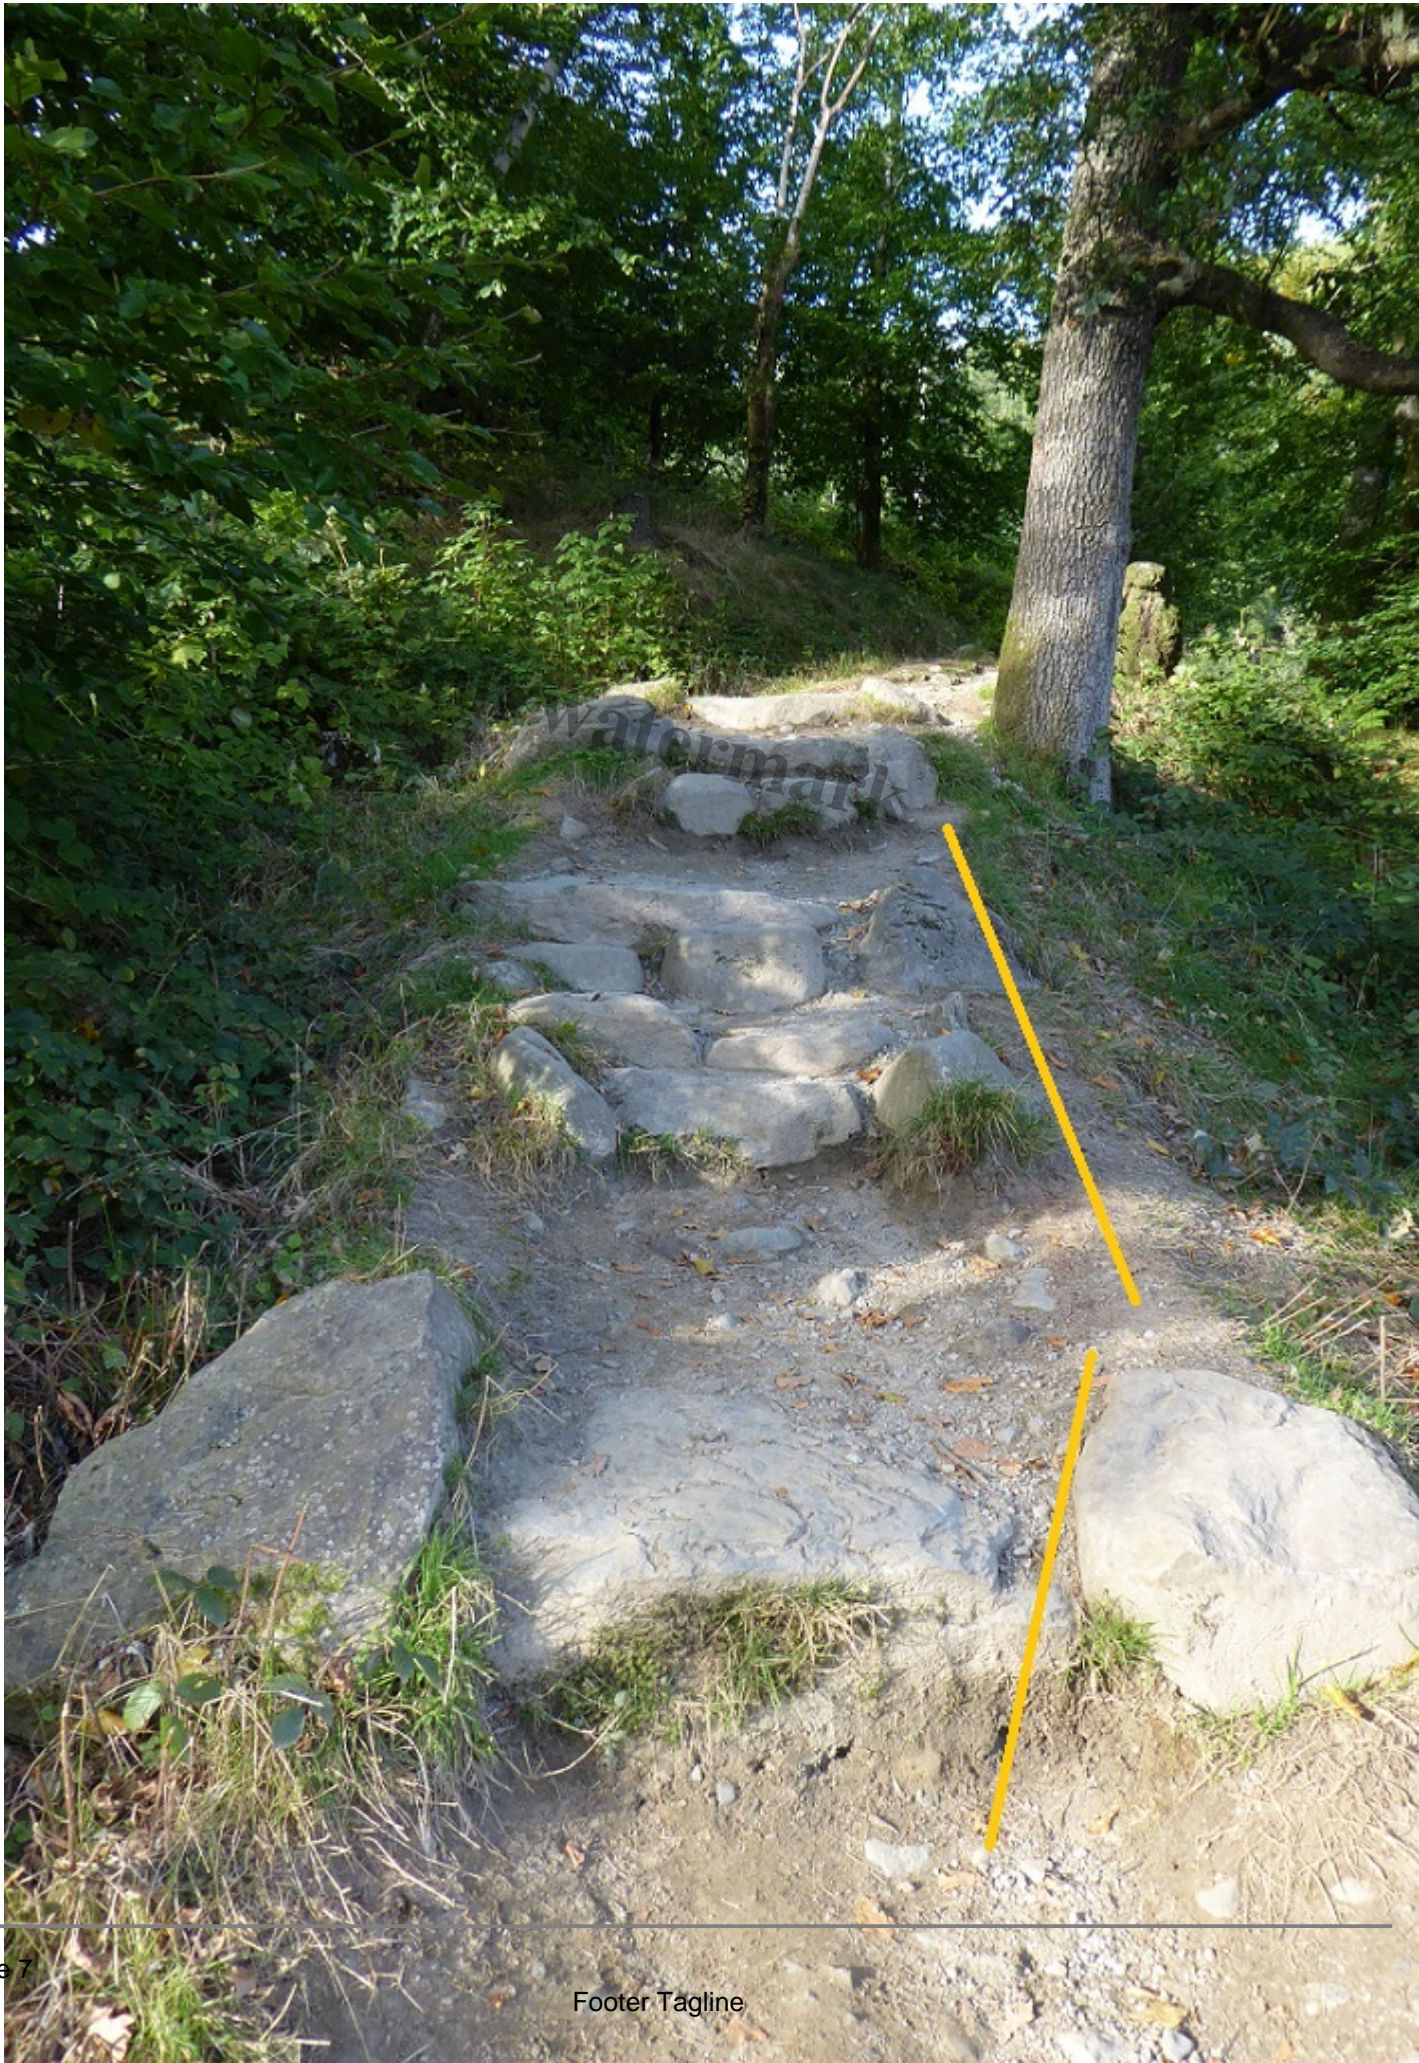
October 2020

The speed with which the new path has failed to serve its intended purpose is illustrated by comparing the photo above with that below. Two and a half years ago some people were taking the rather awkward route marked by the yellow lines to avoid the step.

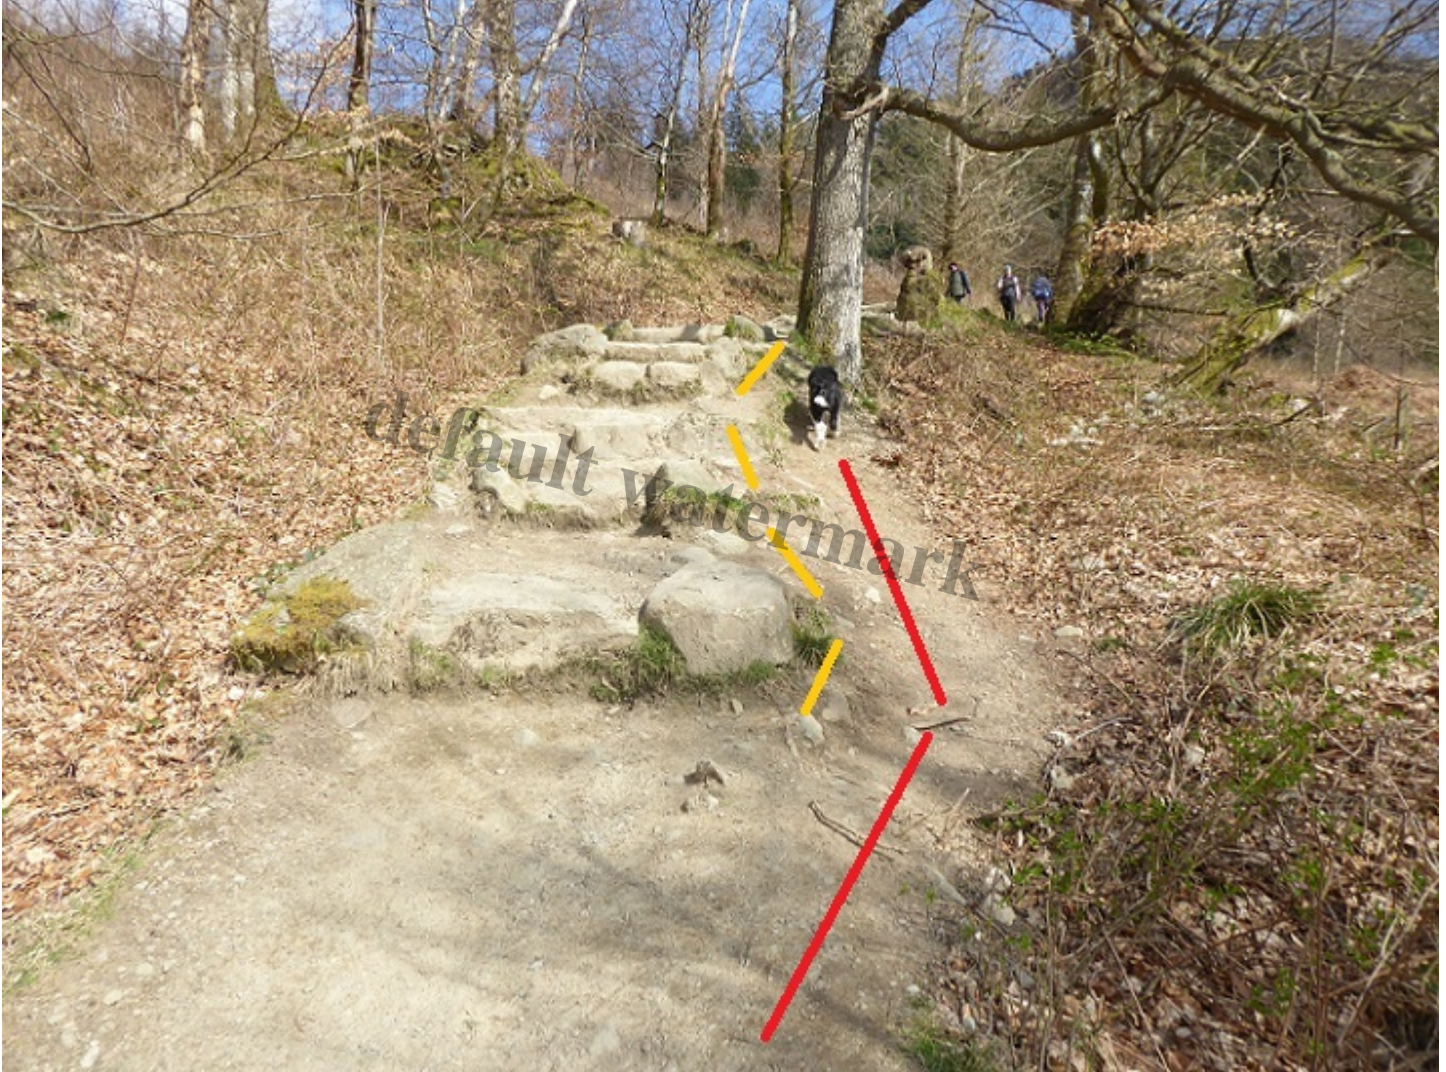
Since then that route, which I have marked with the dashed yellow line, has been more or less abandoned and replaced by a new path below taken by the dog and marked by the red line. Humans are like animals and tend to take the easiest route! Looking at the first photo, this might have seemed an unlikely line but once people started trampling over vegetation to avoid the steps, the red line quickly developed into the preferred route.

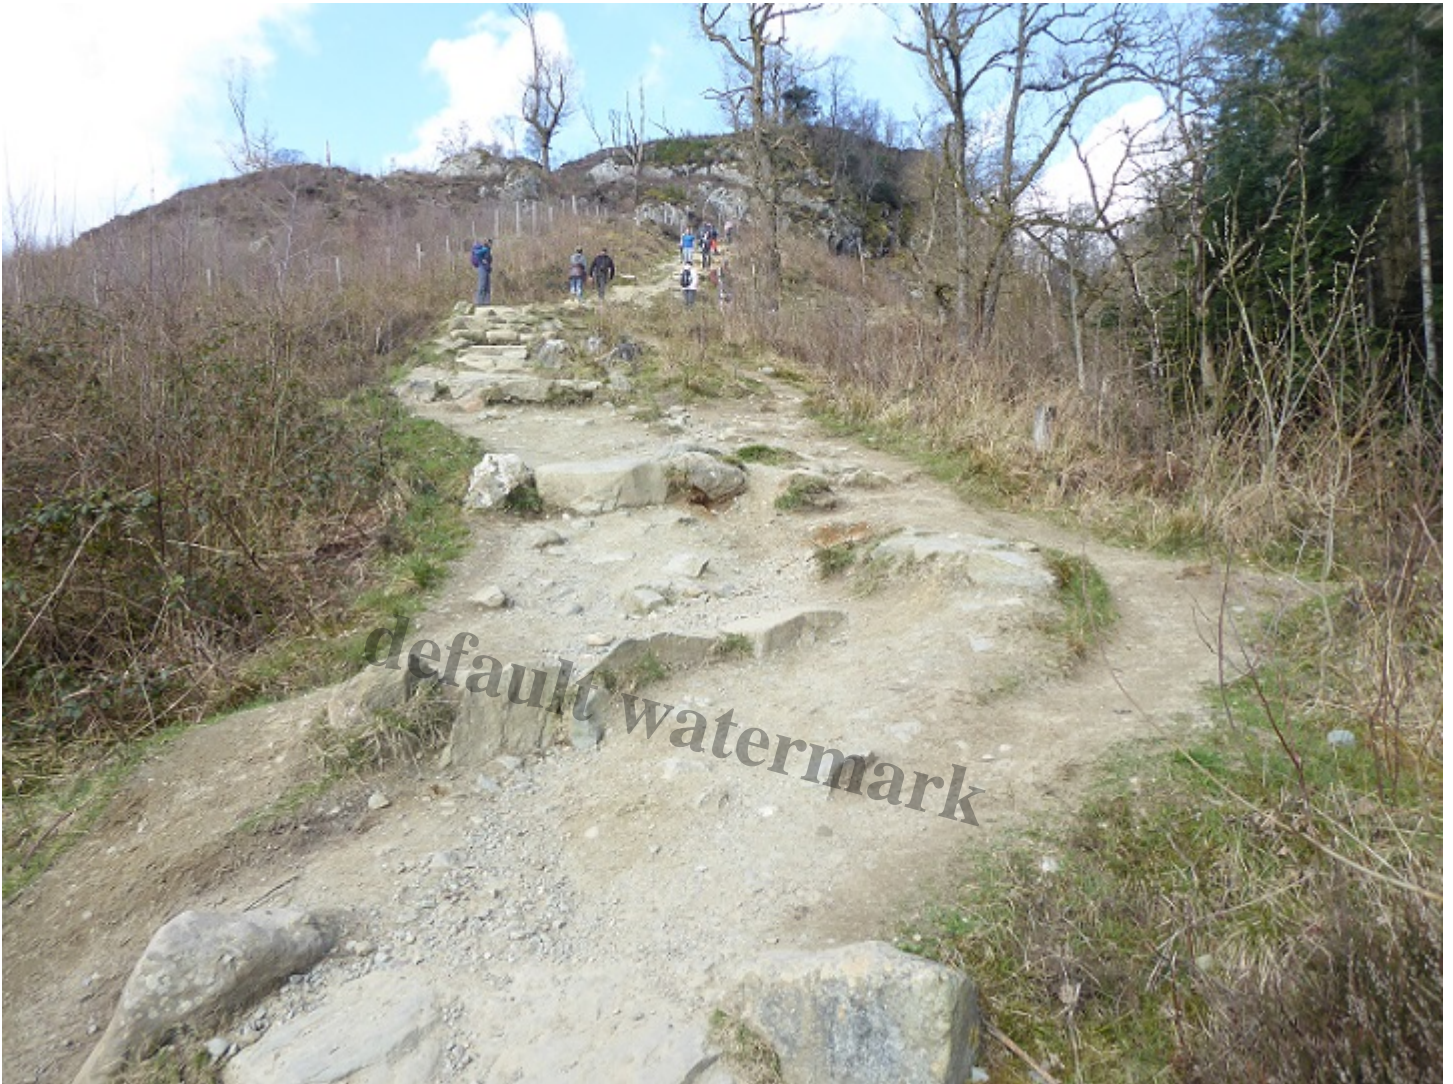
Higher up the hill, where the route is less constrained, people have been able to take longer diversions to avoid the steps spreading the erosion further.

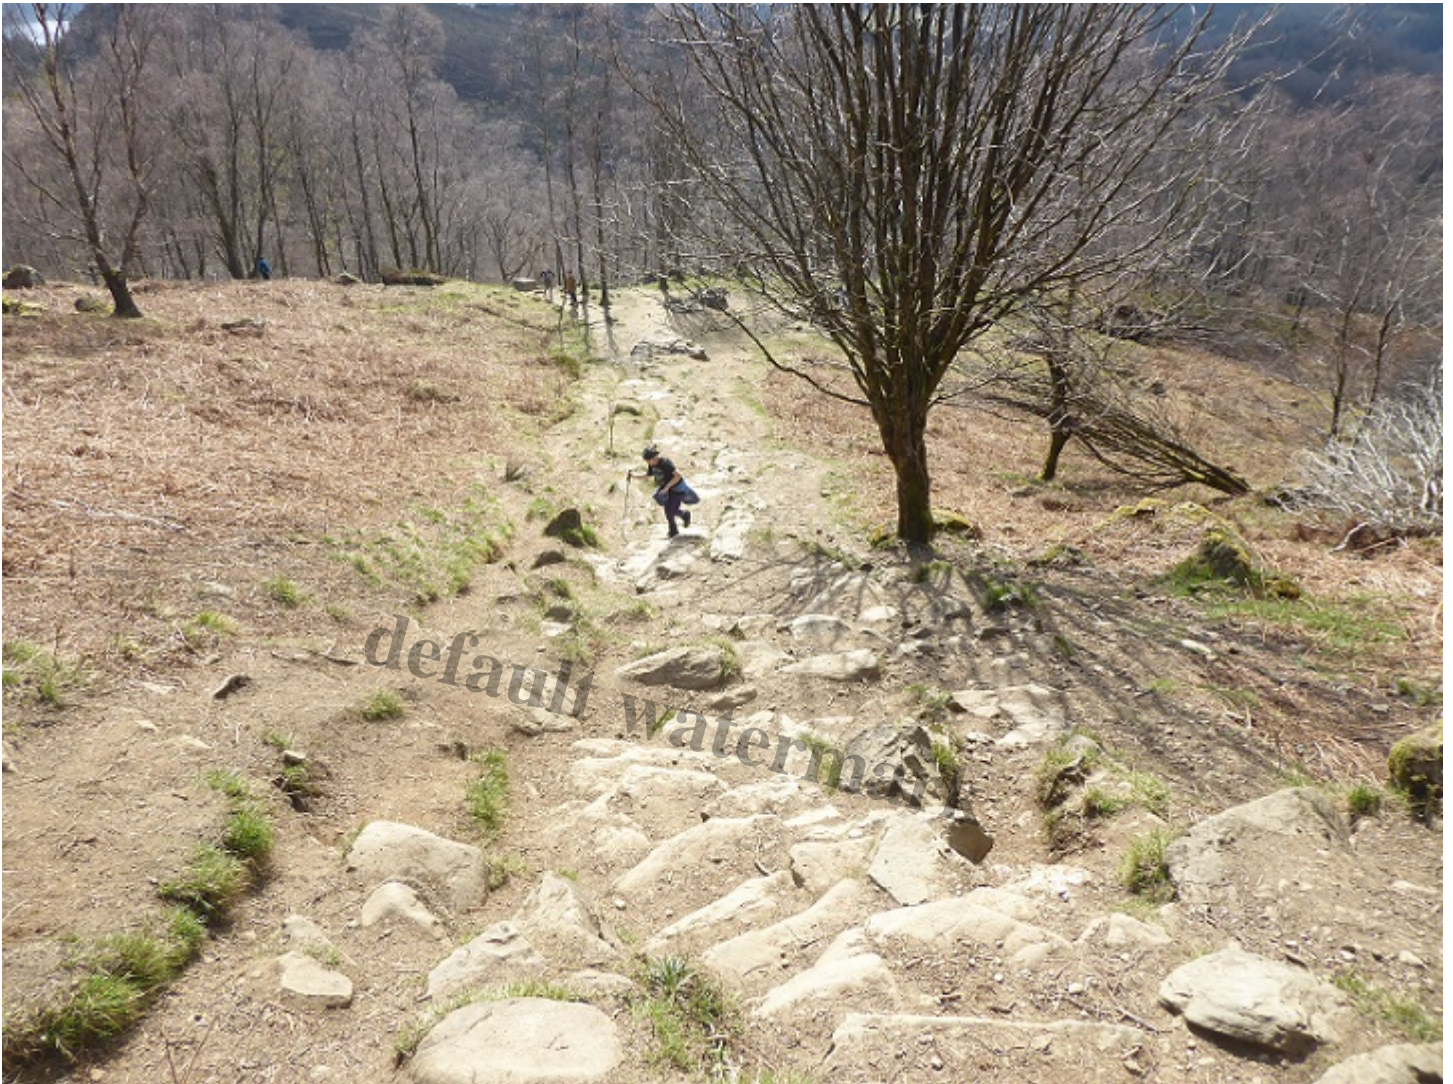
Even on the final third of the path, which ascends a fairly steep slope, people have been avoiding the steps where possible. This illustrates that designing and building a path that people will use on such ground is a skilled process. Unfortunately it appears that neither FLS nor the contractor had the skills necessary. A wasted opportunity and a wasted investment.

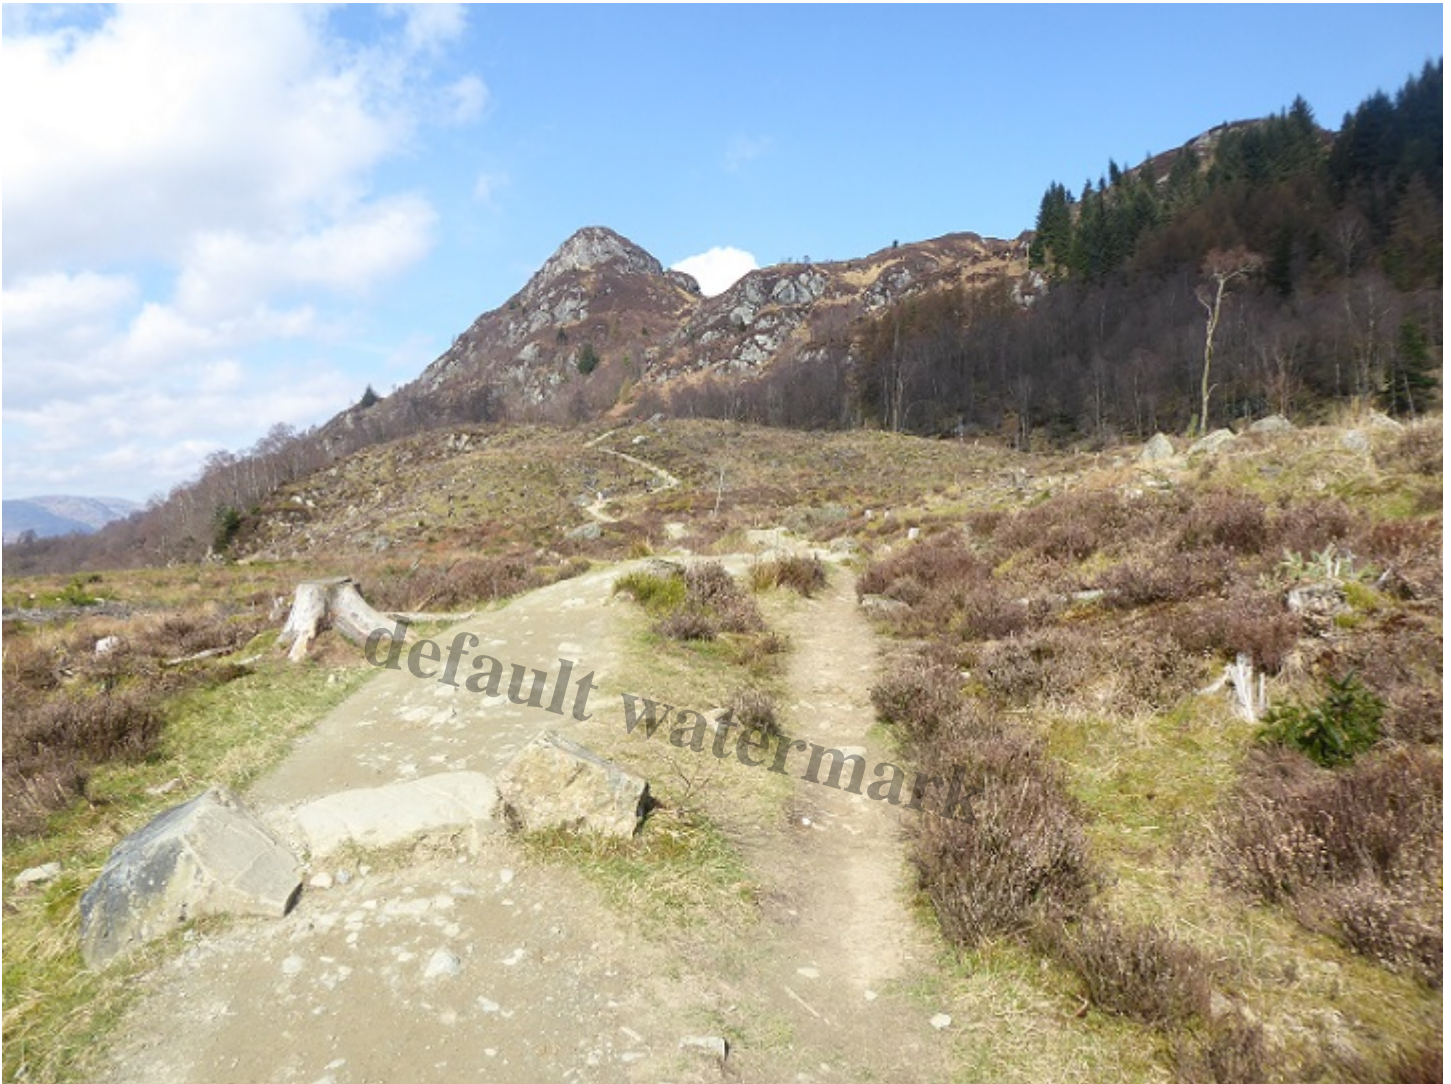
The problems are also apparent on the middle section of the path, which is gently rolling and has relatively few steps. Put them in the wrong place, however, leave a short cut and people will stop using what is otherwise a reasonably designed section of path.

These design problems are being made worse as a result of a lack of maintenance by FLS. There is no point having drains across the path if water is able to flow over them. I could see no signs of maintenance, let alone of any remedial action to fix some of the design flaws. It would be easy enough, for example, to place a couple of felled tree trunks across the shortcut in the photo (two) above.

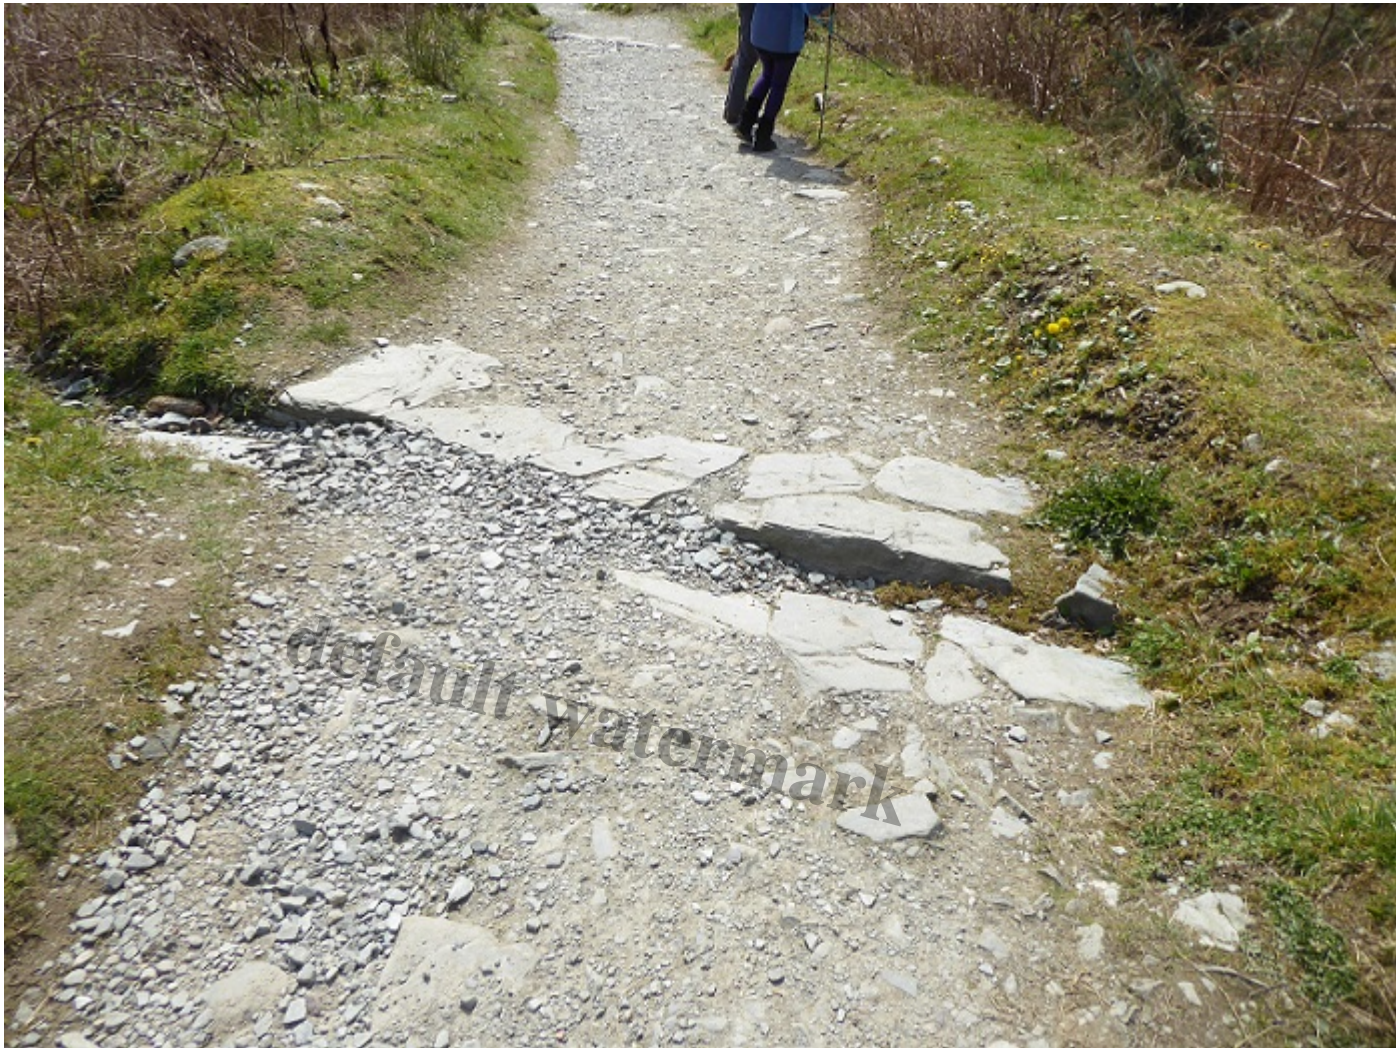
Cross drain clogged up with eroded material

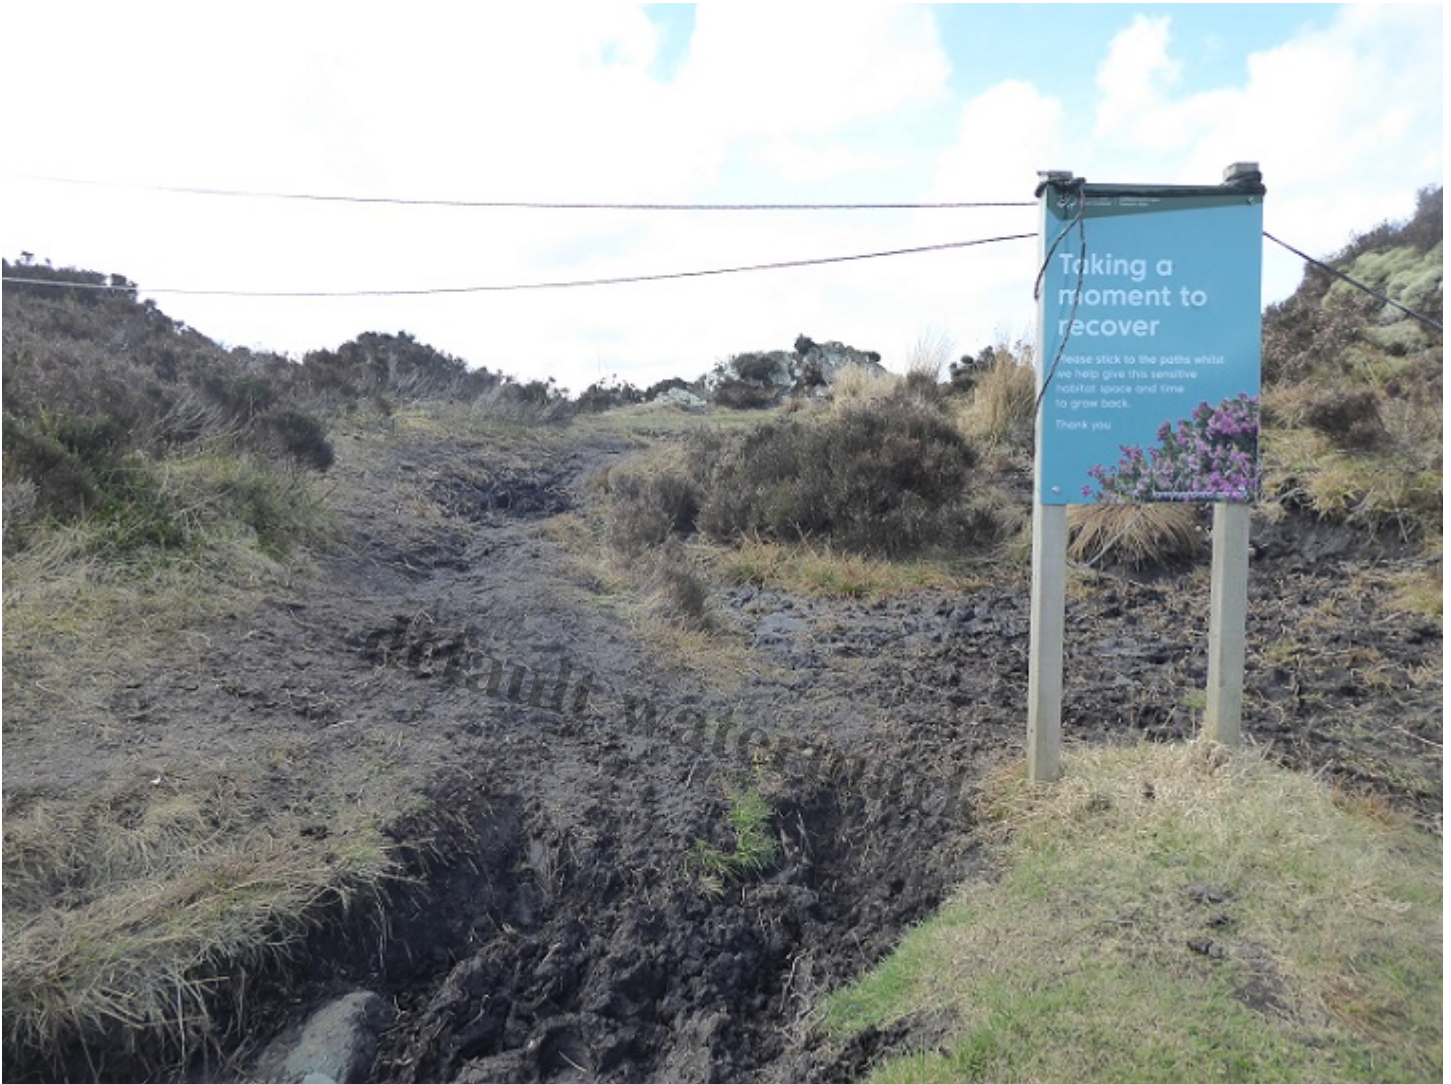
Near the summit of Ben Aonach was this sign asking people to keep off what it described as a sensitive habitat. One could question whether this heathery habitat is any more sensitive than that being eroded below, where there were no such signs. But the message wasn't working and for good reason: 20m beyond the sign are fantastic views out across Loch Katrine and people want to enjoy these.

If FLS wanted to reduce the area of ground that is being eroded they could do so quite easily with a bit of judicious path work funded by some of the £1000s they are collecting from the Ben Aonach car park. It is cheaper, however, to virtue signal with an occasional sign. That appears to be about as redundant as much of the path below.

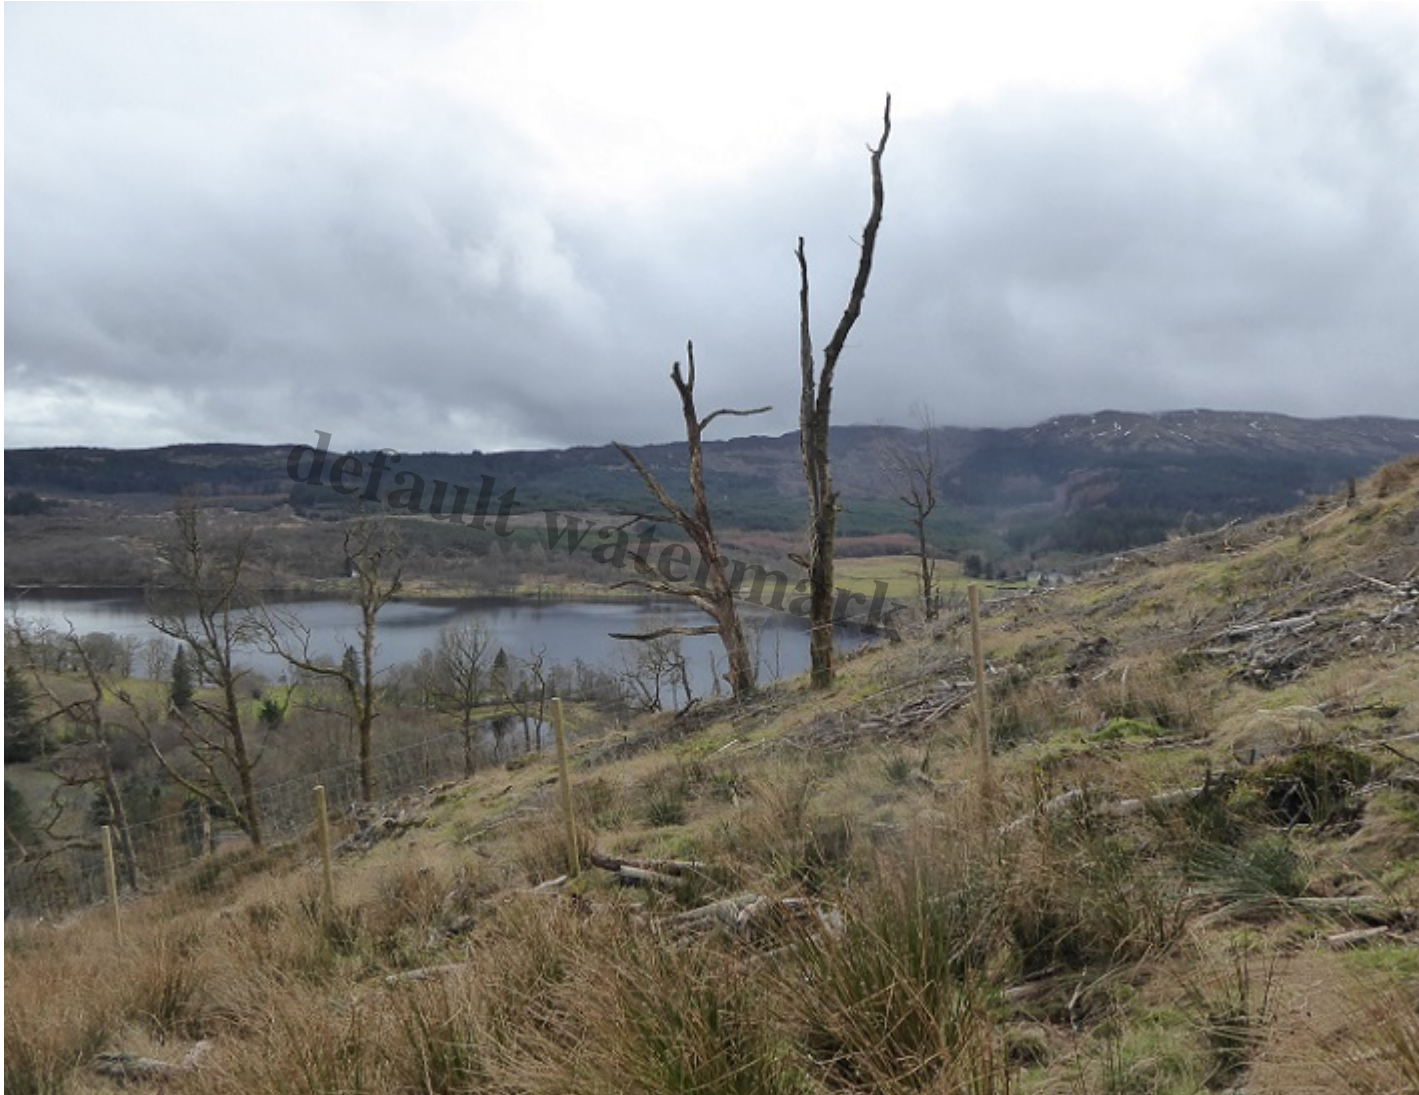
The landscape impact was brutal:

Note the deer fence

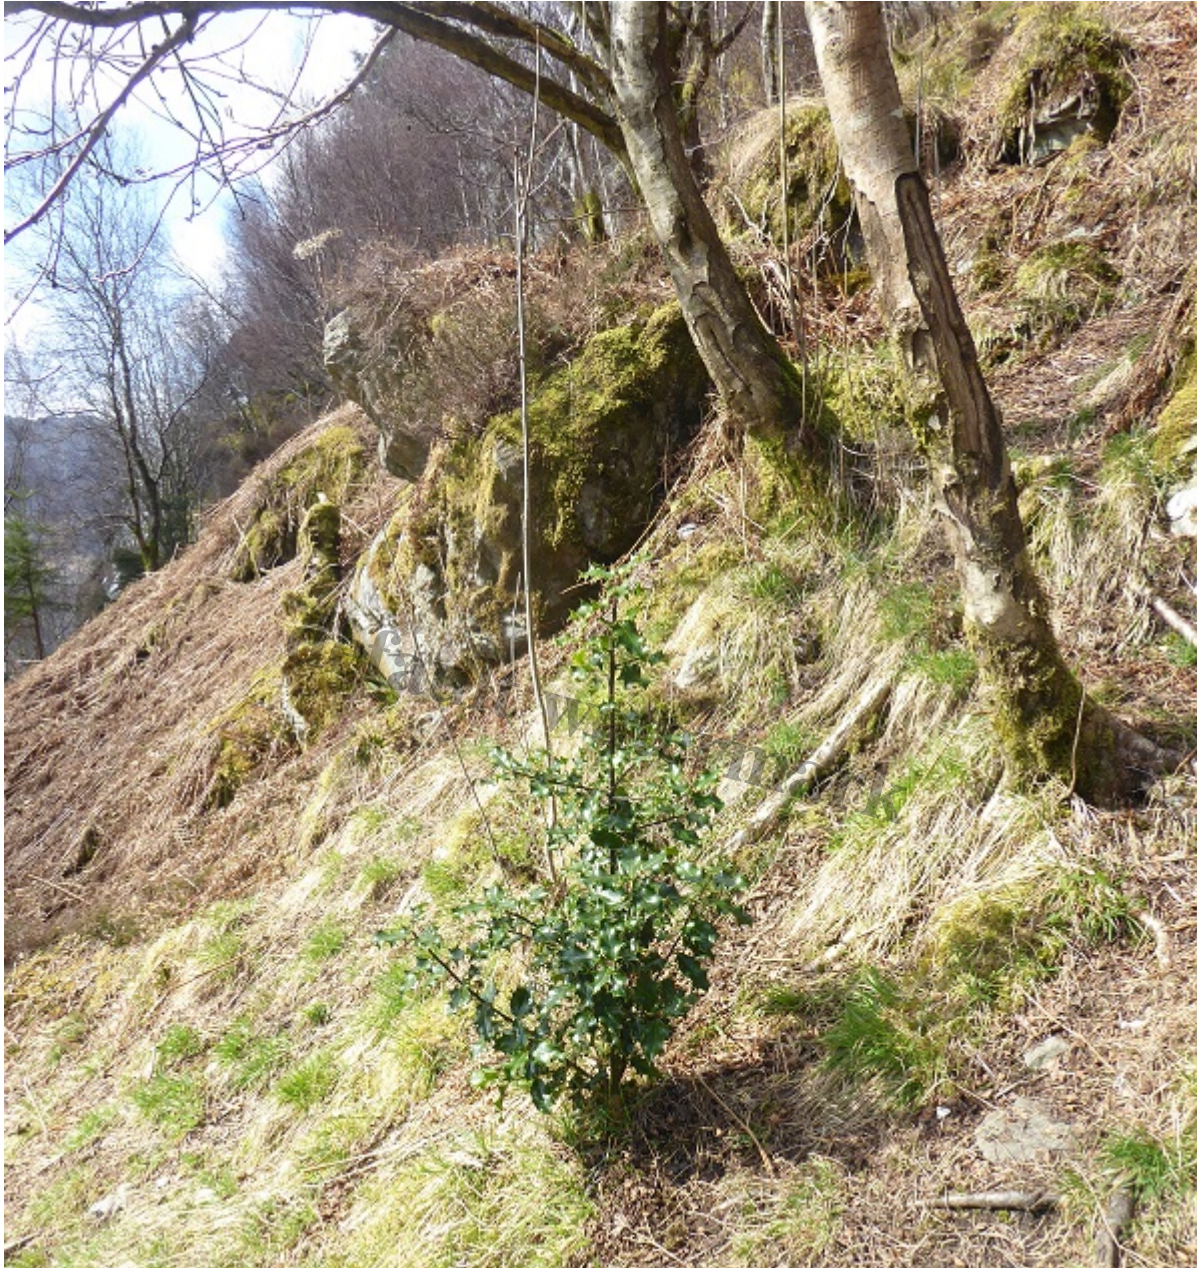
Holly, a species particularly susceptible to grazing, unbrowsed with regenerating birch (?) saplings behind

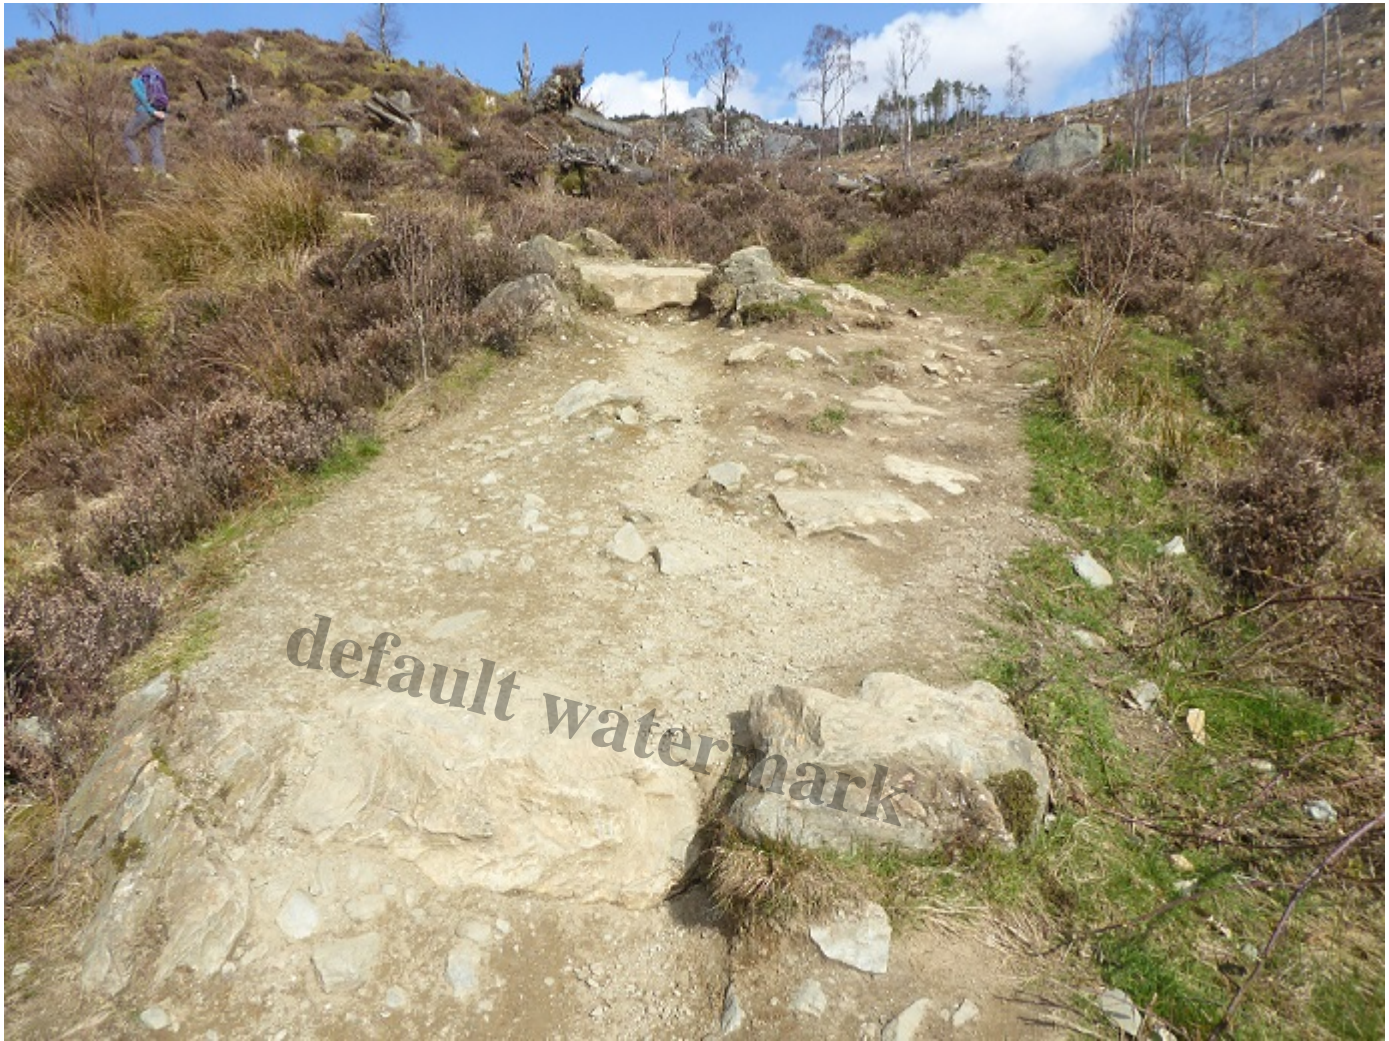
Regenerating birch on both side of path just below the now isolated steps

In the medium term the growth of trees may also serve to restrict the area around the path that is being eroded by feet.

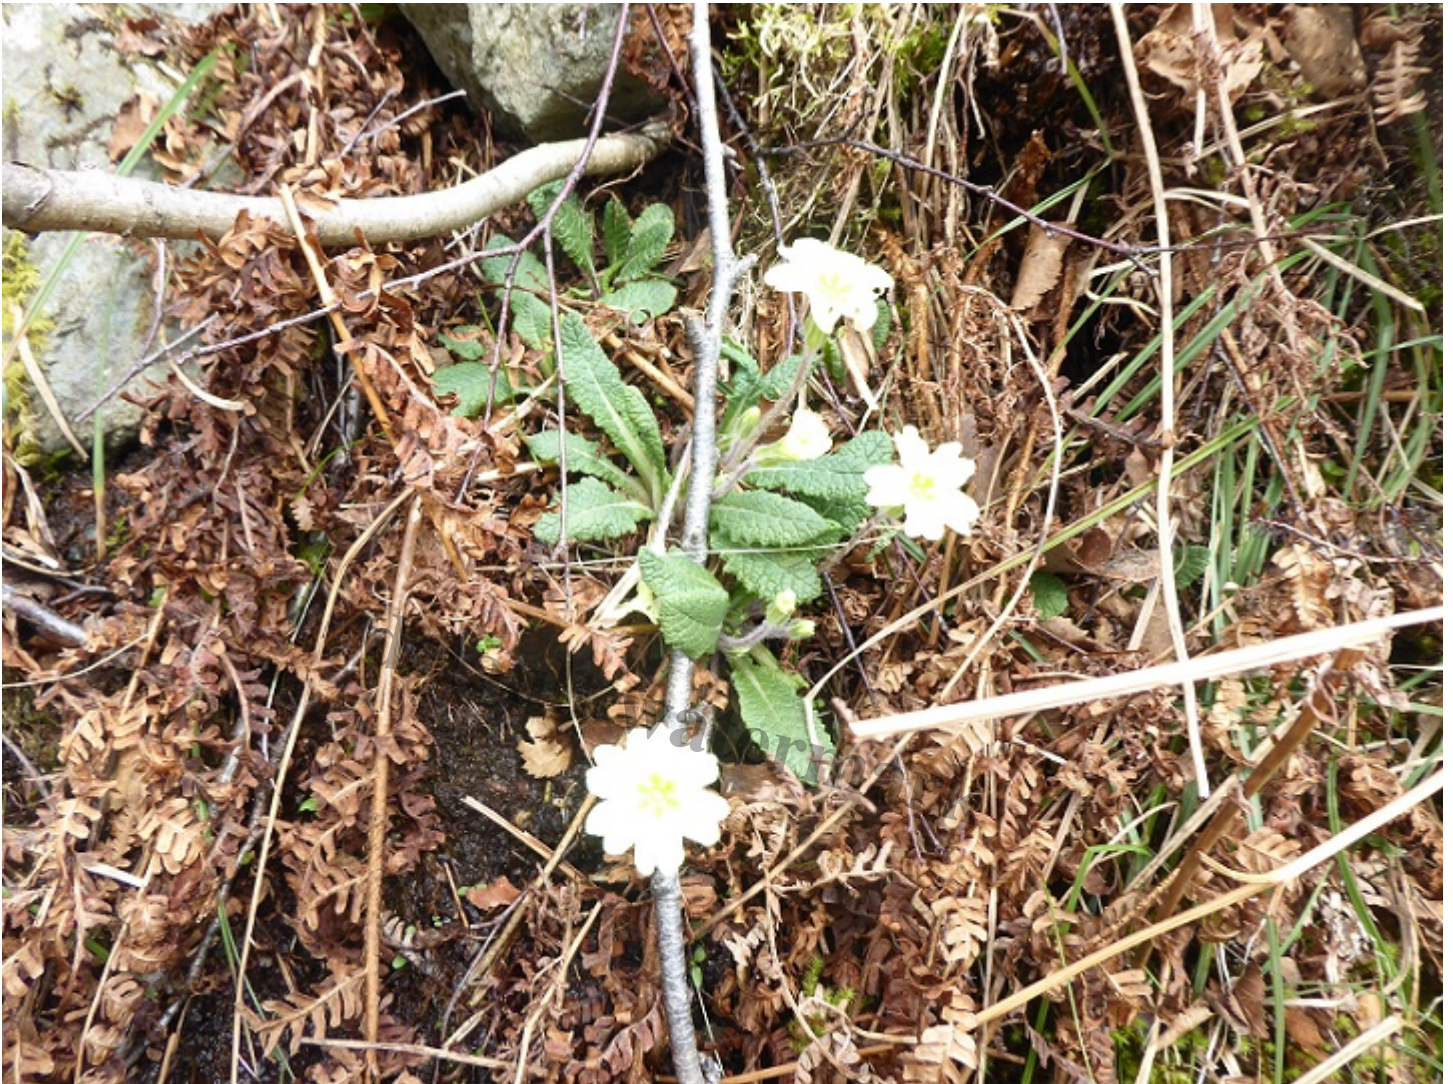
It was not only trees and shrubs (birch, holly, Scots Pine, willow, broom) that were regenerating, but also common flowers like primrose, wood anemone and celandine. In a month's time, when spring has fully sprung, I am sure there would be a lot more. That, however, was what I would have expected and was not what impressed me about how FLS land at Ben A'an, aside from the path, is being managed.
