## Forest and Land Scotland's failed path but flourishing woodland at Ben A'an revisited

## The state of the tourist path up Ben Aân

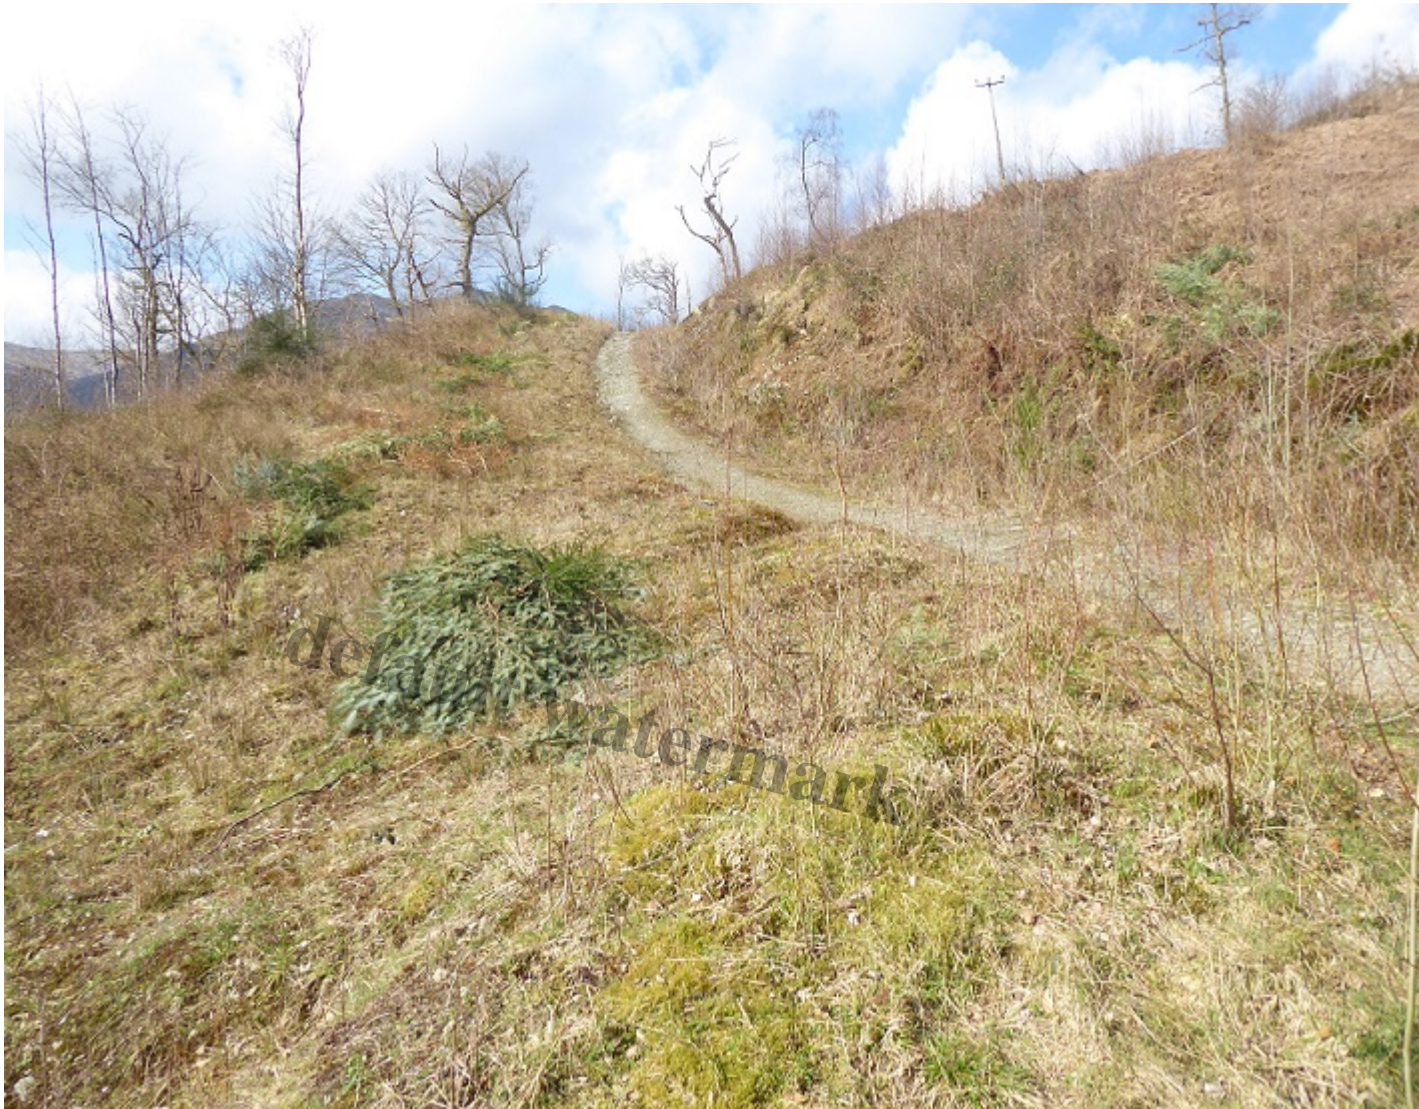
Regenerating scrub and chopped spruce saplings by the side-path just above the car park

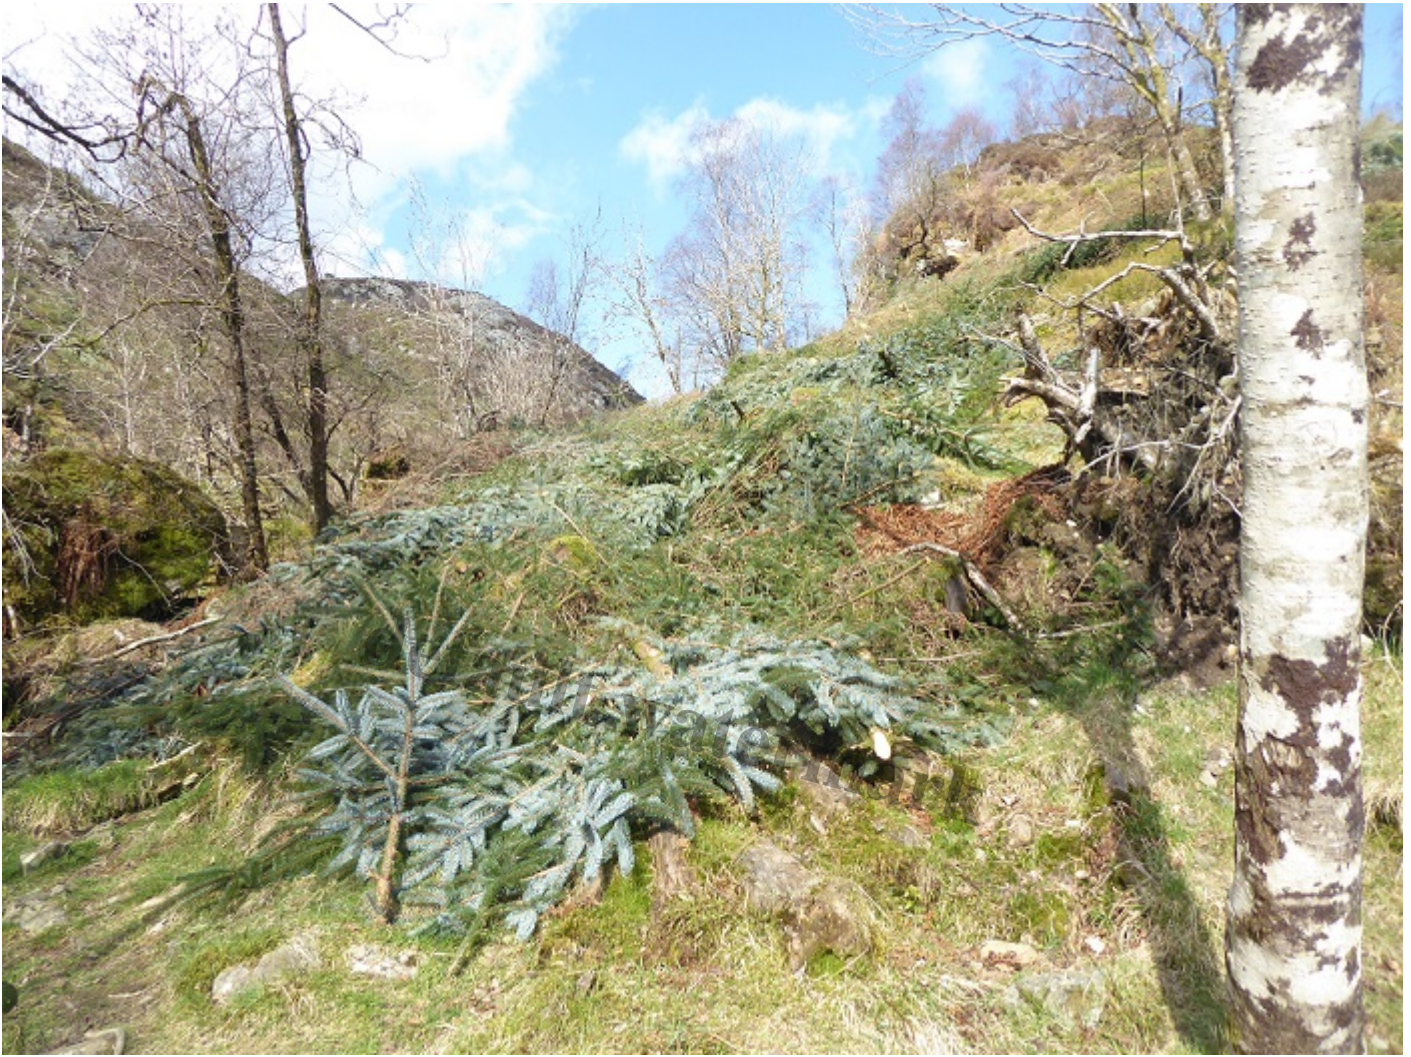
The answer is to fell/remove the non-native species before they become old enough to seed. That is exactly what has been happening at Ben Aon. If left in place after felling, as here, the earlier this happens, the smaller the area that will be shaded out, a way of helping the ground flora which depends on sunlight.

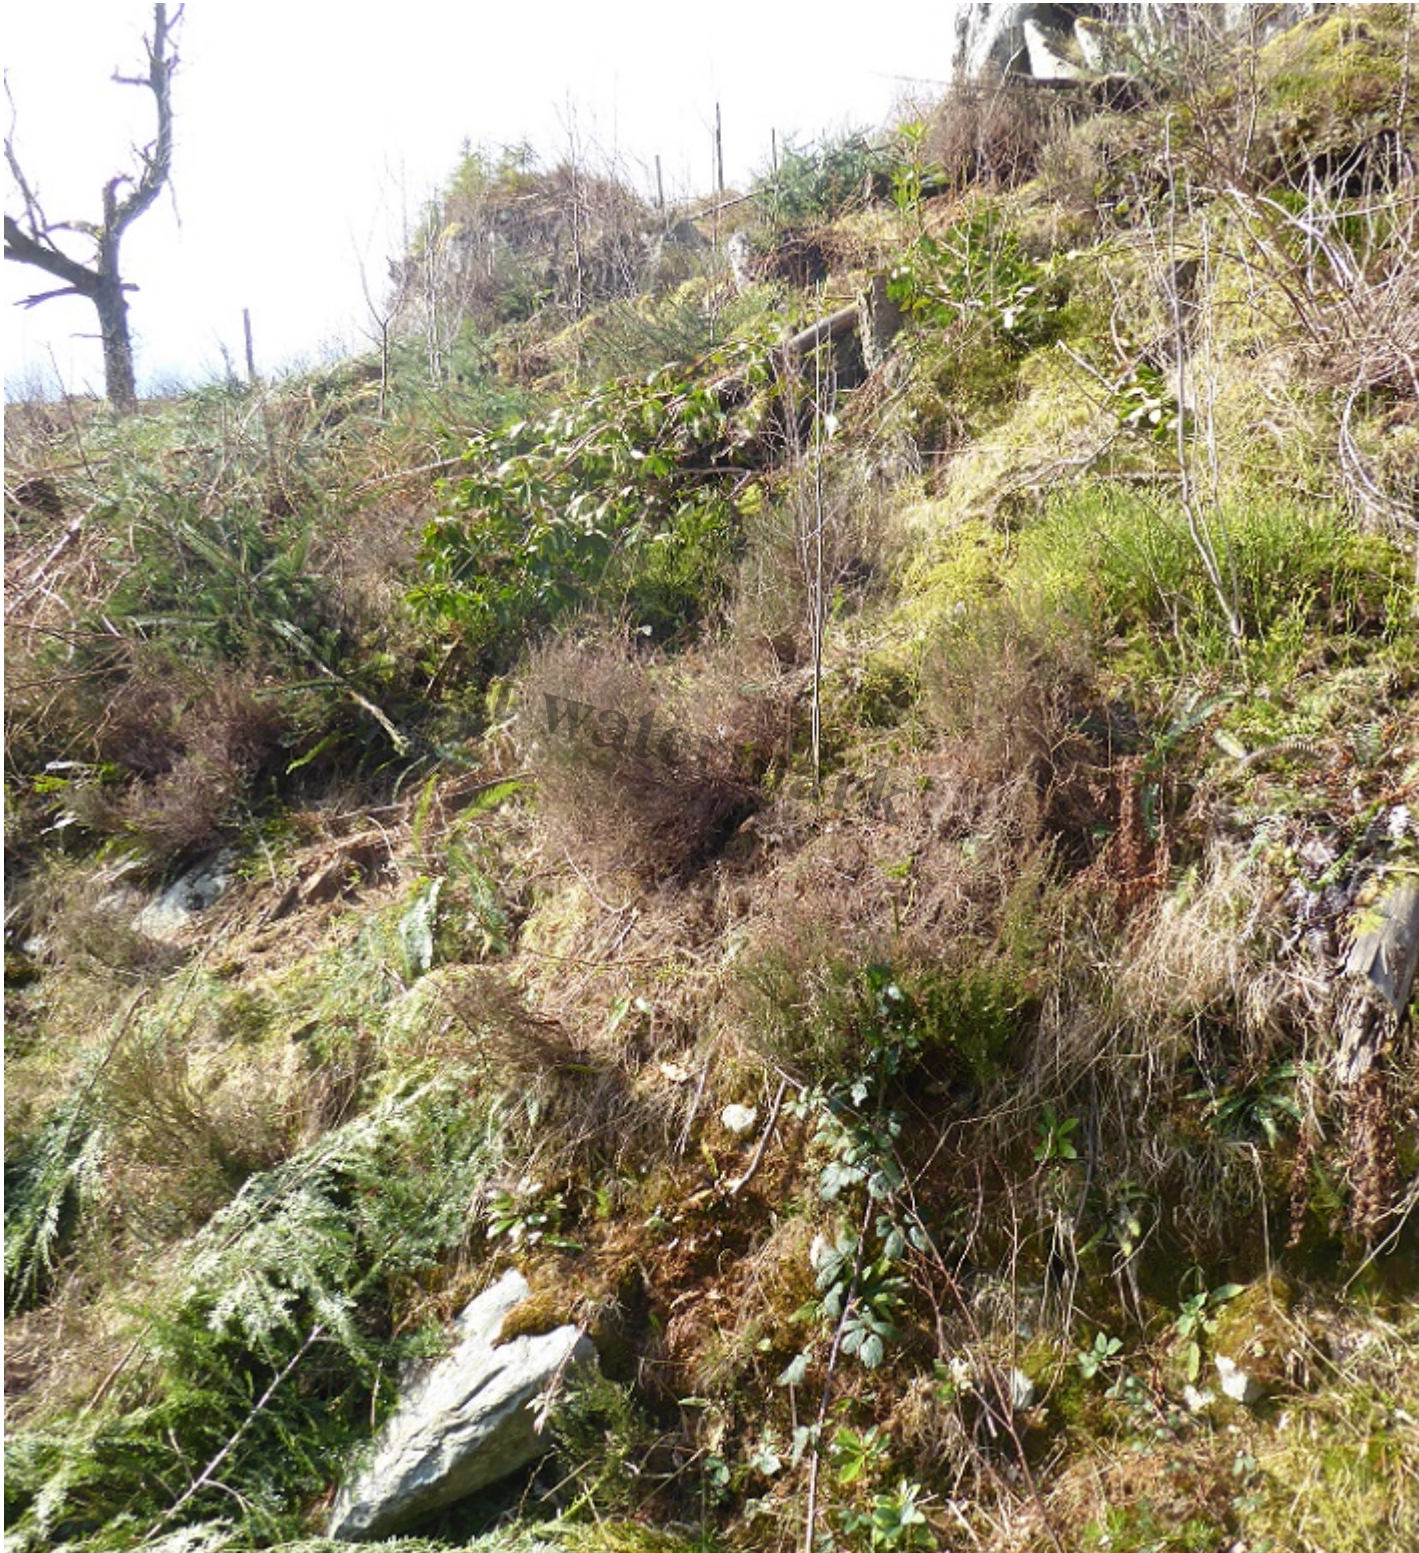
Rhododendron and spruce being felled from amongst naturally regenerating birch and willow just above the path

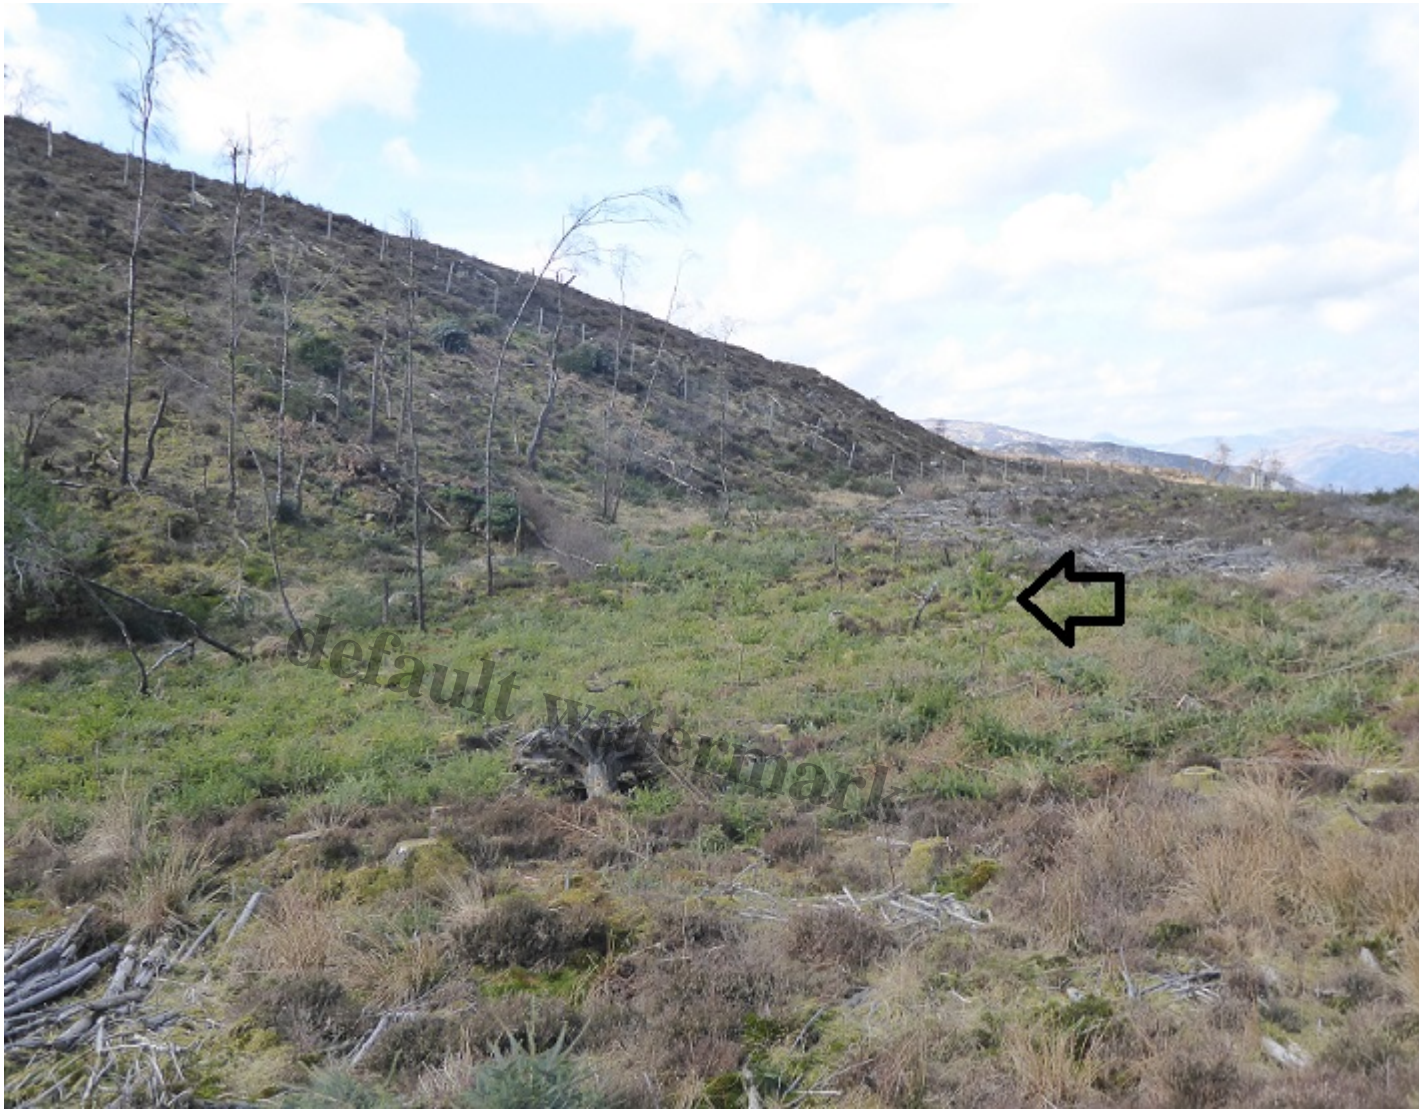
The arrow marks a Scots Pine (hard to see) which has been left standing, while the surrounding spruce had been felled

This commendable approach will require ongoing management, as non-native seed is likely to survive in the ground for some time. That could support local jobs, with locally based foresters weeding out non-native species and controlling deer numbers in the short-medium term and then in the longer-term harvesting some of the native trees for commercial use
