A National Park without planning authority â?? the Pitmain Estate and the Gynack overflow

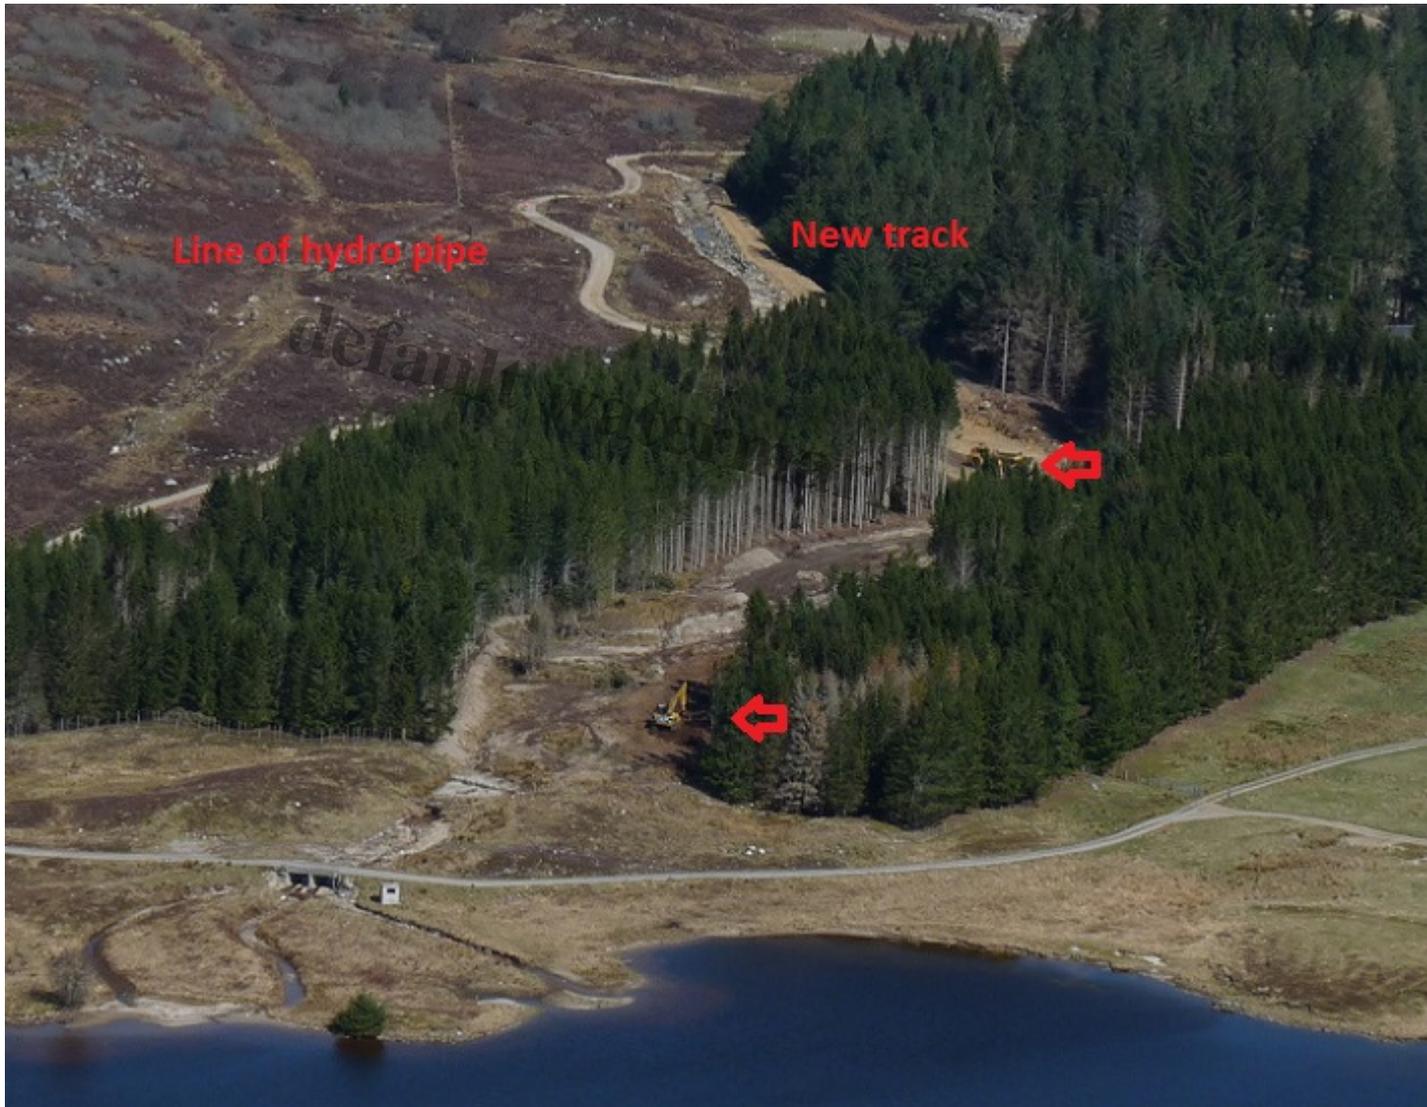
View of Gynack flood alleviation channel from Creag Bheag, April 2023, showing JCB, Truck and new track alongside it. Loch Gynack in foreground. Photo credit parkswatch reader.

Judging by the new tracks shown in the top photo and that above, the impact and the extent of the works is such that full planning permission should have been required.

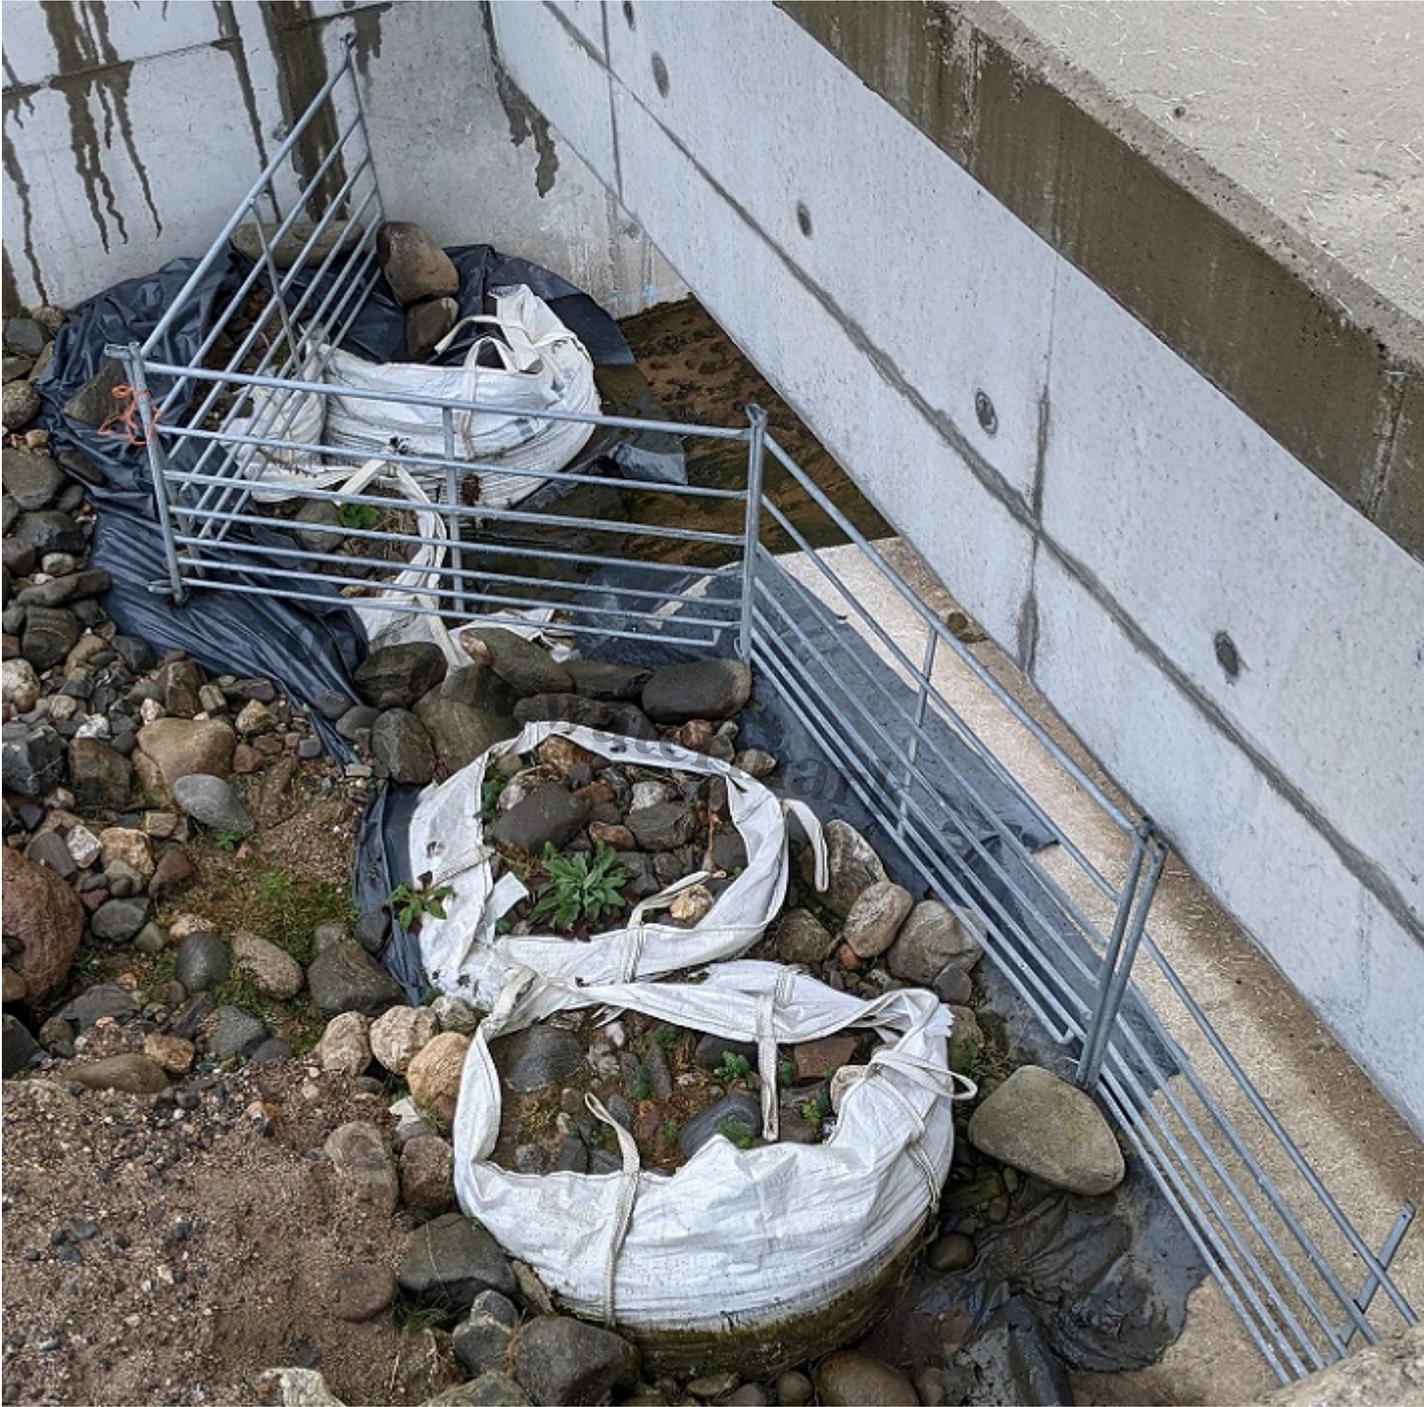
The blocked off intake by the River Gynack November 2022.

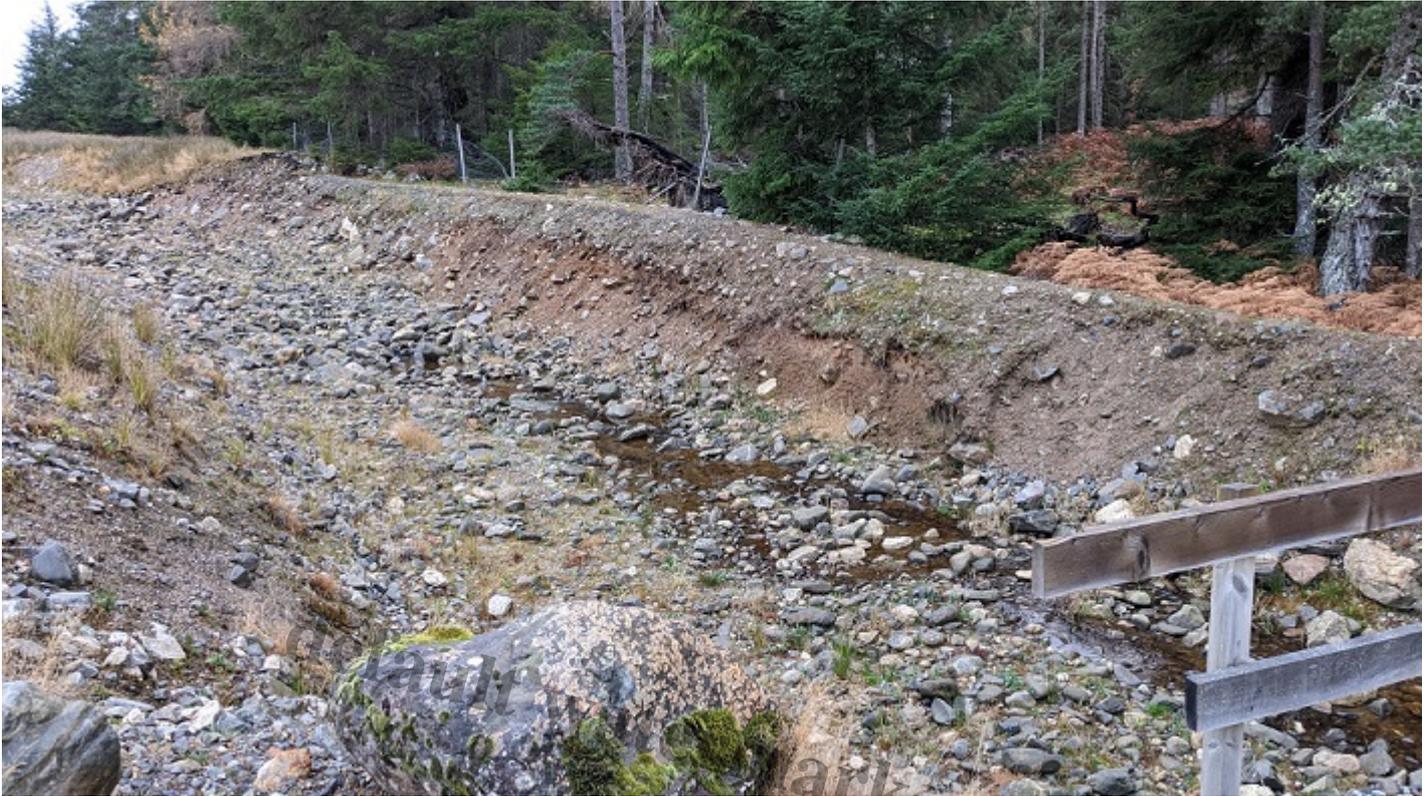
The upper part of the diversion channel with a heavily eroded section of the channel containment bund on the right. Photo Nov 2022.

The worst design flaw was the proposal that an embankment, a heaped up bank of material, should be used to form the true left-hand side of the channel and would be able to withstand the erosive force of the water when in flood.

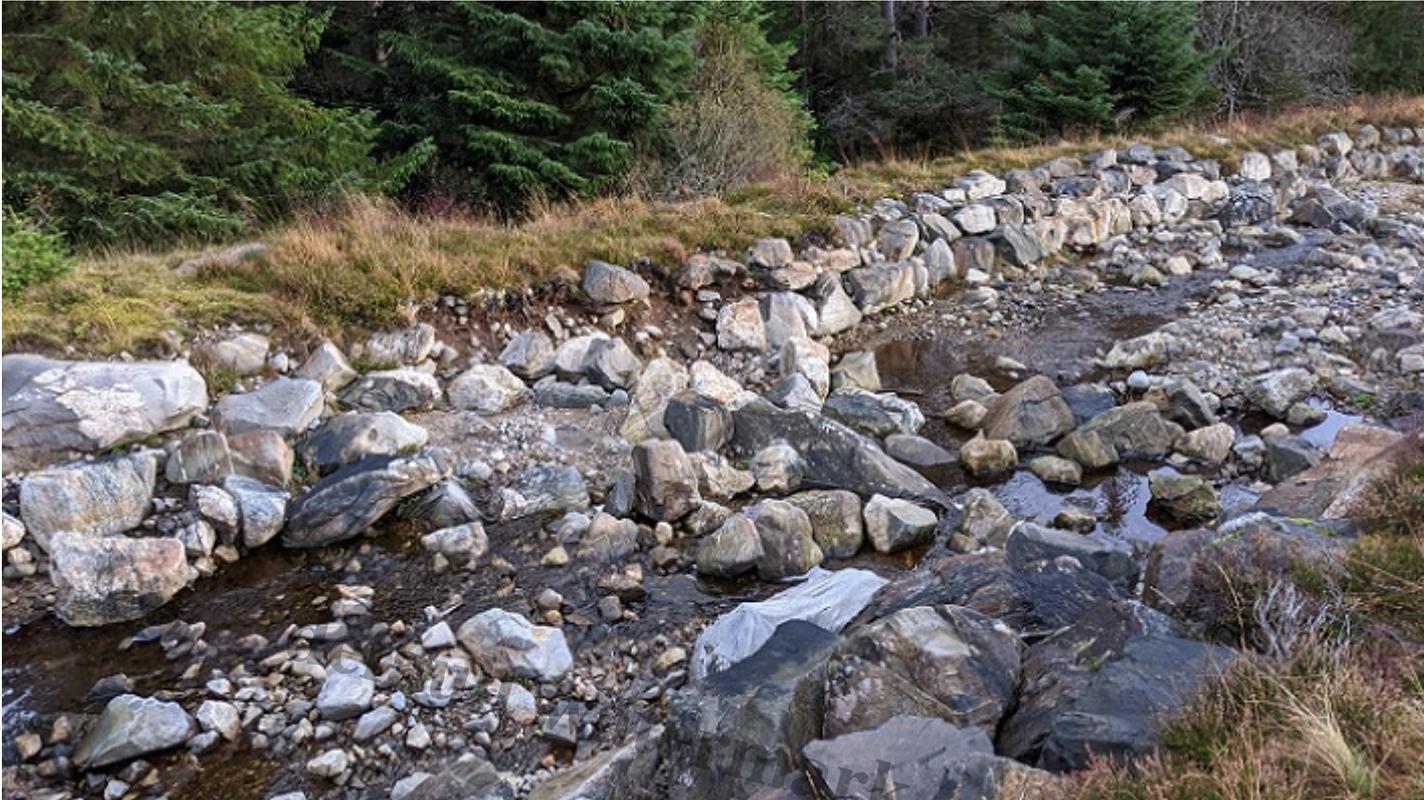
A section of failed rip rap bouldering with boulders which once formed the embankment now lying in the bed of the channel. The channel was blocked off to prevent sections like this failing and flooding the woods and Pitmain Lodge below.

While some of the embankment was reinforced with rip rap bouldering, as with several run of river hydro schemes ([see here](#)), that also proved unfit for purpose. The basic problem is that when a river is in flood, water is forced behind the boulders and prises them away from the bank. Grassy river banks resist flood water quite effectively. By contrast where soil is exposed between or below boulders it is likely to be subject to severe erosion:

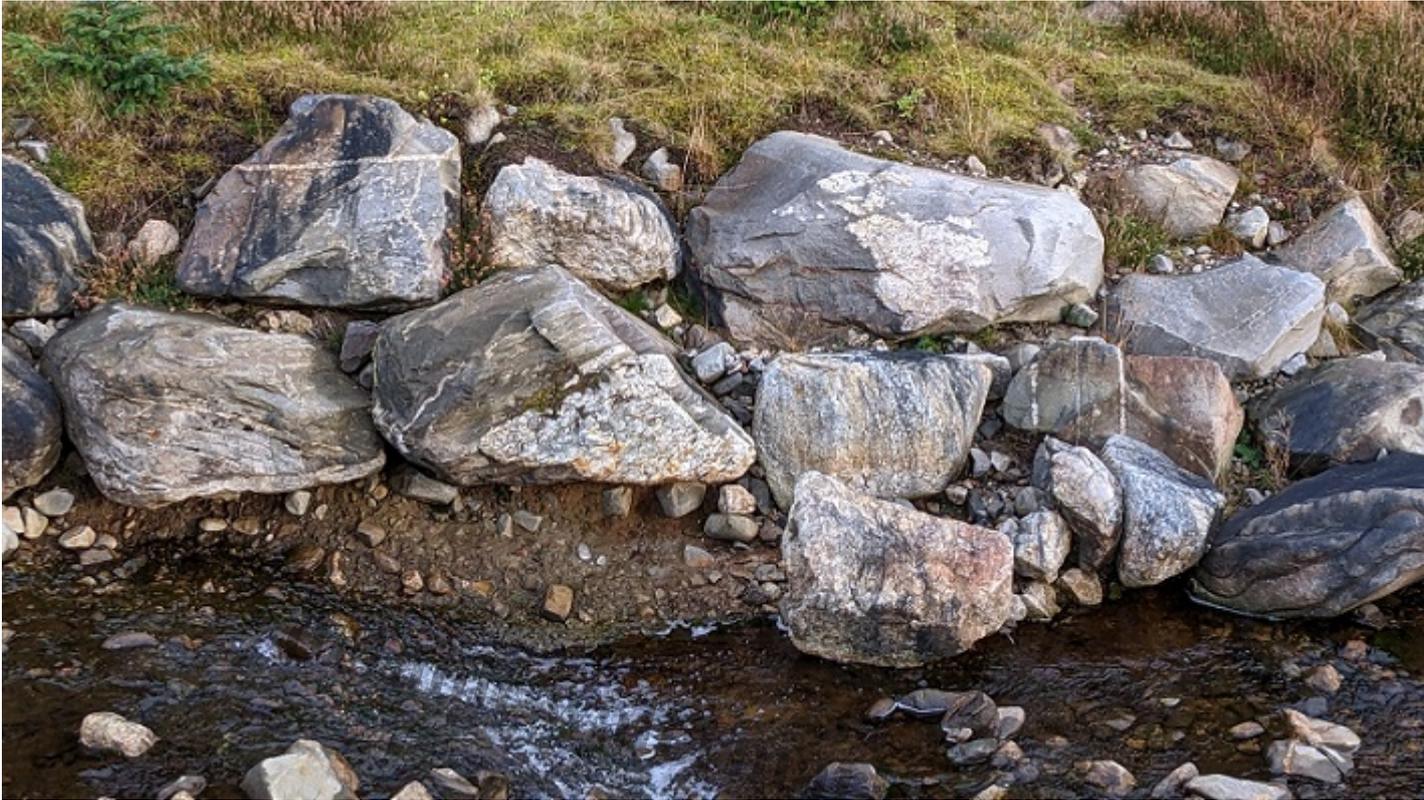
Rip rap bouldering continue to erode away below where the subsidiary burn enters the channel.
Nov 2022.

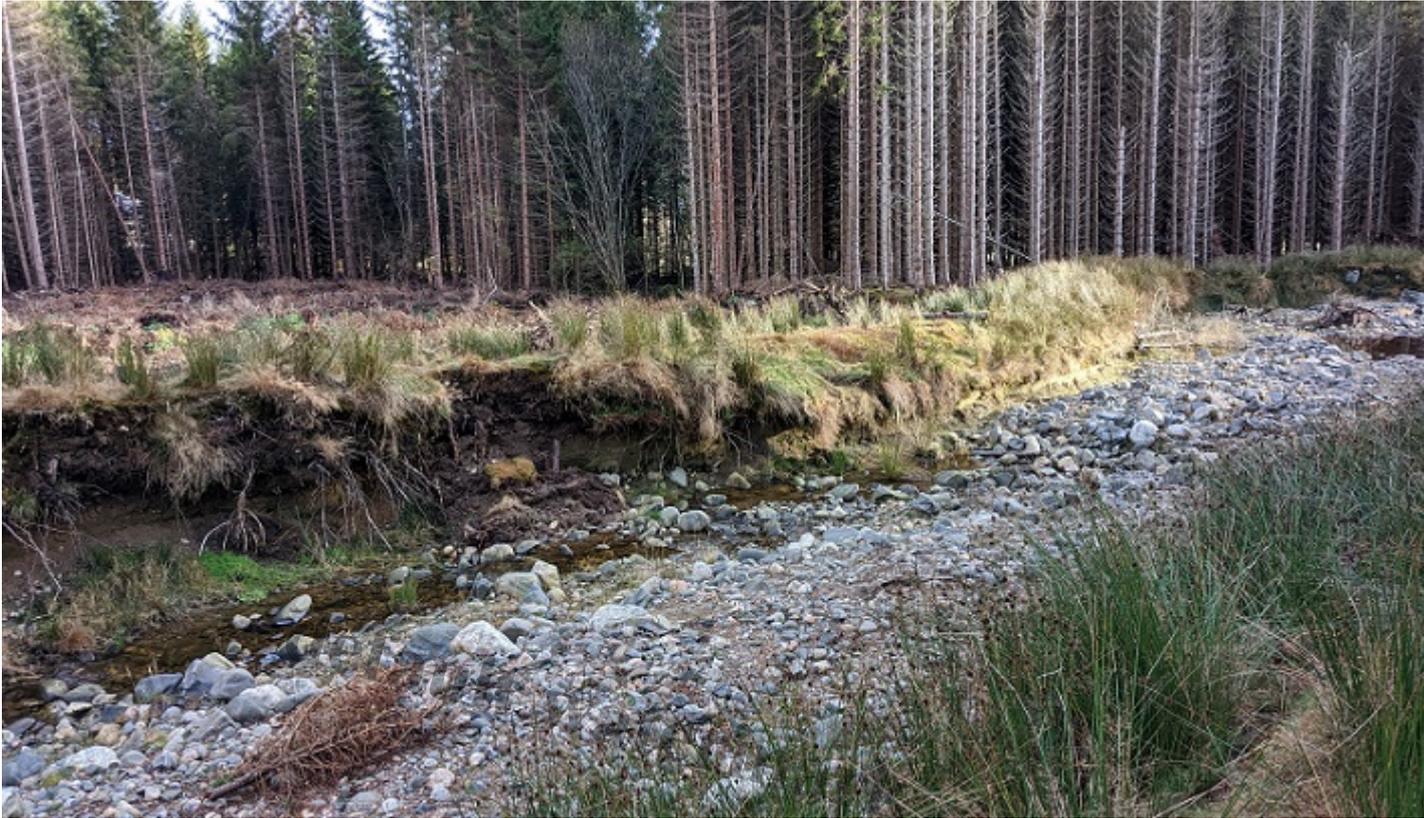
Photo Nov 2022

Since the channel was blocked off, some sections of the peaty embankment have vegetated and might now be better able to withstand flood water but the damaged sections with exposed sections of peat are highly vulnerable to further erosion:

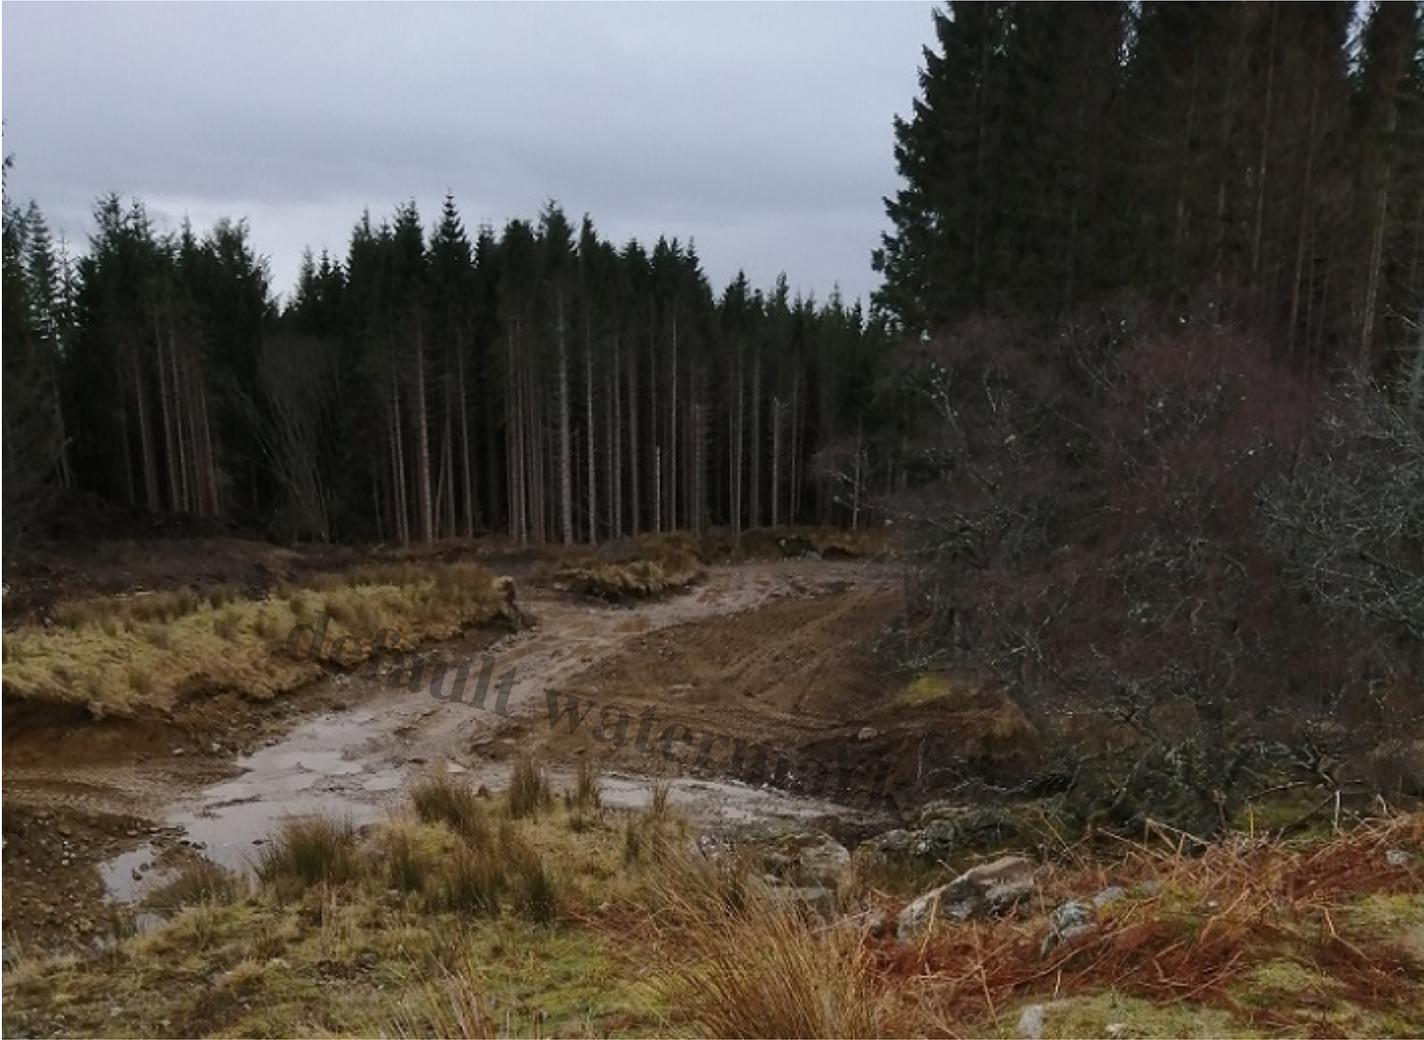
Early preparatory work alongside the channel April 2023. Photo credit parkswatch reader

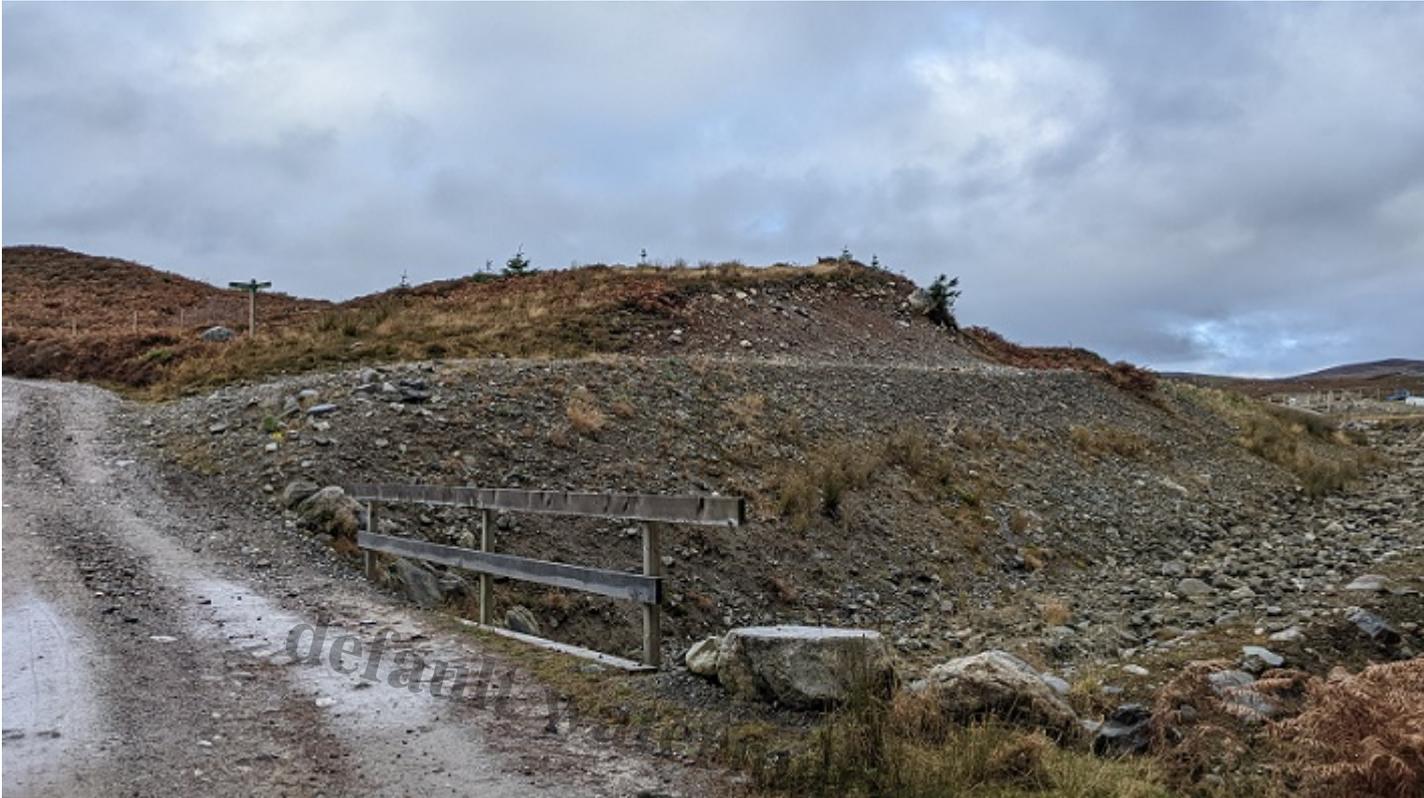
Unrestored bank and track cutting just below the intake to the channel. November 2022.

In my view the CNPA is partly responsible for this debacle. Whatever the complexities of redesigning the channel to get it working, as soon as work on the scheme had finished it was clear that some of the work was not of an acceptable standard as in the landscape sore in the photo above. Had the CNPA taken enforcement action on such issues, the Pitmain Estate might have taken it a bit more seriously. Instead, it clearly now believes it can more or less do what it likes.

There is no doubt that the Gynack flood alleviation channel needs to be fixed or, if it can't, the land restored to its original state. The Pitmain Estate has had four years now to come up with a plan to do so and has had plenty of time to discuss that with the CNPA. Instead, it has ignored the CNPA and just gone ahead, appointed a new contractor and commenced the work.
