A National Park without planning authority – the Pitmain Estate and the Gynack overflow

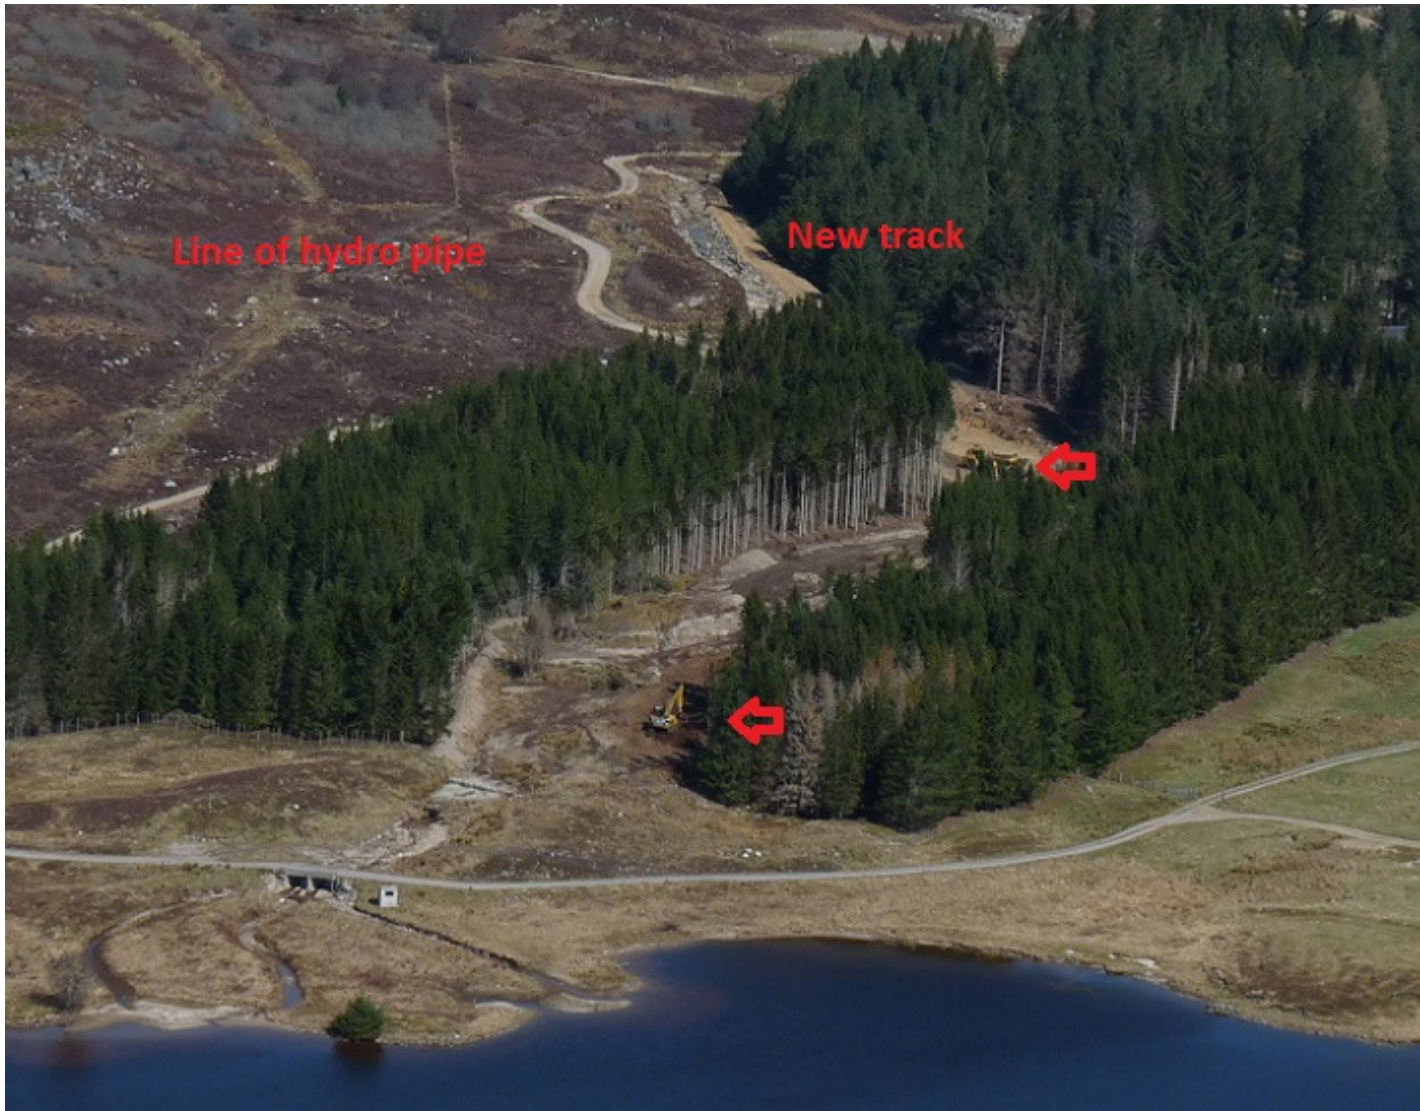
View of Gynack flood alleviation channel from Creag Bheag, April 2023, showing JCB, Truck and new track alongside it. Loch Gynack in foreground. Photo credit parkswatch reader.

Judging by the new tracks shown in the top photo and that above, the impact and the extent of the works is such that full planning permission should have been required.

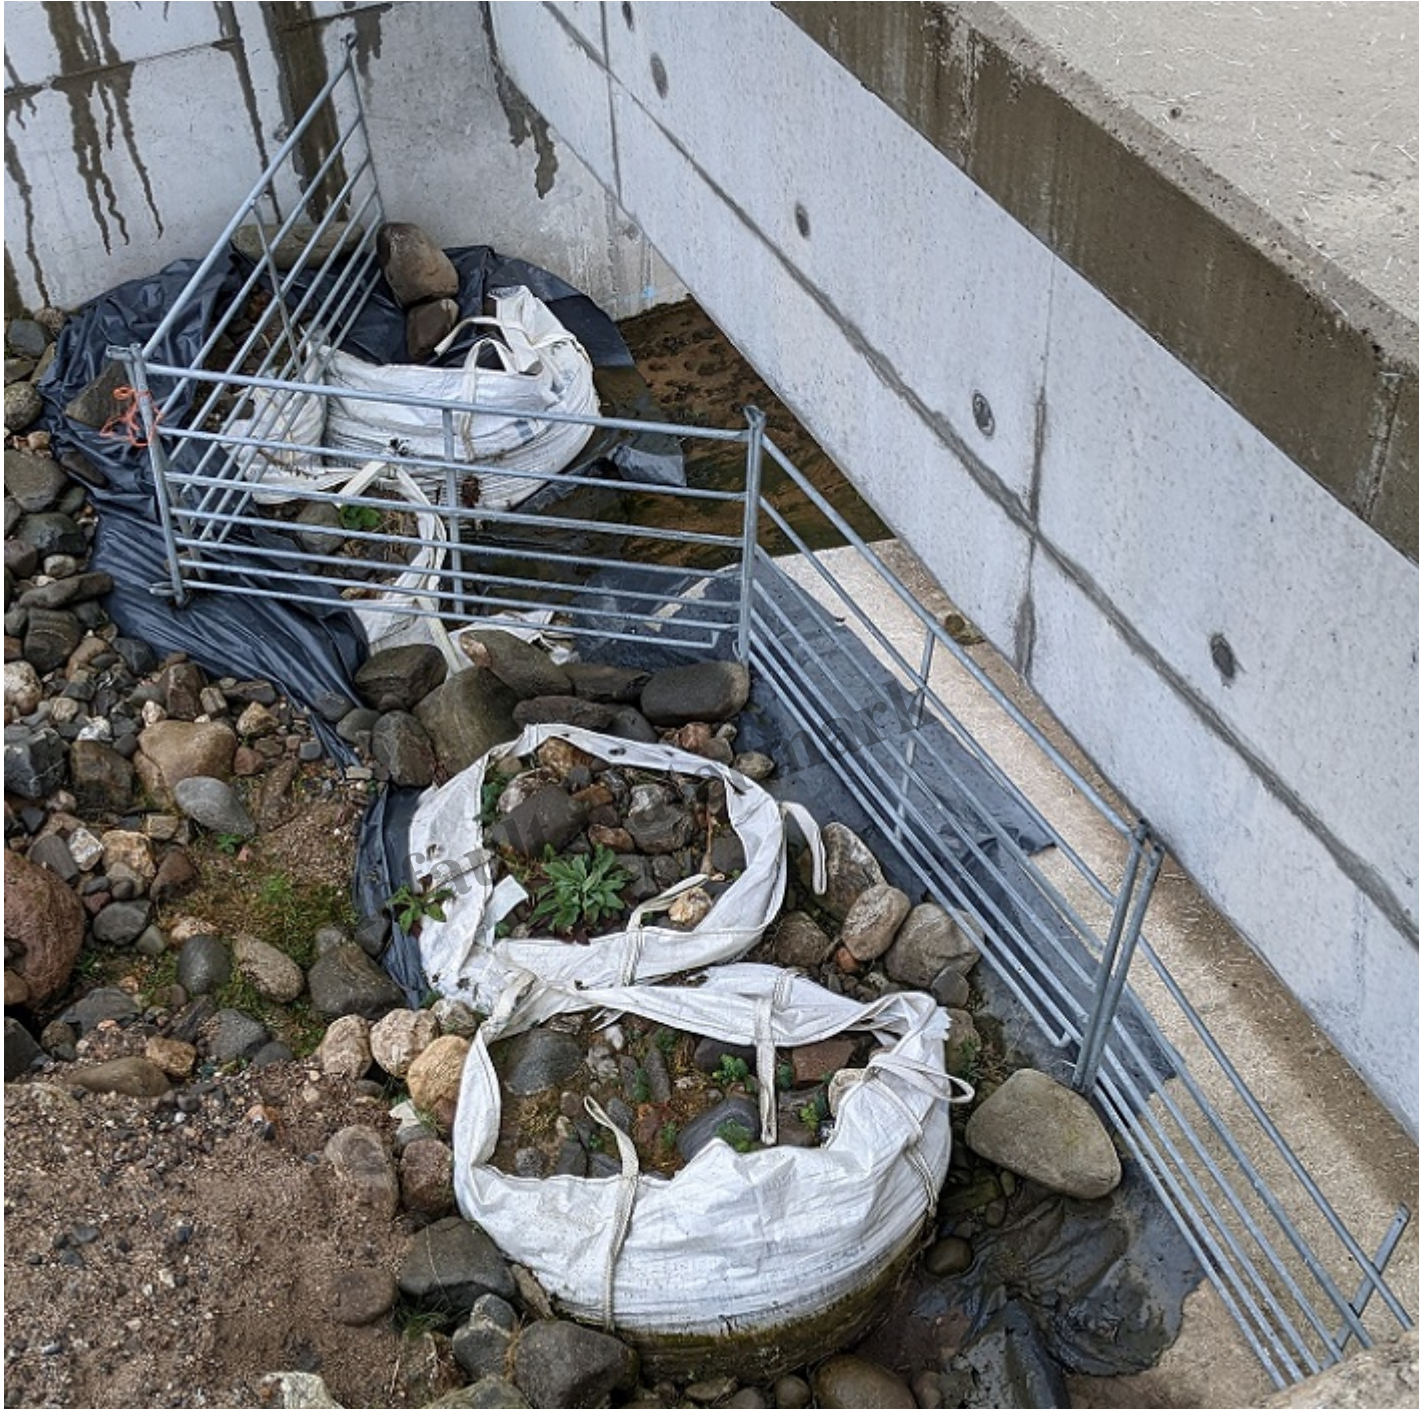
The blocked off intake by the River Gynack November 2022.

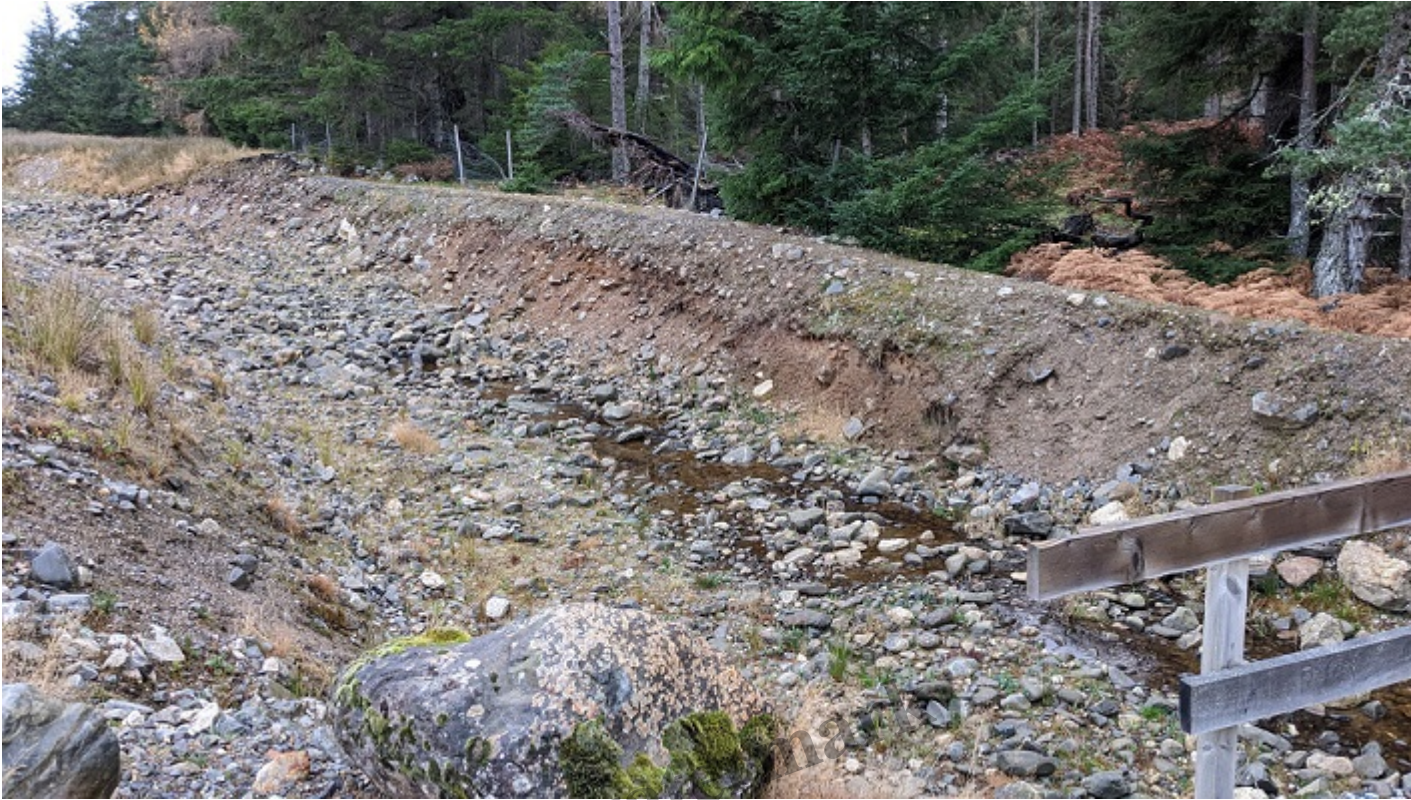
The upper part of the diversion channel with a heavily eroded section of the channel containment bund on the right. Photo Nov 2022.

The worst design flaw was the proposal that an embankment, a heaped up bank of material, should be used to form the true left-hand side of the channel and would be able to withstand the erosive force of the water when in flood.

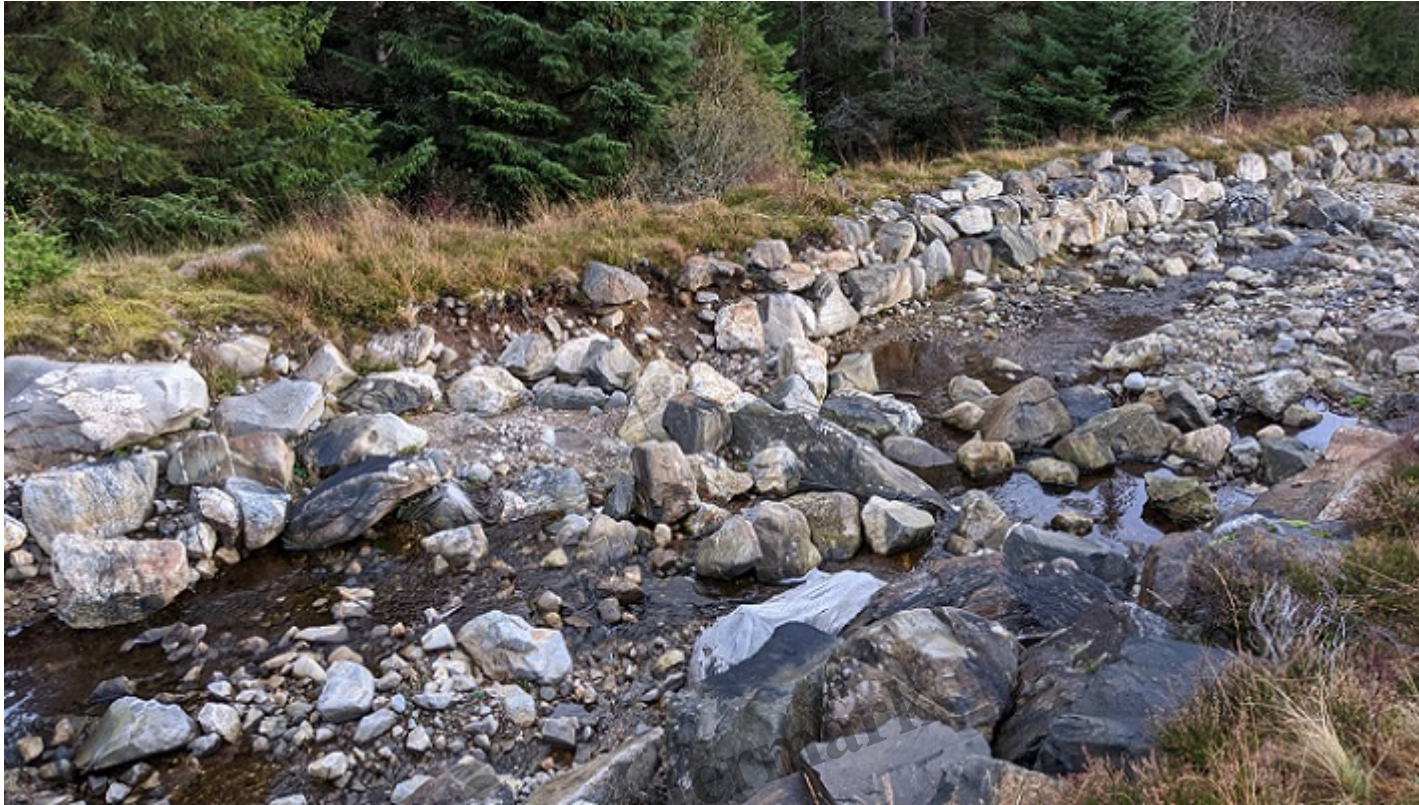
A section of failed rip rap bouldering with boulders which once formed the embankment now lying in the bed of the channel. The channel was blocked off to prevent sections like this failing and flooding the woods and Pitmain Lodge below.

While some of the embankment was reinforced with rip rap bouldering, as with several run of river hydro schemes ([see here](#)), that also proved unfit for purpose. The basic problem is that when a river is in flood, water is forced behind the boulders and prises them away from the bank. Grassy river banks resist flood water quite effectively. By contrast where soil is exposed between or below boulders it is likely to be subject to severe erosion:

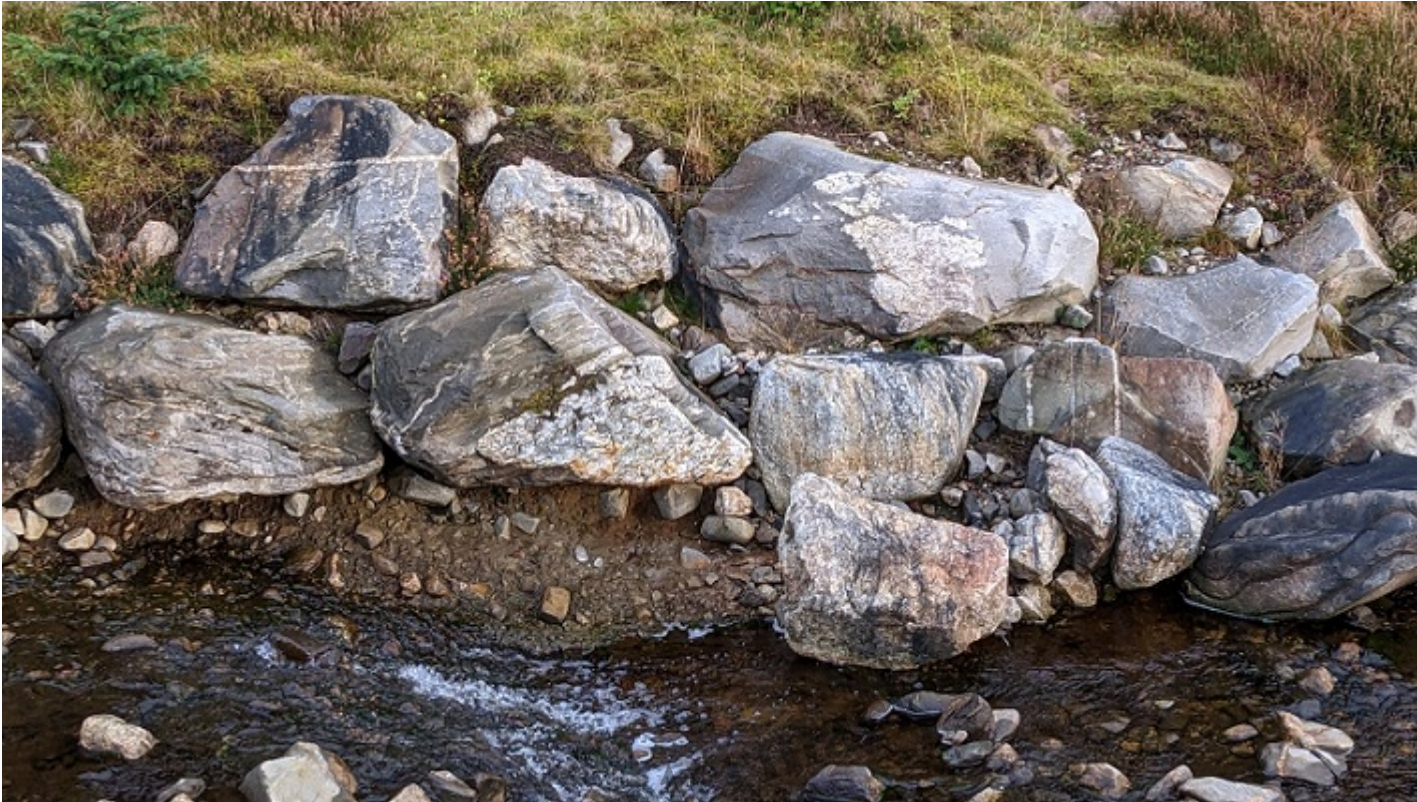
Rip rap bouldering continue to erode away below where the subsidiary burn enters the channel.
Nov 2022.

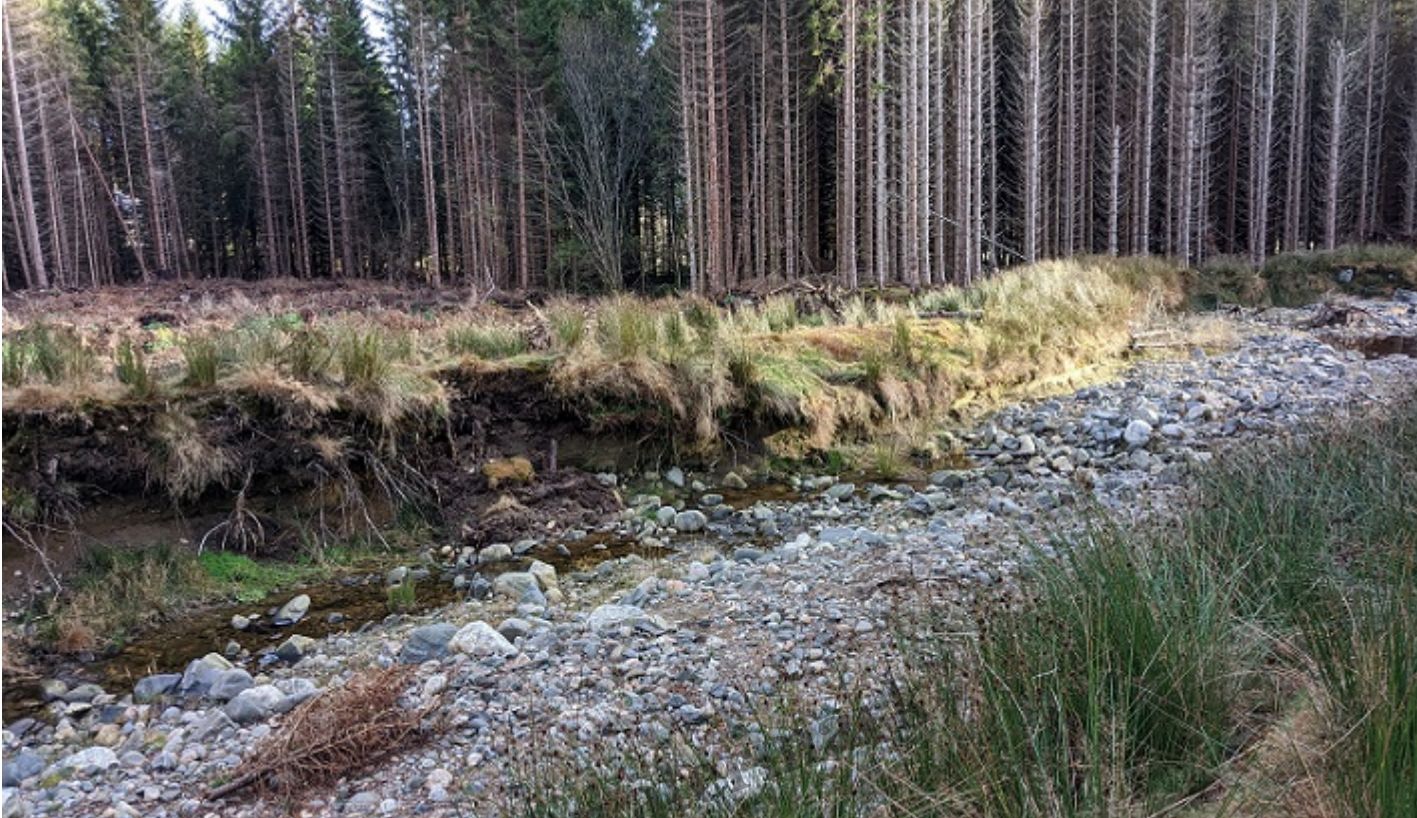
Photo Nov 2022

Since the channel was blocked off, some sections of the peaty embankment have vegetated and might now be better able to withstand flood water but the damaged sections with exposed sections of peat are highly vulnerable to further erosion:

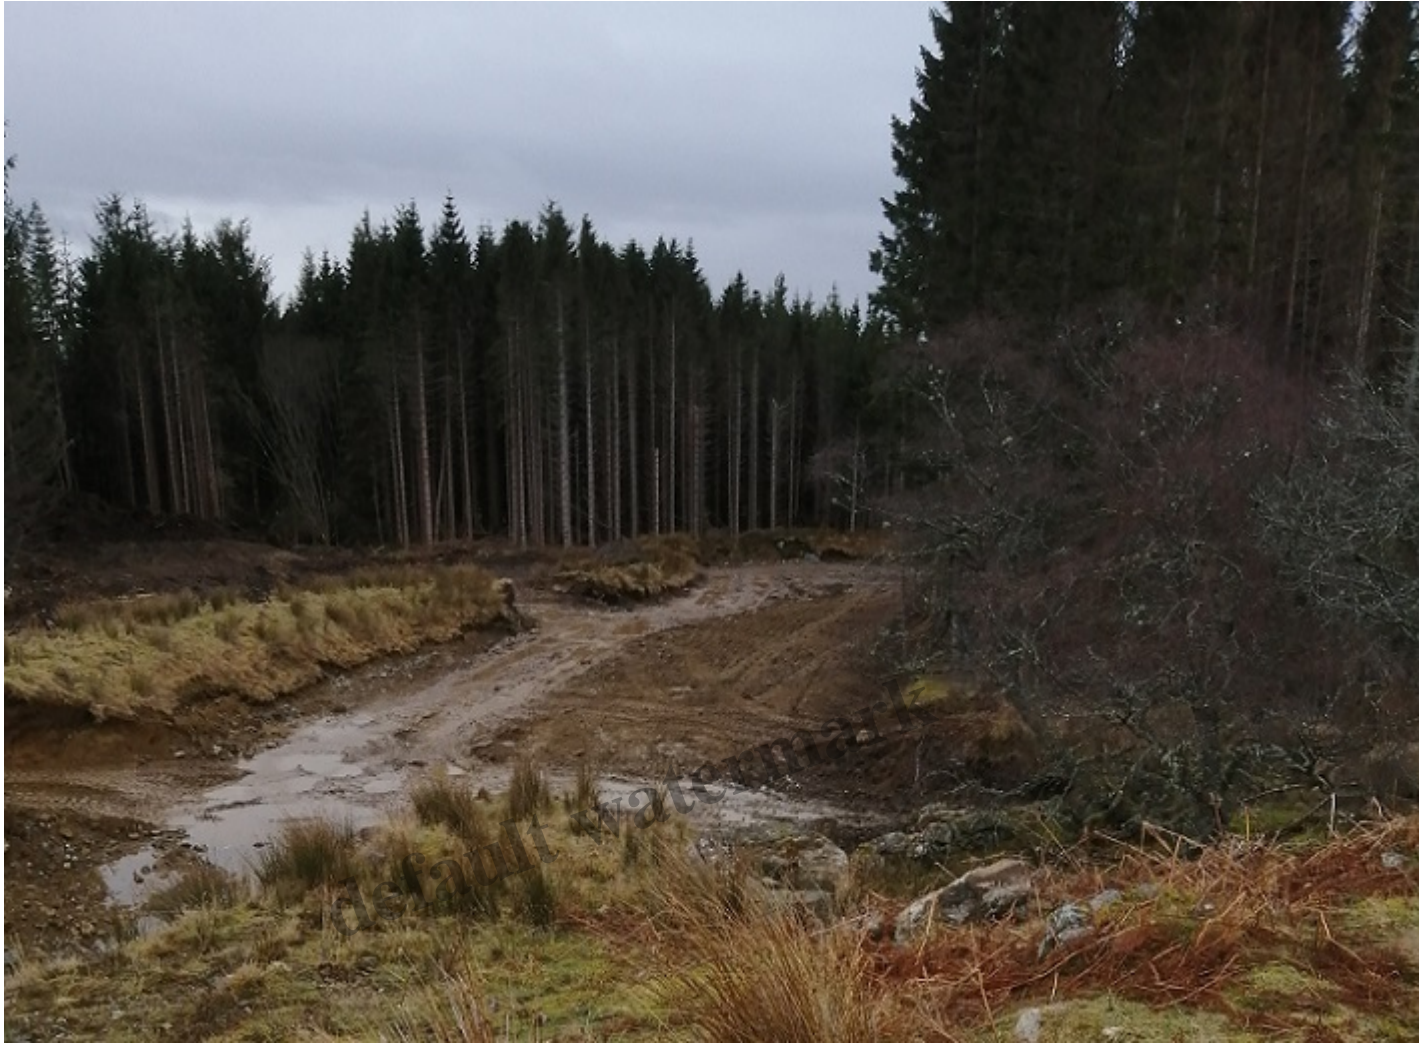
Early – preparatory? – work alongside the channel April 2023. Photo credit parkswatch reader

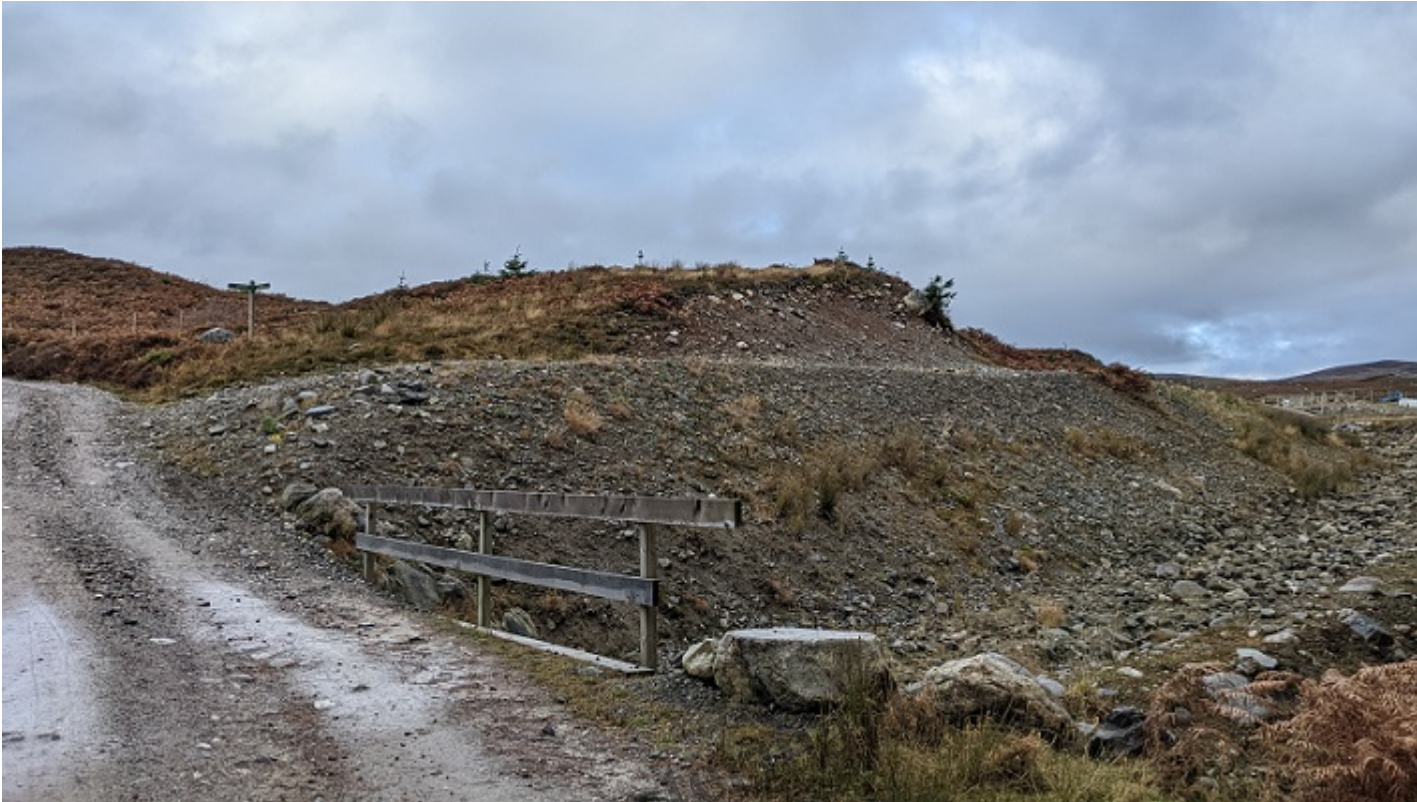
Unrestored bank and track cutting just below the intake to the channel. November 2022.

There is no doubt that the Gynack flood alleviation channel needs to be fixed or, if it can't, the land restored to its original state. The Pitmain Estate has had four years now to come up with a plan to do so and has had plenty of time to discuss that with the CNPA. Instead, it has ignored the CNPA and just gone ahead, appointed a new contractor and commenced the work.

In my view the CNPA is partly responsible for this debacle. Whatever the complexities of redesigning the channel to get it working, as soon as work on the scheme had finished it was clear that some of the work was not of an acceptable standard – as in the landscape sore in the photo above. Had the CNPA taken enforcement action on such issues, the Pitmain Estate might have taken it a bit more seriously. Instead, it clearly now believes it can more or less do what it likes.
