And still the silt flows on the Pitmain Estate – what is the point of the Cairngorms National Park Planning Authority?

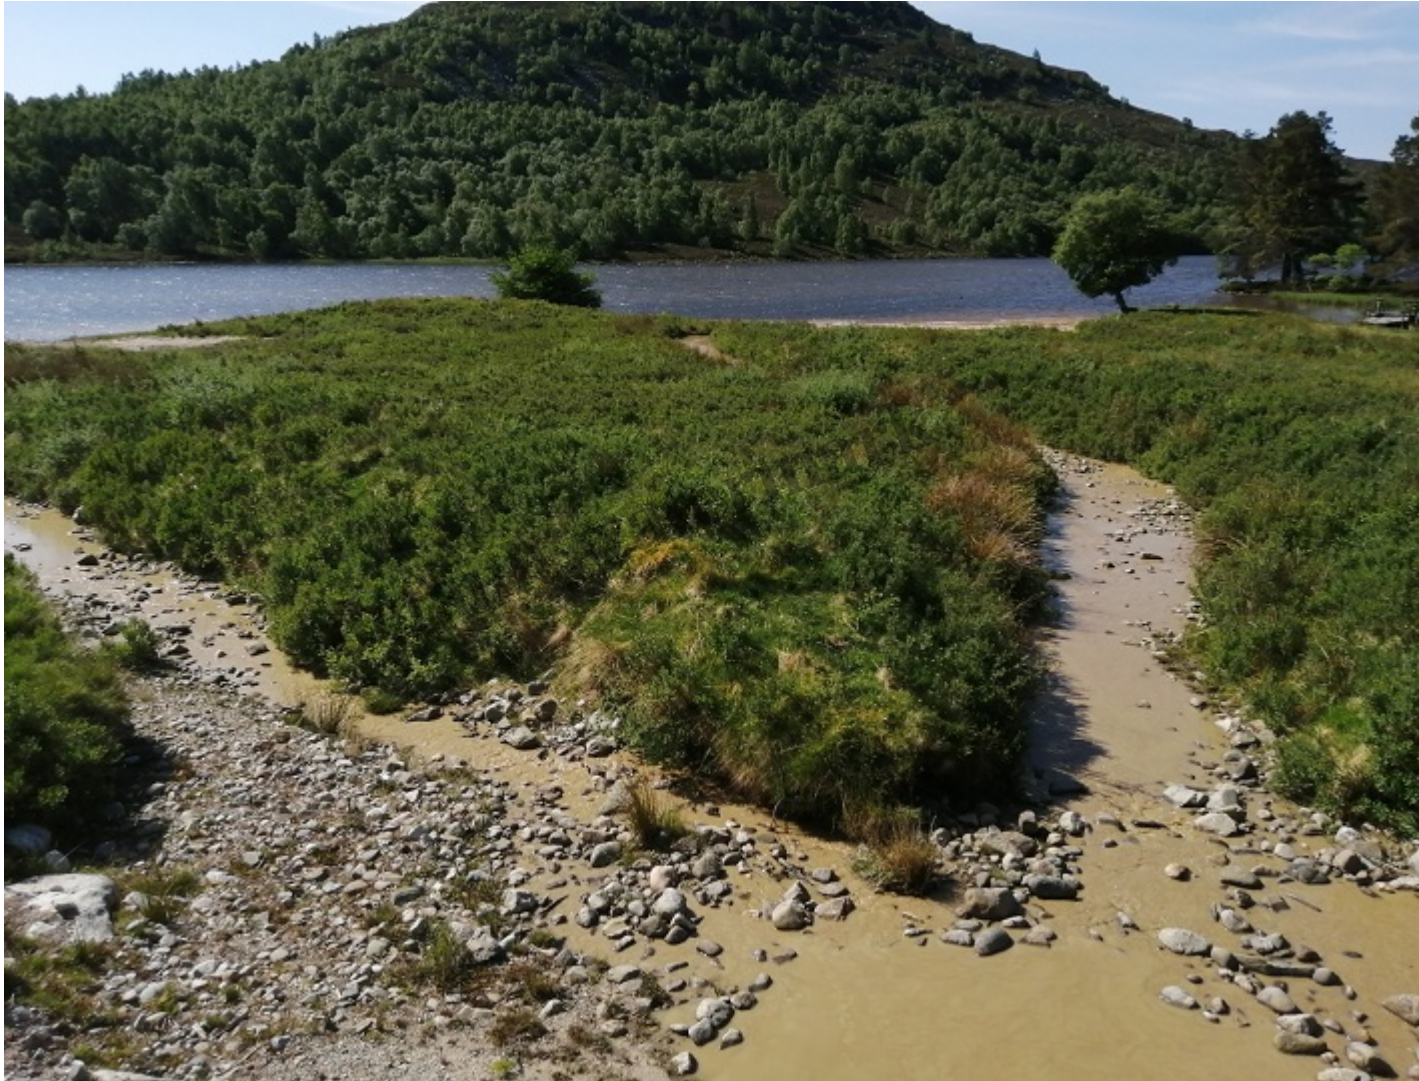
Outflow of Gynack overflow channel 9th June where it flows into Loch Gynack. Photo credit Parkswatch reader

There is no doubt, however, that the silt that was being washed into Loch Gynack yesterday was

flowing the overflow channel which is currently being “repaired” after it failed soon after construction ([see here](#)). The silt is therefore a planning enforcement matter.

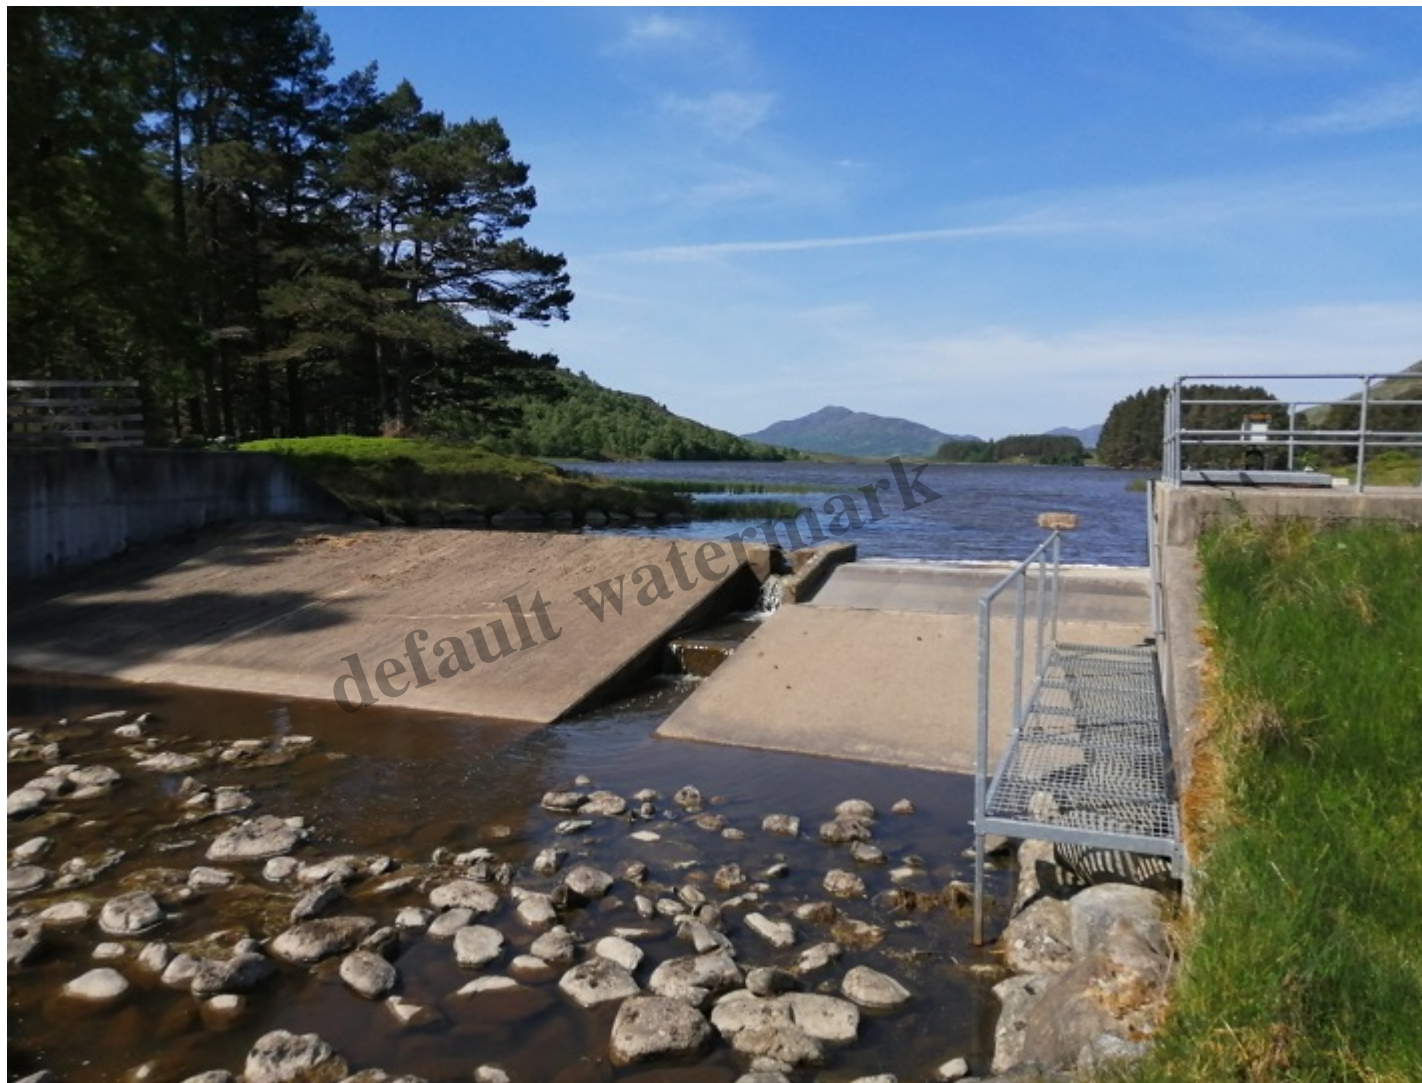
The Loch Gynack outflow, which now also serves as a hydro intake. The water on 9th June appeared slightly murky. Photo credit Parkswatch reader.

Loch Gynack, itself, acts like a giant sedimentation pond for the silt flowing down the overflow, however that has not been sufficient to stop some of the silt flowing out and down into the River Spey Special Area of Conservation below. NatureScot, the agency responsible for these protected areas, should also be up in arms.

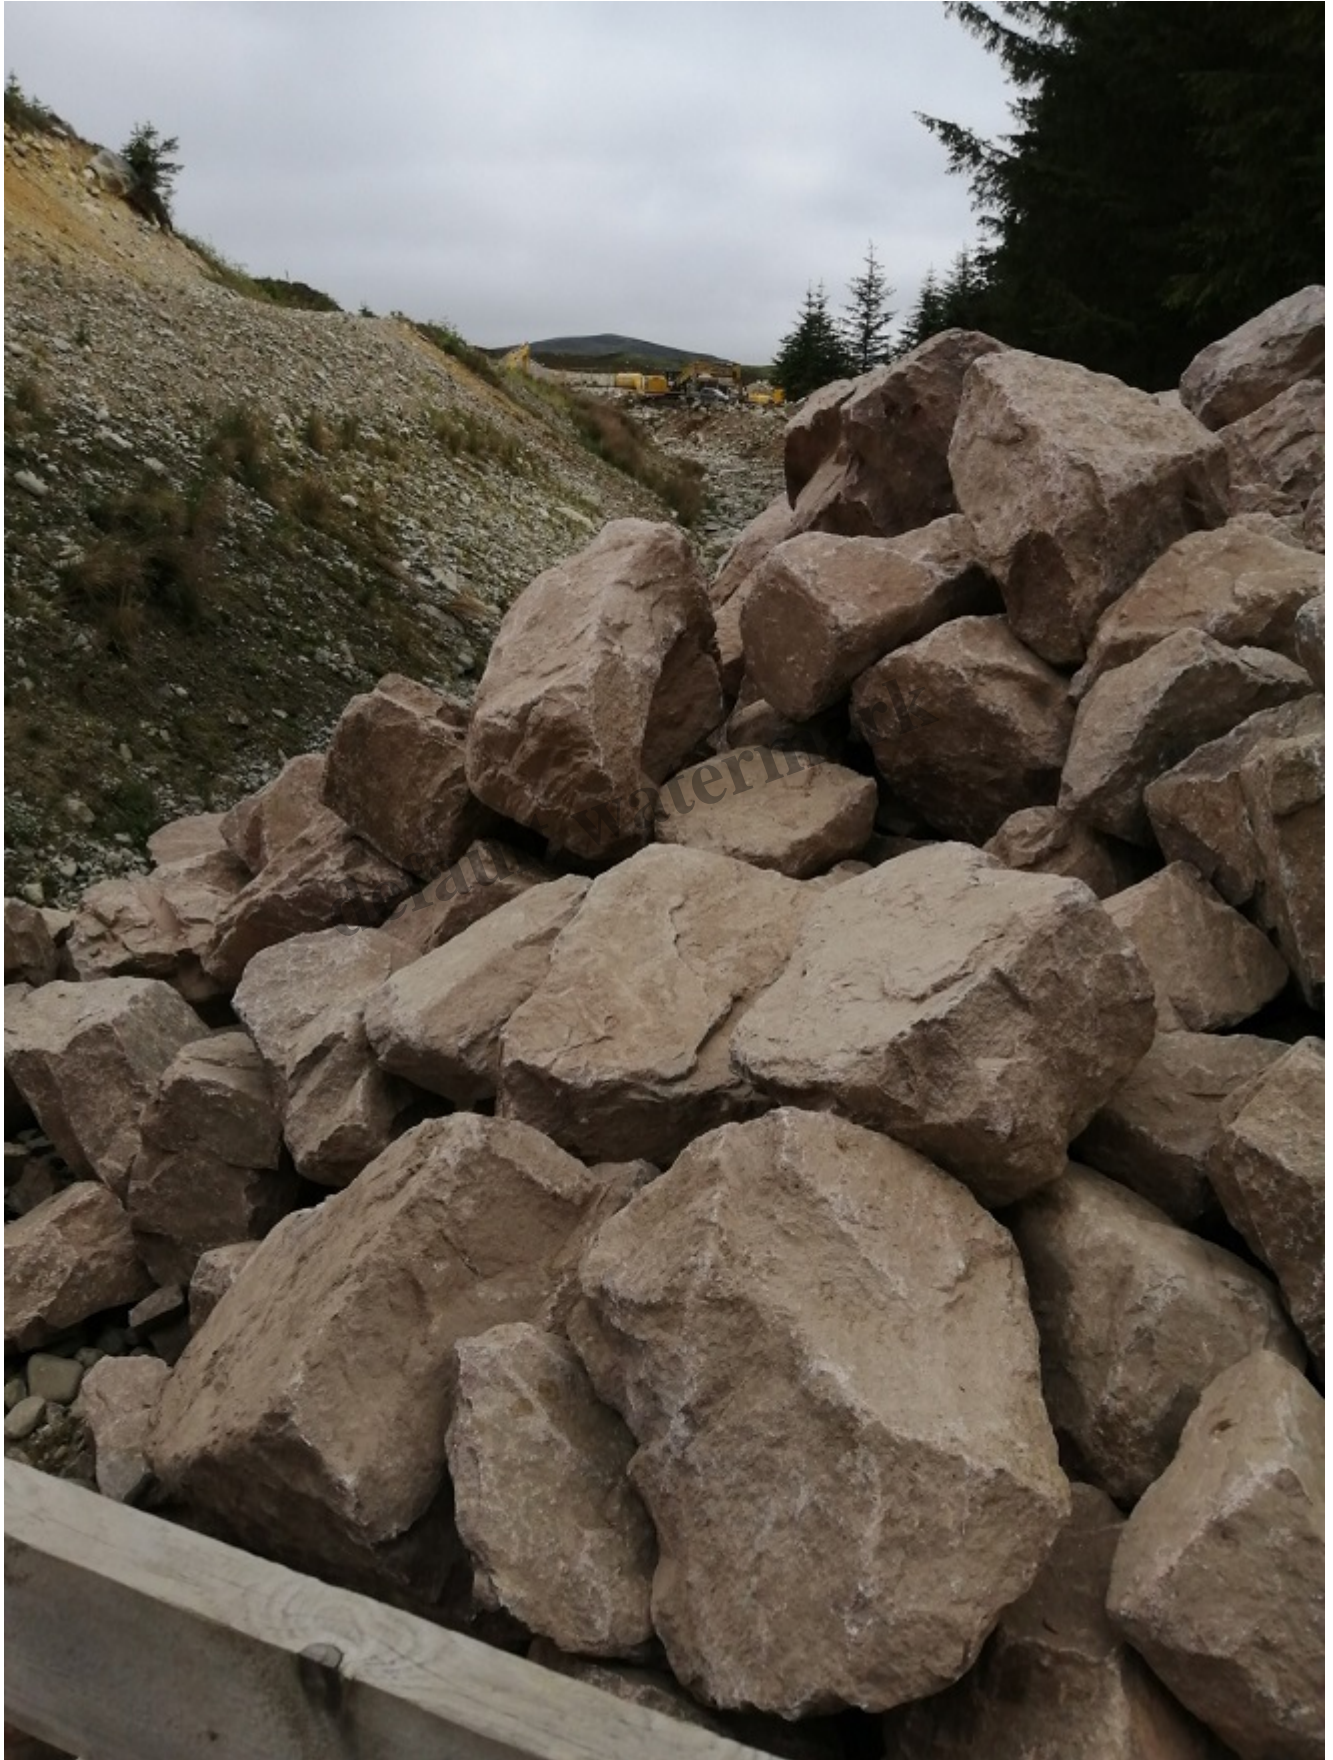
View from the bridge over the overflow channel, with the intake to the diversion scheme

visible on the near horizon. Photo credit Parkswatch reader.

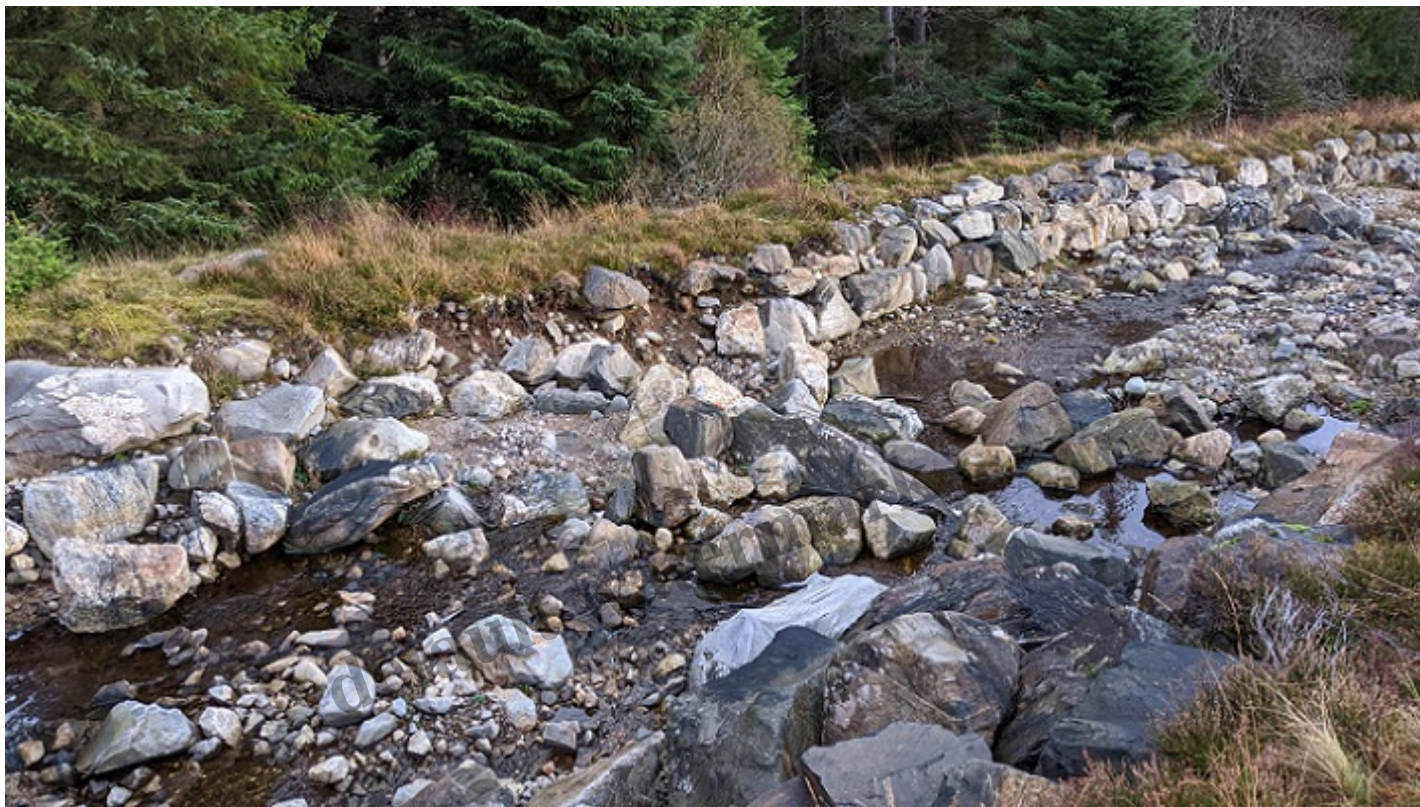
Photo 2022.

Meantime other recent photos suggest that large amounts of rock re-inforcement has been brought in to Pitmain to reinforce the sides of the overflow channel. Whether this will work is a moot point as some of the rip rap bouldering used to line the channel previously was washed away soon after it was first used:

Judging by a comparison of the size of the boulders in the two photos, the idea appears to be that enormous rocks – rumoured to have come from a quarry near Nairn – will contain flood water where smaller ones didn't.

There are reasons to doubt that, given the force that flood water will be forced through the boulders and the size of the bank behind, but perhaps the current plan is to embed the new boulders in concrete? That surely should require a fresh planning application. Unfortunately, without any plans there is no way for anyone to evaluate the current repair work, either whether it will work or the environmental costs.
