The Pitmain Estate's Gynack overflow will the repairs, undertaken without planning permission, work?

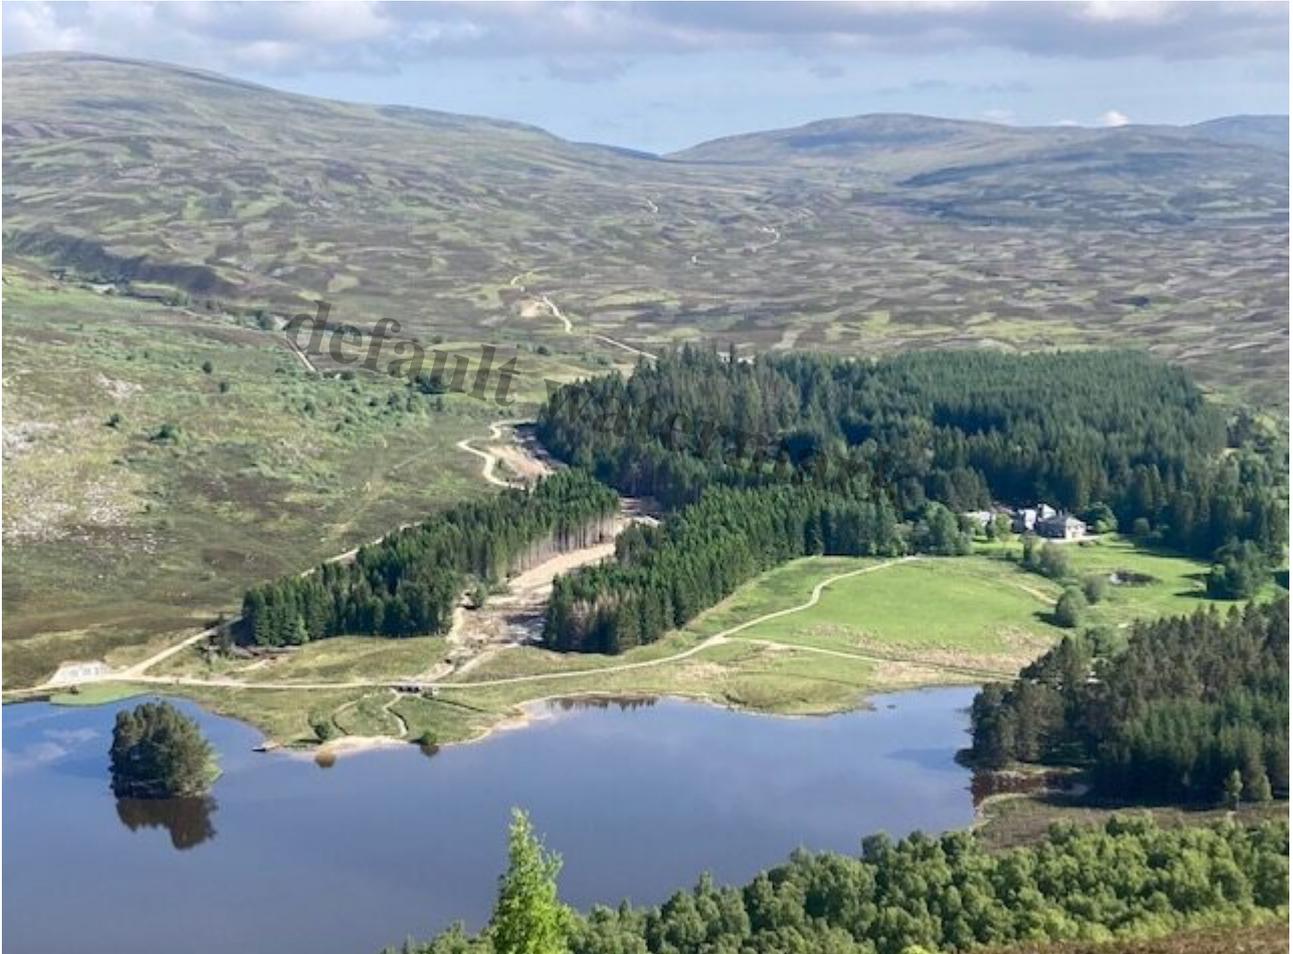
Pitmain, the view from Creag Bheag west of Kingussie showing the overflow channel through the trees, Pitmain Lodge and the extent of the muirburn beyond. Photo credit Parkswatch reader

on 11th June about whether any plans had been submitted by the estate) or that sensitive river systems are protected from silt (it was flowing into the River Gynack for two months) its about tackling the source of the problems. The photo above brilliantly shows the extent of the muirburn above the intake of the overflow, located at the top left of the plantation. Muirburn destroys trees and bog forming plants, both of which would help to hold retain water above Kingussie, and caused more rapid water run-off when it rains. Intensive grouse moor management by the Pitmain estate has been the main contributor to the flood problem in the first place.

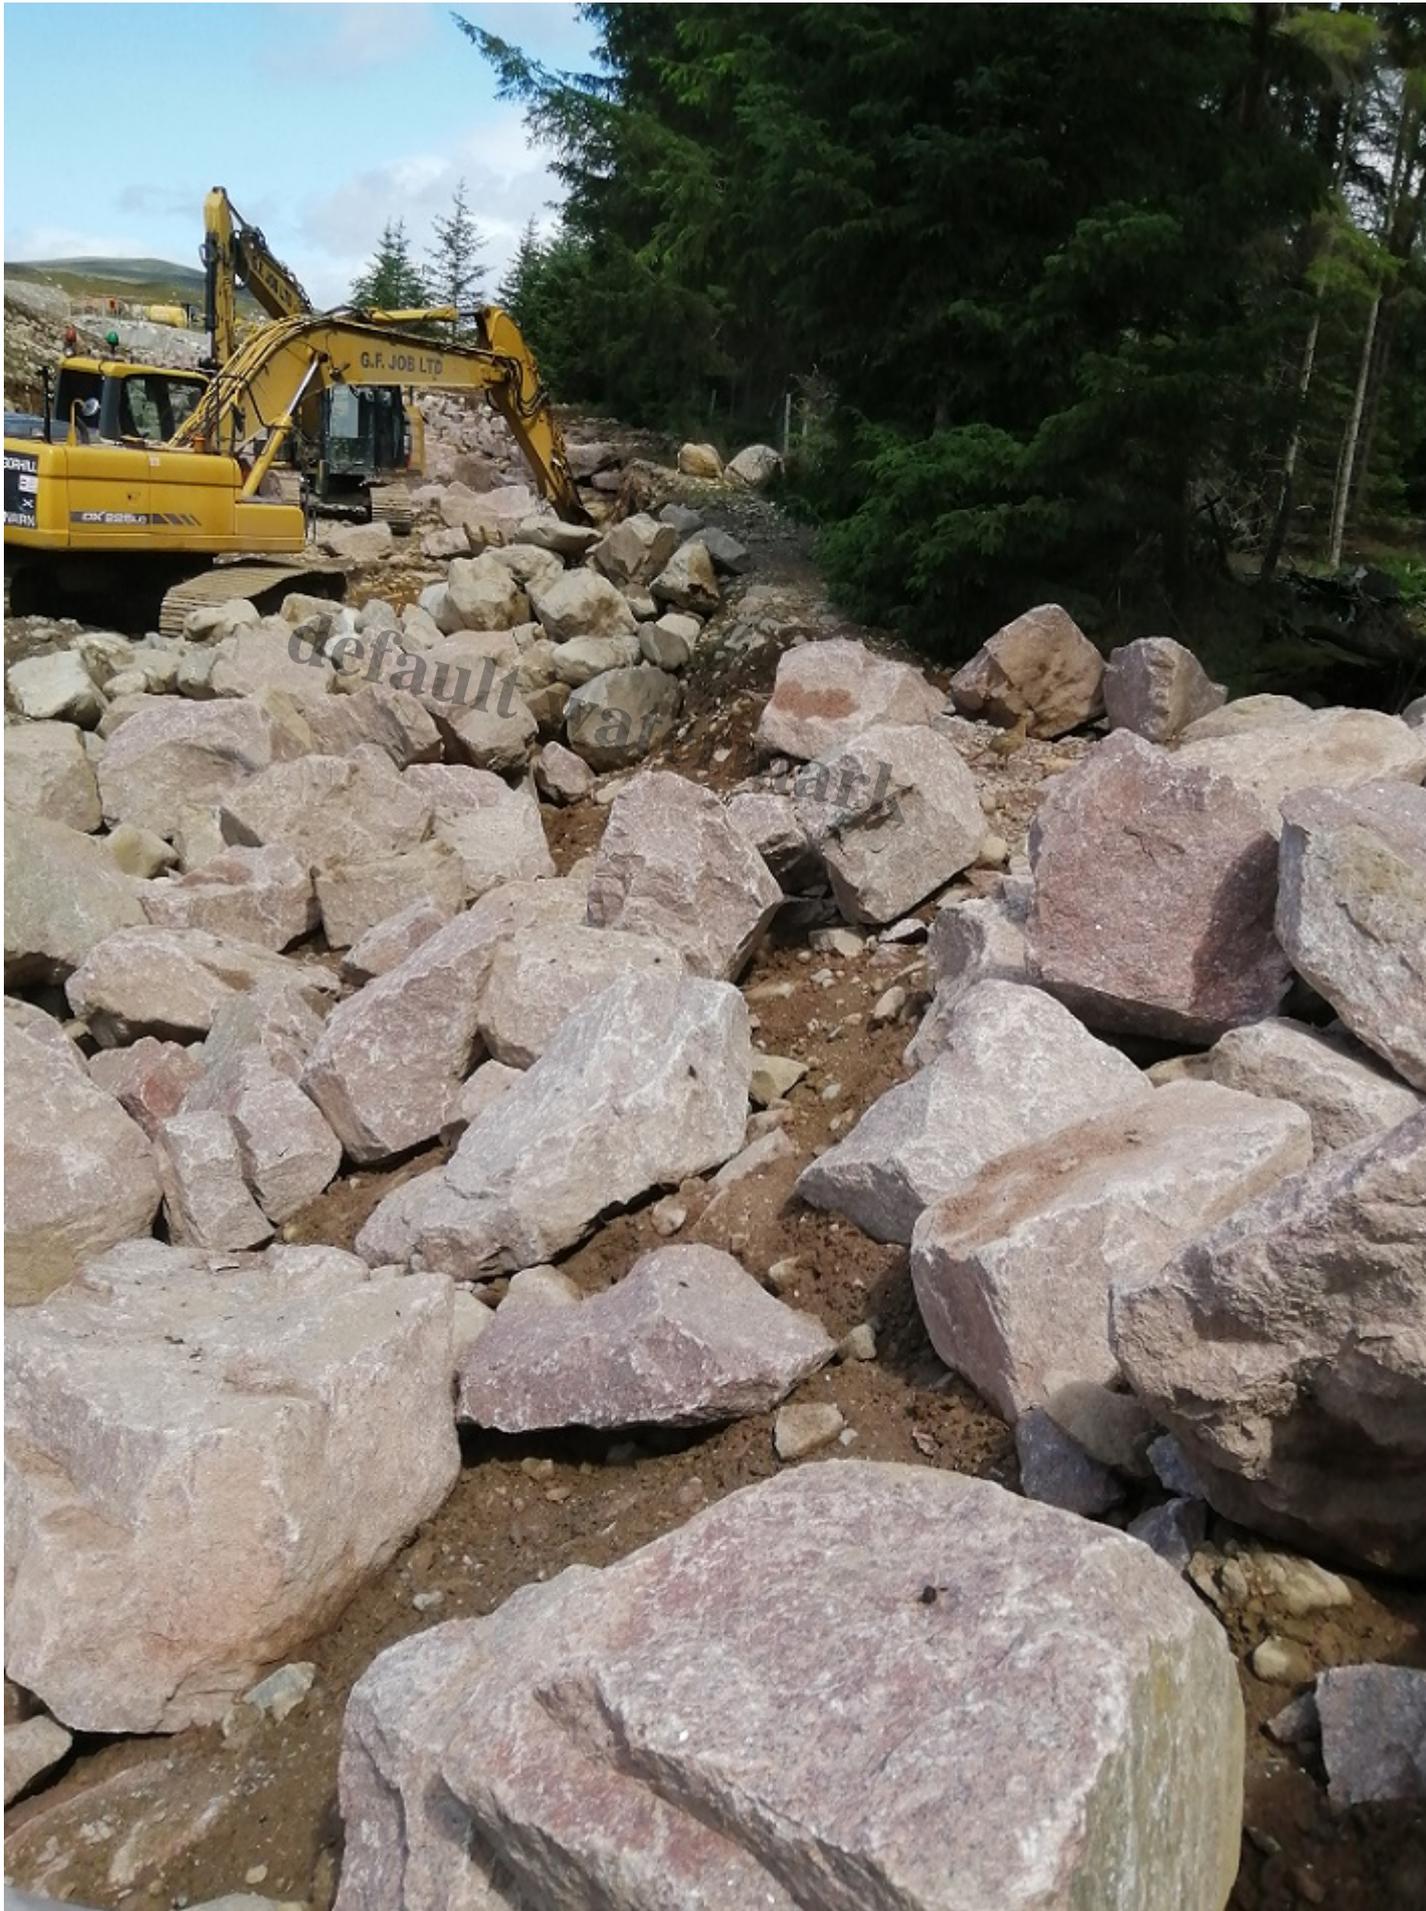
The current work appears to include reinforcing/replacing sections of earth bank with rip rap bouldering:

Moving imported boulders into place along same section of bank July 2023. Photo credit Parkswatch reader.

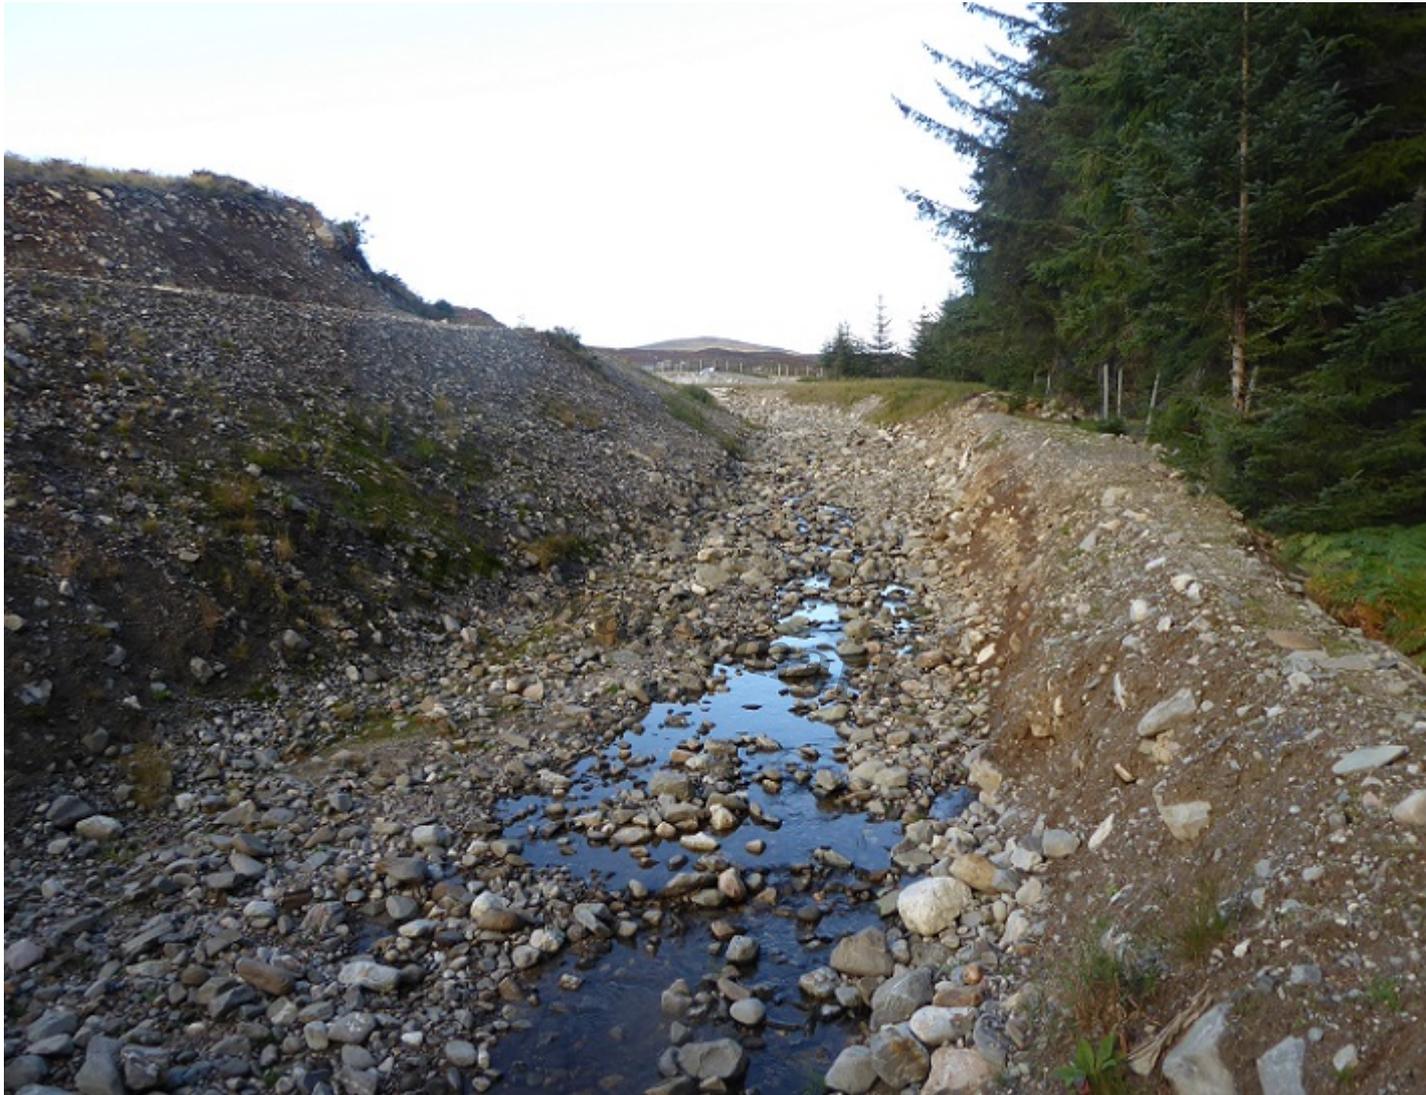
View of the upper section of the overflow from the bridge September 2020 showing eroded bank on right

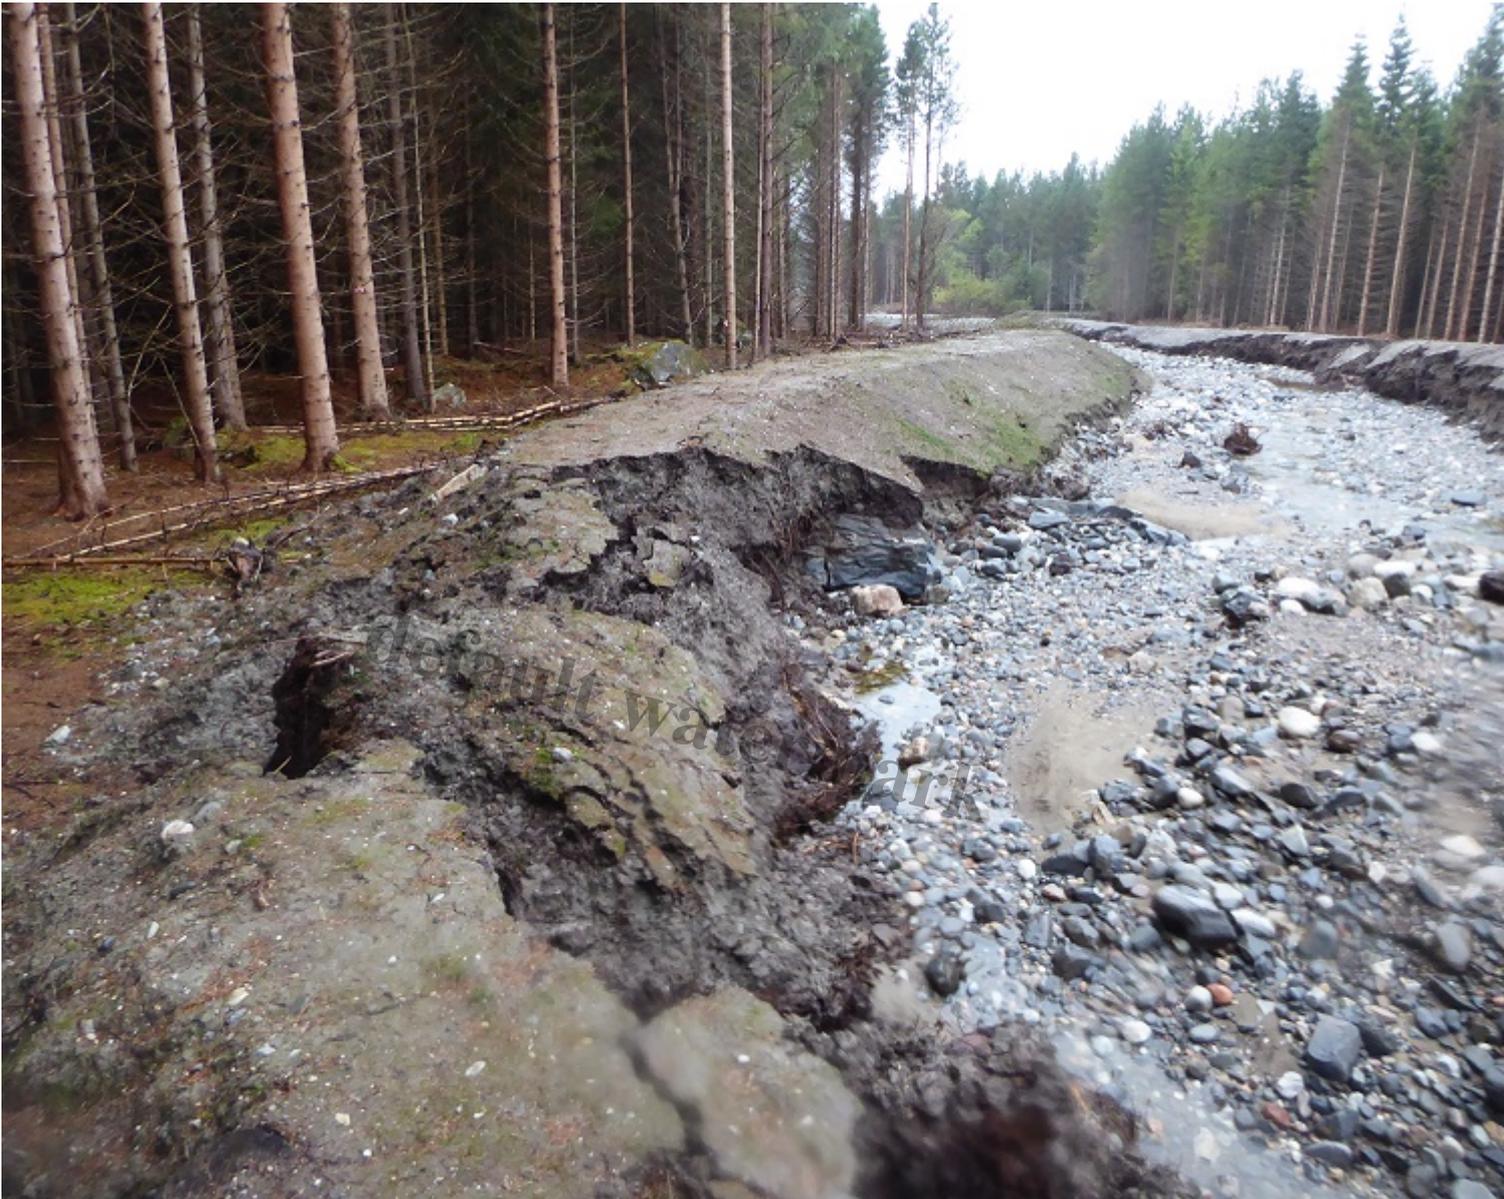
The design and construction of the banks along the lower sections of the channel was even worse and completely unfit for purpose:

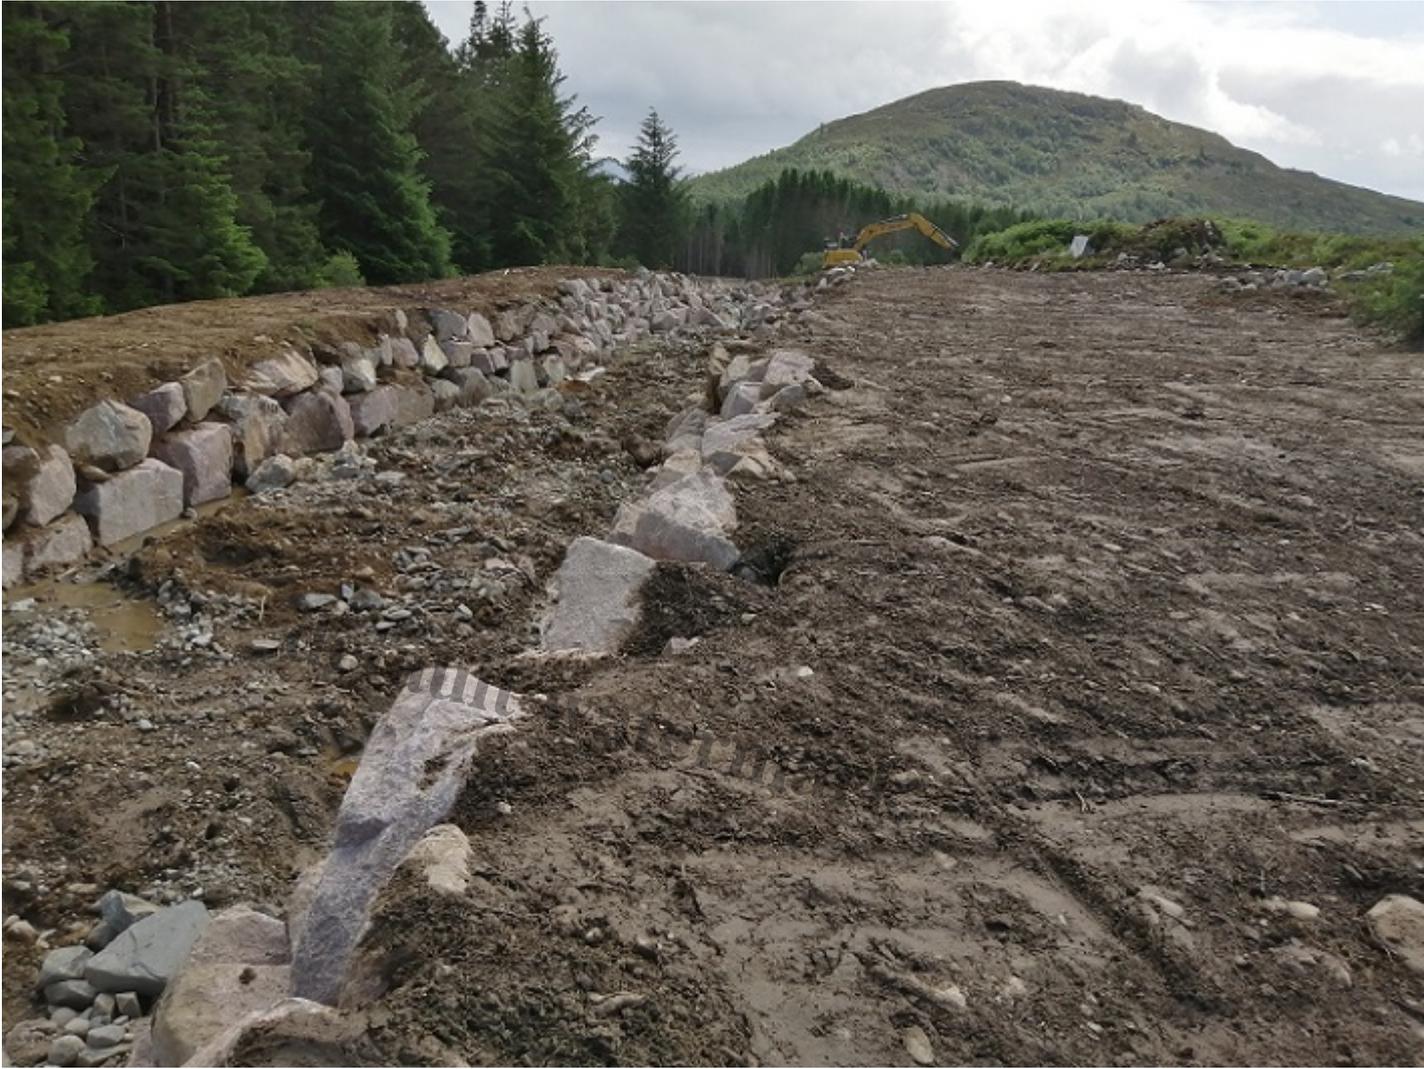
Looking down the channel from around half way towards Creag Bheag. The jumble of boulders in the middle ground shows the work is not complete. Photo credit Parkswatch reader July 2023.

From the photos it appears that bank on the left may be slightly broader and the channel itself slightly narrower than previously. This suggests that the water that will be diverted down it may be less than originally planned. However, the rip rap bouldering and floor of the channel looks little different to what was done previously. As my post back in November 2019 showed both eroded seriously as soon as the channel was used ([see here](#)). Despite my call for the CNPA and others to investigate what lessons could be learned from this engineering disaster, no-one appears to have done this.

The recent photo also shows that so far there has been no attempt to restore any of the vegetation on the right bank and it is flatter than previously, creating an unnatural landscape.

From an engineering perspective the new channel looks to me like another disaster waiting to happen. On the first serious flood, what is to stop some of the rip rap boulders being plucked from the banks or to prevent the loose debris on the floor of the channel being swept away once again, releasing yet more silt into the river system? Time will tell but if the channel fails the Scottish Parliament's Climate Change Committee, part of whose role is to look at how Scotland is adapting to Climate Change, should investigate.

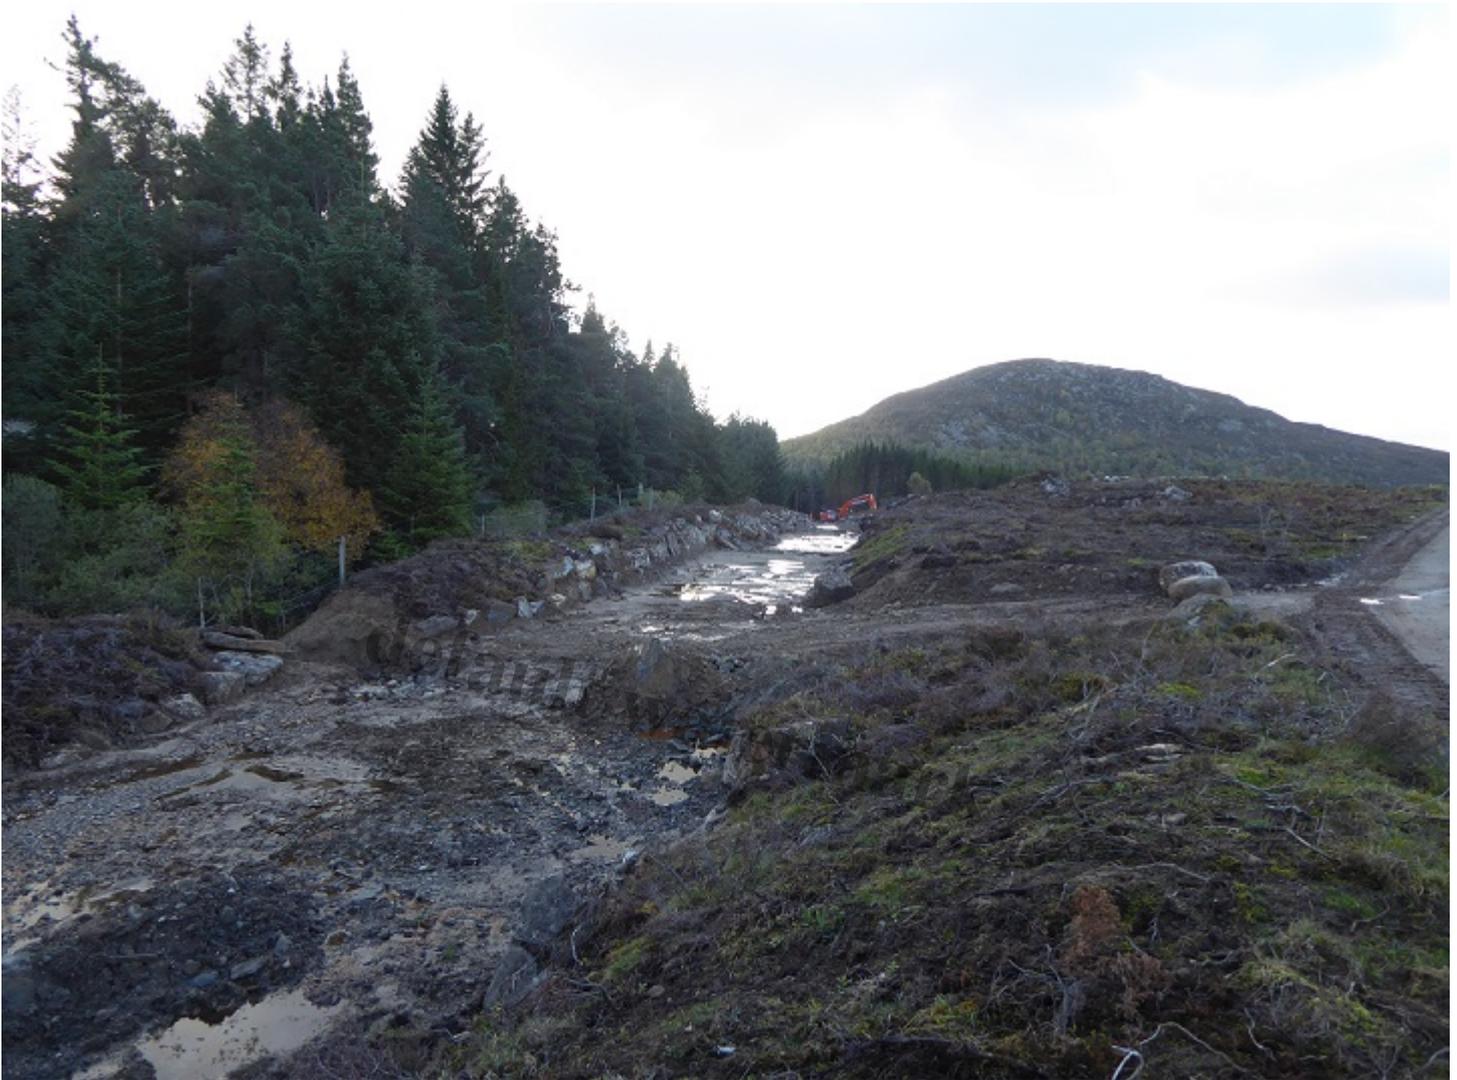
Comparing this with a photo from a similar viewpoint showing how the channel looked during construction in October 2017 shows that while the work has been extensive many of the original design flaws have been repeated:
