The Pitmain Estate's Gynack overflow – will the repairs, undertaken without planning permission, work?

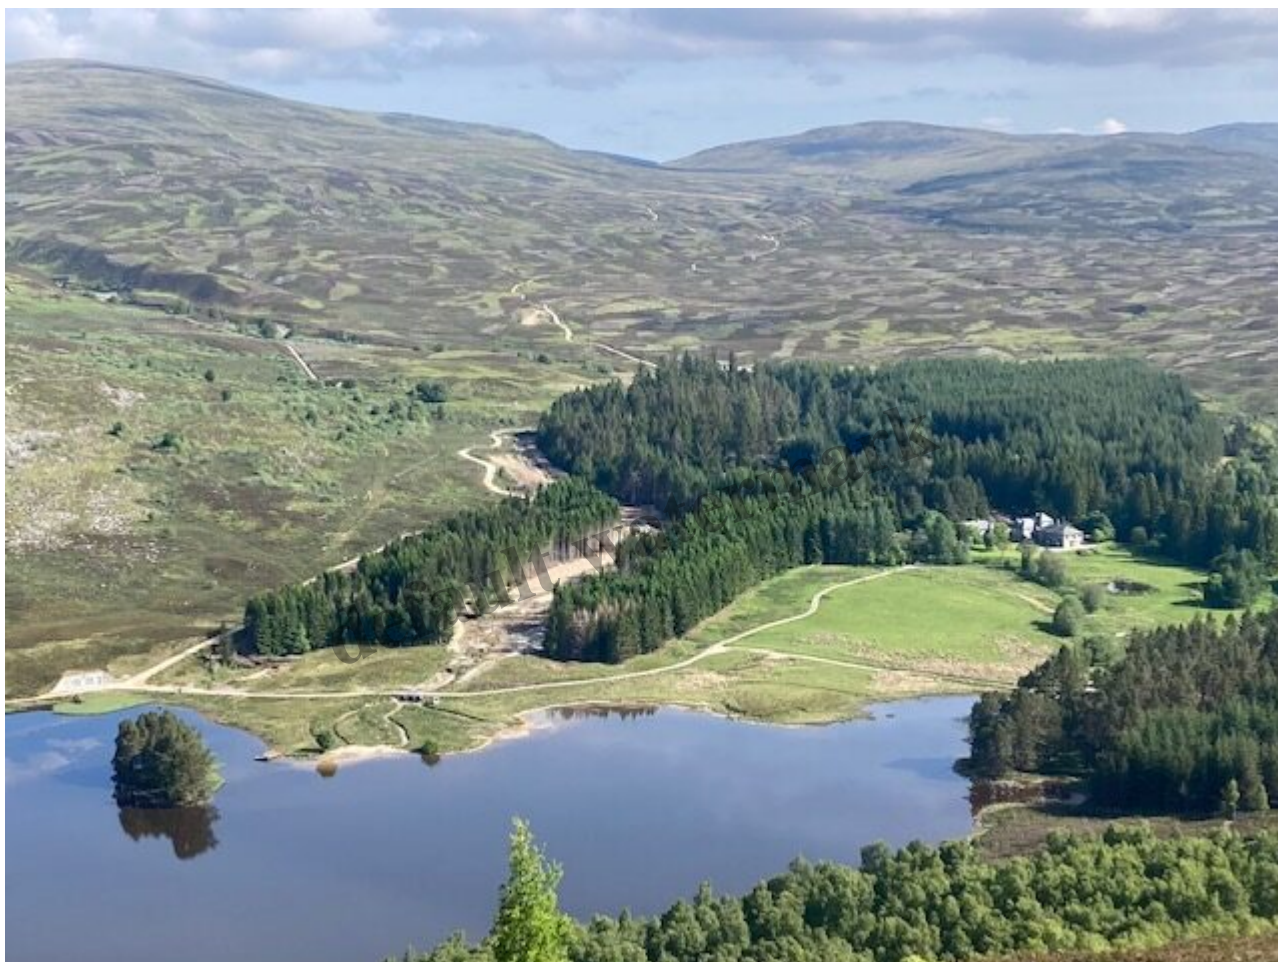
Pitmain, the view from Creag Bheag west of Kingussie showing the overflow channel through the trees, Pitmain Lodge and the extent of the muirburn beyond. Photo credit Parkswatch reader

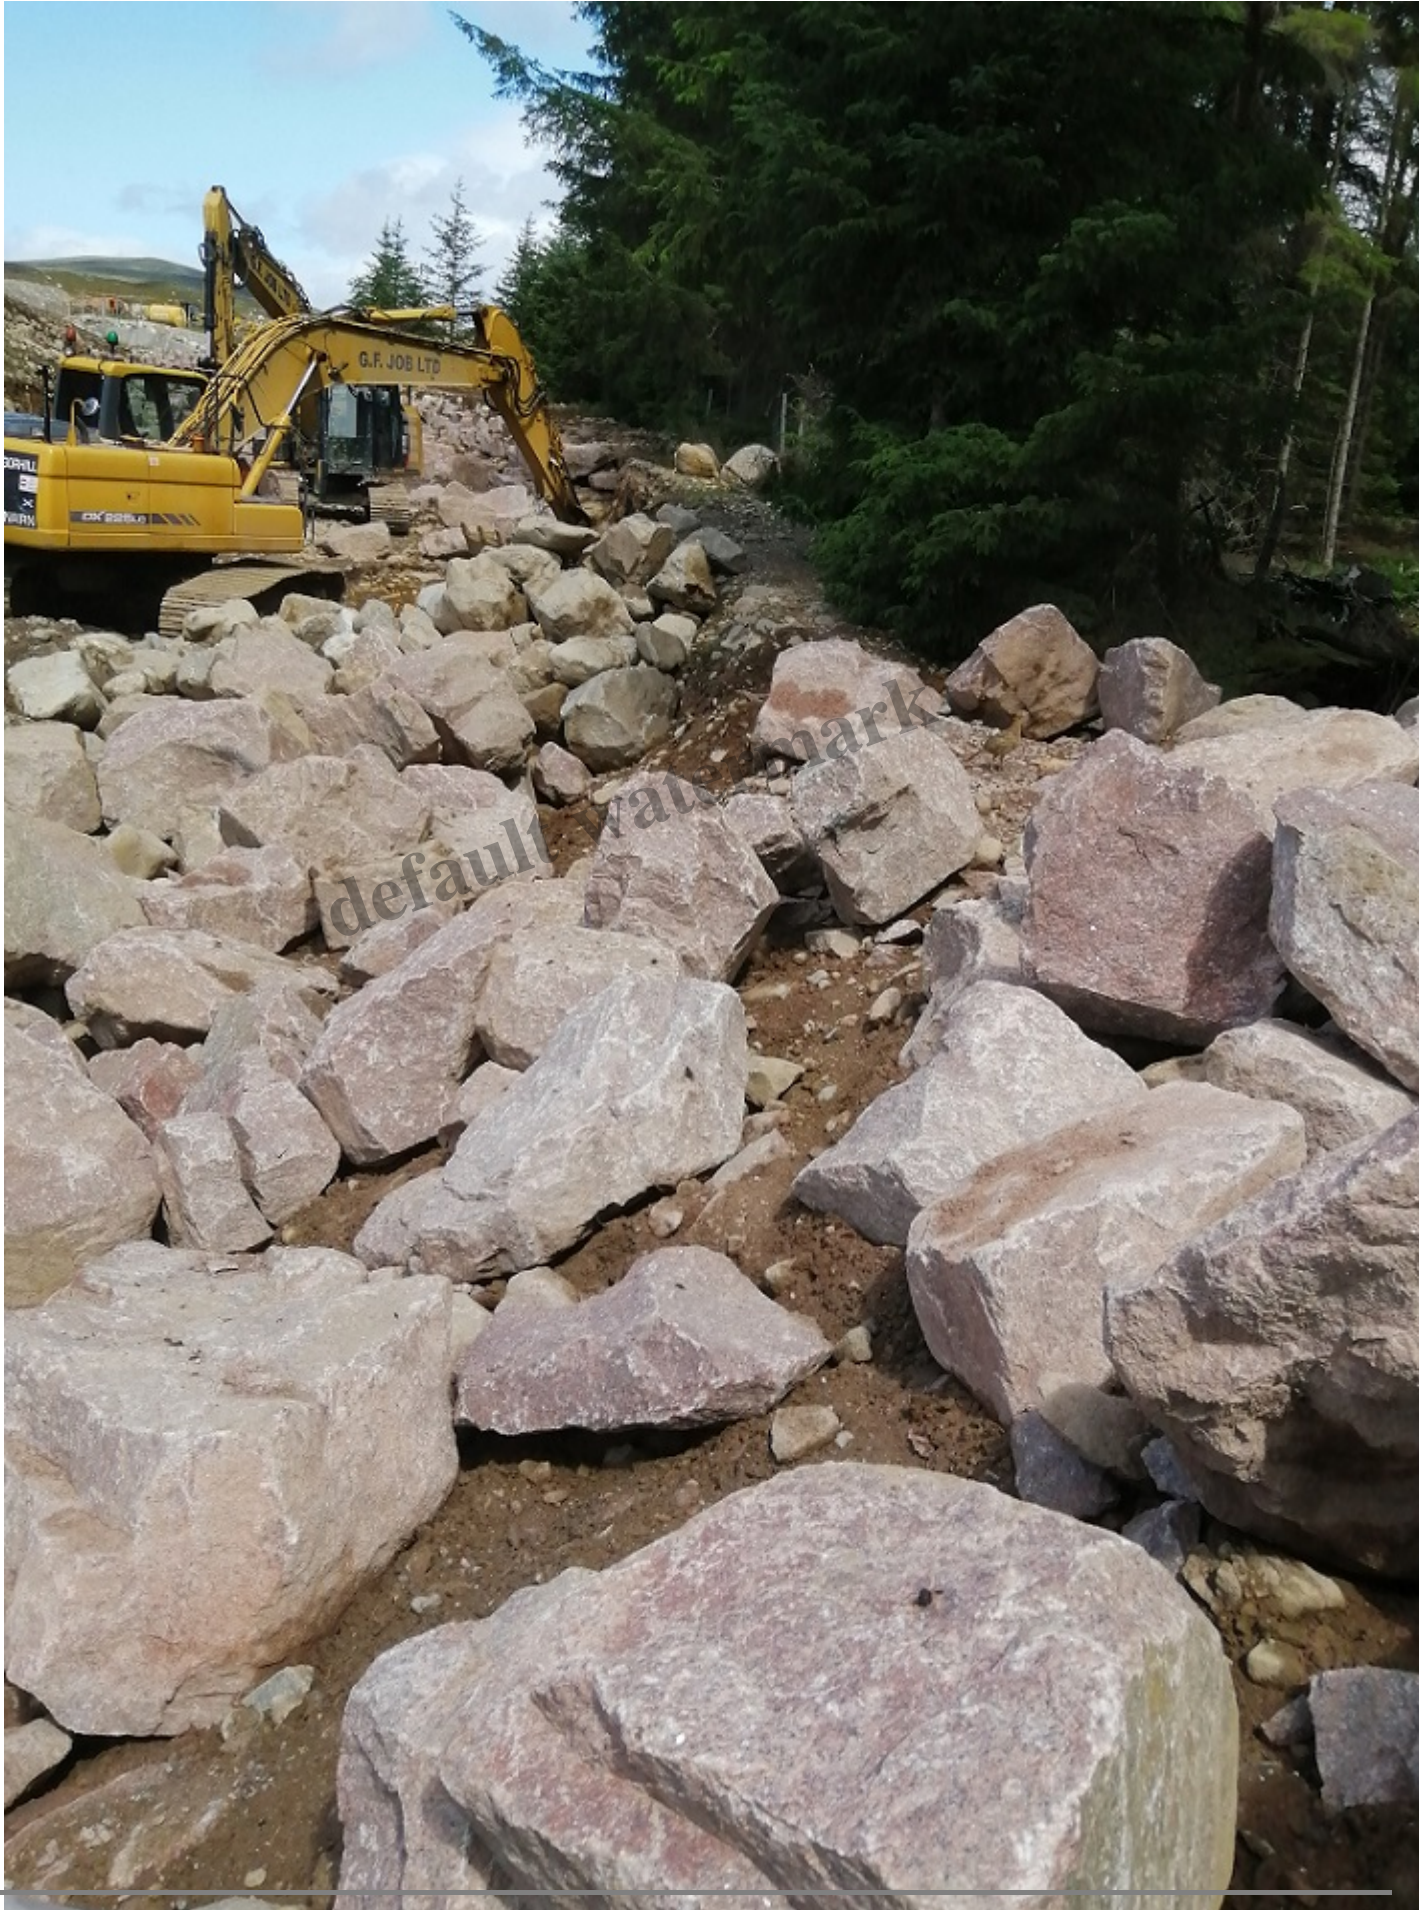
The current work appears to include reinforcing/replacing sections of earth bank with rip rap bouldering:

Moving imported boulders into place along same section of bank July 2023. Photo credit Parkswatch reader.

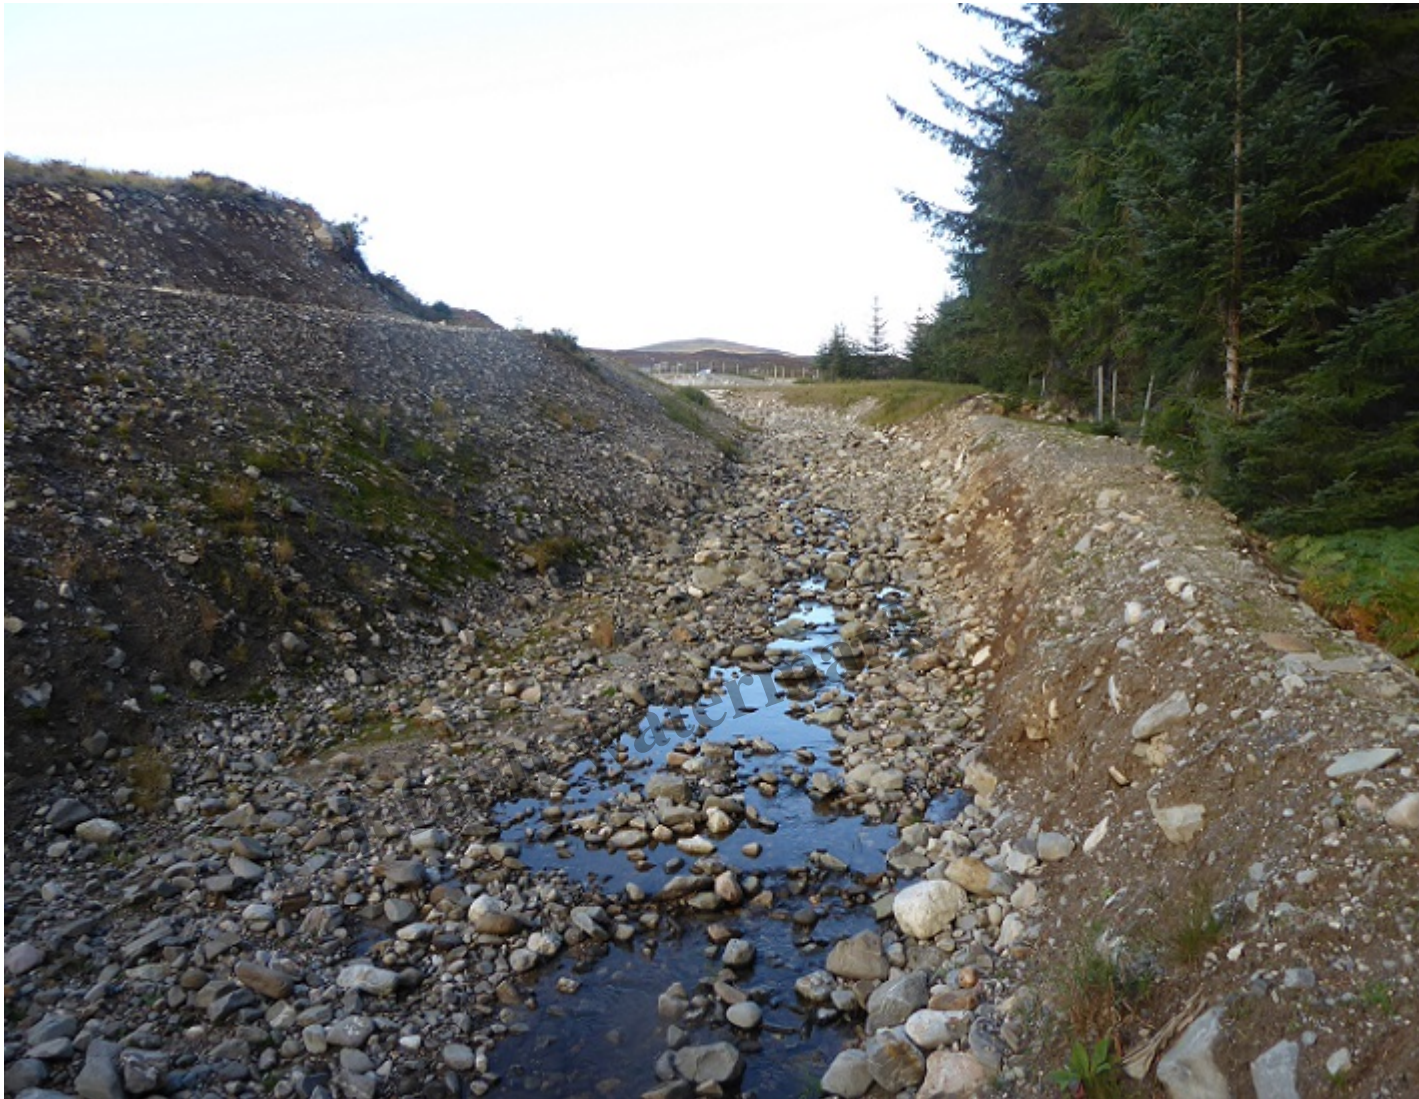
View of the upper section of the overflow from the bridge September 2020 showing eroded bank on right

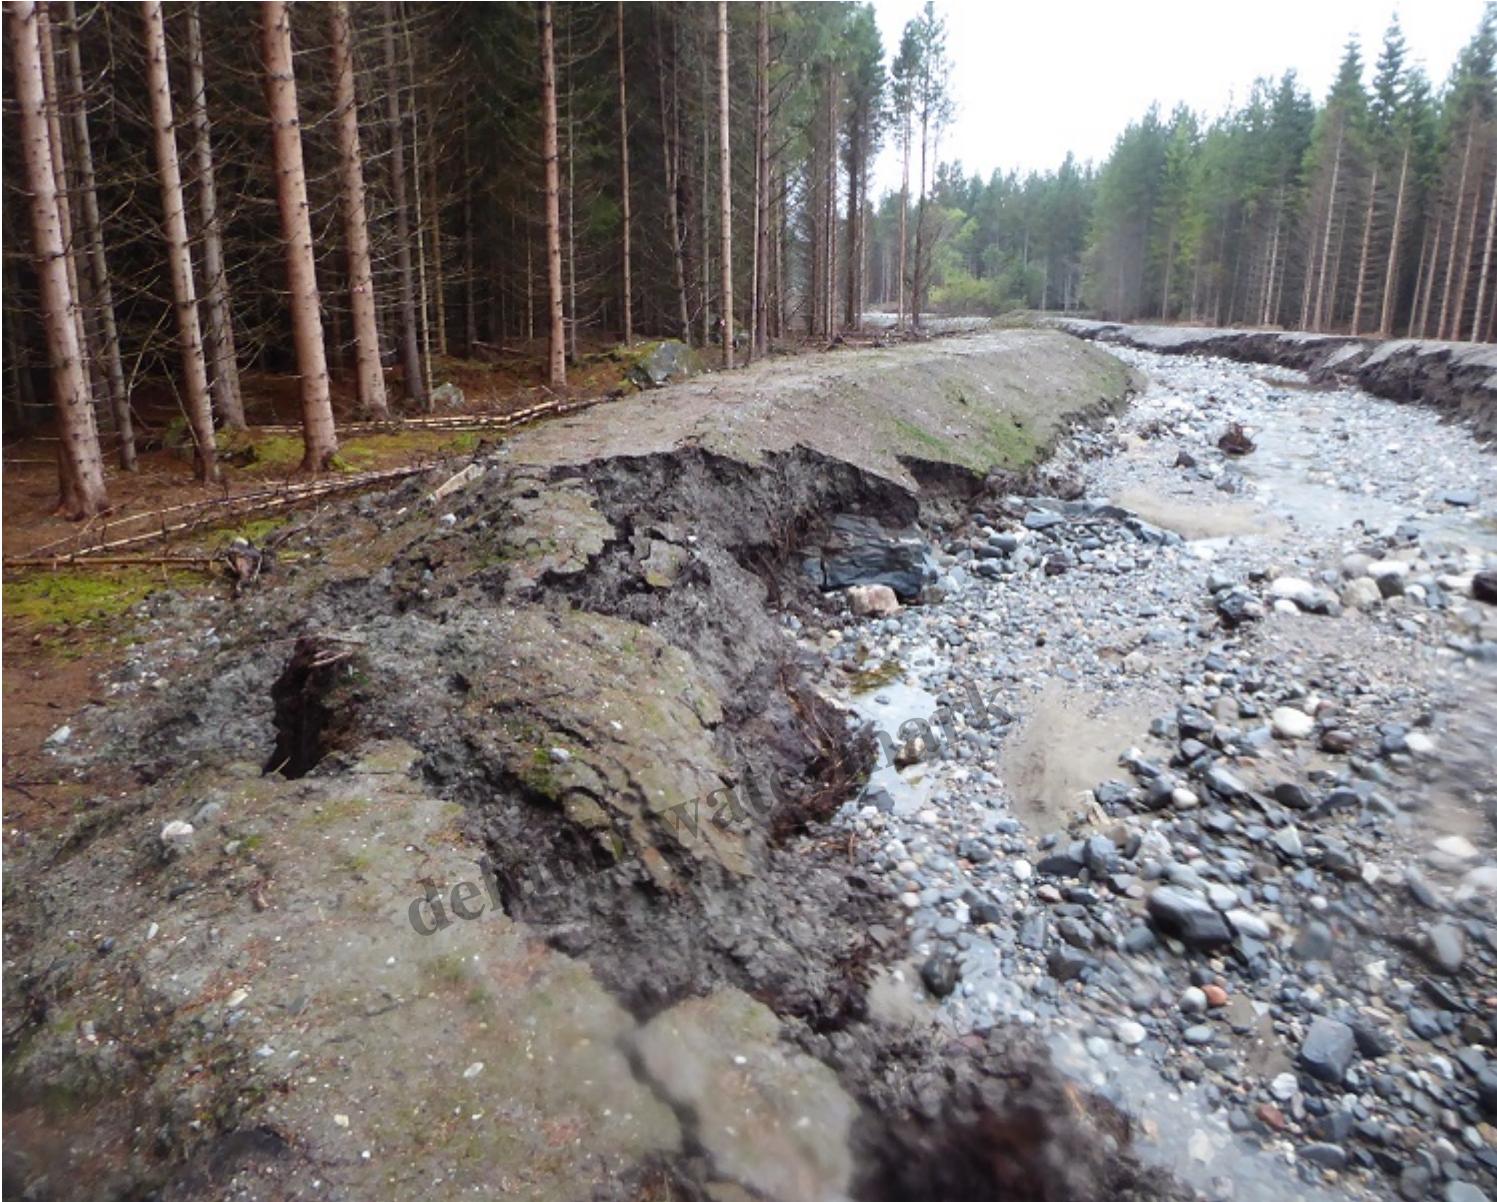
The design and construction of the banks along the lower sections of the channel was even worse and completely unfit for purpose:

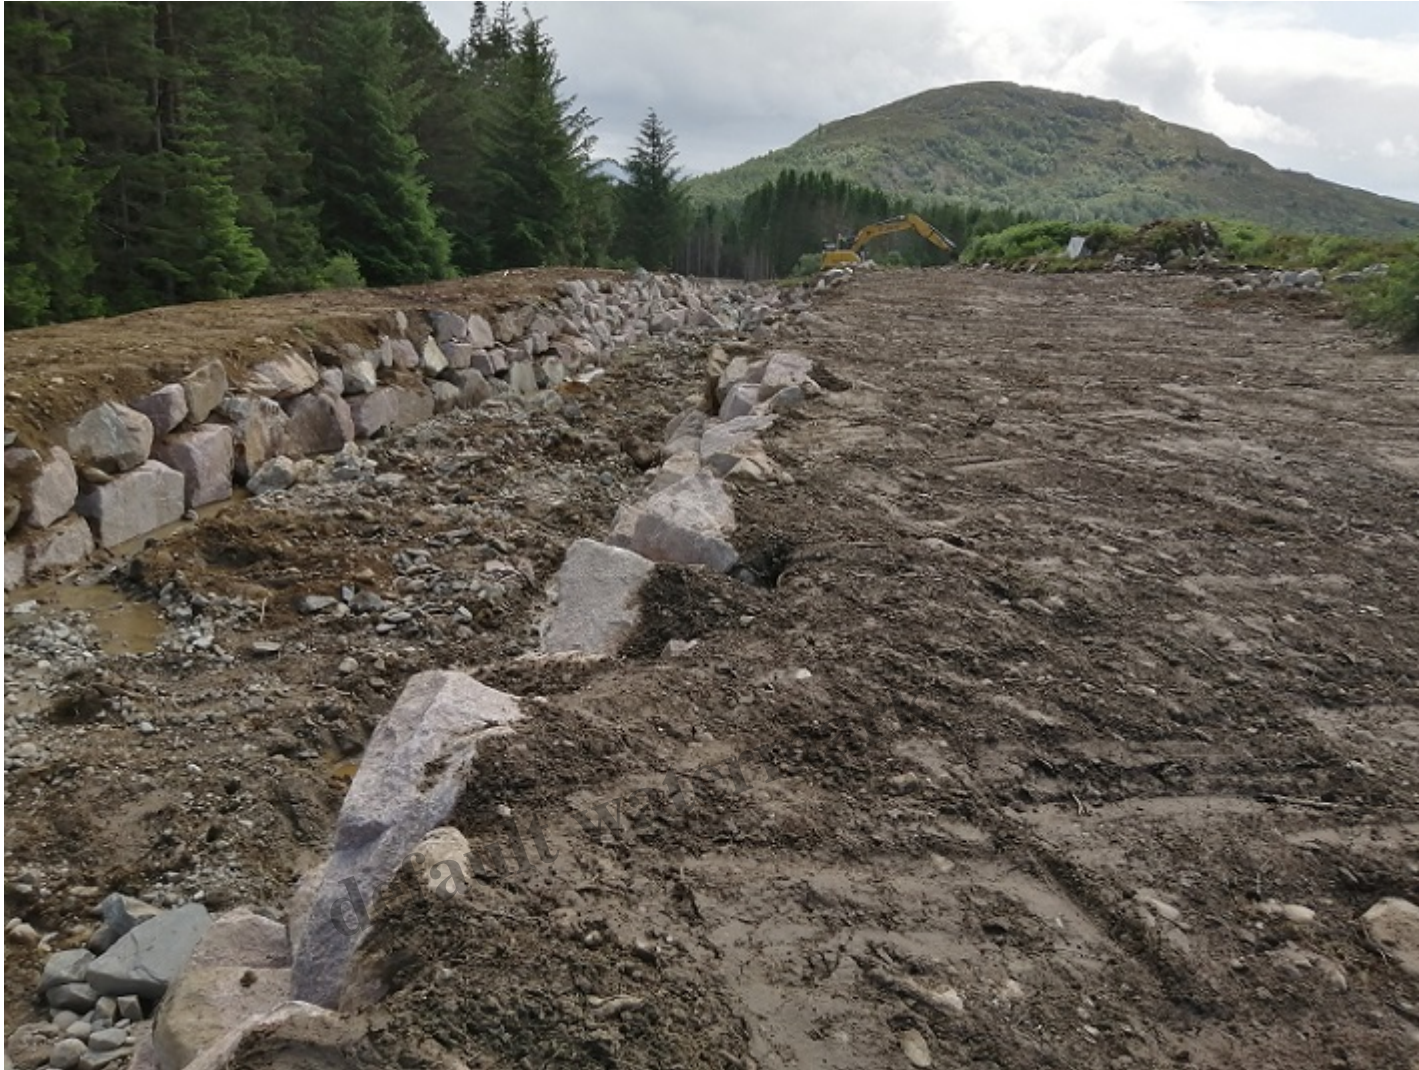
Looking down the channel from around half way towards Creag Bheag. The jumble of boulders in the middle ground shows the work is not complete. Photo credit Parkswatch reader July 2023.

From the photos it appears that bank on the left may be slightly broader and the channel itself slightly narrower than previously. This suggests that the water that will be diverted down it may be less than originally planned. However, the rip rap bouldering and floor of the channel looks little different to what was done previously. As my post back in November 2019 showed both eroded seriously as soon as the channel was used ([see here](#)). Despite my call for the CNPA and others to investigate what lessons could be learned from this engineering disaster, no-one appears to have done this.

The recent photo also shows that so far there has been no attempt to restore any of the vegetation on the right bank and it is flatter than previously, creating an unnatural landscape.

From an engineering perspective the new channel looks to me like another disaster waiting to happen. On the first serious flood, what is to stop some of the rip rap boulders being plucked from the banks or to prevent the loose debris on the floor of the channel being swept away once again, releasing yet more silt into the river system? Time will tell but if the channel fails the Scottish Parliament's Climate Change Committee, part of whose role is to look at how Scotland is adapting to Climate Change, should investigate.

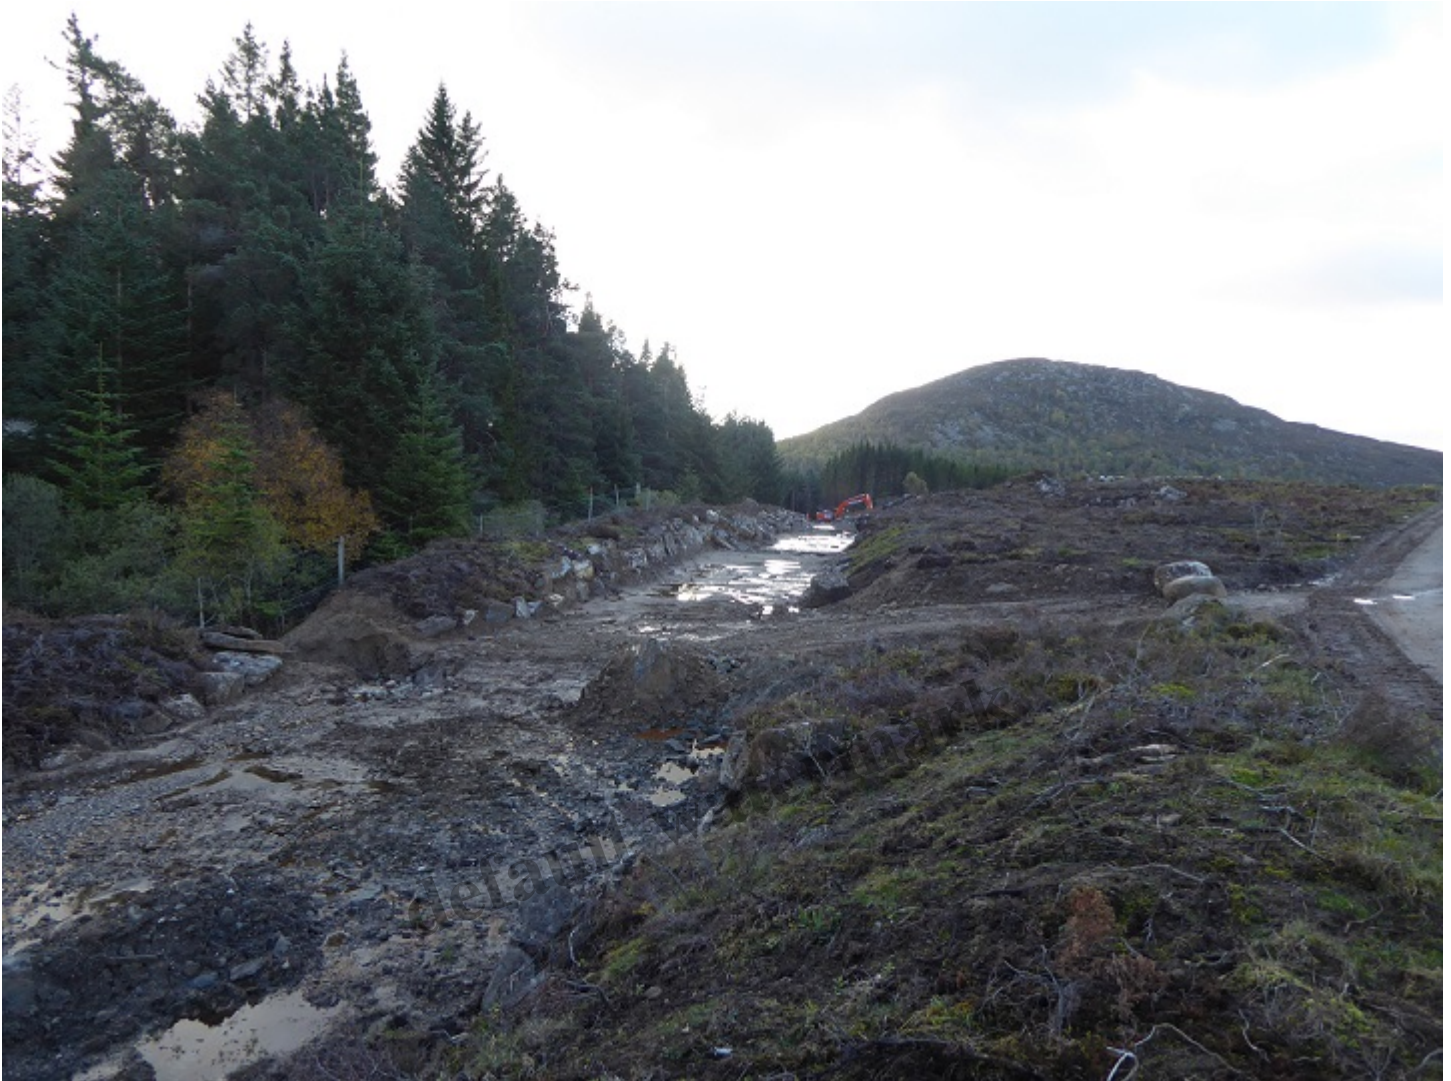
Comparing this with a photo from a similar viewpoint showing how the channel looked during construction in October 2017 shows that while the work has been extensive many of the original design flaws have been repeated:
