The Pitmain Estate's Gynack overflow – will the repairs, undertaken without planning permission, work?

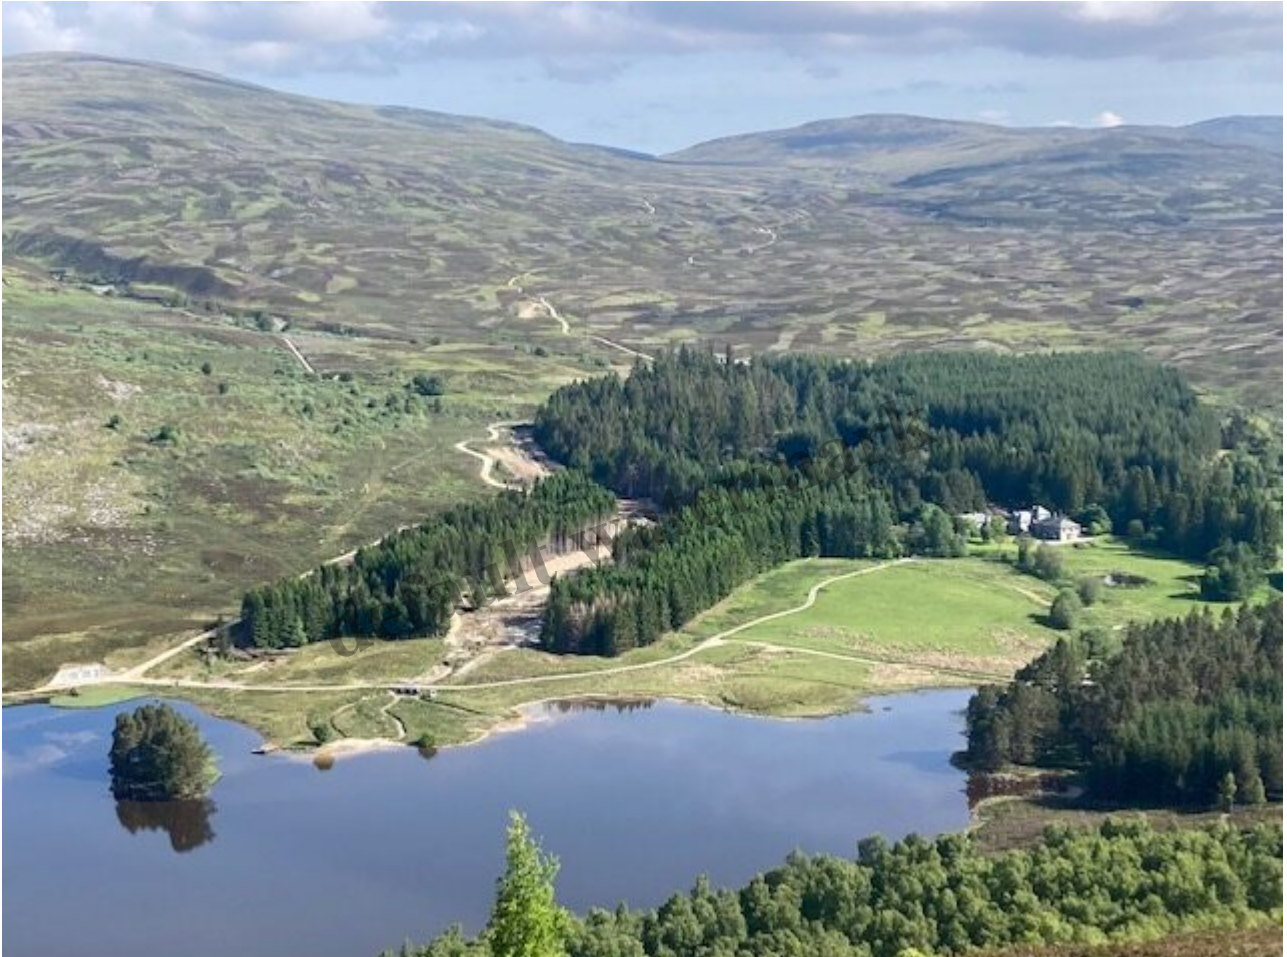
Pitmain, the view from Creag Bheag west of Kingussie showing the overflow channel through the trees, Pitmain Lodge and the extent of the muirburn beyond. Photo credit Parkswatch reader
