Some questions HIE needs to answer about the safety of the Cairn Gorm funicular

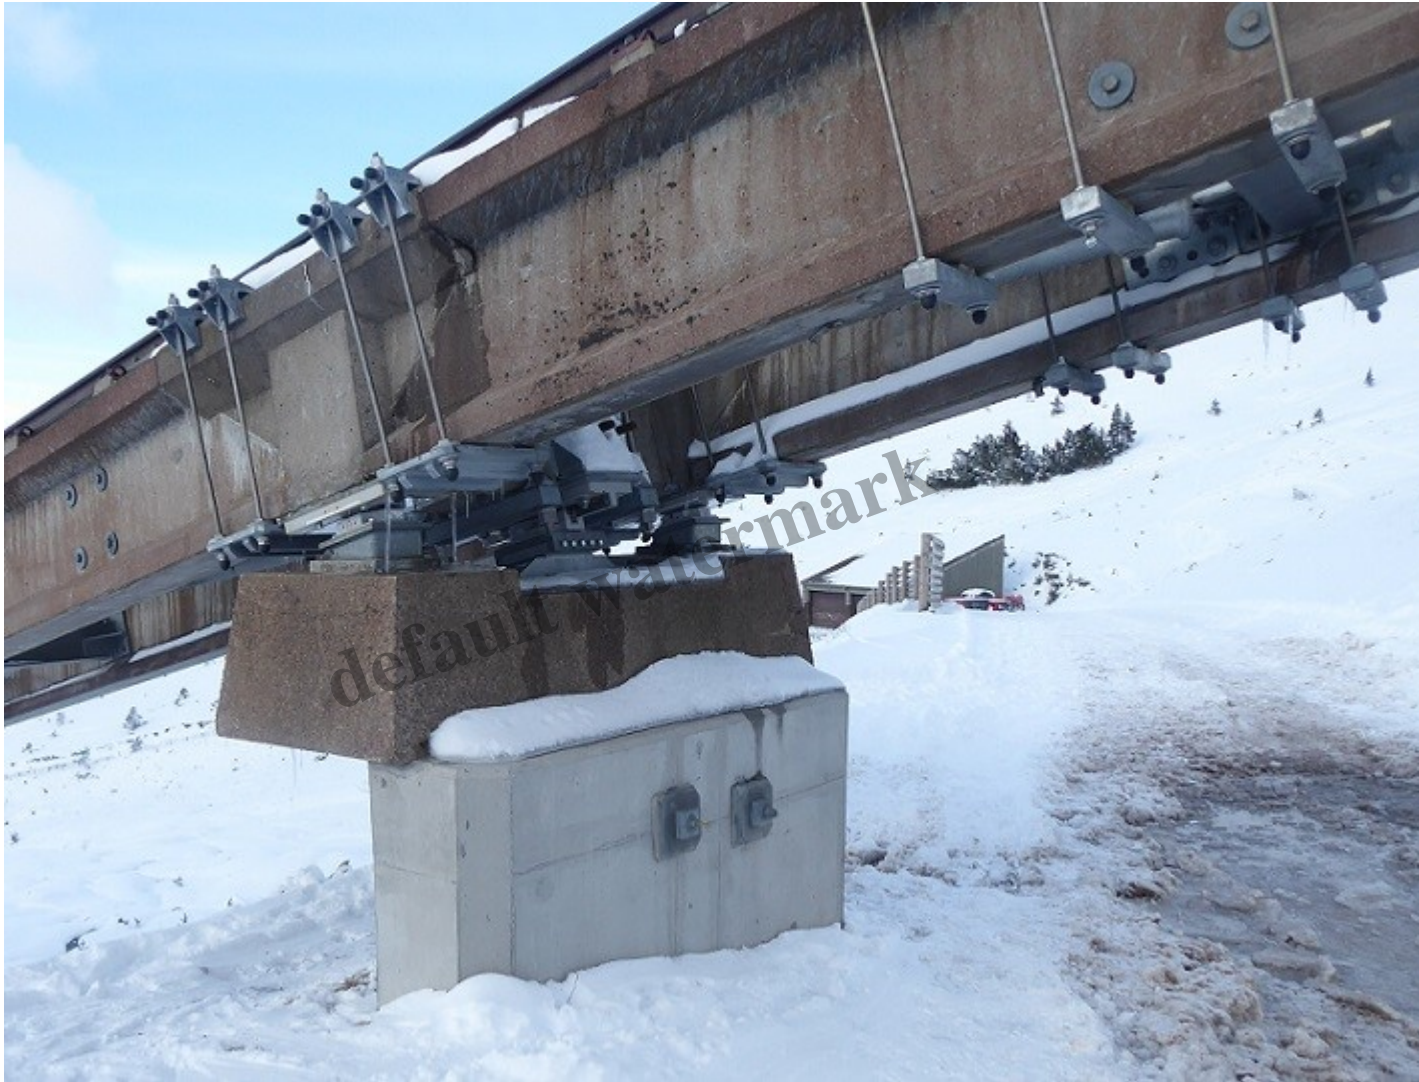
Pier below shieling with new concrete collar and metal braces on the "I" beam

(a) That the concrete “I” beams are not strong enough for the length of the span (I was made aware of this by a person with 36 years experience in this line of work). This would appear to be confirmed by the steel work around the “I” beams (see top photo), although HIE has never explained the reason for this;

(b) Related to this, the COWI report of December 2018 stated “The precast beams are reinforced but not pre-stressed”. I am grateful to an academic lecturer in railways for informing me that the minimum depth for a concrete “I” beam which is not pre-stressed should be 8cm for every 1m length. That means the safe depth of the “I” beam is therefore  $8 \times 18 = 144\text{cm}$  not the actual 80cm! This figure may be for current standards and not those from 1999 but the conclusion is that after the funicular failed all the beams should either have been replaced or strengthened along their whole length in order to comply with today’s standards.

One option to do this would be to use a Carbon Fibre Reinforced Polymer wrap, as explained by this company:

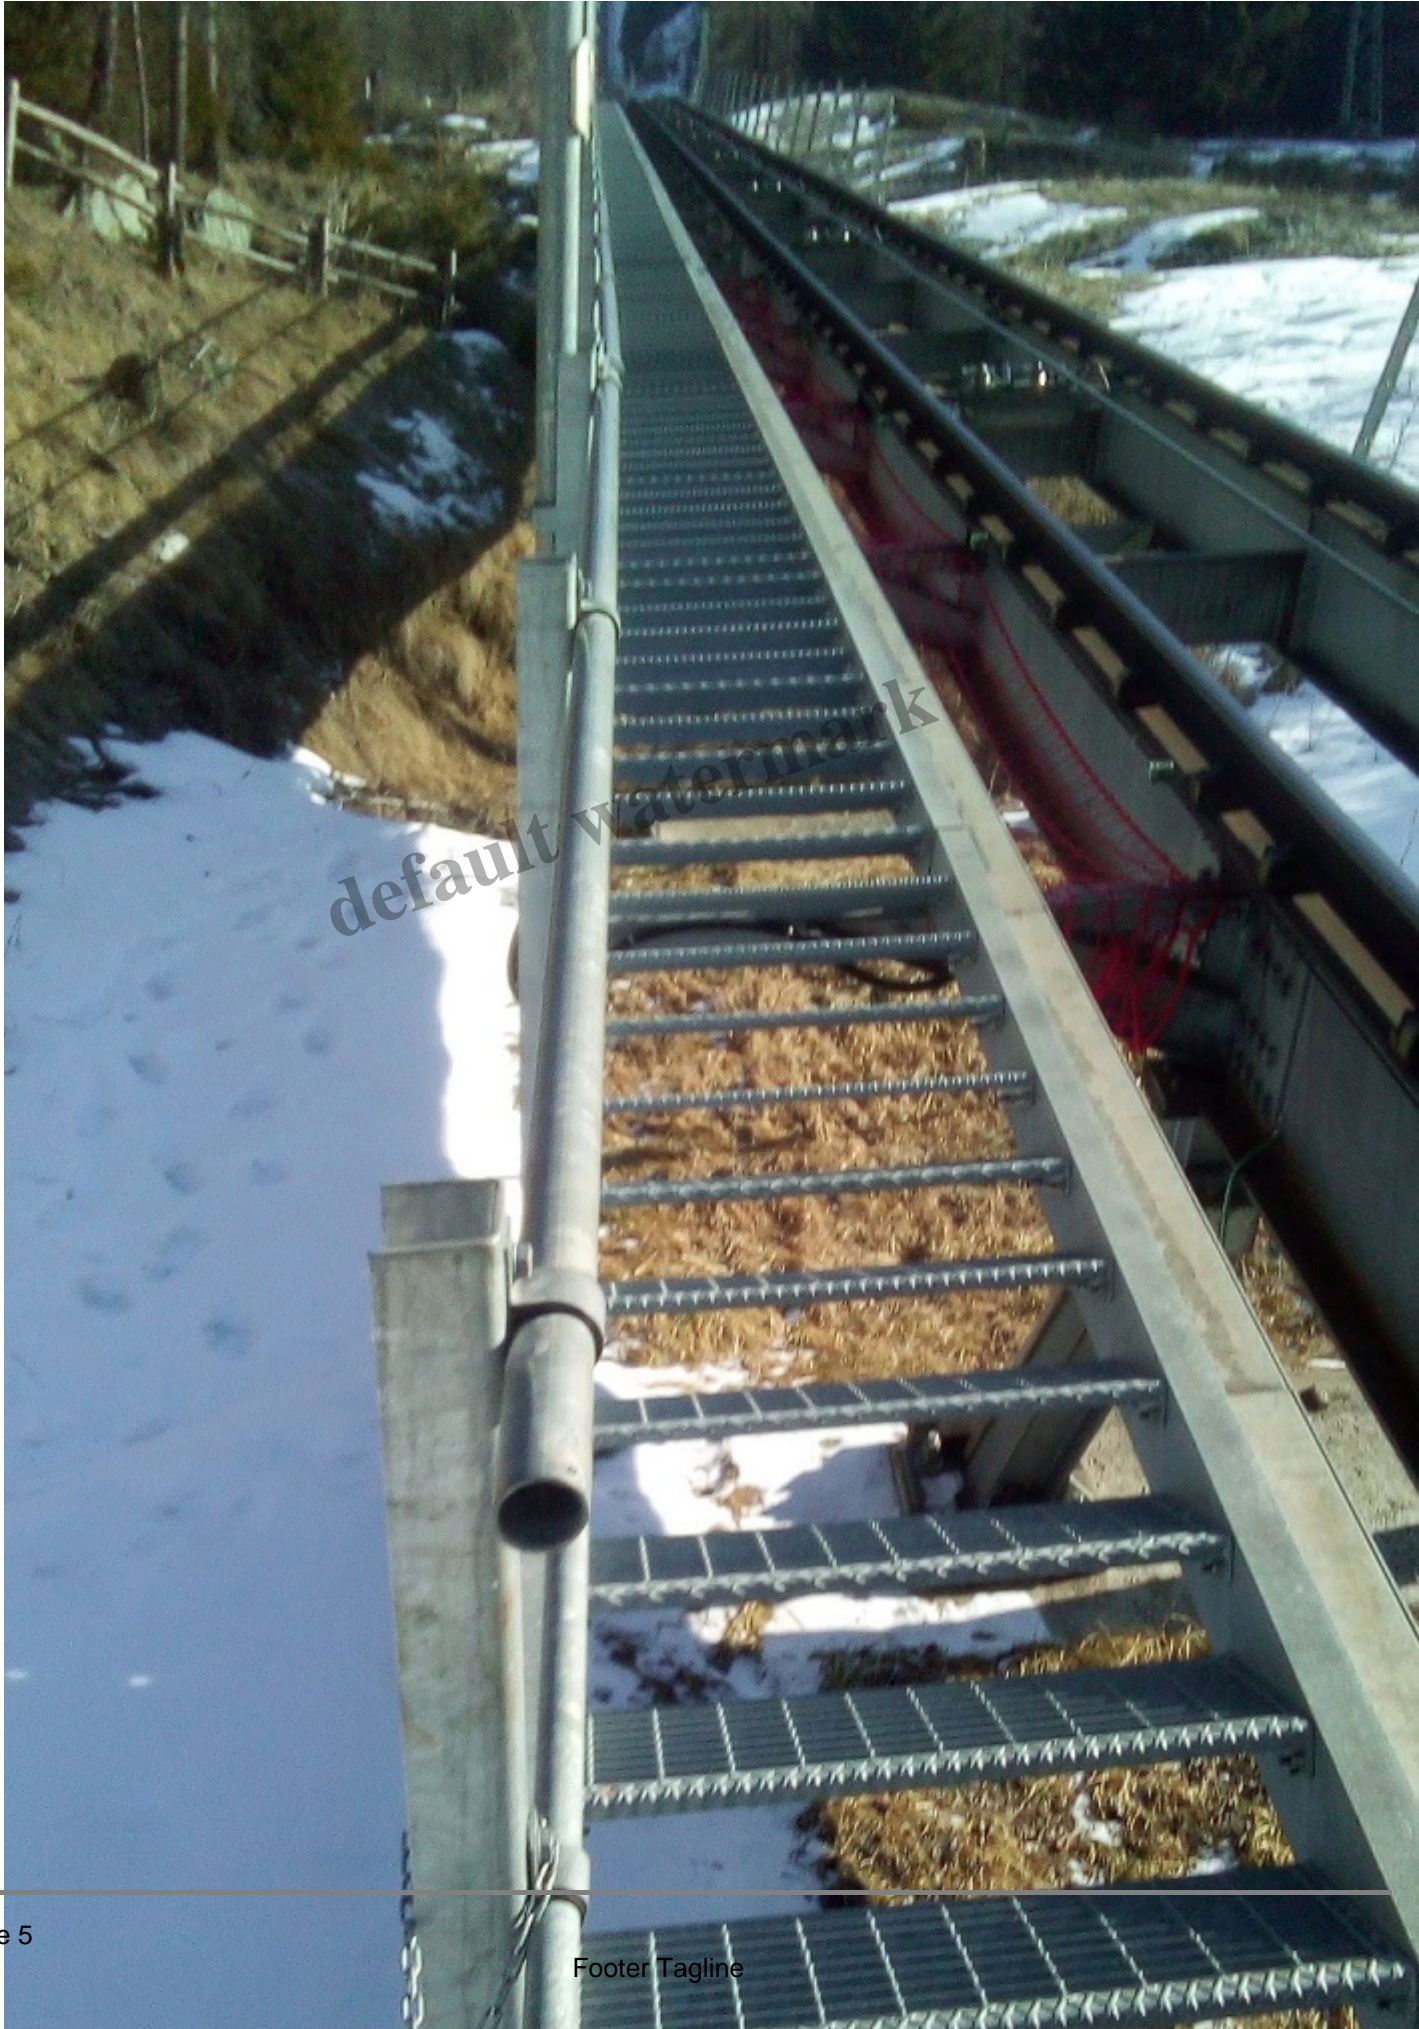
Walkway alongside the Frachey Funicular in Champoluc showing what an escape walkway should look like

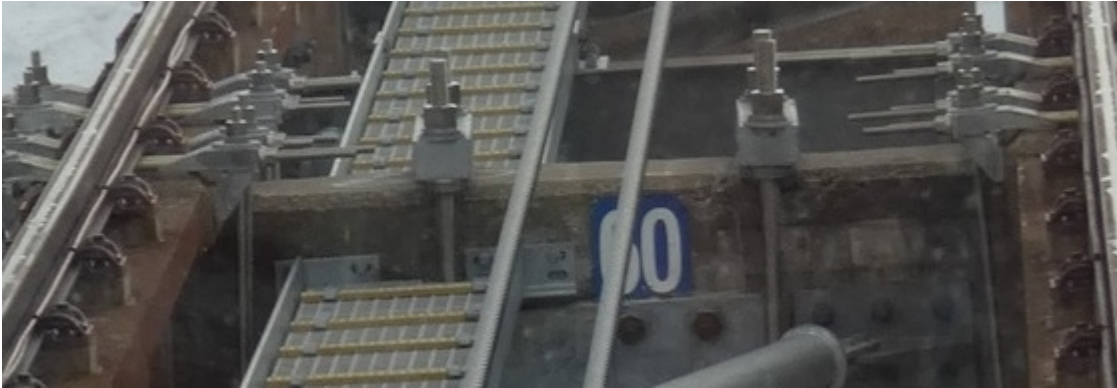
And at Cairn Gorm:

What has now been installed on the Cairn Gorm funicular, a walkway between the tracks, may be acceptable for maintenance but is completely unsuitable as an escape route in case of breakdown as there is no access to the walkway from the train. Therefore if stranded, customers and staff would be stuck!

**The views of the HSE suggest the re-opening of the funicular should not have been approved as there appears to be no means in place for safe evacuation of passengers. Should the funicular now be closed until the HSE agree that a safe means of evacuation, for both staff and passengers, is in place?**
