Some questions HIE needs to answer about the safety of the Cairn Gorm funicular

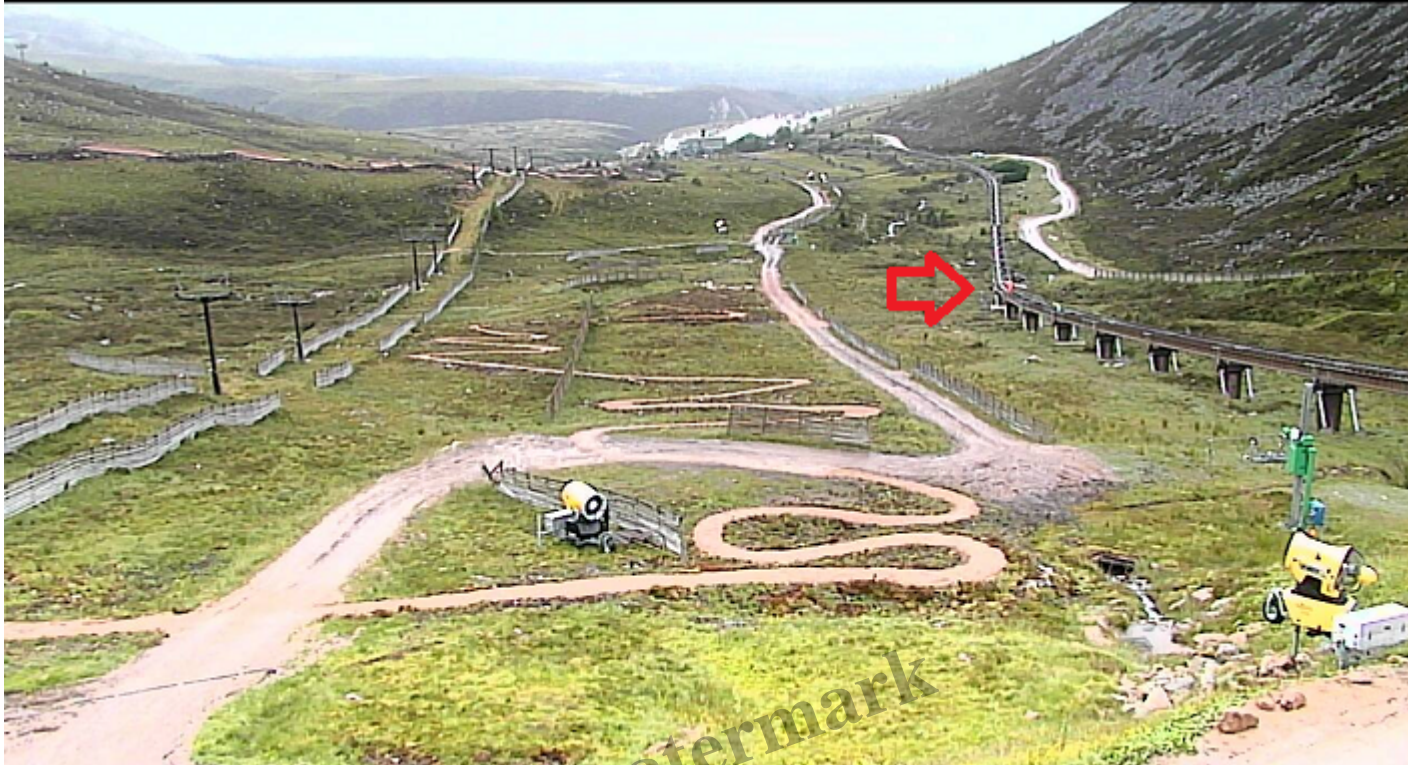
Two people working on the funicular structure on a Thursday evening
