Some questions HIE needs to answer about the safety of the Cairn Gorm funicular

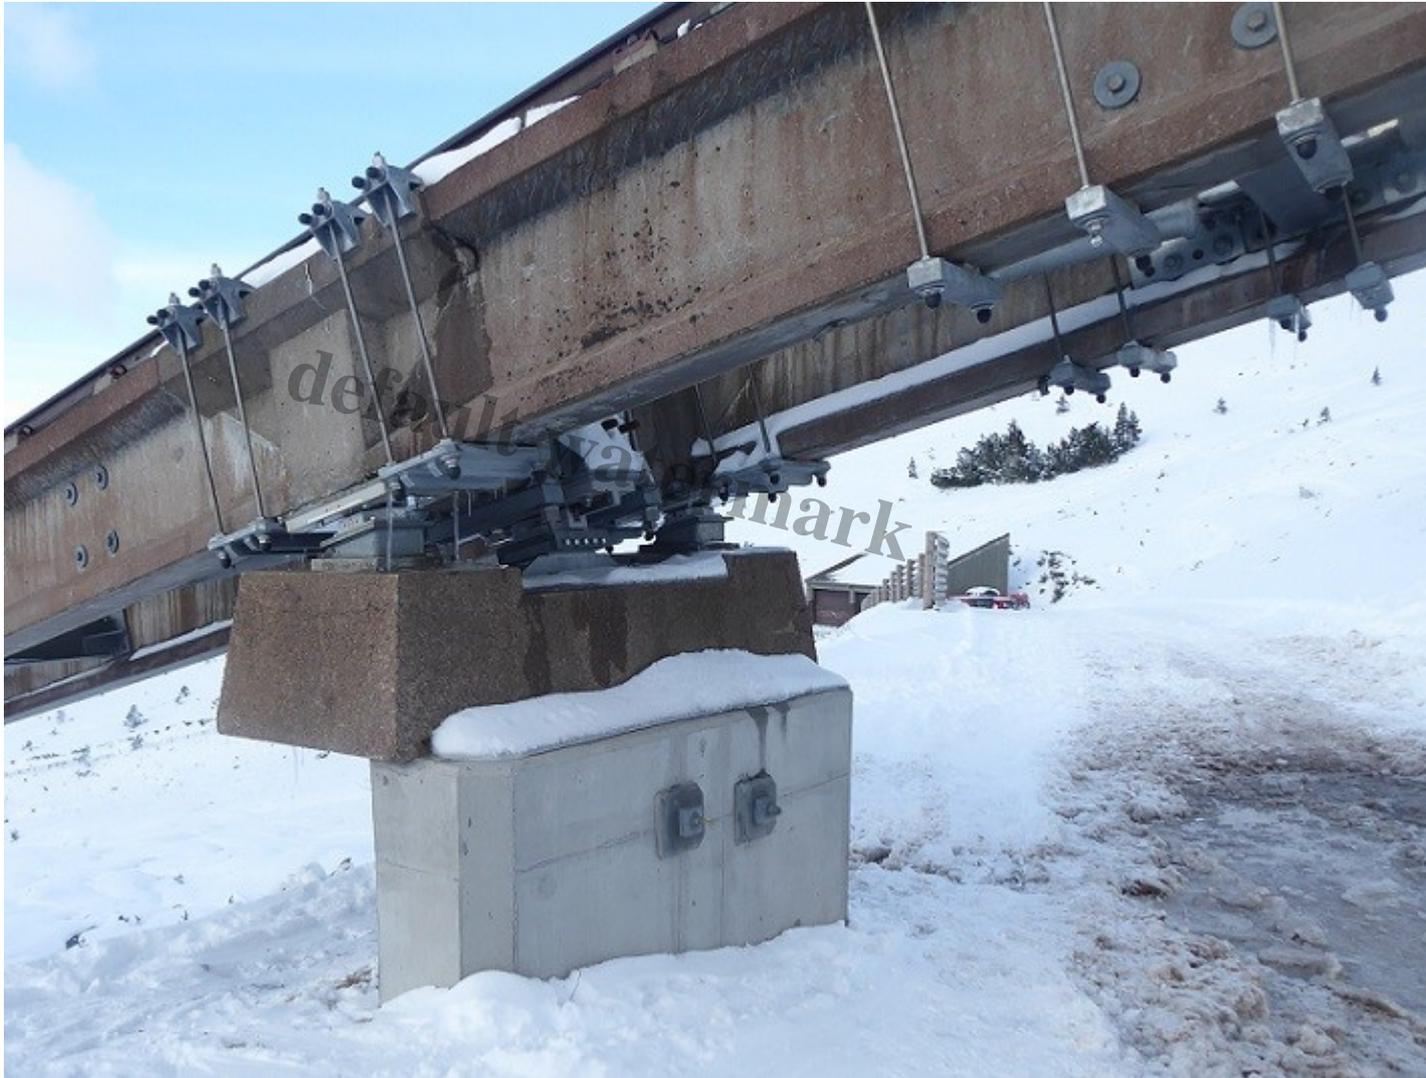
Pier below shieling with new concrete collar and metal braces on the beam

(a) That the concrete beams are not strong enough for the length of the span (I was made aware of this by a person with 36 years experience in this line of work). This would appear to be confirmed by the steel work around the beams (see top photo), although HIE has never explained the reason for this;

(b) Related to this, the COWI report of December 2018 stated "The precast beams are reinforced but not pre-stressed". I am grateful to an academic lecturer in railways for informing me that the minimum depth for a concrete beam which is not pre-stressed should be 8cm for every 1m length. That means the safe depth of the beam is therefore $8 \times 18 = 144\text{cm}$ not the actual 80cm! This figure may be for current standards and not those from 1999 but the conclusion is that after the funicular failed all the beams should either have been replaced or strengthened along their whole length in order to comply with today's standards.

One option to do this would be to use a Carbon Fibre Reinforced Polymer wrap, as explained by this company:

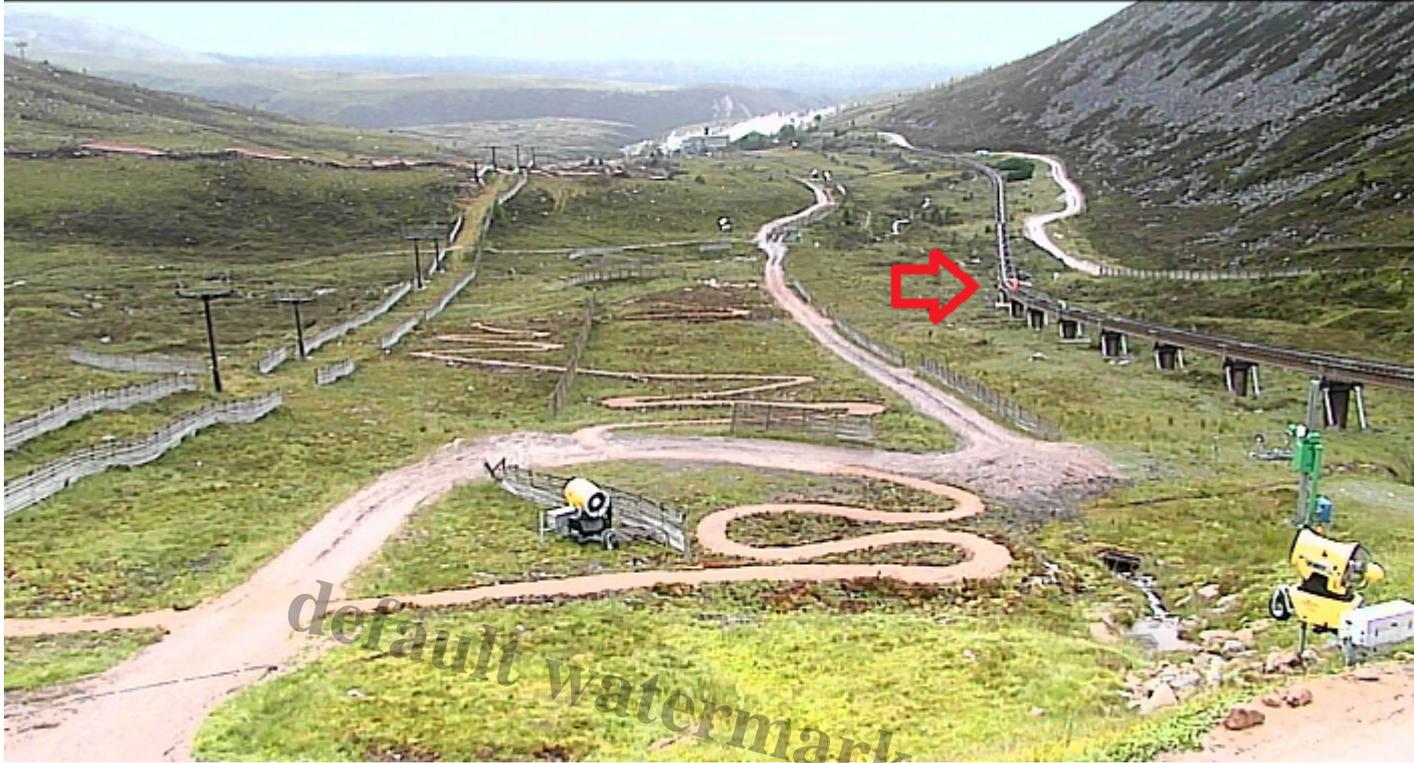
Two people working on the funicular structure on a Thursday evening

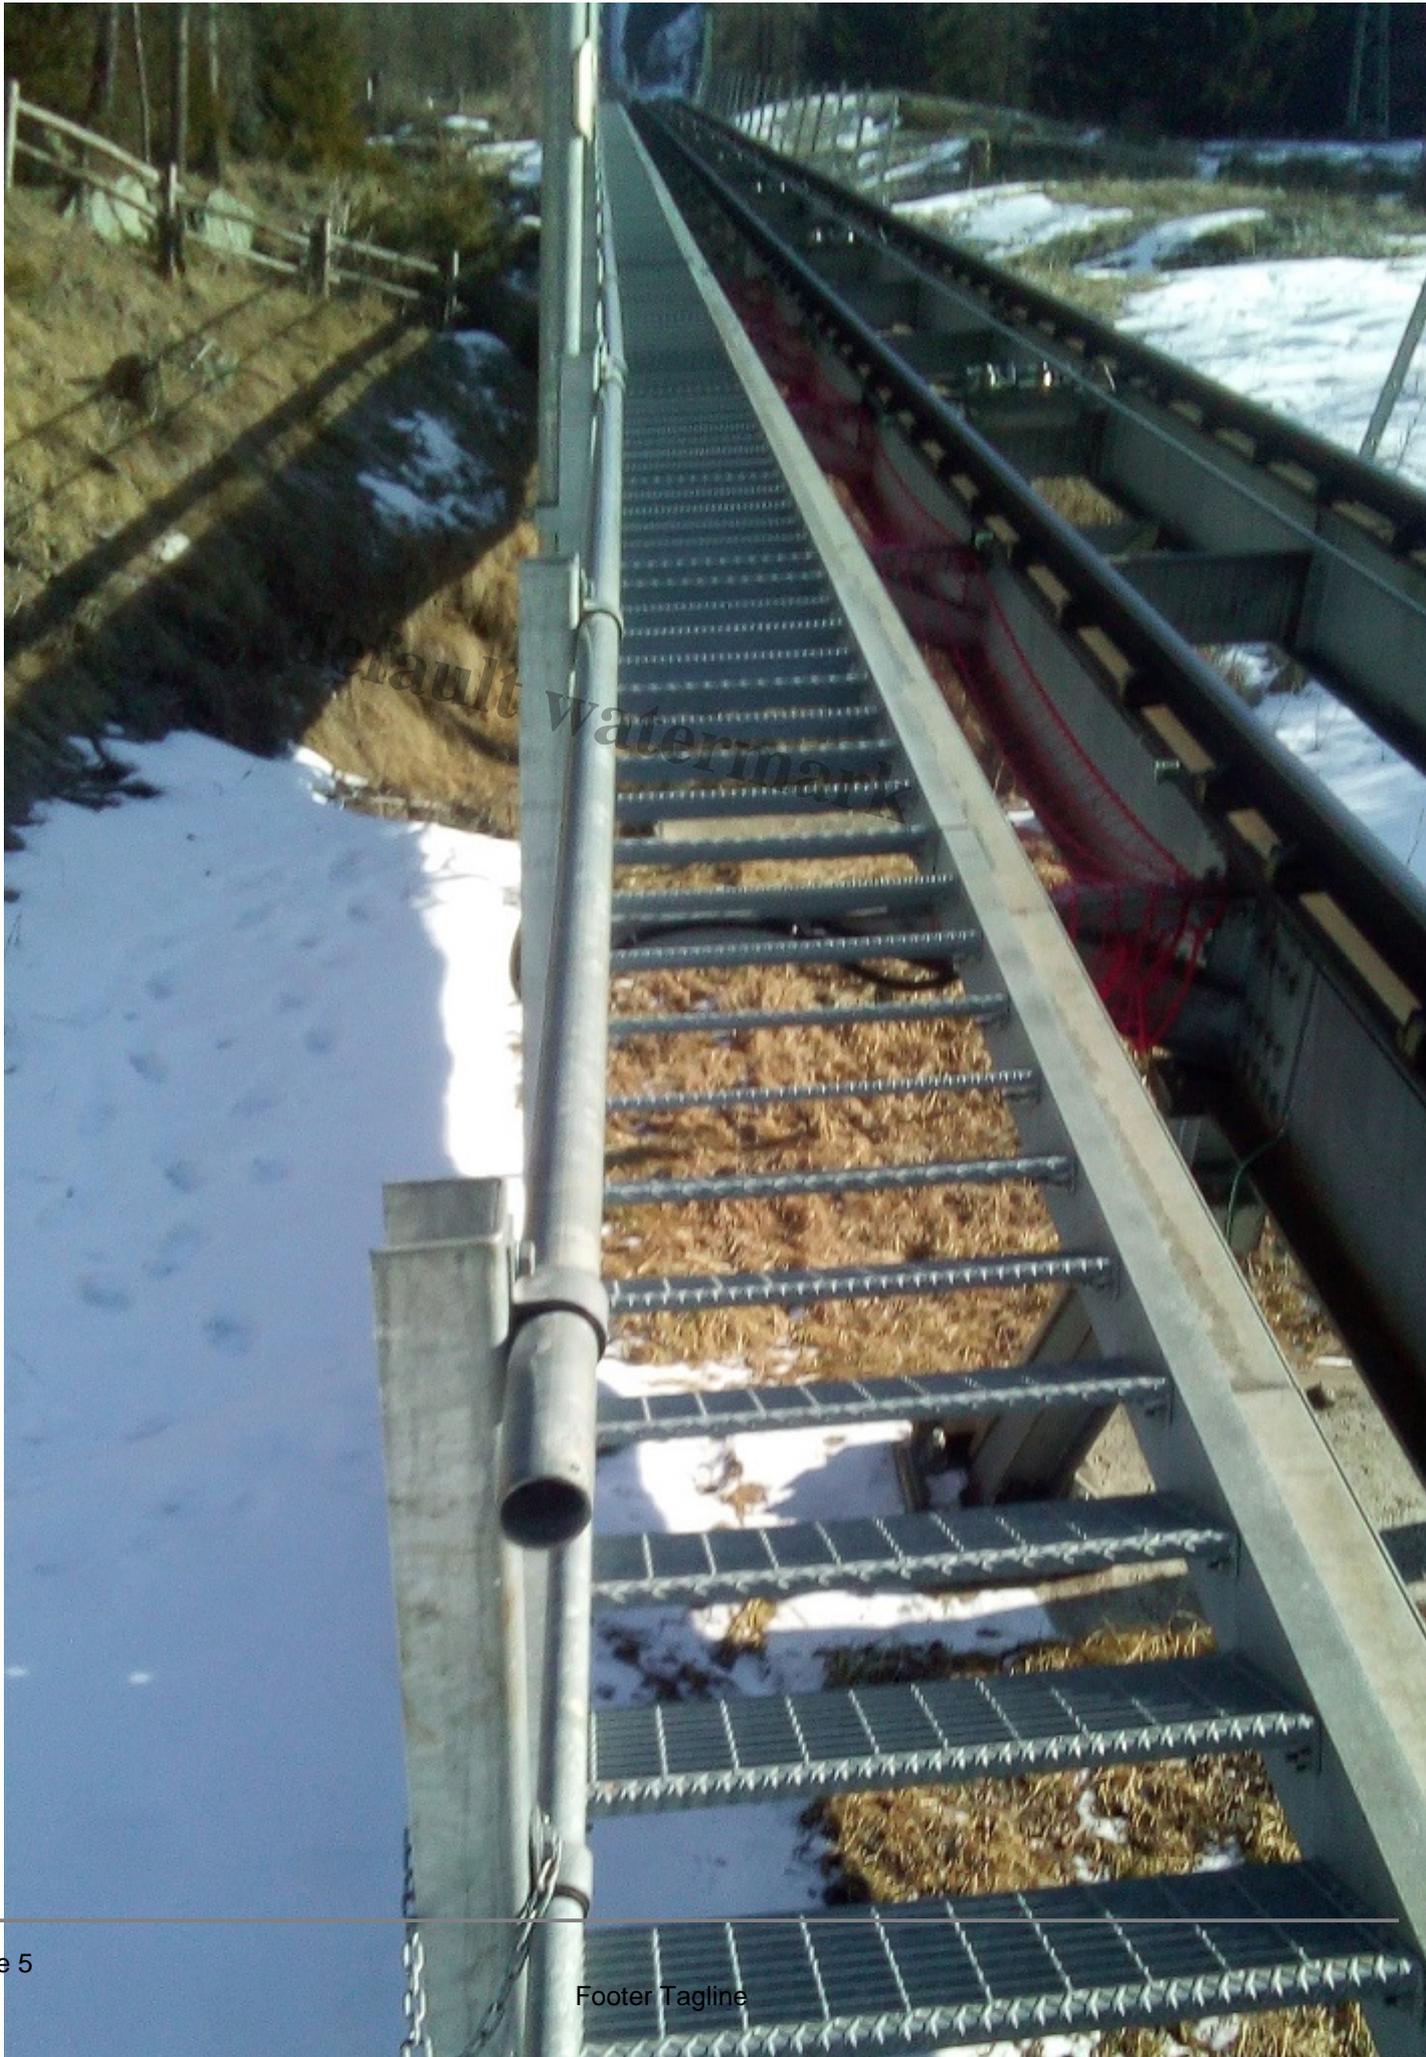
Walkway alongside the Frachey Funicular in Champoluc showing what an escape walkway should look like

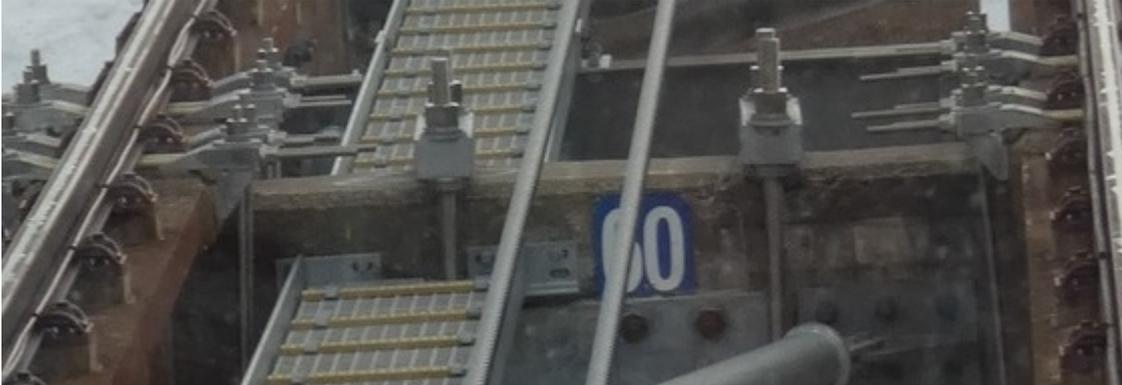
And at Cairn Gorm:

What has now been installed on the Cairn Gorm funicular, a walkway between the tracks, may be acceptable for maintenance but is completely unsuitable as an escape route in case of breakdown as there is no access to the walkway from the train. Therefore if stranded, customers and staff would be stuck!

The views of the HSE suggest the re-opening of the funicular should not have been approved as there appears to be no means in place for safe evacuation of passengers. Should the funicular now be closed until the HSE agree that a safe means of evacuation, for both staff and passengers, is in place?
