HIE's decision to close the Cairngorm funicular – again!

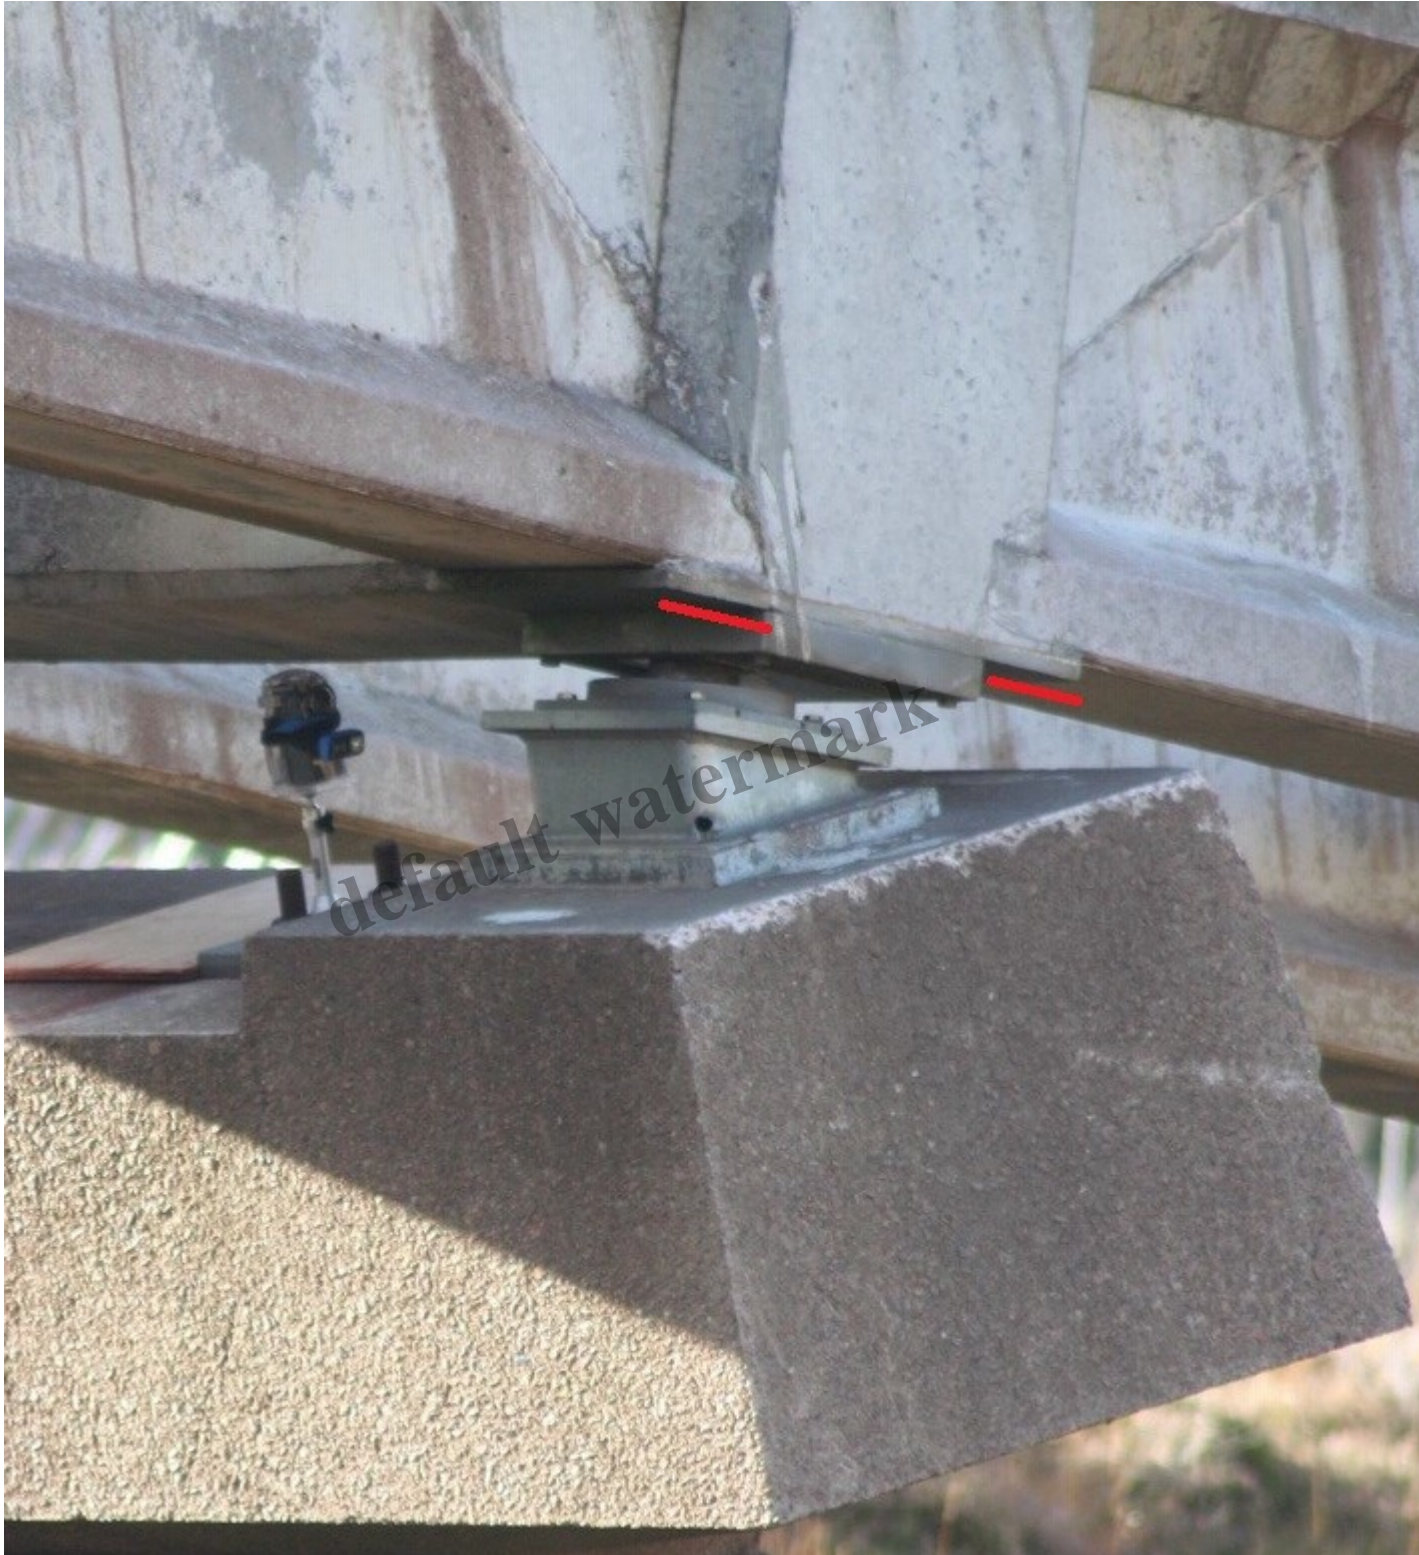
The concrete support beams are very heavy ([see here](#)) and were supported by a small metal plate at the base of the insitu block between them:

The red lines shows how little metal was supporting these enormous beams.

In a post I wrote two and a half years ago asking [Will the repair of the Cairngorm Funicular Railway work \(4\)?](#) I argued that, in order to support the ends of the “I” beams, the bearing plate should, at the very minimum, extend to the point vertically below the top of the scarf joint (i.e. where the beam reaches its full height) making each plate 1.55m long and probably at least 25mm deep. The problem

was not the strength of the metal in the plates, it was the forces that were exerted on the thin ends of the concrete beams. As a consequence, these started to crack. HIE appears to have decided to address the issue not by inserting larger metal plates but by strapping pairs of brackets to the end of each beam to hold them together

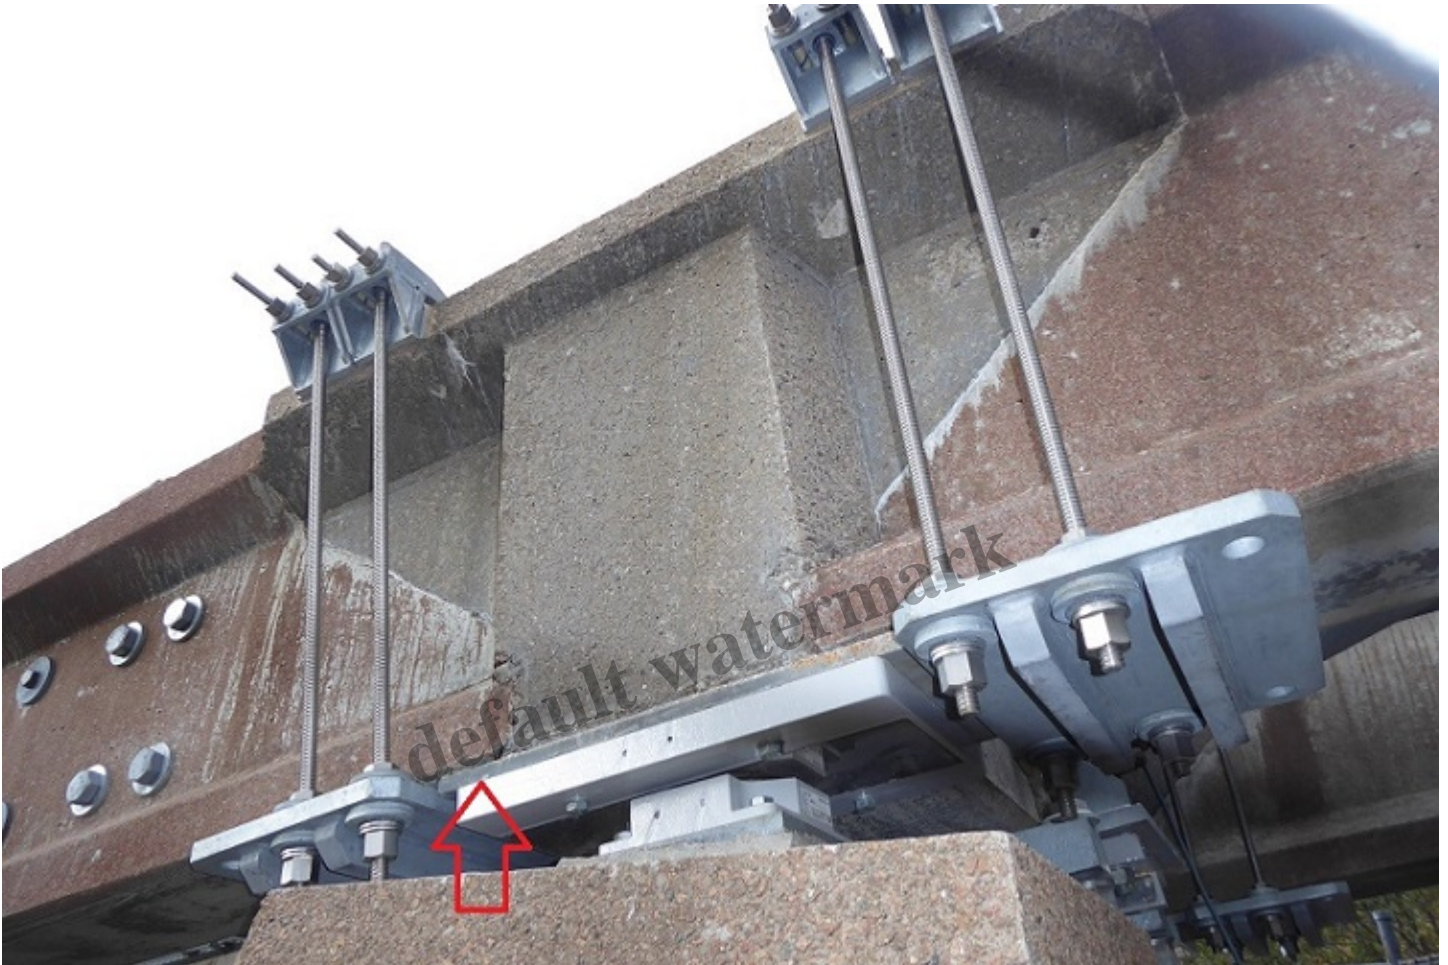
The red arrow shows how the original supporting plate has been retained although the bearing and support below it have been replaced.

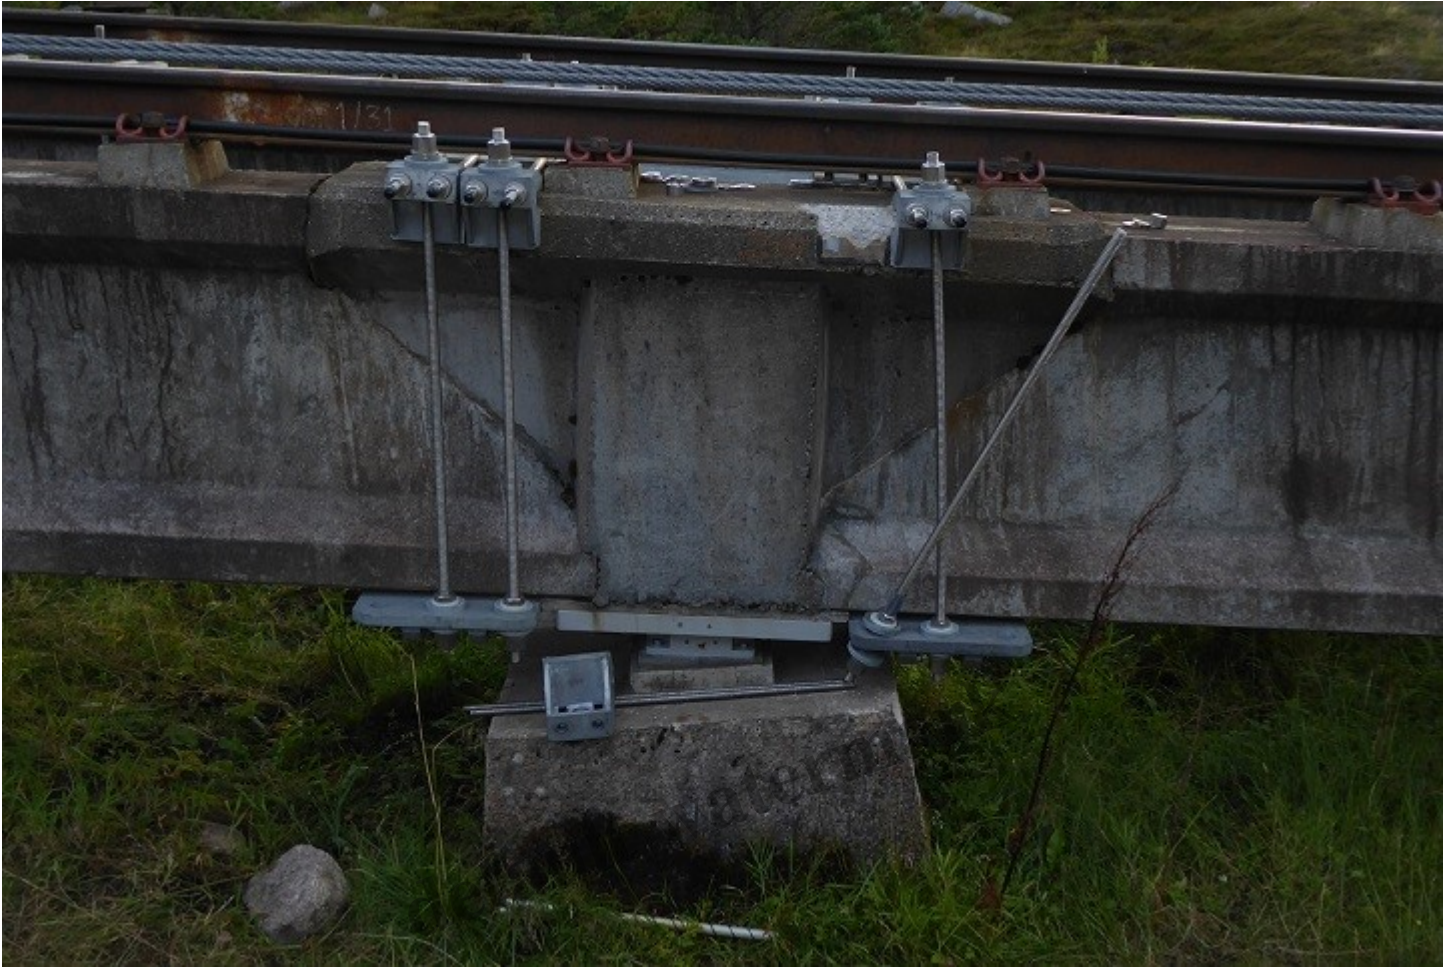
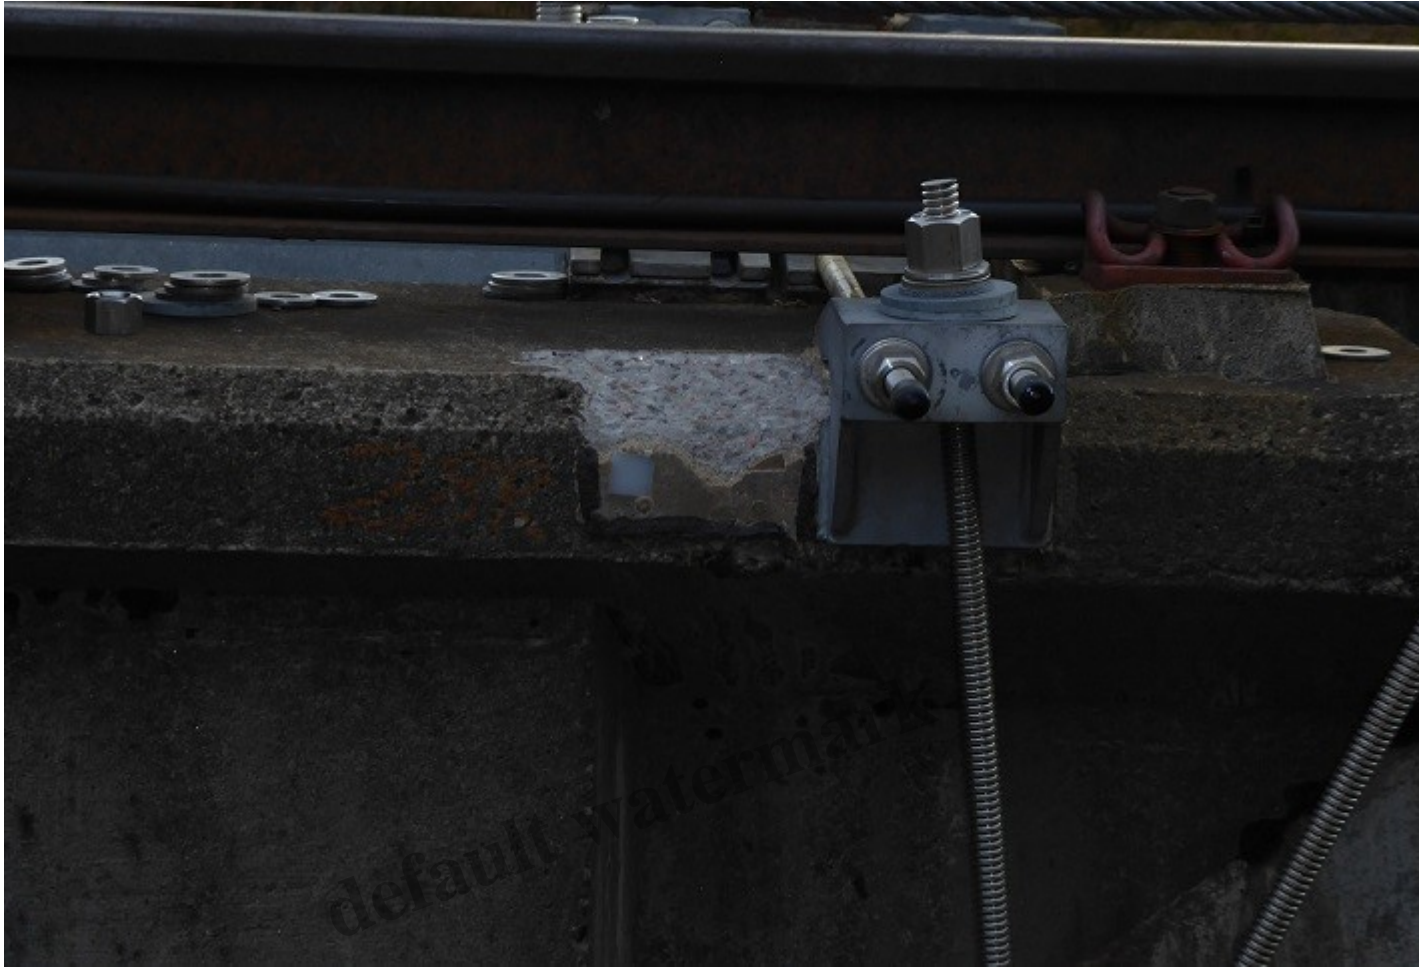
What HIE did not say was that in at least one case the tension of the new support brackets appears to have been responsible for breaking up the concrete!

Close up – note the layer of grout on the outside face of the broken concrete

And that despite the fact that there is a layer of grout to cushion the pressure between the concrete and the bracket.

While it is clear the tension of the brackets was wrong, the reasons for this have not been explained by HIE. Generally stainless steel expands and contracts very little but if the brackets were put round the concrete in some of the very hot weather earlier this year, that might explain why the concrete shattered in the photo above. Other possible explanations is that brackets are not fit to do the job they were supposed to do or that the original people working on them were trained properly
