HIE's decision to close the Cairngorm funicular – again!

In August HIE closed the funicular because it was unsafe

The cause of the problem and HIE's solution

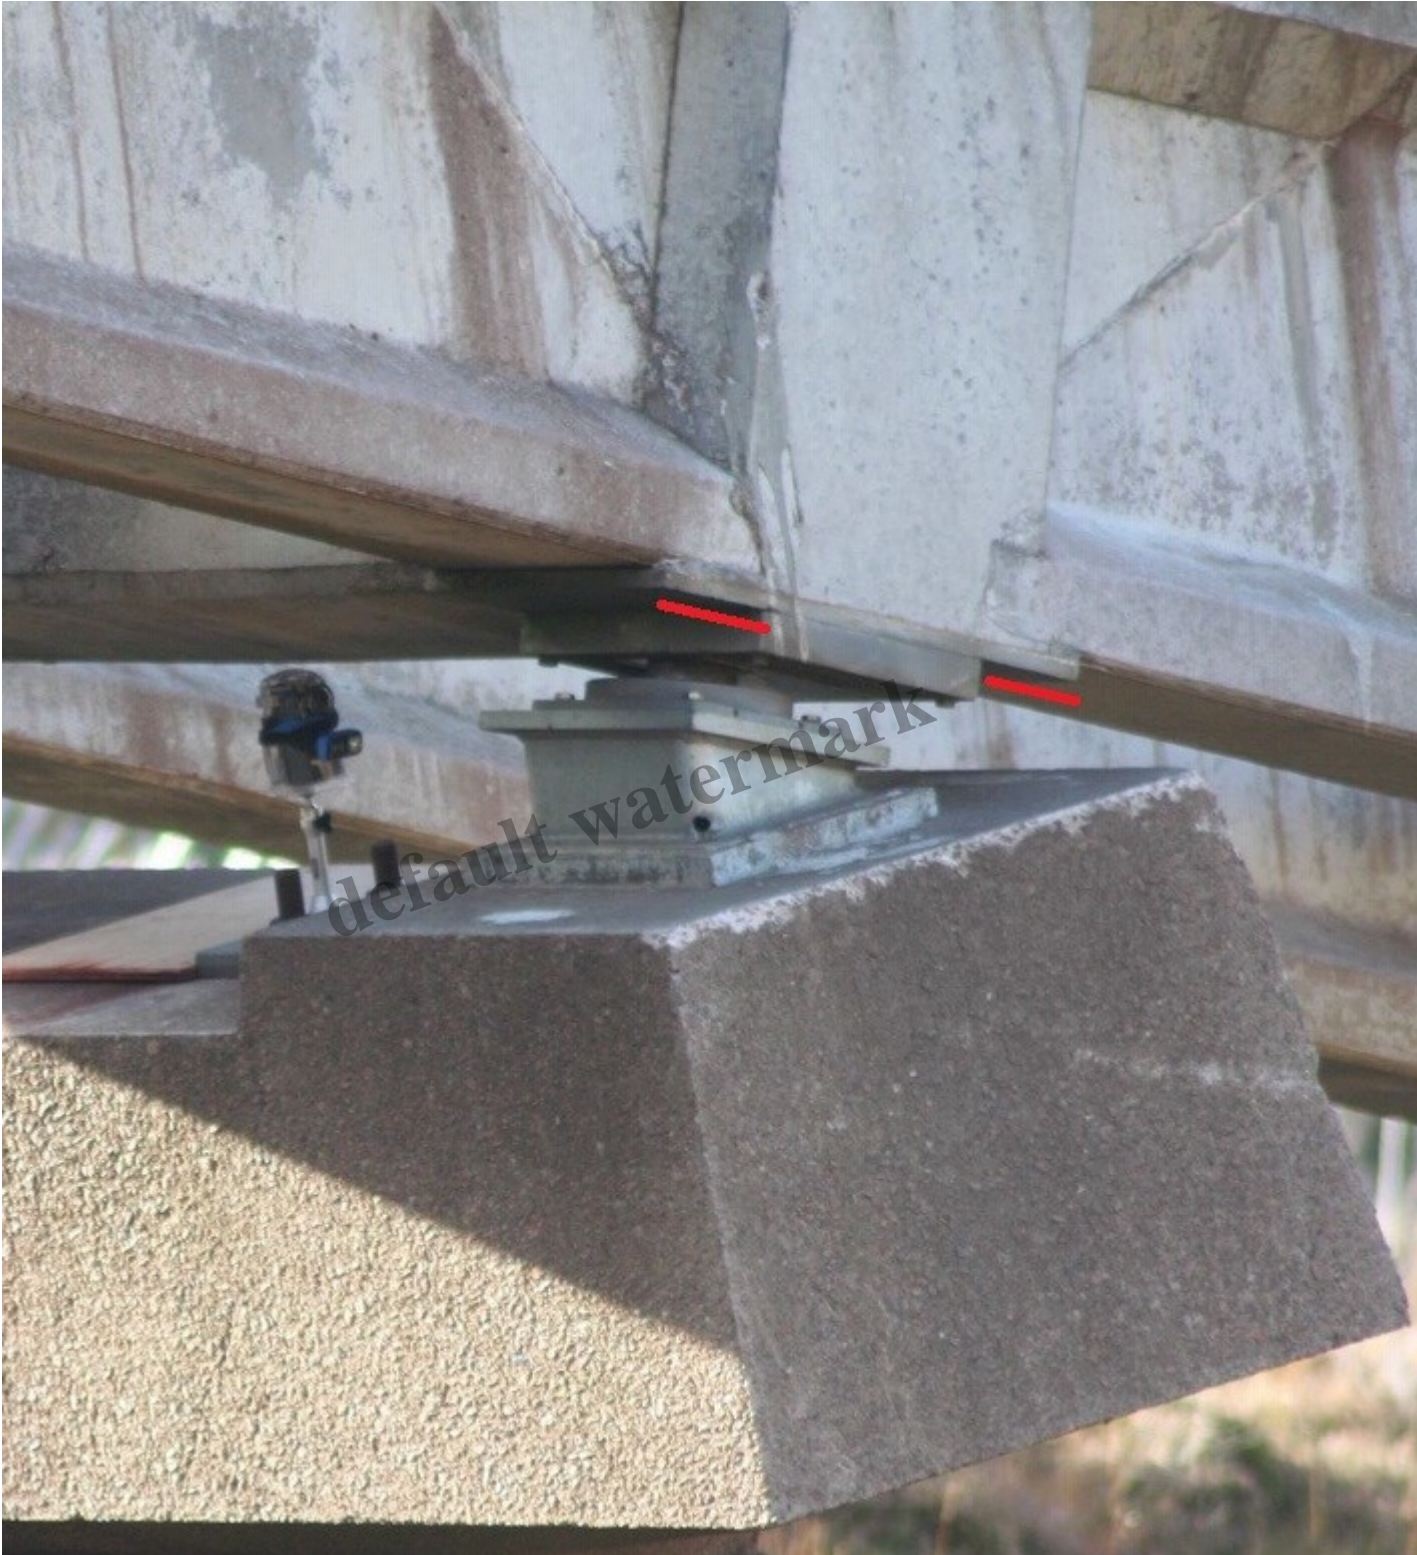
The concrete support beams are very heavy ([see here](#)) and were supported by a small metal plate at the base of the insitu block between them:

The red lines shows how little metal was supporting these enormous beams.

In a post I wrote two and a half years ago asking [Will the repair of the Cairngorm Funicular Railway work \(4\)?](#) I argued that, in order to support the ends of the “I” beams, the bearing plate should, at the very minimum, extend to the point vertically below the top of the scarf joint (i.e. where the beam reaches its full height) making each plate 1.55m long and probably at least 25mm deep. The problem

was not the strength of the metal in the plates, it was the forces that were exerted on the thin ends of the concrete beams. As a consequence, these started to crack. HIE appears to have decided to address the issue not by inserting larger metal plates but by strapping pairs of brackets to the end of each beam to hold them together

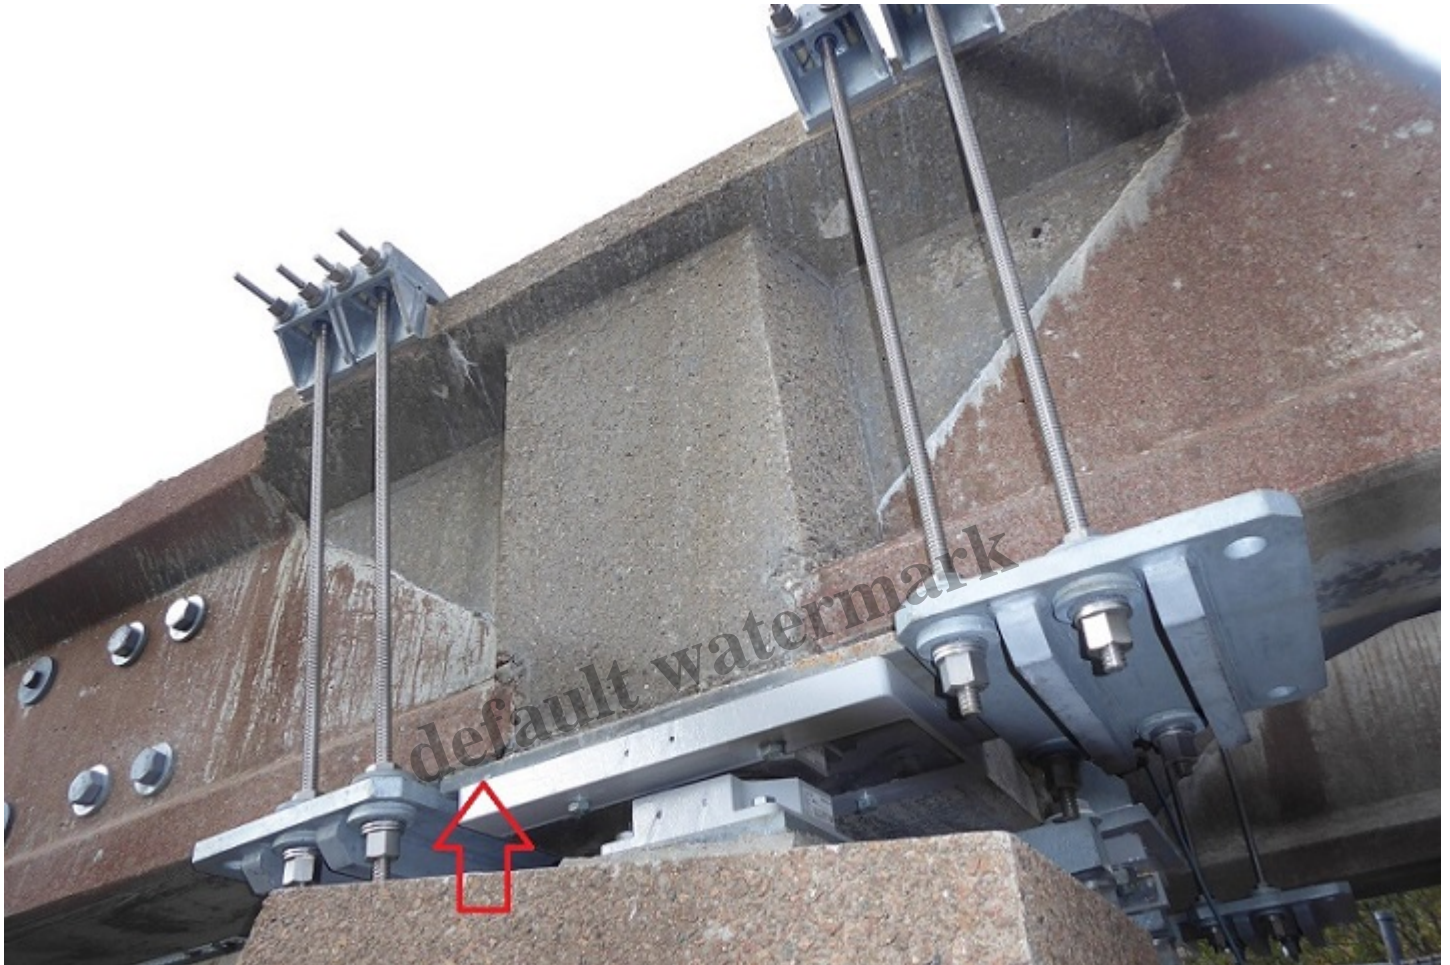
The red arrow shows how the original supporting plate has been retained although the bearing and support below it have been replaced.

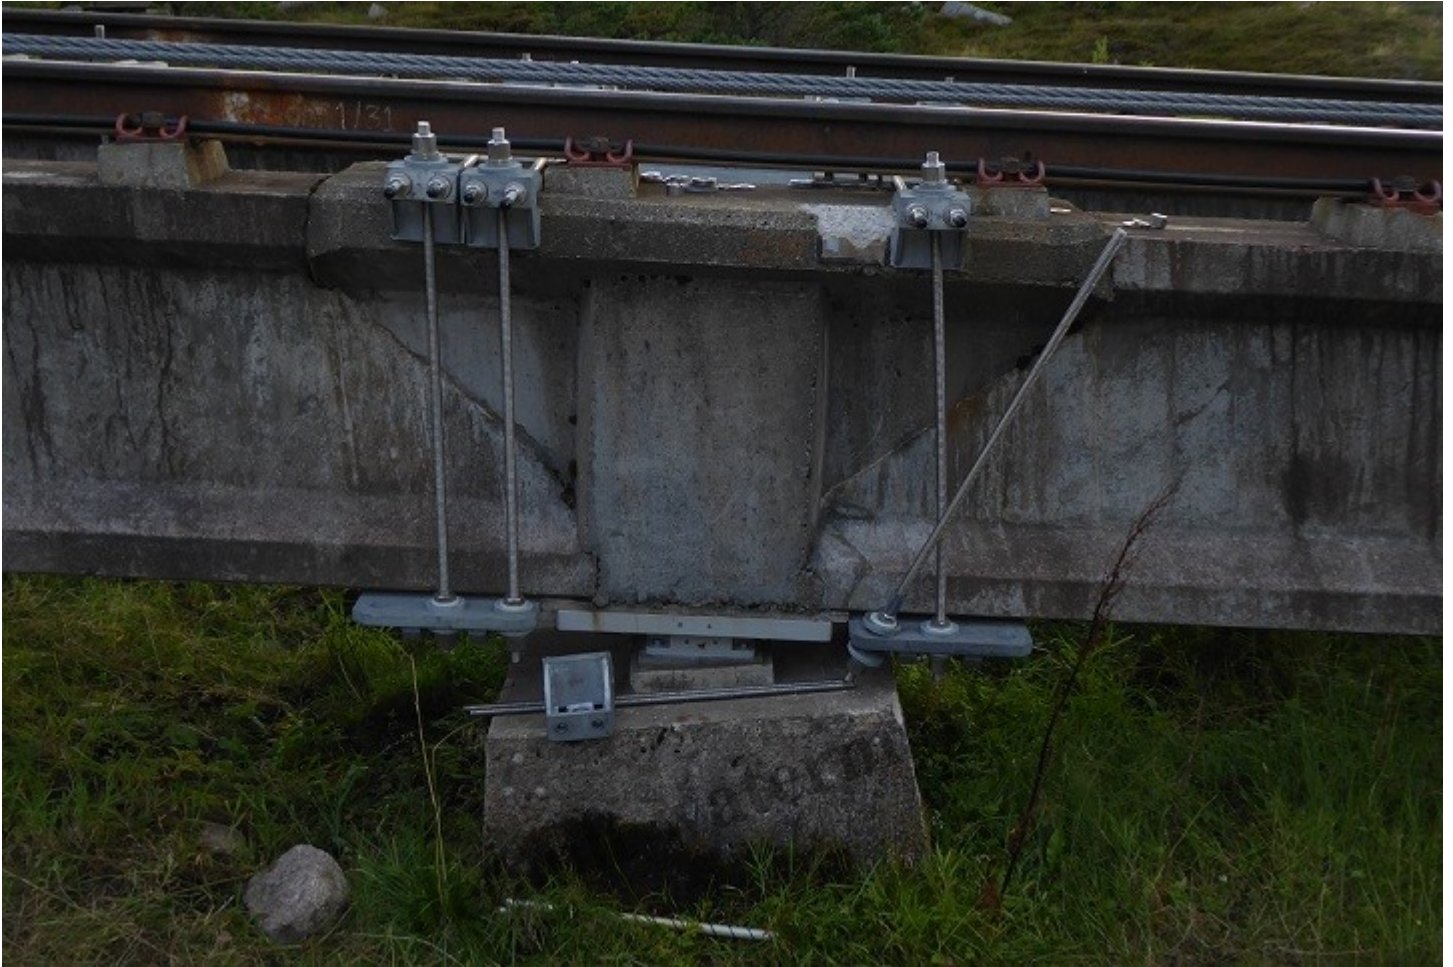
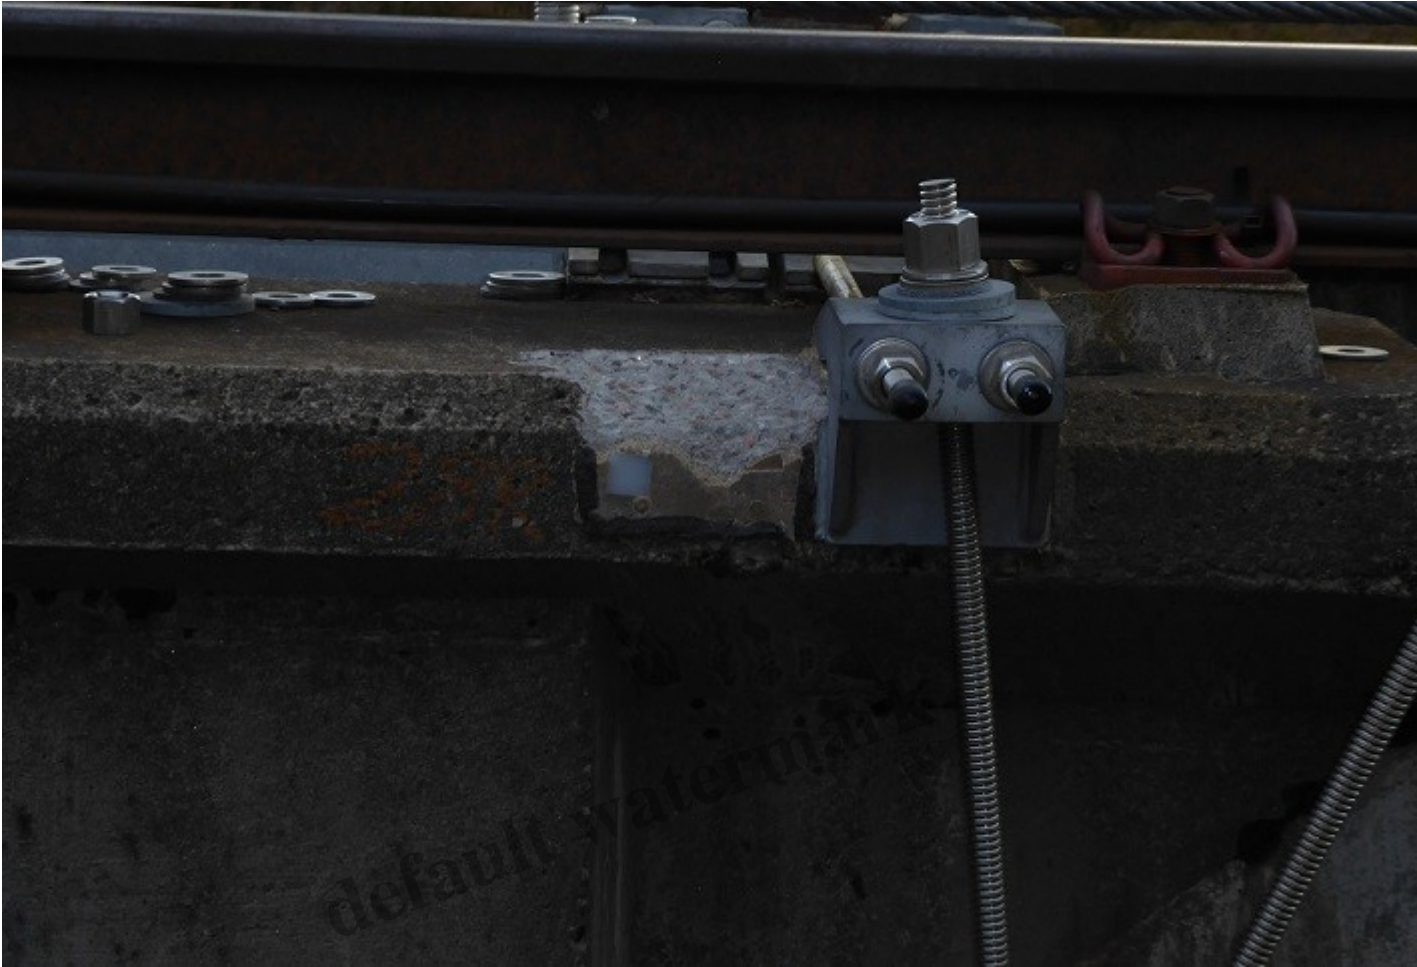
What HIE did not say was that in at least one case the tension of the new support brackets appears to have been responsible for breaking up the concrete!

Close up – note the layer of grout on the outside face of the broken concrete

And that despite the fact that there is a layer of grout to cushion the pressure between the concrete and the bracket.

While it is clear the tension of the brackets was wrong, the reasons for this have not been explained by HIE. Generally stainless steel expands and contracts very little but if the brackets were put round the concrete in some of the very hot weather earlier this year, that might explain why the concrete shattered in the photo above. Other possible explanations is that brackets are not fit to do the job they were supposed to do or that the original people working on them were trained properly

“an inspection showing that some of the ‘scarf joint assemblies’ that link the beams at the top of the piers did not meet the required tension” but that “work to increase the tension of these assemblies is progressing well.”

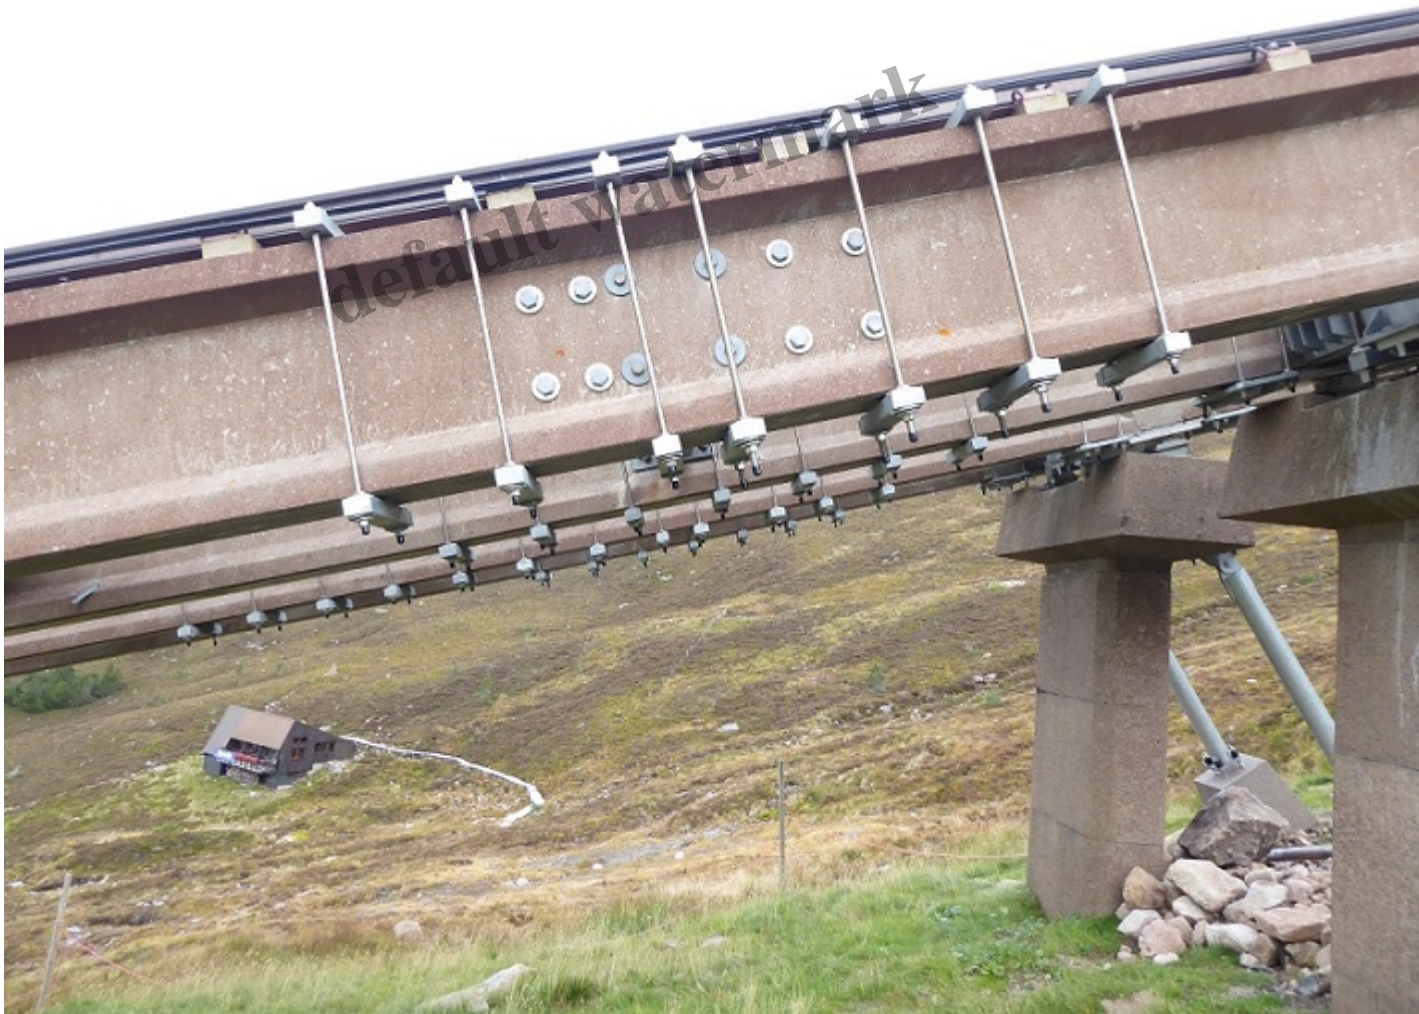
Photo showing how different additional brackets have been placed on each beam, in addition to the pairs around the scarf joints, and how the number of these brackets vary.

If the additional brackets that have been placed around some of the beams, as illustrated above, also

need to be checked that raises questions whether the funicular will be repaired in time for the forthcoming winter season? The most that HIE will now commit too is the funicular COULD be back in service at the end of the month ([see here](#)).
